TECHNICAL REPORT ARCSL-TR-78034

A METHOD OF SOFT BODY ARMOR EVALUATION: CARDIAC TESTING

November 1978

US ARMY ARMAMENT RESEARCH AND DEVELOPMENT COMMAND
Chemical Systems Laboratory
Aberdeen Proving Ground, Maryland 21010

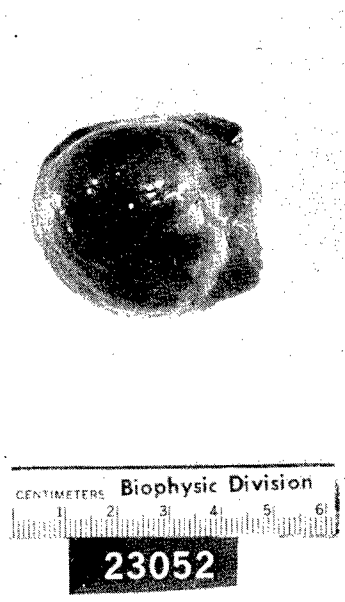
Figure 1. Partial Thickness Contusion (0.5 cm) in Cardiac Apex

One animal (52) had a 0.5-cm partial thickness contusion in the cardiac apex, associated with a small pulmonary contusion (left cardiac lobe). See figure 1.

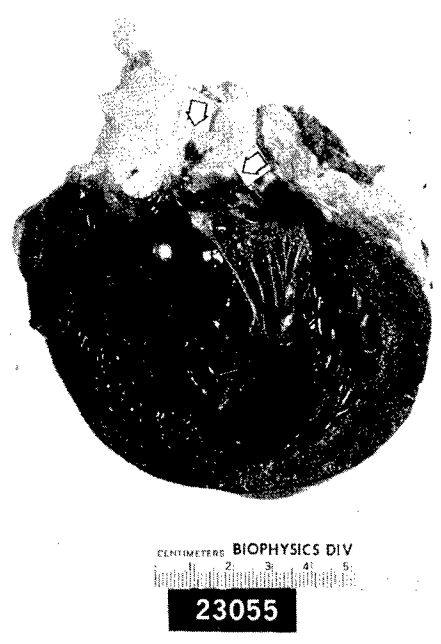
Figure 2. Aortic Lacerations

One animal (54) had no cardiac damage, but this animal experienced injuries to both the aorta and right lung. The aorta exhibited a full-thickness transverse laceration in the ascending portion approximately 3 cm in length. There was a parietal pleural tamponade which prevented massive hemorrhage. A partial-thickness 2-cm transverse laceration of the aorta with intimal disruption also occurred approximately 3 cm from the aortic valve. Examination revealed multiple contusions involving the entire right lung (figures 2 and 3). The velocity of the projectile was 830 ft/sec.

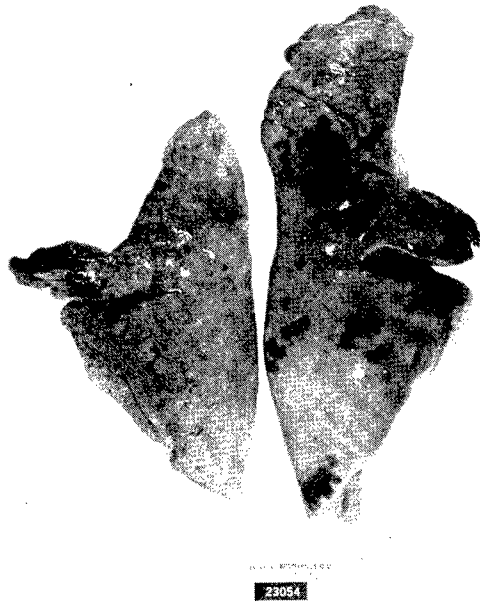
Figure 3. Multiple Pulmonary Contusions, Right Lung

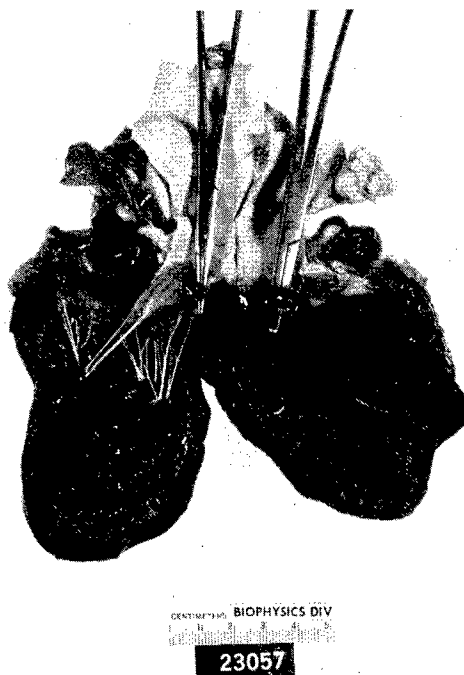
Figure 4. Disrupted Cusps of the Aortic Valve

One animal (57) had no evidence of epicardial or pulmonary damage. However, two cusps of the aortic valve were disrupted from the annulus of the aortic valve with surrounding subendocardial hemorrhage (figure 4). The projectile velocity was 834 ft/sec.

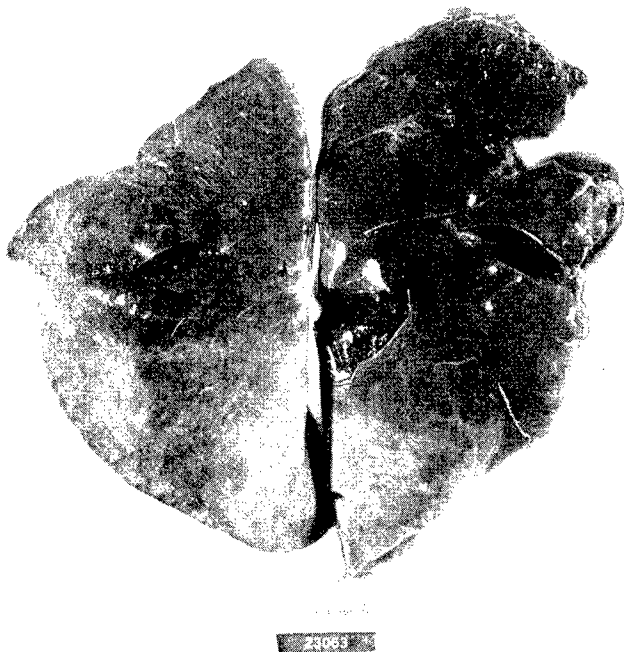
Figure 5. Linear Tear Across the Right Hilum.
Left Lung Contusion on Cardiac Lobe

One animal (63) was impacted with a .45-caliber projectile at 813 ft/sec. This animal died 10 hours post shot. At autopsy approximately 1.5 liters of blood was present in the right pleural cavity. There was a massive hemorrhage into the parenchyma of the right lung with a linear tear (5-cm) across the right hilum. A left lung contusion (approximately 150 cc) was present on the cardiac lobe. There was a superficial epicardial contusion across the posterior aspect of the right ventricle (figures 5 and 6).

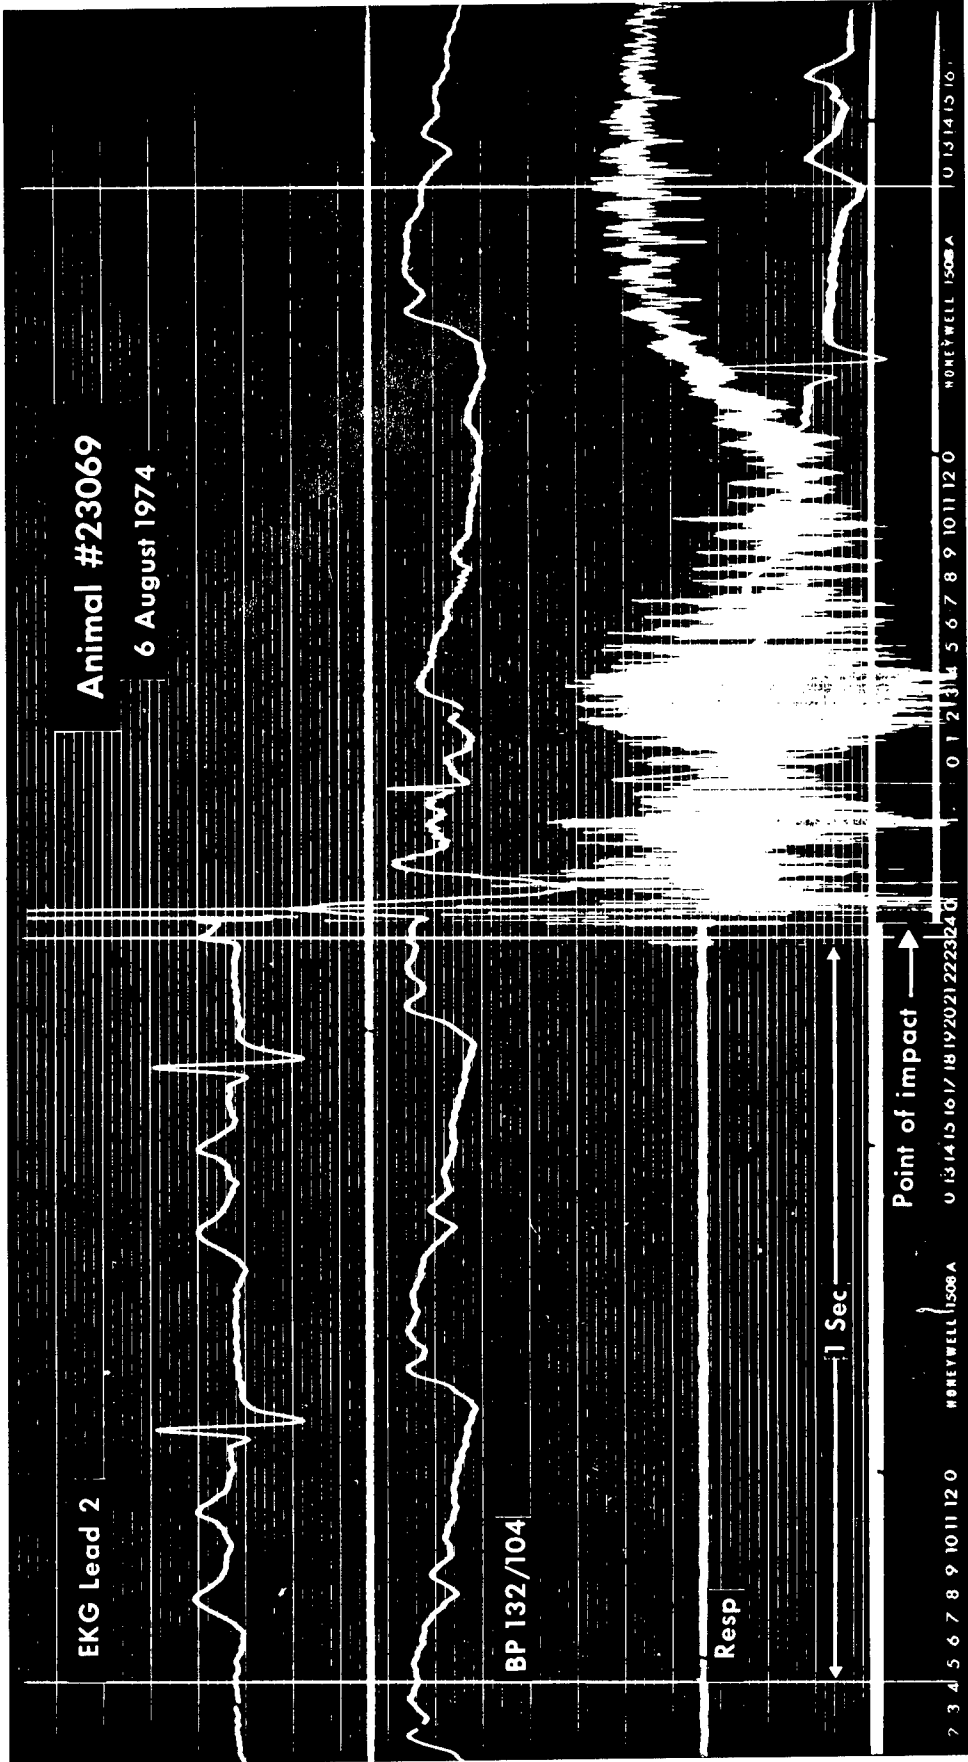
Figure 7. Typical Record for Synchronizing Projectile Firing with Electrical Events of Myocardial Contractility and Respiratory Cycle

This group consisted of nine animals. The protocol used was the same as the protocol for group II with one exception: the projectile was fired during maximum diastolic filling of the heart and maximum expiration. This was accomplished by firing the projectile at end expiration between completion of the QRS wave and end of the T wave on the electrocardiogram.

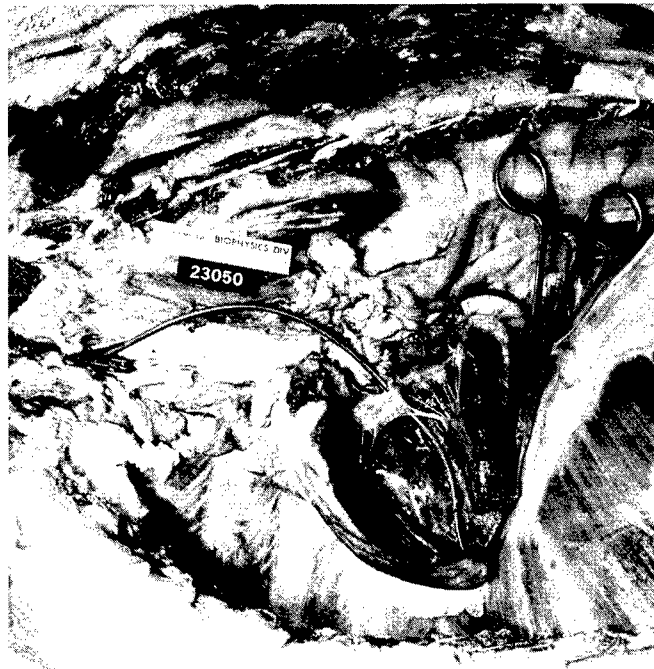
Figure 8. Left-Ventricular End-Diastolic Catheter in Place

In this group of seven animals, a PE No. 230 catheter was placed percutaneously via the left common carotid into the left ventricle to monitor end diastolic pressure. Correct positioning of the catheter was ascertained by recording typical ventricular pressure curves.

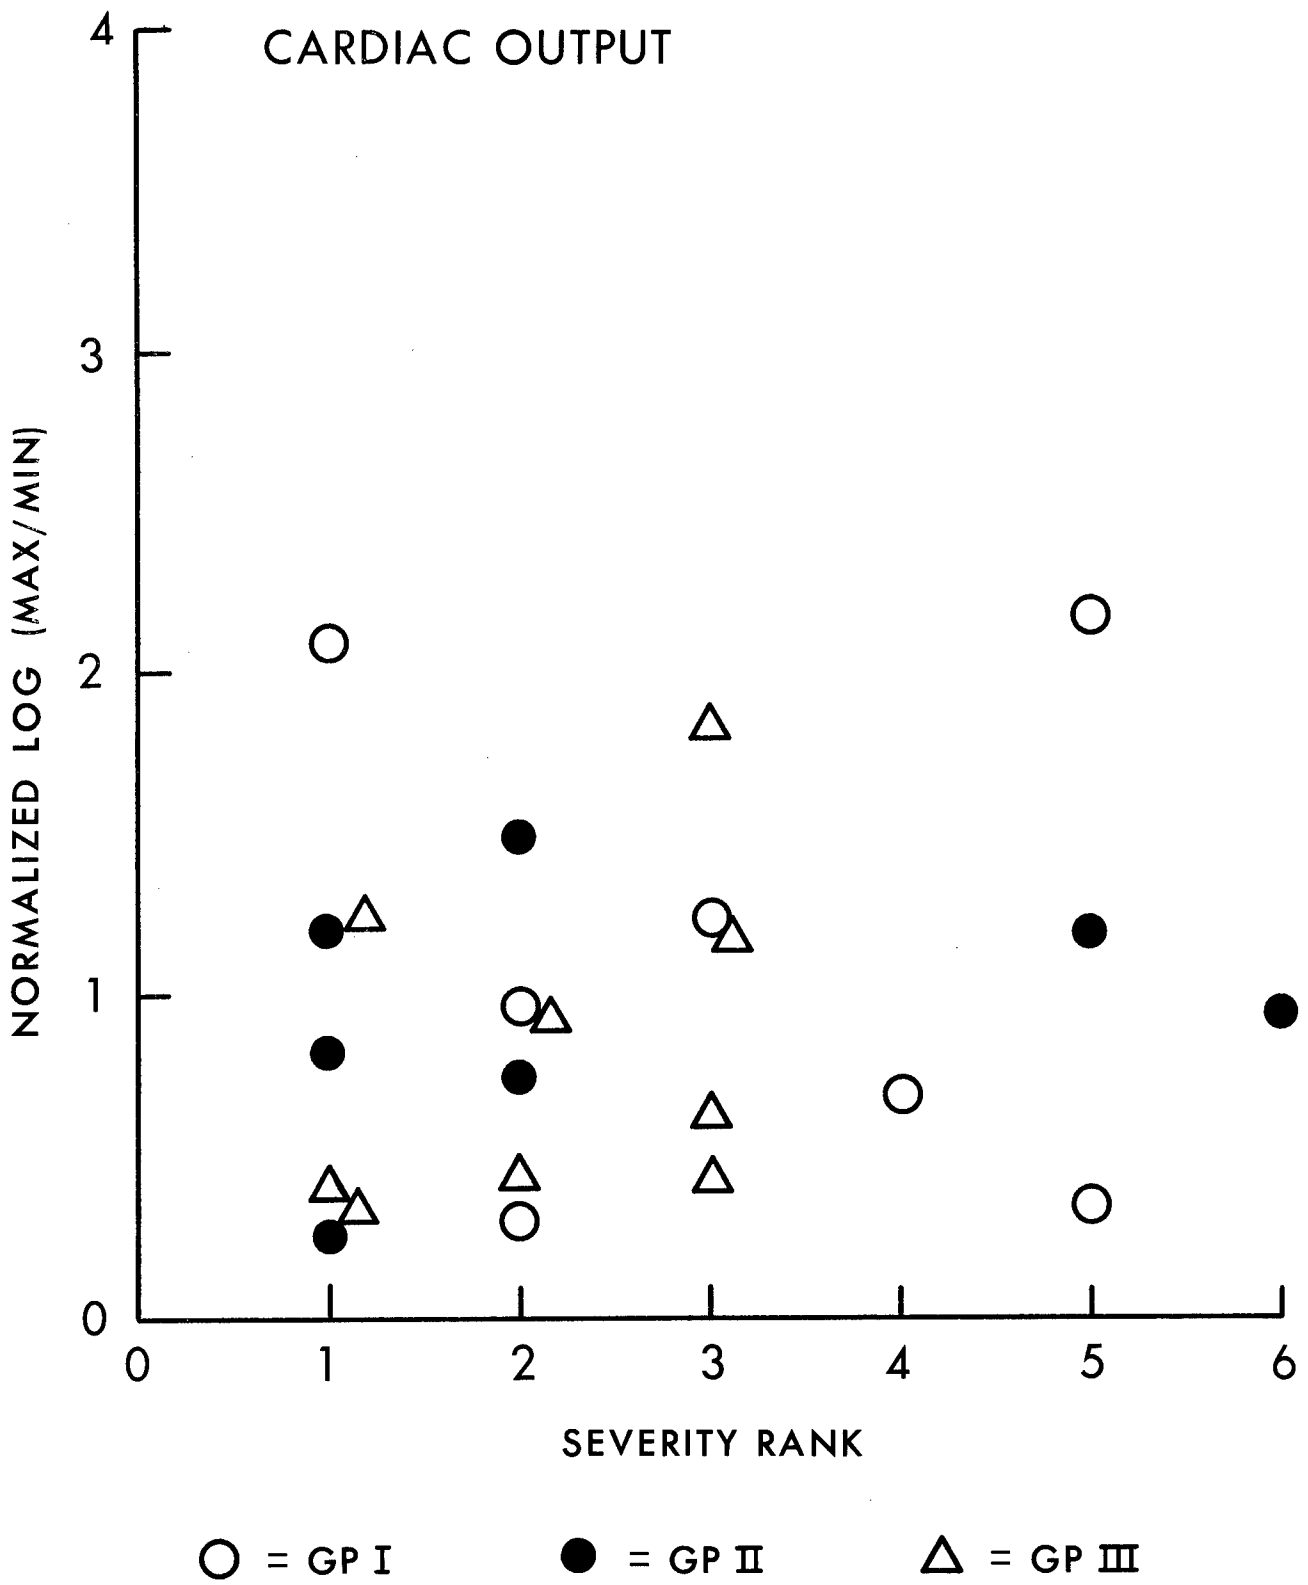
Figure A-1. Cardiac Output Versus Severity of Injury

For each of these 10 response variables, a point plot was made of derangement score versus Pathology Severity Rank (figures A-1 through A-10). On none of these point plots was there visible a consistent pattern of high scores in more severely injured animals and low scores in the less severely injured, or vice versa.

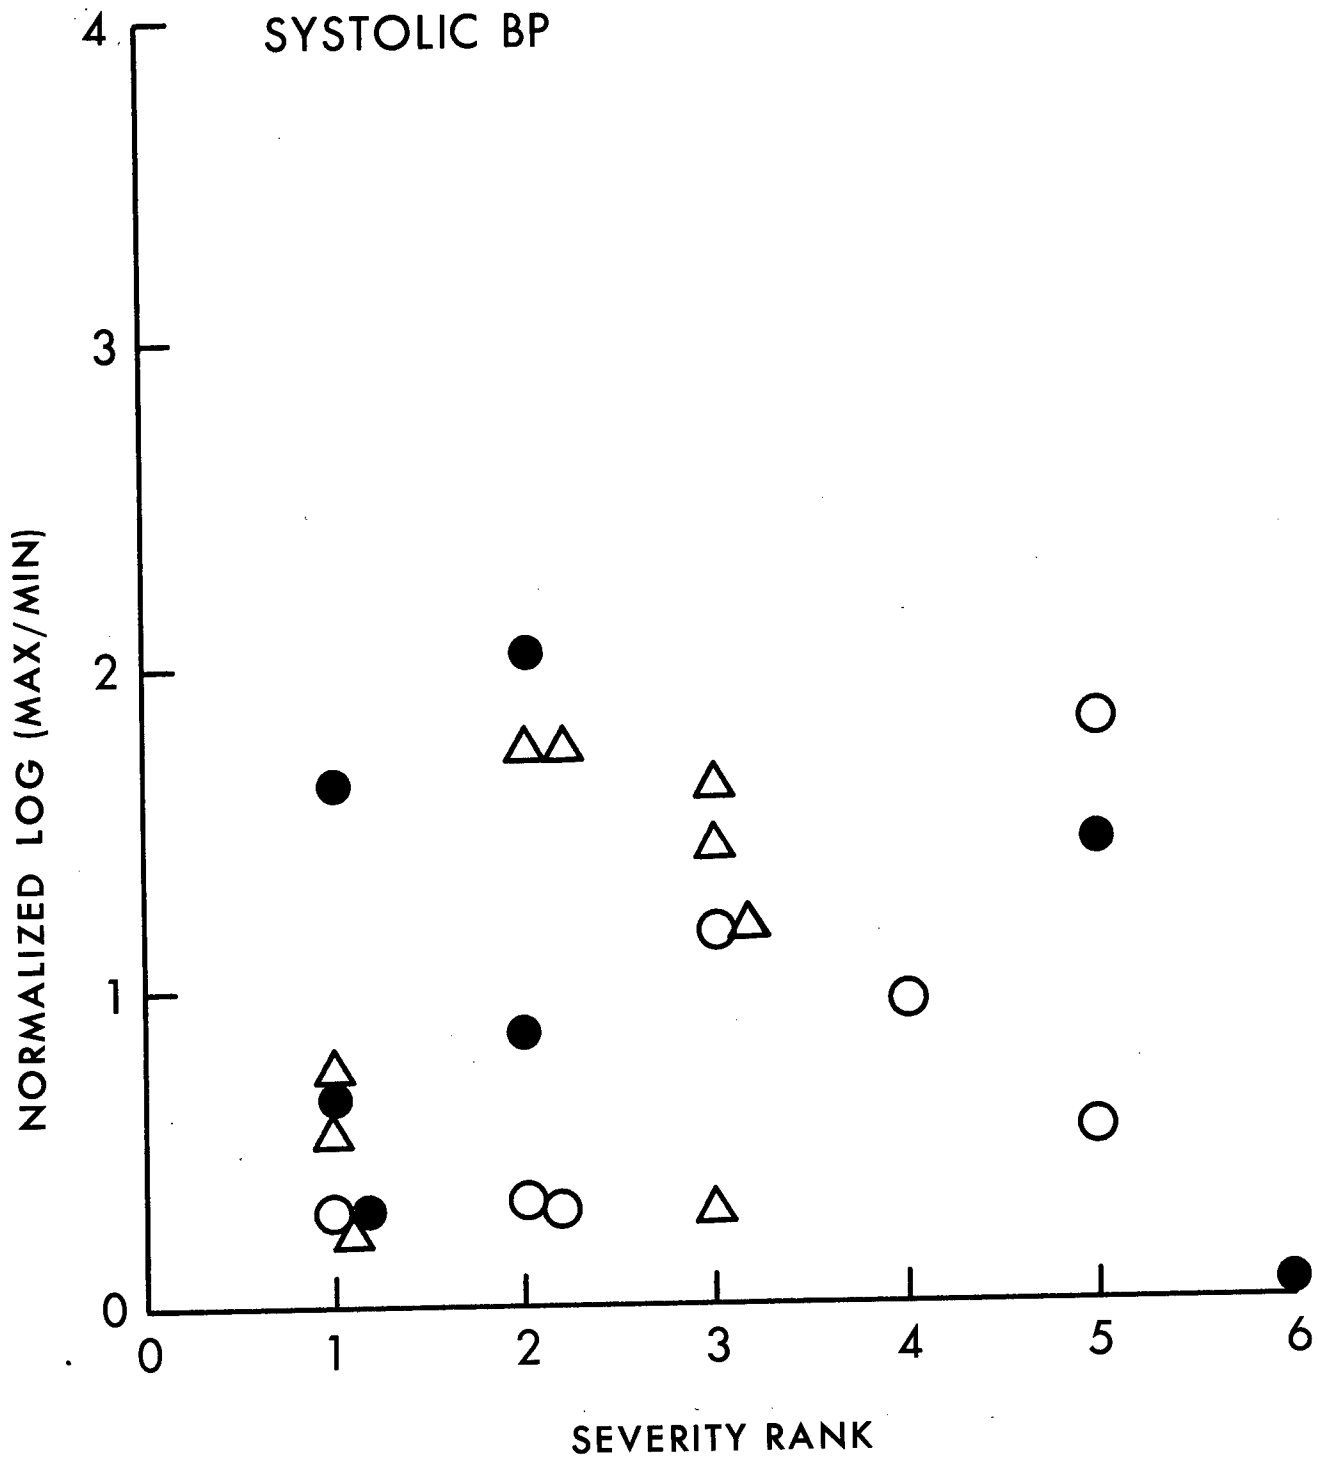
Figure A-2. Systolic BP Versus Severity of Injury

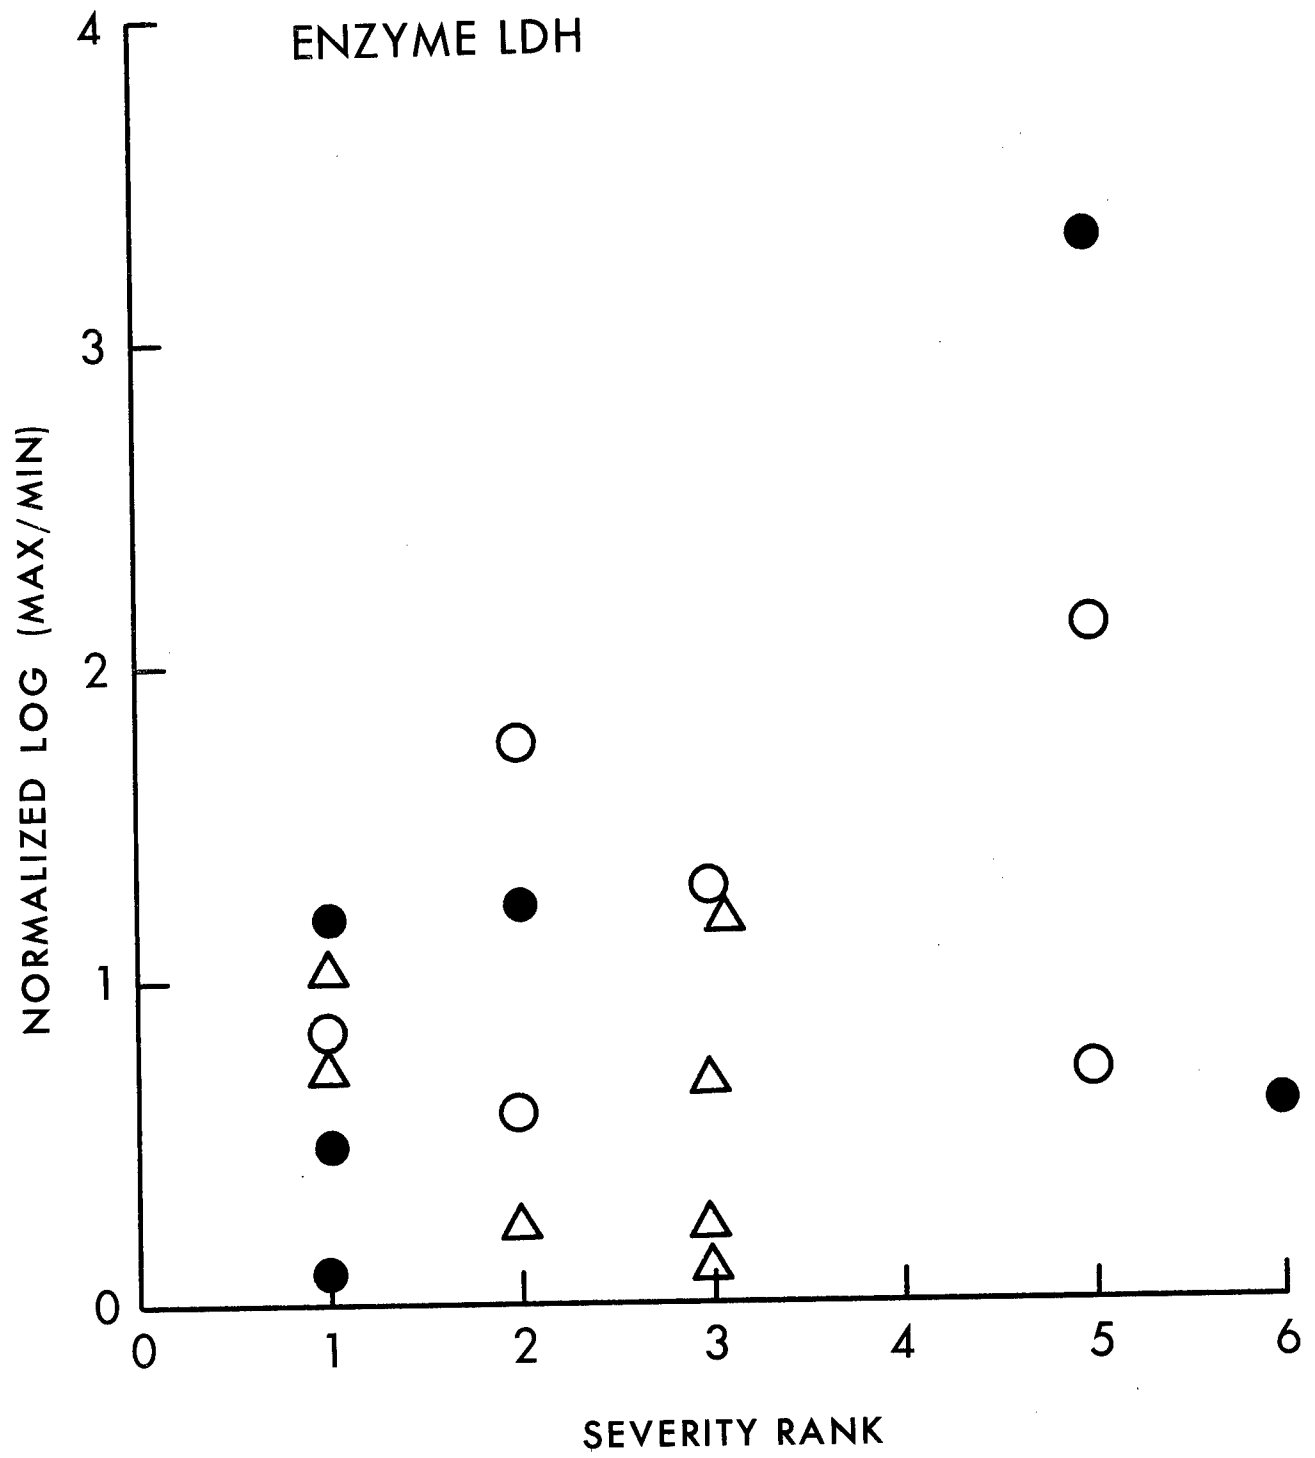
Figure A-3. Enzyme LDH Response to Severity of Injury

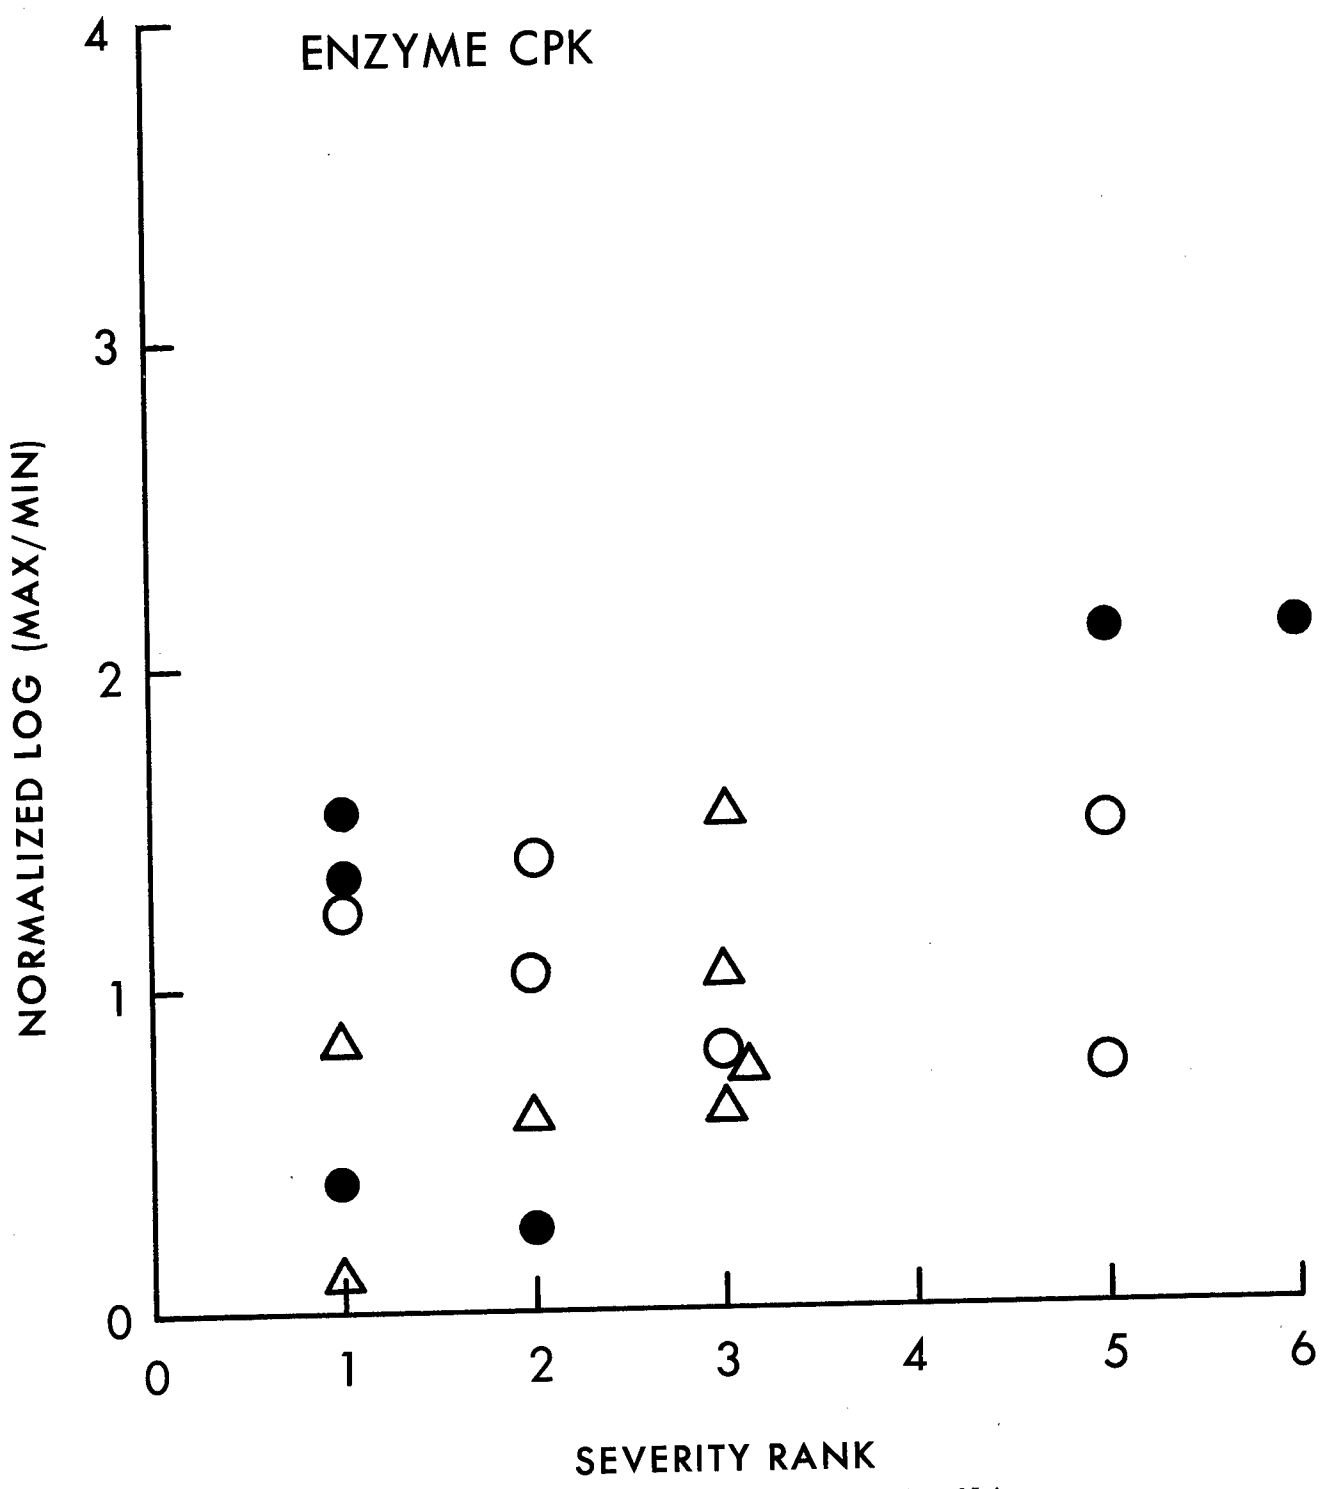
Figure A-4. Enzyme CPK Response to Severity of Injury

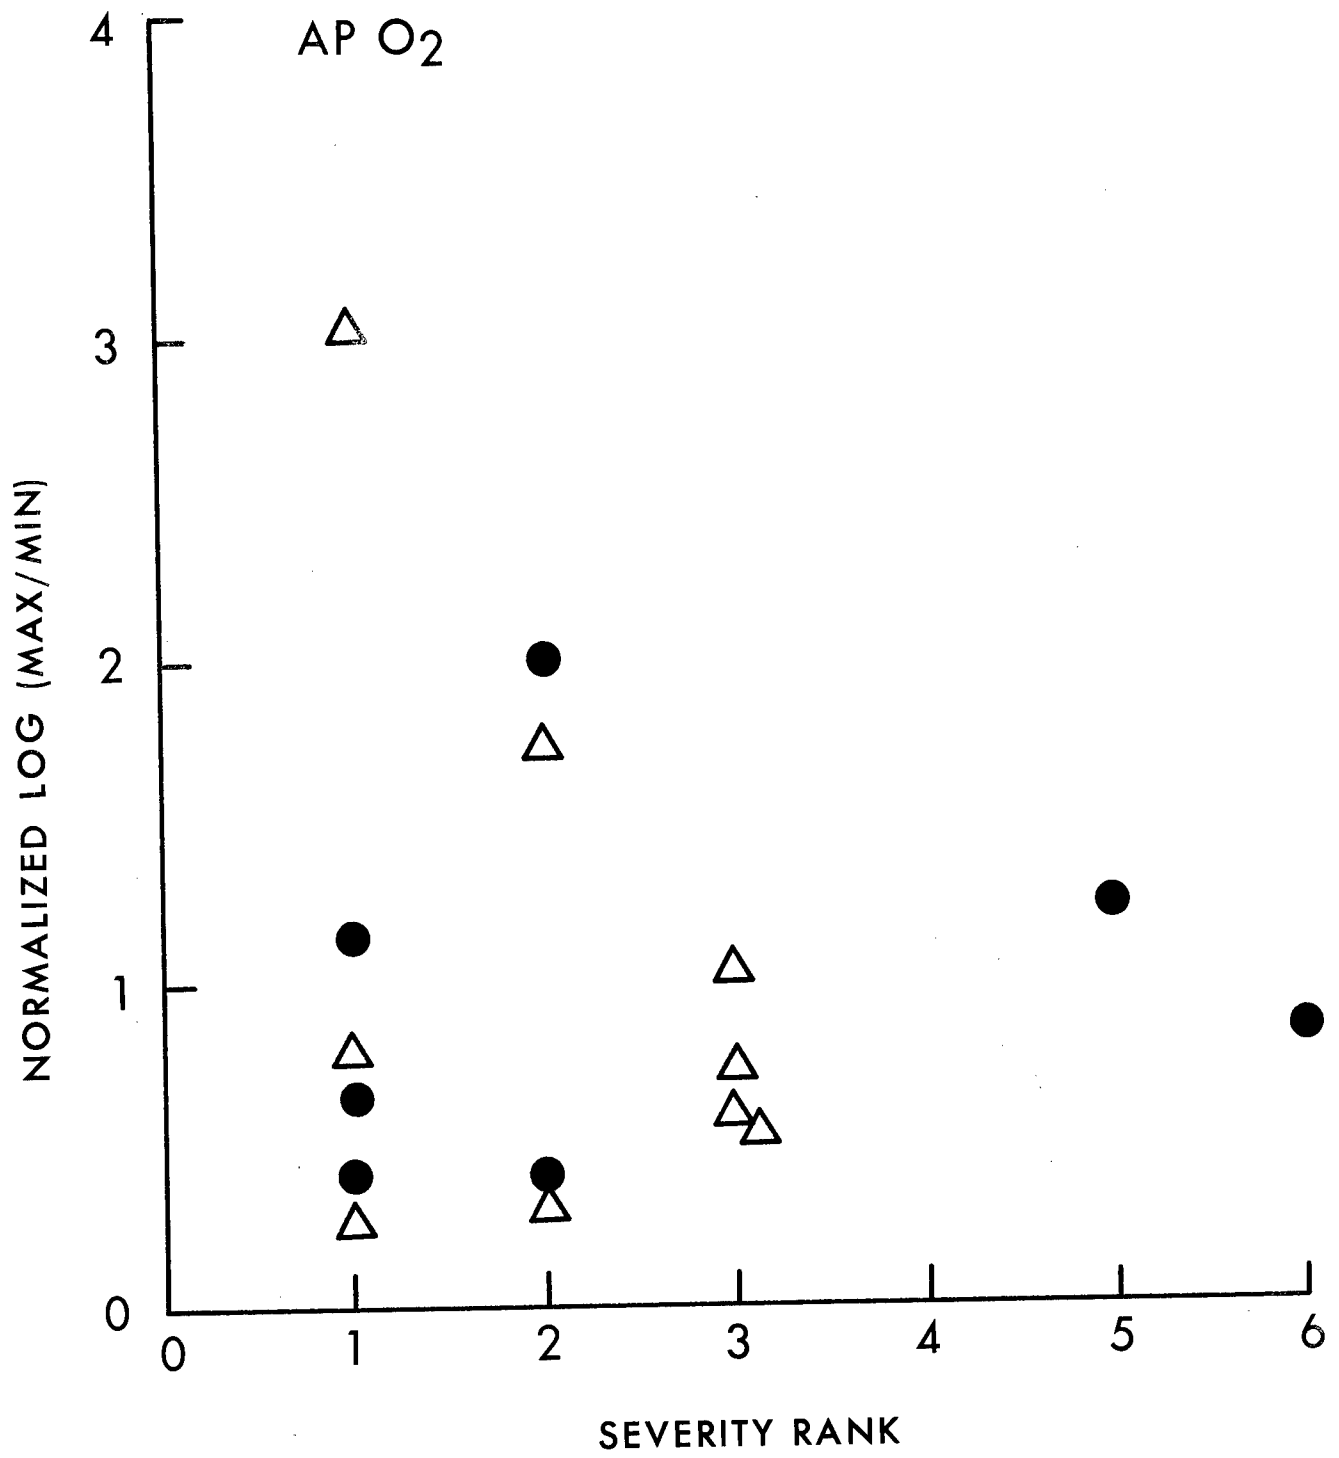
Figure A-5. Arterial Pressure of Oxygen Versus Severity of Injury

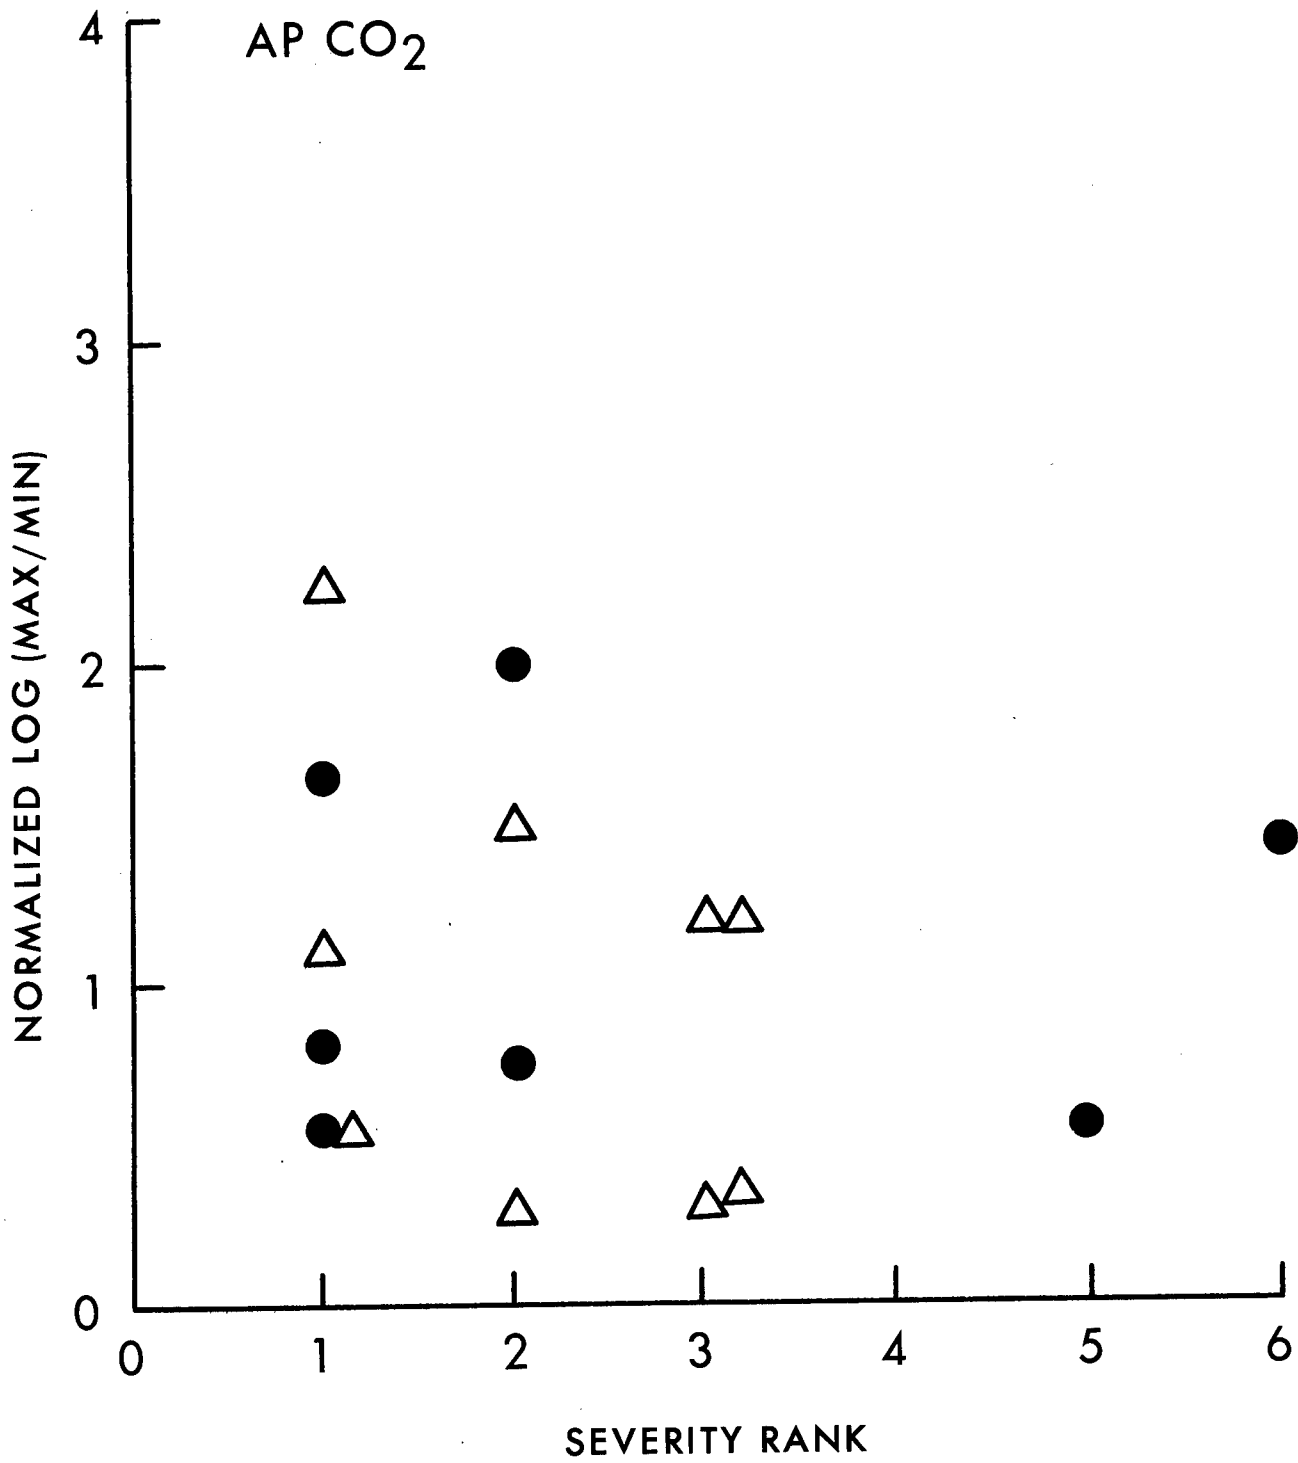
Figure A-6. Arterial Pressure of CO₂ Versus Severity of Injury

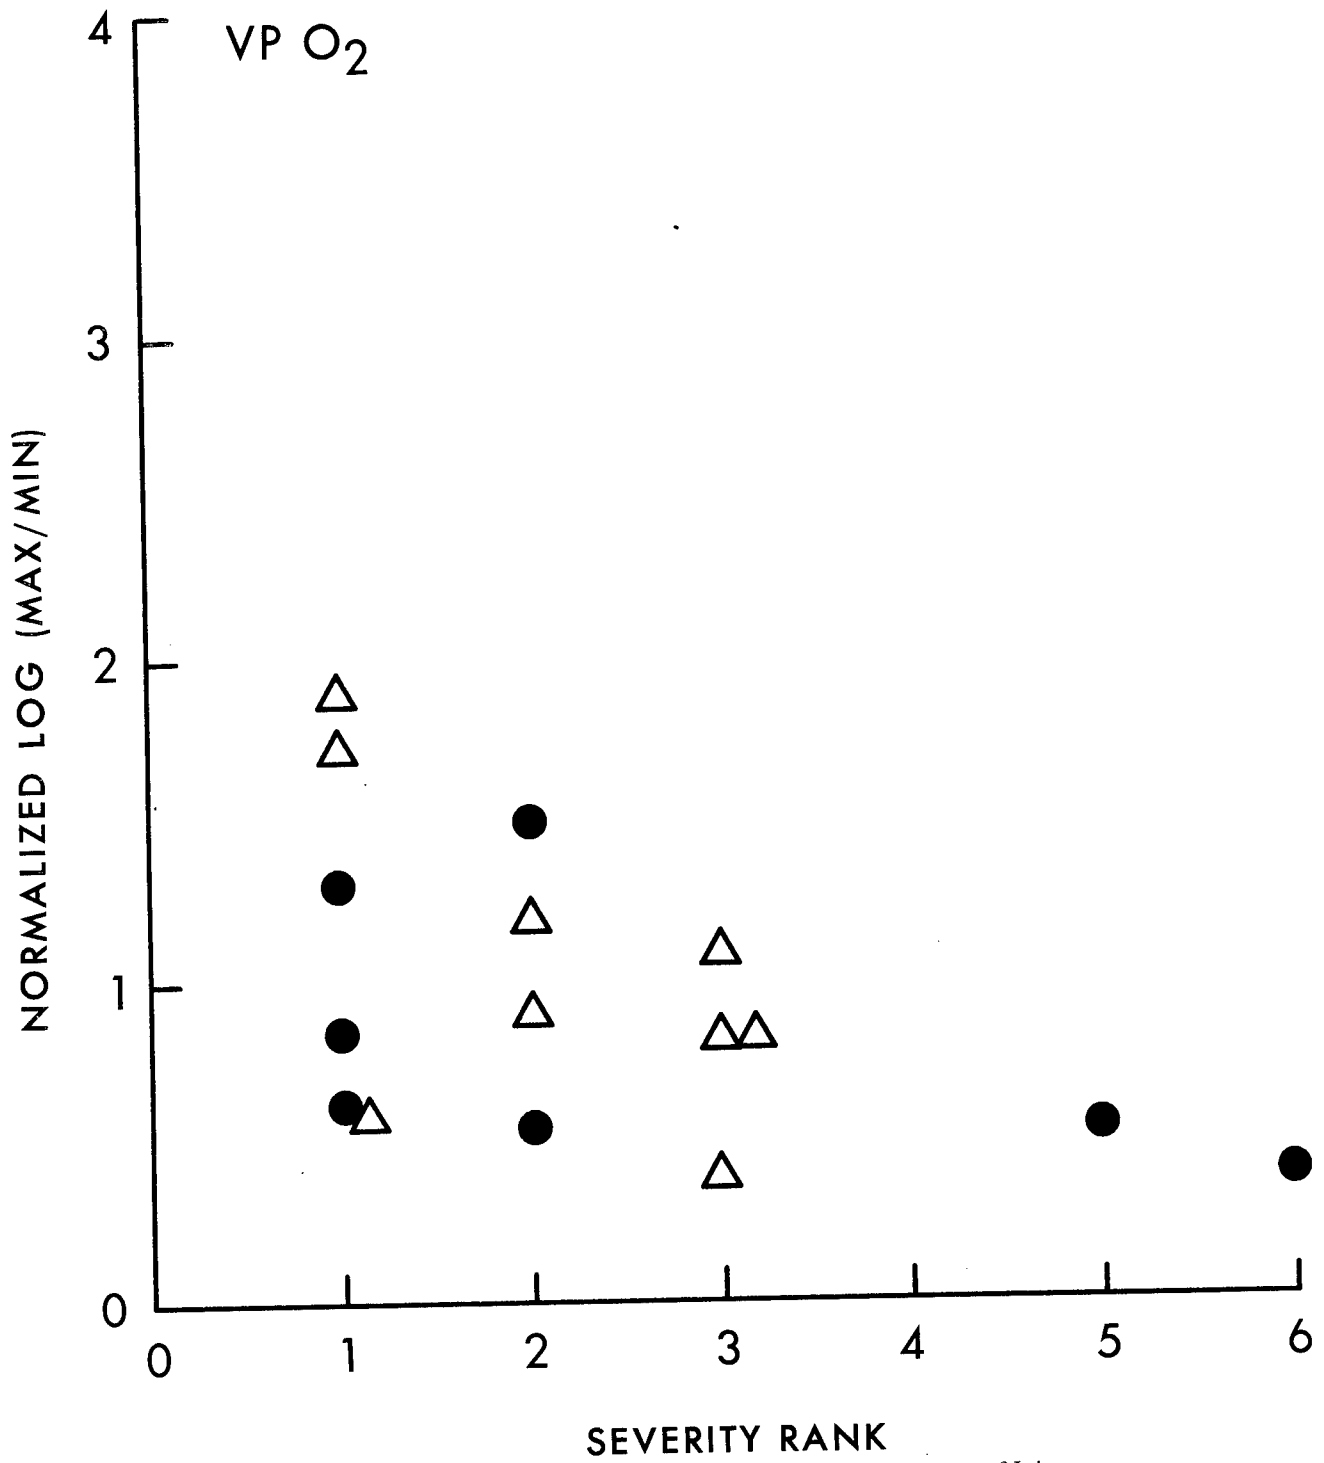
Figure A-7. Venous Pressure of Oxygen Versus Severity of Injury

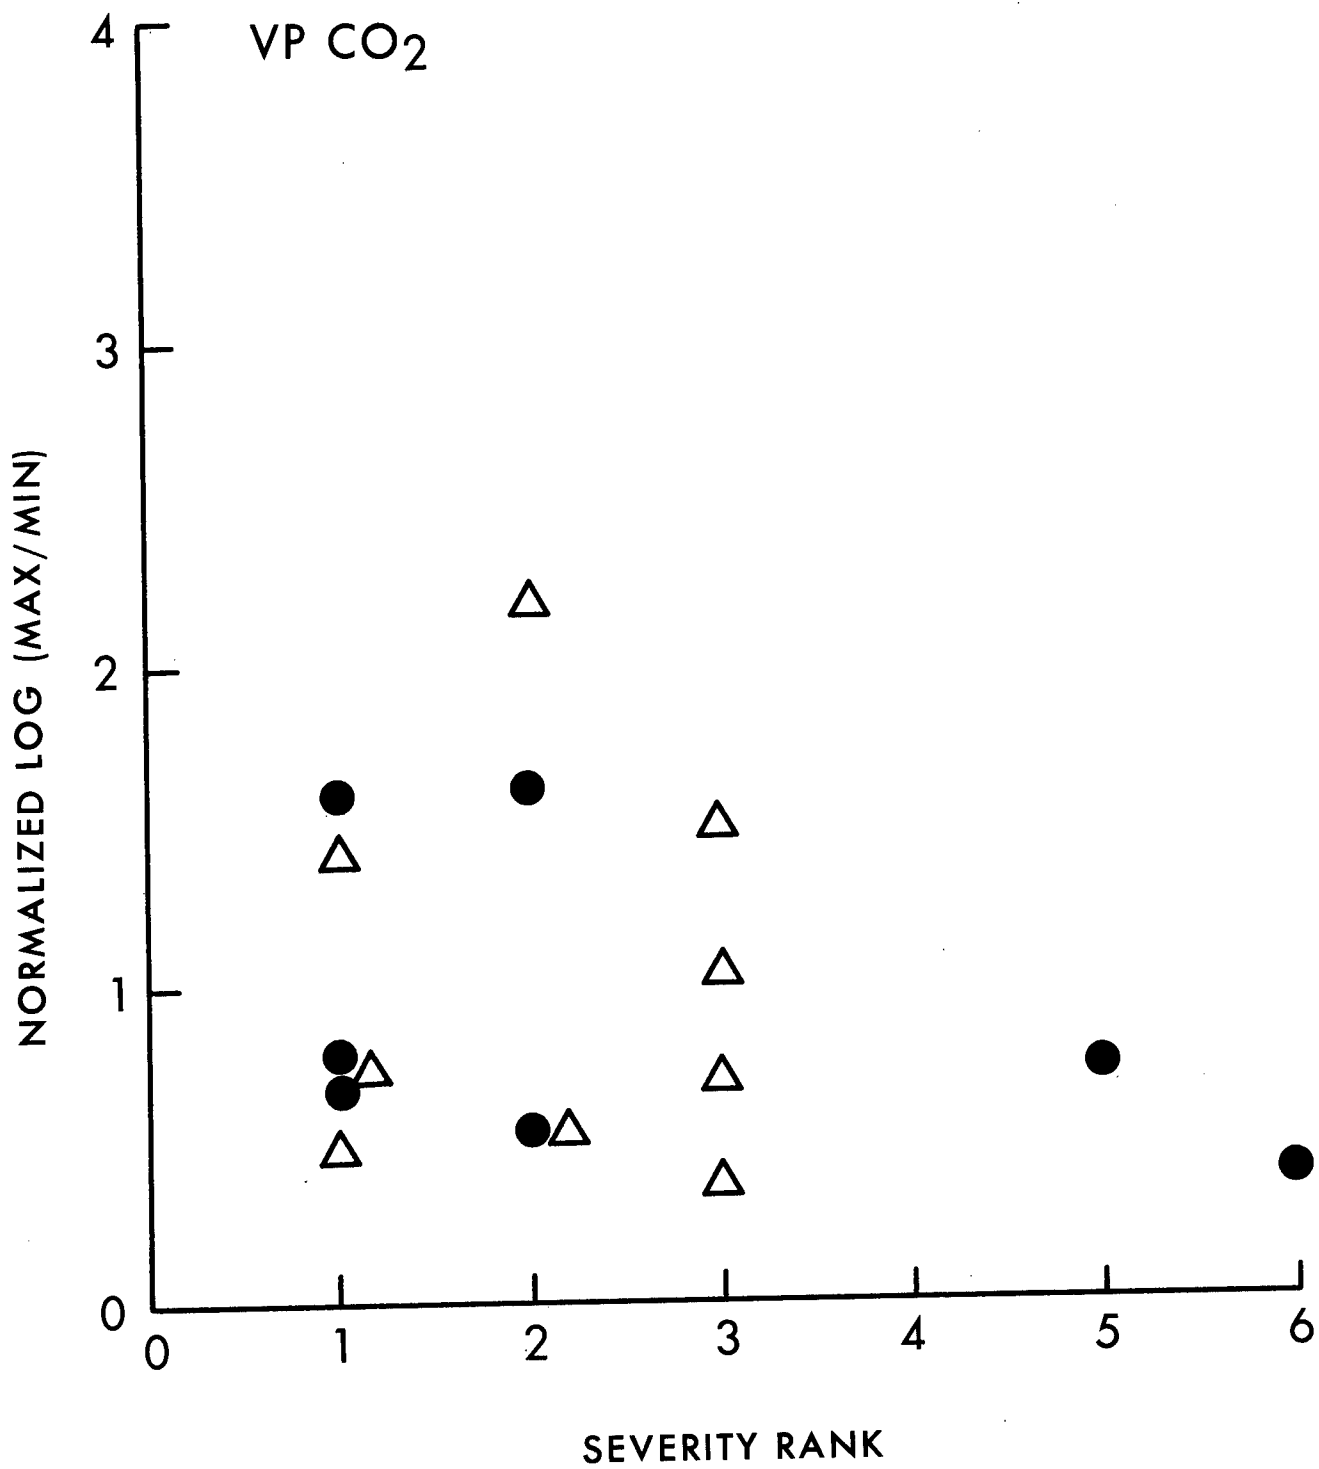
Figure A-8. Venous Pressure of CO₂ Versus Severity of Injury

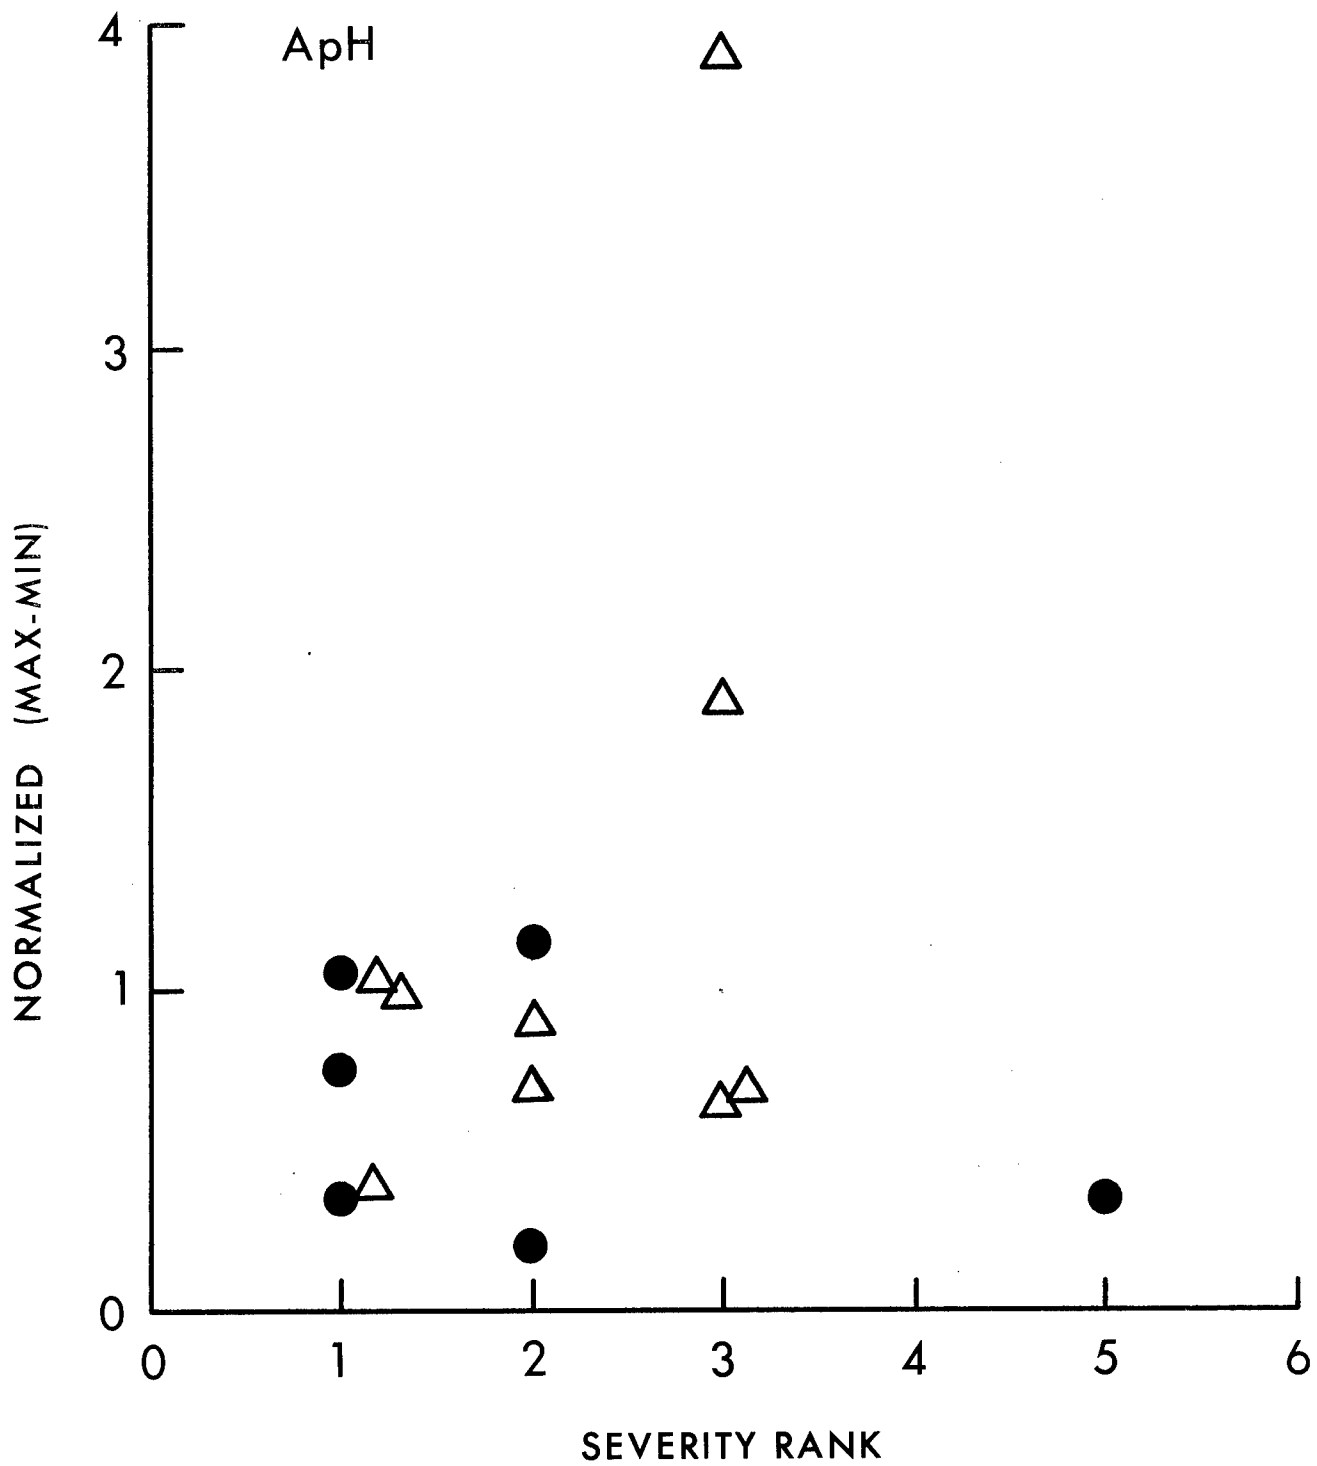
Figure A-9. Arterial pH Versus Severity of Injury
