TECHNICAL REPORT ARCSL-TR-78034

A METHOD OF SOFT BODY ARMOR EVALUATION: CARDIAC TESTING

November 1978

US ARMY ARMAMENT RESEARCH AND DEVELOPMENT COMMAND
Chemical Systems Laboratory
Aberdeen Proving Ground, Maryland 21010

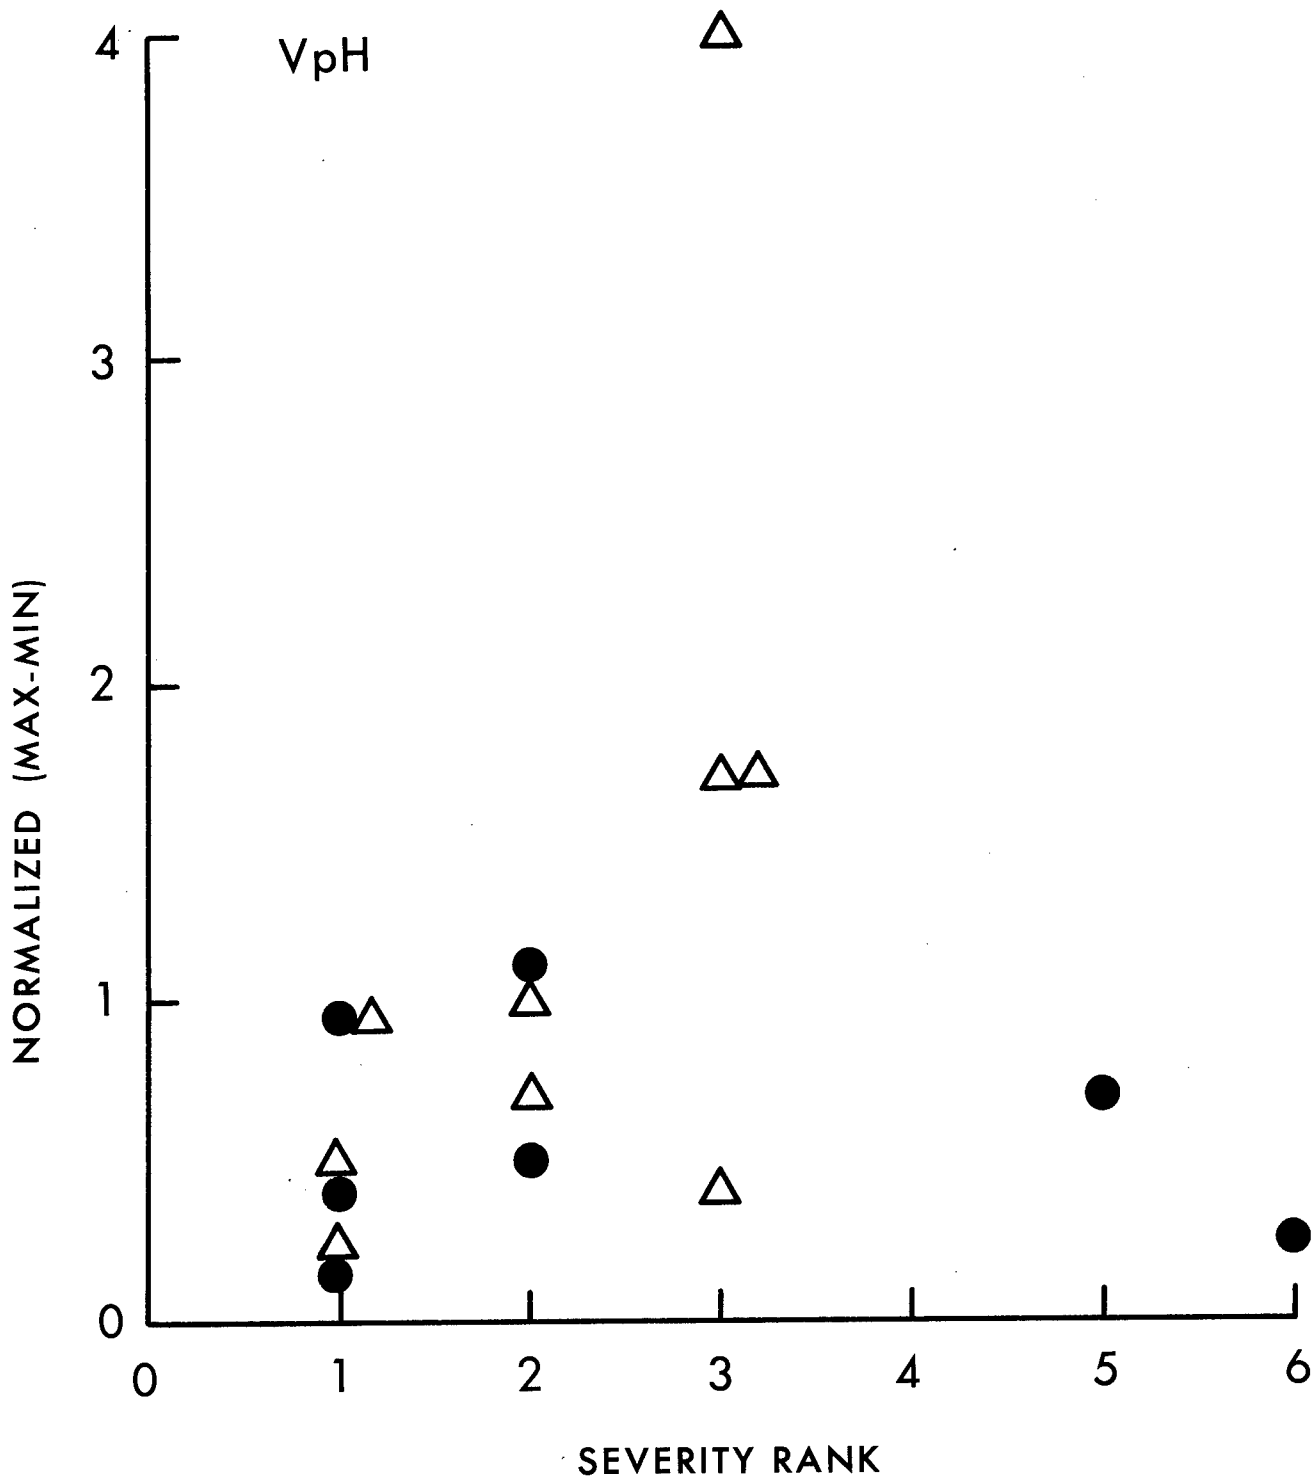
Figure A-10. Venous pH Versus Severity of Injury

For each of these 10 response variables, a point plot was made of derangement score versus Pathology Severity Rank (figures A-1 through A-10). On none of these point plots was there visible a consistent pattern of high scores in more severely injured animals and low scores in the less severely injured, or vice versa.
