DSTO-TN-0059

Methods of Early Fatigue Detection

**Airframes and Engines Division
Aeronautical and Maritime Research Laboratory**

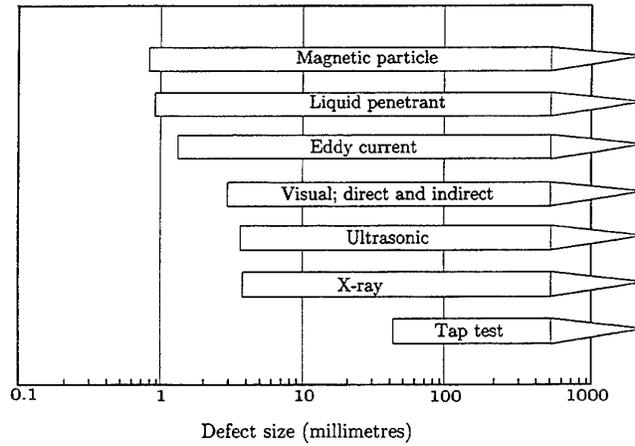
Figure 1. Defect detection capabilities of some conventional NDI techniques. (ESDU (1991))

This note presents an investigation into methods of early fatigue-damage detection that, at least in principle, are far more sensitive than conventional NDI methods, considered here to comprise those shown in Fig. 1. Existing methods of early fatigue-damage detection are reviewed, and two new techniques that are currently the subject of feasibility studies are also described. The note is structured in two sections dealing separately with (i) techniques that involve the direct inspection of the structure of interest, and (ii) techniques that involve the application of a fatigue 'sensor' to the structure. A list of the methods to be considered, categorised in this manner, is given in Table 1.

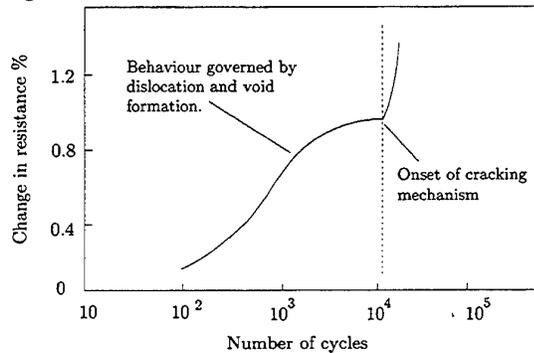
Figure 2. Typical resistance change in polycrystalline copper due to fatigue cycling.

The behaviour depicted in Fig. 2 is not typical of all metals. In Cu-Ni alloys for example, Charsley & Robins (1975) and Charsley & Shimmin (1979) found the characteristics of the resistance change to depend on the nickel content. Figure 3 shows a comparison of the approximate resistance change due to fatigue of two Cu-Ni alloys of different composition, Cu - 20% Ni and Cu - 51% Ni.

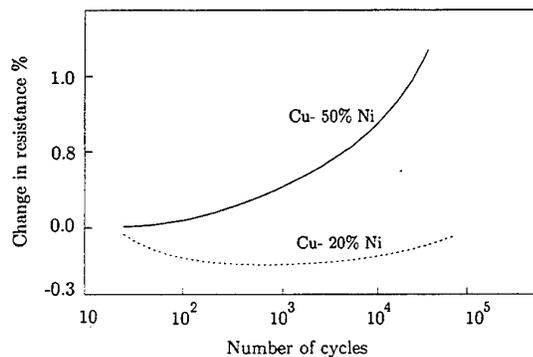
Figure 3. Typical resistance change in Cu-Ni alloy due to fatigue cycling.

A clear difference in behaviour is apparent in the early stages of fatigue; the alloy of lower nickel content initially decreases in resistance, whilst that of higher nickel content increases. Somewhat curiously, both behaviours arose via a single dominant mechanism involving the comminution of nickel clusters by mobile dislocations (Charsley & Robins (1975)). It was later reported (Robins & Charsley (1976)) that resistance changes in these alloys are dependent upon grain size, a feature not found in polycrystalline copper.

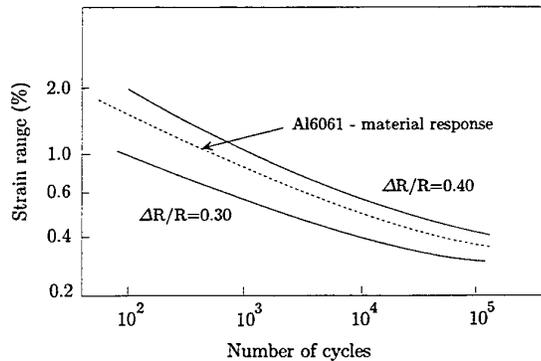
Figure 4. S-N curve for Al6061 and curves of constant $\Delta R/R$ for polymer fatigue gauge. ΔR is the change in resistance from an initial value of R

subjected to constant-amplitude fatigue cycling. They found that the change in resistance of the polymer gauge was strongly correlated with the fatigue failure of the structure for certain metals. The correlation was expressed in terms of the similarity between the S-N curve for the metal and the S-N curve for the polymer gauge at a constant $\Delta R/R$. This is depicted in Fig. 4 in which an S-N curve for Al6061 is seen to be approximately parallel to curves of constant $\Delta R/R$ for the polymer fatigue gauge. The curve for $\Delta R/R = 0.37$, not shown in the figure, was reported by the authors to coincide with the Al6061 S-N curve.

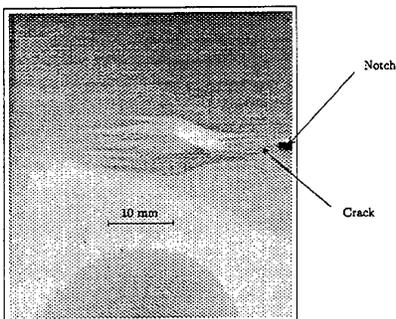
Figure 5a. Plastic zone.

The plastic deformation of a highly polished specimen can often lead to a noticeable surface roughening due to the impingement of dislocations on the specimen surface. Shown in Fig. 5a is a polished mild-steel specimen containing a fatigue crack, and adjacent to and extending from the crack, a region shaped like a hand which is effectively the zone of monotonic plastic deformation caused by the application to the specimen of a tensile load normal to the crack propagation direction. In the case depicted in this figure (see Rajic 1995), the observed surface roughening was exploited to identify the extent of a plastically deformed region. However, the phenomenon has also been proposed as a useful means of fatigue characterisation. In a recent paper by Nagase *et al* (1995), thin aluminium foils were bonded to a fatigue-loaded structure with the view of correlating the evolution of surface roughening in the foil with the fatigue history of the specimen. Under constant stress-amplitude loading, the relationship between the measure of surface roughness, Ra , stress amplitude, σ , and number of loading cycles, N , was expressed as,

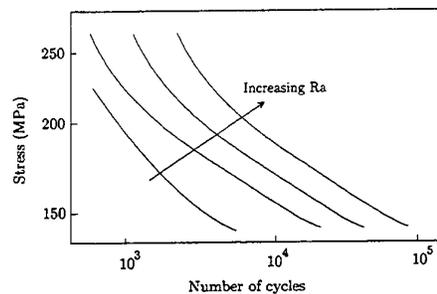
Figure 5b. S-N curves for constant Ra 's.

where Ra_n is the roughness measured after $\sum N_i$ cycles. This expression was applied to experimental data with mixed results. In tests involving only a few stress-amplitude variations, the expression failed to describe the gauge behaviour well because of its disregard of the ordering of these variations (i.e. high-low & low-high). However, with increasing numbers of stress-amplitude variations, the effect of ordering diminishes and the expression under these conditions was found to provide a satisfactory description of the gauge behaviour.

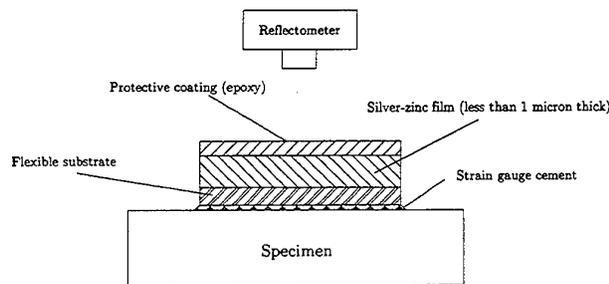
Figure 6. Colour Displaying Fatigue Sensor, from Scott (1977).

Scott (1977) describes a fatigue sensor that exploits the tendency of silver-zinc alloy to change colour in response to fatigue loading. The colour change is reported to occur due to the silver-zinc film undergoing a martensitic phase transformation in response to cold work induced by cyclic loading. Since it exploits colour variations, this gauge has a unique advantage among fatigue sensors in that it should enable one to gain a qualitative indication of the fatigue state of the underlying structure by simple visual inspection. A more quantitative measure of the colour change, which is stated as being from pink to silver, can be obtained with a spectrometer. The sensor is shown schematically in Fig. 6.

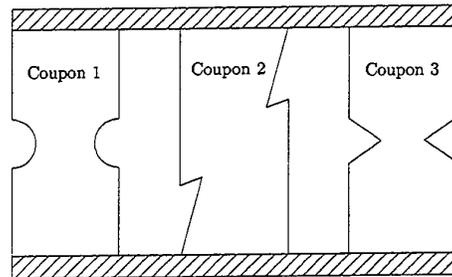
Figure 7. Tensiodyne fatigue fuse.

it is possible to estimate the residual life of the structure at several stages in its life. Figure 7 shows a basic outline of the fuse. The coupons presented in this figure are derived from patent held by Tensiodyne (1986) and represent only a few of the many shapes available. Note that only the hatched portion of the fuse is bonded to the structure.

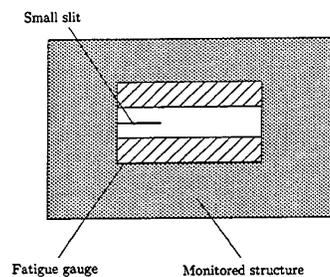
Figure 8. Fatigue gauge from Smith (1976).

Smith (1976) developed and patented a device similar to the *Fatigue Fuse*, which, instead of having a notch, has a small slit, see Fig. 8. The principle is the same, that is the accumulation of damage in the device, in this case indicated by progressive crack growth, is used to infer information about the fatigue state of the structure. Geissler & Gallagher (1983) describe an investigation carried out for the USAF into the application of this type of gauge to aircraft fatigue-damage tracking. They concluded that the proposed

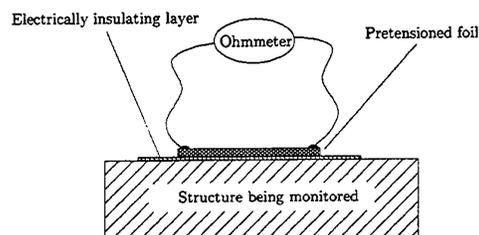
Figure 9. Mean-stress Gauge.

It is well known that the superposition of a tensile mean stress on a fluctuating load has a detrimental effect on fatigue life. Furthermore, it is possible to estimate the reduction in life from S-N curves which include R-ratio (mean stress) variations. Given this, it should in theory be possible to attach to a structure a pretensioned foil made of the same material, such that it breaks at a predetermined (from S-N curves) number of fatigue cycles before the structure, and thereby gives warning of the structure's impending failure. The fatigue state of the foil could be tracked by continuously measuring its electrical resistance; failure would obviously be indicated by a large increase in its resistance. This is however a rather crude application of the concept. One will recall from earlier discussions that the residual resistivity of a metal is generally dependent upon its fatigue state and that changes in this resistivity occur well before the formation of a macrocrack. Hence, if the resistance measurements were to be made with sufficient precision to detect changes in the residual resistivity, it should be possible to know the fatigue state of the foil (and therefore the structure) continuously and from an early stage in its life. The basic elements of the gauge are shown in Fig. 9.

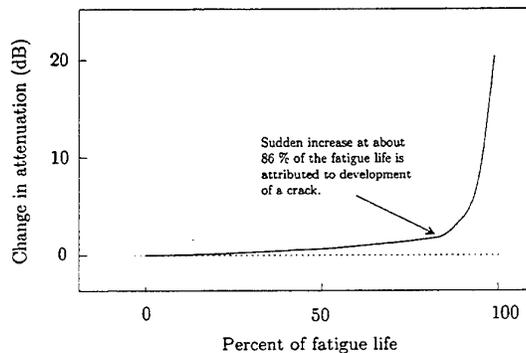
Figure 10. Schematic of an ultrasonic attenuation response for Al7075-T6 alloy

A representative plot of ultrasonic attenuation as a function of the number of loading cycles is shown in Fig. 10, which depicts a similar behaviour to that in Mignogna *et al* (1980), and relates to a fatigue test on 7075-T6 aluminium alloy. Although the attenuation is seen in this figure to increase in the early stages of fatigue, this behaviour is not observed in all cases. Depending on the material composition, loading conditions and temperature, the attenuation may actually decrease (Joshi & Green (1975)). For a detailed treatise on the relationship between dislocations and ultrasonic attenuation, the reader is referred to Nabarro (1987).
