**NSWCCD-TR-65-97/18 April 1997**

Survivability, Structures, and Materials Directorate  
Technical Report

## **An Experimental Investigation of the Ultimate Strength of Stiffened Panels**

### **- Volume 2, Test Data**

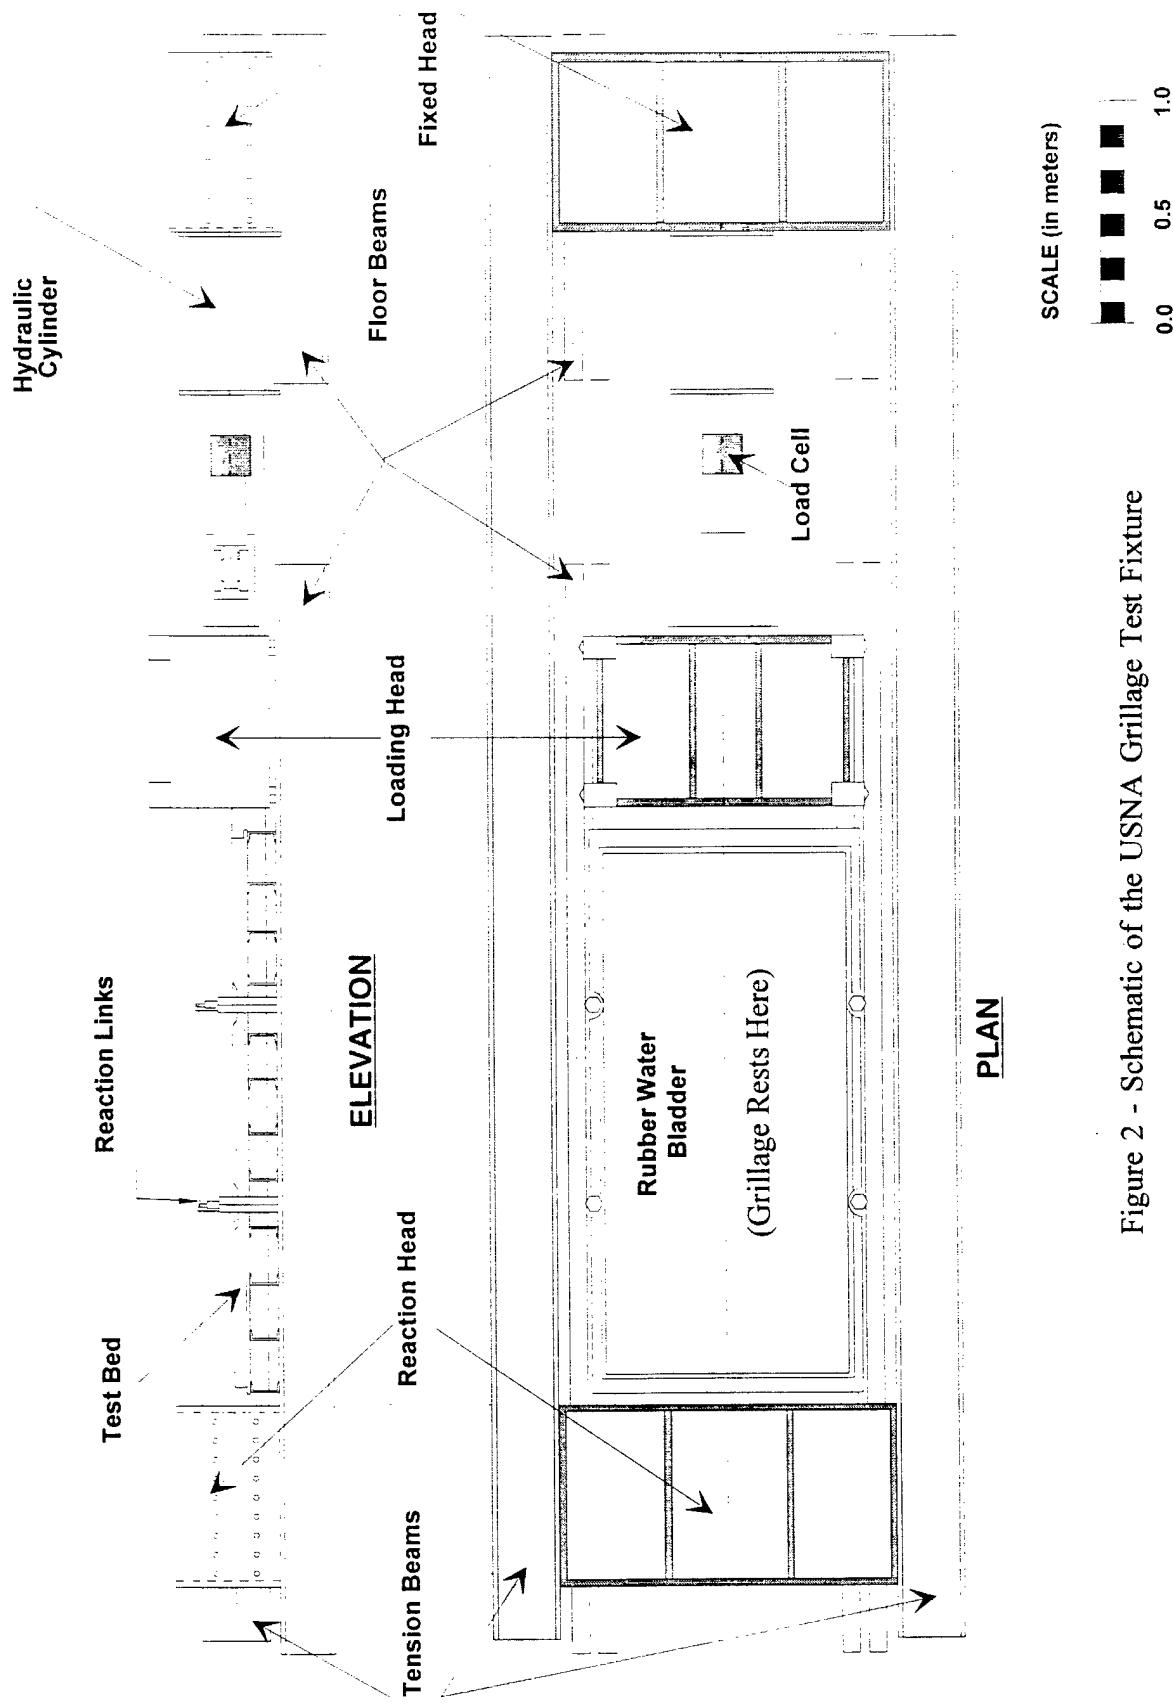
Figure 2 - Schematic of the USNA Grillage Test Fixture

The test specimens were mounted in a testing fixture capable of applying in-plane axial

compressive load, up to 360,000 pounds, into the end of the test specimen and lateral pressure load, up to 40 psi, over the plate (as opposed to stiffener) side of the test specimen. The test fixture is shown in Figure 2.

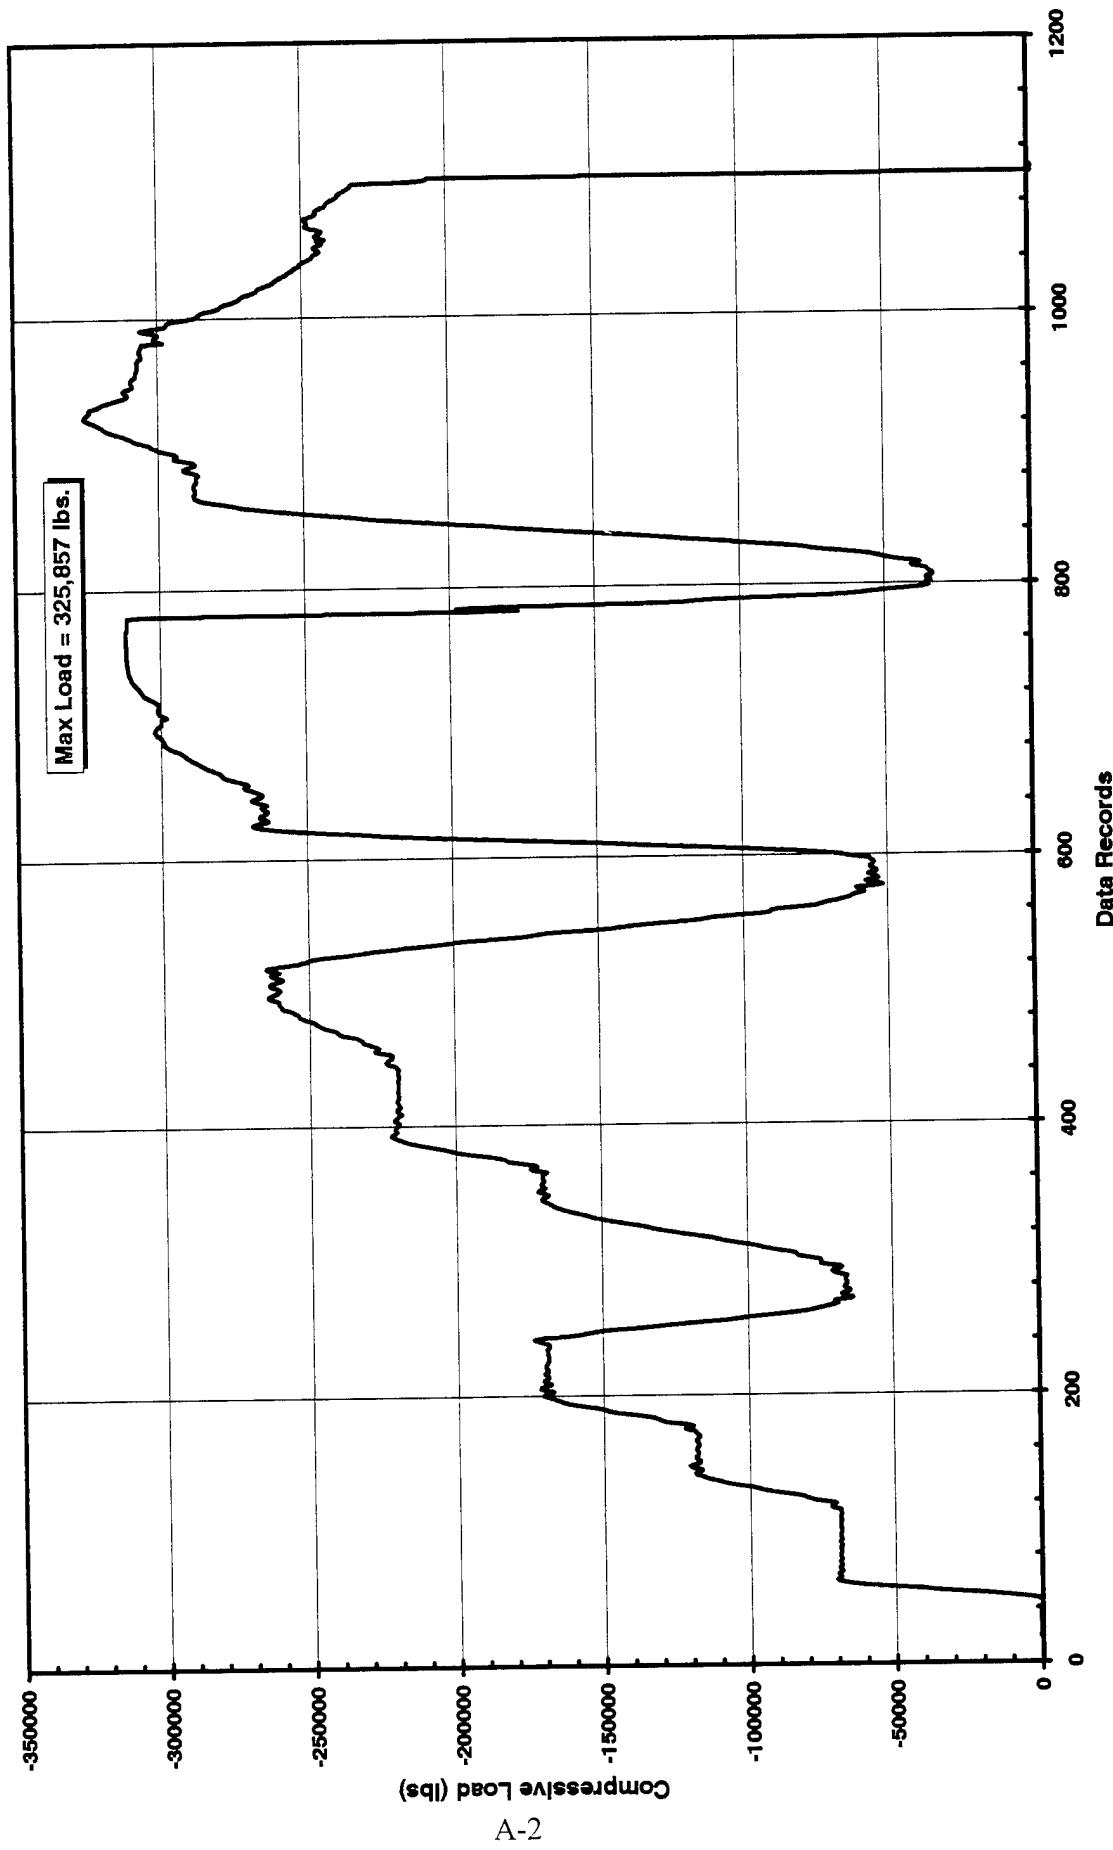
**Specimen 0494 Axial Load**

## Load History

The data obtained from each test were similar and are therefore arranged in the same order and in the same format for each test specimen. At the beginning of each section, the first plot shows a time history of the compressive load applied to the test specimen, where "time" is measured as data records acquired. This plot shows how the specimen was loaded in increments, periodically unloaded and reloaded up to and beyond failure.

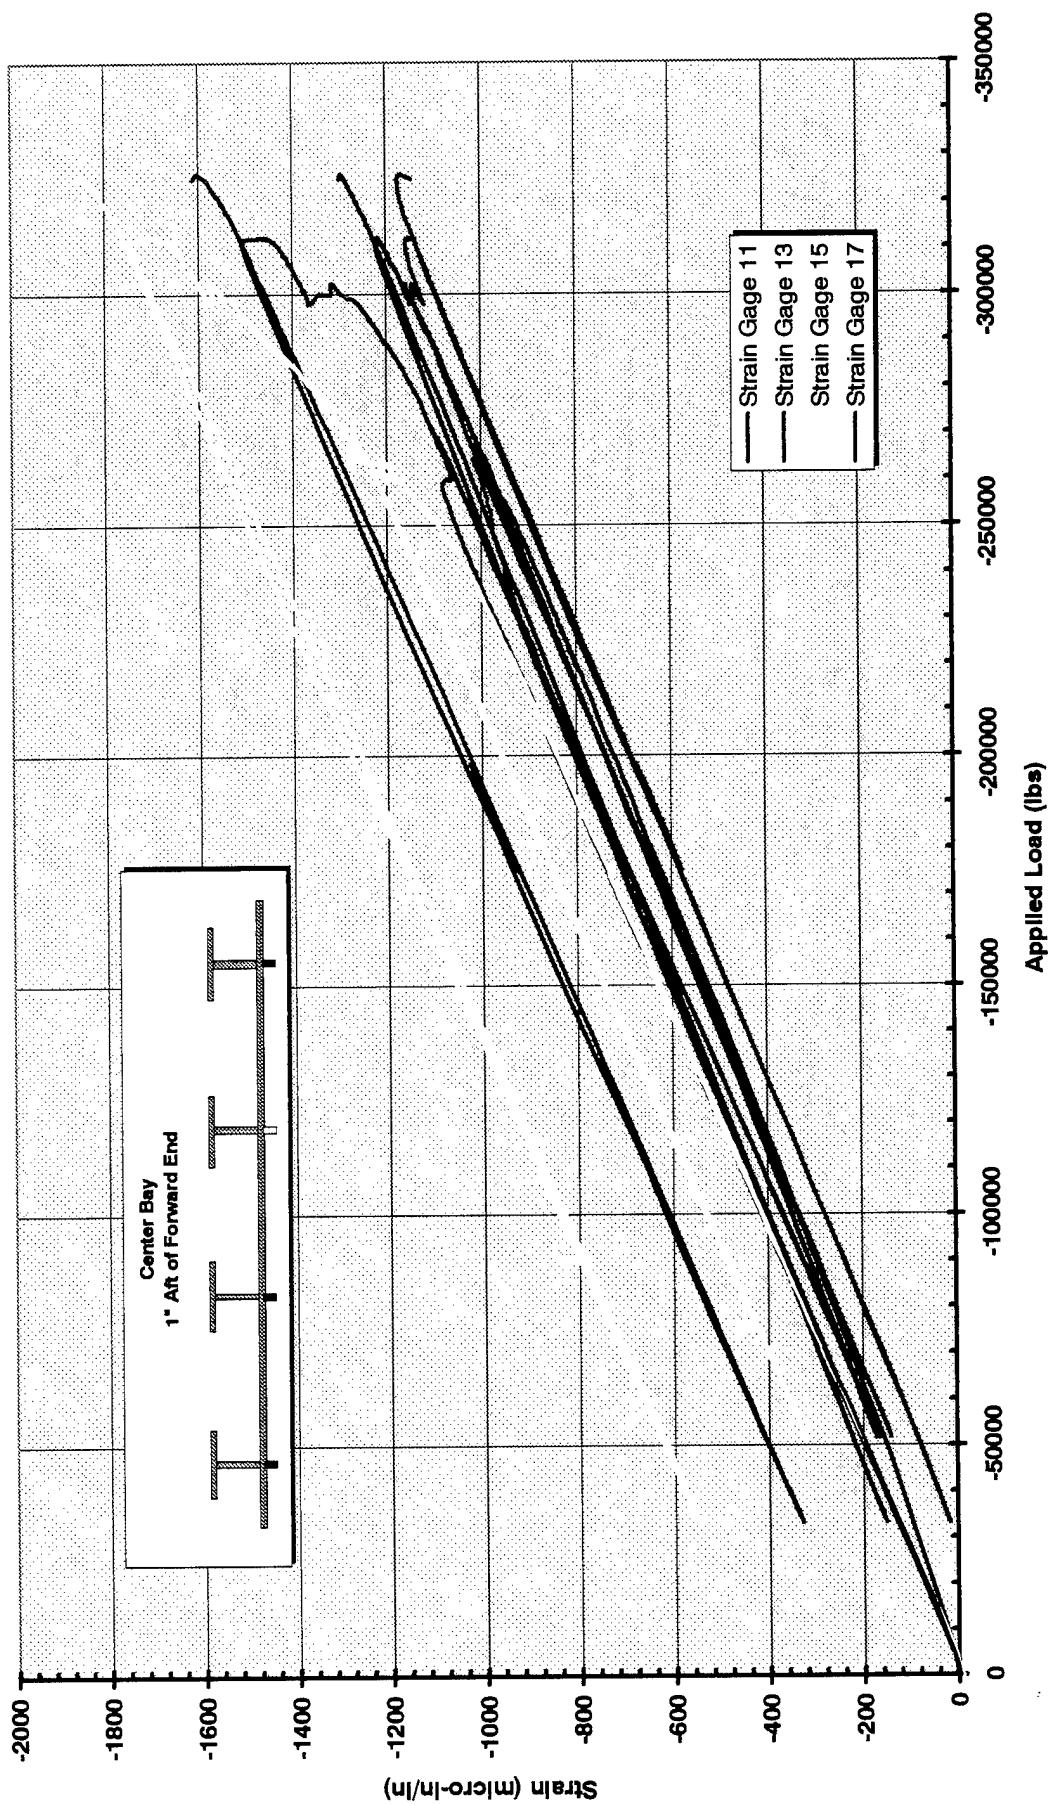
**Strain vs. Applied Load**

The remainder of the figures in each group of data show plots of measured strain versus applied compressive load. The gages shown on each plot are grouped conveniently to show strain profiles across a section of the grillage, across the flange of a stiffener, or on sections of plating between stiffeners.

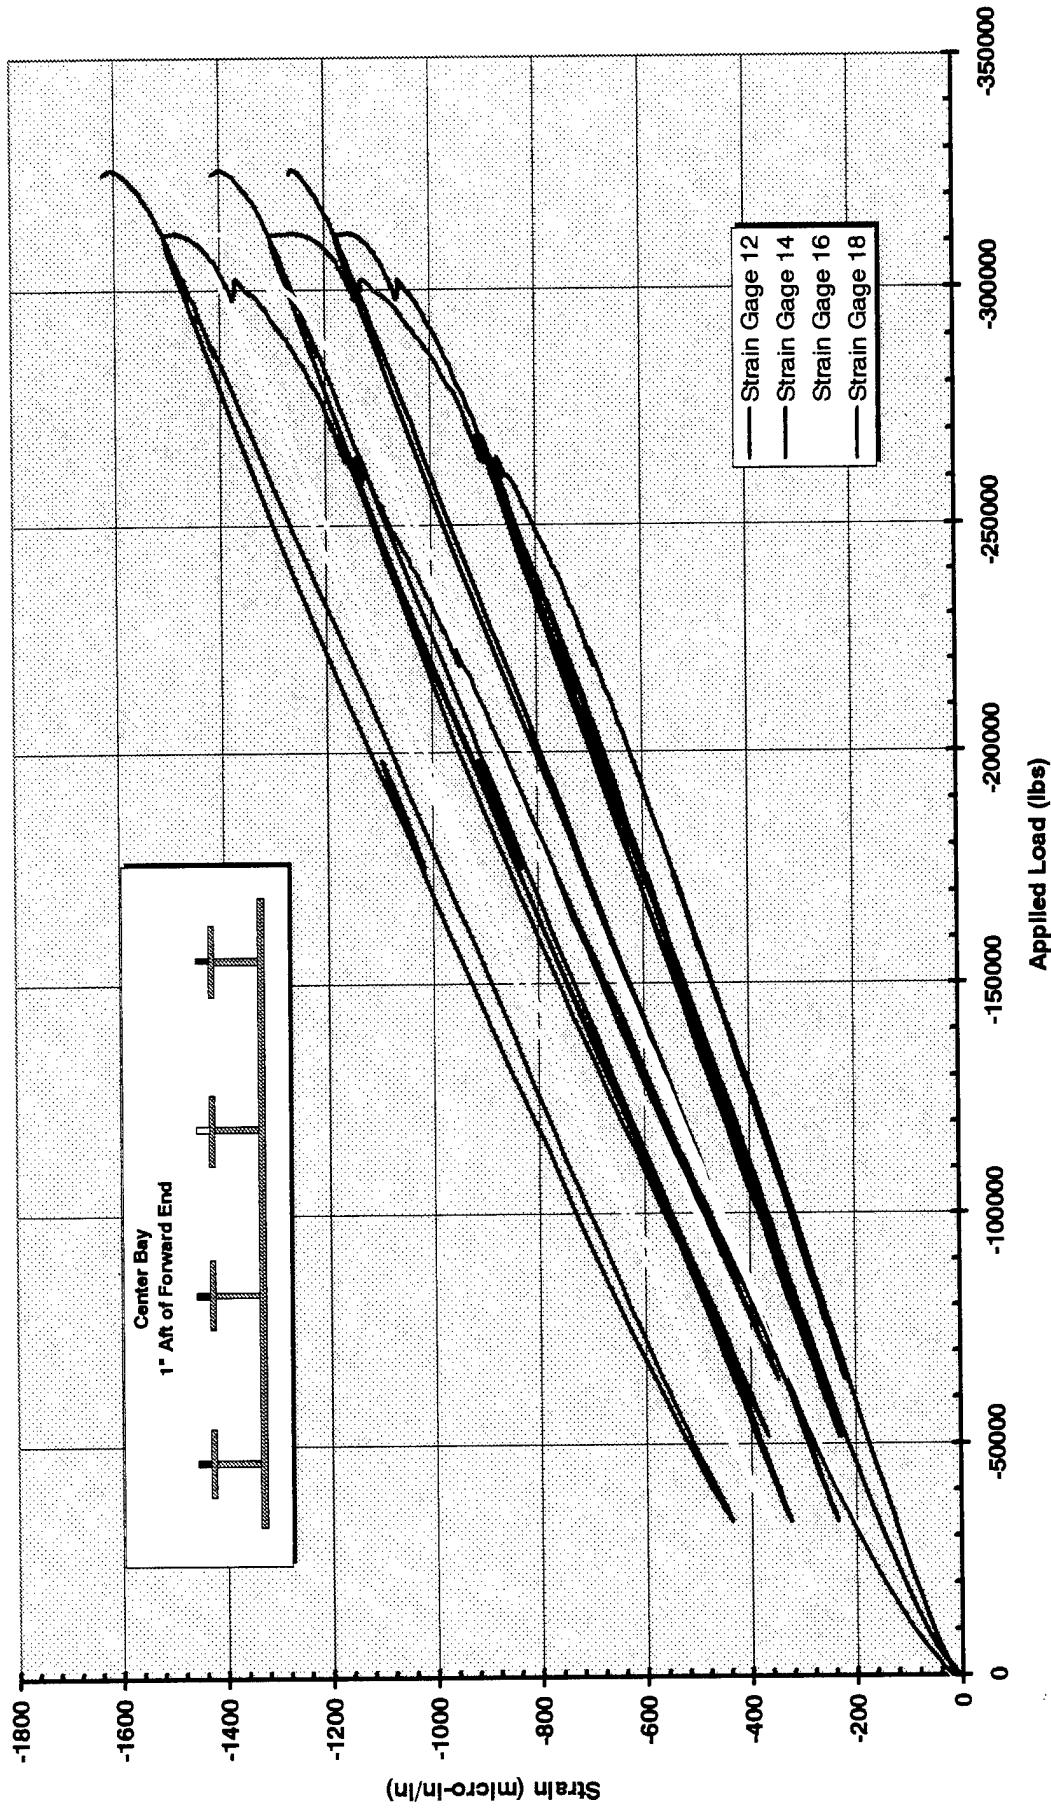
**Strain vs. Applied Load**

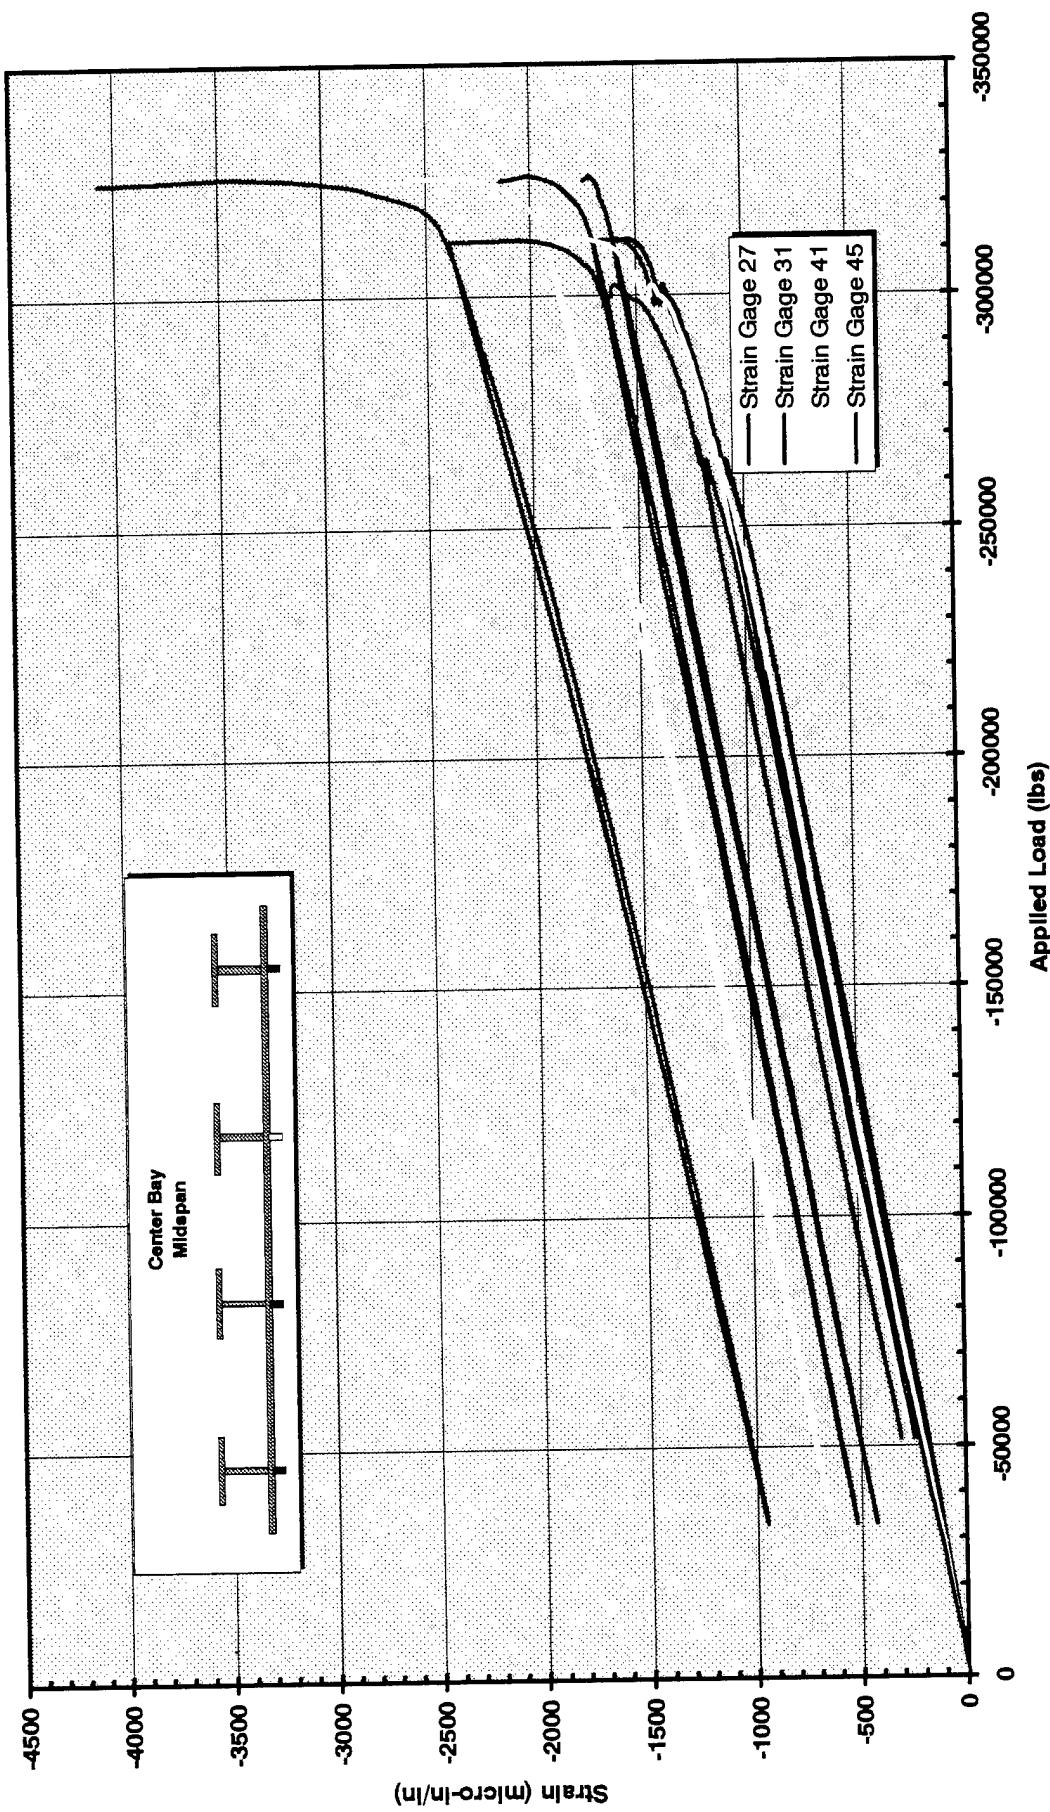
**Strain vs. Applied Load**

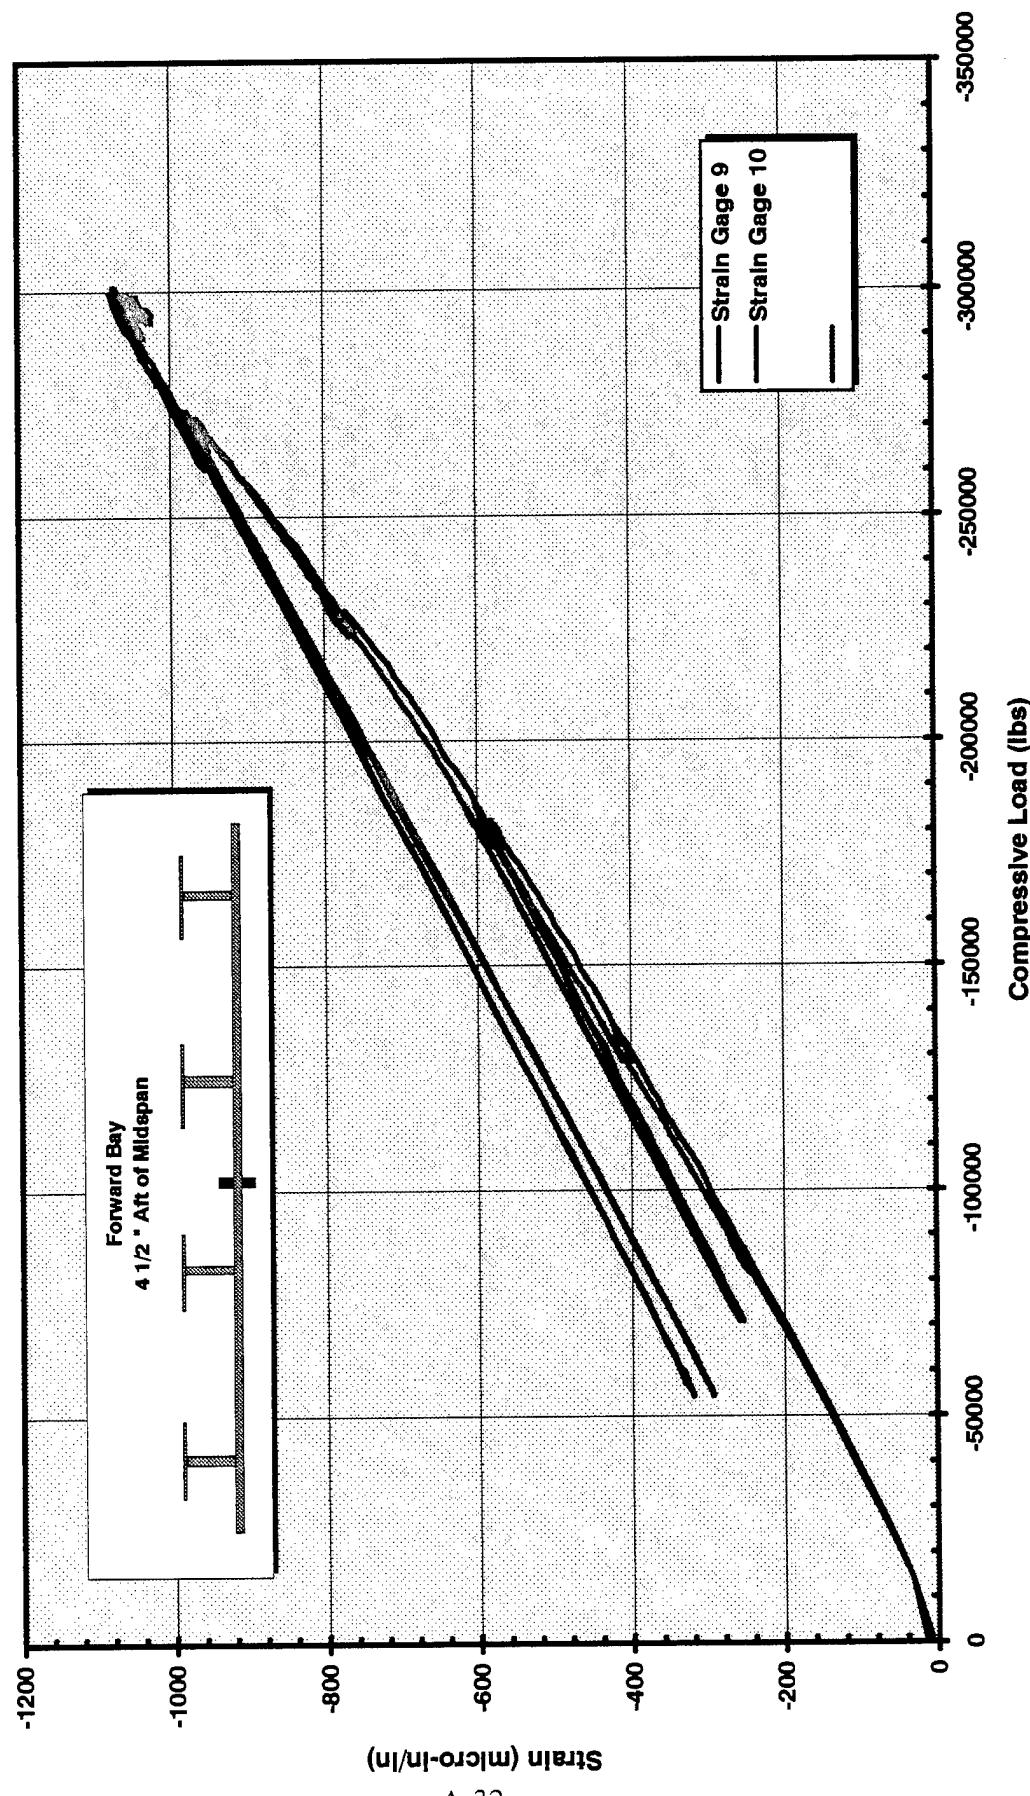
**Strain vs. Applied Load**

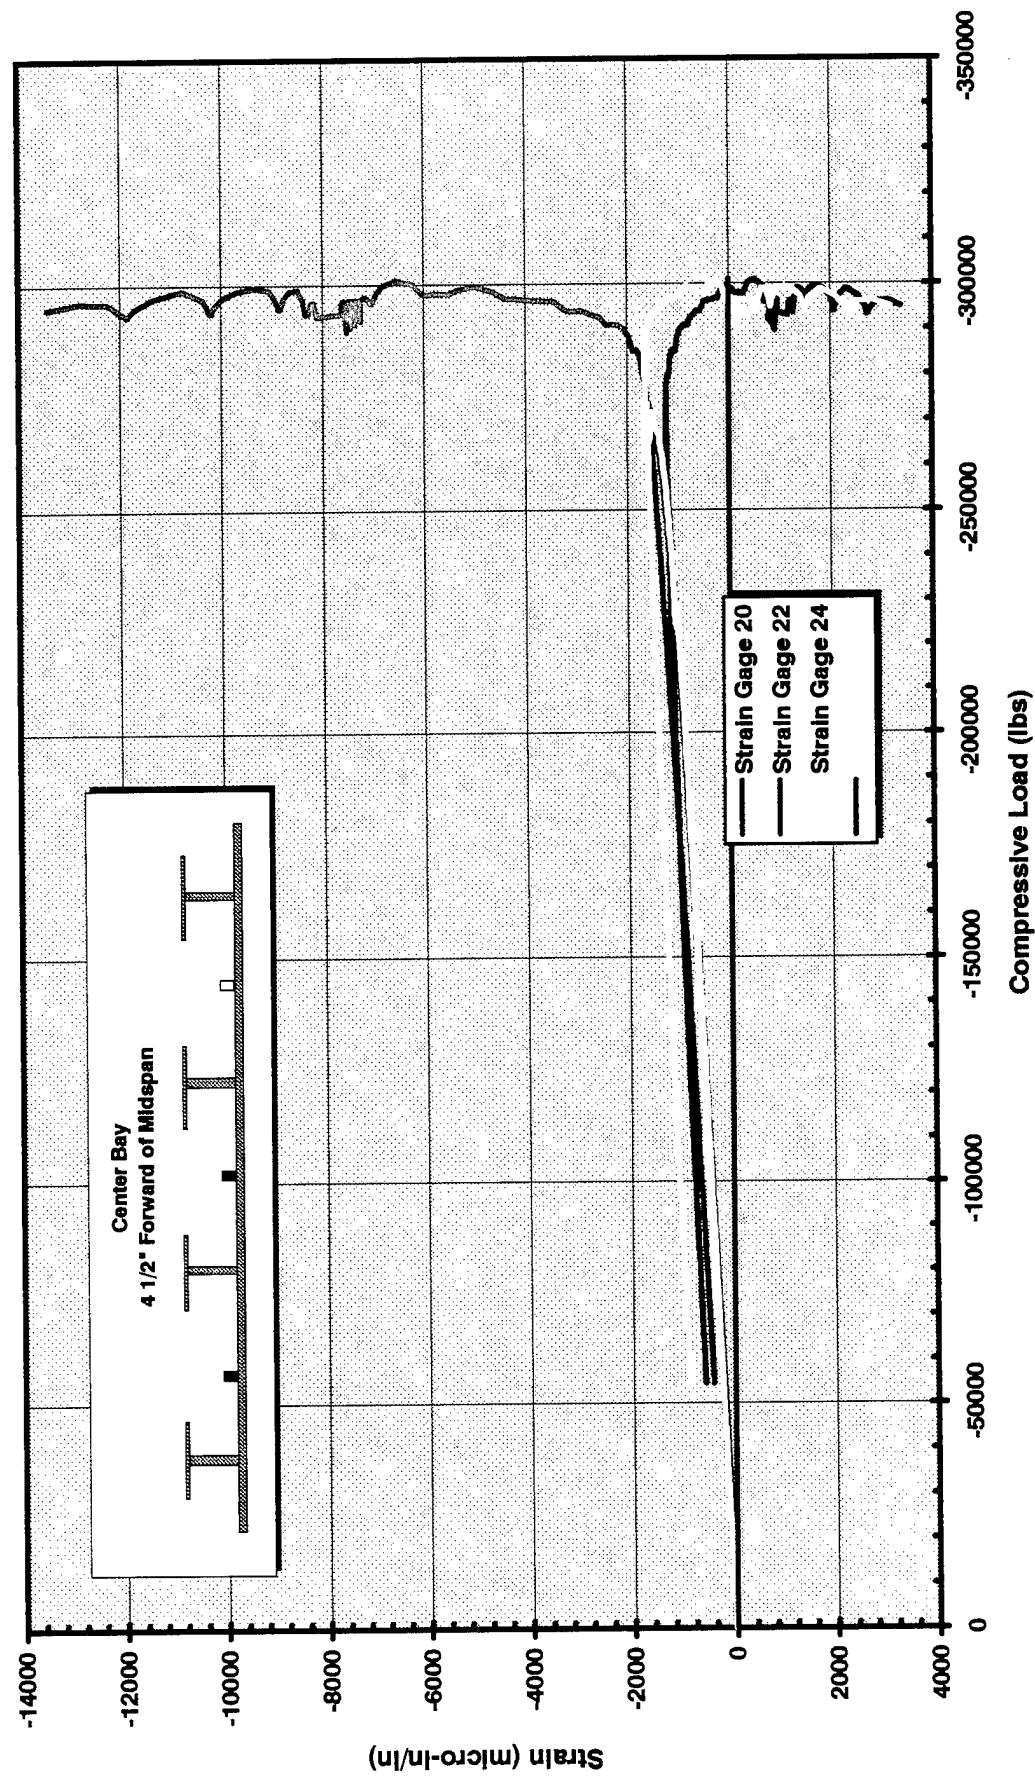
**Strain vs. Applied Load**

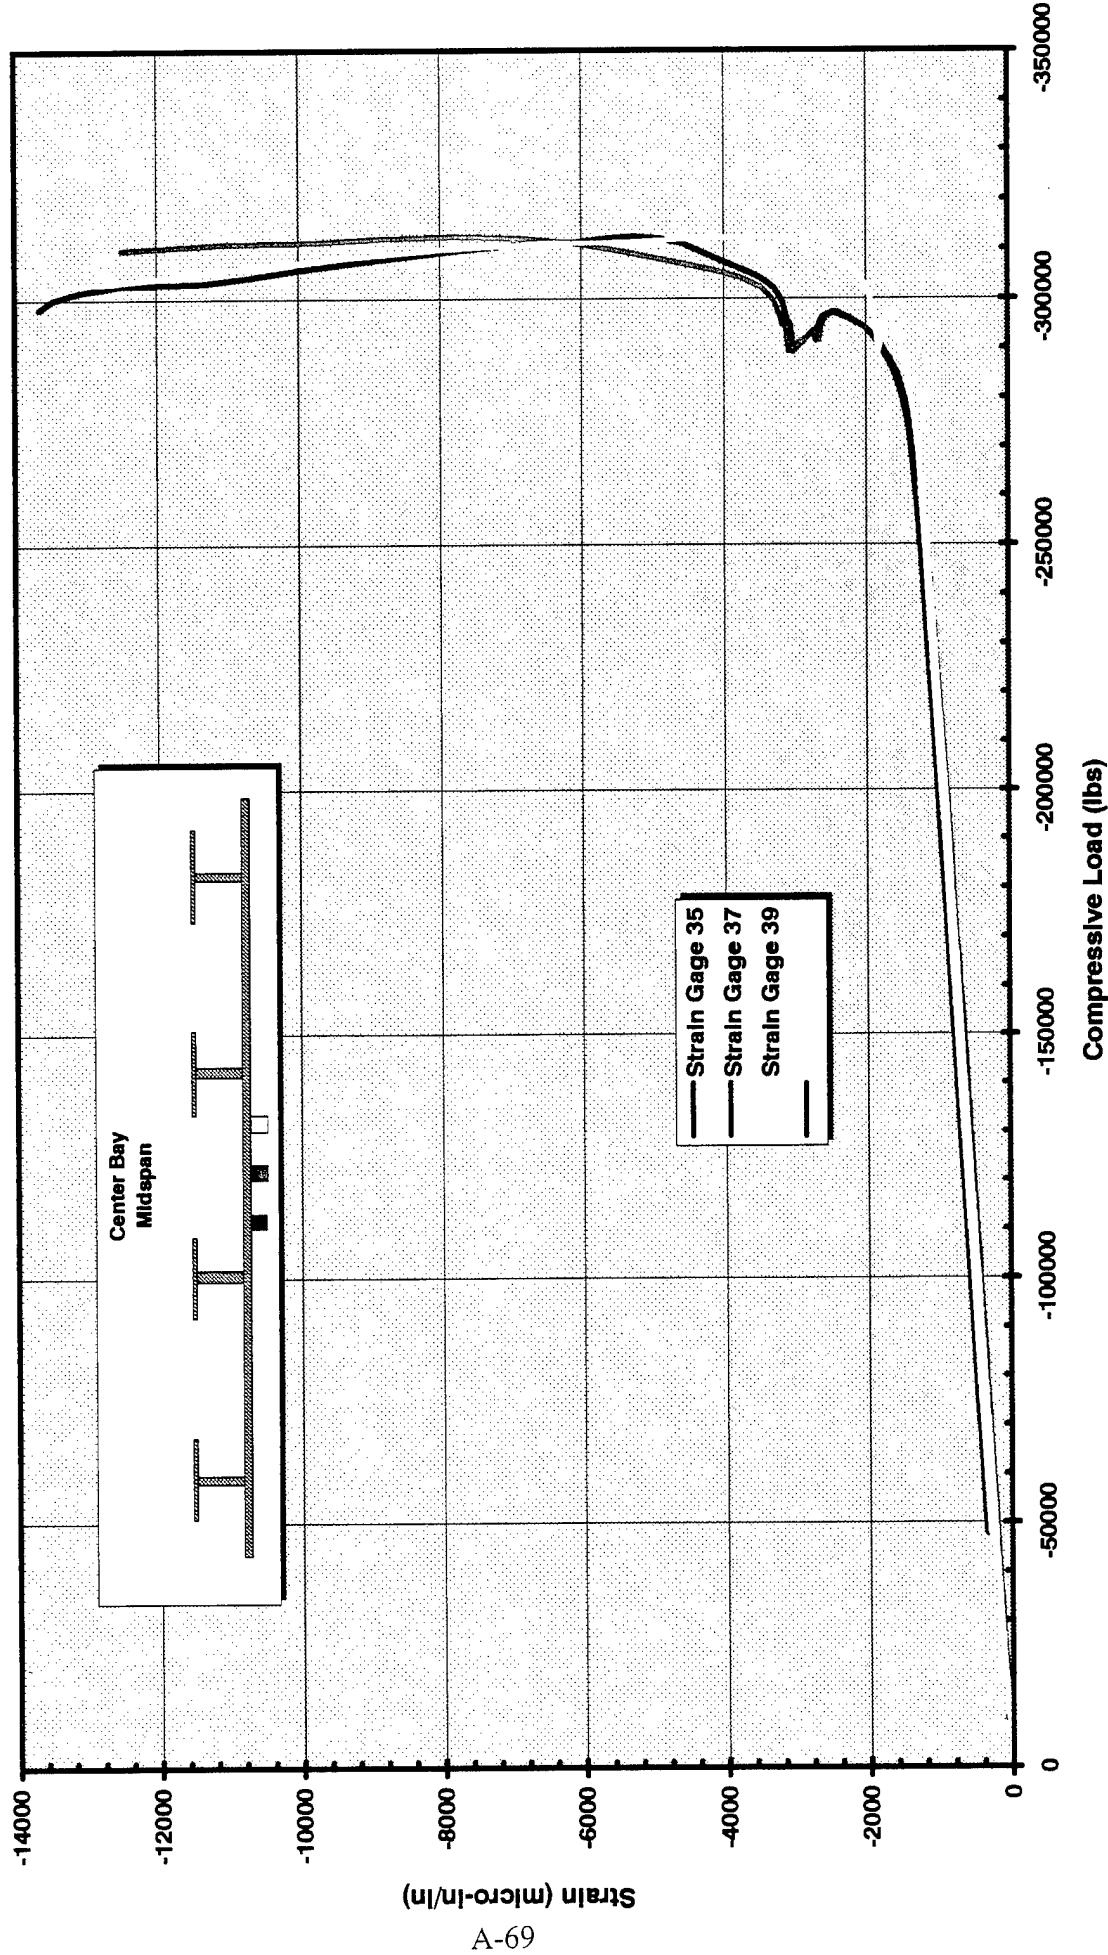
### Strain vs. Applied Load

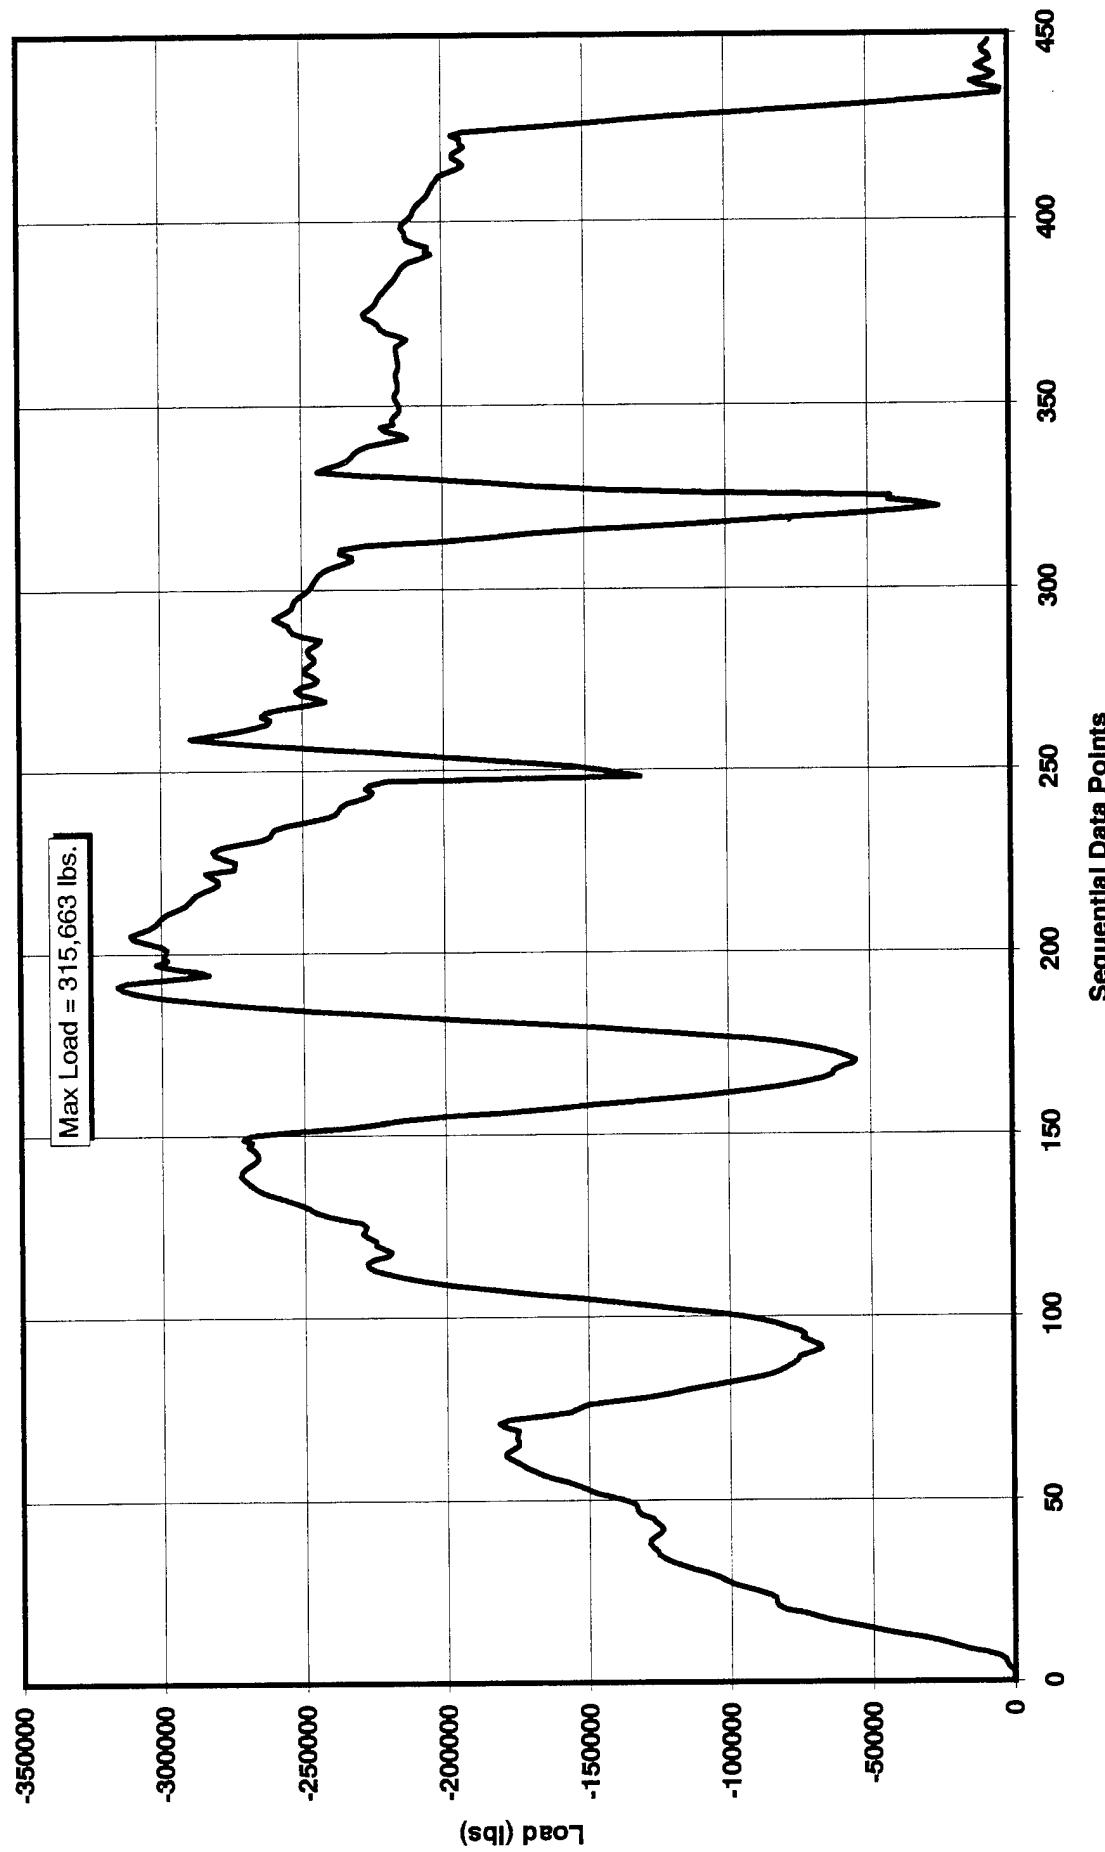
**Specimen 0595 Axial and Lateral Load**

### Load History

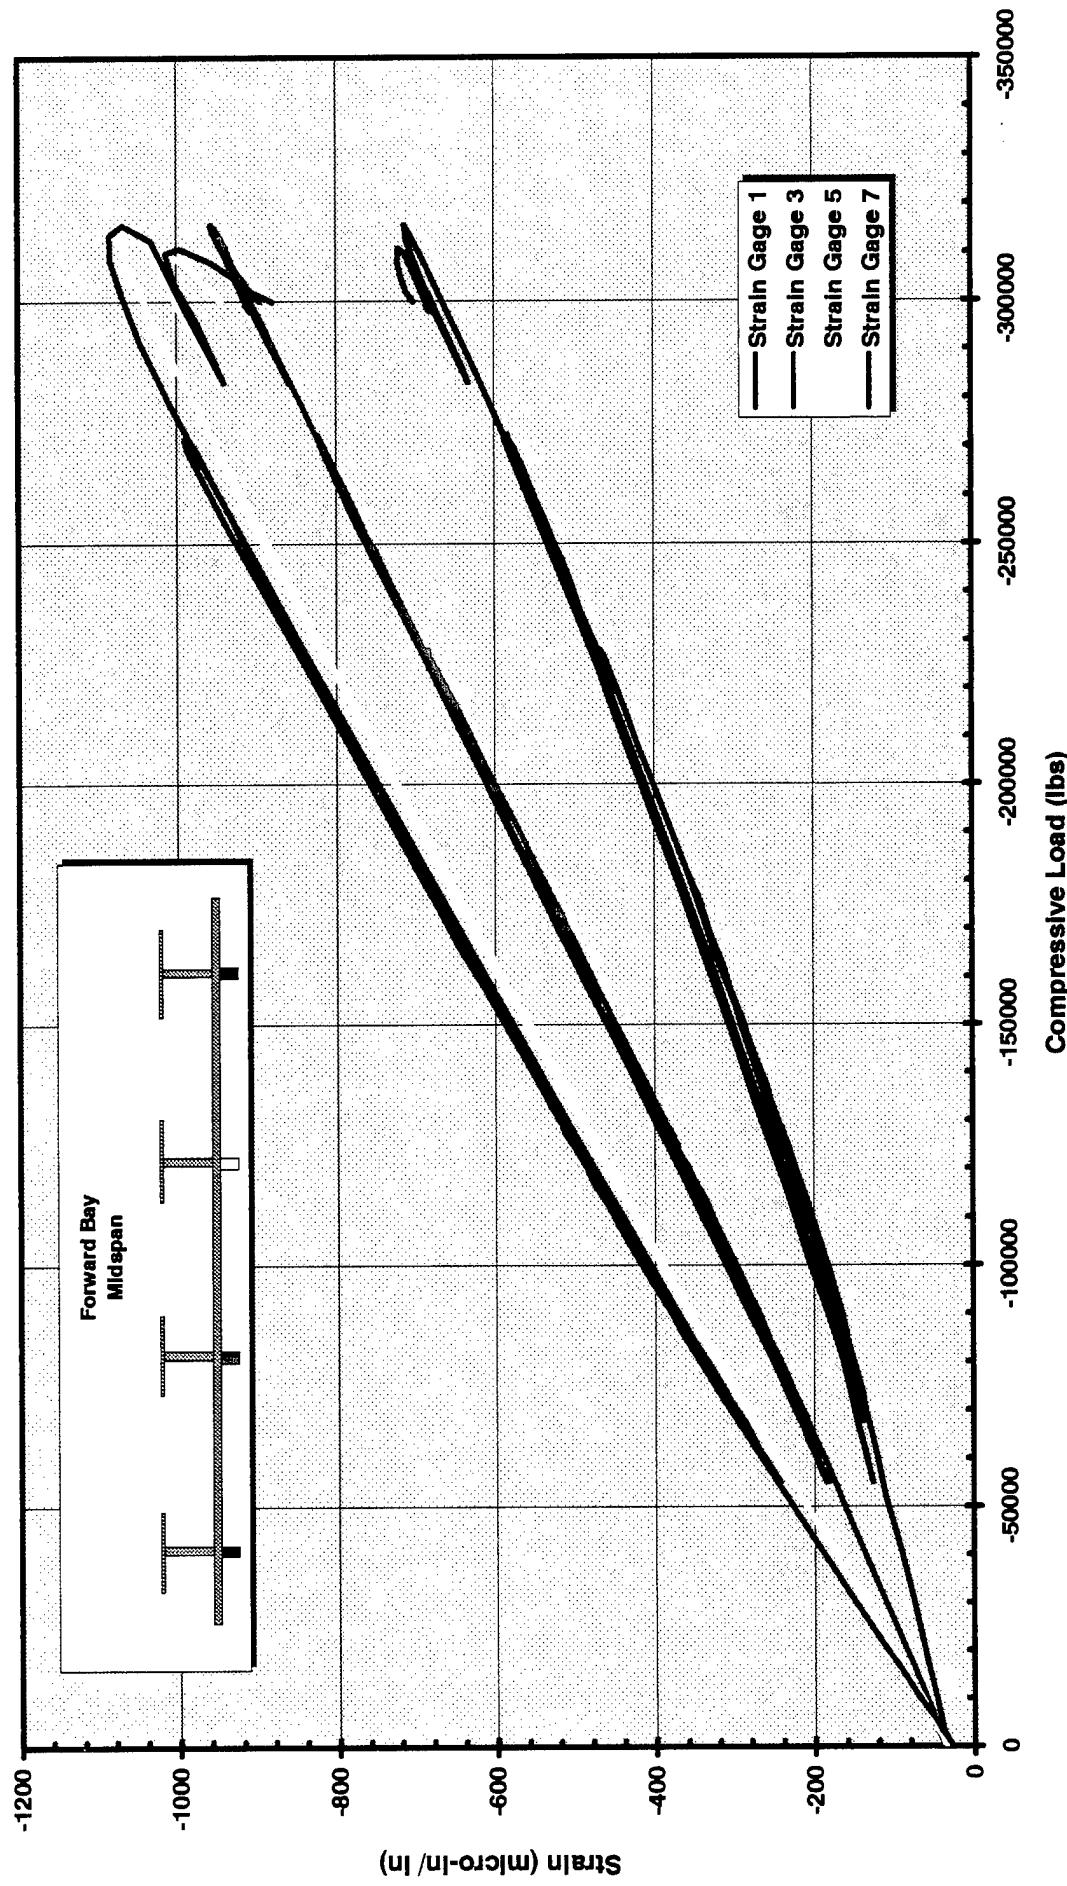
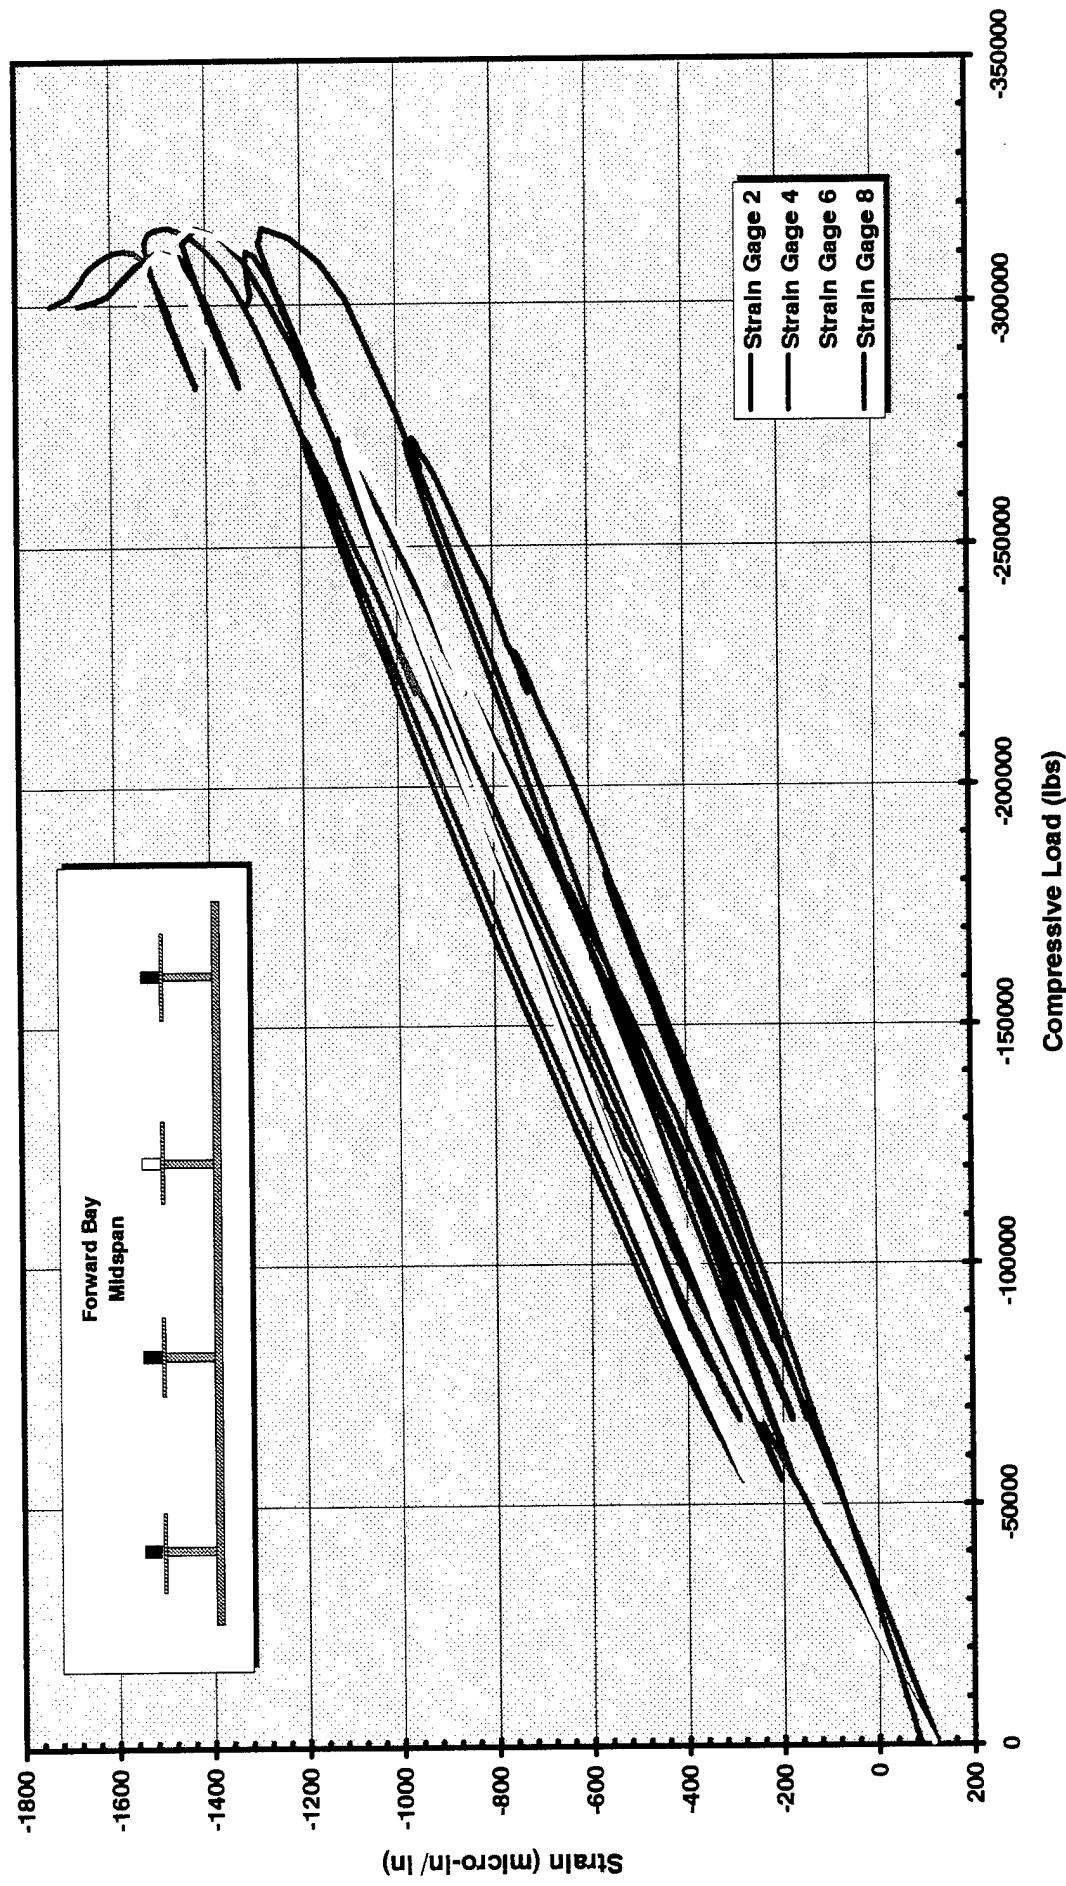
**Strain vs. Load**
