**NSWCCD-TR-65-97/18 April 1997**

Survivability, Structures, and Materials Directorate  
Technical Report

## **An Experimental Investigation of the Ultimate Strength of Stiffened Panels**

### **- Volume 2, Test Data**

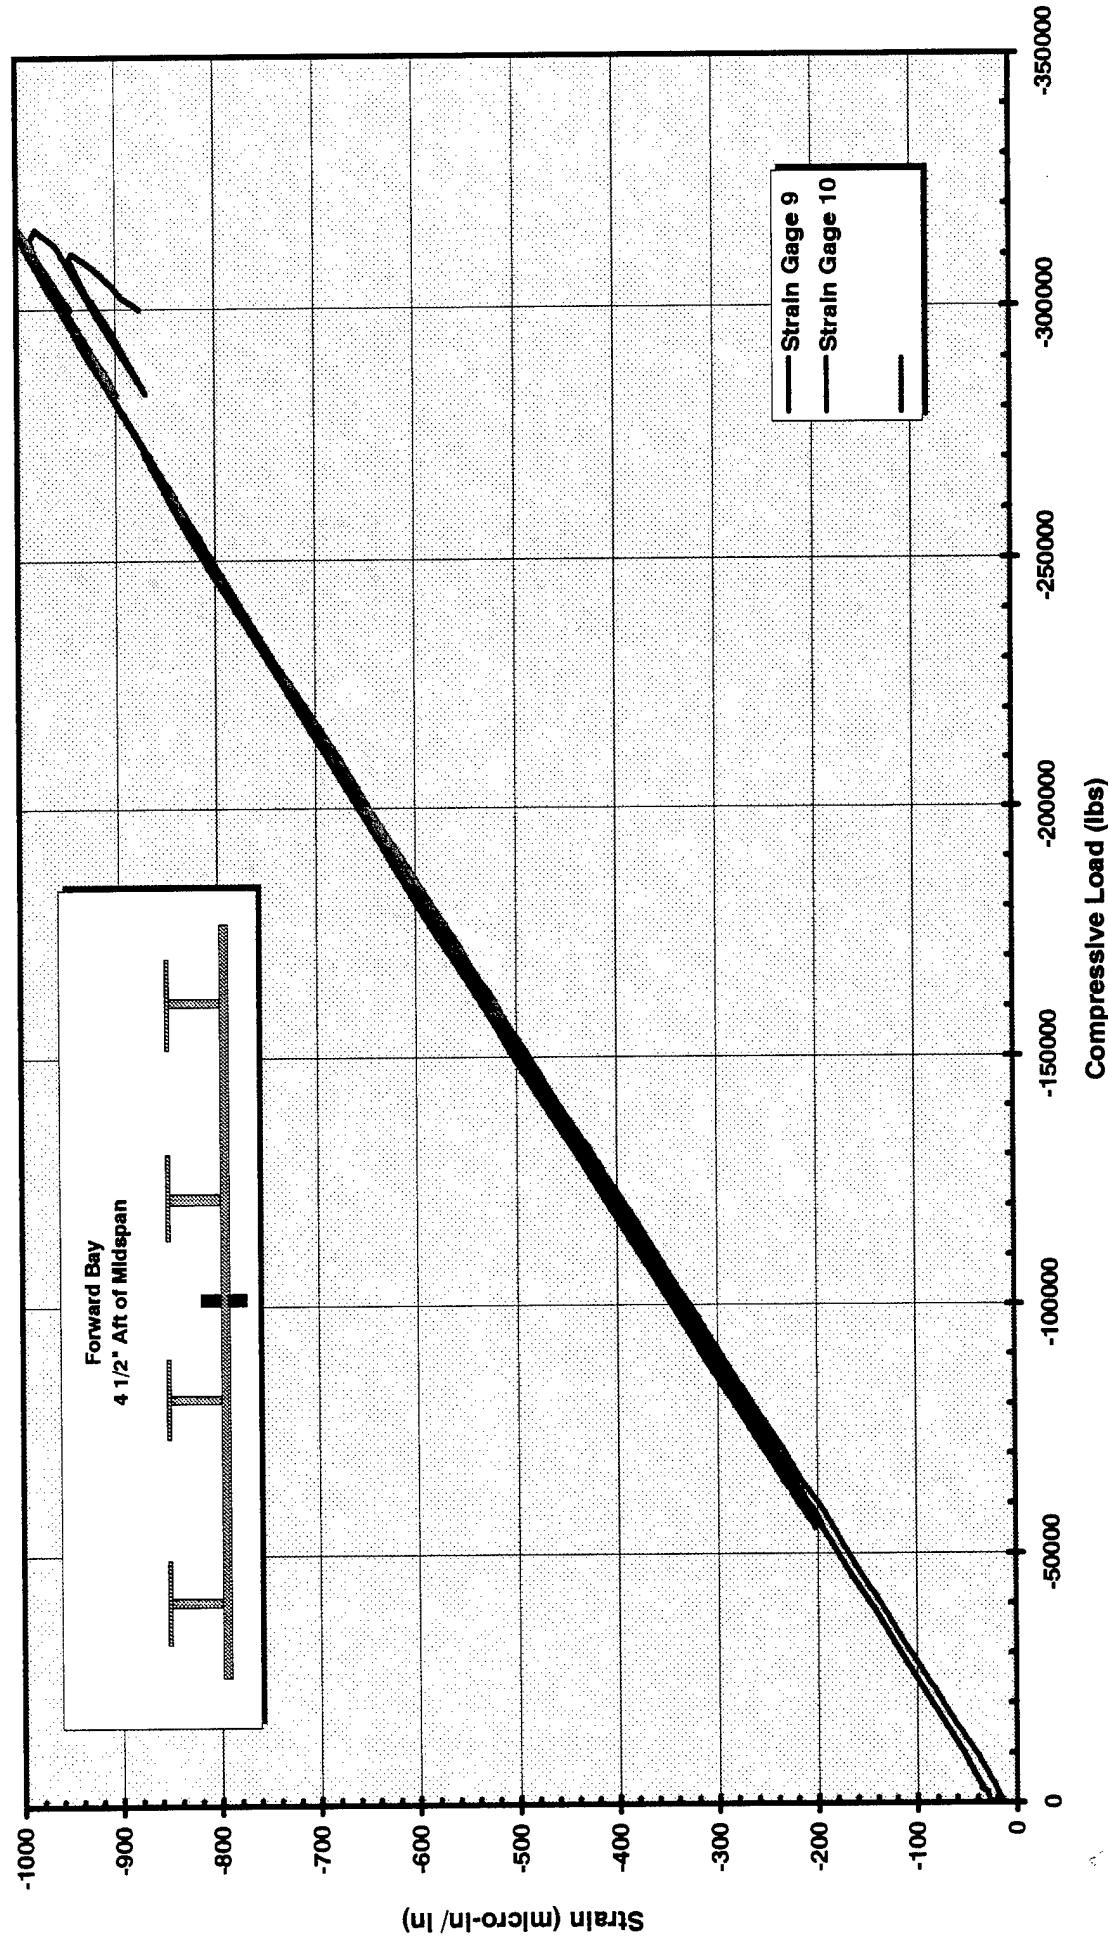
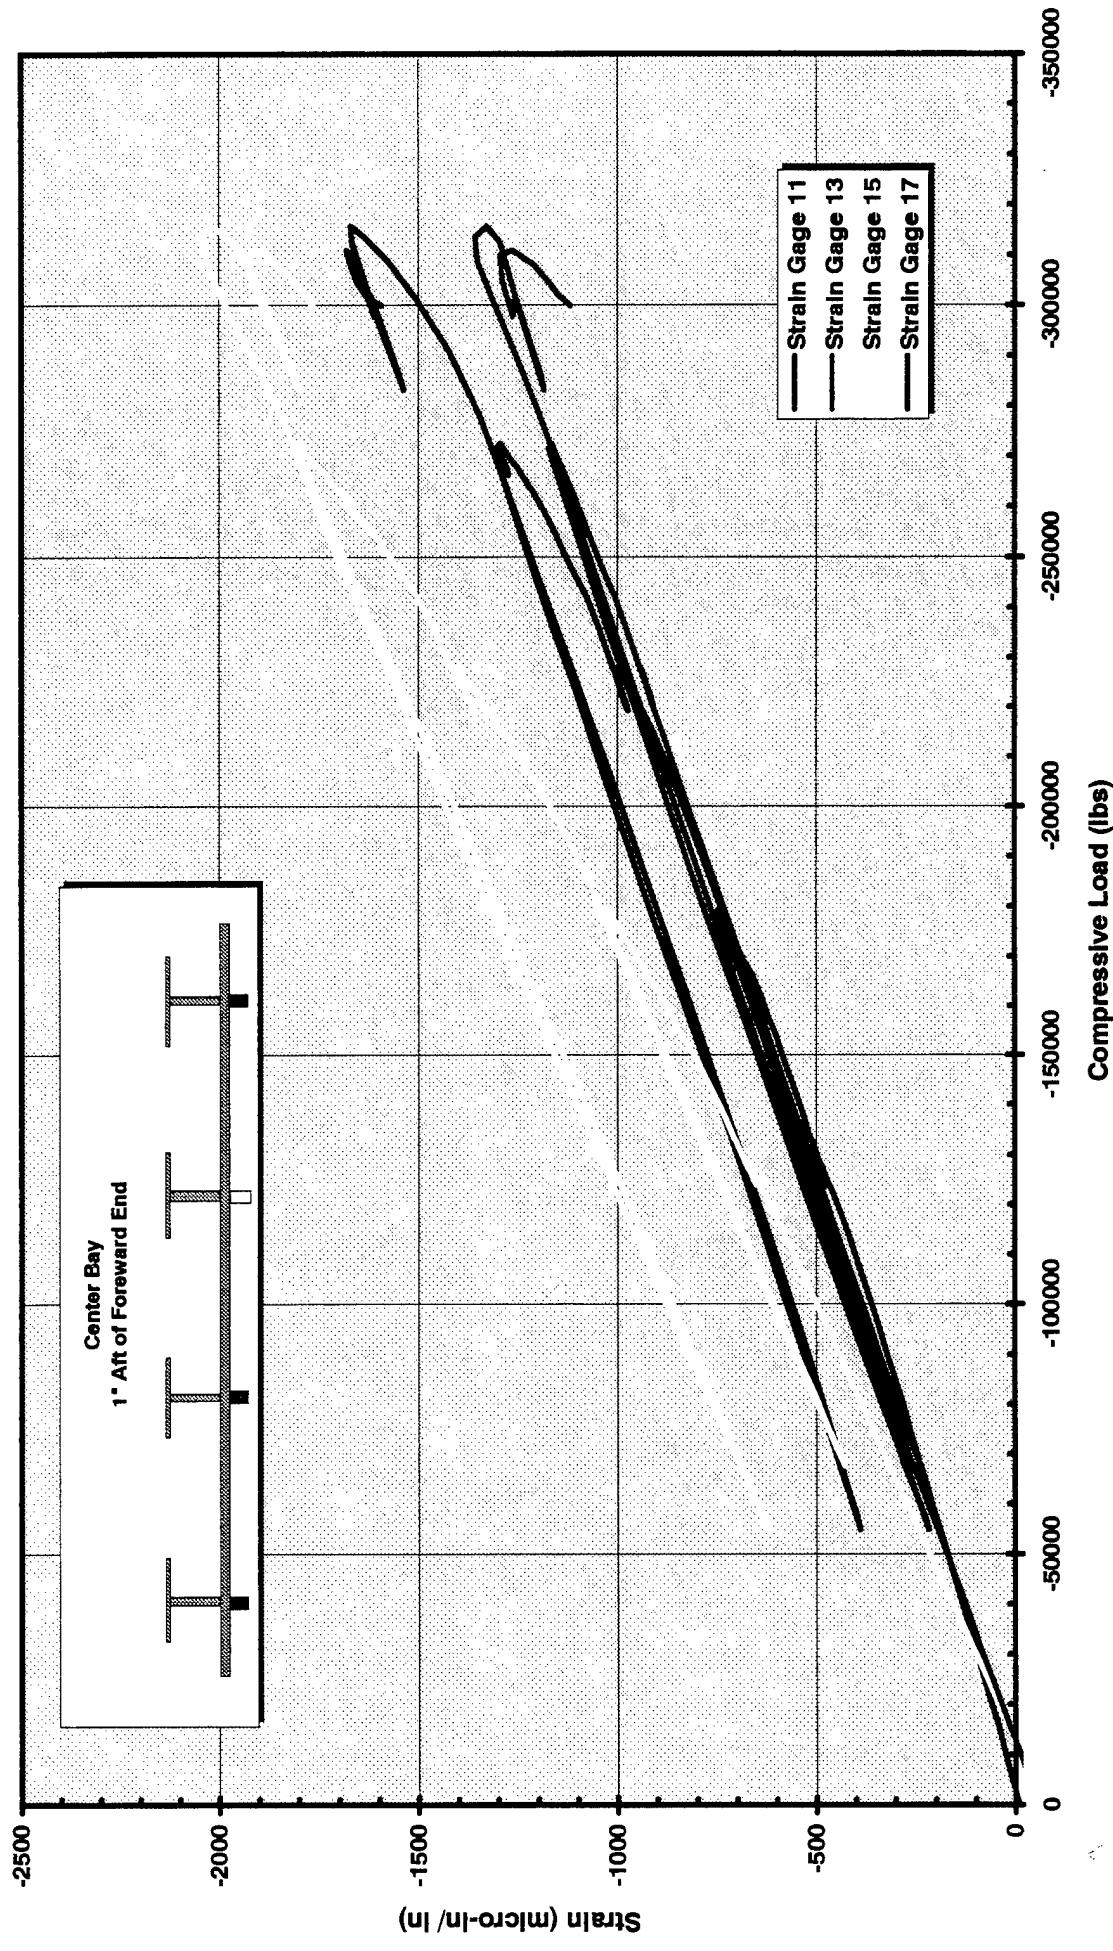
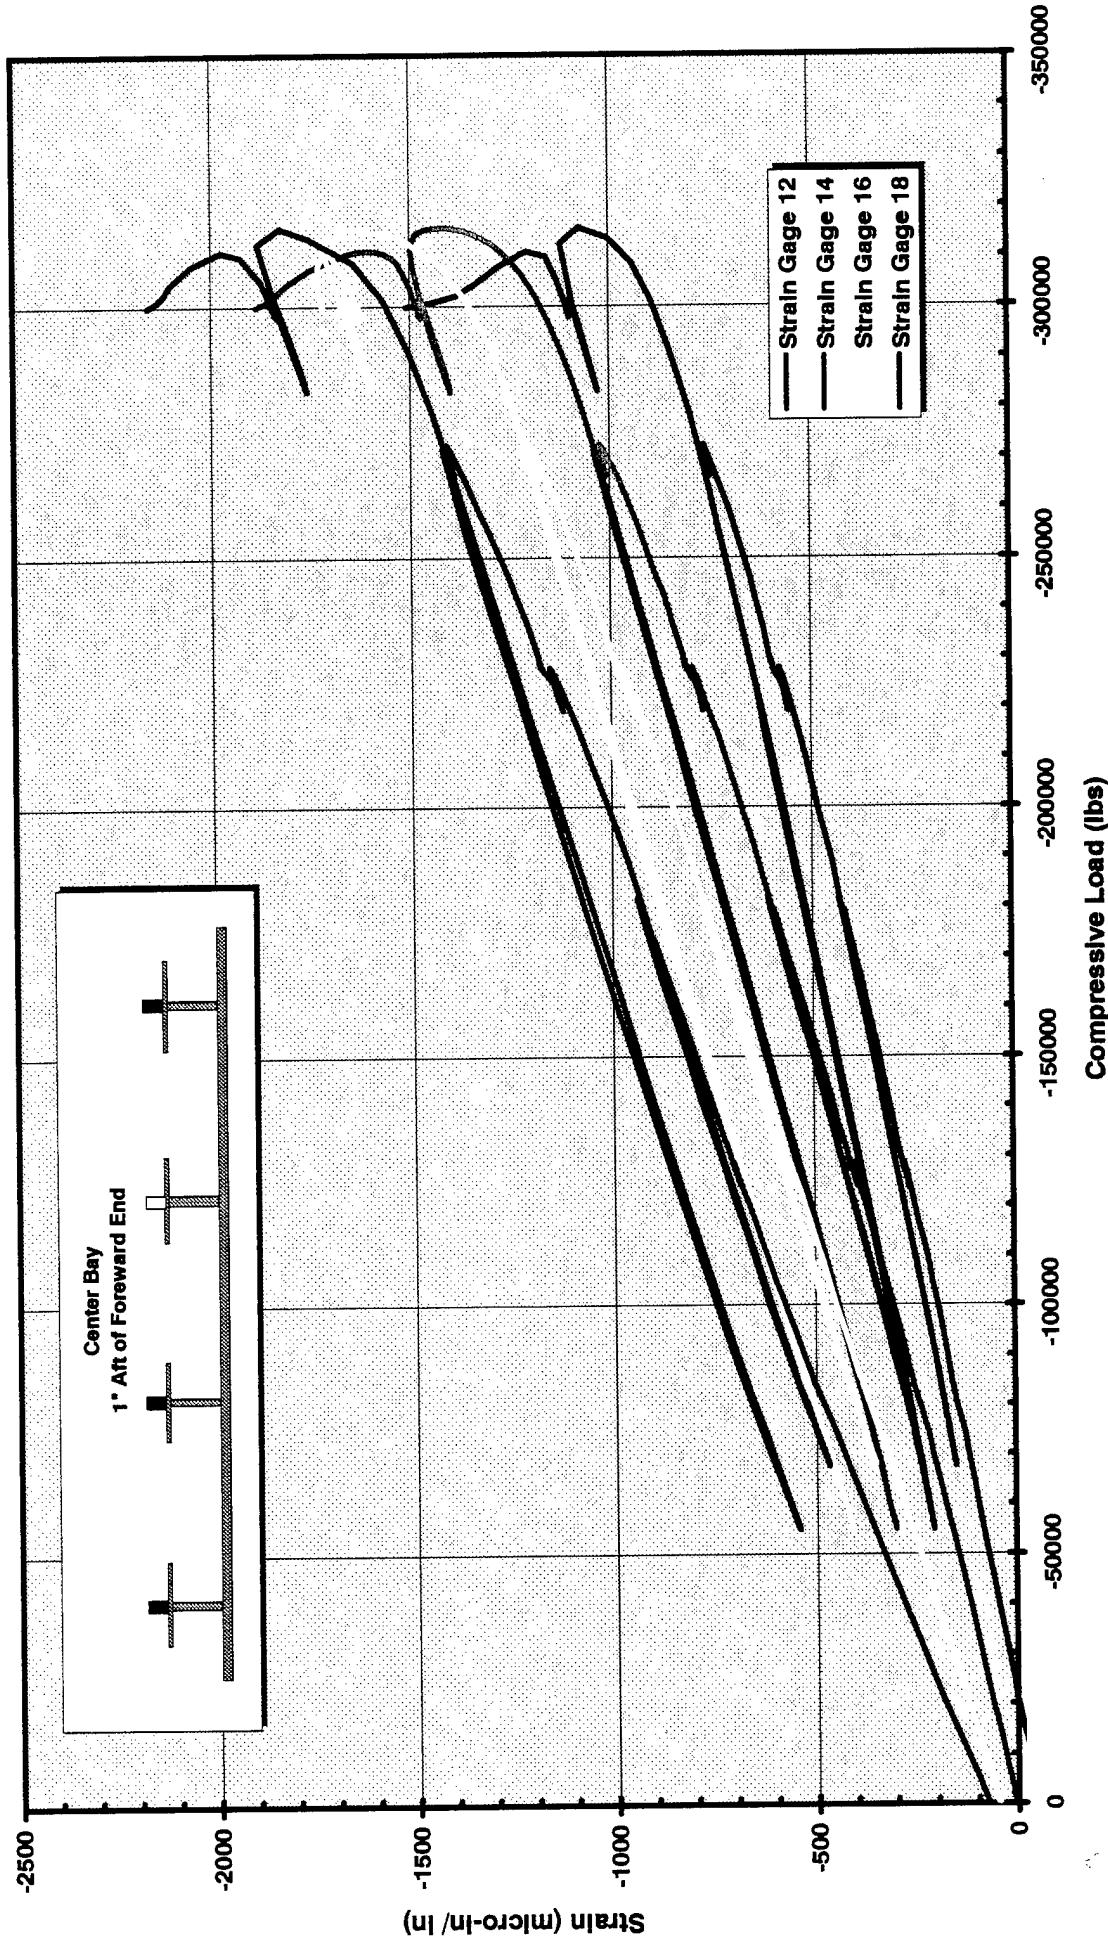
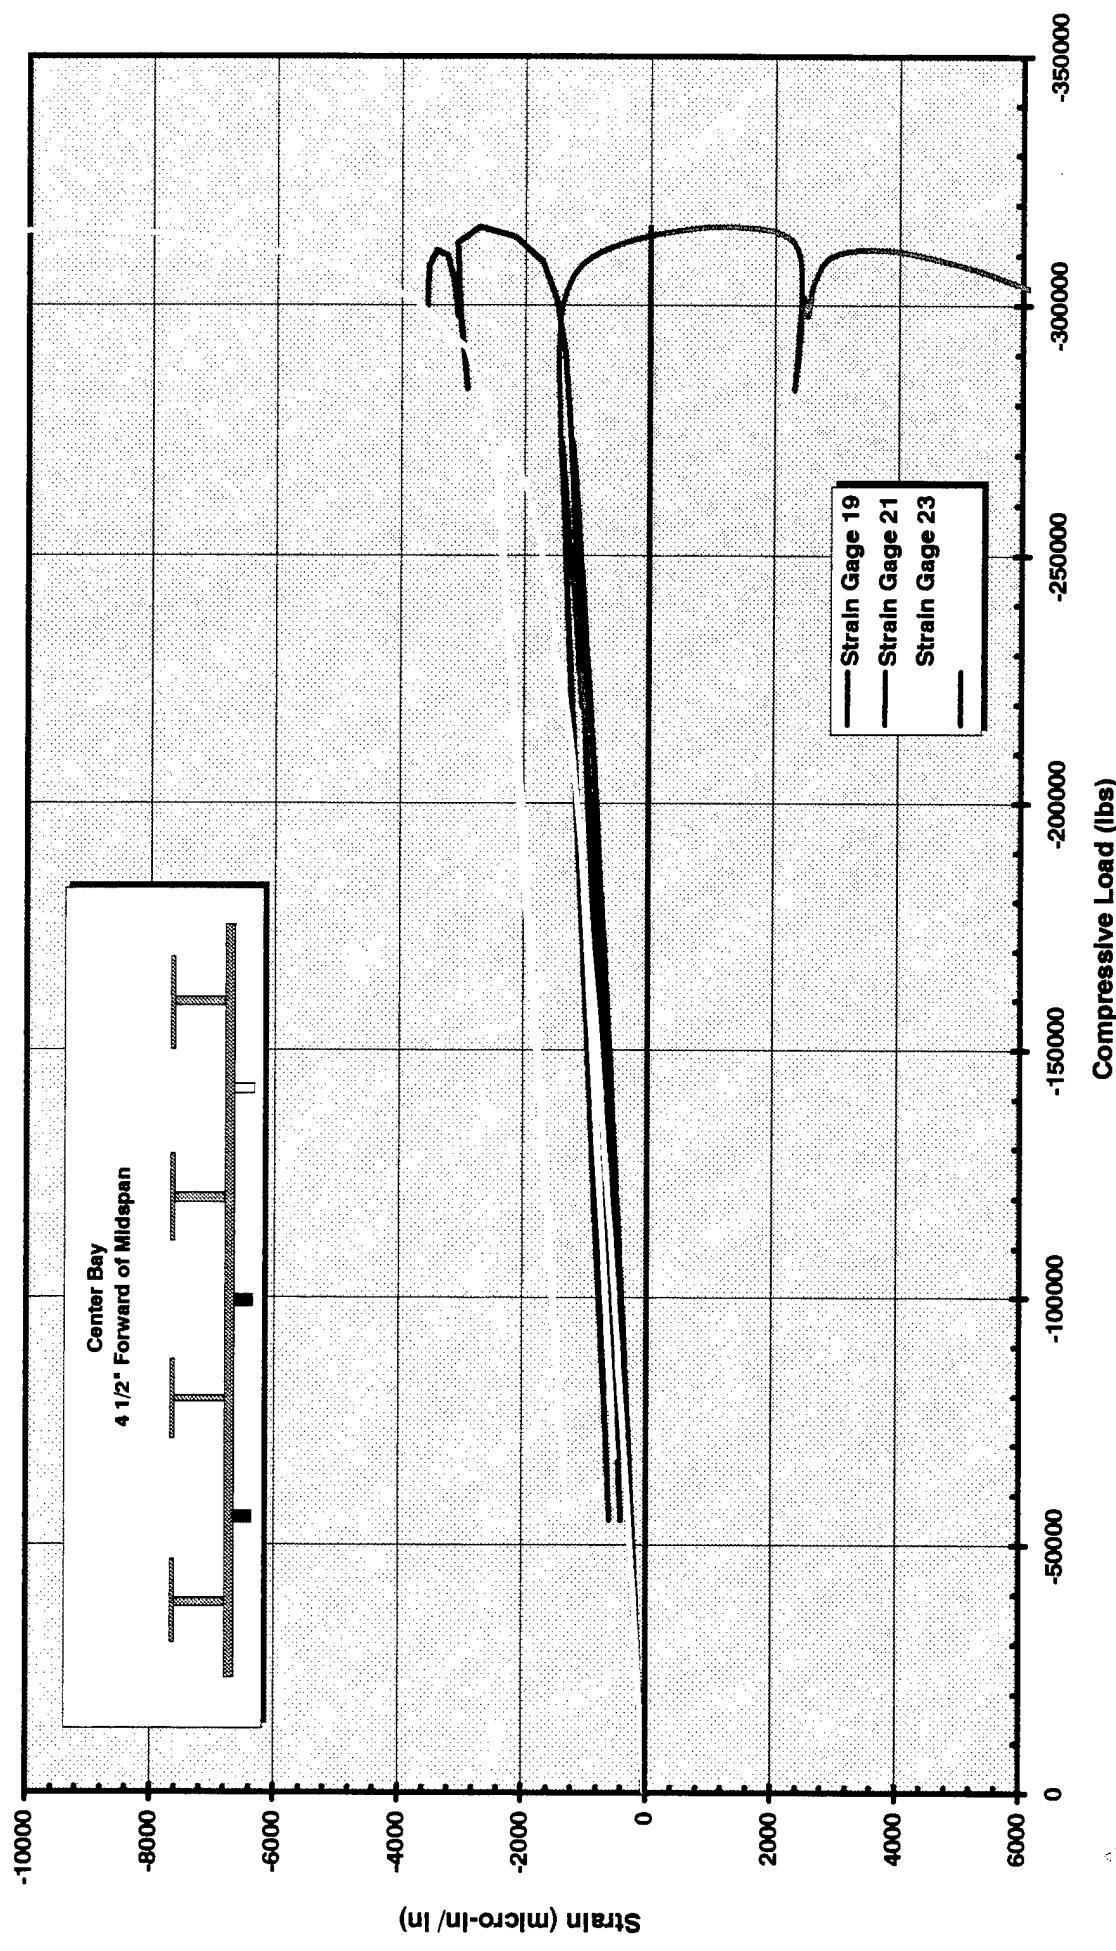
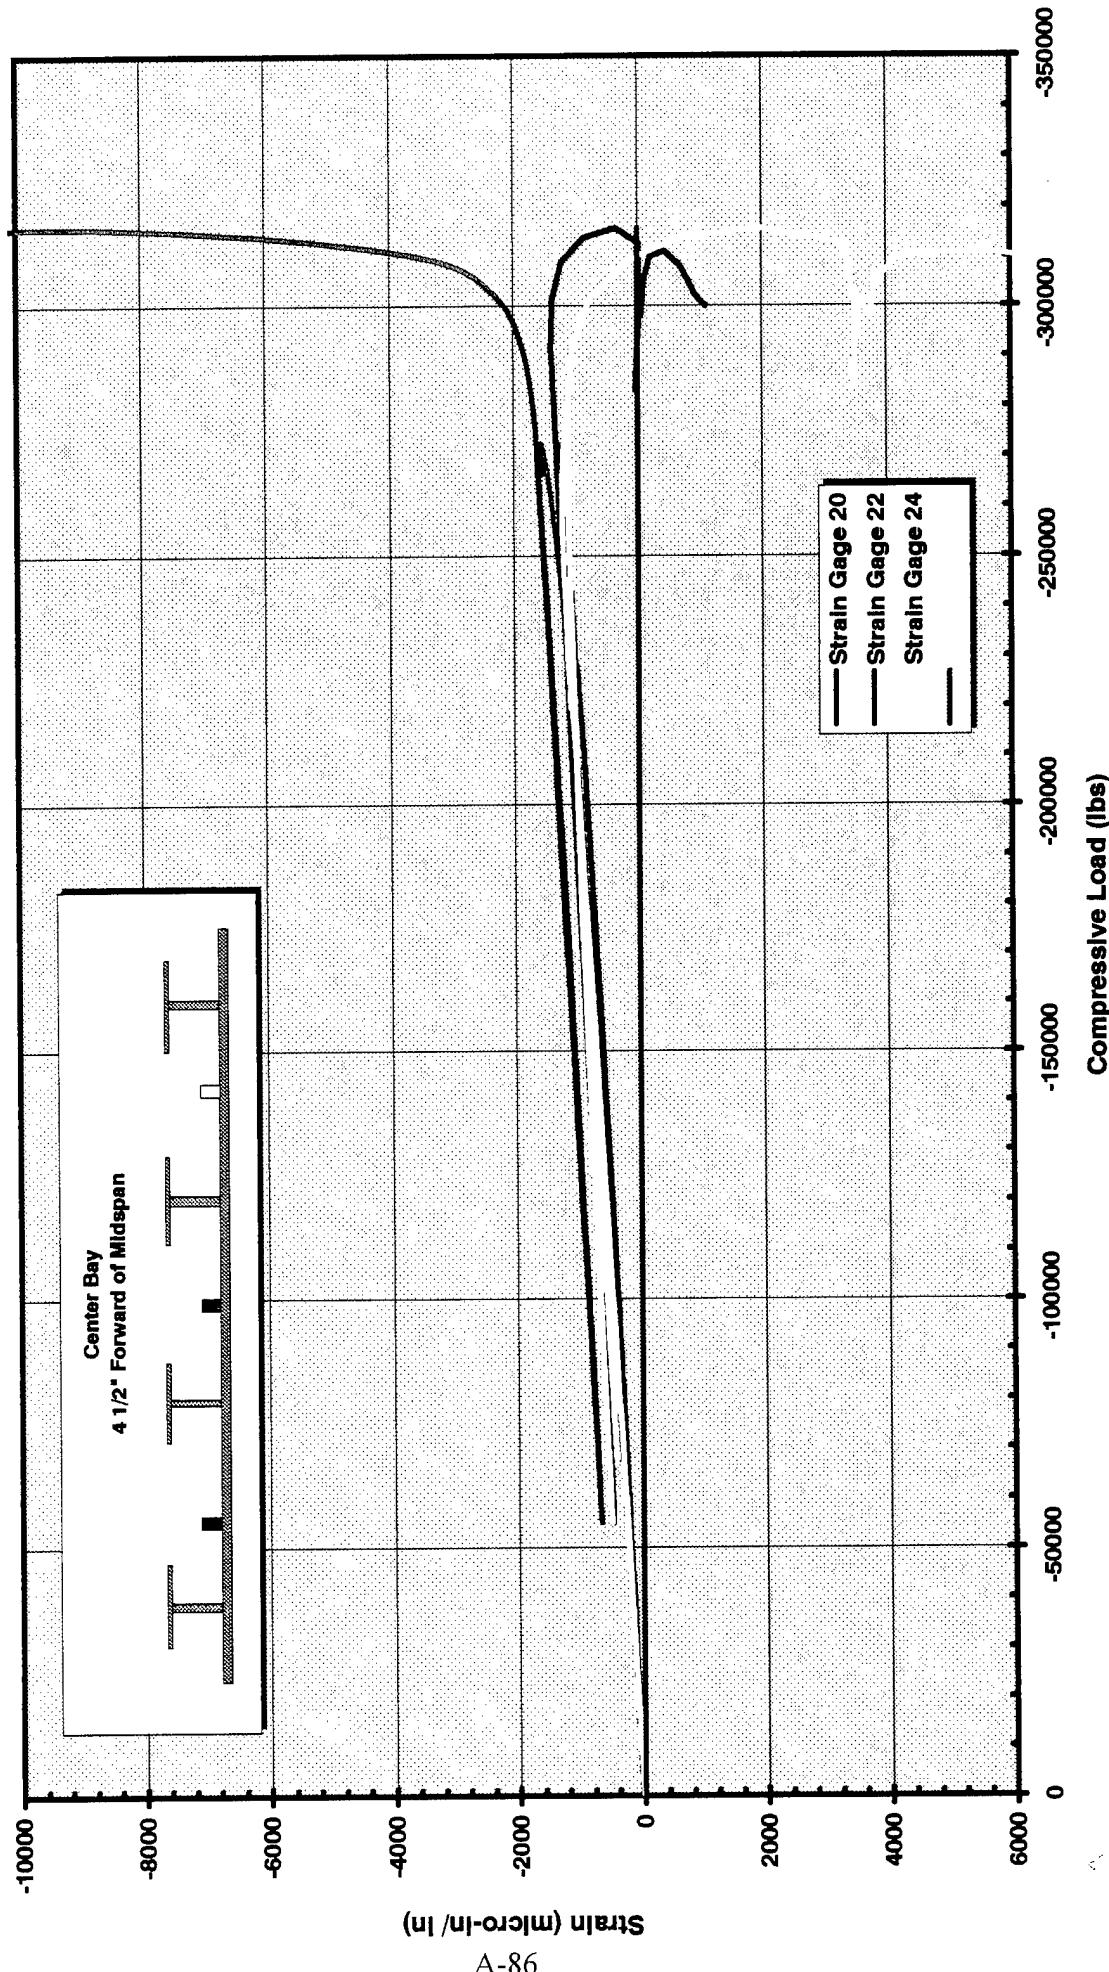
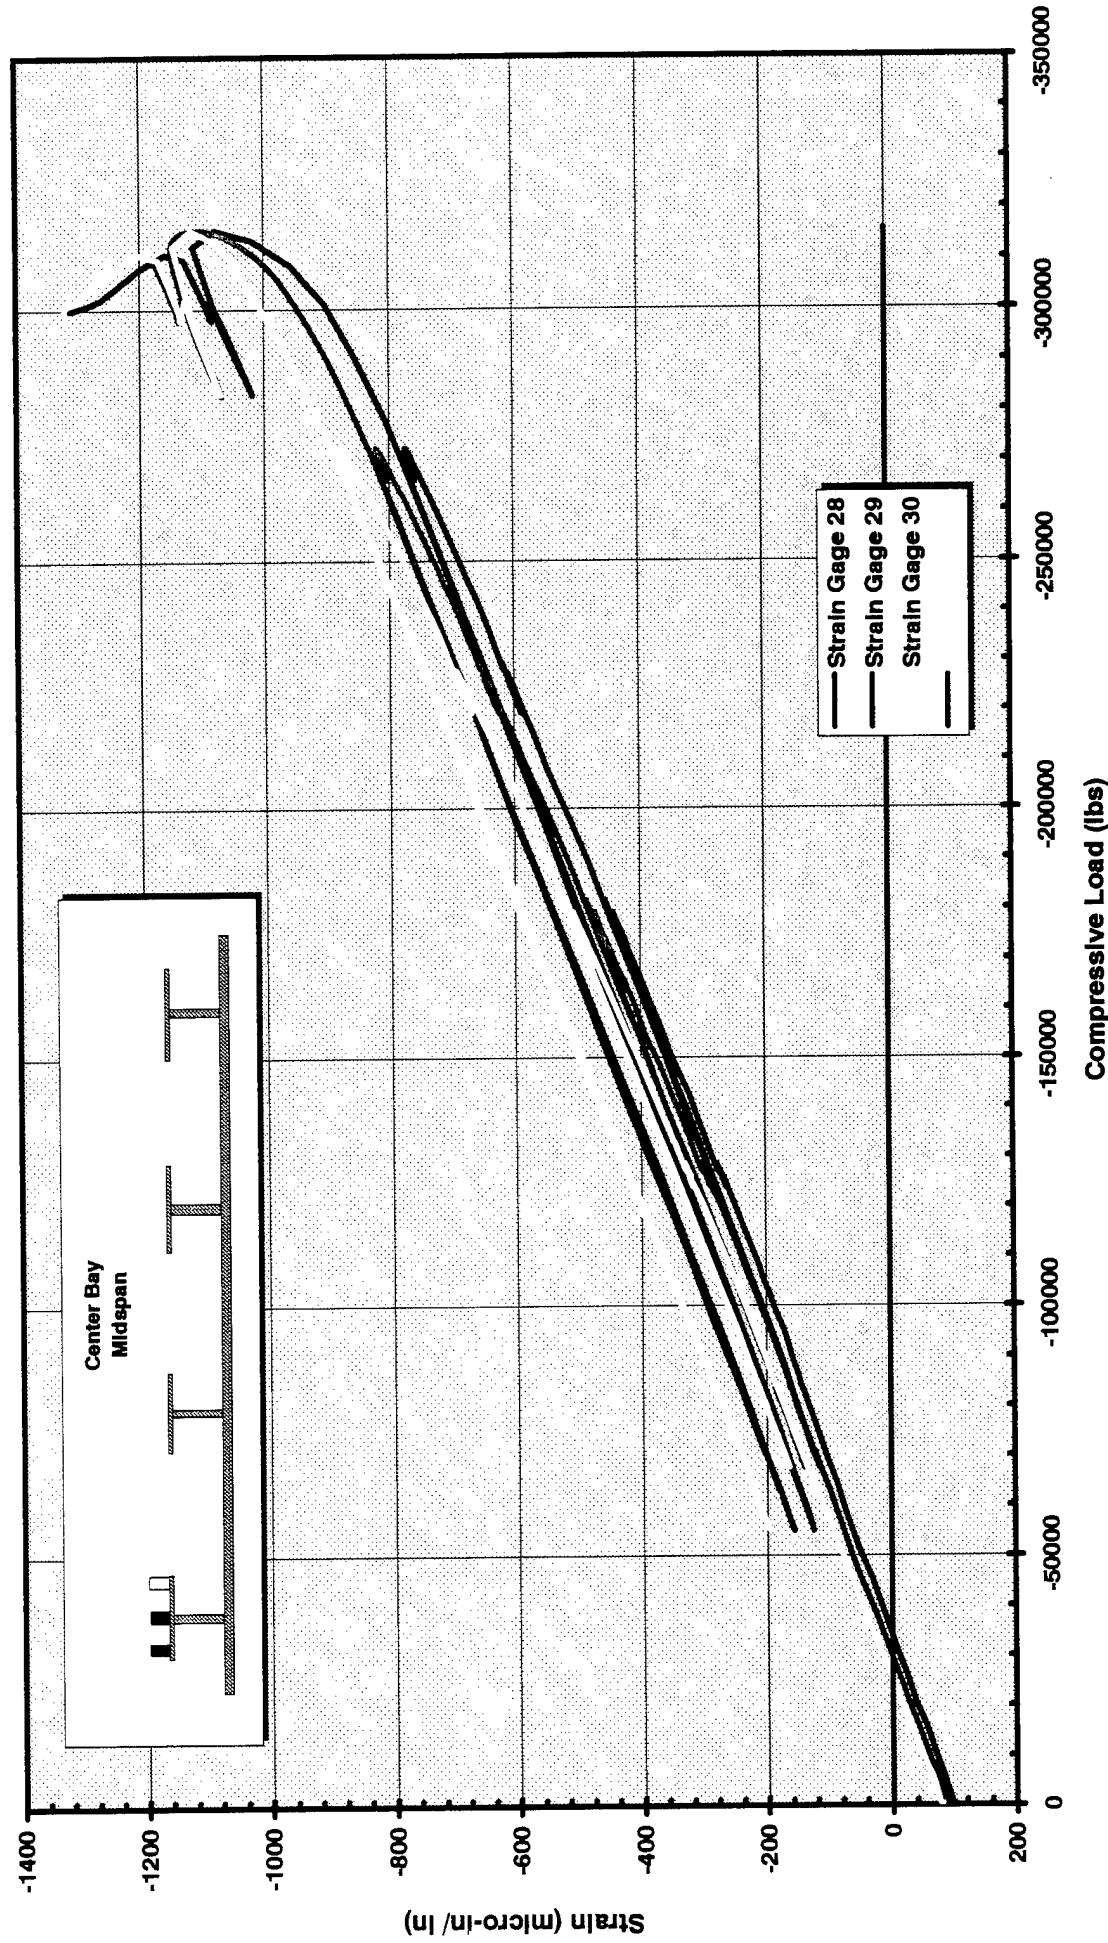
### Strain vs. Applied Load

The remainder of the figures in each group of data show plots of measured strain versus applied compressive load. The gages shown on each plot are grouped conveniently to show strain profiles across a section of the grillage, across the flange of a stiffener, or on sections of plating between stiffeners.

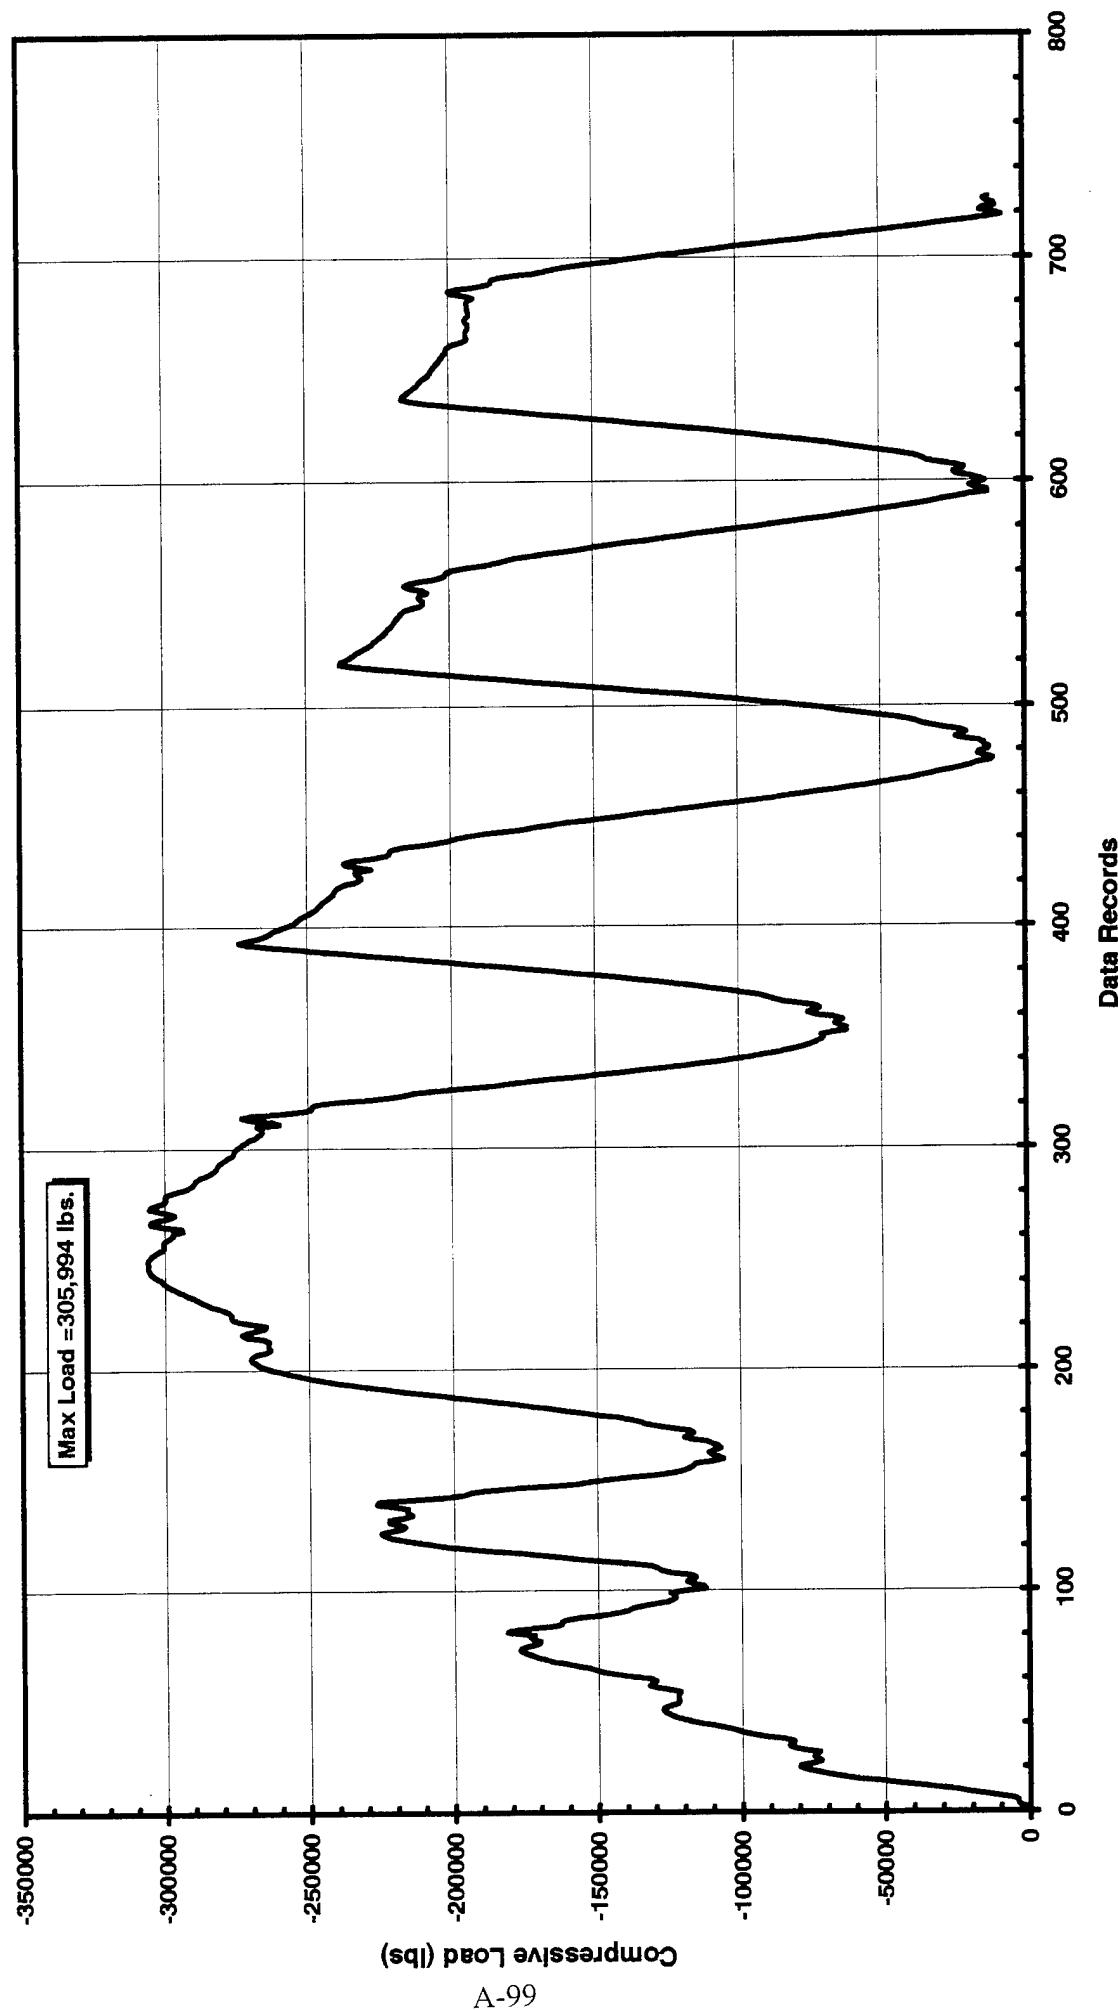
**Specimen 0695      Axial and Lateral Load**

**Load History**

The data obtained from each test were similar and are therefore arranged in the same order and in the same format for each test specimen. At the beginning of each section, the first plot shows a time history of the compressive load applied to the test specimen, where "time" is measured as data records acquired. This plot shows how the specimen was loaded in increments, periodically unloaded and reloaded up to and beyond failure.

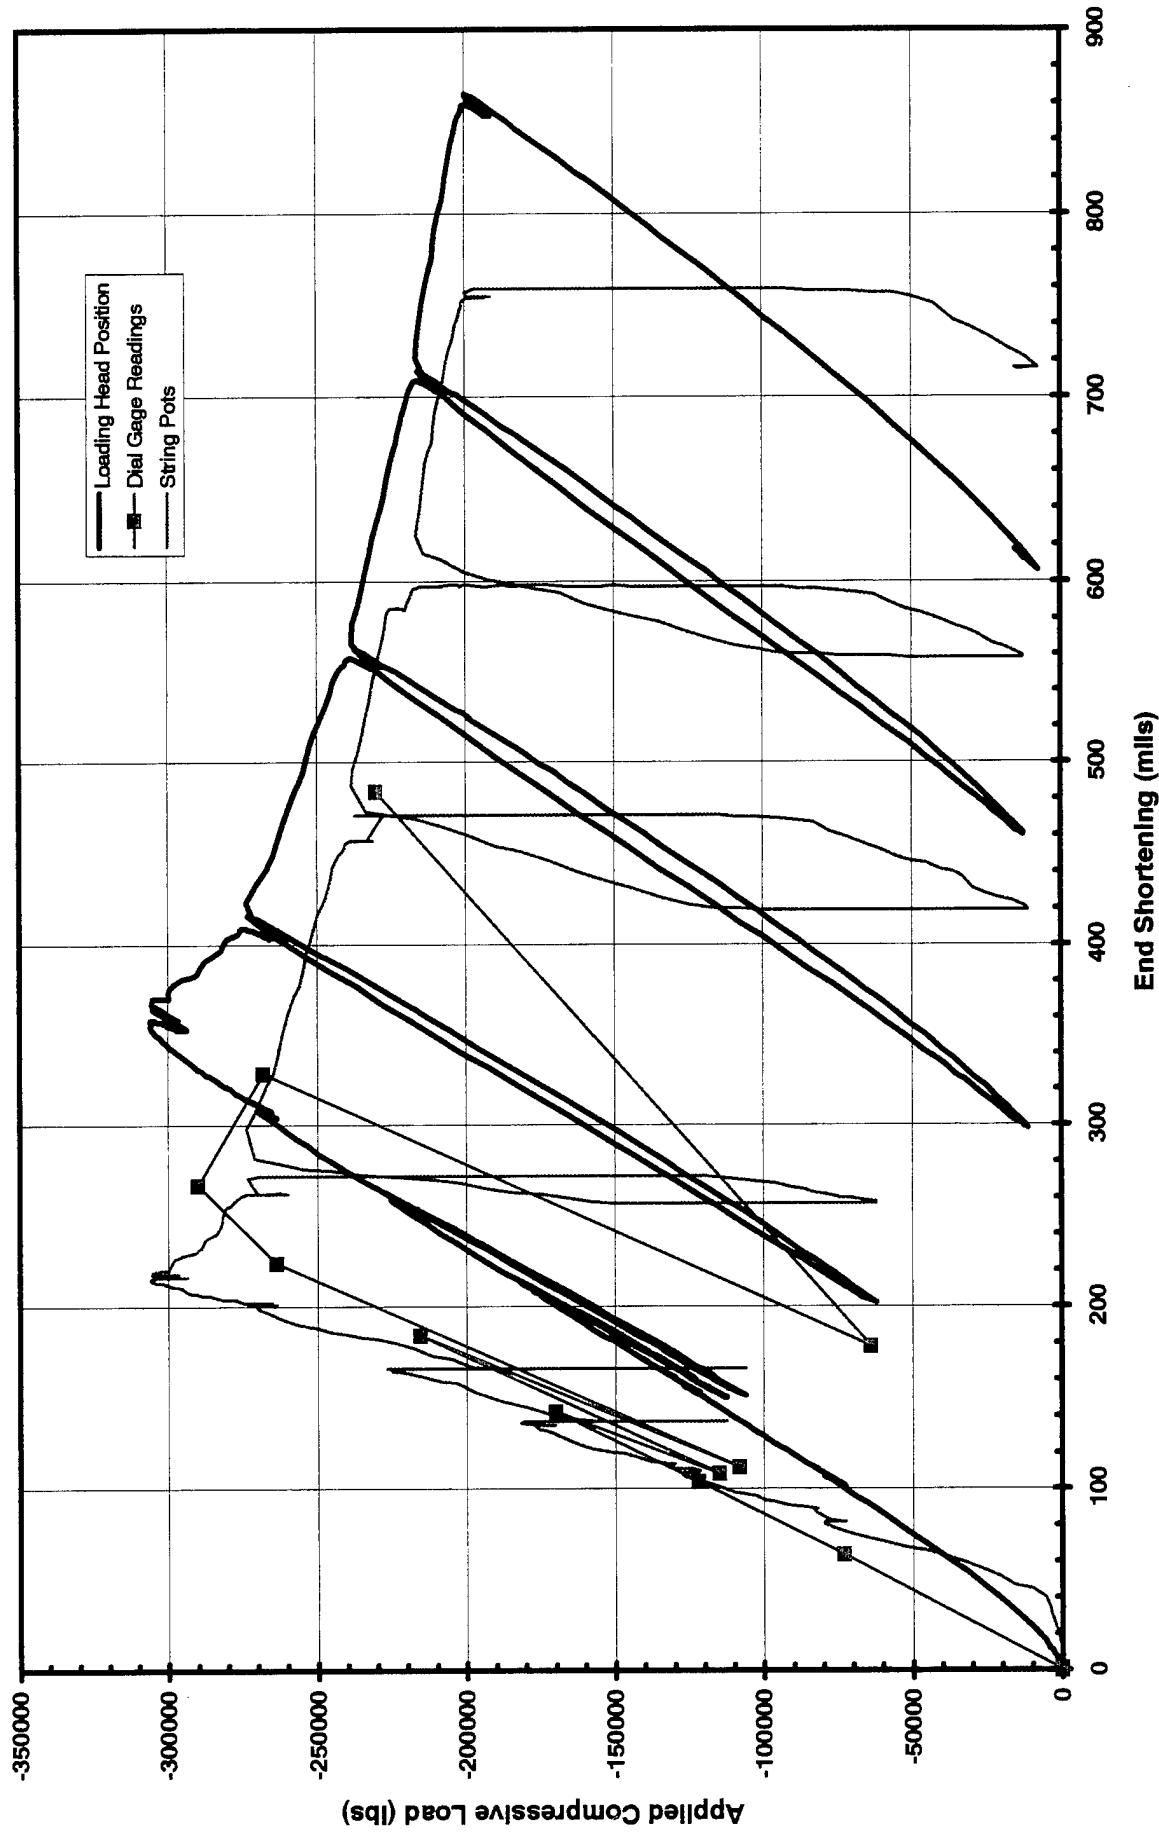
## Load vs. End Shortening

The next plot is one of end shortening versus compressive load applied. As discussed earlier, the plots may vary somewhat from specimen to specimen, depending on how the end

shortening measurement was made (string pots, actuator LVDT, or dial gages).
