**NSWCCD-TR-65-97/18 April 1997**

Survivability, Structures, and Materials Directorate  
Technical Report

## **An Experimental Investigation of the Ultimate Strength of Stiffened Panels**

### **- Volume 2, Test Data**

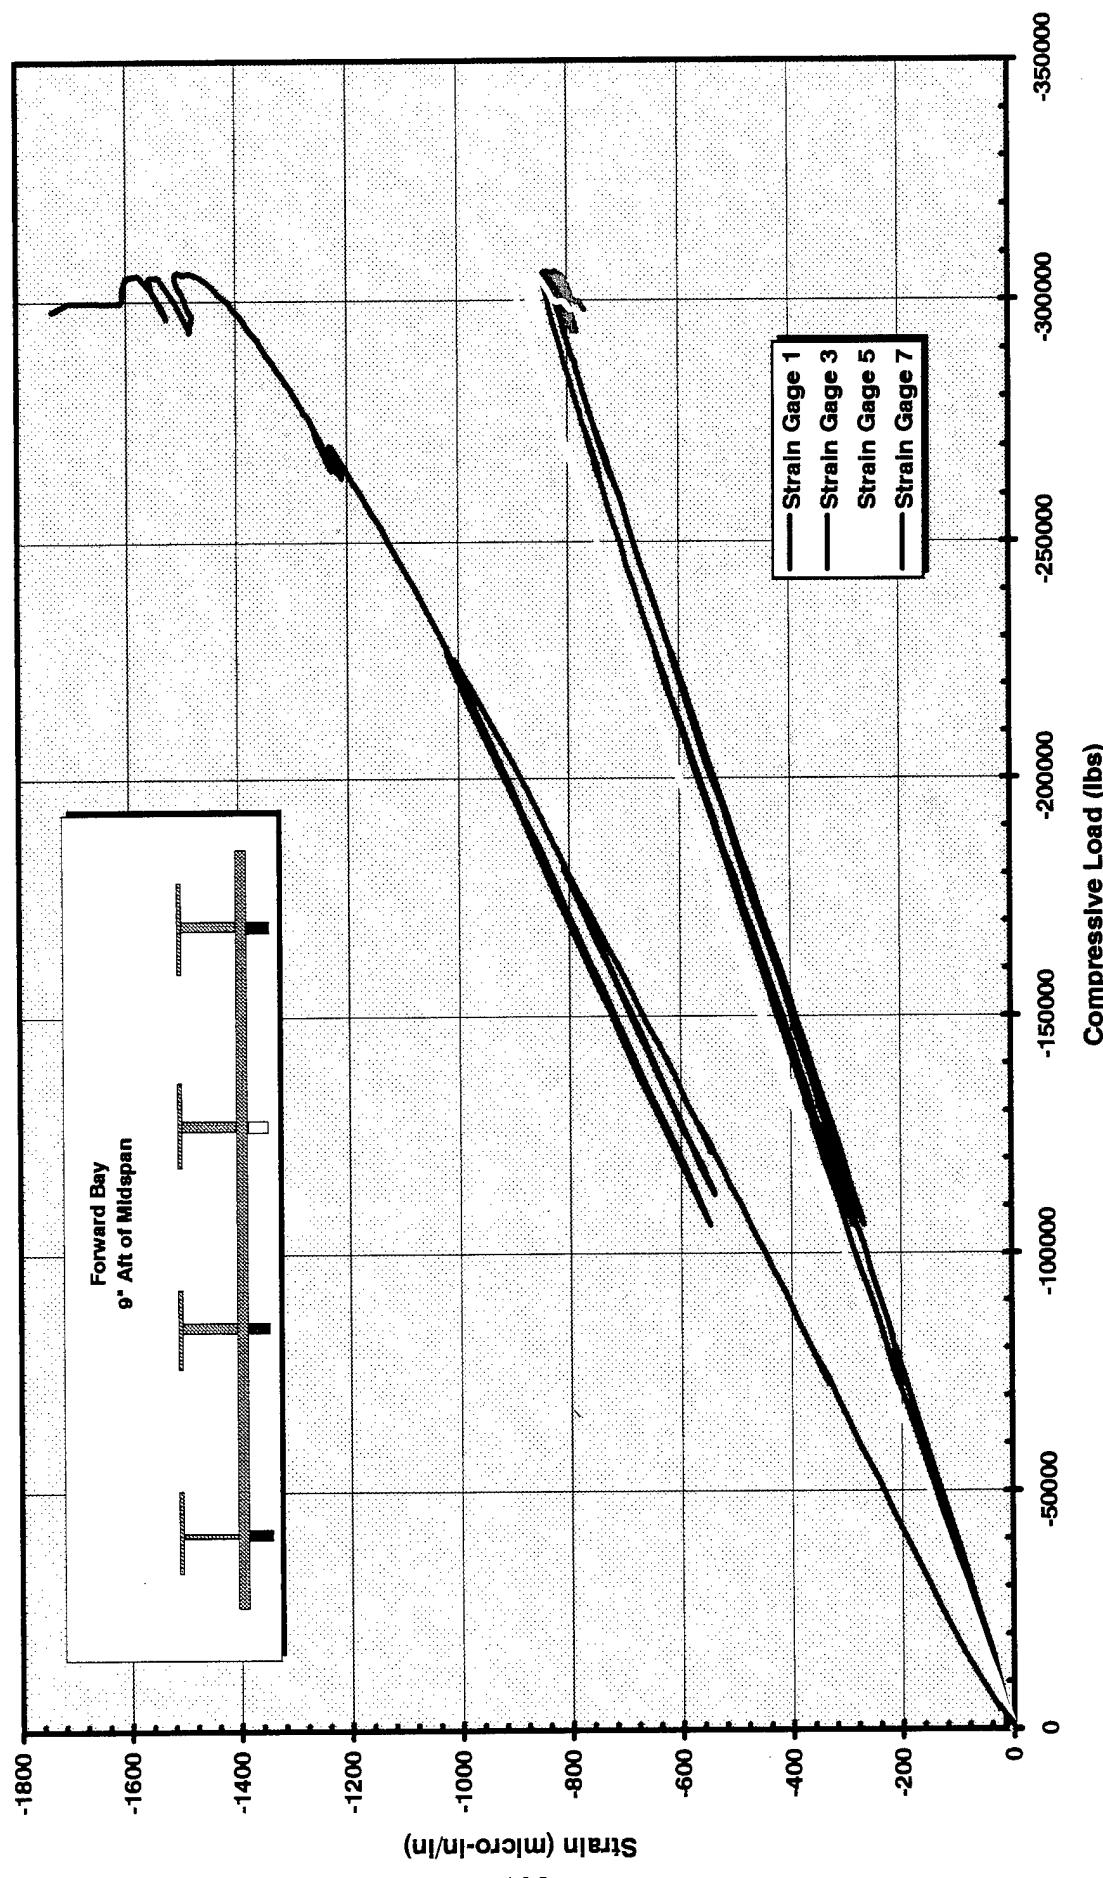
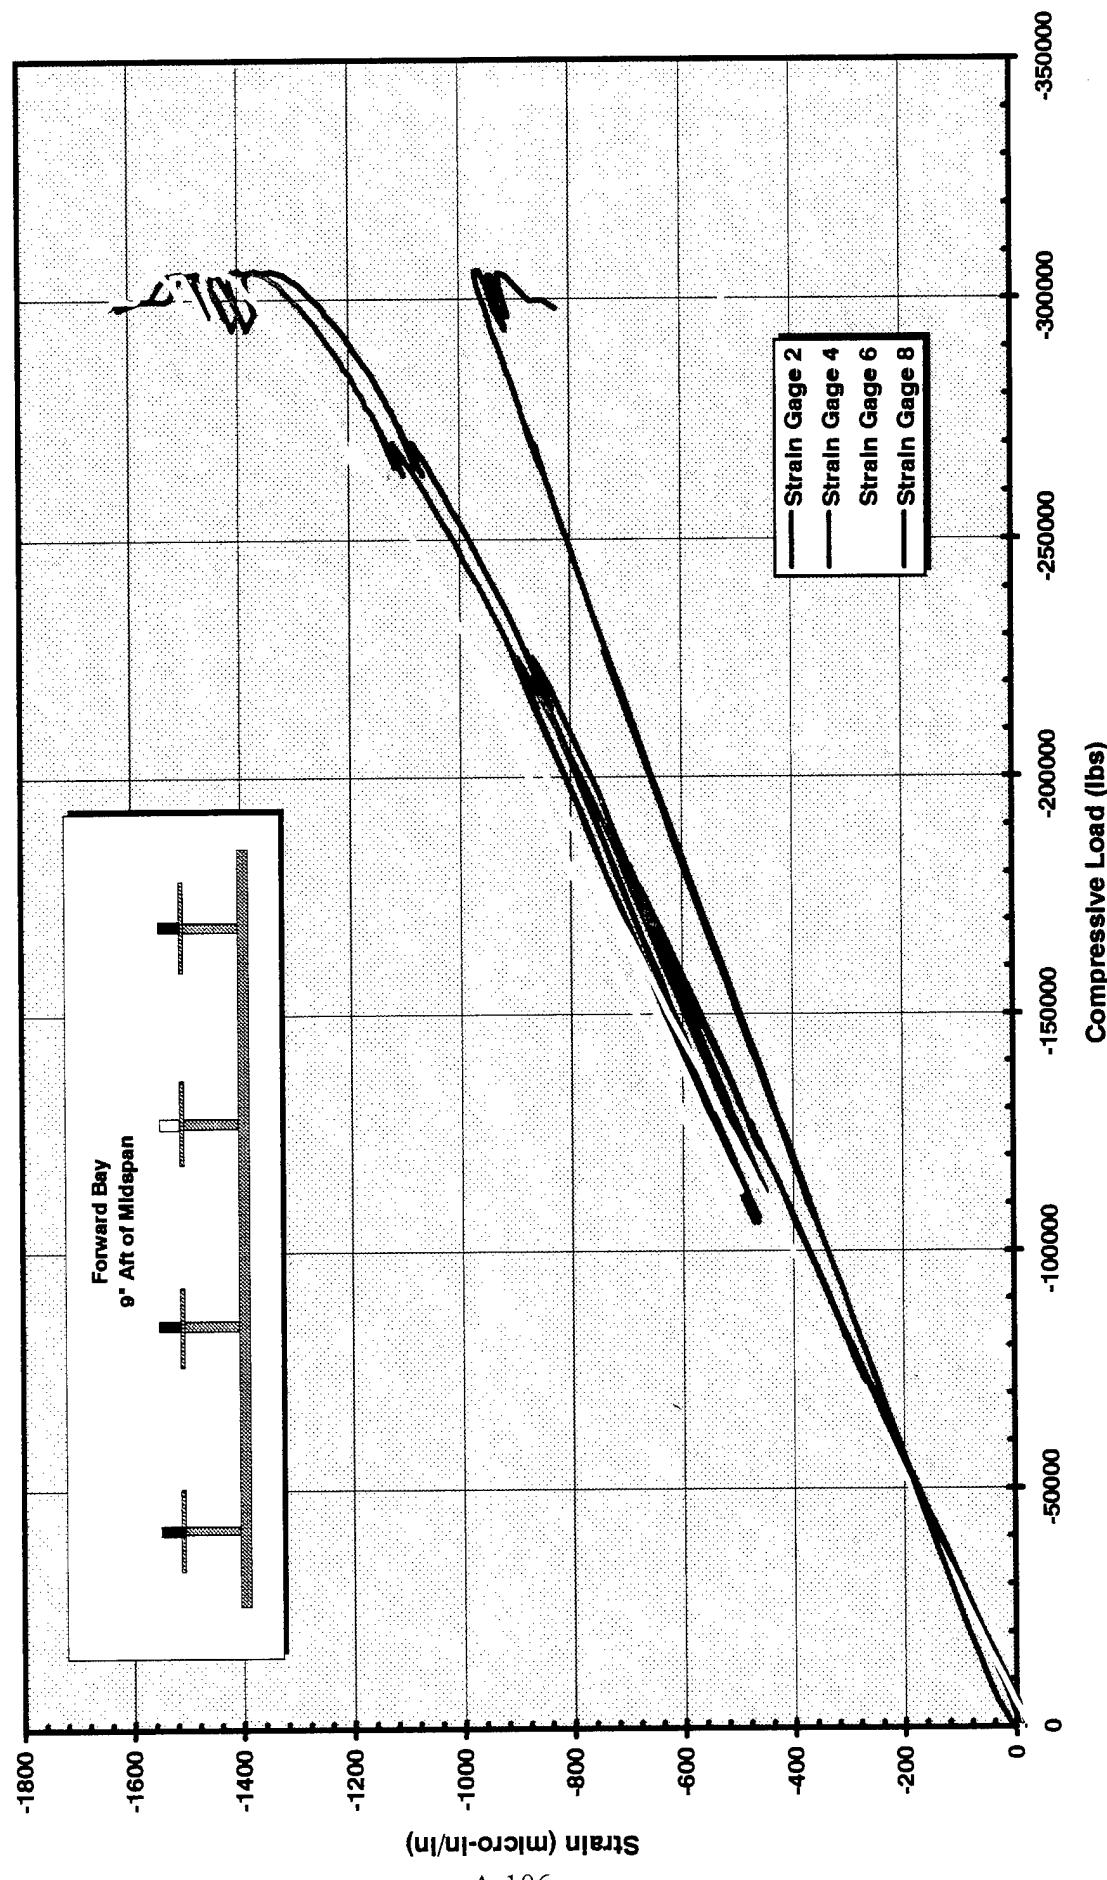
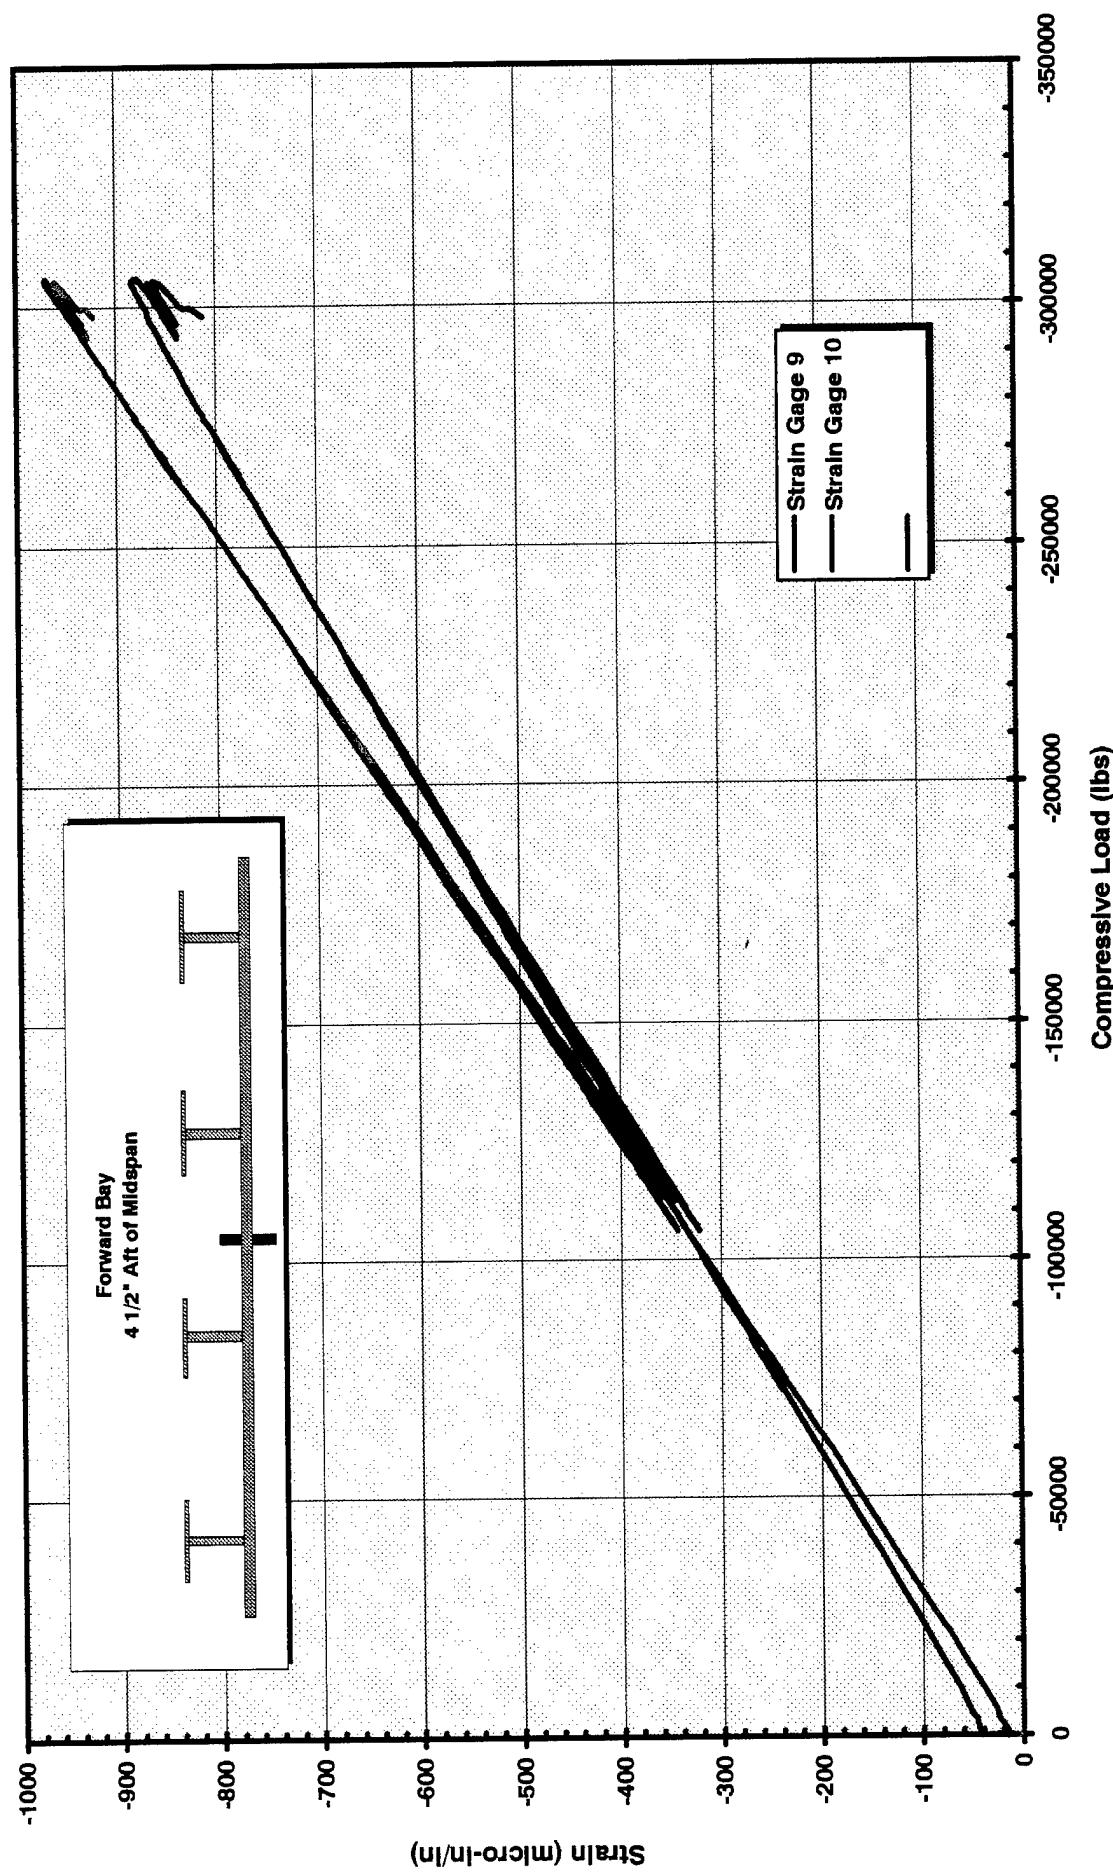
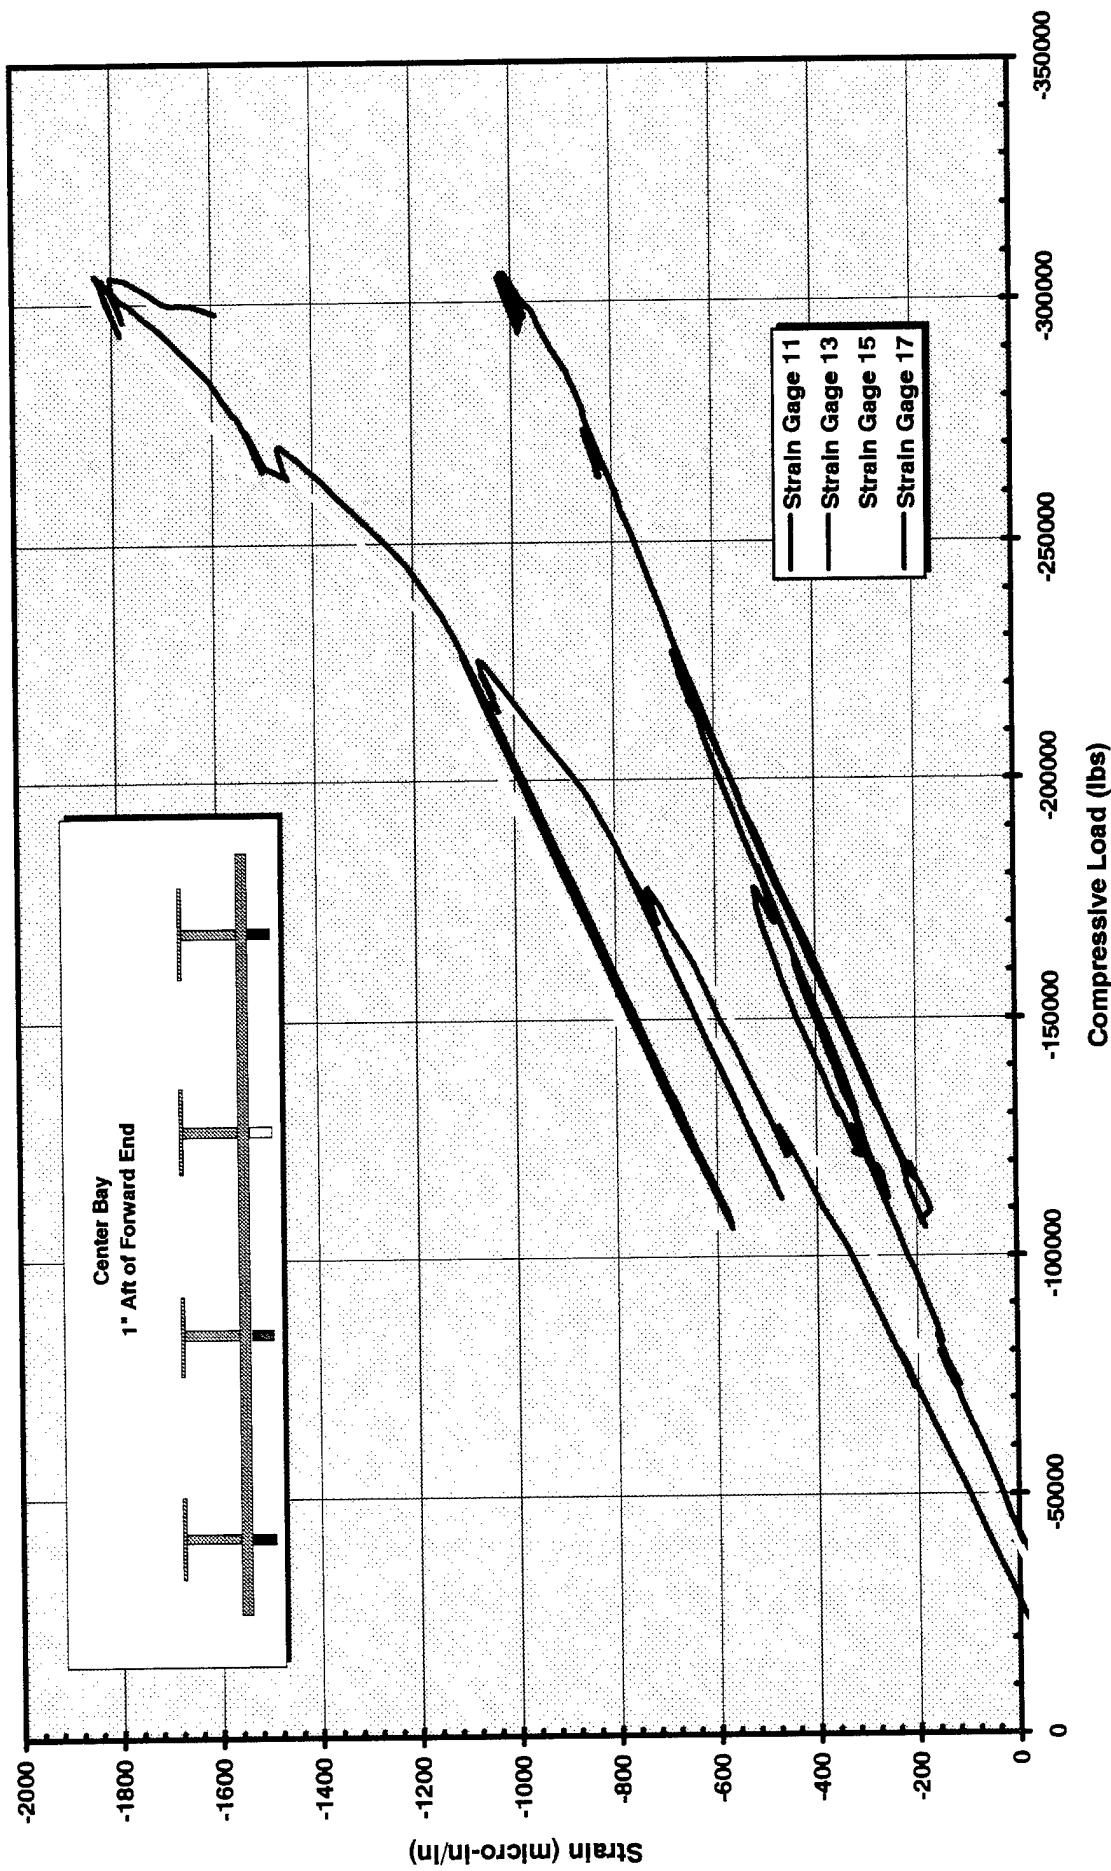
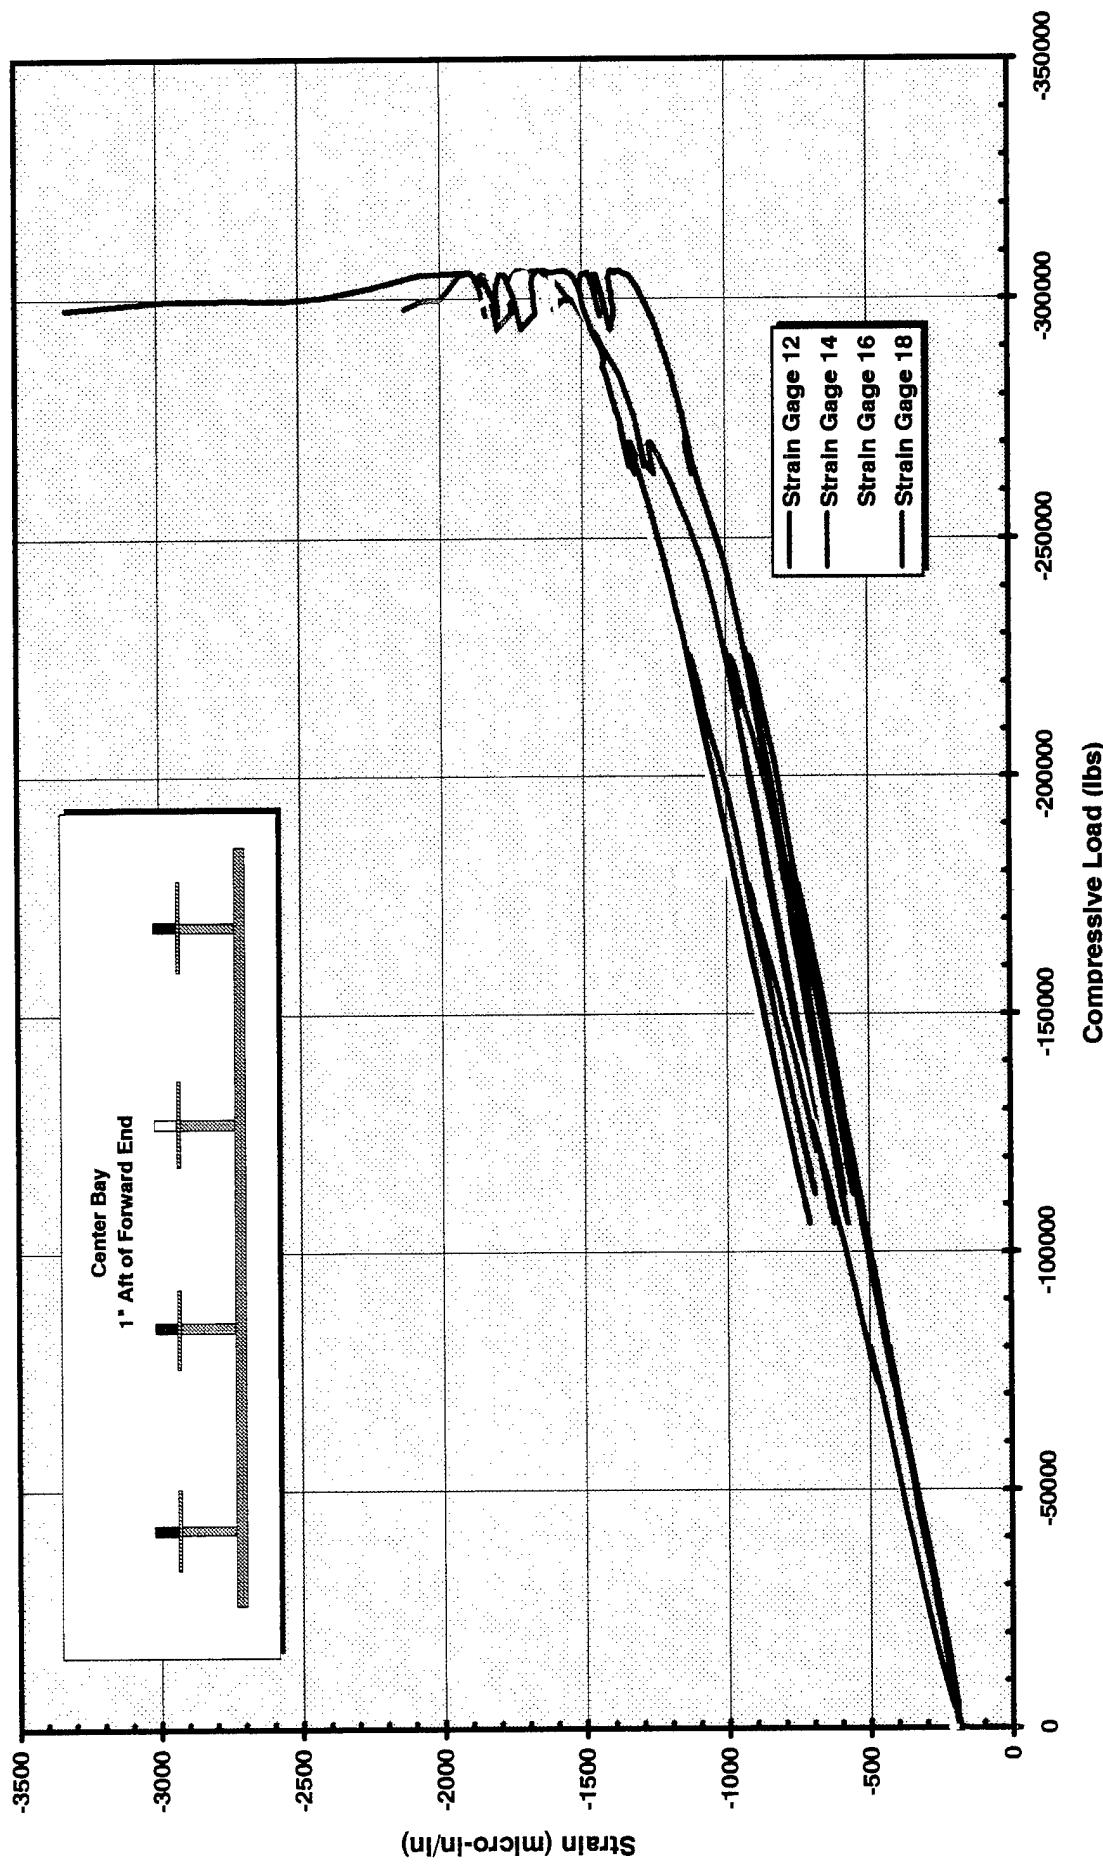
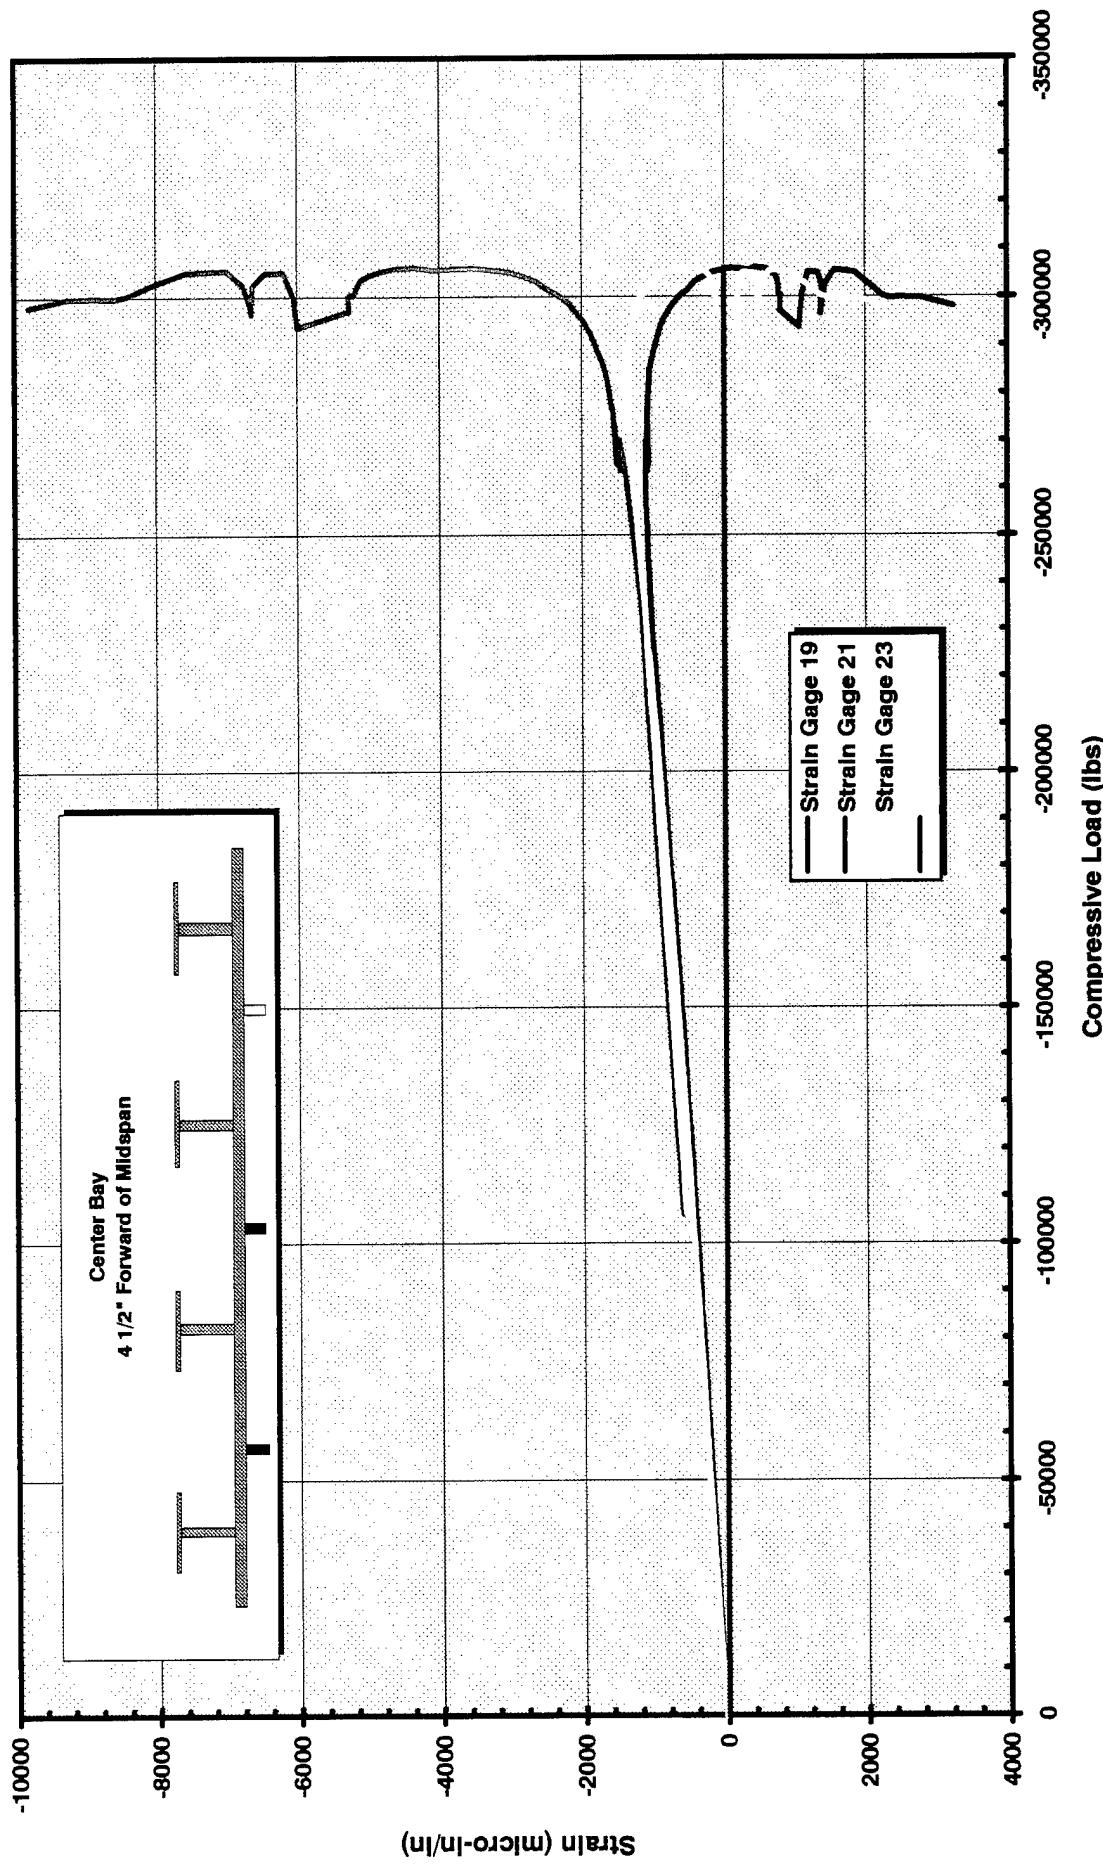
**Strain vs. Applied Load**

The remainder of the figures in each group of data show plots of measured strain versus applied compressive load. The gages shown on each plot are grouped conveniently to show strain profiles across a section of the grillage, across the flange of a stiffener, or on sections of plating between stiffeners.

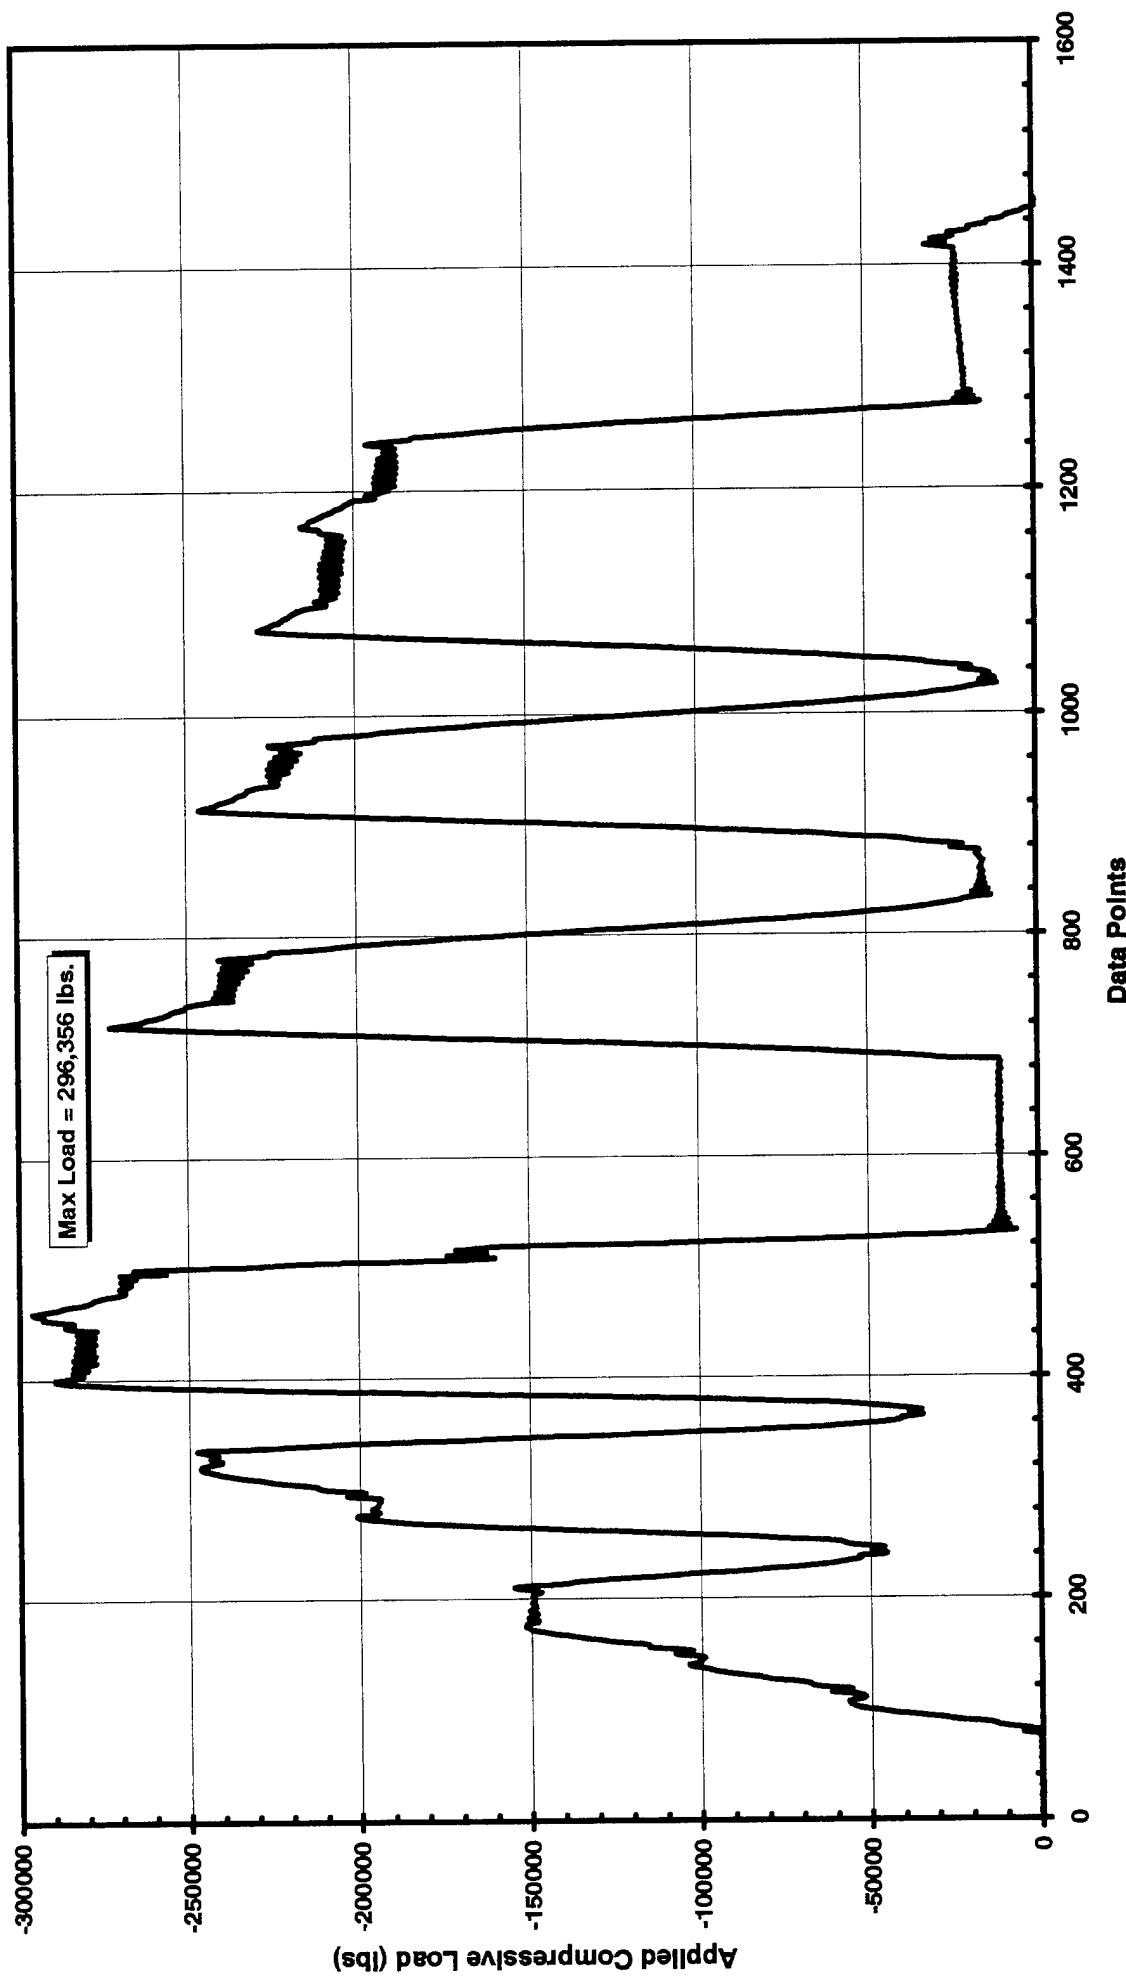
**Specimen 0995 Axial and Lateral Load**

## Load History

The data obtained from each test were similar and are therefore arranged in the same order and in the same format for each test specimen. At the beginning of each section, the first plot shows a time history of the compressive load applied to the test specimen, where "time" is measured as data records acquired. This plot shows how the specimen was loaded in increments, periodically unloaded and reloaded up to and beyond failure.

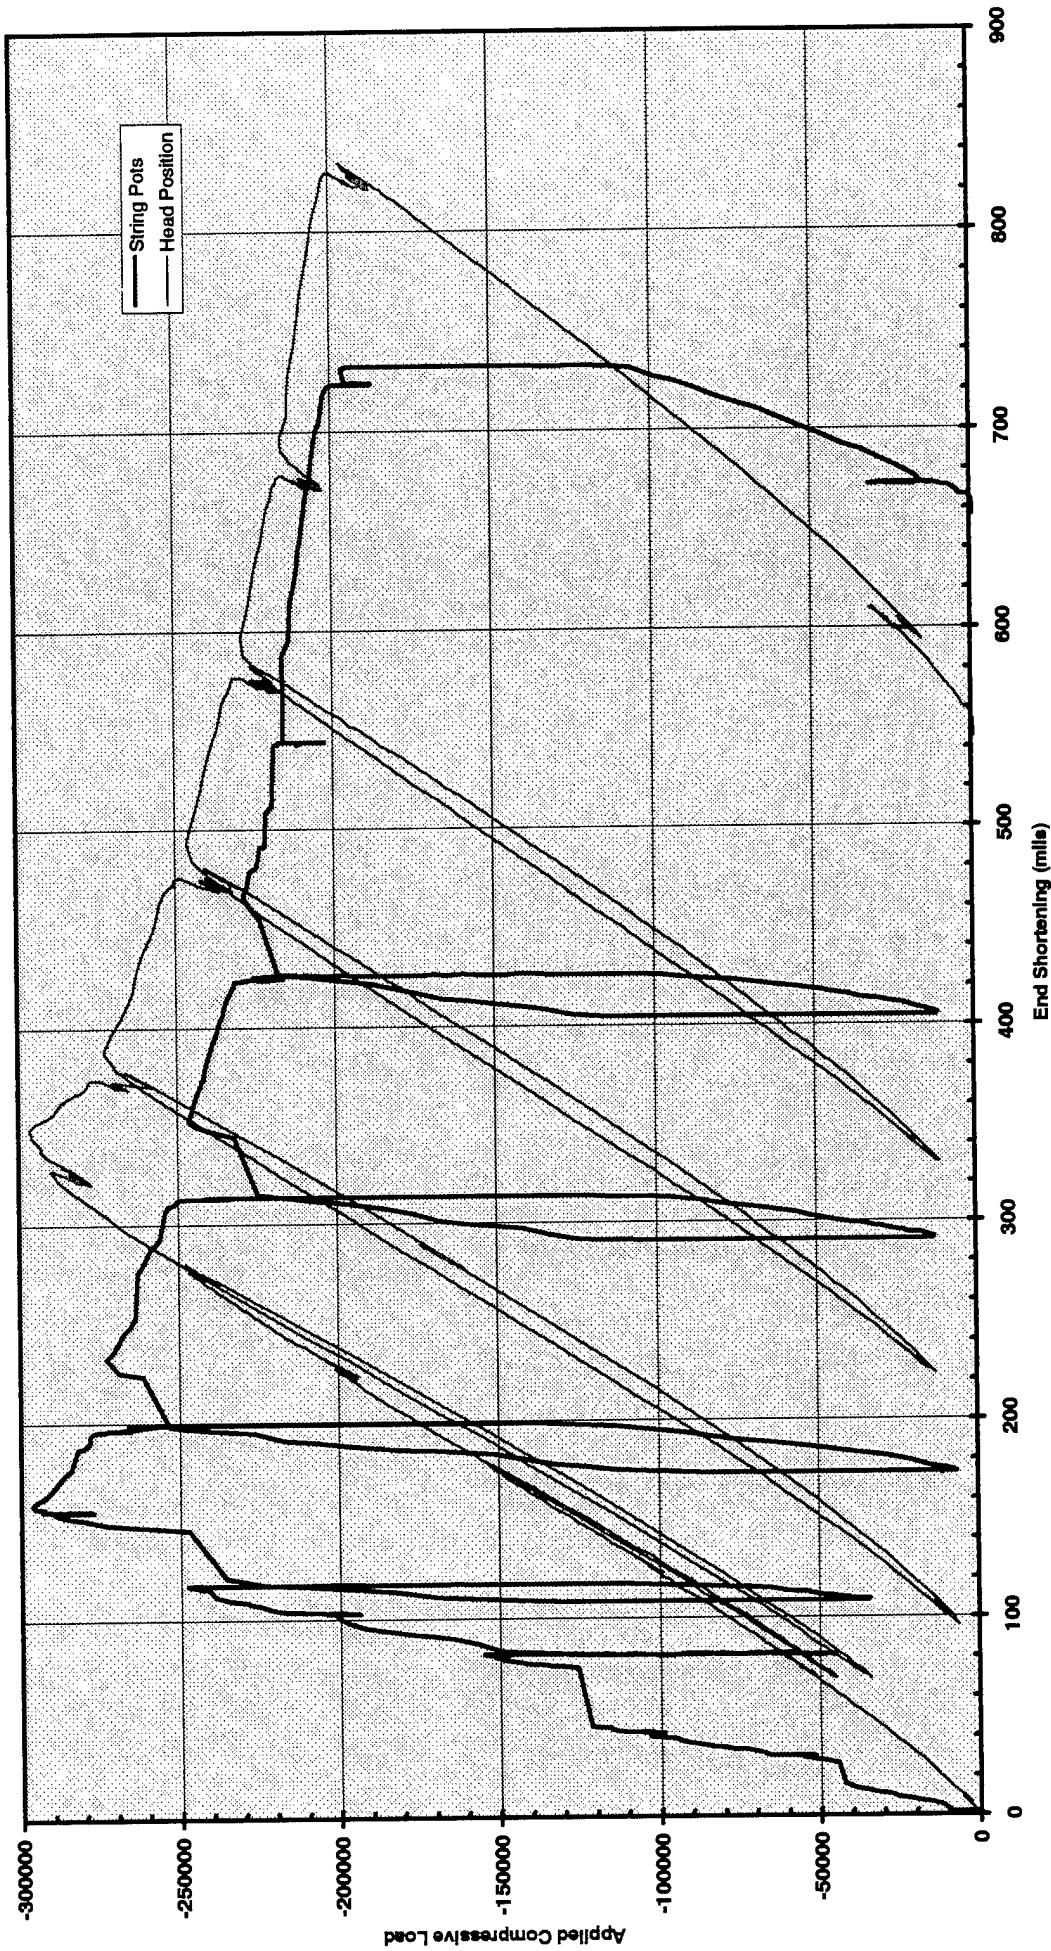
## Load vs. End Shortening

The next plot is one of end shortening versus compressive load applied. As discussed earlier, the plots may vary somewhat from specimen to specimen, depending on how the end

shortening measurement was made (string pots, actuator LVDT, or dial gages).
