**NSWCCD-TR-65-97/18 April 1997**

Survivability, Structures, and Materials Directorate  
Technical Report

## **An Experimental Investigation of the Ultimate Strength of Stiffened Panels**

### **- Volume 2, Test Data**

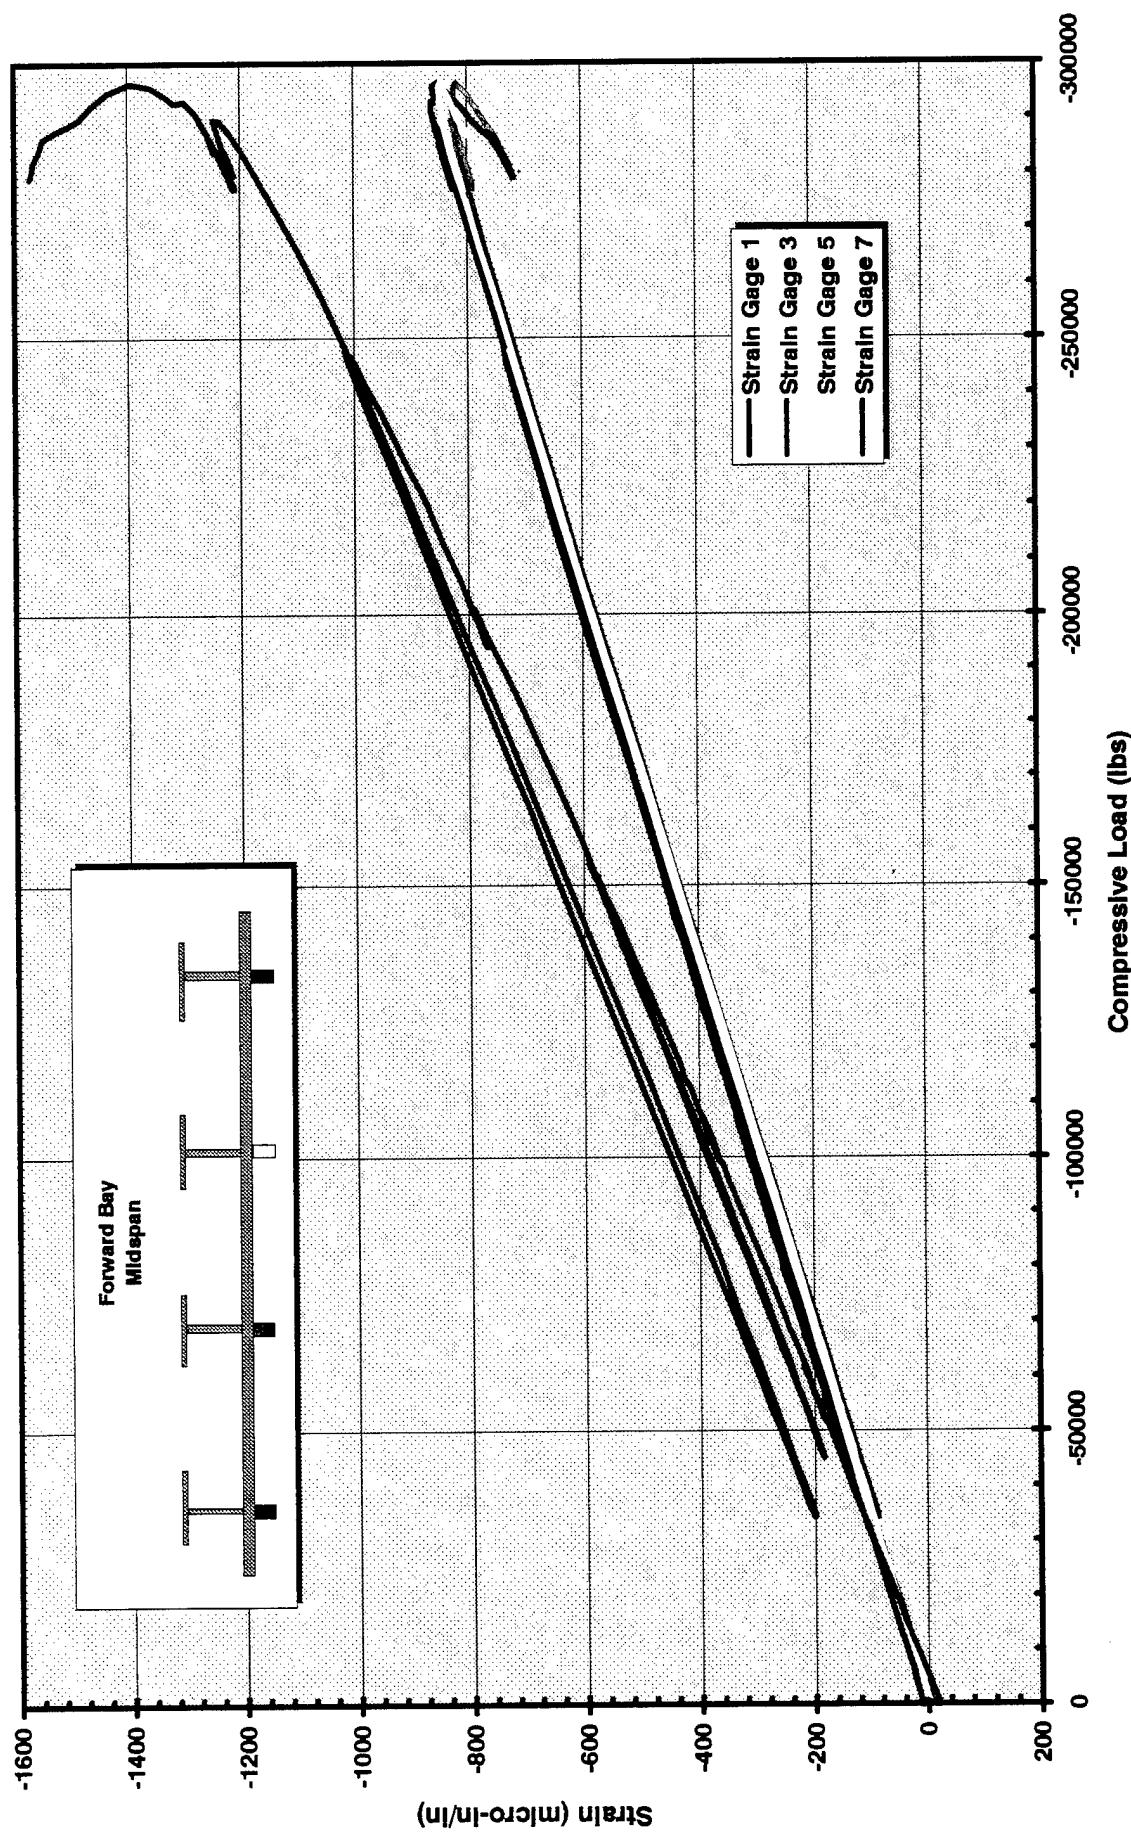
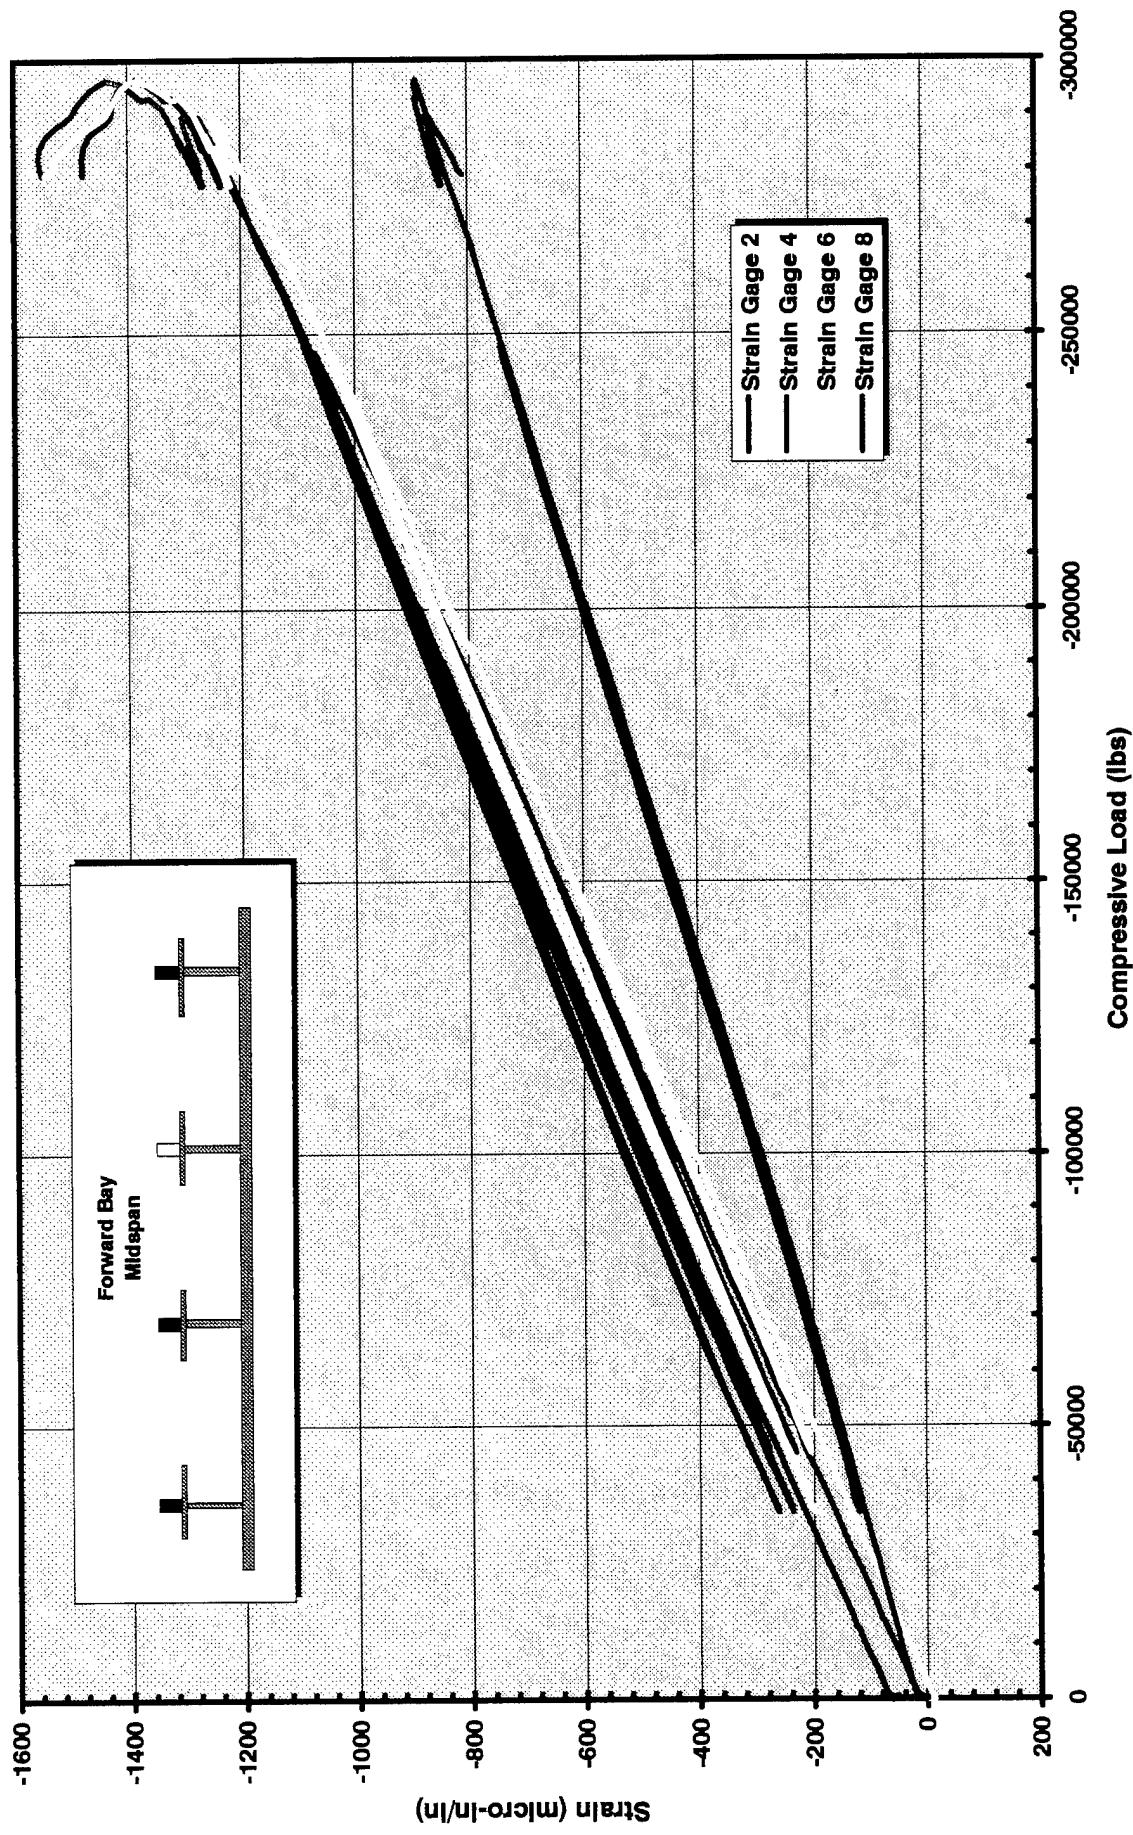
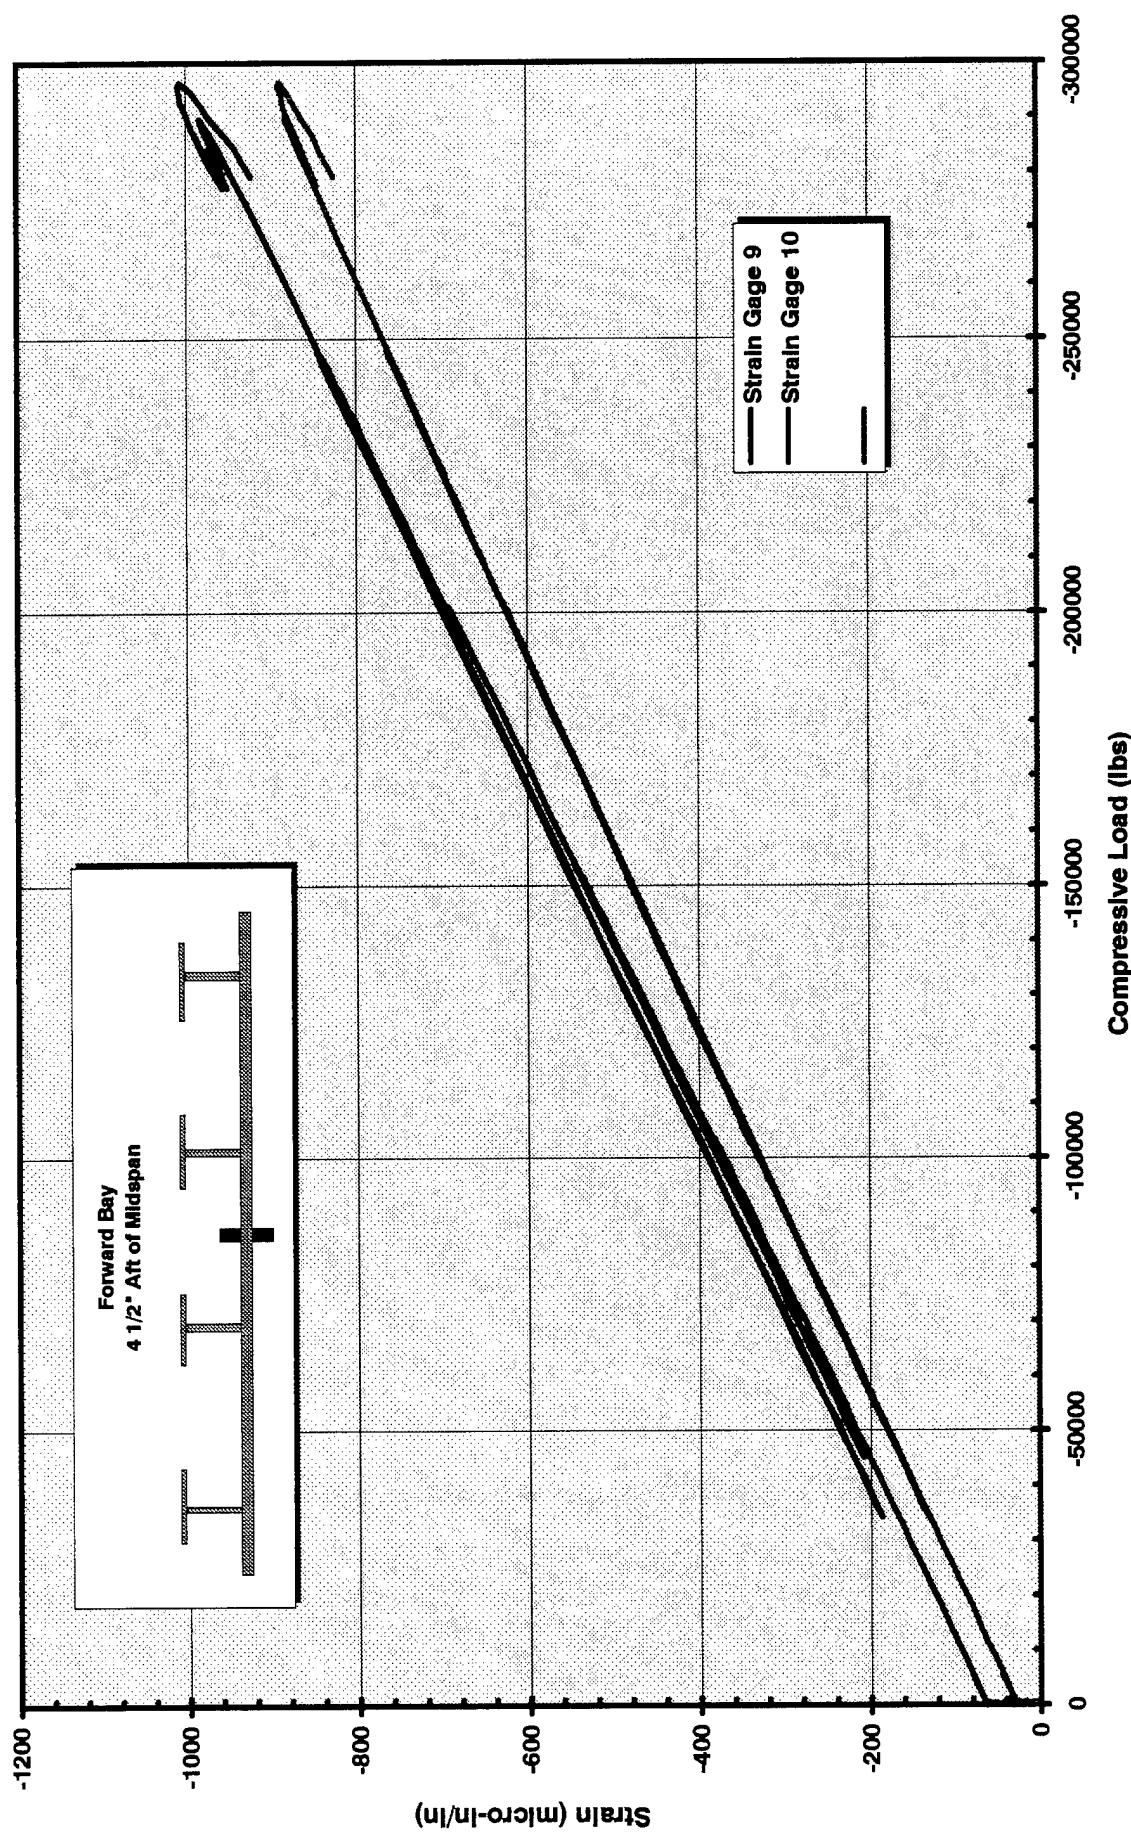
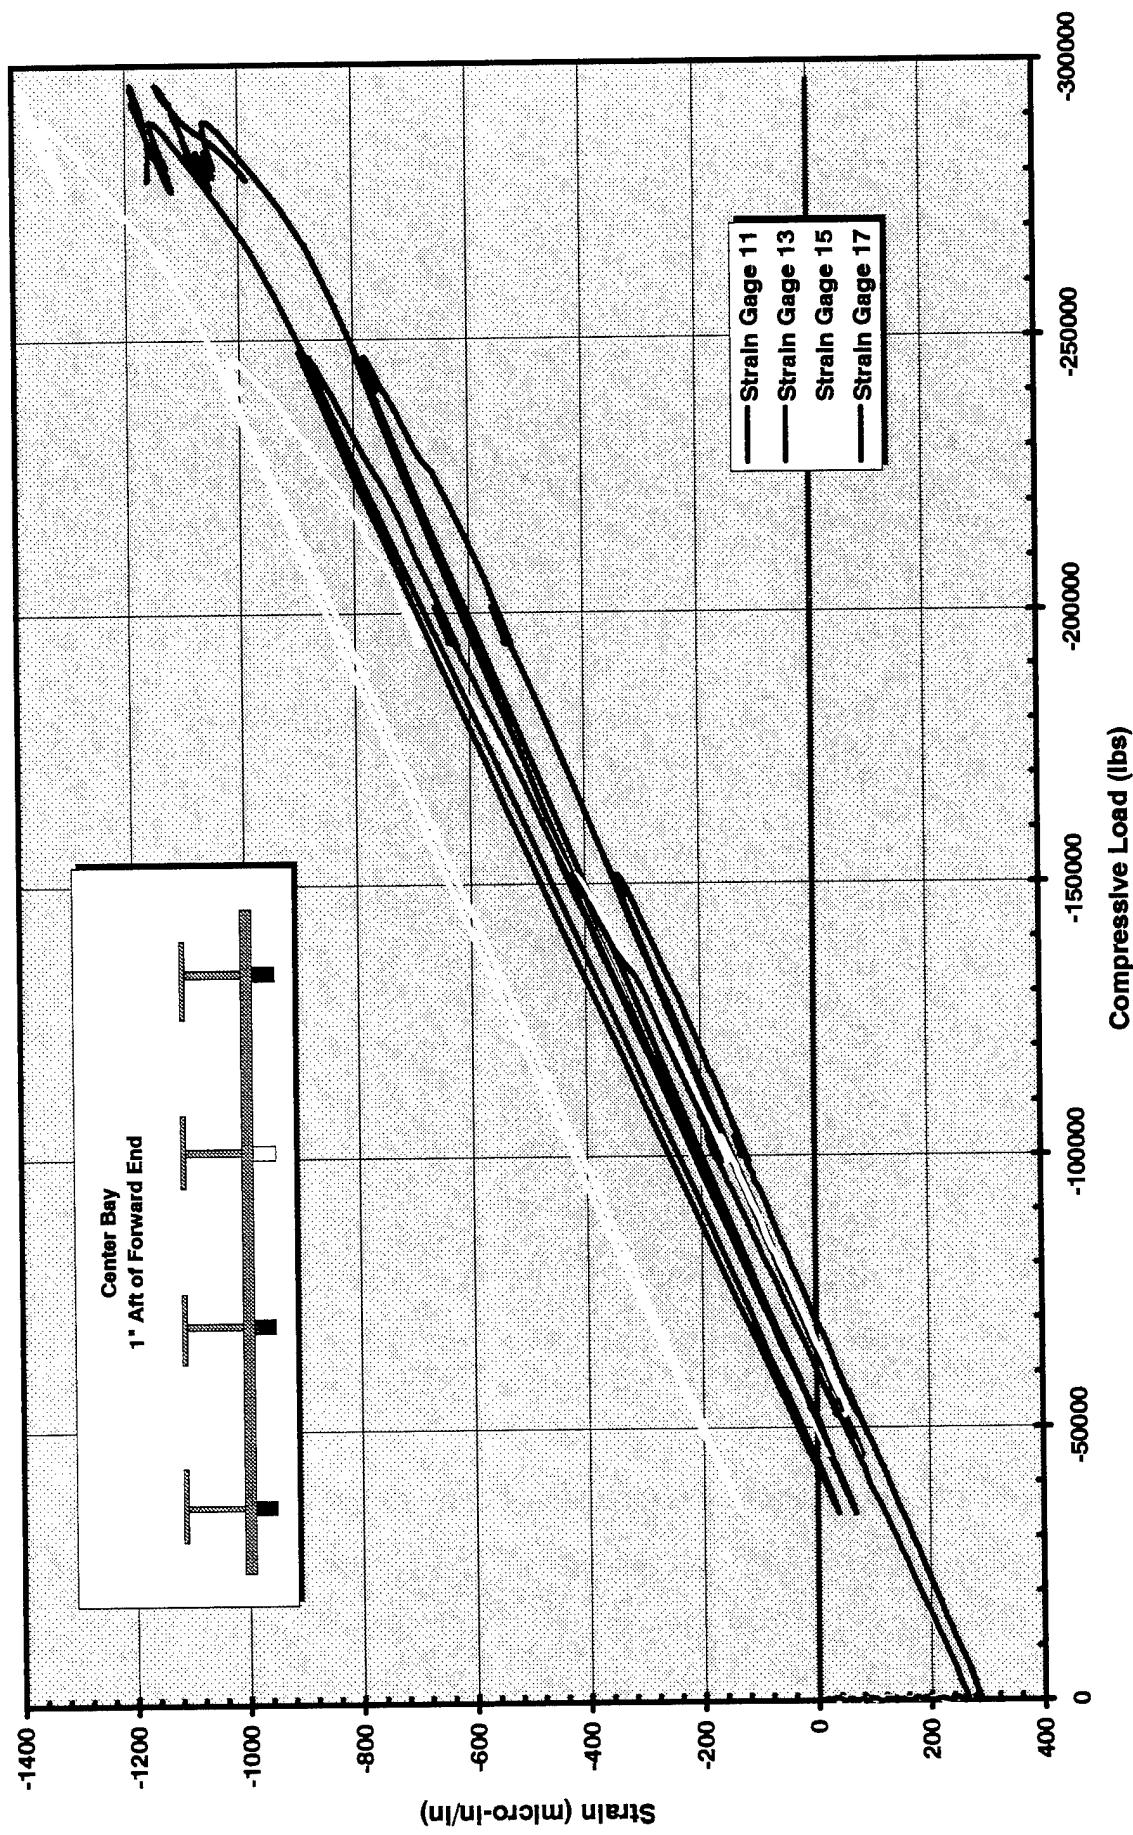
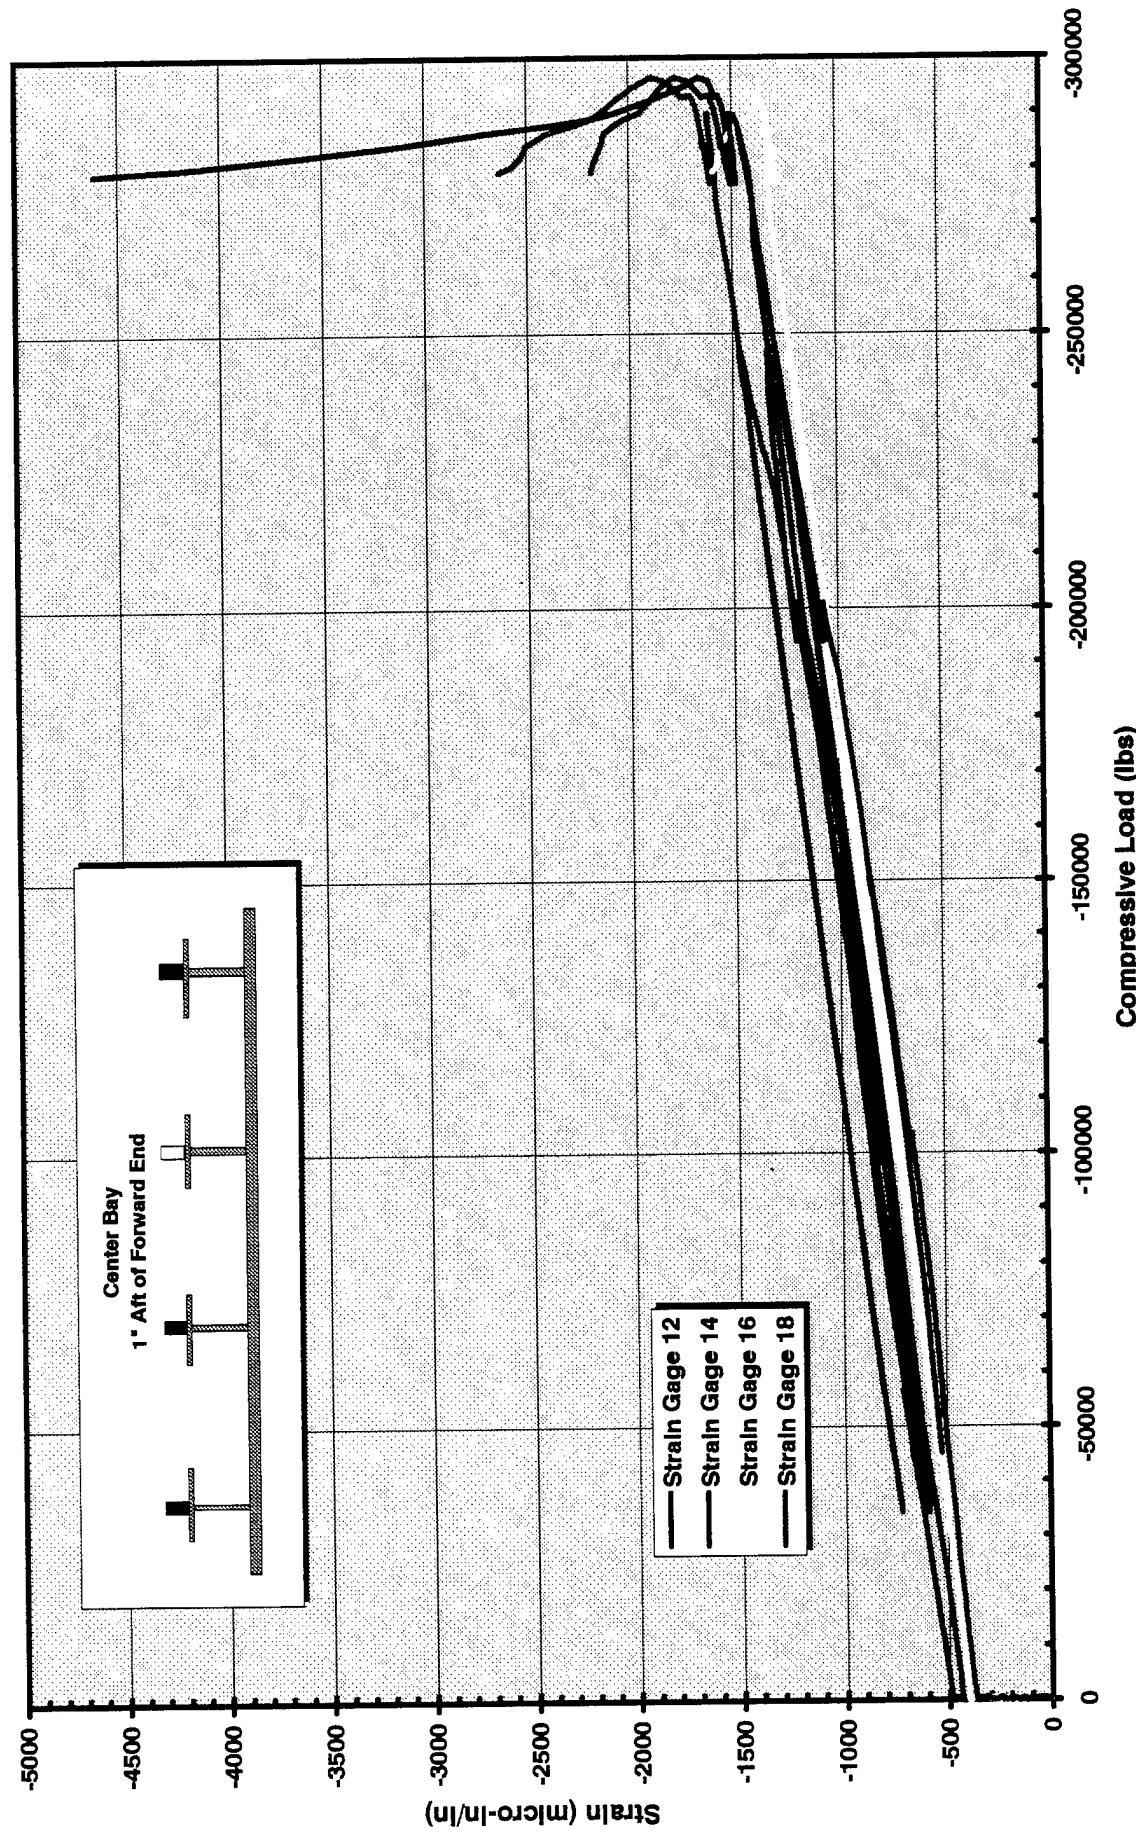
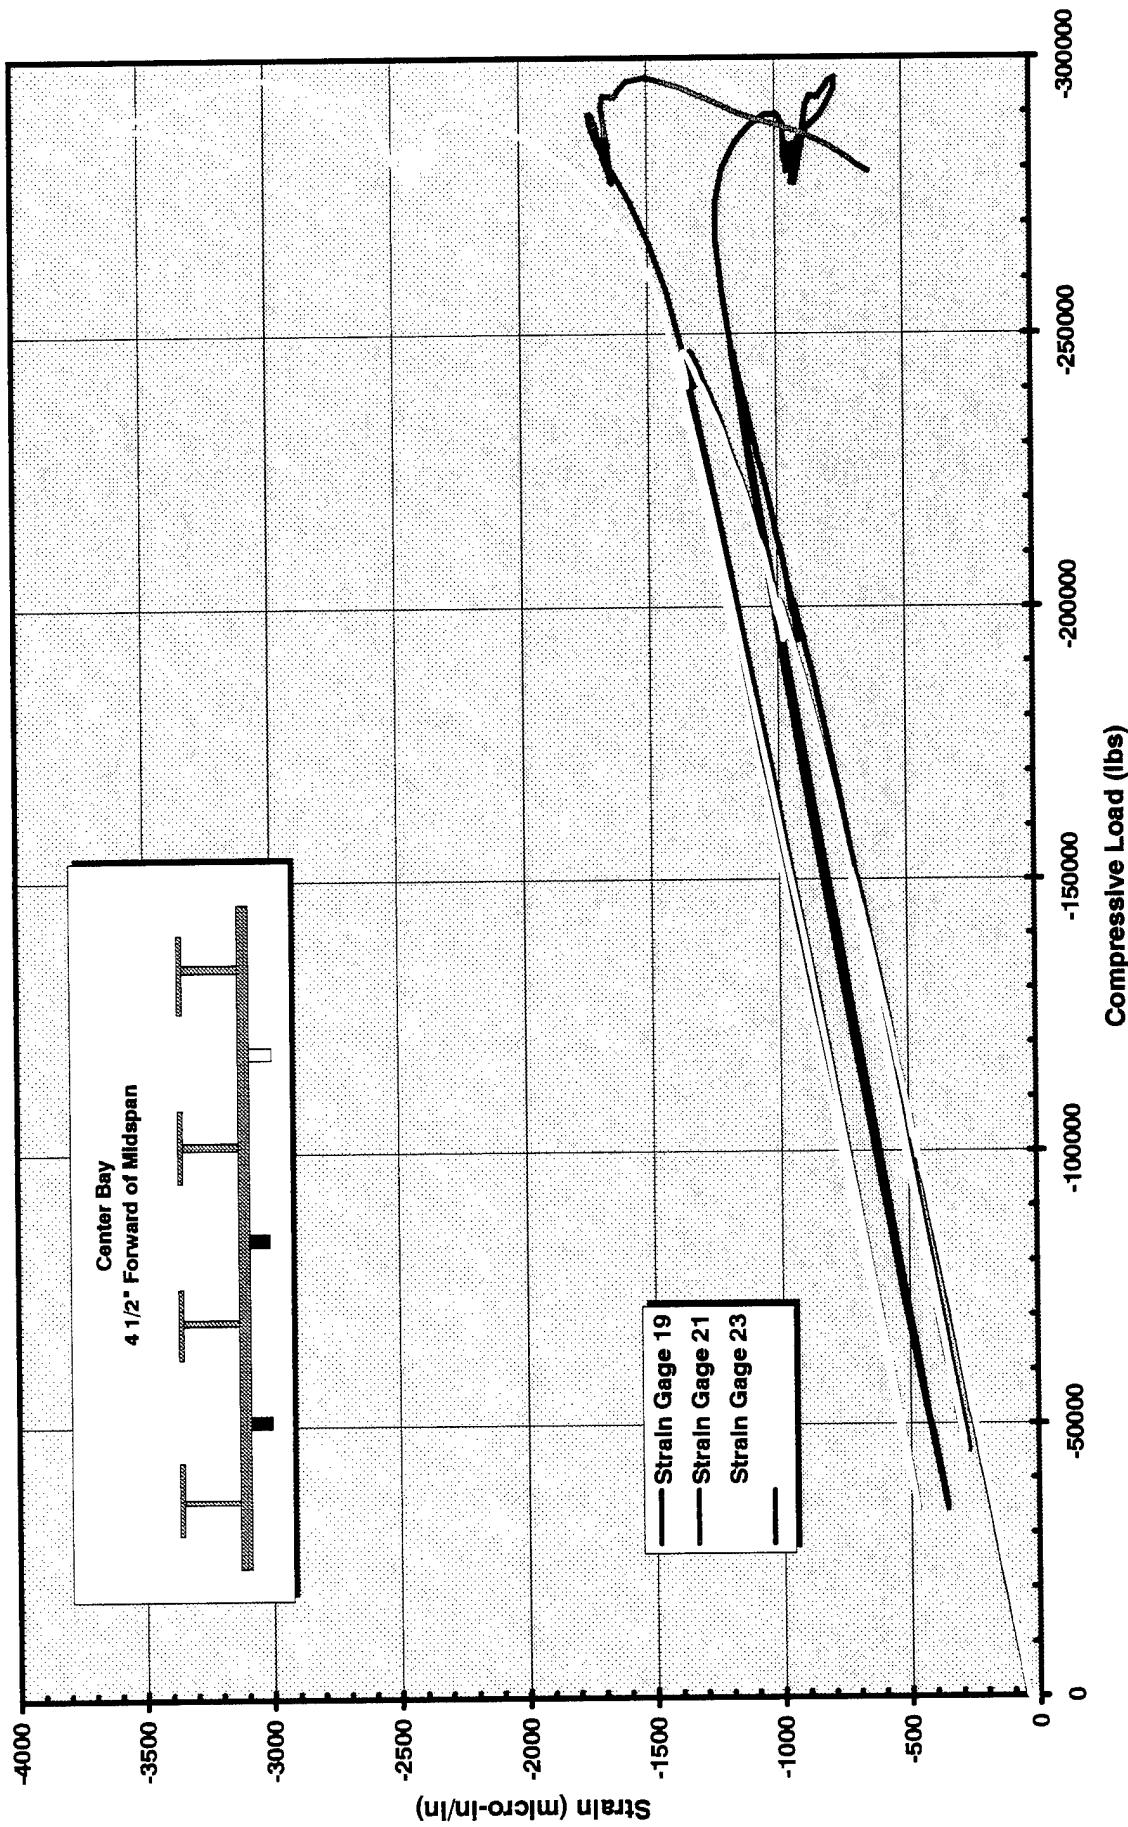
### Strain vs. Applied Load

The remainder of the figures in each group of data show plots of measured strain versus applied compressive load. The gages shown on each plot are grouped conveniently to show strain profiles across a section of the grillage, across the flange of a stiffener, or on sections of plating between stiffeners.
