AD REPORT NO. R-1131 DATE: 12 SEPT. 1974

HOT VACUUM CREEP FORMING OF SCALE SHUTTLE

EXTERNAL TANK DOME CAPS

FINAL TECHNICAL REPORT

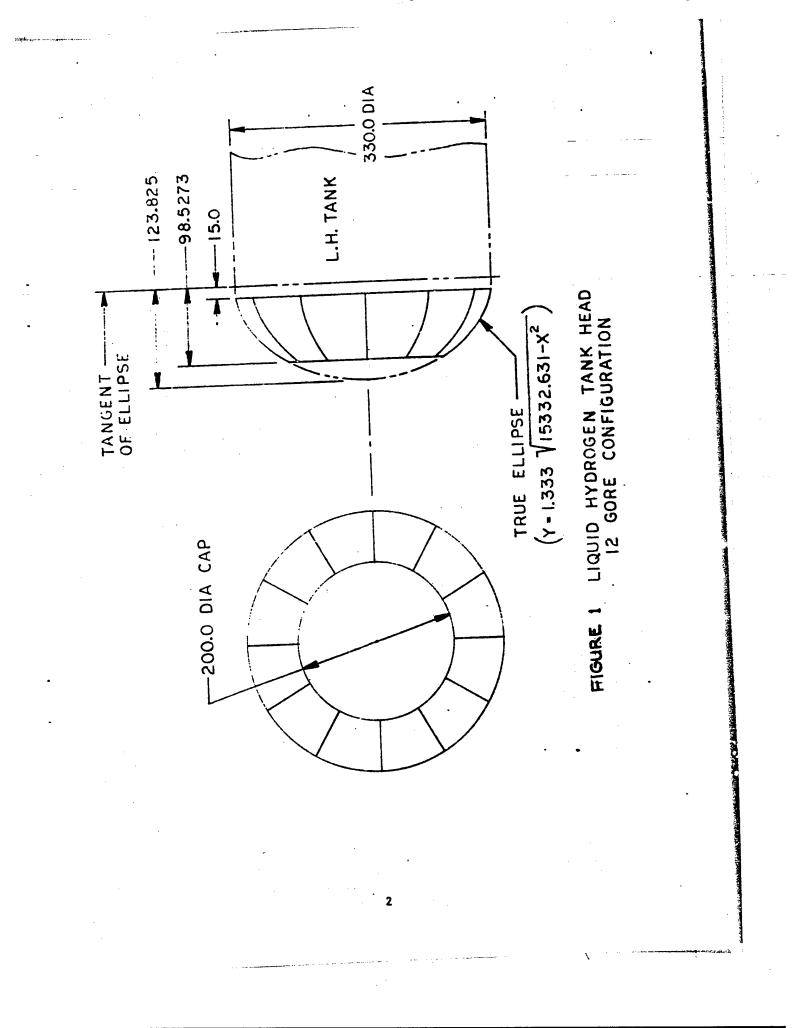
The present design concepts for the space shuttle fuel tanks incorporate large sculptured panels of 2219-T87 aluminum. This particular program is concerned with the end bulkheads. The size and contour of these bulkheads are shown in Figure 1. It is understood that the base line method to produce these panels is bulge forming.

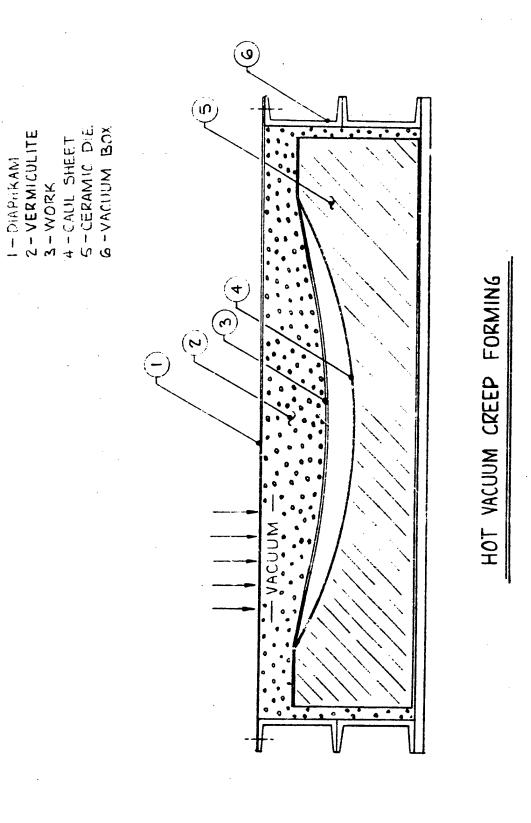
FIGURE 3.

The forming method known as hot vacuum creep forming consists of a integrally heated ceramic forming die (AVCORAMIC TOOLING) enclosed in a structural steel container with an open top. The material to be formed is first placed in the die. Then the remainder of the container is filled with a granular insulating material known as vermiculite. The top is sealed with a plastic sheet diaphragm identified as VAC PACK. A vacuum system is used to evacuate the sealed enclosure. When evacuated, the plastic diaphragm transmits the load resulting from the pressure differential to the work surface via the vermiculite medium. A combination of heat and controlled pressure provides conditions for creep stretching the work into the ceramic die.

Figure 3 illustrates the fundamental arrangement of a HVCF die with work in place.

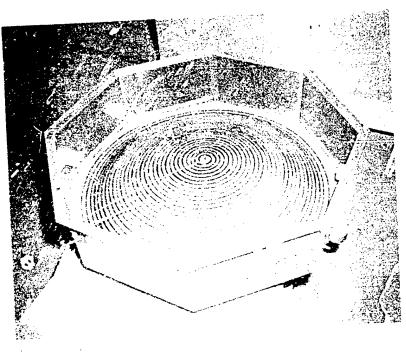
FIGURE 5

Figure 5. Placement of styrofoam casting cores to produce cooling cavities and reduce overall tooling weight.

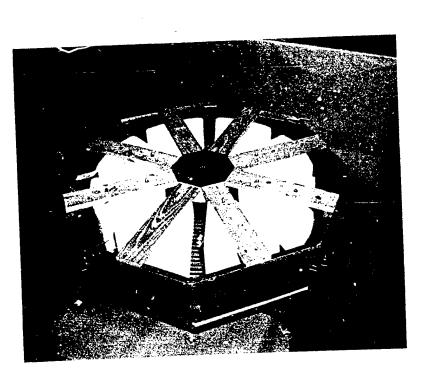
FIGURE 7

Figure 7. Ceramic casting operation.

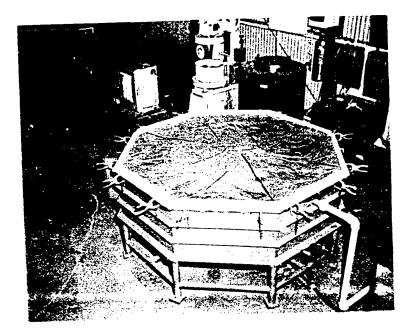
FIGURE 11

both die and part from surface galling and to further reduce the Δ temperature. Figure 10 shows the flat blank "caul sheet" in place to be formed. Note the flange around the perimeter which provides positive drawing of the material into the contour. The sealed enclosure is shown in Figure 11 prior to applying vacuum. Figure 12 shows the formed "caul sheet" after the forming cycle. The forming cycle was accomplished at 900°F for two hours and a forming pressure up to 8.3 inches Hg.

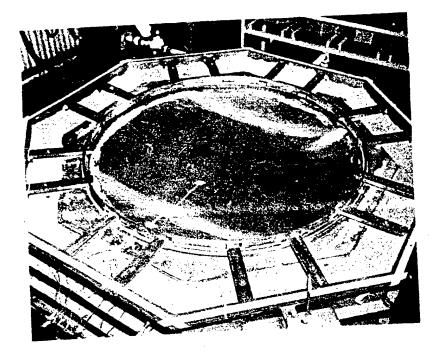
FIGURE 24.

Task DD forming cycle ran with reduced clamping torque (18 ft./lbs.) to allow a limited amount of material movement into the contour. Figure 24 shows Task DD after forming. Buckling occurred at the ring in the weld area.

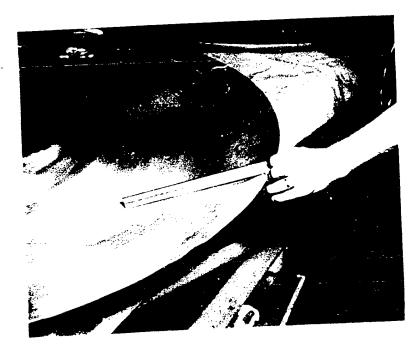
FIGURE 25

An additional blank was machined with a stepped cross section; the material was AVCO supplied. The stepped blank, Task E, had a cross section thickness of .125, .104, .083, and .062. The forming cycle used a clamping torque of 20 ft./lbs. Figure 25 shows the buckling which occurred in the stepped area during the forming cycle.
