HAFB Report #1996-006  
Project KWRD 973200 B

**BUILDINGS 107, 289, AND 291 DEMOLITION  
HABS/HAER ARCHITECTURAL ASSESSMENT  
HOLLOMAN AIR FORCE BASE  
OTERO COUNTY, NEW MEXICO**

REPORT OF INVESTIGATIONS  
No. 120EP

January 1998

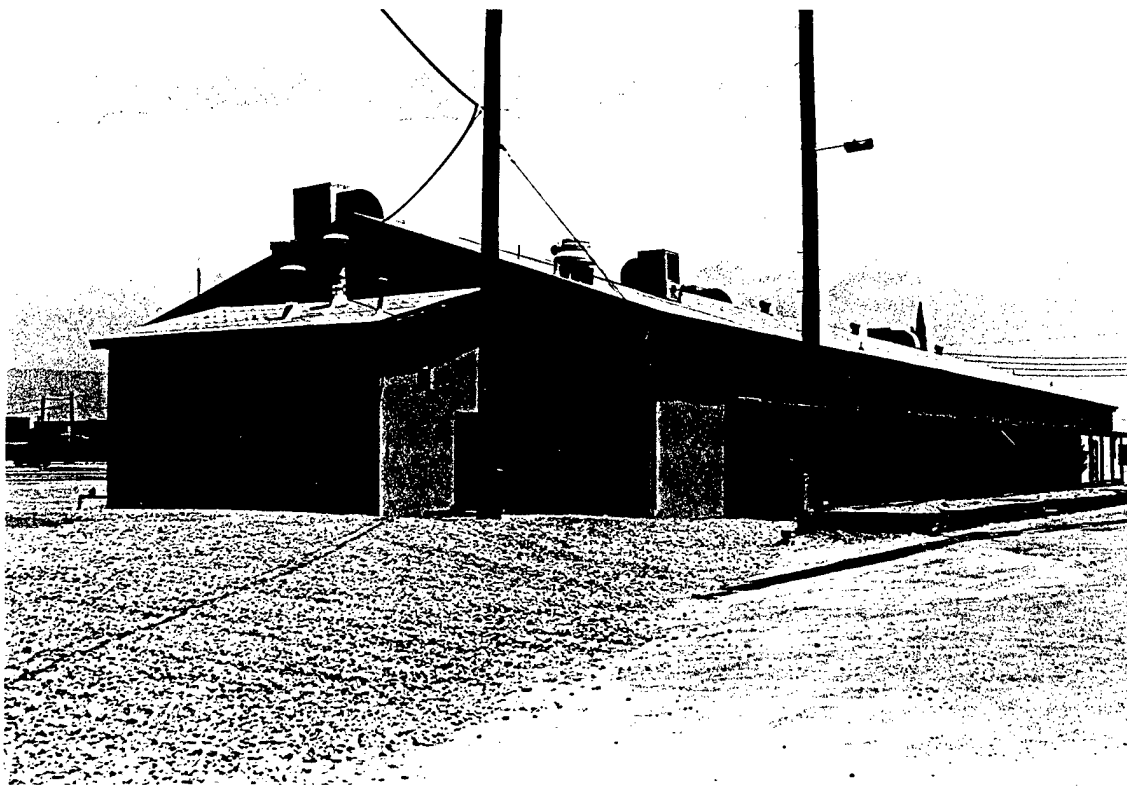
Figure 5. Building 107, facade.

The main building is 50 x 191 ft, with two offsets of 5 x 5 ft each, and an 11 x 24 ft wing (see Figure 5). The additions are located at the south end and to the north and west (Figures 6 and 7). The building is a one-story, gable-roofed structure with a concrete foundation and 9,914 sq ft of interior space. It has metal gutters and downspouts. New aluminum windows have replaced the original wood sash and the original doors have been replaced with aluminum and flush metal doors (Figure 8). The exterior was originally asbestos shingle siding on wood framing with 90-lb. gable-roll roofing. Currently, the exterior is stucco over the existing wood frame and the roof is clad with asphalt shingles. Eaves and gable ends have small overhangs trimmed in wood (Figure 9).

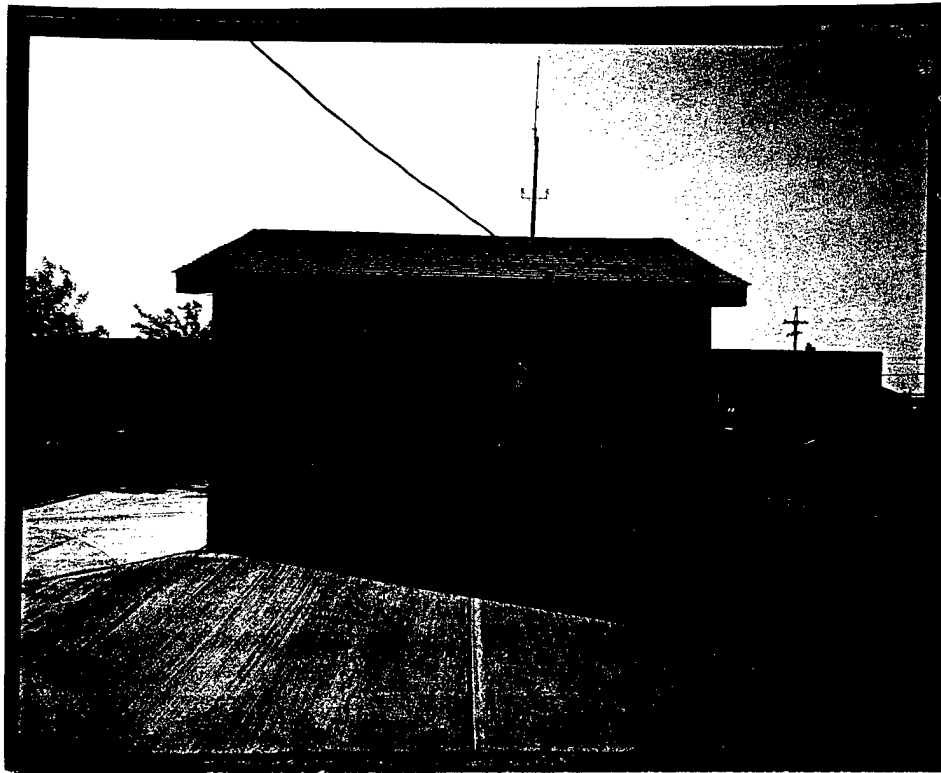
Figure 10. Building 289, entrance at northwest facade.

Building 289 is currently designated as a Nitrogen Liquid and Gaseous Oxygen Storage building (Figure 10). Real Property Accountable Record/289 indicates that it was completed in 1943 and has continuously functioned as a storage facility; it has been assigned as a Hazardous and Flammable Materials Storage Building (c1943) and Oil and Grease Storage (c1958). The building is one of the oldest, continuously used structures on the base. Neither the architect nor the builder is known.

Building 289 is utilitarian in design, with no architectural or design embellishments (see Figure 10). Common construction materials and techniques were utilized. A single door is centrally placed at the principal (northwest) elevation. This door is left hand,  $\frac{3}{4}$ -inch thick, hollow metal, and shows an outward

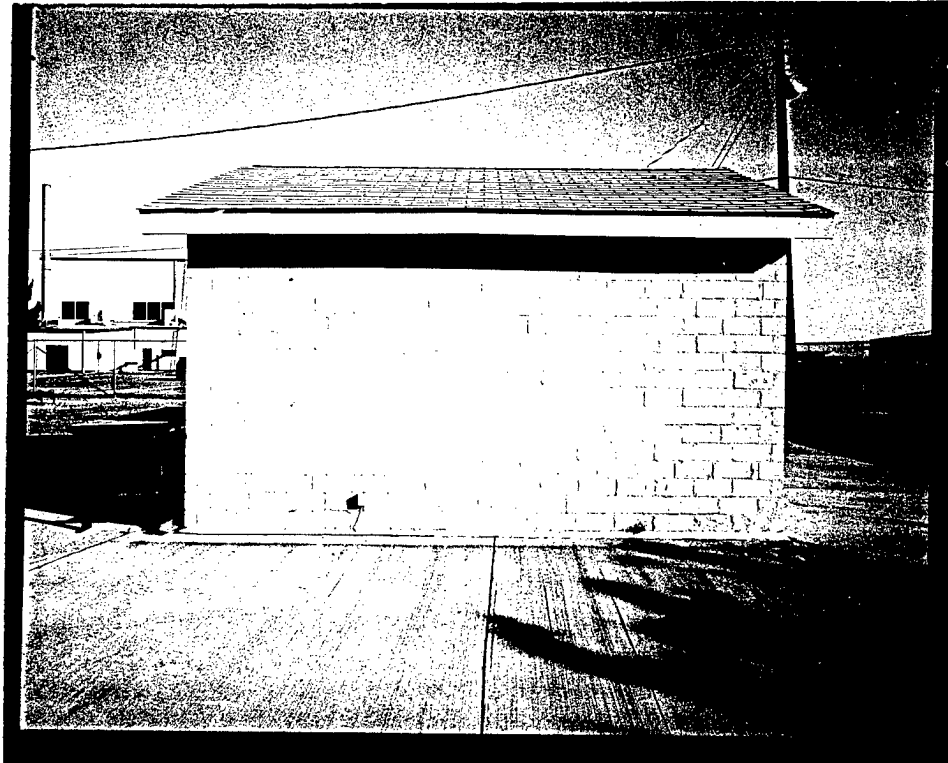
Figure 13. Building 289 rear, exterior clay tiles.

swing. The structural clay tile walls are exposed at both the interior and the exterior (Figure 13). Each tile is 12- (length) x 5- (height) x 7¼-inches (depth). The walls are one 7¼-inch tile thick. The interior and exterior surfaces have been recently painted. It could not be determined if the walls were originally painted. Fenestration is symmetrical. Framed wood louvers are located just below the eave line on both sides of the northwest elevation door.

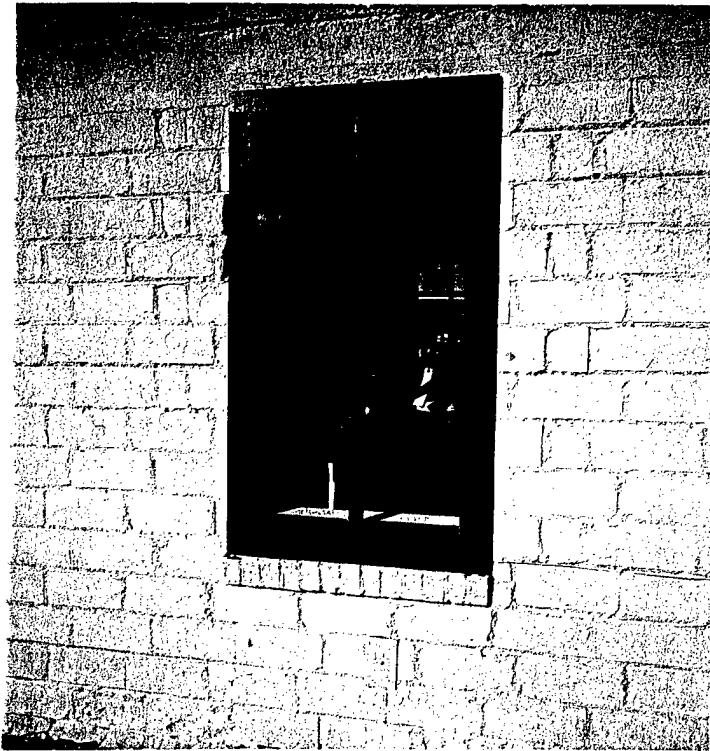
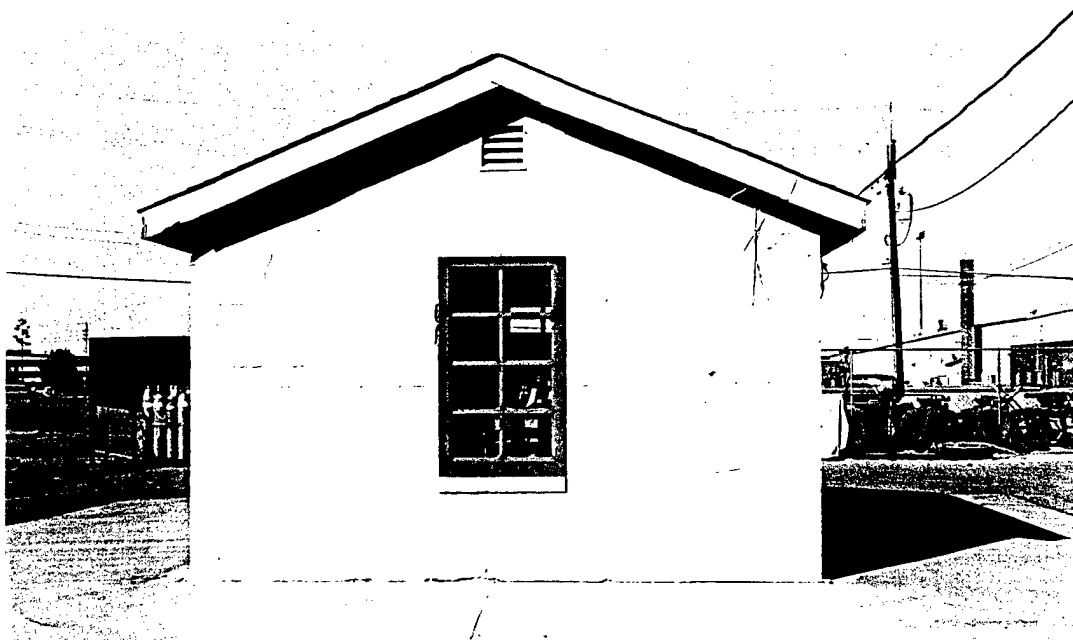
Figure 14. Building 289 window detail, northeast elevation.

Two windows are centrally located, one each at the southwest and northeast elevations. Each window has been replaced with Plexiglass, due to storm damage to the original wooden windows in 1995 (Tagg, 1996 personal communication). A painted wood muntin grid is attached to 1 x 4-inch wood trim. A row of bricks on edge forms the sill. Framed wood louvers are centrally located above each of the two windows, just below the gable (Figures 14 and 15). The southeast elevation has no openings.

Figure 15. Building 289 window with framed wood louver, northeast elevation.

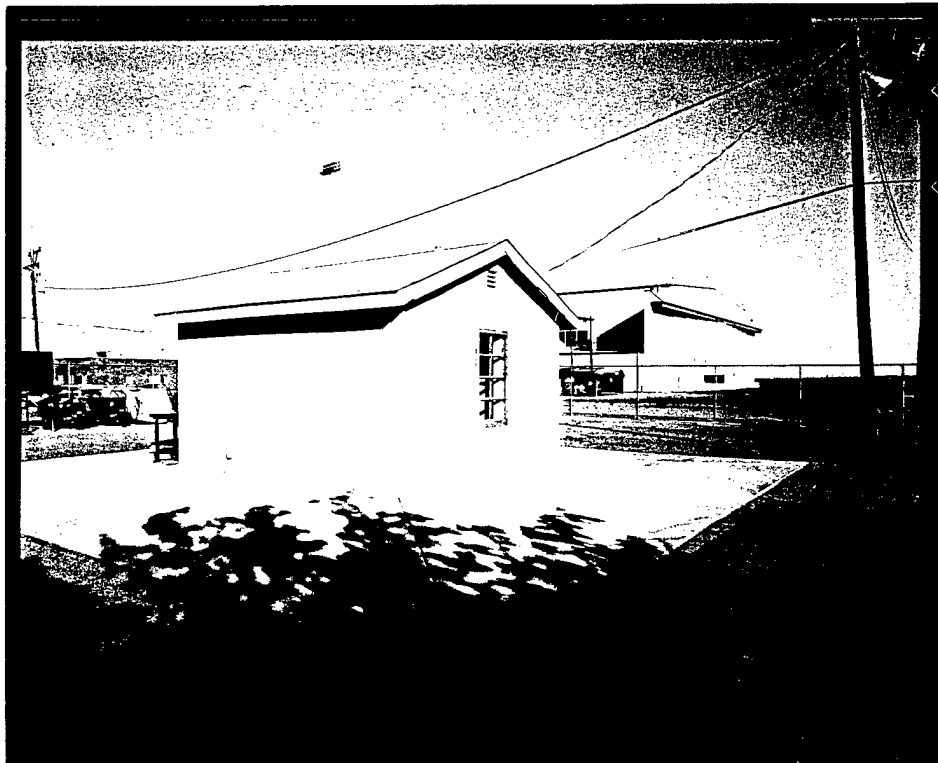
Figure 16. Building 289, east elevation, Building 291 in background.

Real Property Accountable Record/289 indicates that Building 289 was not necessarily associated with any particular hangar or building, but provided storage for the base, in general. However, Building 289 may have been historically associated with Building 291, an aircraft hangar just 200 ft to the northwest (Figure 16).

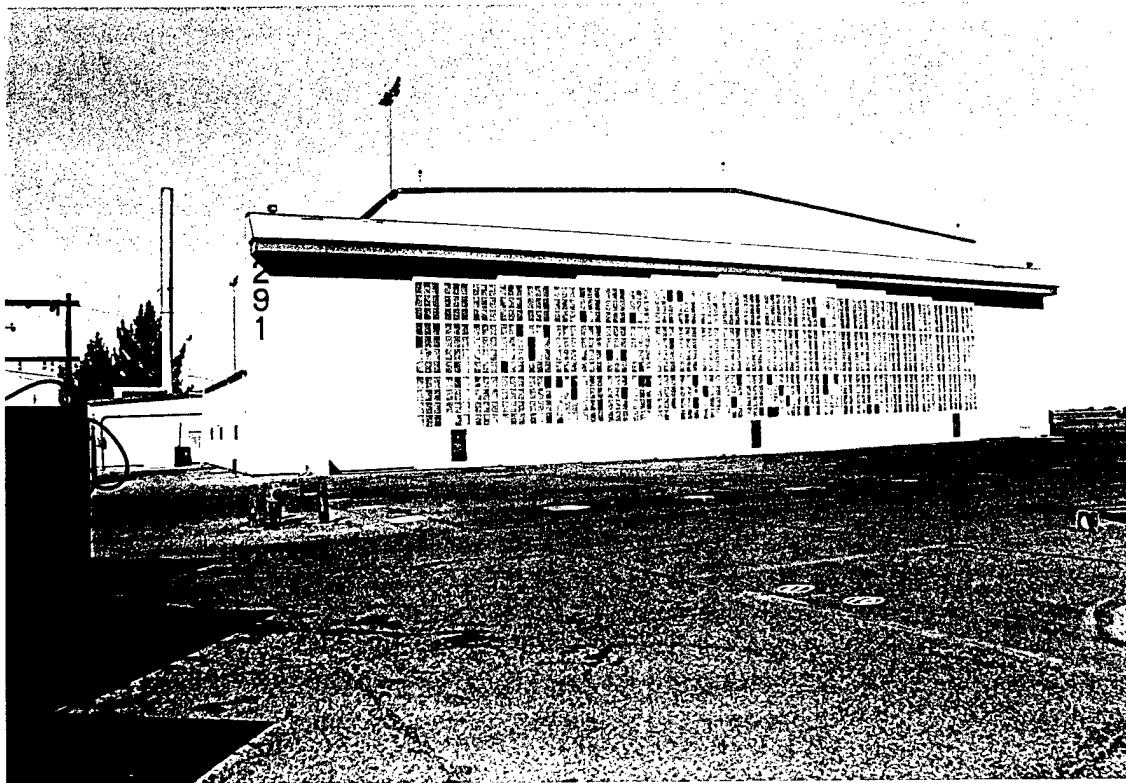
Figure 17. Building 291, east elevation.

Building 291 is a steel-framed structure, eight bays wide and five bays deep. The overall dimensions of the building are 126 x 170 ft with 17,195 sq ft of interior space. Originally rectangular in shape, a boiler room offset at the south elevation and additions to the west elevation give Building 291 its irregular footprint. The main building is 102 x 151.5 ft, with a 20 x 20 ft and a 22 x 61 ft offset (Figure 19). Six large, exposed quadrangular trusses span approximately 110 ft in a north-south direction, creating five bays of uninterrupted hangar floor space. Offices flank the sides of the steel bays.

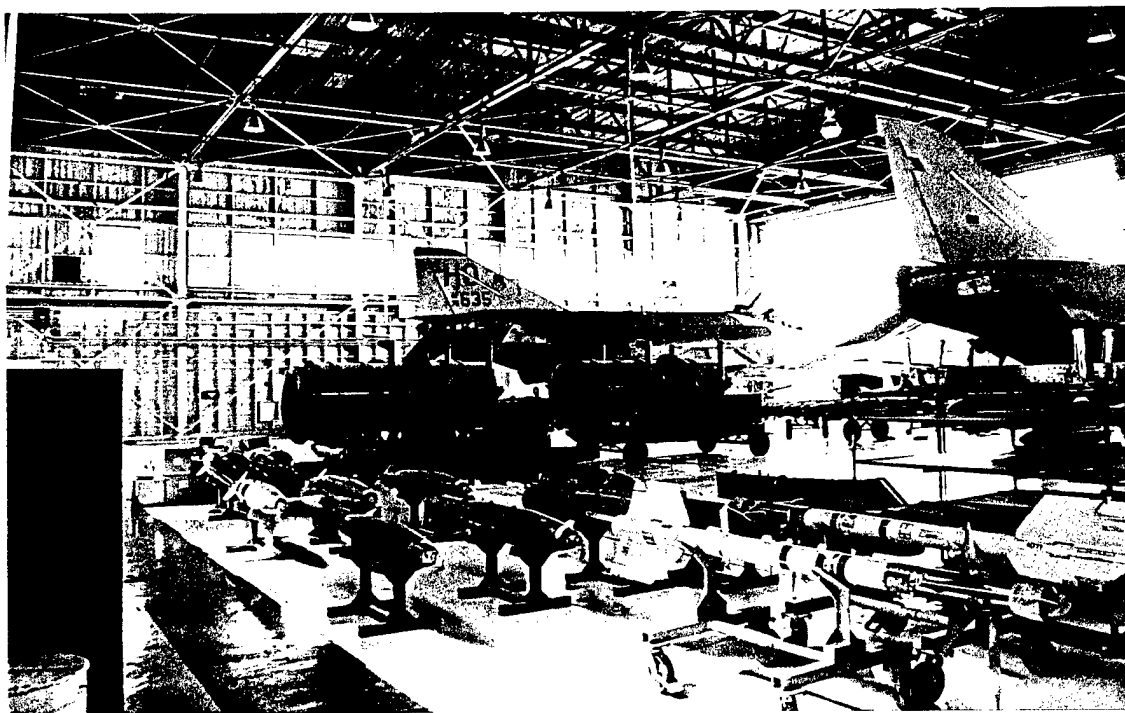
Figure 18. Building 291 interior view, bombs, missiles, and F-4 aircraft.

Building 291, completed c1943, is one of the earliest World War II-era aircraft hangars constructed at HAFB (Figure 17). Originally designated a Maintenance Field Hangar, Real Property Accountable Record/291 indicates the building has had various designations over the years. These include: Ground Support Equipment Shop/Aircraft Ground Equipment Shop (c1963); Small Aircraft Maintenance Dock (c1970); Base Support & Equipment Warehouse (c1972); Aircraft Ground Equipment Shop/Storage Facility (c1975); and Maintenance Hangar (c1983). It is currently designated as a Small Aircraft Maintenance Dock for F-4 aircraft, and continues to function adjacent to an active airfield (Figure 18). Neither the architect nor the builder is known.

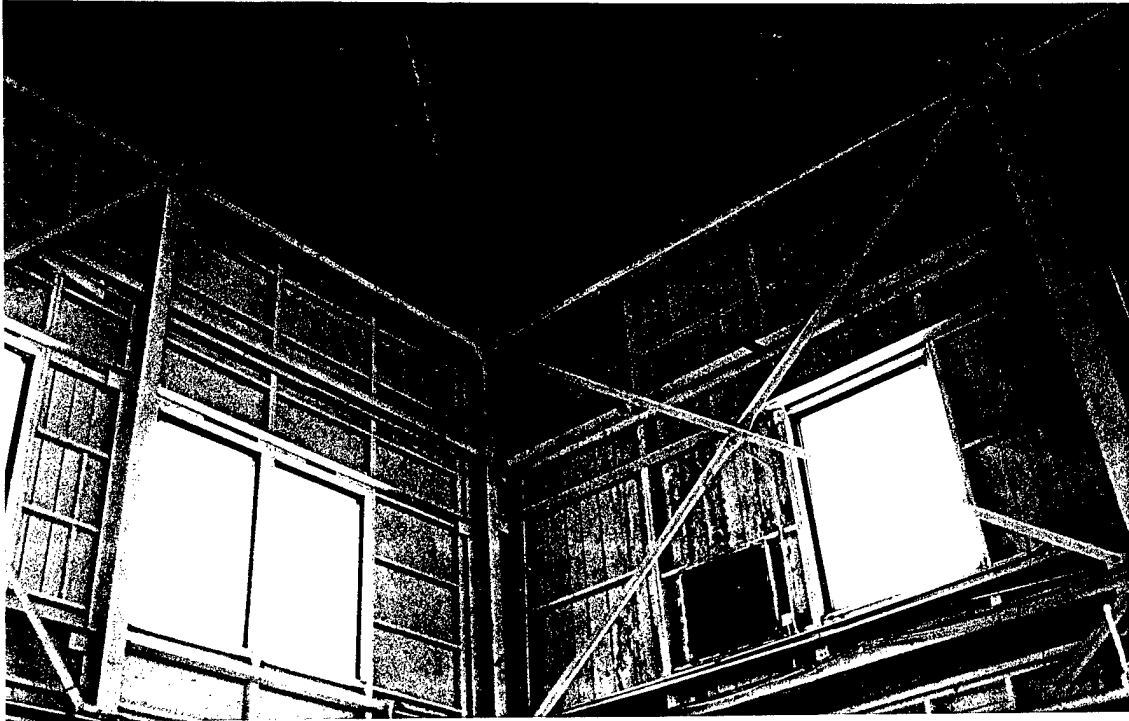
Figure 20. Building 291 interior, braced 'H' columns and spandrels.

Built on a 6-inch concrete slab foundation with concrete piers, the clear floor width is approximately 100 ft. The steel trusses of the roof structure are supported by 'H' columns that are diagonally braced and support intermediate spandrels (Figure 20). The clear height to the bottom chord of the truss system is approximately 29 ft. The quadrangle shape of the trusses forms the slightly pitched, gable roof. The roof is felt roofing material on wood deck, supported by steel purlins. The exterior walls are covered with an insulation and siding system.

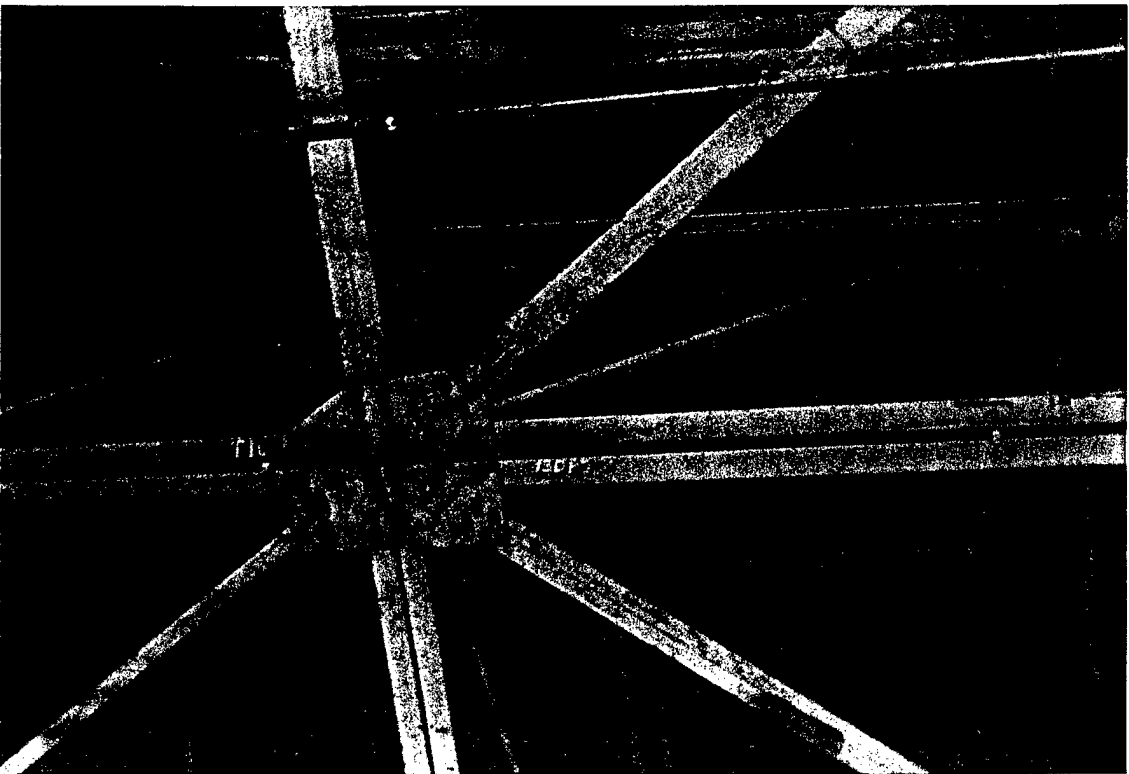
Figure 21. Building 291 interior, wood sheathing and metal truss.

The most prominent features of Building 291 are the nine large, sliding steel doors at the east elevation and the extensive use of 1-inch dimensioned lumber wall and ceiling sheathing (Figure 21). The existing doors are original and show nine panels of lights (panes) (Figure 22). Three panels at the top of each door show nine lights each, three panels at the middle and lower sections show twelve lights each, totaling 99 lights per door. Pilot doors are cut into the middle and two end doors.

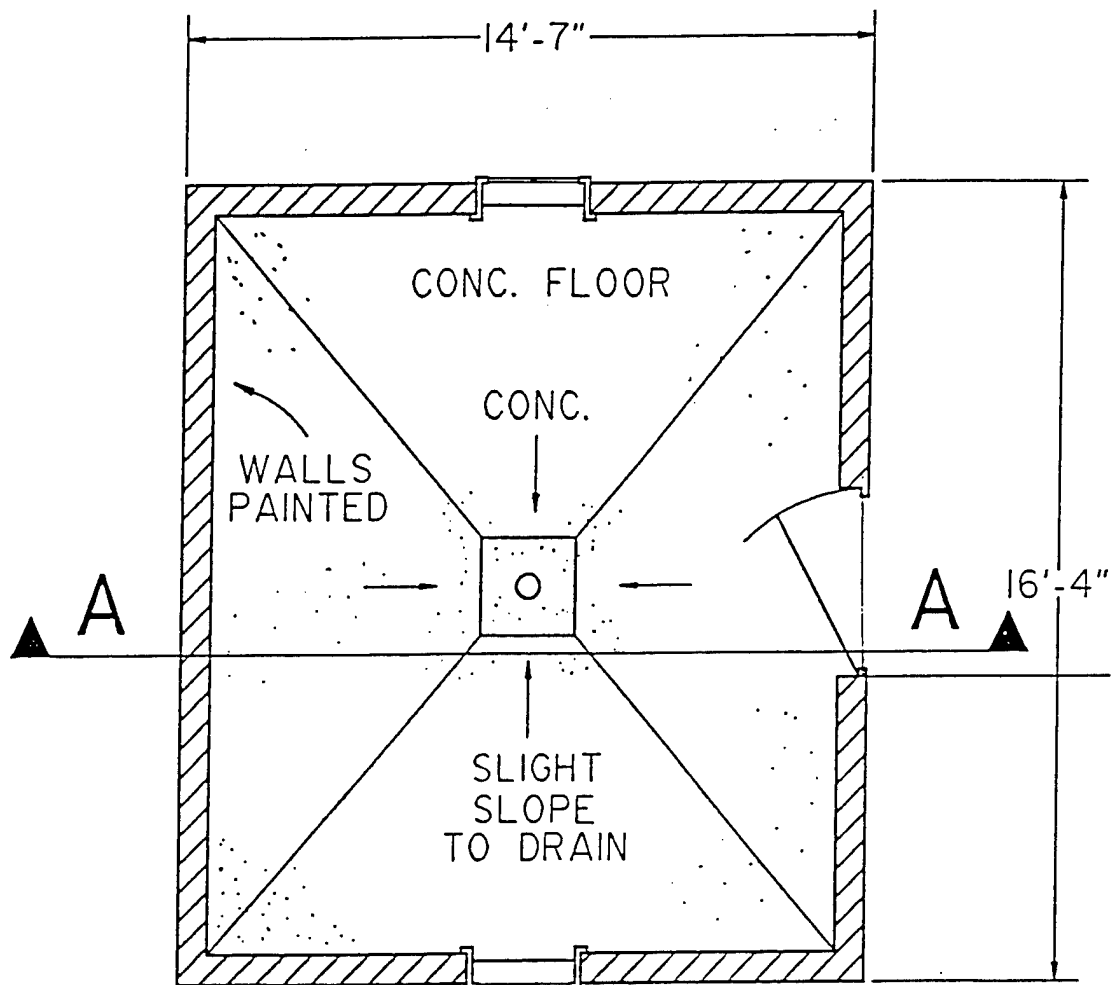
Building 289: Floor plan

Scale:  $\frac{1}{4}" = 1'$
