# Runnins River Watershed Stormwater Management Study

December 1994

**US Army Corps  
of Engineers**  
New England Division

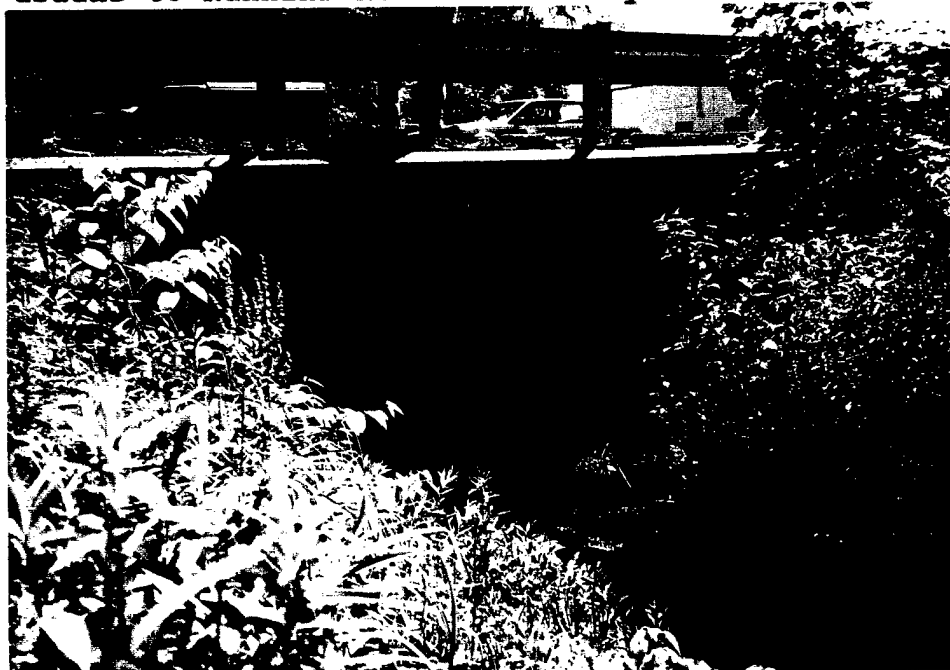
**Photo 4: Upstream face of Taunton Avenue (US Route 44) Bridge, Seekonk. One of approximately 14 bridge or culvert crossings.**

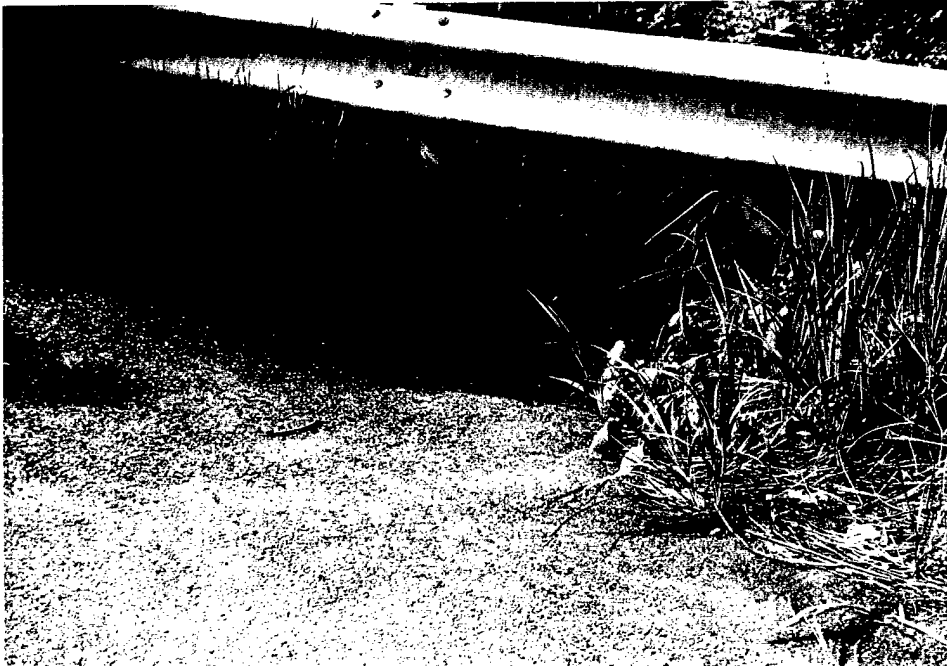
**Photo 8: Paved Drainage Swale, School Street  
(stateline)**
