# 1986 Water Resources Development Act Section 903(a), Specific Project Report and Environmental Assessment

## Connecticut River Basin Fish Passage Facilities for Townshend and Ball Mountain Lakes West River, Vermont

February 1992

US Army Corps  
of Engineers  
New England Division

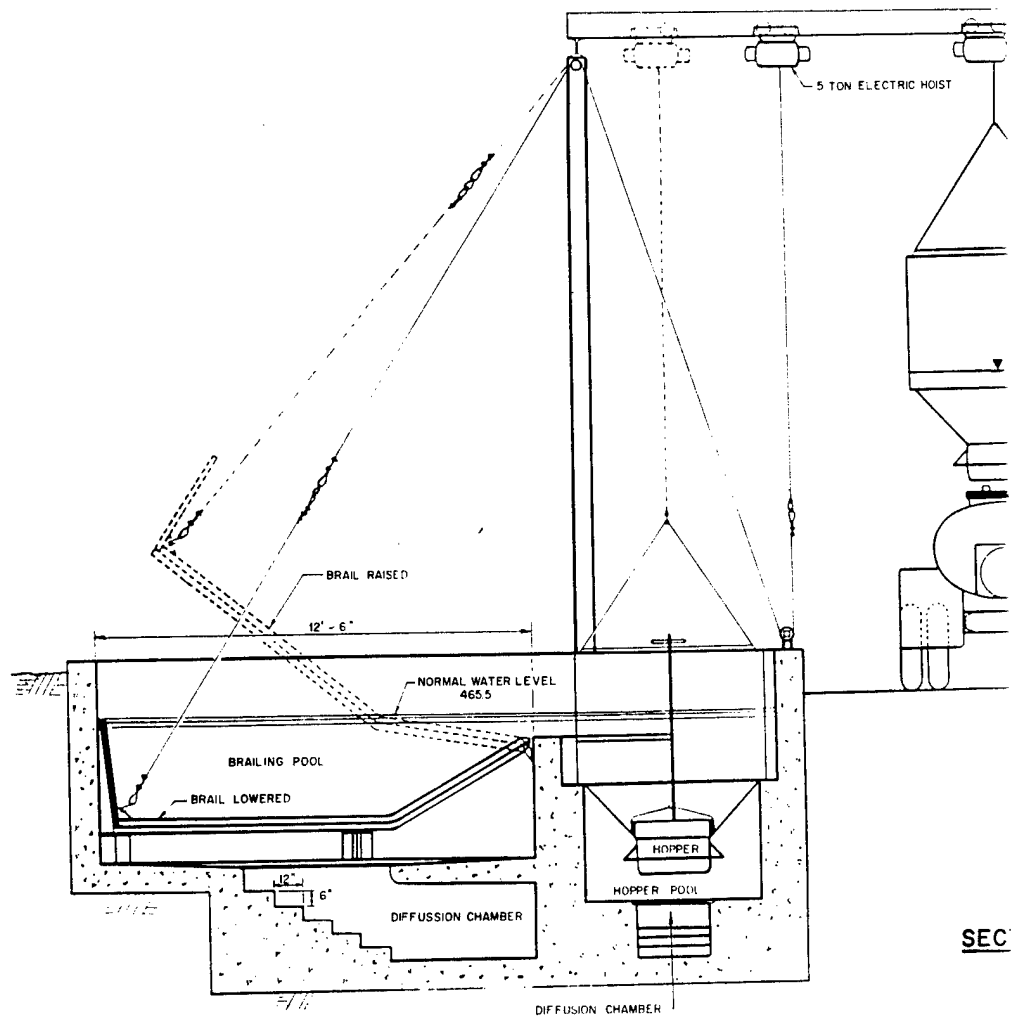
PHOTO: 600 GAL. TANK TRUCK-LOADING FISH FROM HOPPER

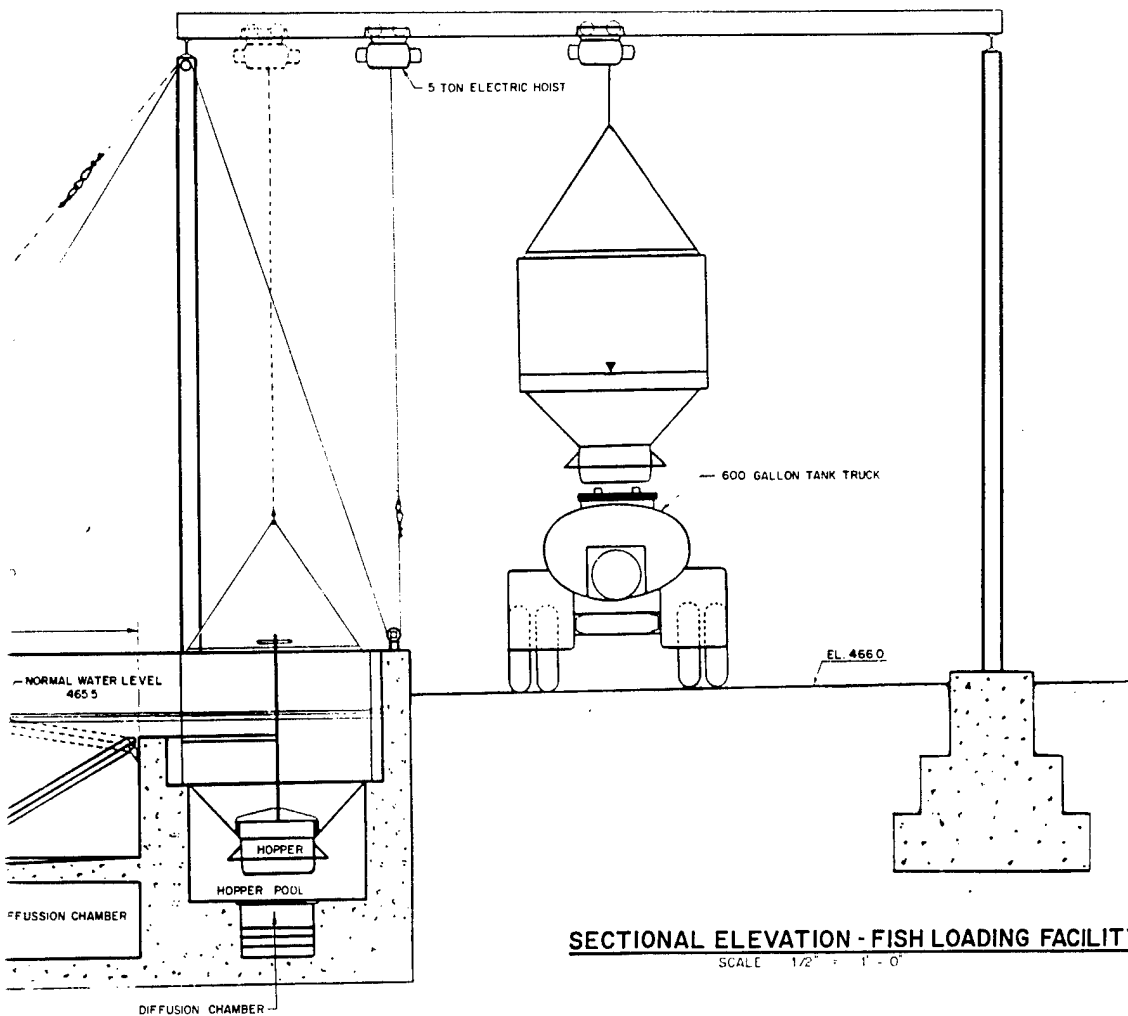
**SECTIONAL ELEVATION - FISH LOADING FACILITY**

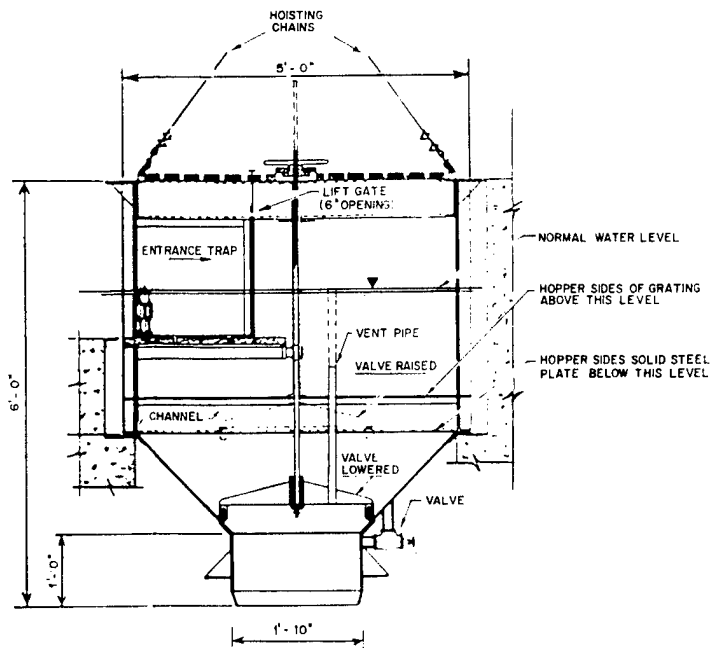
### HOPPER DETAIL

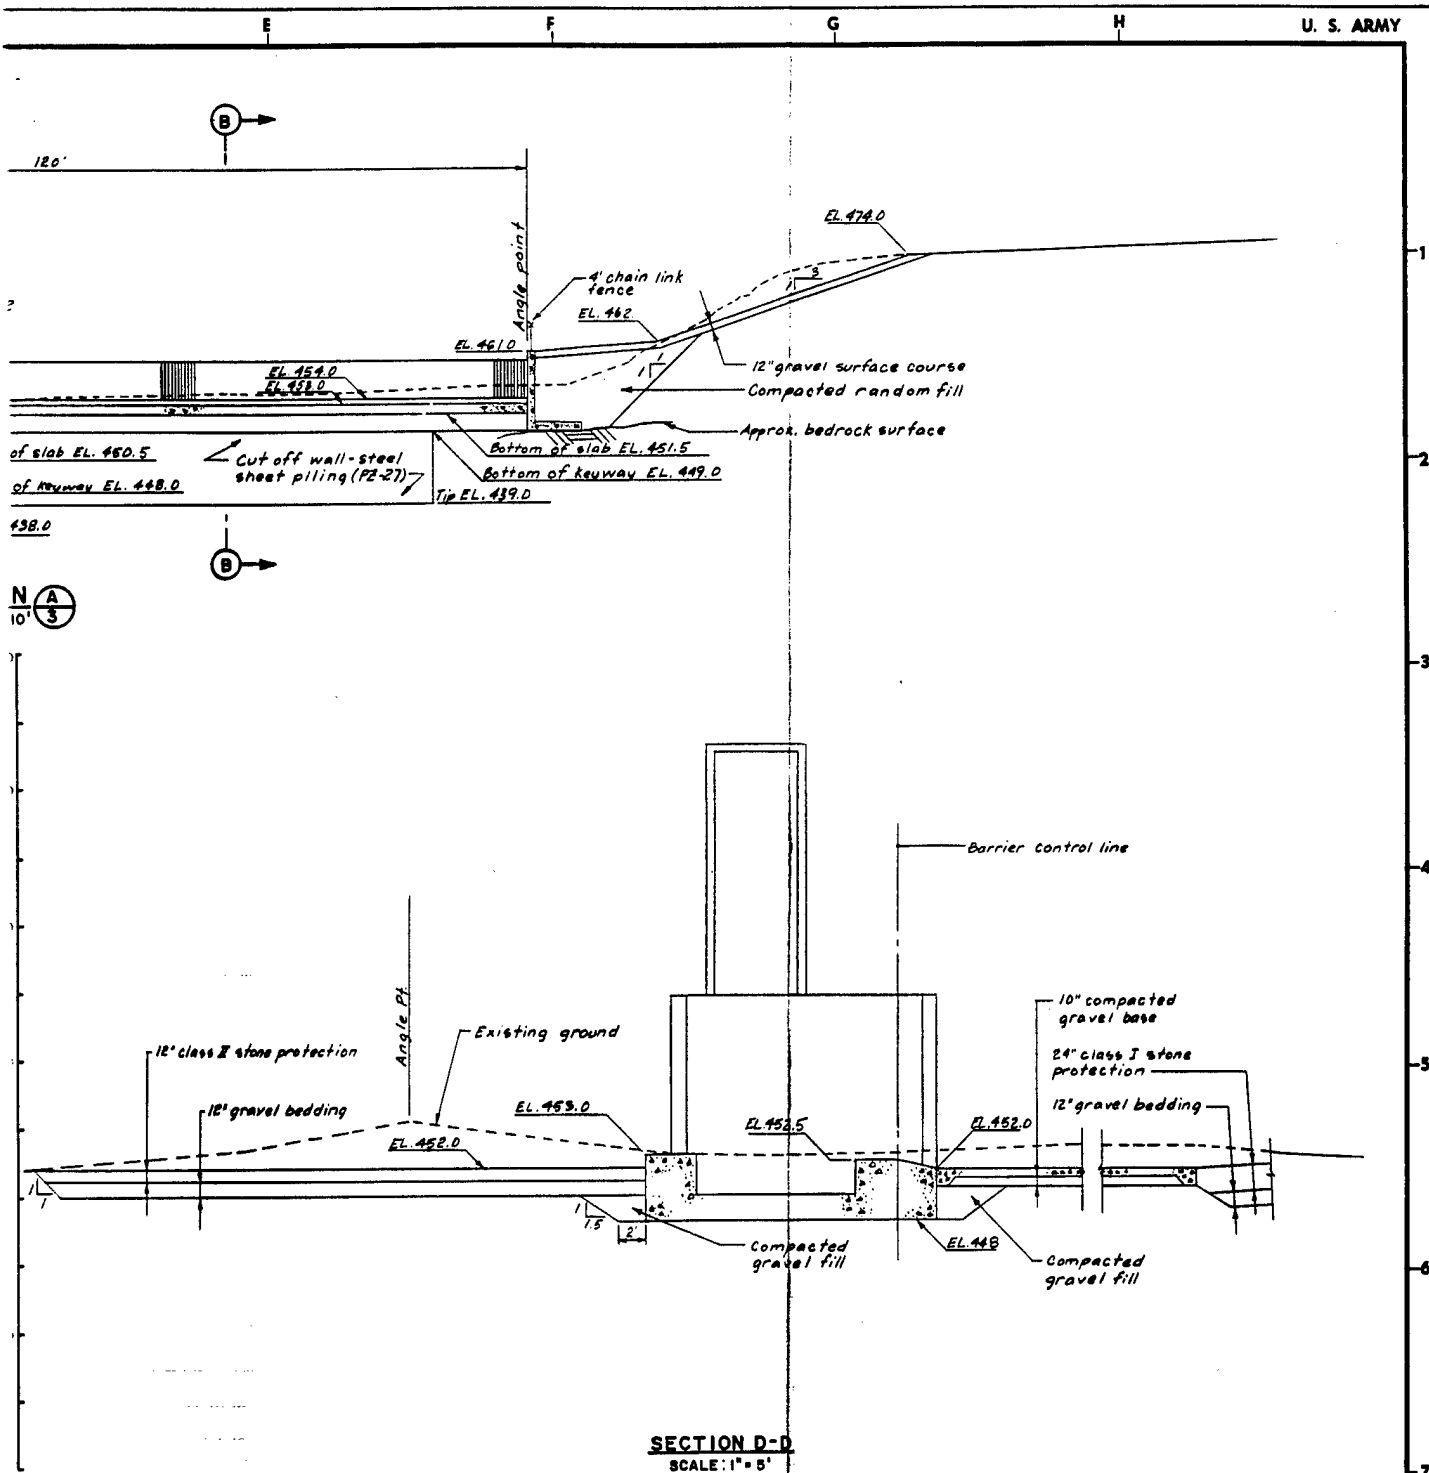
SECTION D-D  
SCALE: 1" = 5'

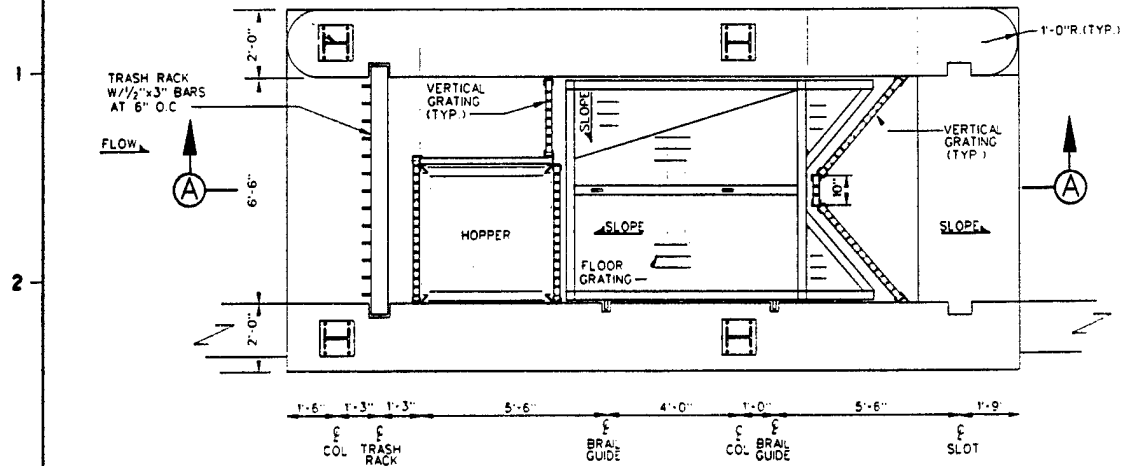
**PLAN-FISH TRAPPING STRUCTURE**

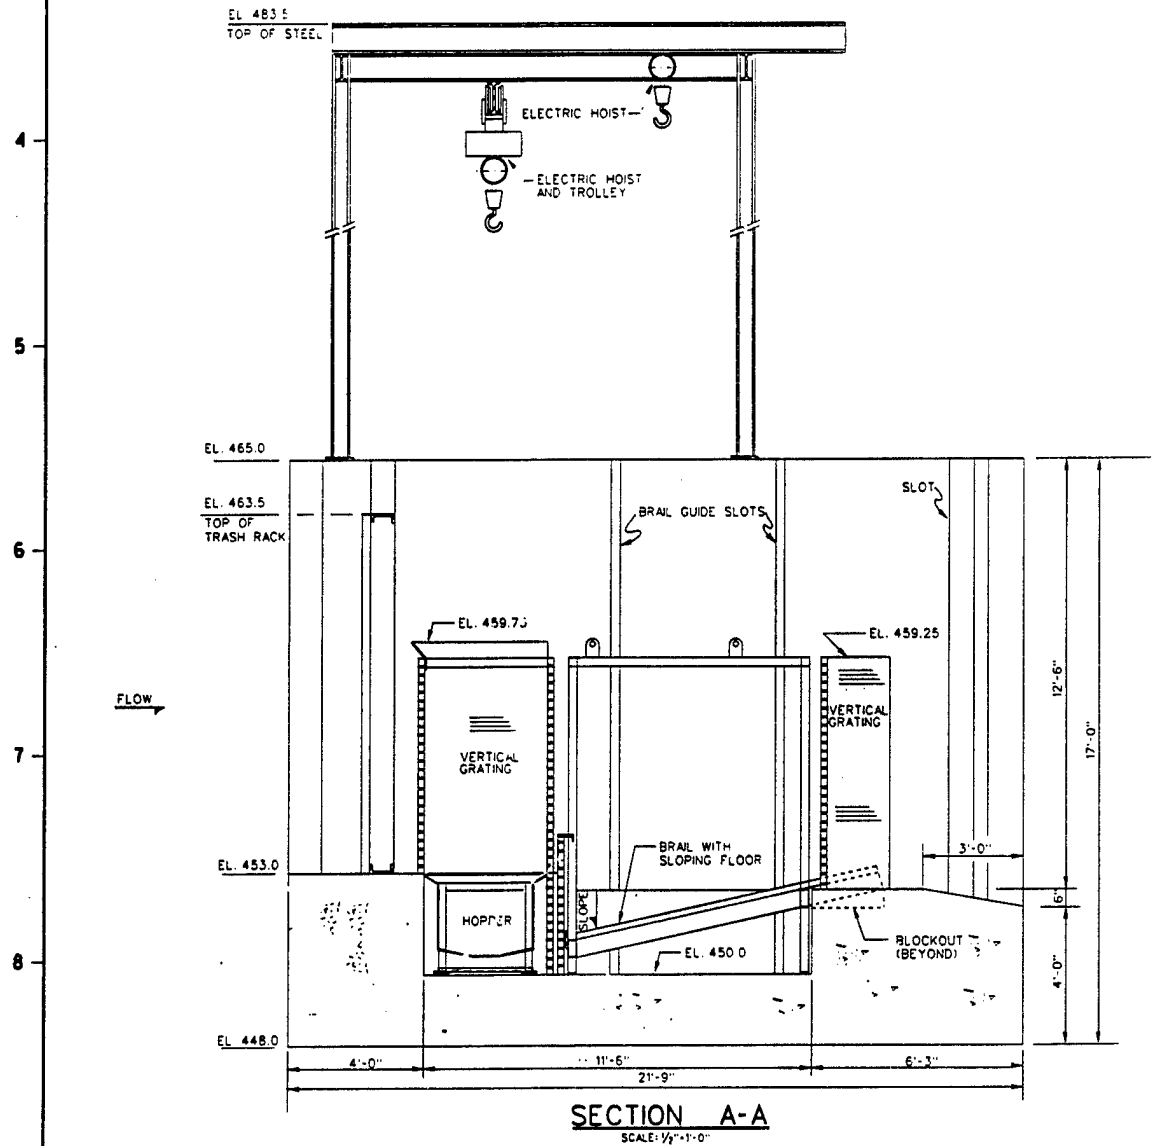
**SECTION A-A**

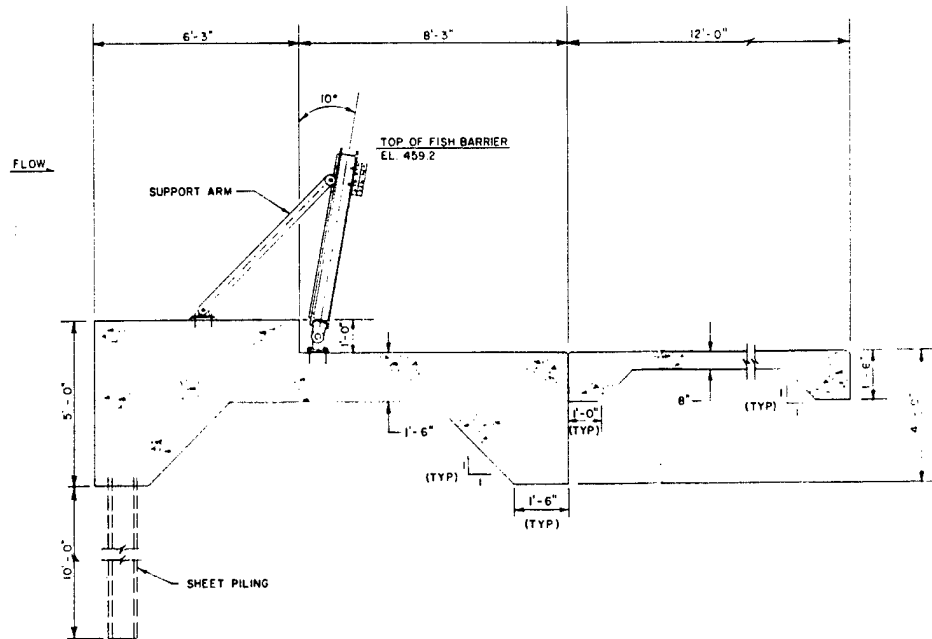
### TYPICAL FISH BARRIER SECTION

(1) Fish Barrier. The barrier is 120 feet long and made of 1/2-inch bars spaced 2 inches on center. This spacing allows downstream passage of smolts and minimizes debris blockage while still preventing upstream-migrating salmon from getting wedged between the bars. Invert of the first 30 feet of the barrier (on the right hand side) is at elevation 453 feet NGVD. The remainder is at invert 454 feet NGVD; this approximates conditions in the river channel. Top of the barrier is set at elevation 459.2 feet NGVD, making the barrier 6.2 feet high at the low flow channel and 5.2 feet high for the rest of the barrier.

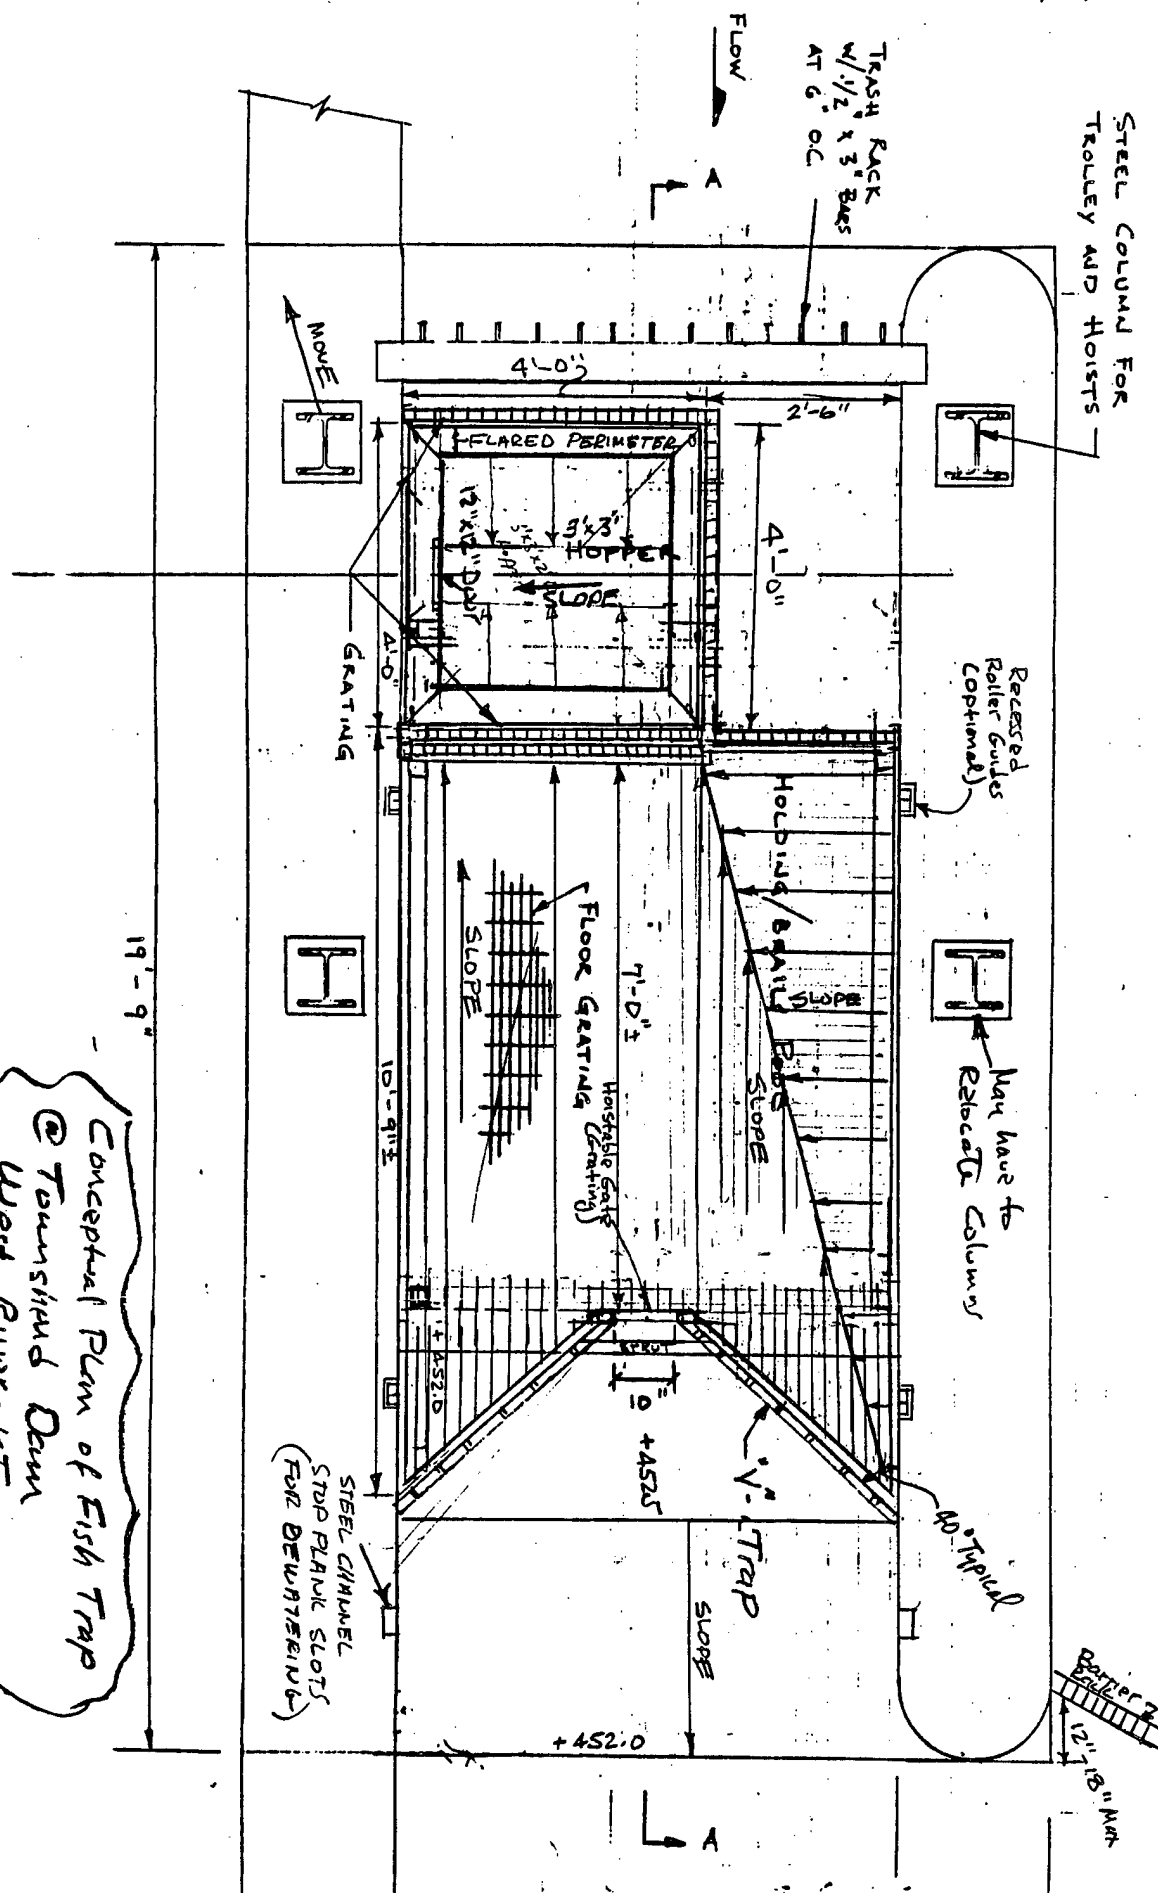
Conceptual Plan of Fish Trap  
@ Townsend Dam  
West River - VT  
Rt B. Pizzos, FWS  
Nov 29/91

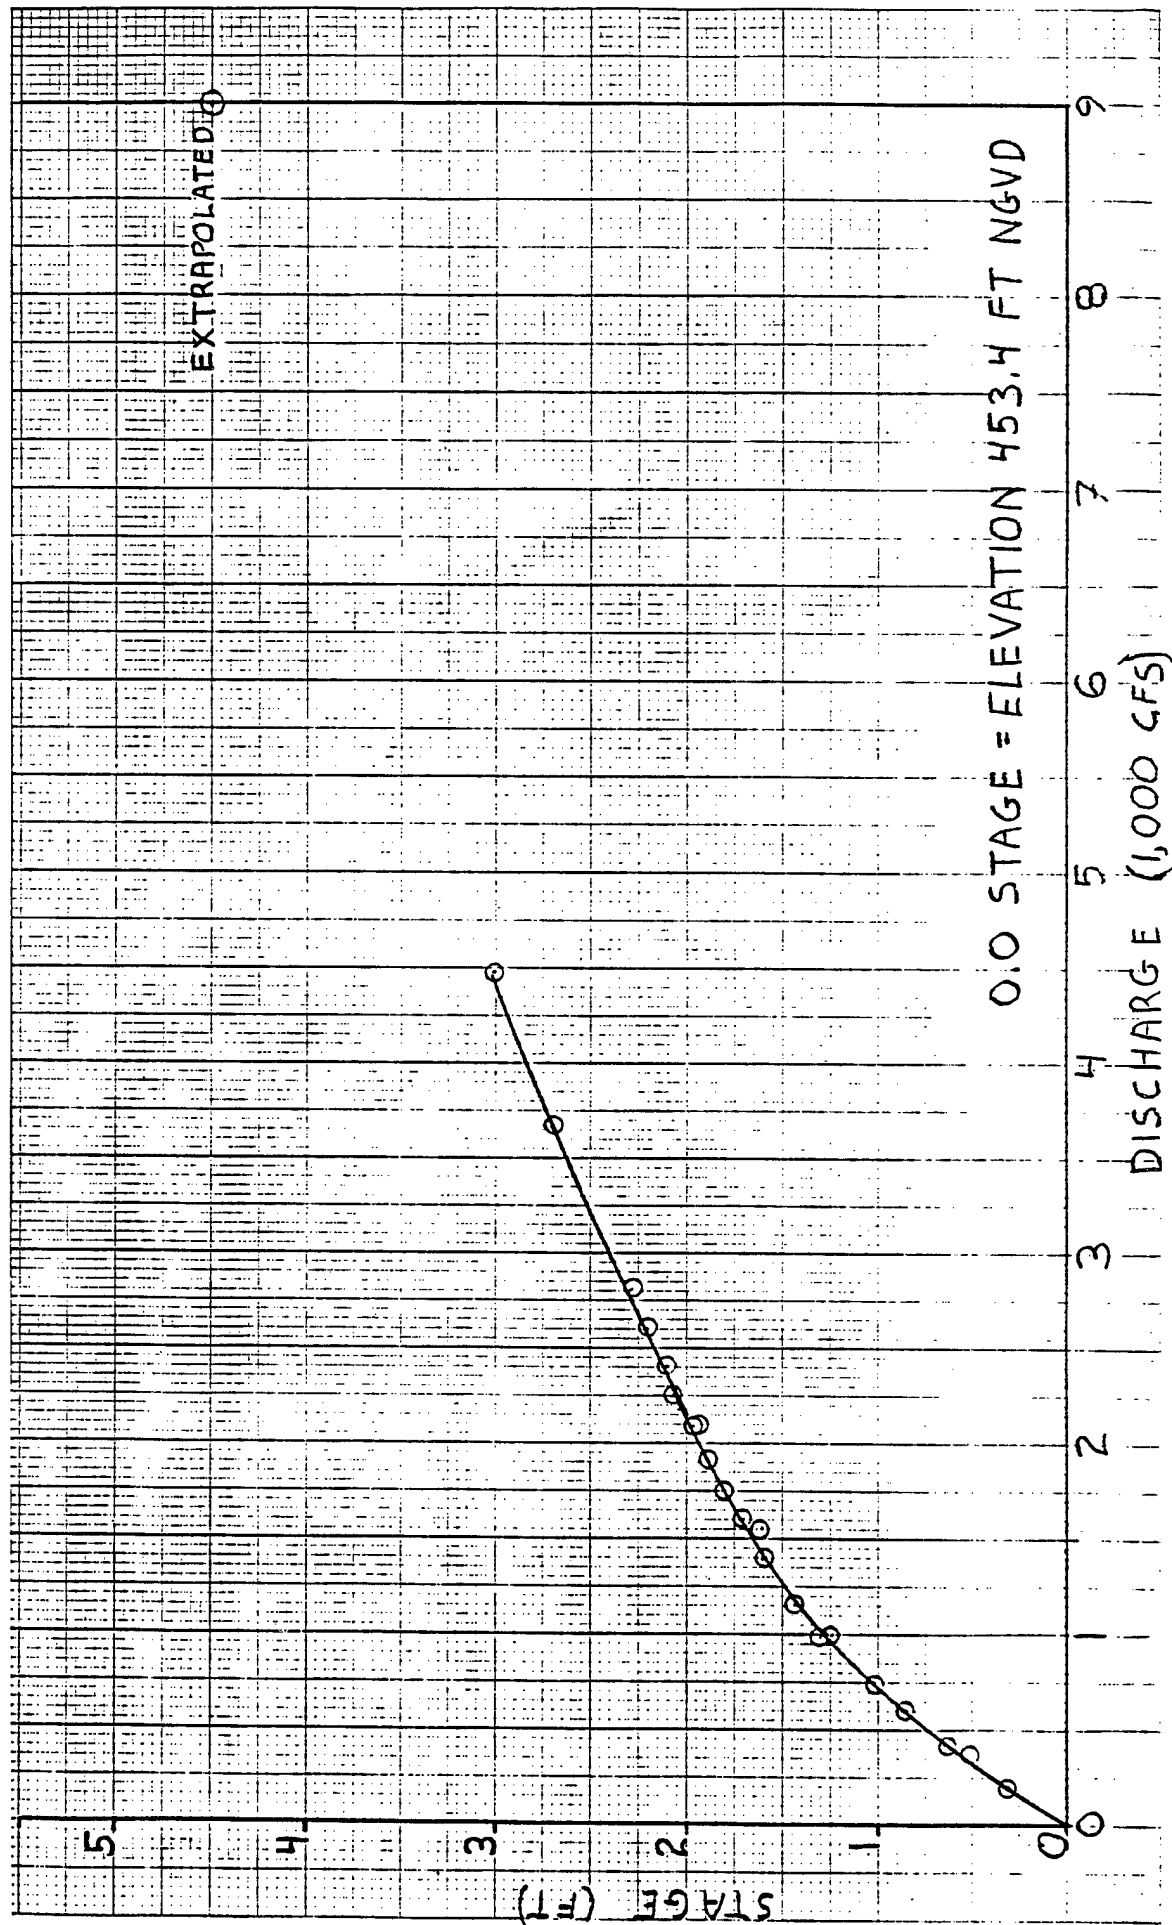
Figure 3

# RATING CURVE FOR WEST RIVER 618 FEET DOWNSTREAM FROM TOWNSHEND DAM CONDUIT OUTLET

(3) 9,000 CFS. With barrier racks in place, and 25 percent clogged with debris, the upstream water surface elevation under maximum regulated reservoir release of 9,000 cfs is 465.5 feet NGVD. Tailwater elevation is 462.5 feet NGVD, giving a total drop in water surface across the racks of 3 feet. At the conduit exit, the water surface elevation is 466.1 which is 16.1 feet above the outlet invert. The operating plan for the barrier calls for racks to be removed during flows of 5,000 cfs or greater. With the racks removed, water level during maximum controlled releases would

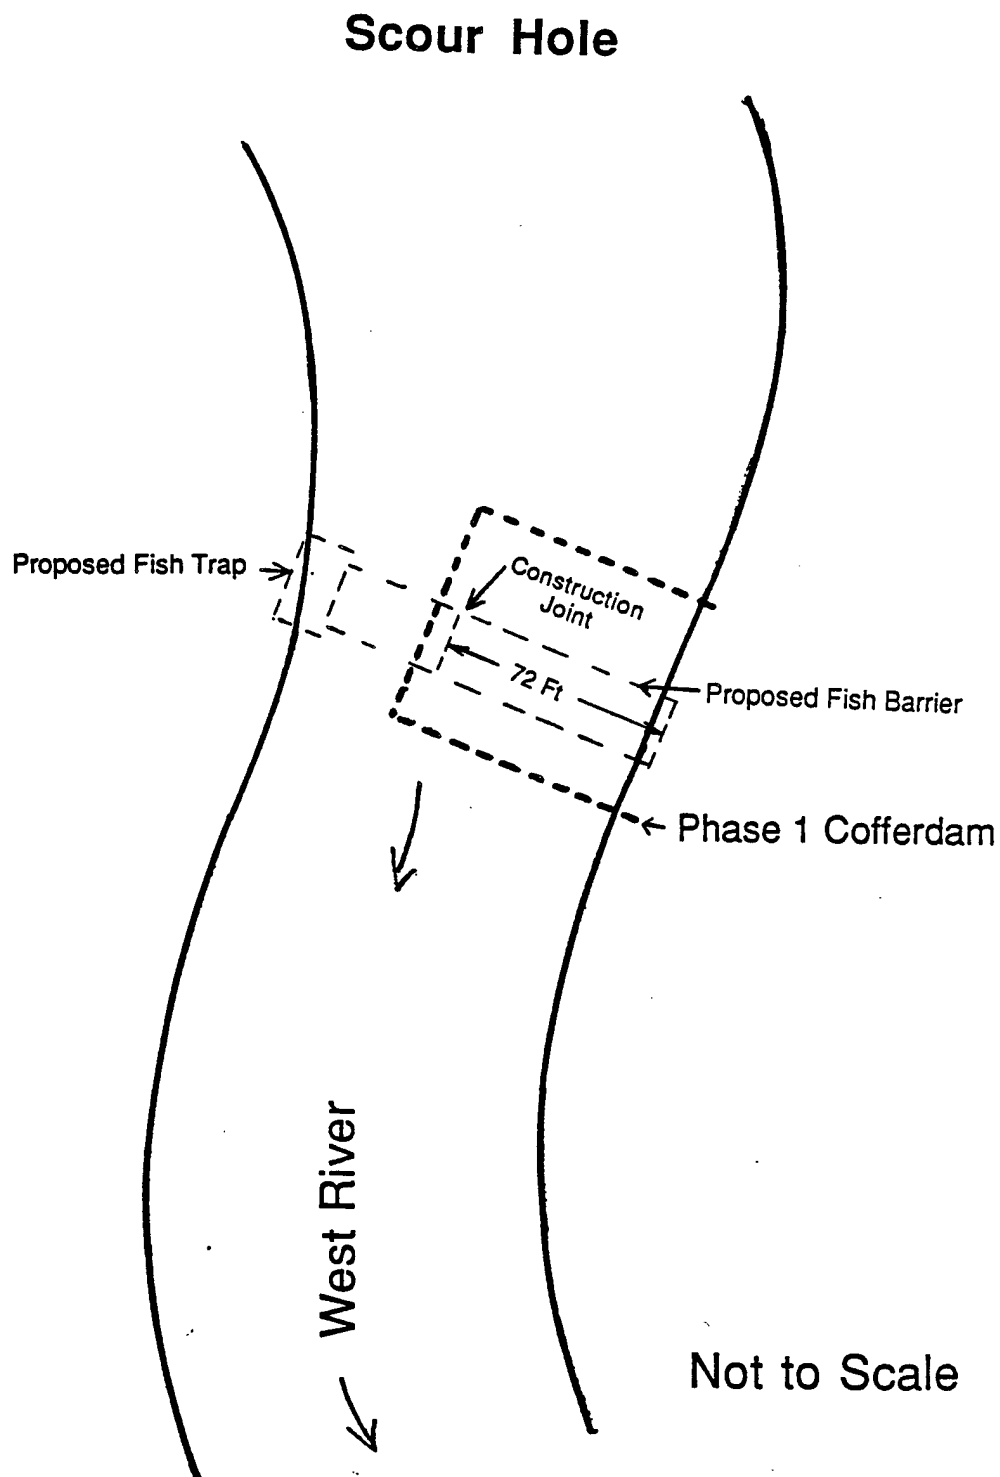
Figure 4

# Phase 1 Cofferdam Schematic

a. General. The barrier and fish trap will be constructed in two phases (see figures 4 and 5). During the first phase, a cofferdam will be built out from the left bank to enclose the first 72 feet of river where the barrier will be constructed. During the second phase, a cofferdam will be built from the right bank to enclose the fish trap area and remaining unconstructed barrier. Flow area for diversion of water during construction is very tight and using up to an inch of runoff storage at Ball Mountain and Townshend Lakes will be necessary to restrict discharges (The Reservoir Regulation Evaluation Appendix discusses construction storages at Ball Mountain and Townshend Lakes in detail including the rationale for using 1 inch of runoff storage). Although these lakes have capacity to allow complete control of the river during all but extreme events, there are disadvantages to storing more than an inch of runoff. Storing water at Townshend Lake to reduce flows during construction will cause the recreation area to be flooded out and possible damage to trees surrounding the lake. The Winhall recreation area at Ball Mountain Lake is well above the elevations that would be flooded by construction storages. However, there is the potential that trees will be killed if inundated too long during the growing season, and there may be small increases in turbidity and sedimentation in the lake due to sloughing and bank erosion caused by higher pool levels. Consequently, it is necessary to achieve a balance between size of the cofferdam and the amount of construction season lake storage.

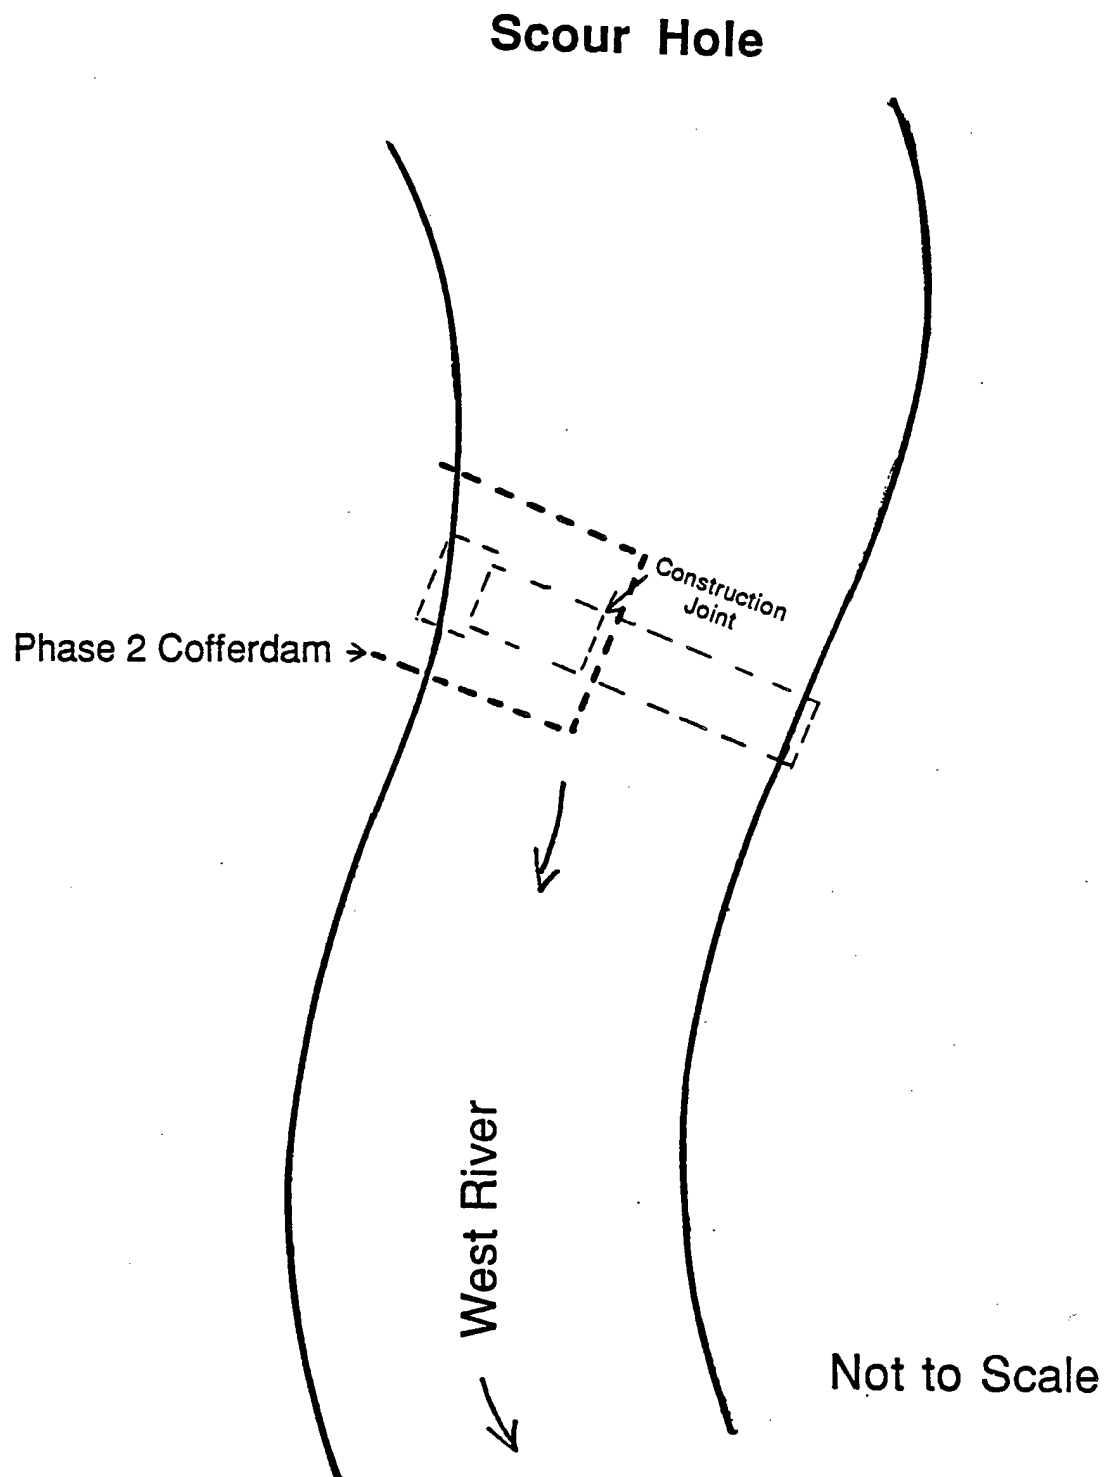
Figure 5

# Phase 2 Cofferdam Schematic

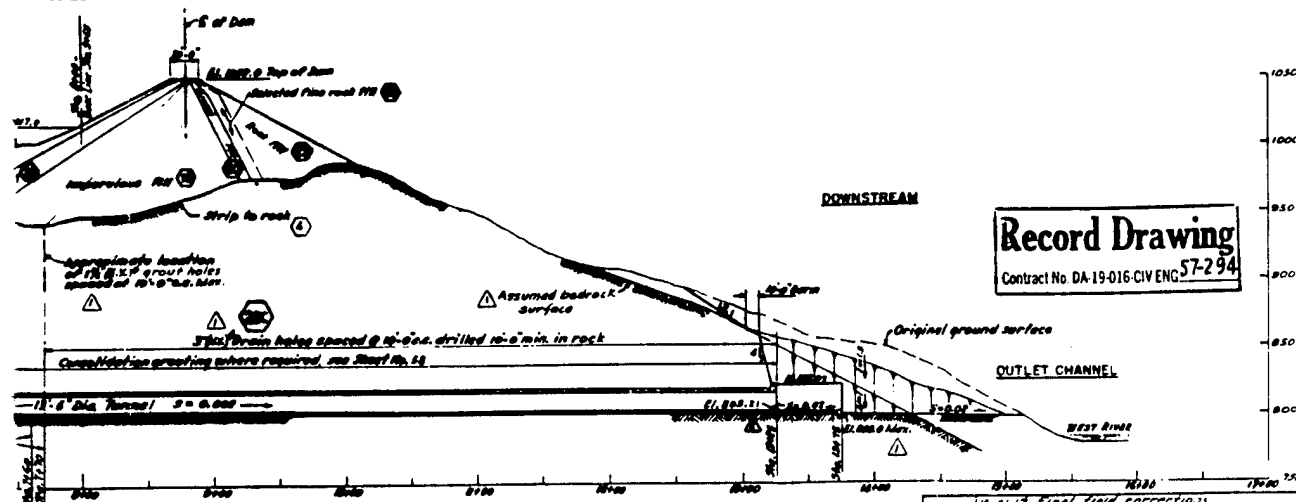
SECTION F-F

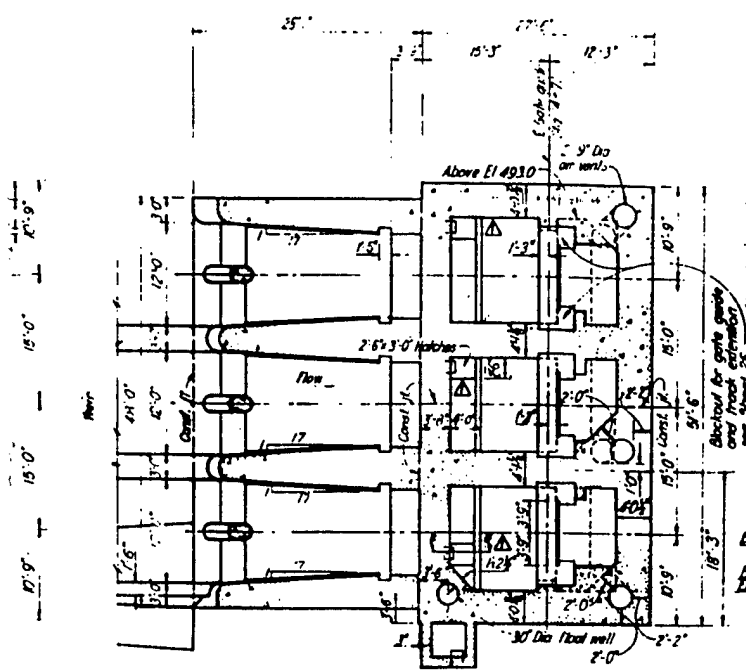
SECTIONAL PLAN AT EL. 491.0

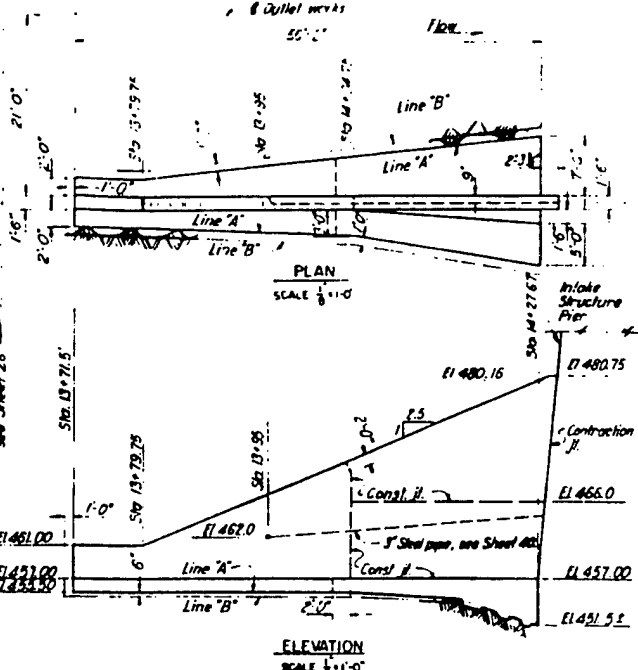
ELEVATION

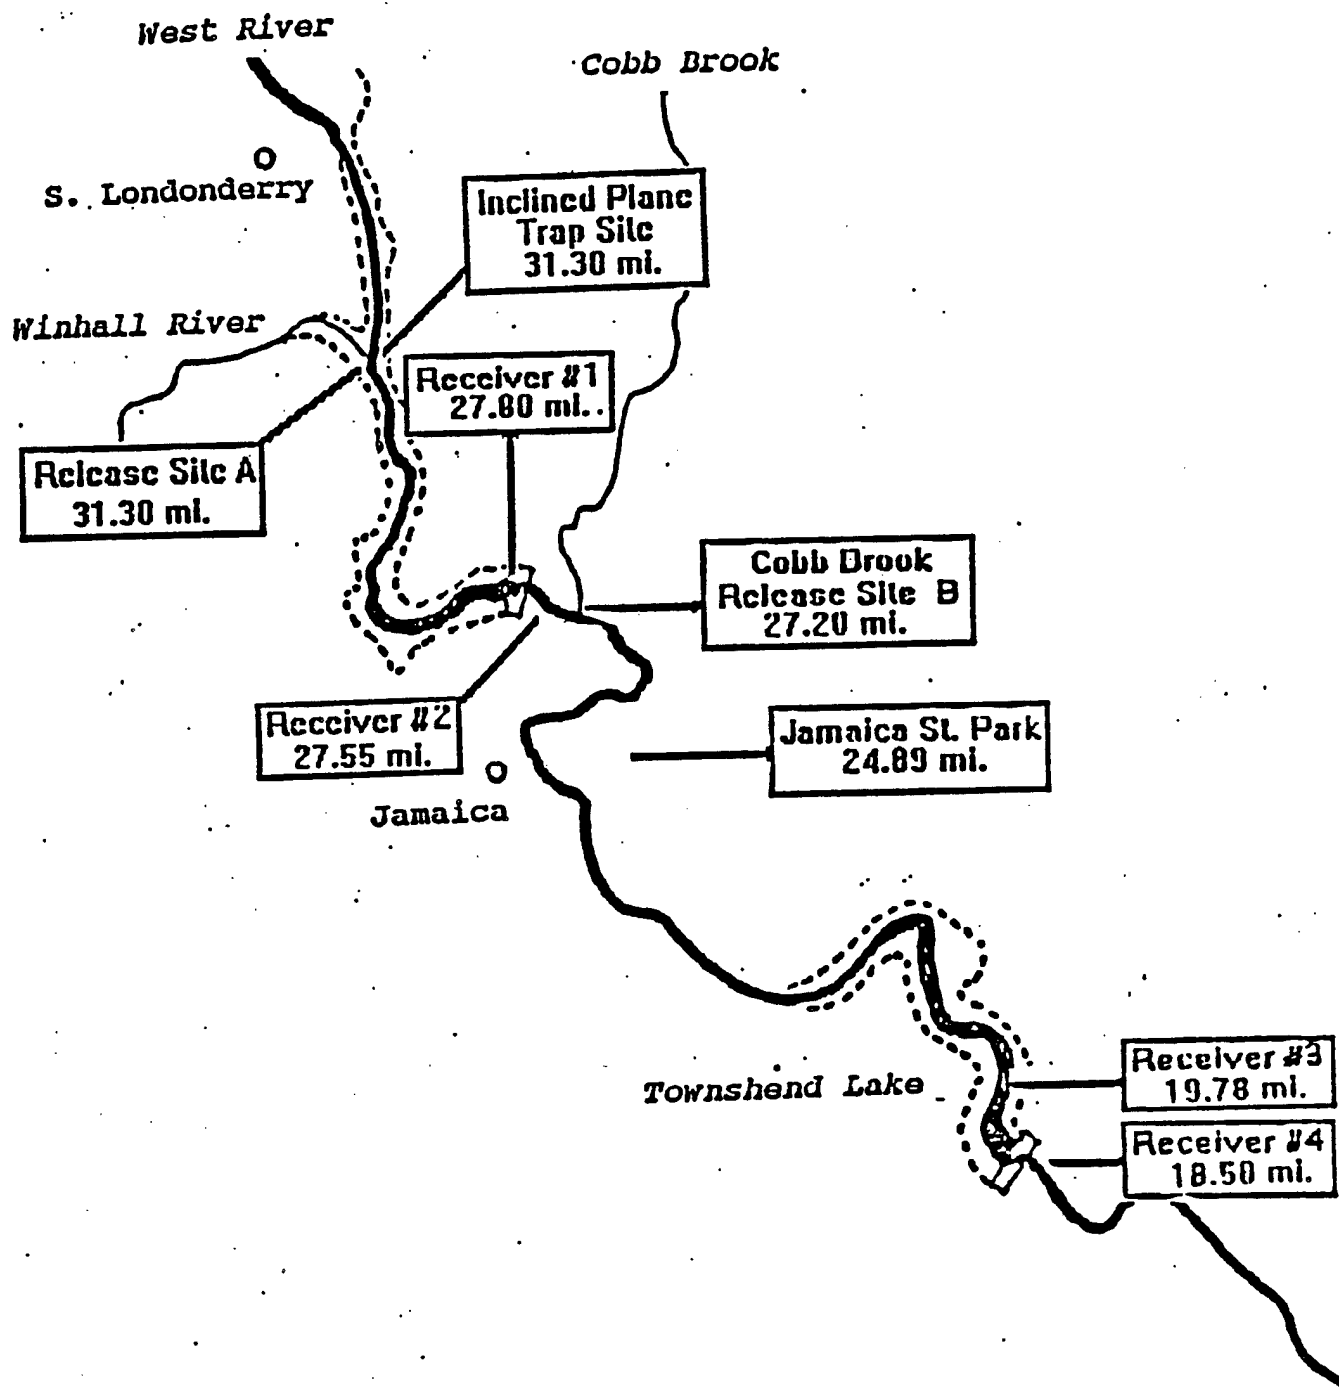
**Figure 2.** Atlantic salmon release sites and telemetry monitoring locations for the 1991 West River, Vermont study.

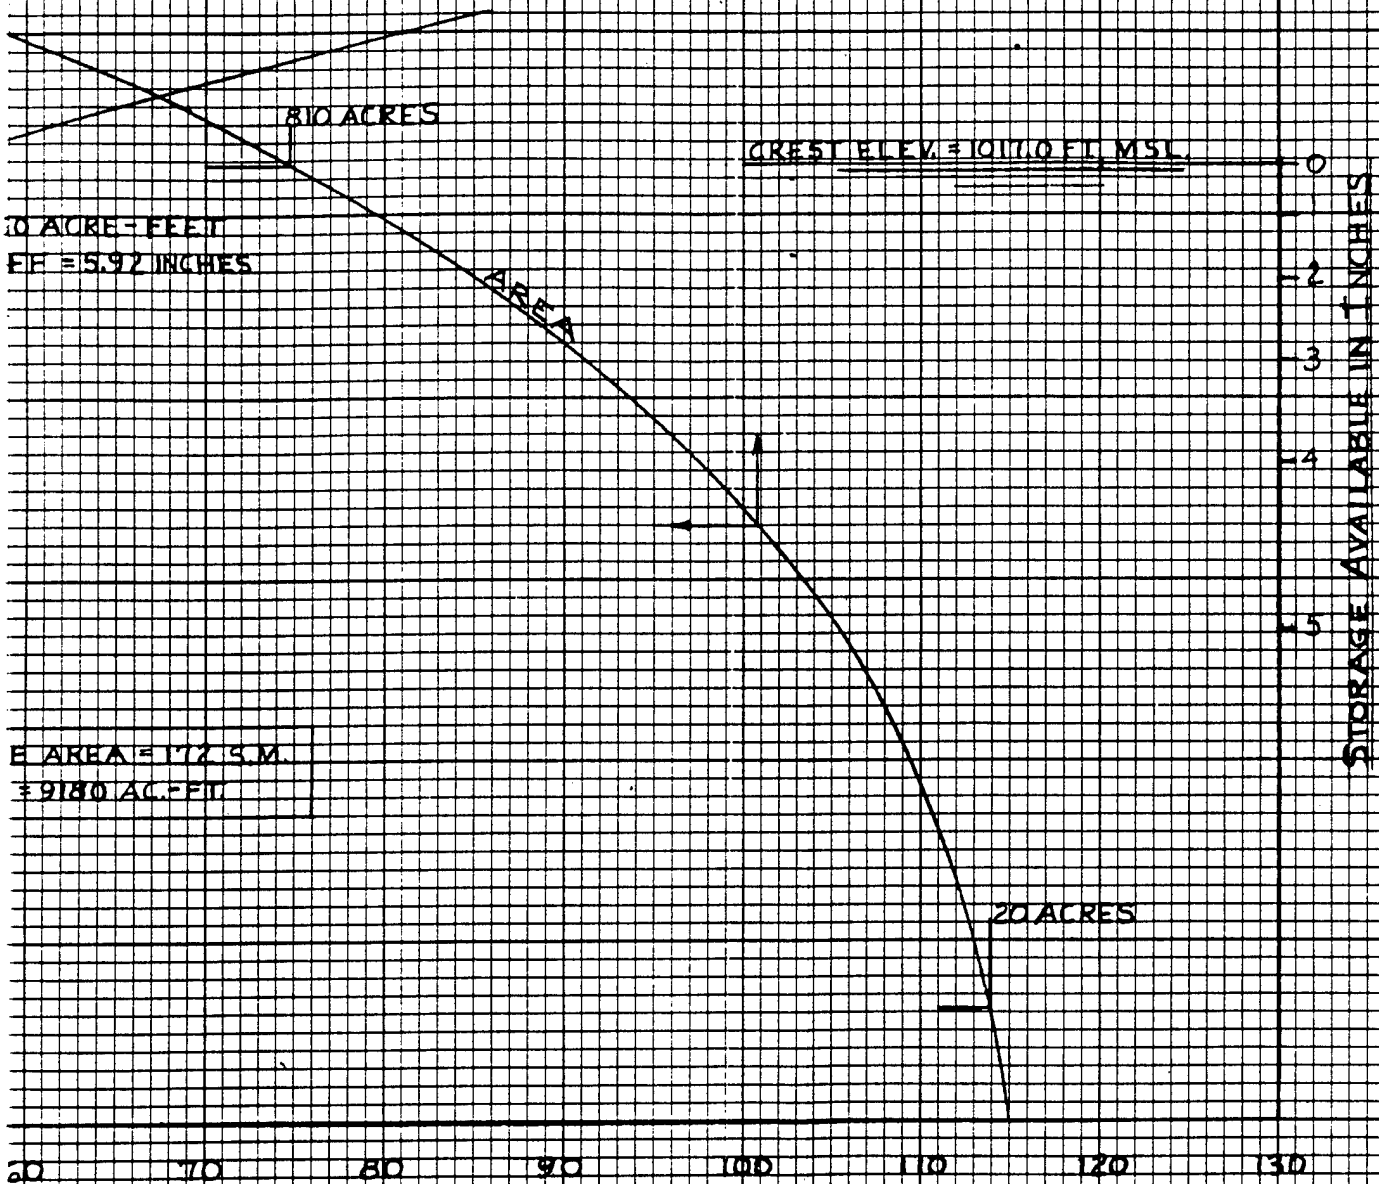
CONNECTICUT RIVER FLOOD CONTROL  
BALL MOUNTAIN LAKE  
AREA CAPACITY  
CURVES  
NEW ENGLAND DIVISION WALTHAM, MASS.  
JUNE 1973

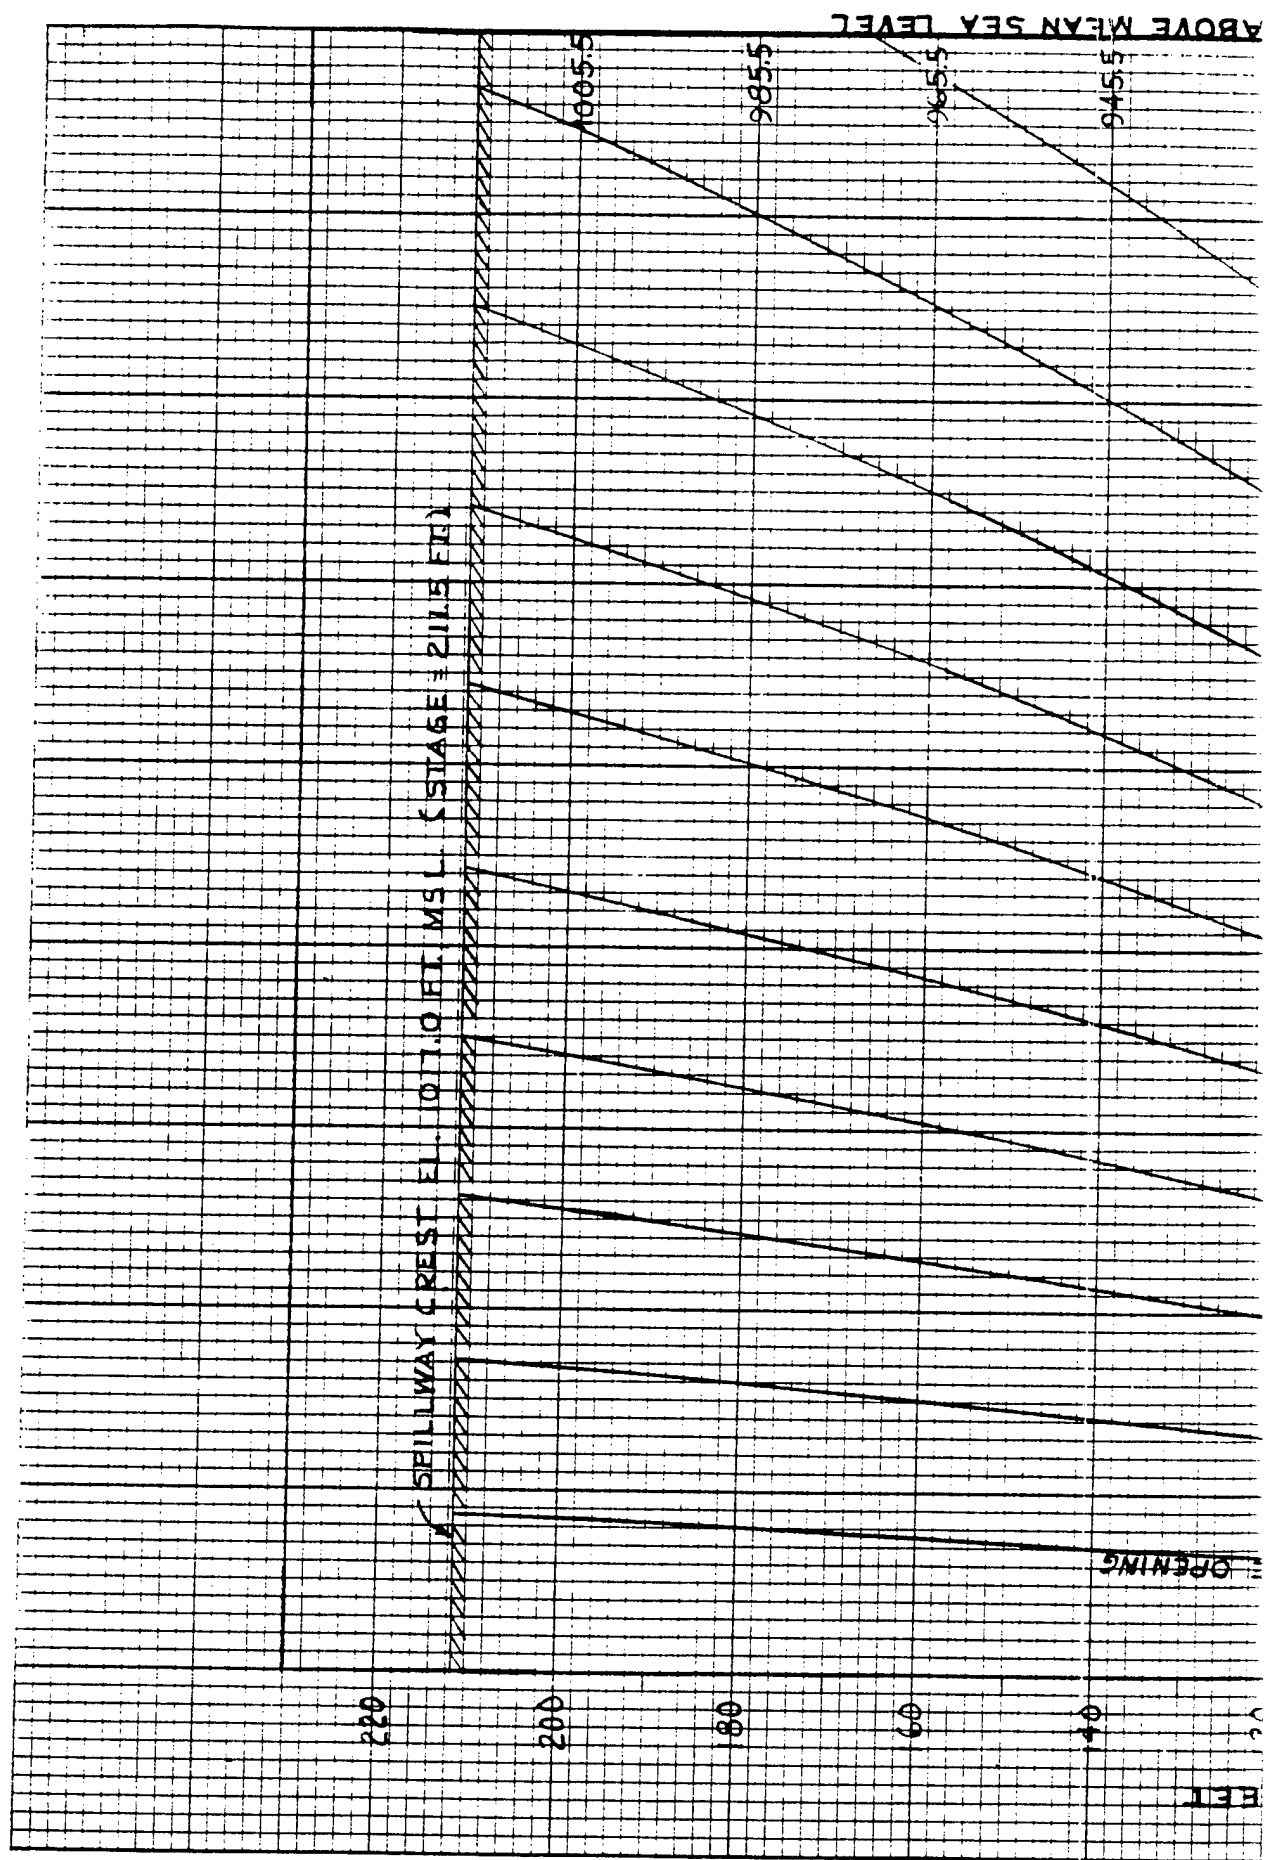
CONNECTICUT RIVER FLOOD CONTROL  
 BALL MOUNTAIN LAKE  
 OUTLET RATING CURVES  
 FOR ONE GATE  
 NEW ENGLAND DIVISION WALTHAM, MASS.  
 JUNE 1973

THREE 5'-8" x 10'-0" GATES  
 13'-6" DIA. CONDUIT
