NAVAL AIR WARFARE CENTER AIRCRAFT DIVISION  
PATUXENT RIVER, MARYLAND

REPORT NO: NAWCADPAX--98-8-TR

### FIBER FINISHES FOR IMPROVING GALVANIC RESISTANCE OF IMIDE-BASED COMPOSITES

12 February 1998

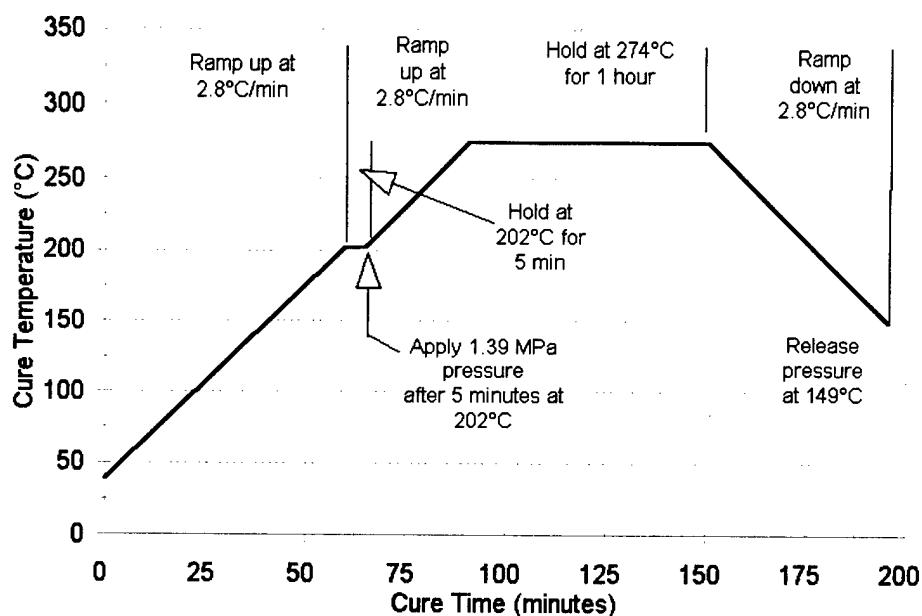
Figure 5. Composite cure cycle for BMI matrix panels

Unidirectional composites were fabricated using a vacuum bag hot press molding technique in hard tooling. Eight ply stacks of staged prepregs were used to fabricate the unidirectional composites for the corrosion studies. The cure cycle is shown in Figure 5.

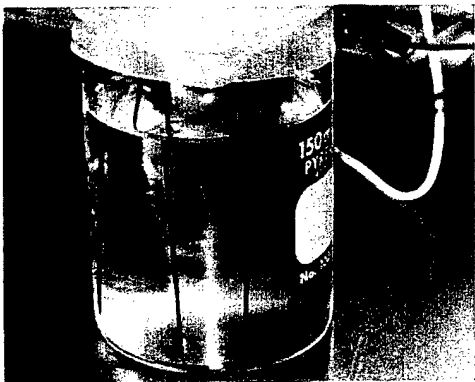
Figure 24. Galvanic corrosion samples after 2 days of immersion

The second screening tests examined galvanic corrosion susceptibility. The appearance of the sample rods after 2 days of immersion is shown in Figure 24. Little aluminum corrosion product was seen with the PH9301F and PH9304F finishes shown in 24a and 24b. A small amount of corrosion product is seen with the PH9306F finish (24c) and a larger amount with the PH9305F finish (24d). The control samples (24e and f) exhibited a similar amount of corrosion product as the PH9305F sample.  $Al(OH)_3$  is the expected corrosion product.

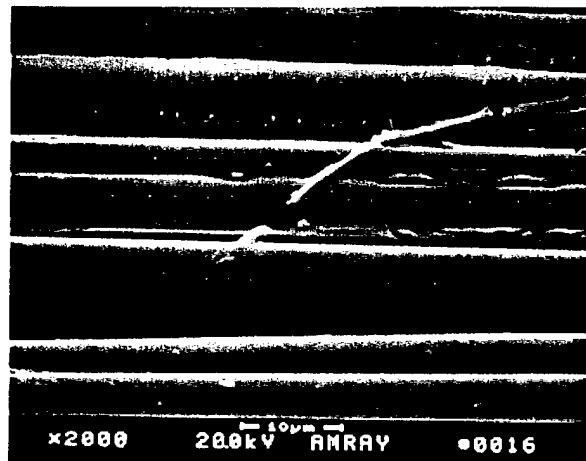
Figure 28. Composite surface appearance with PH9304F finish

The finished specimens showed varying degrees of resin degradation, all less than the unsized controls. Surface appearance of the finished specimens is shown in Figures 27-30. The PH9301F (Figure 27) and PH9304F (Figure 28) finished samples have most of the BMI resin intact and show the beginning of resin degradation exhibited in cracking and delamination. Both the PH9305F (Figure 29) and PH9306F (Figure 30) finished specimens show the BMI resin delaminating and peeling from the composite in long strips in areas of the surface. Other areas show the resin intact. Higher magnification views show the delamination process beginning (Figure 29) and only a small amount of resin remaining in the delaminated regions with the PH9306F finish (Figure 30).

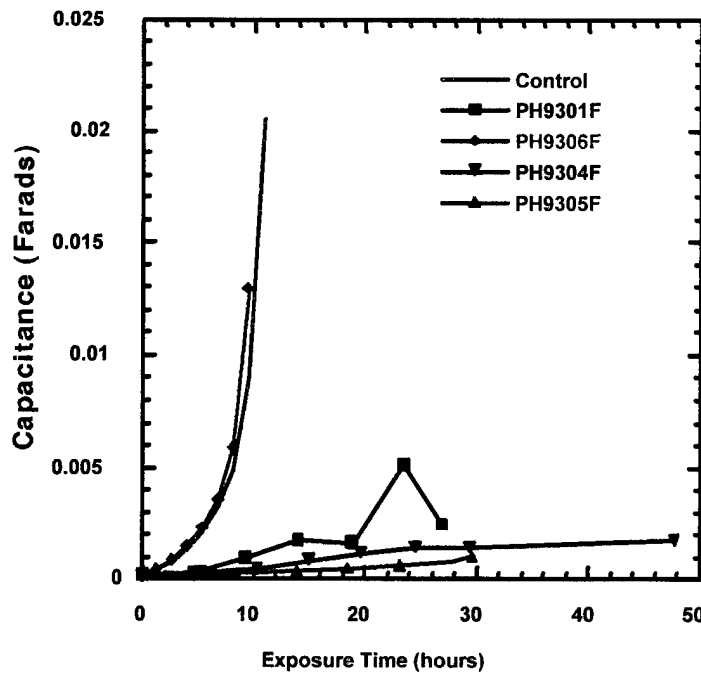
Figure 40. Sample capacitance versus exposure time for control and coupling agent modified composite samples tested to expose fiber lengths

Figure 40 shows capacitance versus time responses for the composite samples exposed along the fiber lengths. A control sample containing no surface finish was tested for comparison. Measured capacitance does not significantly increase for the PH9301F, PH9304F, and PH9305F finishes indicating that excellent resistance to cathodic disbondment is conferred. Significant increases in capacitance are detected for the control sample and PH9306F showing that disbondment proceeds in a much more rapid fashion. The fact that the PH9306F curve is nearly identical to that for the control sample indicates that no beneficial effect is derived from the use of this finish.

Figure 41 shows capacitance versus time curves obtained from the “end-on” test configuration. These data corroborate those shown in Figure 40 (PH9306F not included) showing that the effect of the finishes on cathodic disbondment operates independent of orientation and that the effect is significant enough to be observed in these aggressive types of tests. The calculated debond area for the end-on EIS measurements is given in Table X.
