DOT/FAA/AR-97/69

Automated Inspection of Aircraft

April 1998

Final Report

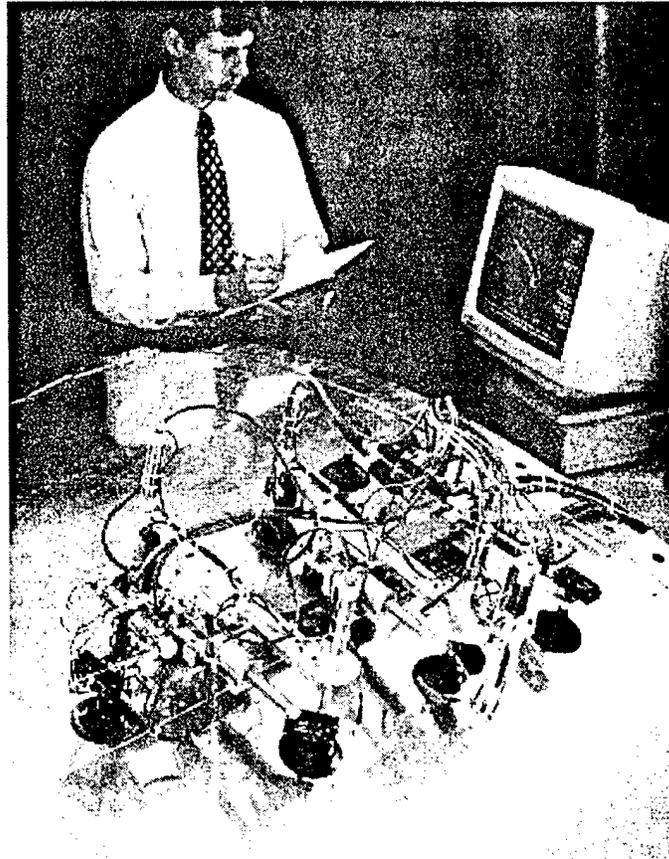
FIGURE 2. FIRST-PHASE ROBOT AND LAB SETUP

A simulated aircraft panel manufactured by Foster-Miller, Inc., was provided to the CMU Automated Inspection of Aircraft Project by the FAA Aging Aircraft Nondestructive Inspection Validation Center (AANC). The panel's curvature and fastener layout are similar to that of a Boeing 737. During the initial phase of development, the simulated aircraft panel was mounted horizontally in the lab; all testing on the panel during this phase was performed with the panel mounted in this position. Because the panel was a curved surface, the robot was also tested on a modest slope during this phase. The lab setup is shown in figure 2.

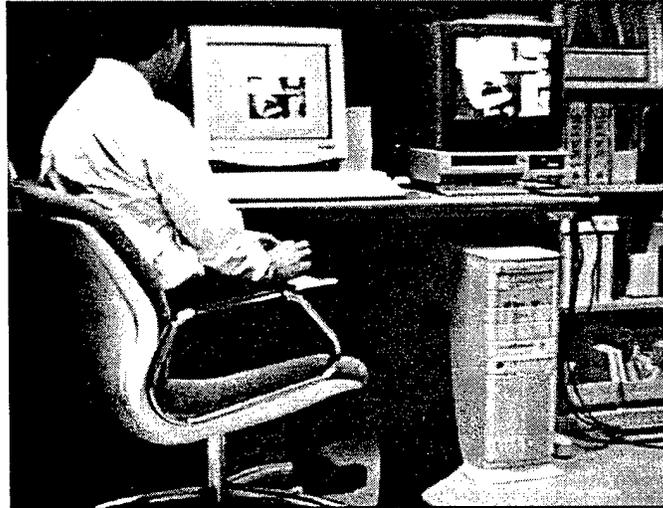
FIGURE 37. OPERATOR WORKSTATION AND VIDEO MONITOR/RECORDER

The operator workstation computer is the main control point for the robotic system. It provides the display and interface resources required by the operator to control and monitor the robot. These interfaces are described in further detail in section 5.3. All high-level robot control and coordination are performed by this machine. Communication channels are provided to the motor controllers, the on-board computer, and the video-processing computers. The eddy-current instrument is contained in and controlled by this machine. A photograph of the operator workstation is presented in figure 37.
