# Cargo Compartment Fire Protection in Large Commercial Transport Aircraft

July 1998

DOT/FAA/AR-TN98/32

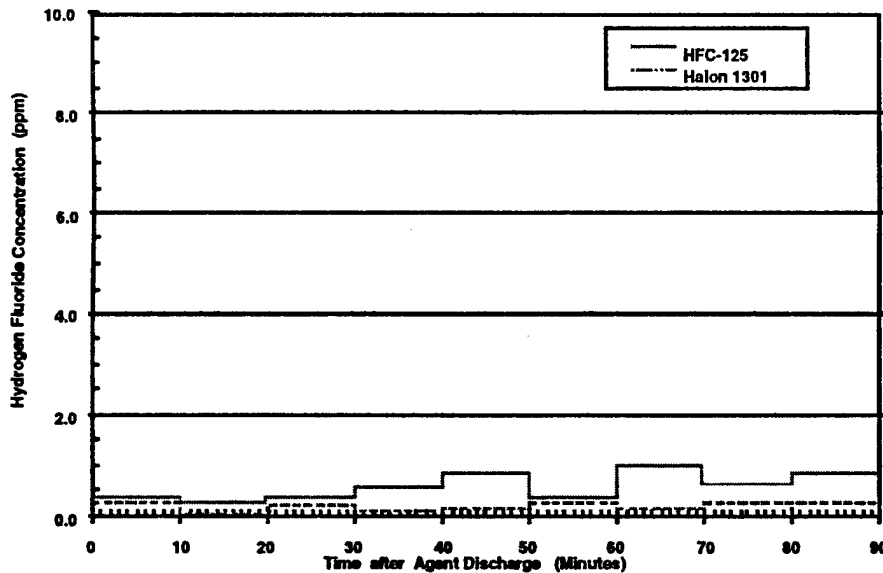
FIGURE 4. HYDROGEN FLUORIDE PROFILES IN PASSENGER CABIN DURING BULK-LOADED FIRE SUPPRESSION TESTS WITH HALON 1301 AND HFC-125

required compared to Halon 1301. Figure 4 shows the HF concentrations in the passenger cabin above the cargo compartment. HF concentrations are again higher in the test with HFC-125 for the same reasons as stated above. However, the data show that there is not a significant accumulation of HF in the cabin area. The fuselage ventilation system exhausts the decomposition products out of the cabin at a rate similar to the inflow rate of these products. The measured levels for both tests were well below the maximum Occupational Safety and Health Administration (OSHA) 15-minute exposure limit of 6 parts per million (ppm) and the Immediately Dangerous to Life and Health (IDLH) limit of 30 ppm.

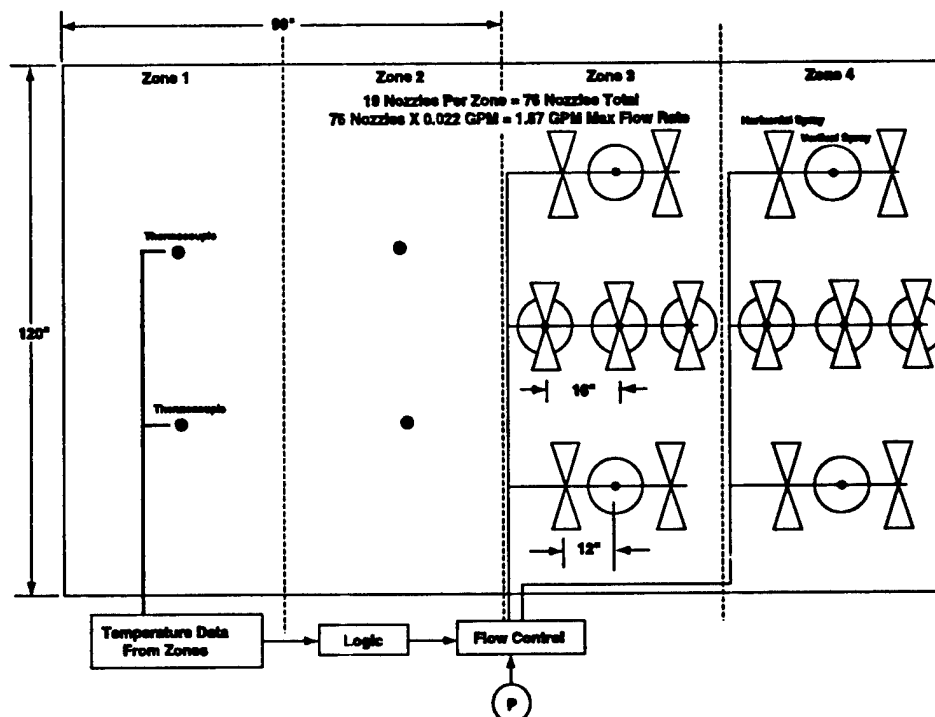
FIGURE 5. WATER MIST SYSTEM SCHEMATIC

The water mist system was supplied by Environmental Engineering Concepts (EEC). These systems are commercially available under the trade names Microcool® and Enviromist® Fog Systems and are primarily used for environmental cooling and vegetable hothouse humidification. The system used for the cargo compartment testing was co-designed by the FAA and EEC and consisted of a high-pressure pump, four zone control valves, and the basic piping and nozzles. The water mist system, designed to minimize the amount of waste water by applying the mist to the areas of the fire, was divided into four zones that could be individually activated (see figure 5). Each zone contained 19 nozzles and covered an area of approximately 4 by 10 feet. The nozzles were oriented to spray mist both horizontally and vertically (down) to maximize mixing and coverage. The mist was automatically controlled by two thermocouples mounted in the ceiling of each zone. The control of the spray activation could be adjusted prior to each test. During the test, when either of the zone thermocouples exceeded the preset value, a signal was sent to open the zone control valve, discharging the mist in that zone. The water mist pressure was adjustable from 800 to 1200 psi, as supplied by an electrically driven pump.

A B727 aft cargo compartment test article was used to evaluate a high-pressure water mist system. The test article measured approximately 120 inches wide by 200 inches long at the ceiling (the floor of the compartment covered significantly less area due to the curvature of the fuselage). The compartment volume was approximately 550 cubic feet. The ceiling and sidewall were constructed of the original fiberglass cargo liners; the forward and aft bulkheads were made of aluminum. Two thermocouples were installed along the compartment centerline with three probes each located at 1-, 2-, and 3-foot levels. Video and photographic equipment were placed in the aft bulkhead to monitor test progress.

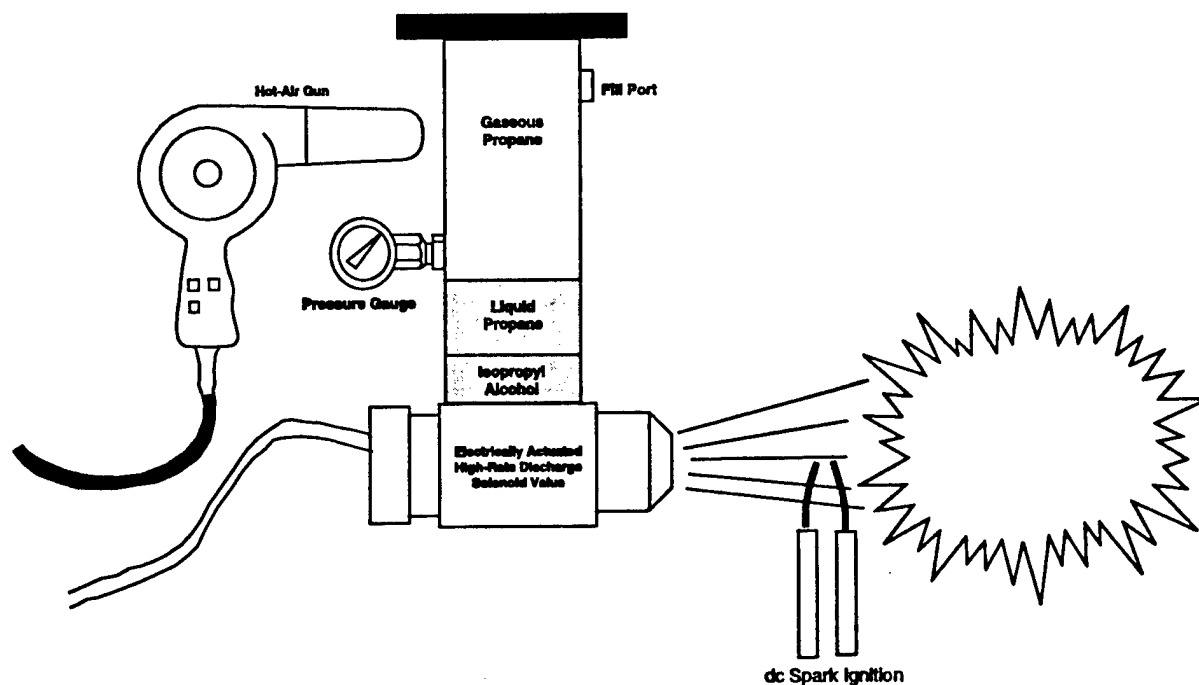
FIGURE 6. EXPLODING AEROSOL CAN SIMULATOR

The initial simulator design was a steel pipe pressure vessel mated to a high-rate discharge (HRD) electrically actuated solenoid valve (see figure 6). The vessel contained ports and valves to transfer the base product (initially isopropyl alcohol) and hydrocarbon propellant (typically propane). The contents are heated by blowing a hot-air gun against the surface of the steel vessel, effectively raising the pressure of the contents. When the pressure was sufficient to burst a standard strength can, approximately 210 psig, the contents were released over a set of direct current (dc) spark igniters. A high-voltage transformer produced the electric spark to bridge the 1.2-cm gap between the pair of electrodes.

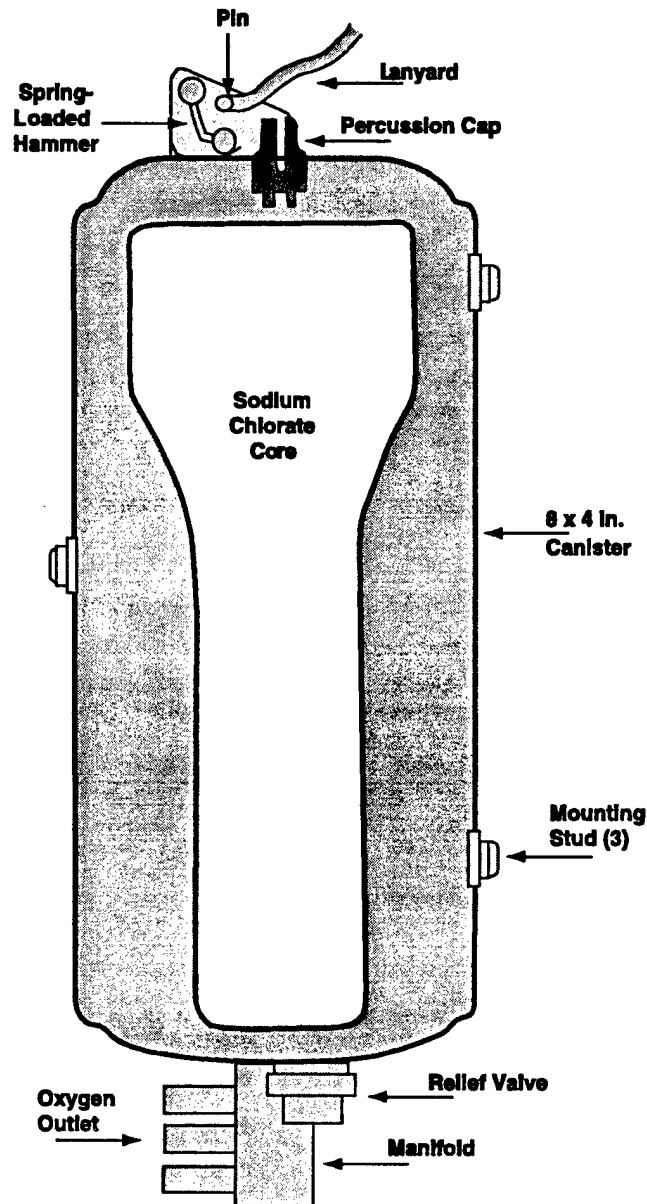
FIGURE 7. CHEMICAL OXYGEN GENERATOR

Most commercial transport aircraft use oxygen canisters to supplement or replace cabin air for passenger breathing in the event of a cabin depressurization. Figure 7 shows the design of a common oxygen canister. The main components are the chemical core composed of sodium chlorate and iron particles, a stainless steel housing, a means of initiating the chemical reaction (such as a spring-loaded hammer striking a percussion cap), and outlets for the gaseous oxygen generated. Because the oxygen-producing reaction is exothermic, the steel housing is insulated from the chemical core to maintain the temperature of the housing below 500°F. As discussed earlier, the activation of improperly packaged and shipped oxygen canisters in the forward cargo compartment was the probable cause of the fatal ValuJet in-flight fire. [5]

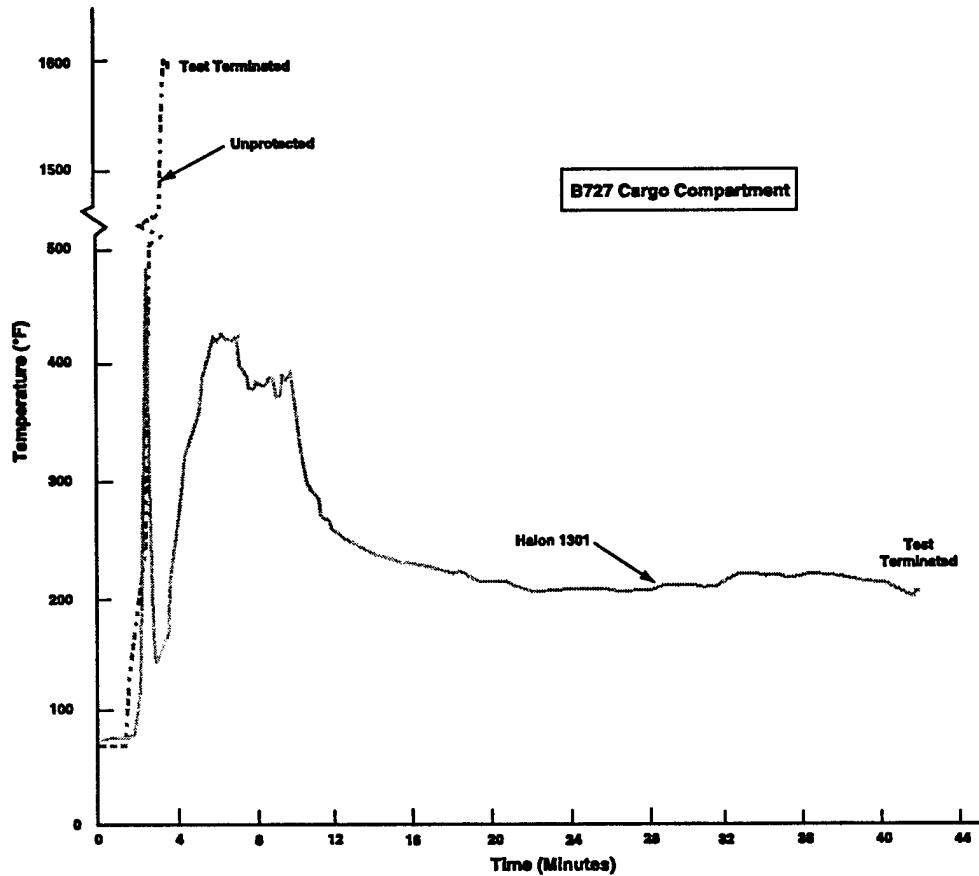
FIGURE 8. COMPARISON OF CEILING TEMPERATURES DURING A CARGO FIRE INVOLVING 12 OXYGEN CANISTERS WITH HALON 1301 SUPPRESSION AND UNPROTECTED

The third test was a repeat of test two without using any suppression agent. Temperatures at the ceiling rapidly reached the point where the liner would be breached and the test was immediately terminated (see figure 8).

The second test was similar to the first with the following exceptions. Only 12 generators were used; all were stored in one cardboard box. Only a single layer of boxes filled with shredded paper was used. In this test the fire was detected much faster than in the first test (see figure 8). Temperatures at the ceiling never exceeded 500°F. As in the first test, upon discharge of Halon 1301 the visible flaming was immediately extinguished. However, in this test the ceiling temperature was maintained at about 400°F for approximately 10 minutes and decreased to approximately 200°F for the next 30 minutes. After the fire was extinguished, it was discovered that only 2 of the 12 generators had activated.

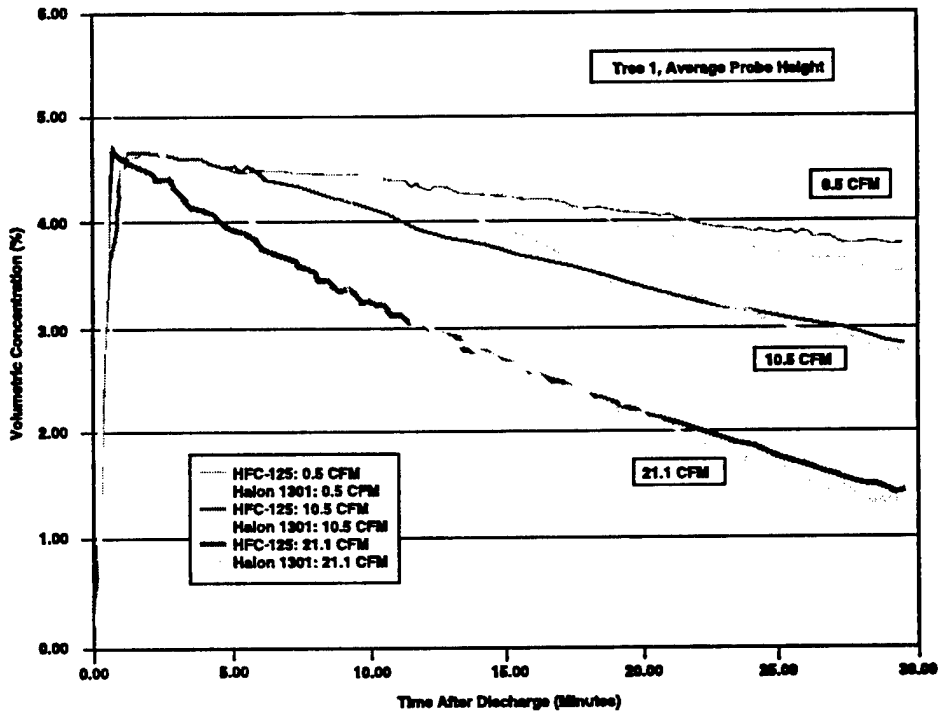
FIGURE 9. AGENT CONCENTRATION HISTORY AT DIFFERENT LEAK RATES

A comparison of the HFC-125 and Halon 1301 concentration histories at the three leakage rates for the sampling tree nearest the leak duct is shown in figure 9. The data represents the average concentration measured at the six sampling heights and from replicate tests at each leakage rate. The higher peak concentrations of Halon 1301 were expected due to the difference in charged weight; 5.8 pounds and 4.45 pounds for Halon 1301 and HFC-125, respectively. Also, the Halon 1301 decays faster than HFC-125 due to its higher vapor density; however, the difference in decay rate lessens as the leakage rate increases. It appears that HFC-125 can be used as a simulant for Halon 1301 provided that suitable conversion equations are used to correlate the concentrations of Halon 1301 and HFC-125.

Discharge tests with HFC-125 and Halon 1301 were conducted and compared in a 300-cubic foot cargo compartment. The air leakage rate in the test article could be set at 0.5, 10.5, or 21.1 cubic feet per minute (CFM). The main instrument was a Heat Technology Laboratory (HTL)

Halonyzer, a 12-channel continuous gas analyzer calibrated for HFC-125 in air and Halon 1301 in air. Gas samples were taken from six sampling tree elevations at two locations. To obtain similar storage bottle discharge characteristics for both agents, the bottle was filled with the equivalent liquid fraction, as used previously, [14] and pressurized with nitrogen to 375 pounds per square inch absolute (psia).
