MRC/COS-R-1309-SAN  
Copy

## TEST DIRECTOR'S REPORT FOR ~~XXXXXXXXXXXXXXXXXXXX~~ HEMP SIMULATION TEST,

This report documents the on-site test activities for the Advanced Fixed-Ground Based Electromagnetic Pulse (EMP) Testing program (AFEMPT) High-Altitude EMP (HEMP) simulation test.

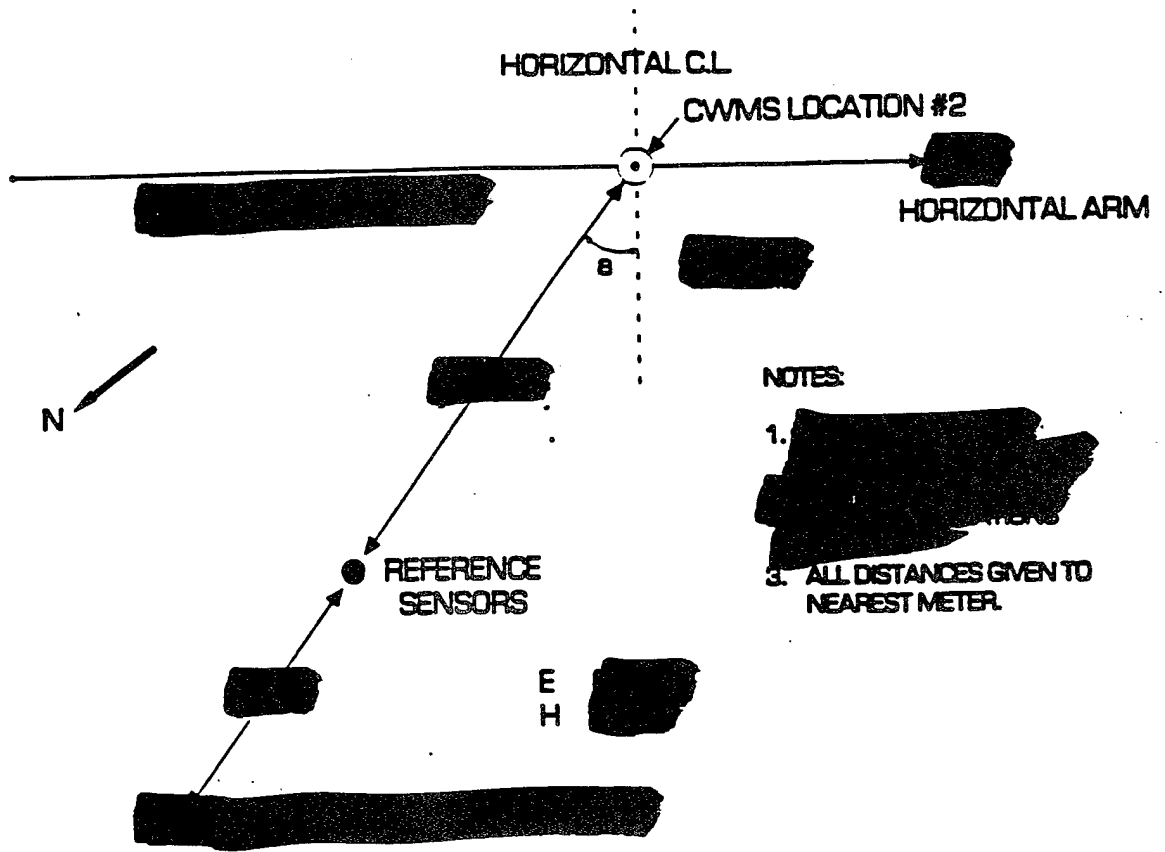
1. [REDACTED]
3. ALL DISTANCES GIVEN TO NEAREST METER.

Table 4 provides a list of all measured responses including the 1m/13m reference transfer functions. Figures 6 through 11 show pertinent geometry relationships of the CWMS antenna, the antenna under test, and the reference sensors.

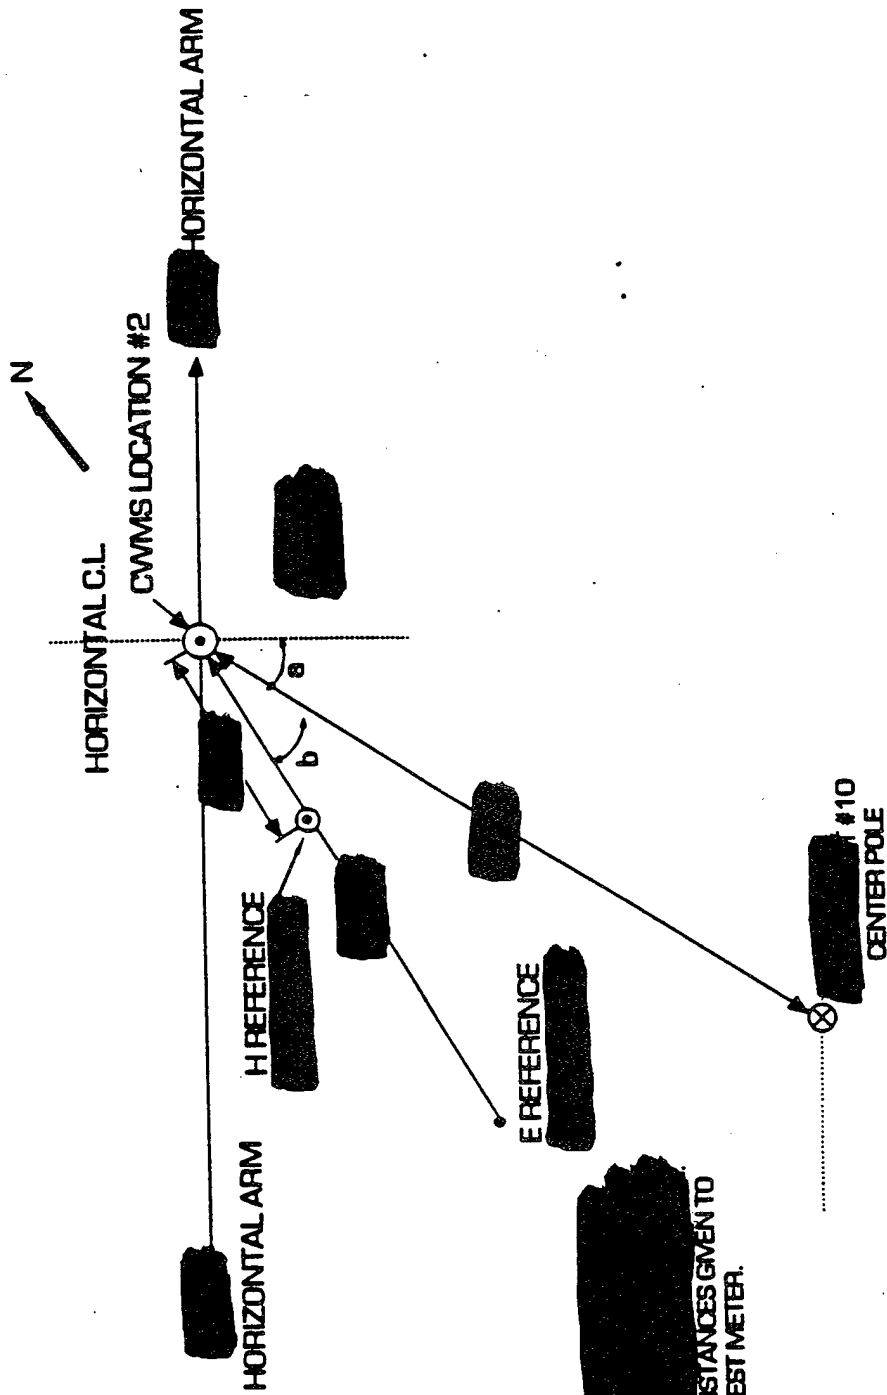
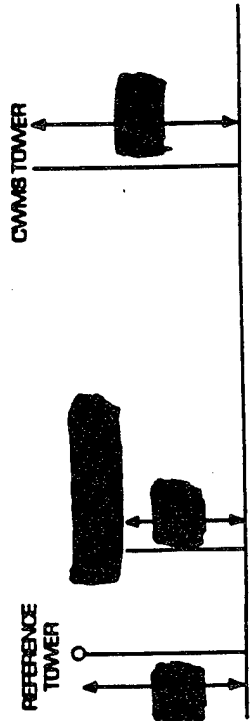
Figure 8. Geometry for [REDACTED] # 10

1. [REDACTED]
2. [REDACTED]
3. ALL DISTANCES GIVEN TO NEAREST METER.

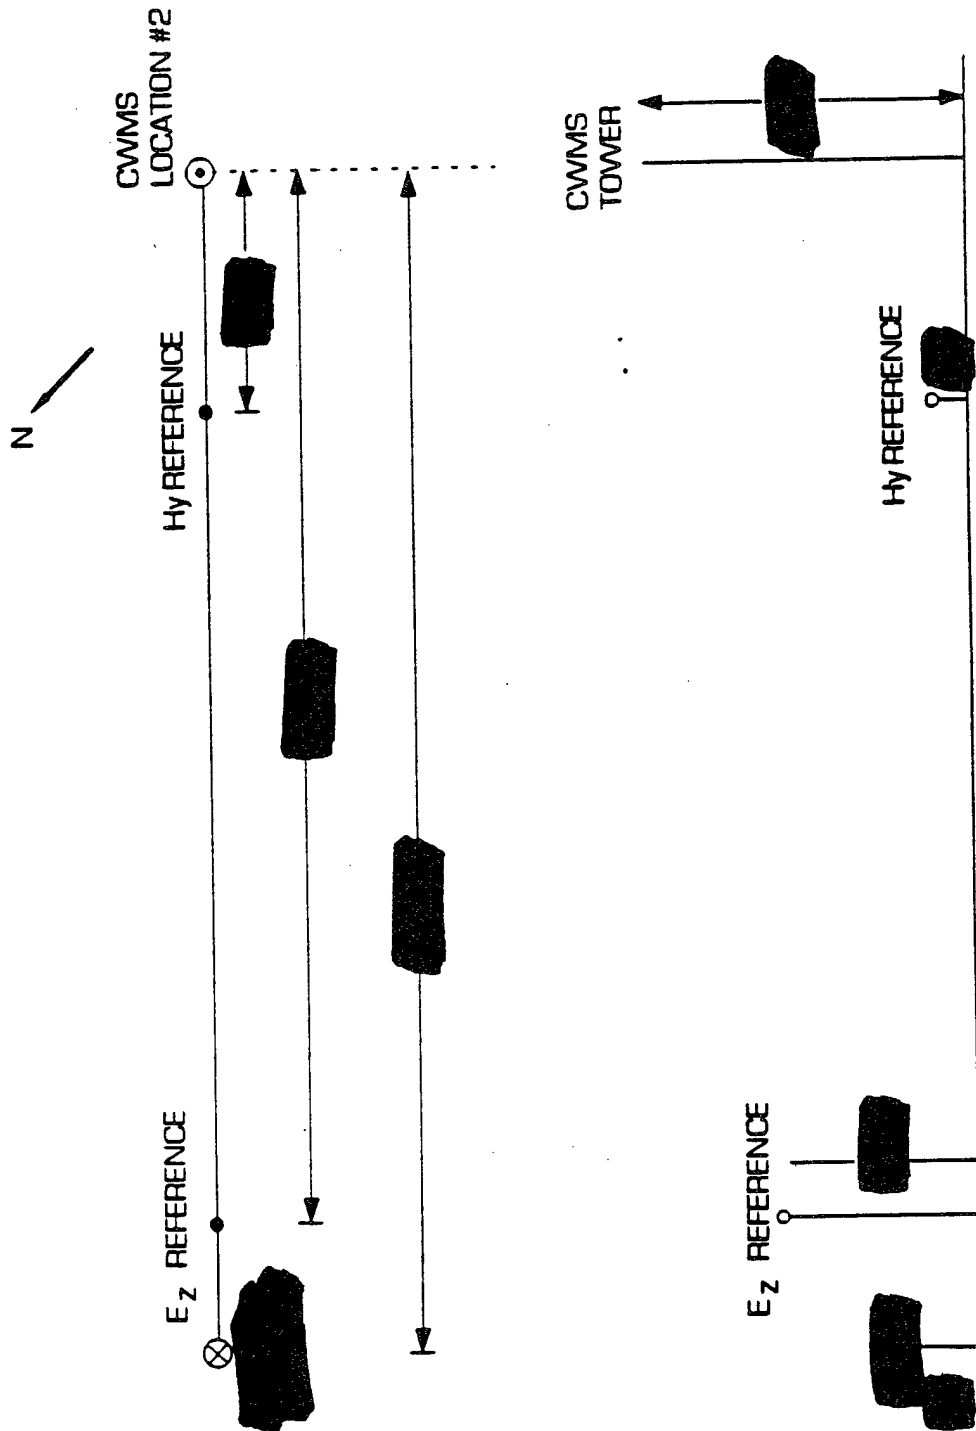
Figure 9. Geometry

1. [REDACTED]
2. [REDACTED]
3. ALL DISTANCES TO NEAREST METER.

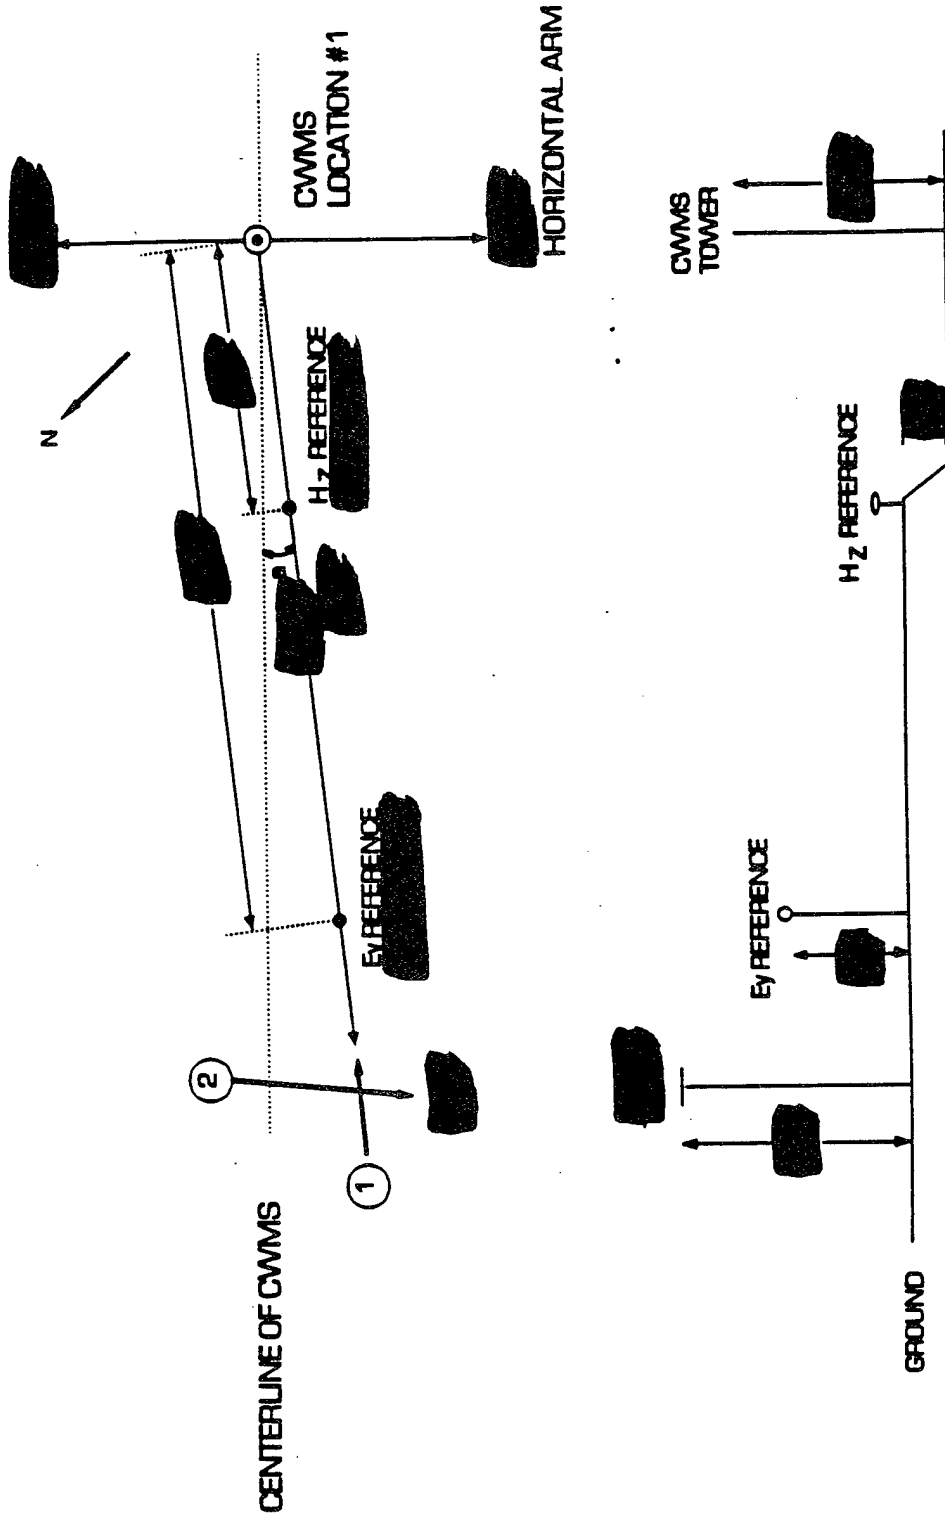
Figure 11. Geometry for [redacted] Antenna

- NOTES:
1. POINTING DIRECTION
  2. CWMS UP ON CENTERLINE.
  3. HORIZONTAL POLARIZATION ONLY.
  4. ALL DISTANCES TO NEAREST METER.
