| REPORT DOCUMENTATION PAGE | | | Form Approved<br>OMB No. 0704-0188 | |
|---|---|---|---|---|
| 4. TITLE AND SUBTITLE<br>USING RIENFORCED EARTH WALLS FOR BLAST MITIGATION | | | 5. FUNDING NUMBERS | |
| 6. AUTHOR(S)<br>CAPT PIERI RONALD L | | | | |
| 7. PERFORMING ORGANIZATION NAME(S) AND ADDRESS(ES)<br>UNIVERSITY OF FLORIDA | | | 8. PERFORMING ORGANIZATION<br>REPORT NUMBER | |

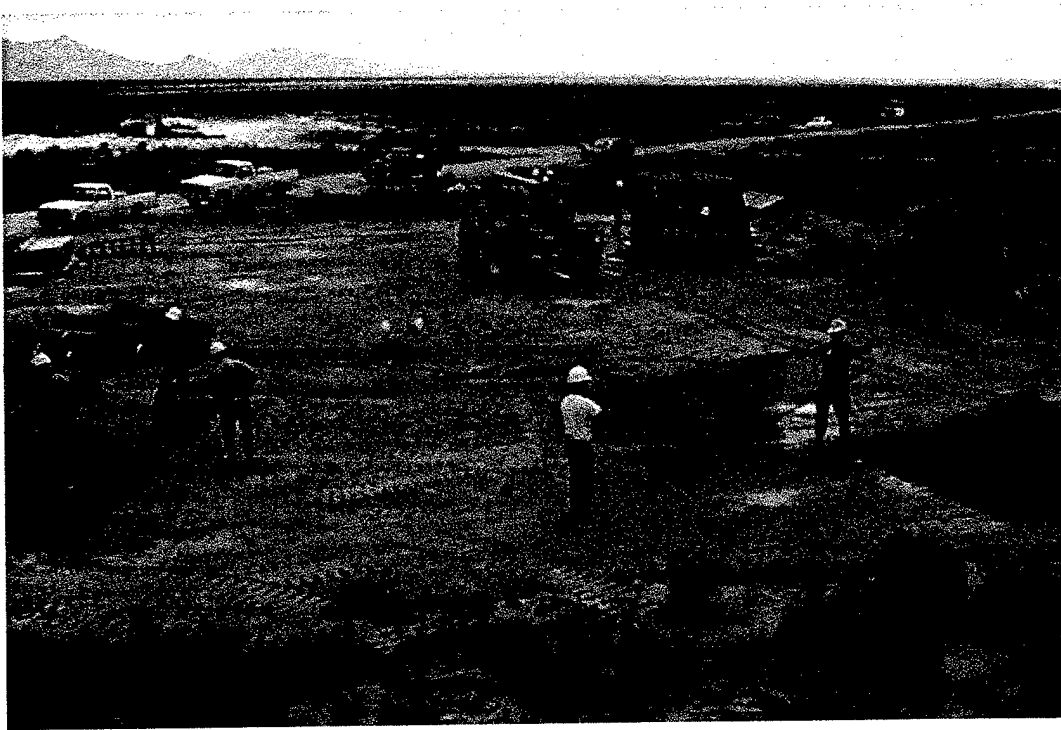
Photograph 5.1: Placing Biaxial Geogrid

After attaching the erosion mat to the biaxial geogrid, the next step was to position the geogrid. The shape looked like a horseshoe since the initial plan was to have three 80° slopes. The geogrid was positioned so that four feet of the biaxial geogrid would rest beneath the first lift.

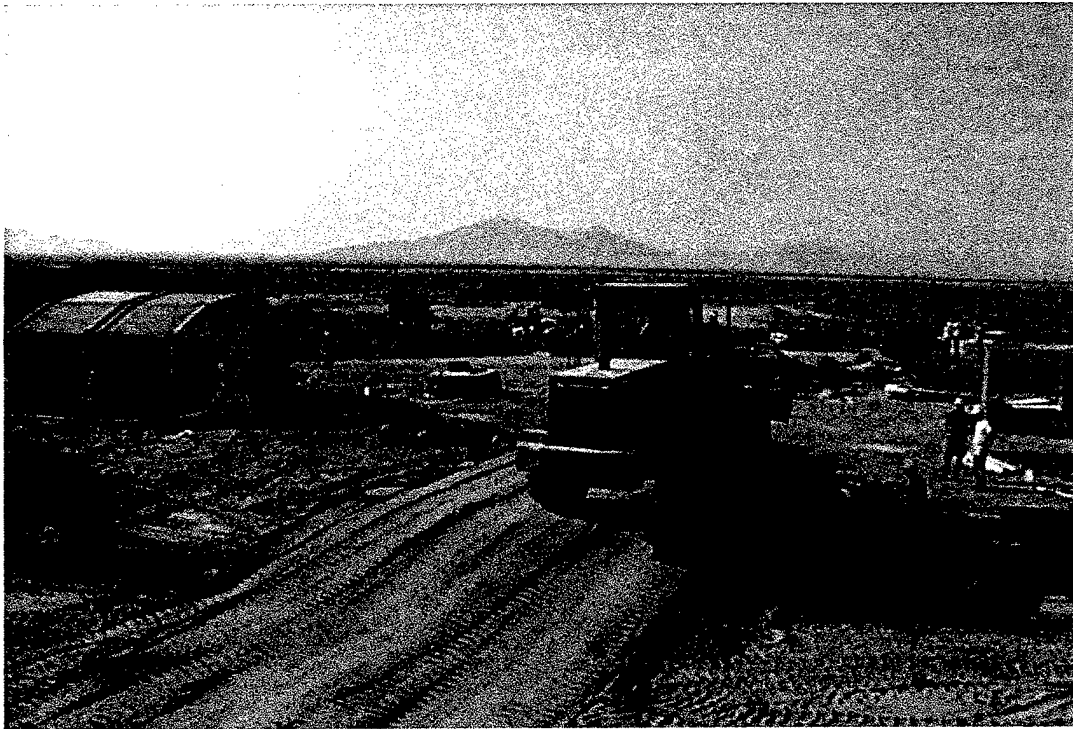
Photograph 5.4: Compacting Lift #1

The next step was to place the last twelve inches of fill so that the first lift could be wrapped with the biaxial geogrid. The loader system was repeated until the lift reached three-feet in elevation. The lift was brought to approximately 40" in elevation. Next, the loader compacted most of the area but stayed away from the edges.

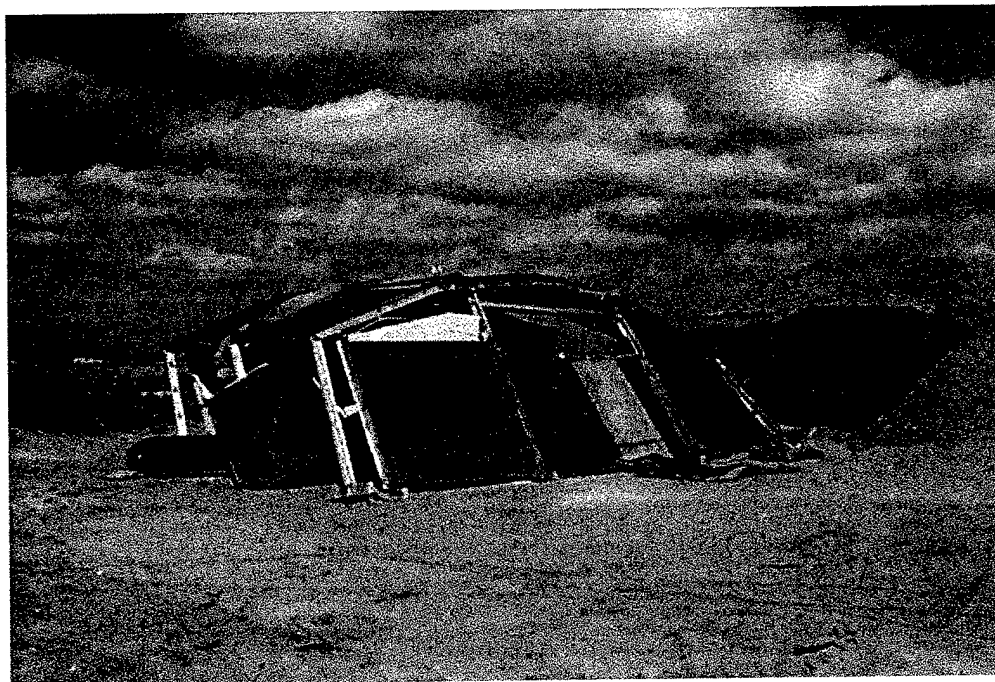
Photograph 6.2: GPS 2 after the blast.

The photographs depict what Table 2.3 predicts for butler buildings and tent structures. For expedient facilities, failure could be a subjective criteria. Failure could be considered a certain amount of deflection to engineers, but it could also be determined by whether or not the structure is still standing. With respect to the DIVINE BUFFALO Test, all the facilities were left standing but they cannot be considered functional. For this report, all the facilities failed due to the blast effects.

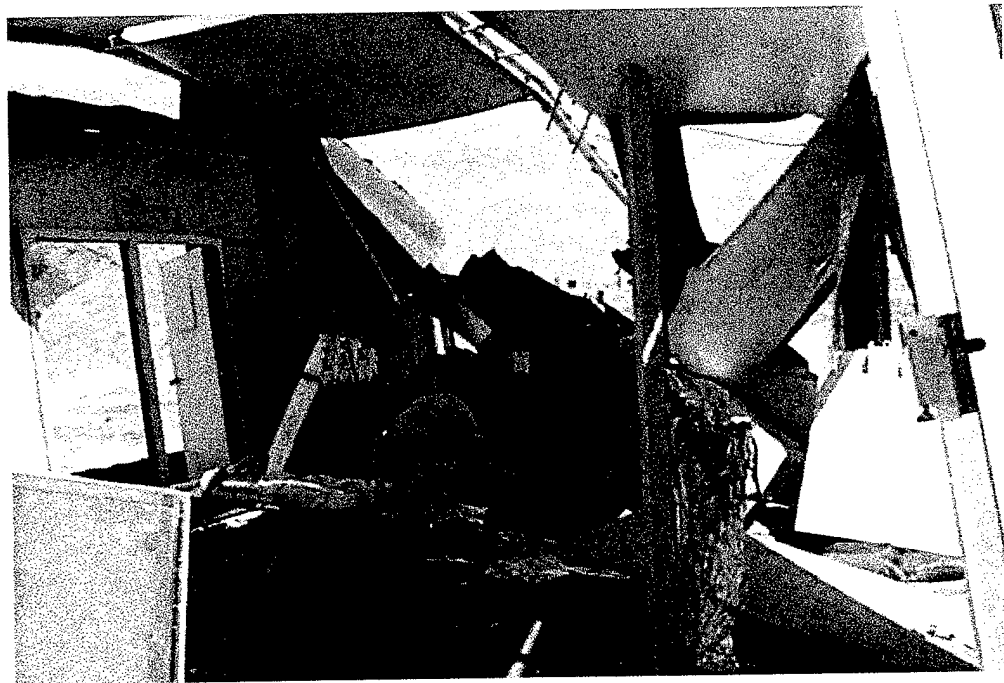
Photograph 6.5: Interior of GPS 1 after the blast.
