**Helmet-Mounted Displays and Facial  
Injury in U.S. Army AH-64A  
Apache Accidents  
(Reprint)**

**John S. Crowley**

**January 1999**

**U.S. Army Aeromedical Research Laboratory  
Fort Rucker, Alabama 36362-0577**

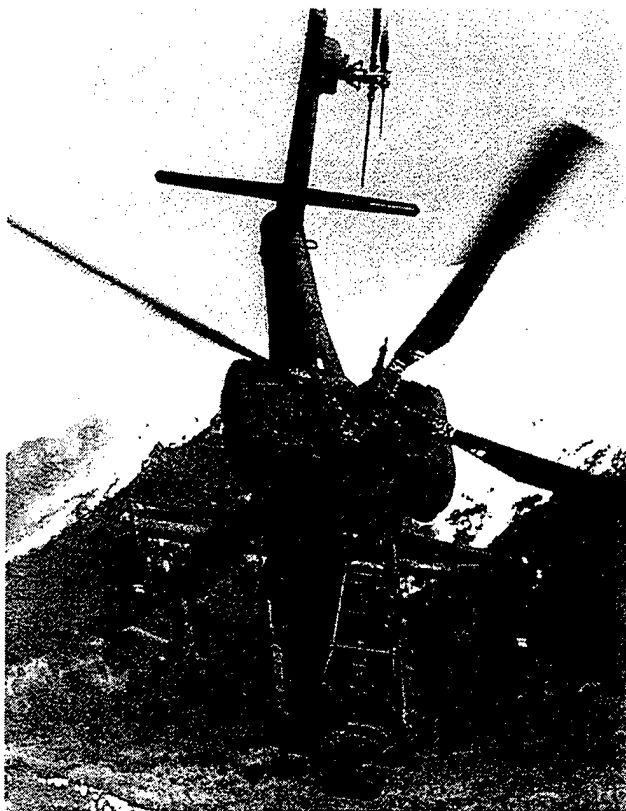
Fig 1. The US Army AH-64A helicopter (US Army photograph).

The AH-64A Apache is a tandem seat, dual engine attack helicopter (Fig 1) that is equipped with an integrated helmet and display sighting system (IHADSS) (Figs 2, 3, 4). This

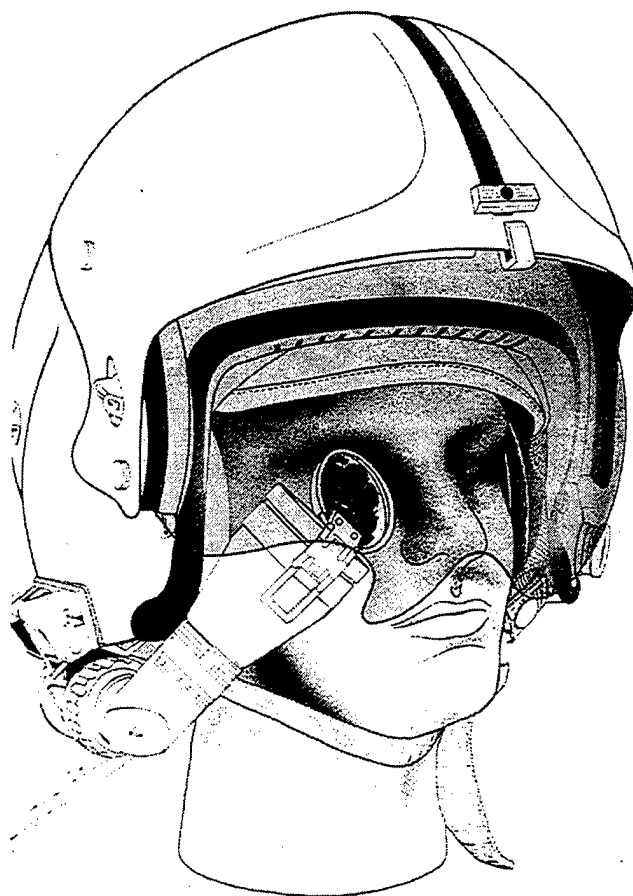
Fig 2. The AH-64 integrated helmet and display sighting system (IHADSS) helmet. Note the proximity of the HDU to the right side of the aviator's face.

These visual aids must be worn extremely close to the aviator's eye(s) and face, constituting a potential injury hazard. The rationale for concern is not that the HDU or NVG will independently cause injury, but rather that in a crash an otherwise blunt impact from a cockpit surface could be focused on critical structures such as the eye or orbit. The HDU combiner lens is made of polycarbonate, so fragmentation is unlikely, but it is positioned at such an angle that orbital injury remains a hazard (Fig. 2). To date no HDU injury analysis has been published.
