PNE-516
FINAL REPORT

PROJECT PRE-SCHOONER II

POSTSHOT GEOLOGIC AND ENGINEERING PROPERTIES INVESTIGATIONS

ALTON D. FRANDSEN

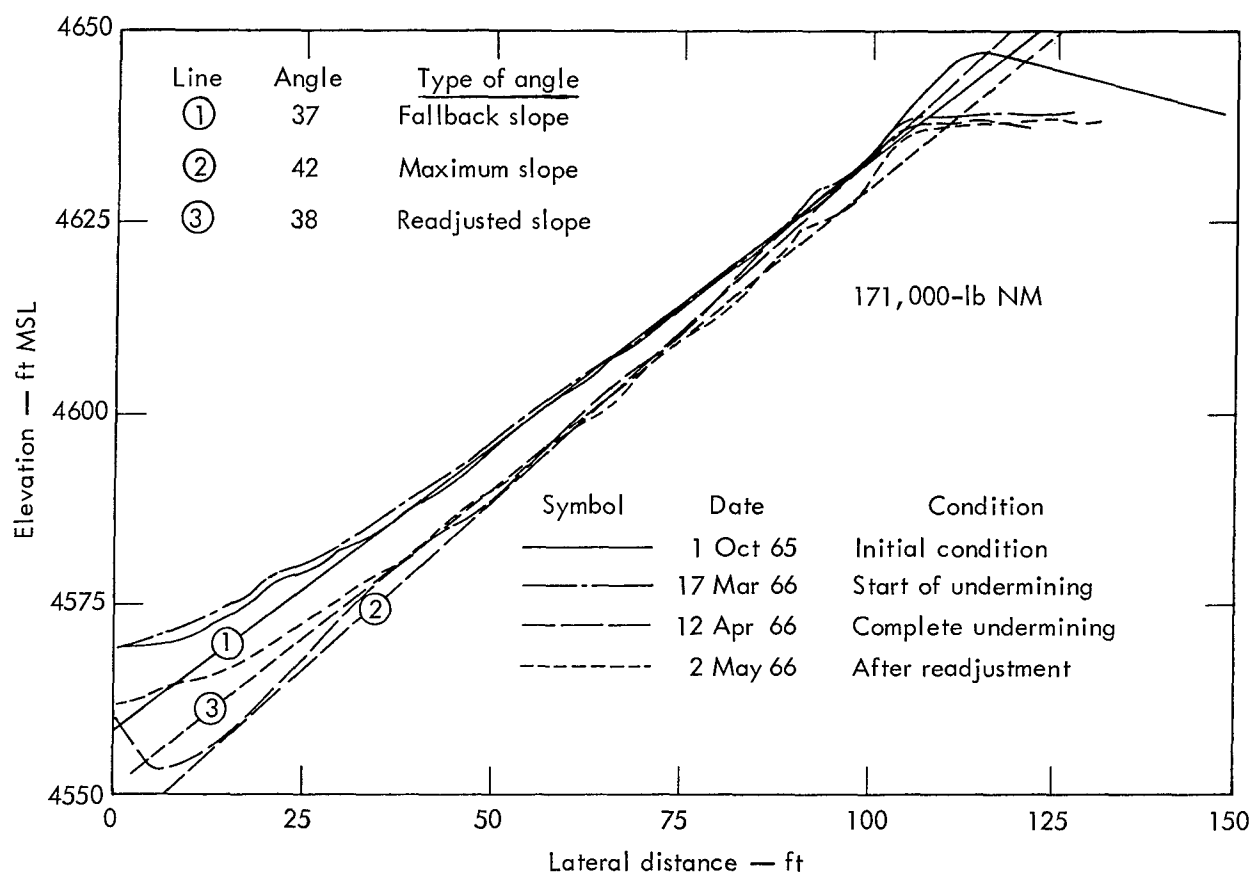
Figure 4.12 Profiles bearing S 40° W of apparent crater illustrating slope adjustment stages (Reference 14).

4.4.3 Slope Angles. The angle of repose for a cohesionless material is the maximum possible inclination of a slope of that material. The angle of deposition has been defined as the inclination of a slope formed by the deposition of cohesionless material

and depends both on the character of the material and the mode of deposition (Reference 14). For all practical purposes, the fallback material at Pre-Schooner II can be considered cohesionless. Therefore, the crater slope angles, prior to any postshot investigations, represented the angle of deposition for this material. This average angle was 37 degrees. The slopes in part of the crater were then steepened by undercutting the toe of the slope to an average inclination (angle of repose) of 42 degrees. After a short period of readjusting (approximately 1 week), the slope stabilized at 38 degrees. Figure 4.12 illustrates the various stages of slope stabilization. A later aerial photograph and topographic map obtained in June 1967 (Figures 4.13 and 4.14) shows that the undercut slopes which readjusted to 38 degrees were remaining at that angle. In other parts of the crater where the slopes were much steeper, readjustment to flatter slopes is occurring. Long term slope adjustments will be examined periodically.

5. The change in slope angle from the initial 37 to 42 degrees caused by excavating the fallback and then readjustment to a stable condition at 38 degrees is an indication that the initial crater formation results in relatively stable crater slopes. This means that the slopes resulting from this detonation are stable provided no disturbing forces are introduced.
