RESTORING THE INITIAL HEAT-RESISTING PROPERTIES OF MATERIALS BY INTERMEDIATE HEAT TREATING

I.I. Trunin, Cand. Eng.

Central Scientific-Research Institute of
Technology and Mechanical Engineering

Results are presented of a study of
the degree of damage at various stages
of creep of specimens of a steel of
the austenitic class.

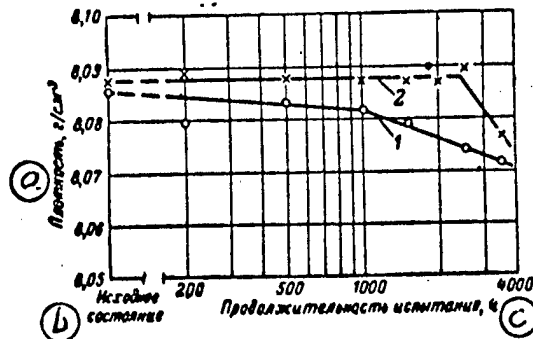
Fig 1. Variation of the density of EI-257 steel during creep as a function of test duration $\Theta = 580\text{C}$, $\sigma = \text{kg/mm}^2$

1 - after creep test the specimen was work hardened by 10% elongation in the cold condition; 2 - after creep testing the sample was heat treated by heating to 800C, soak for 5 hours, then work hardened in the cold condition by 10%
 a - density, g/cm^3 ; b - initial condition; c - test duration, hours

Fig 1 presents a plot of the variation of the density of the metal after creep (curve 1) and after the subsequent heat treatment (curve 2) for the specimens of the first group ($\sigma = 24 \text{ kg/mm}^2$).

We note the following from Fig 1. The damage of the metal starts in the first stage of creep; after 200 and 500 hours of testing there is a reduction of the density. With

an increase of the testing time there is a noticeable acceleration of the damage process; after 1000 hours the rate of decrease of the density goes up. The major portion of the defects are subject to healing with heat treatment if the time to failure is not more than half used up, up to 2500 hours the density is practically completely restored; with longer test duration the magnitude of the density increases insignificantly, i.e. only the small failure centers are subject to healing. In the second group the stress rupture test was conducted at a higher stress ($\sigma = 26 \text{ kg/mm}^2$). Considering the static nature of the stress-rupture test and the associated scatter of the experimental data, we determined the mean time to failure from the results of numerous repeated tests.

If we compare these data with the results of the healing (Fig 1) then we can note that a large number of the defects reach the critical dimension prior to the onset of the third stage of creep in the absence of the localization of the development of the plastic deformation. Actually, after 3500 hours of testing (Fig 1) there is observed a slight increase of the density after the heat treatment, i.e. a significant number of the defects exceeded the critical dimension.

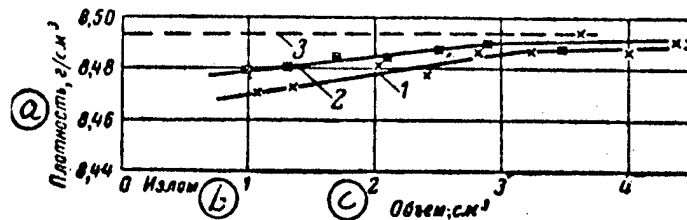
Fig 2. Variation of the density of the forging alloy TsZH-6 after stress rupture ($\theta = 7500$, $\sigma = 30 \text{ kg/mm}^2$, $\theta_k = 140 \text{ hours}$, $\epsilon_k = 9.0\%$, $\psi = 19.0\%$)

1 - after testing; 2 - after testing and heat treatment at 1200C for 1.5 hours, annealed at 750C for 20 hours; 3 - initial condition; a - density in g/cm³; b - fracture; c - volume, cm³

Figs 2 and 3 present plots of the variation of the density of two samples of the nickel alloy. Fig 4 shows the variation of the density in creep conditions of one of the samples of the grade EI-1T steel (Table 1). First of all we should note that in both cases plastic deformations of similar magnitude, both overall (ϵ_k) and local (ψ_k) preceded the fracture.

Analysis of the results of the study of the accumulation of defects in the zones adjacent to the fracture showed that during the first stage of creep the initiation and the growth of the defects takes place throughout the entire volume of the working portion of the samples. However in this stage the dimensions of the defects are small and they are subject to healing; the magnitude of the density reaches the initial level (Figs 2 and 4).

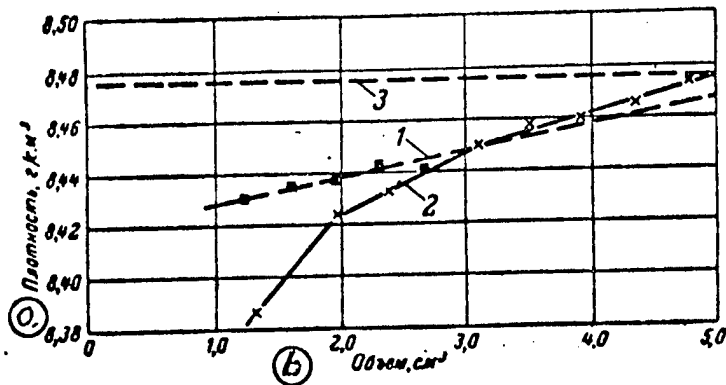
Fig 3. Variation of the density of the forged alloy TsZh-6 after stress rupture ($\theta = 7500$, $\sigma = 25 \text{ kg/mm}^2$, $\theta_k = 585$ hours, $\epsilon_k = 9.2\%$, $\psi_k = 22.8\%$)

1 - after testing; 2 - after testing and heat treatment at 1200°C for 1.5 hours, anneal at 750°C for 20 hours; 3 - initial condition; a - density, g/cm^3 , b - volume, cm^3

Increase of the time up to the point of failure leads to a noticeable localization of the failure processes in the volume of the working portion of the samples. Right in the region of the fracture there is noted a significant acceleration of the decrease of the density (Figs 3 and 4). In this zone there probably occurs growth of the defects, most of which attain a critical dimension and their healing becomes impossible; after the restoring heat treatment the density of the metal is restored only by 50%. Judging from the plots of Figs 3 and 4 the healing is effective only prior to the localization of the failure process.

Some additional information on the kinetics of the stress rupture is given by a comparison of the results of the study of the investigation of the samples of the first (Fig 1) and the third (Figs 3 and 4) groups. In the first group of the tests during the creep process there was no localization of the plastic deformation along the length of the working section noted in any of the samples (absence of a neck) and judging by the initial curves for the stress-rupture (Fig 5) the third stage of accelerated creep did not appear.

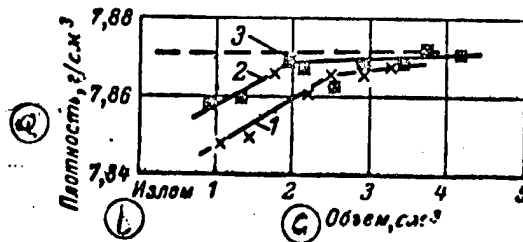
Fig 4. Variation of the density of the EI-1T alloy after stress rupture ($\theta = 6000$, $\sigma = 20 \text{ kg/mm}^2$, $\theta_k = 1846$ hours)

1 - after testing; 2 - after testing and heat treatment at $1040-1100^\circ\text{C}$ for 30 min, anneal at 800°C for 10 hours; 3 - initial condition; a - density, g/cm^3 ; b - fracture; c - volume

Fig 6 is a plot of the tests of the two samples. The results of the measurement of the density of the metal of both samples practically coincided and this permitted drawing single curves for the variation of the density prior to and after heat treatment. Comparison of the graphs of Figs 4 and 6 shows that the variation of the density, and consequently the development of the fracture centers along the volume of the working portion during active deformation, does not differ in nature from the development of the defects in the samples during the creep testing. On the basis of these results we can draw the conclusion that defects formed by both the diffusion and the shear formation mechanisms are subject to healing.

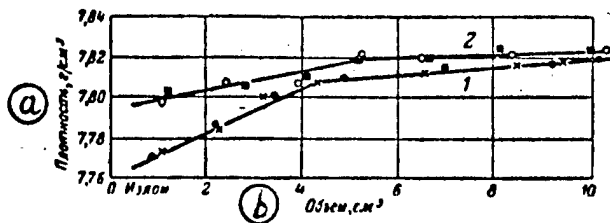
Fig 6. Variation of the density of steel 45 after short-term tension fracture
1 - after testing; 2 - after testing and heat treatment at 800C for 5 hours
a - density, g/cm^3 ; b - volume, cm^3
