NSWCCD-63-TR-2001/104 March 2001

Technical Report

Identification of Welldeck Washout Discharge Constituents: Summary Report

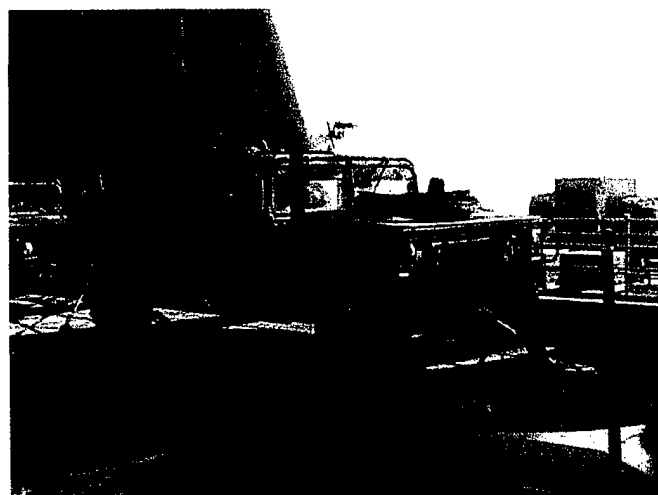
High Mobility Multipurpose Wheeled Vehicle (HMMWV)

High Mobility Multipurpose Wheeled Vehicles³. High Mobility Multipurpose Wheeled Vehicles (HMMWVs), provide a variety of wheeled vehicle platforms. They can function as a cargo and troop carrier, armament carrier, missile system carrier, shelter carrier, and as a ambulance. The vehicles are 15 feet long, 7 feet wide, and are typically manned by a crew of four, depending on HMMWV configuration.

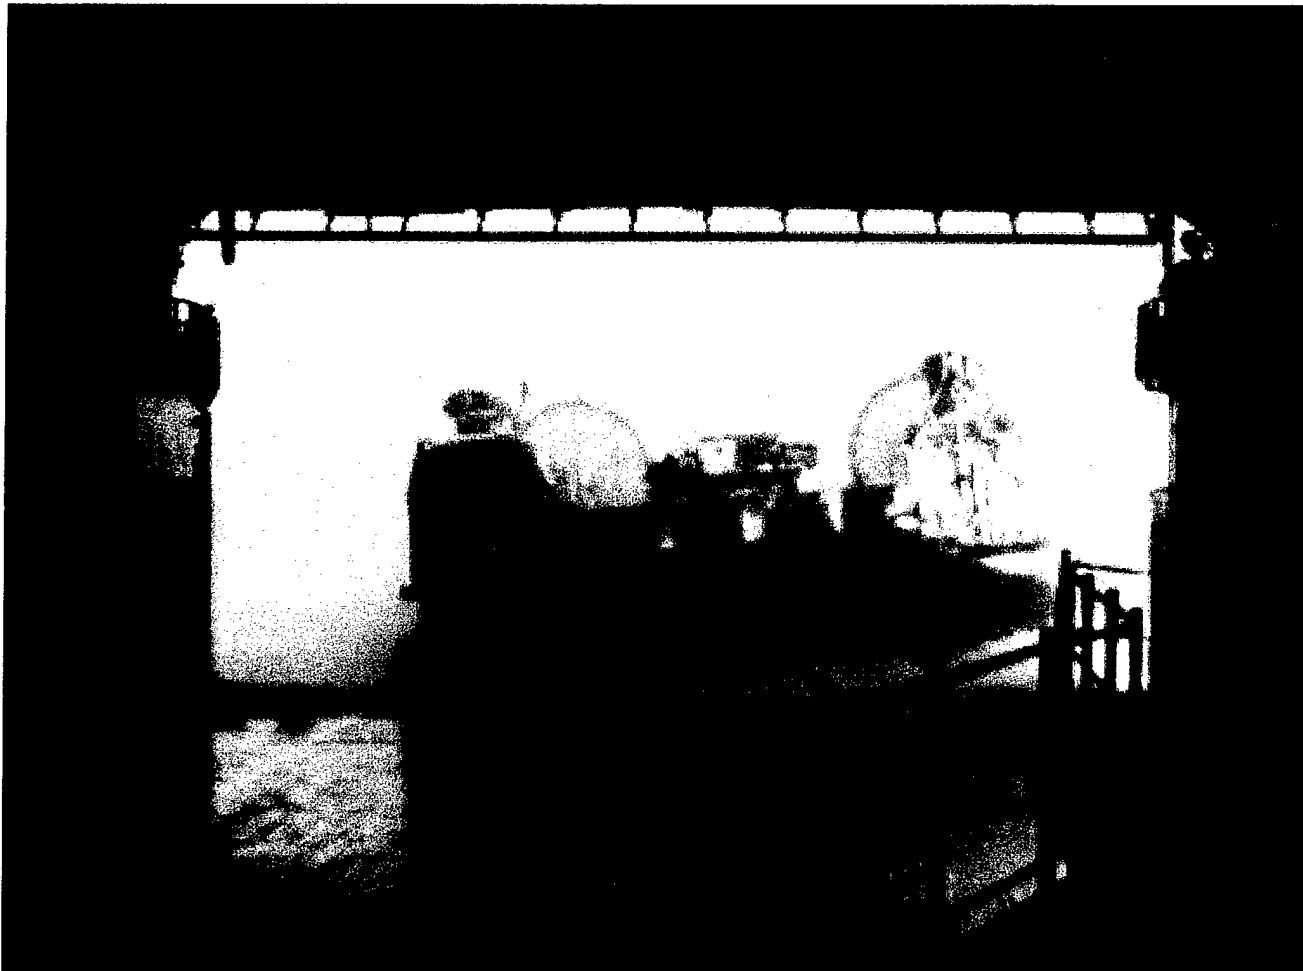
LCAC Entering Welldeck

welldeck remains dry. When launching and recovering LCACs, the stern gate is lowered to -10° below the waterline to allow the LCAC to enter or exit the dry welldeck. When the LCAC enters the welldeck, a surge of seawater and seawater spray accompanies the craft as it transits aboard, Appendix F. After all the LCACs are recovered, it is standard practice to operate the eductors to evacuate standing water. Personnel assigned to Welldeck Control stated that they have never noted a sheen on the water when the welldeck was flooded.

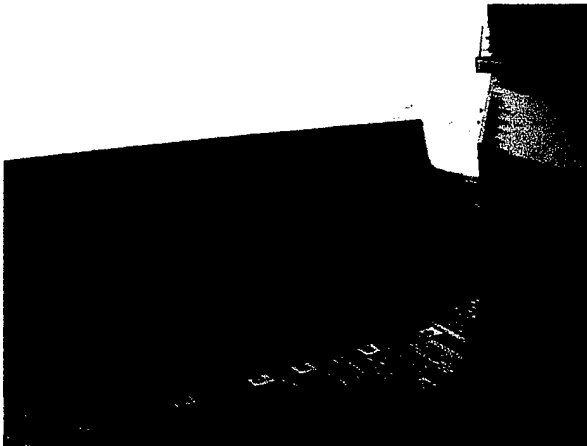
Stern Gate

A 20 ft. high stern gate, located at the aft end of the welldeck, is hydraulically raised and lowered, Appendix H, to allow craft ingress and egress. The stern gate can be secured in heavy seas using the in-place stainless steel locking devices. Immediately above the stern gate is a hydraulically operated "eyebrow" that opens and closes. Although the stern gate is capable of being lowered to -17° below the waterline, it is normally lowered to -10° when launching or recovering LCAC vehicles.

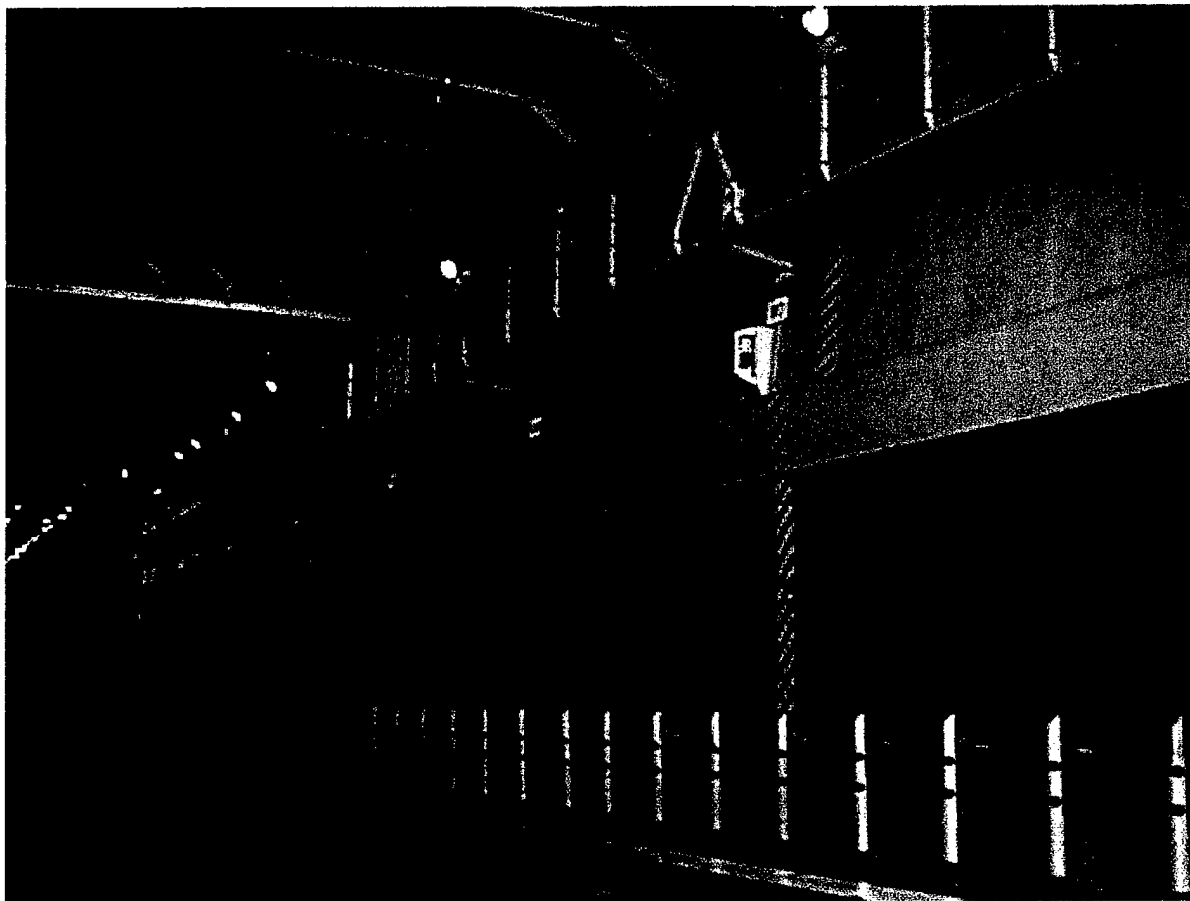
LSD-49 Class Welldeck

Welldeck Structure. The welldeck of LST-49 class ships is 184 feet long and 40 feet wide, Appendix K. Unlike the LHD and LPD, the LSD has a removable flight deck. As a result, sections of the welldeck at the 01 level are open to the exterior weather decks. The deck is covered with 2 in. thick pressure treated douglas fir wood planks secured by bolts covered with caulk to prevent corrosion. Interspersed throughout the deck are 178 tie-down points used to secure craft to the deck. The tie-down points are the same as those on the LPD-4 class ship. On the deck next to the bulkhead are two gravity-fed open drains on each side; the drains are located at 10 feet and 110 feet from the stern gate. At the forward end of the ramp, approximately 190 feet from the stern gate, is a diesel fuel marine station. The "false beach" at the forward end of the welldeck contains a 20 ft. long section of metal grating that extends the entire width of the welldeck. Immediately behind the grating is a metal ramp that lead to the vehicle storage areas. As with the LHD and LST, a 24-in. wide white line is painted on the deck the full length of the welldeck to aid in positioning craft as they are recovered.

The bulkheads are lined with pressure treated douglas fir wooden batter boards and 4 ft. high stainless steel bumpers spaced 4 feet apart (32 bumpers on each side). The aft 95 feet of the bulkhead is covered with synthetic batter boards. All metals surfaces are painted gray, including the tie-downs.

The welldeck overhead contains lighting, a ventilation system, and a single monorail system. The overhead is coated with the edge retentive, chemical and heat resistant coating, Sigma Edgeguard™. This coating was applied on a test basis one year ago and is expected to eliminate maintenance for 10 years. The coating showed no signs of deterioration or rust. The Welldeck Control Officer recommended the coating be considered as a potential MPCD for not only welldeck overheads, but the entire welldeck and vehicle storage areas. These areas are subject to a high degree of corrosion: the entire welldeck from the saltwater spray and high temperature exhaust from landing craft air cushioned vehicles, and the vehicle storage areas from seawater washdowns conducted to prepare for Department of Agriculture inspections.

Welldeck Condition. The shipboard assessment team was provided the opportunity to observe and document the empty welldeck. The deck showed signs of wear, i.e., splintered

and missing pieces of wood. This wear was more pronounced at the forward end of the welldeck and was caused by tracked assault amphibian vehicles traversing the deck. No stains or visible contaminants were noted.

The LSD-49 class ship is a test platform for an edge retentive, chemical and heat resistant coating (Sigma Edgeguard™). This coating covers the welldeck overhead and will eliminate all further maintenance for 10 years. The Welldeck Control Officer of the ship testing the coating requested it be considered as a potential MPCD for not only welldeck overheads, but the entire welldeck and vehicle storage areas. Areas subject to a high degree of corrosion and suitable for the Sigma Edgeguard™ coating are: the entire welldeck due to saltwater spray and high temperature exhaust from LCAC vehicles; and the vehicle storage areas due to seawater washdowns conducted prior to Department of Agriculture inspections.
