**FINAL REPORT
January 2002**

REPORT NO. 01-16

**M871A3 TACTICAL TRAILER
22.5-TON PAYLOAD CAPACITY
TP-94-01,
“TRANSPORTABILITY TESTING PROCEDURES”**

**VALIDATION ENGINEERING DIVISION
MCALESTER, OKLAHOMA 74501-9053**

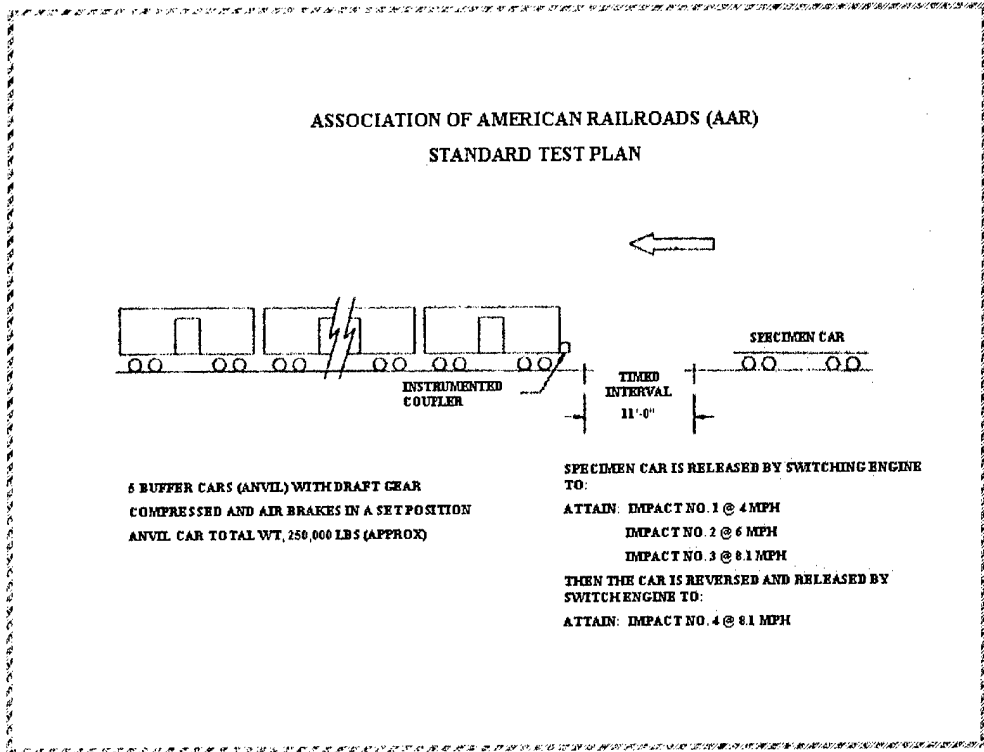
Figure 1. Rail Impact Sketch

A. RAIL IMPACT TEST METHOD. The loaded M871A3 trailer was secured to a conventional friction draft gear non-cushioned TOFC railcar with cushioned stanchion or chain-equipped flatcar. Three chains were used per tie-down ring to secure the trailer to the flatcar. MTMCTEA Pamphlet 55-19 was used as a general guide to build the wooden stanchion required to support the trailer during testing on the chain equipped flatcar. Modifications were required to the MTMCTEA Pamphlet design due to the trailer kingpin height. Equipment needed to perform the test included the specimen (hammer) car, four empty railroad cars connected together to serve as the anvil, and a railroad locomotive. The anvil cars were positioned on a level section of track with air and hand brakes set and with draft gears compressed. The locomotive unit pushed the specimen car toward the anvil at a predetermined speed, then disconnected from the specimen car approximately 50 yards away from the anvil cars allowing the specimen car to roll freely along the track until it struck the anvil. This constituted an impact. Impacting was accomplished at speeds of 4, 6, and 8.1 mph in one direction and at a speed of 8.1 mph in the reverse direction. Tolerances for the impact speeds are plus .5 mph and minus zero mph. The impact speeds were determined by

using an electronic counter to measure the time for the specimen car to traverse an 11-foot distance immediately prior to contact with the anvil cars (see Figure 1).

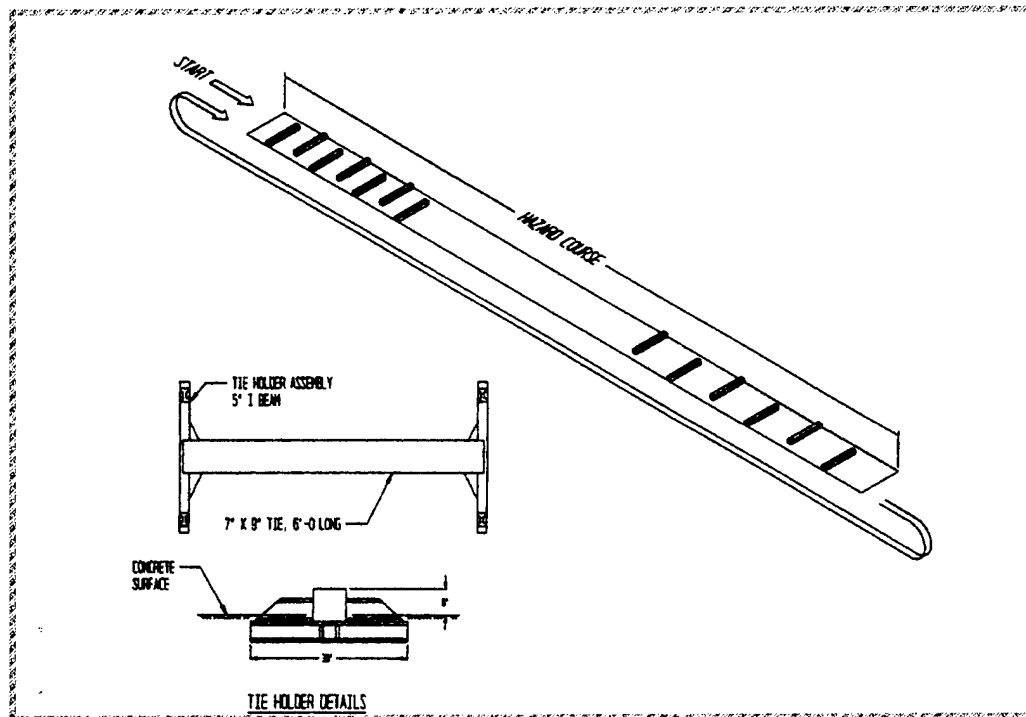
Figure 2. Hazard Course Sketch

B. HAZARD COURSE. The loaded M871A3 trailer was transported over the 200-foot-long segment of concrete-paved road consisting of two series of railroad ties projecting 6 inches above the level of the road surface. The hazard course was traversed two times (see Figure 2).

1. The first series of ties are spaced on 10-foot centers and alternately positioned on opposite sides of the road centerline for a distance of 50 feet.
 2. Following the first series of ties, a paved roadway of 75 feet separates the first and second series of railroad ties.
 3. The second series of ties are spaced on 8-foot centers and alternately positioned on opposite sides of the road centerline for a distance of 50 feet.
- The test load is driven across the hazard course at speeds that would produce the most violent vertical and side-to-side rolling reaction obtainable in traversing the hazard course (approximately 5 mph).

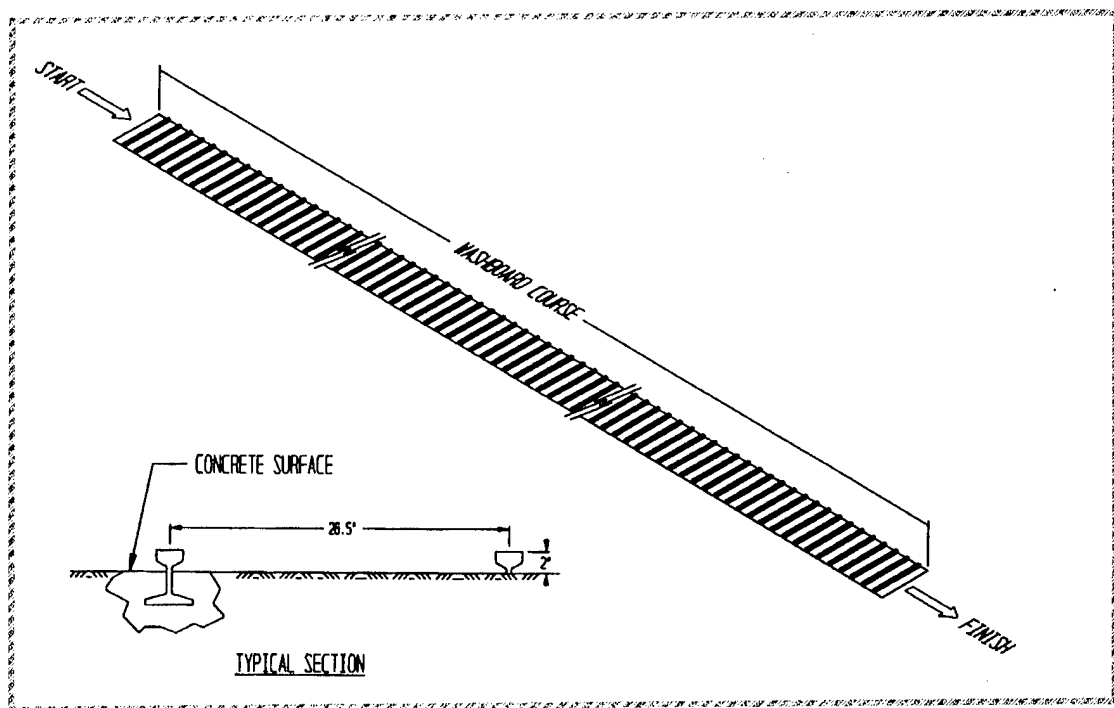
Figure 3. Washboard Course Sketch

E. **WASHBOARD COURSE.** The loaded M871A3 trailer was driven over the washboard course at a speed that produced the most violent response in the vehicles.

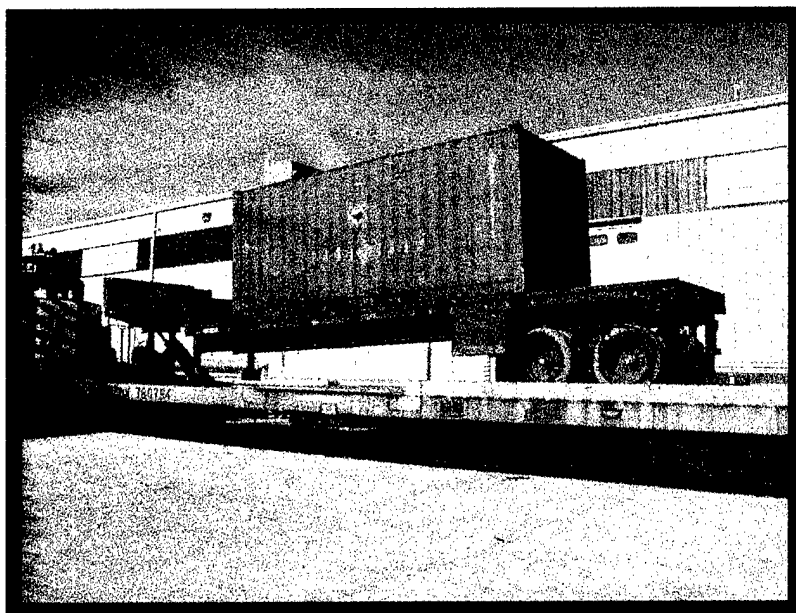
Photo 1: Trailer-on-Flatcar Rail Impact Testing of M871A3 Trailer

1. No damage or excessive movement occurred with the trailer, container or twistlocks during testing.
2. The test times for impacts 1-3 were obtained using a stopwatch. For impact 4 an electronic speed sensor was used.
3. Impacts 1-3 were conducted with the rear of the trailer in the direction of impact. Impact 4 was with the trailer front in the direction of impact.
4. The trailer was inspected following the removal from the railcar. The kingpin had sustained some galling or flattening damage during the rail impact testing. This was due to the railcar stanchion locking plates had some wear which

prevented secure engagement against the trailer kingpin. The trailer was mission capable and testing continued.

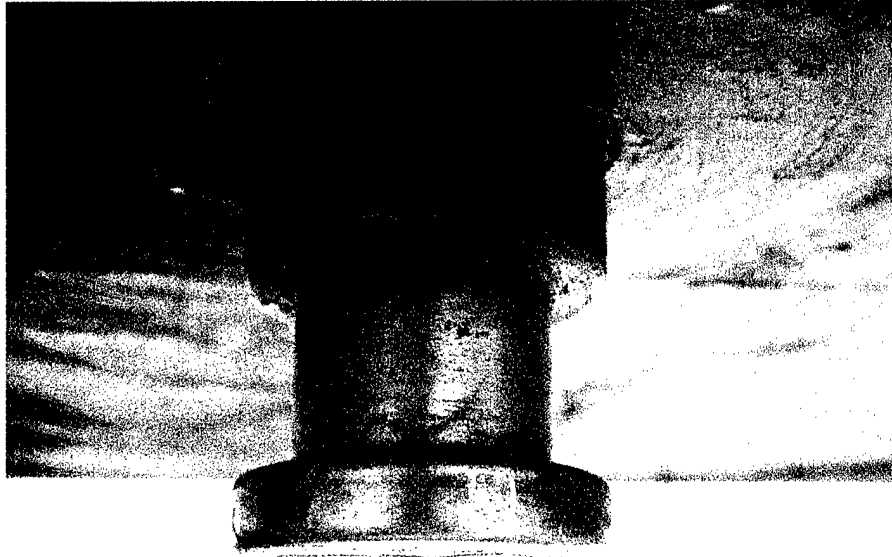
Photo 2: Galling on the kingpin

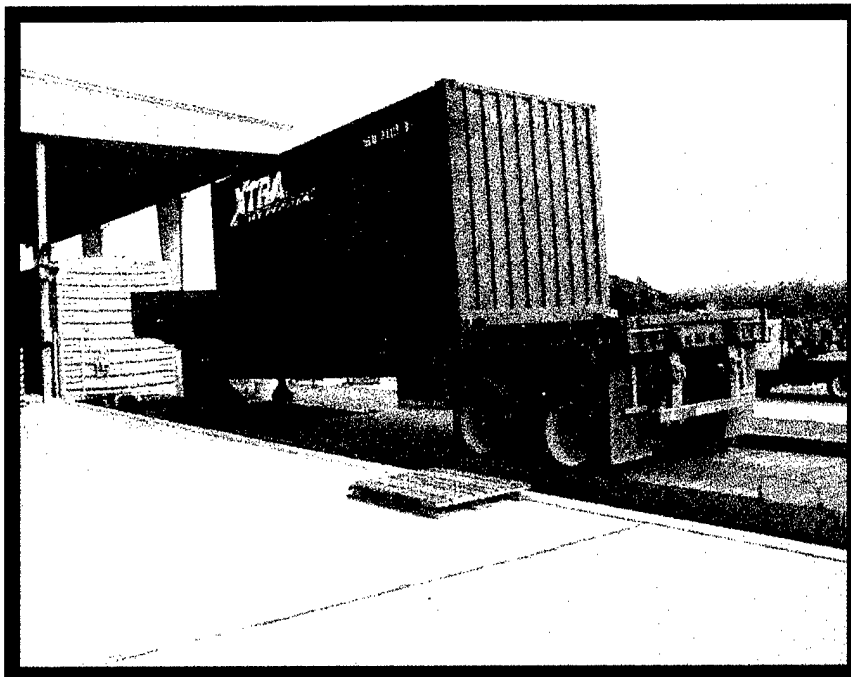
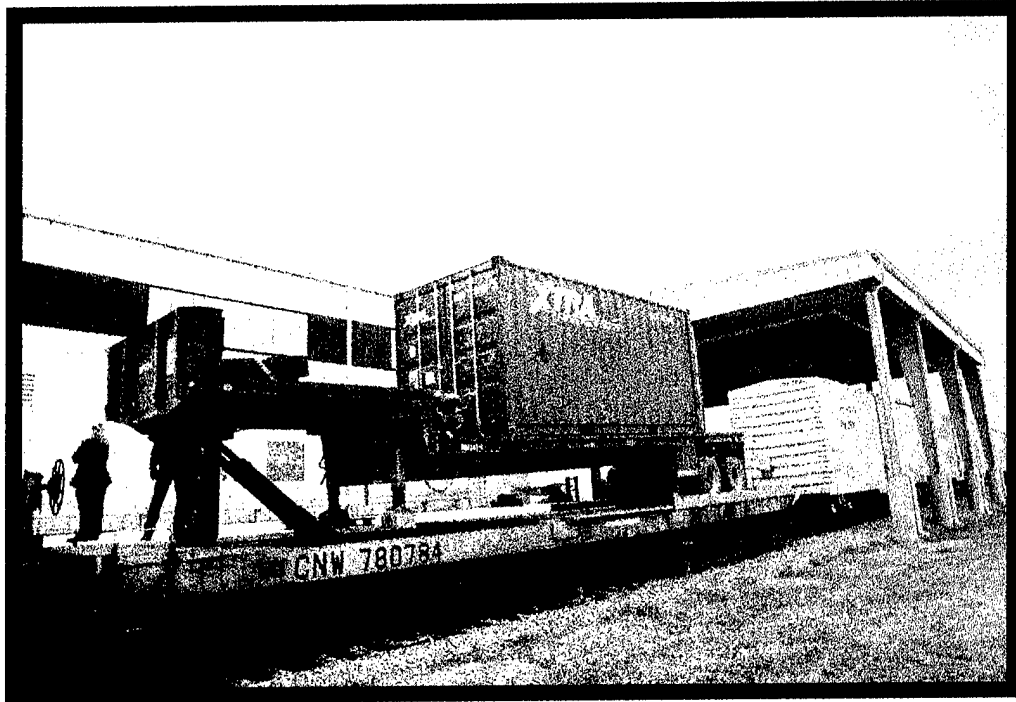
**Photo 4: Trailer-on-Flatcar Rail Impact Testing of M871A3
Trailer at Full Payload**

Photo 5: Trailer on Flatcar Rail Impact Testing of M871A3 Trailer at Full Payload

1. The brake on the railcar did not fully release on Impact 1. The rail crew corrected the problem and testing continued.
2. Following Impact 4 the twistlock at the door end of the container, driver's side, jammed and would not turn freely. No damage was found on the twistlock or container corner casting. The problem occurred due to the tolerances between the twist lock and the deck opening. This allowed the twistlock to be pushed up and caused it to jam. This did not affect offloading of the container.

3. The reverse 8 mph impact was not performed. Inspection of the area around the stanchion kingpin locking plate revealed a gap of 0.50 to 0.75 inches. This gap was deemed to be excessive and rail impact testing was discontinued until an acceptable flatcar was provided by the rail carrier. The rail impact retest results are shown in "F" of this section.

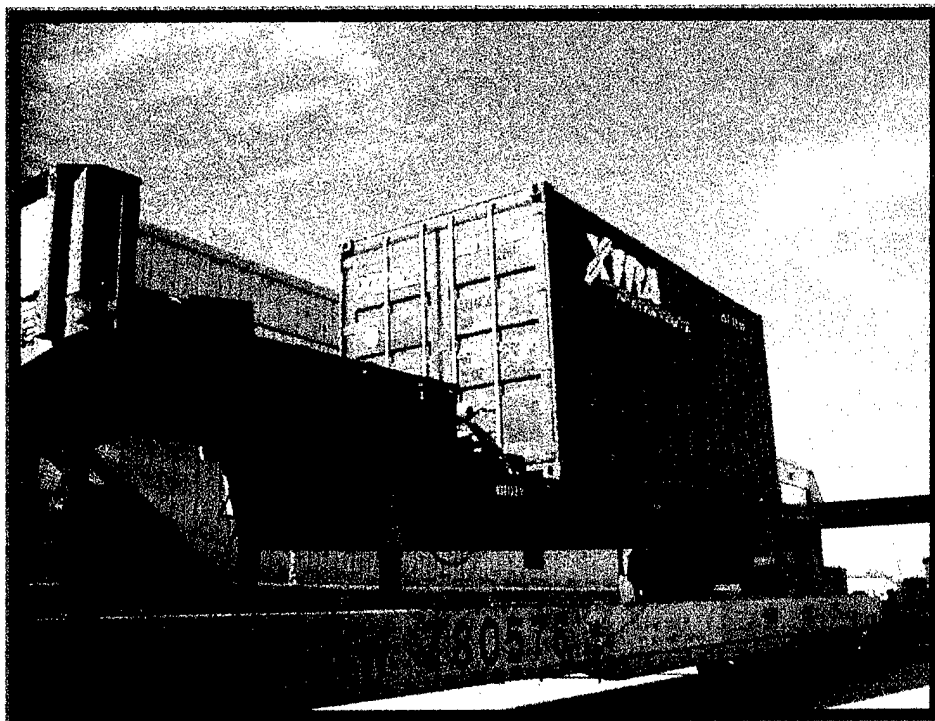
Photo 6: Trailer-on-Flatcar Rail Impact Testing of M871A3 Trailer at Full Payload

1. Following Impact 2, the twistlock at the door end of the container, driver's side, jammed and would not turn freely. The reason has been explained previously. This did not affect offloading of the container. The twistlock jammed following the reverse impact.
2. The container moved 0.375 inches following the reverse impact.

3. Impacts 1-4 were conducted with the rear of the trailer facing the direction of impact. Impact No. 1 was low average velocity due to improper brake release on the specimen flatcar. Impact 5 was conducted with the front of the trailer facing the direction of impact.
4. No damage or excessive movement occurred with the trailer, container or twistlocks during testing.
5. The velocity data represents the average speed during the test.

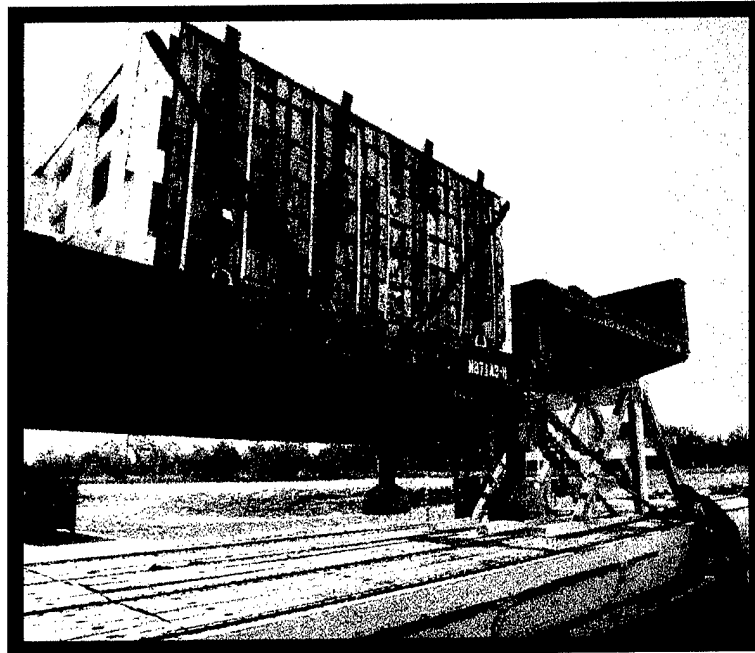
Photo 7: Breakbulk Load on M871A3 Trailer

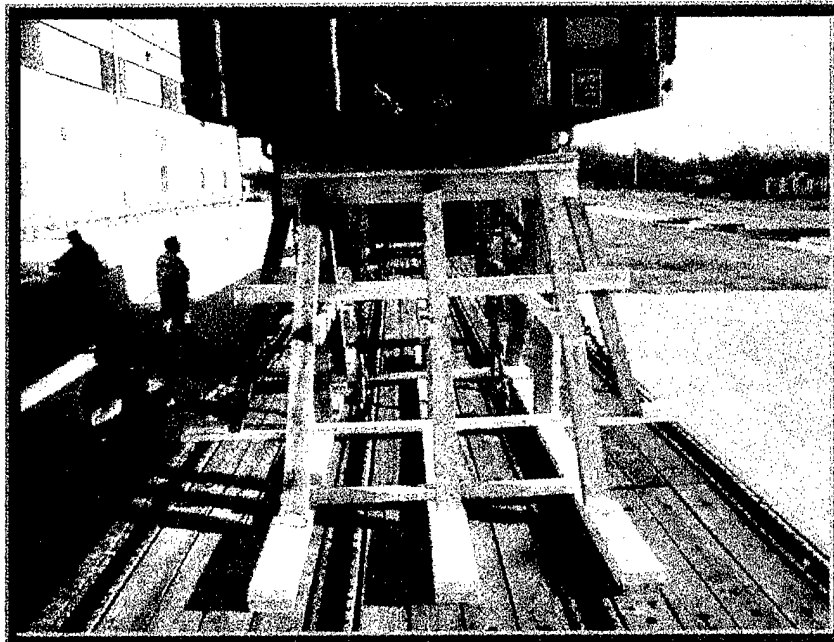
Photo 9: Wood Stanchion Used During Breakbulk Load Testing

1. Following Impact 3 there was 0.125 inch of movement between the wood stanchion and the trailer plate.
2. Following Impact 3 the 105MM wood boxes moved 0.375 inch away from the bulkhead.
3. Impacts 1-3 were conducted with the rear of the trailer facing the direction of impact. Impact 4 was conducted with the front of the trailer facing the direction of impact.
4. No damage or excessive movement occurred with the trailer or cargo during testing.
5. The velocity data represents the average speed during the test.

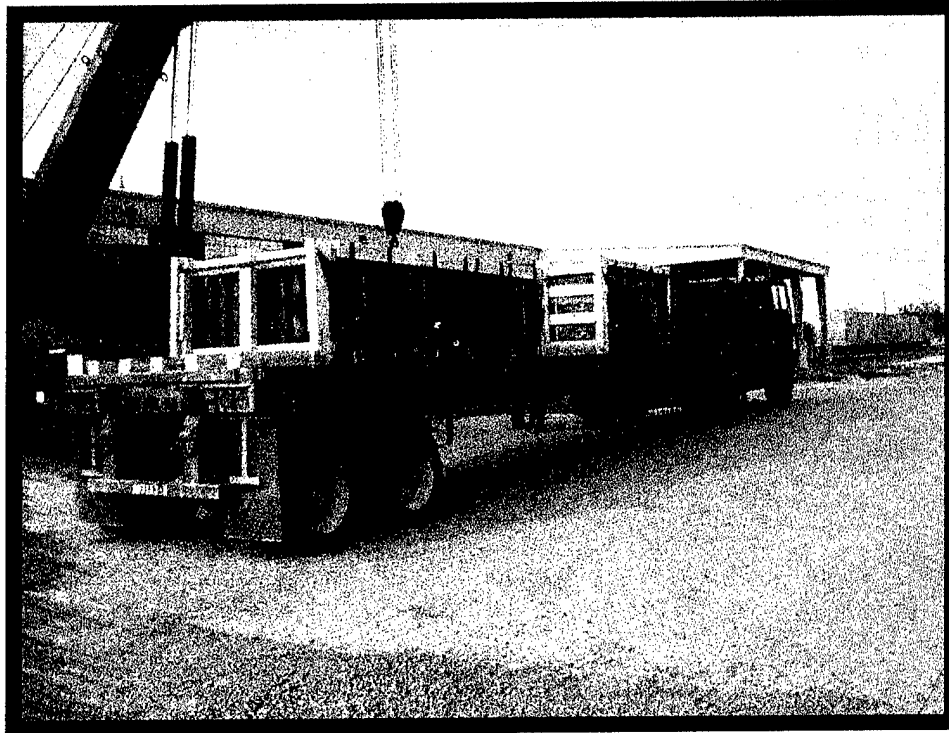
Photo 11: M871A3 Trailer with Breakbulk Cargo Load

1. No damage or excessive movement occurred with the trailer or cargo tie-down rings during testing.
2. Following Pass No. 2, the strapping board broke and the end gate started to collapse. The load straps were tightened. This failure was not a result of the trailer design, and therefore, testing was continued.

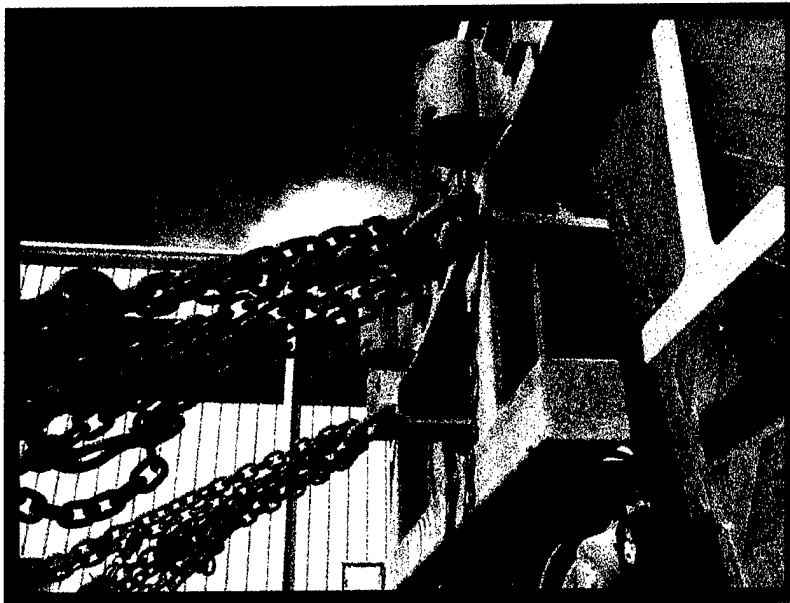
**Photo 12: Rear Chain Tie-down Configuration of the M871A3
with Full Payload**

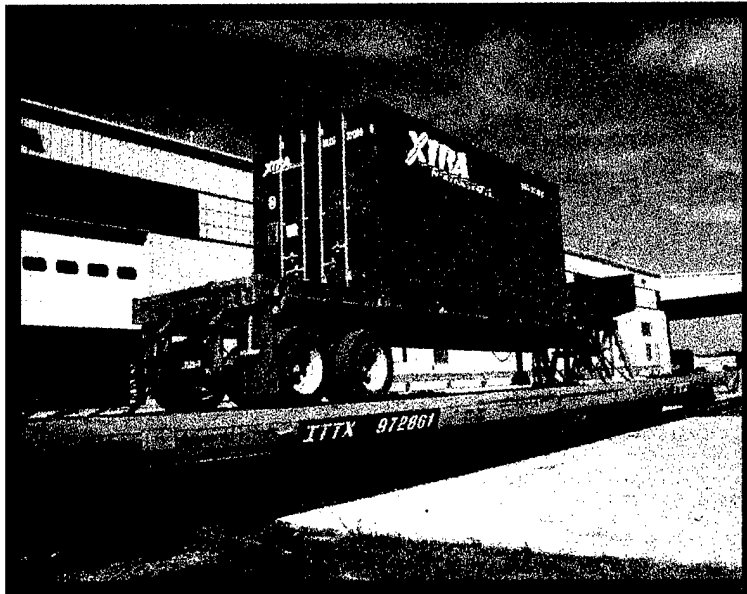
Photo 13: M871A3 Trailer Testing with Full Payload Chained to the Flatcar

1. No damage or excessive movement occurred with the trailer, tiedown rings, or twistlocks during testing. Chains remained tight throughout testing.

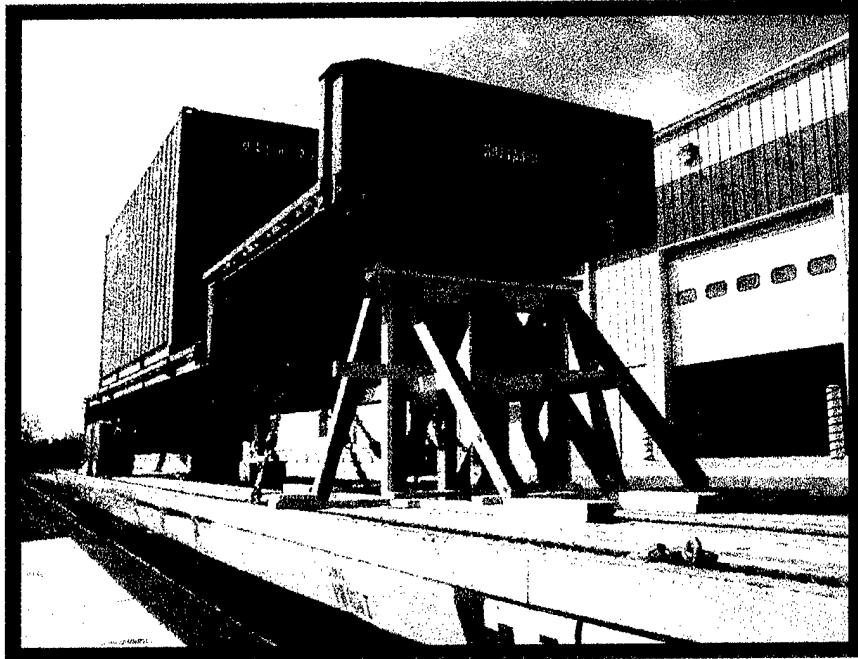
Photo 14: Wood Stanchion for Full Payload Testing

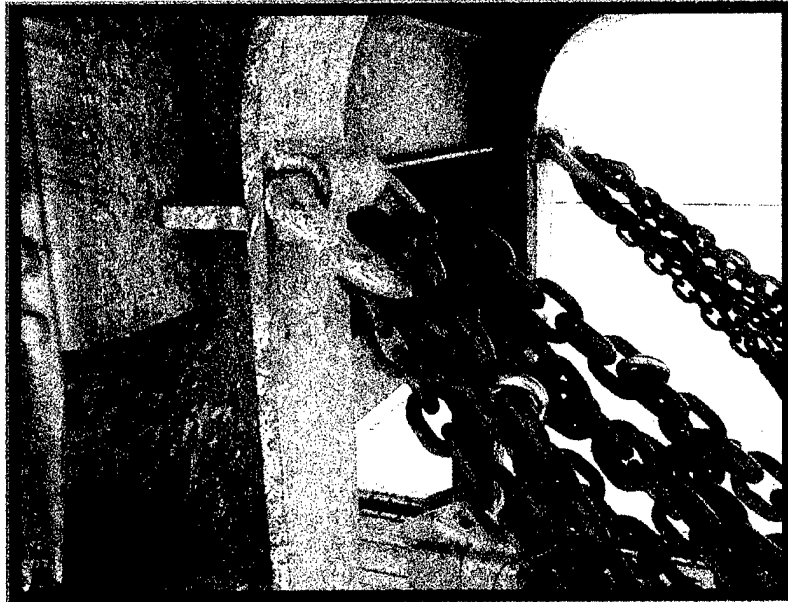
Photo 15: Chain tiedown configuration on forward end of the M871A3

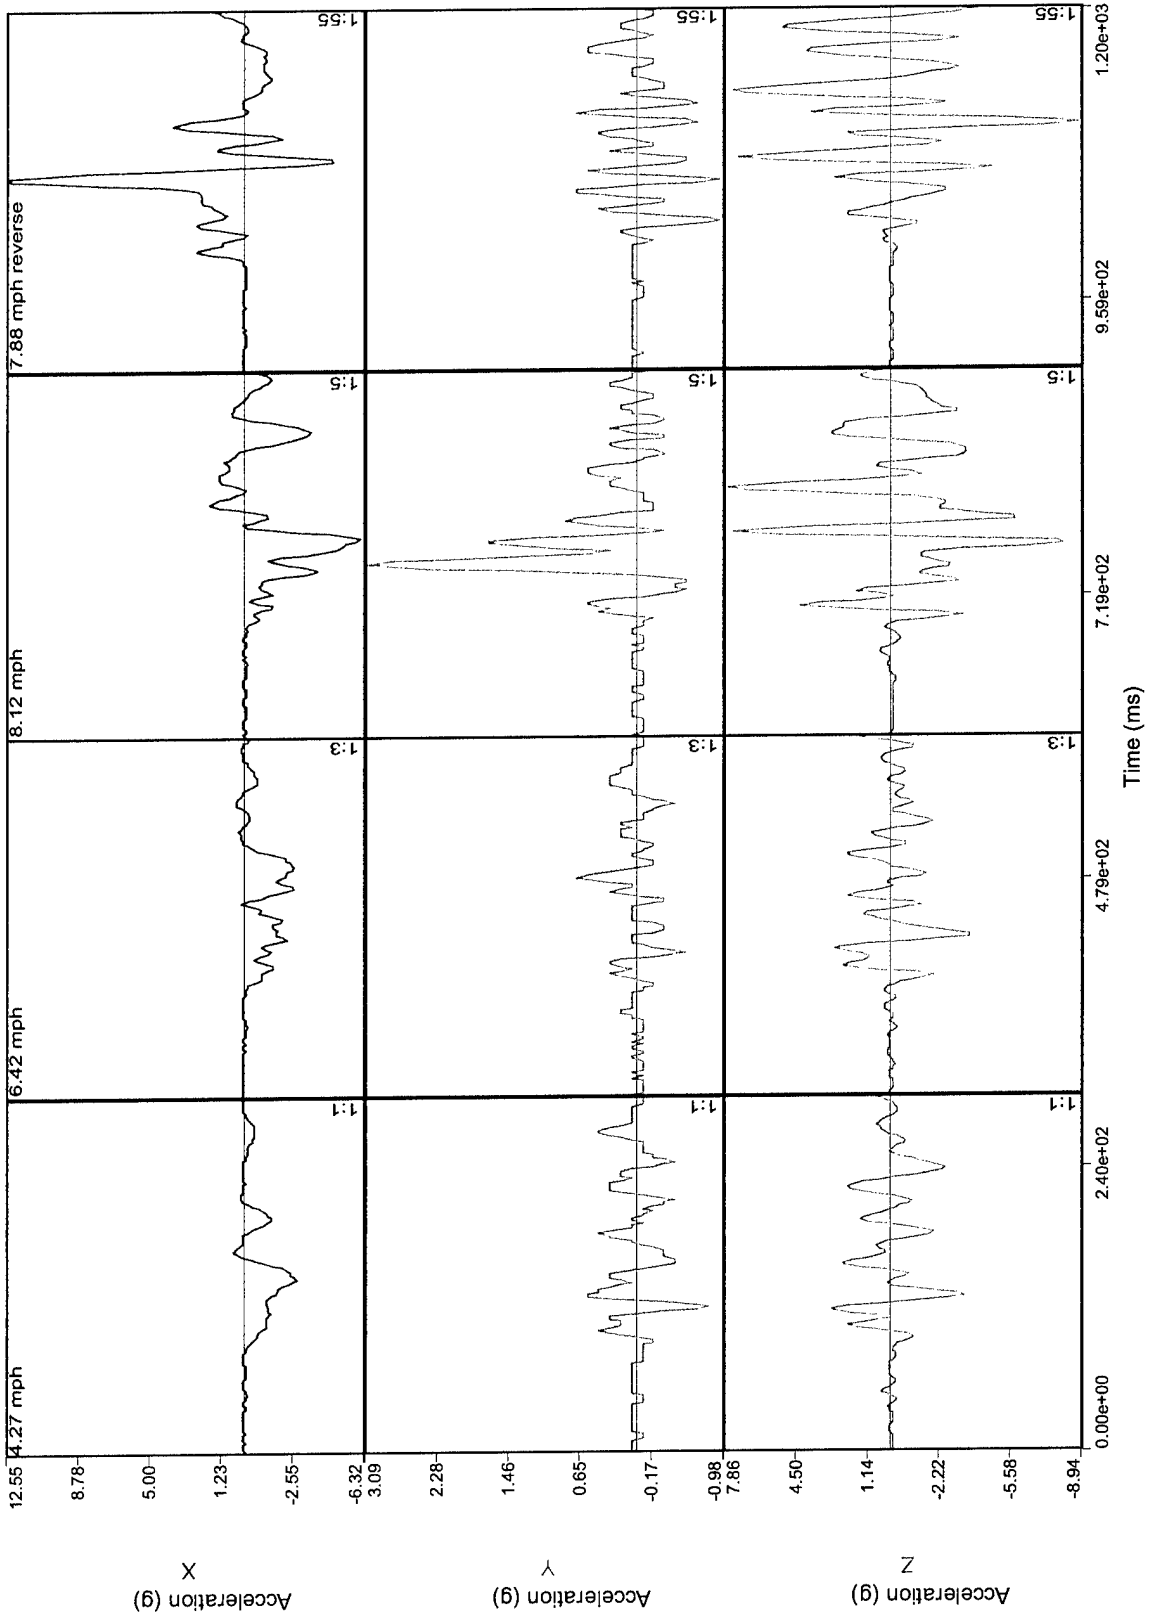
Rail Impact of M871A3 Trailer with 11,859-lb. Payload Sensor Location: Rear Railcar

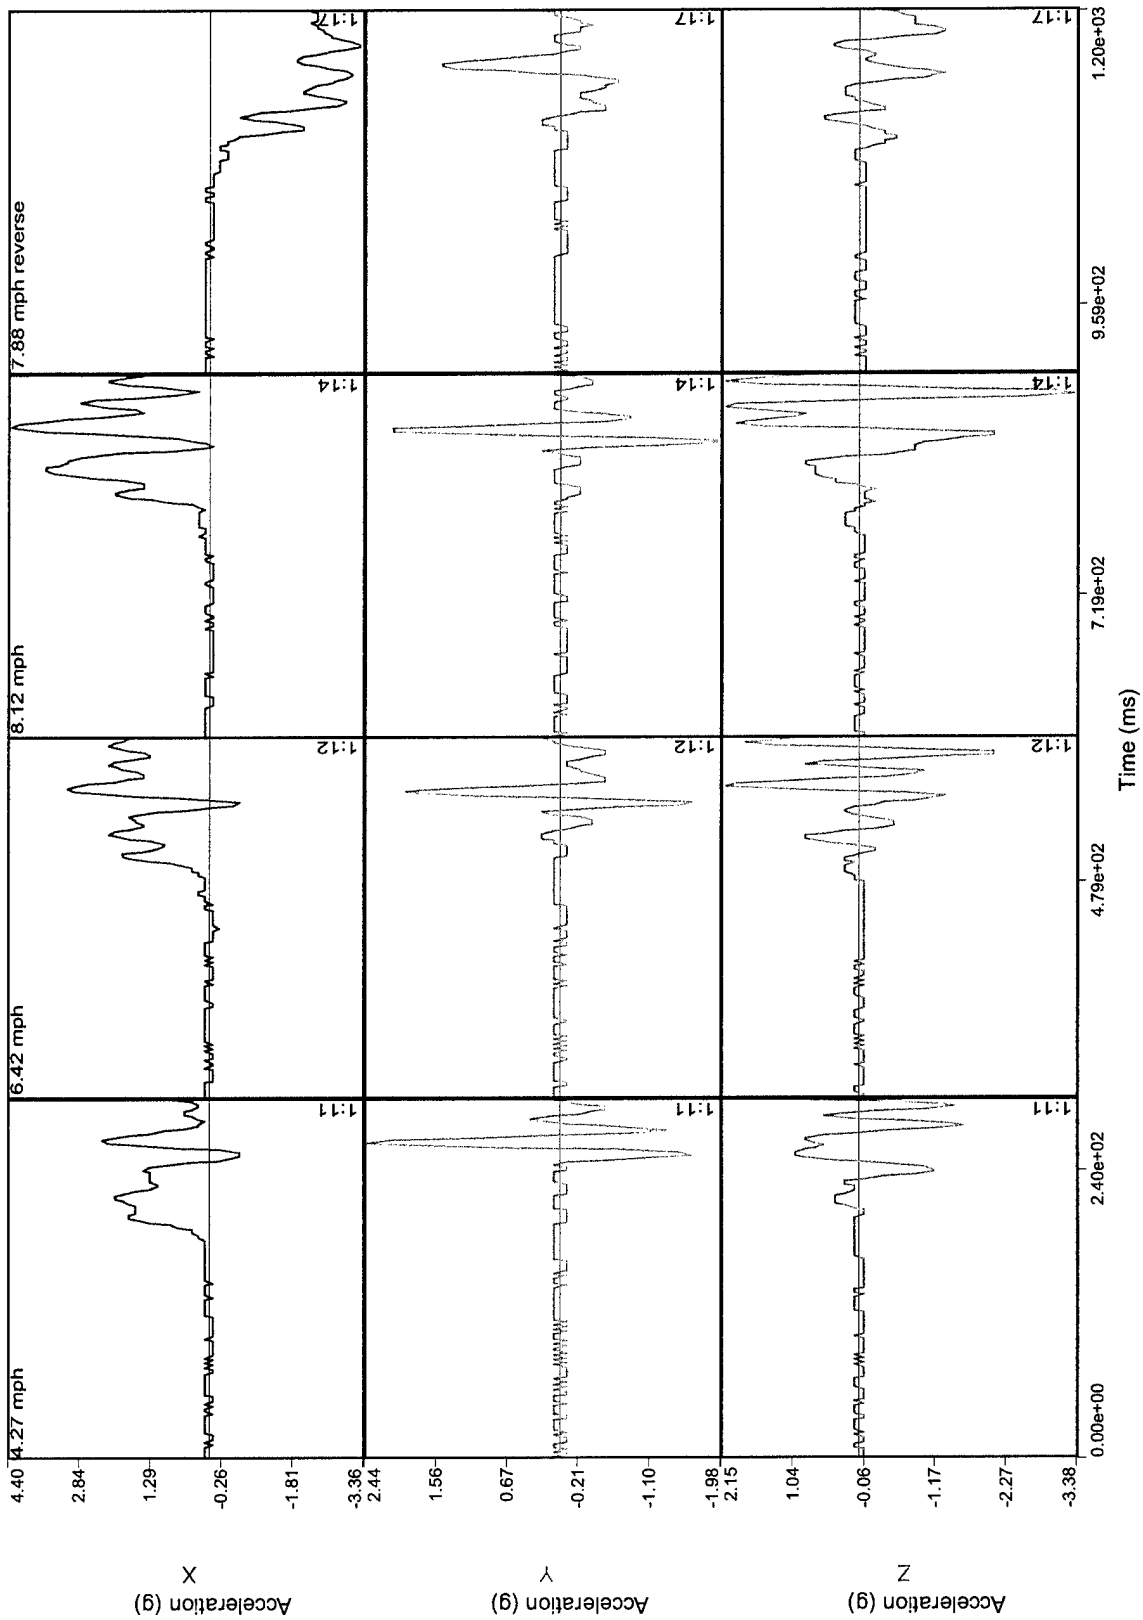
Rail Impact of M871A3 Trailer with 11,859-lb. Payload Sensor Location: Trailer Rear

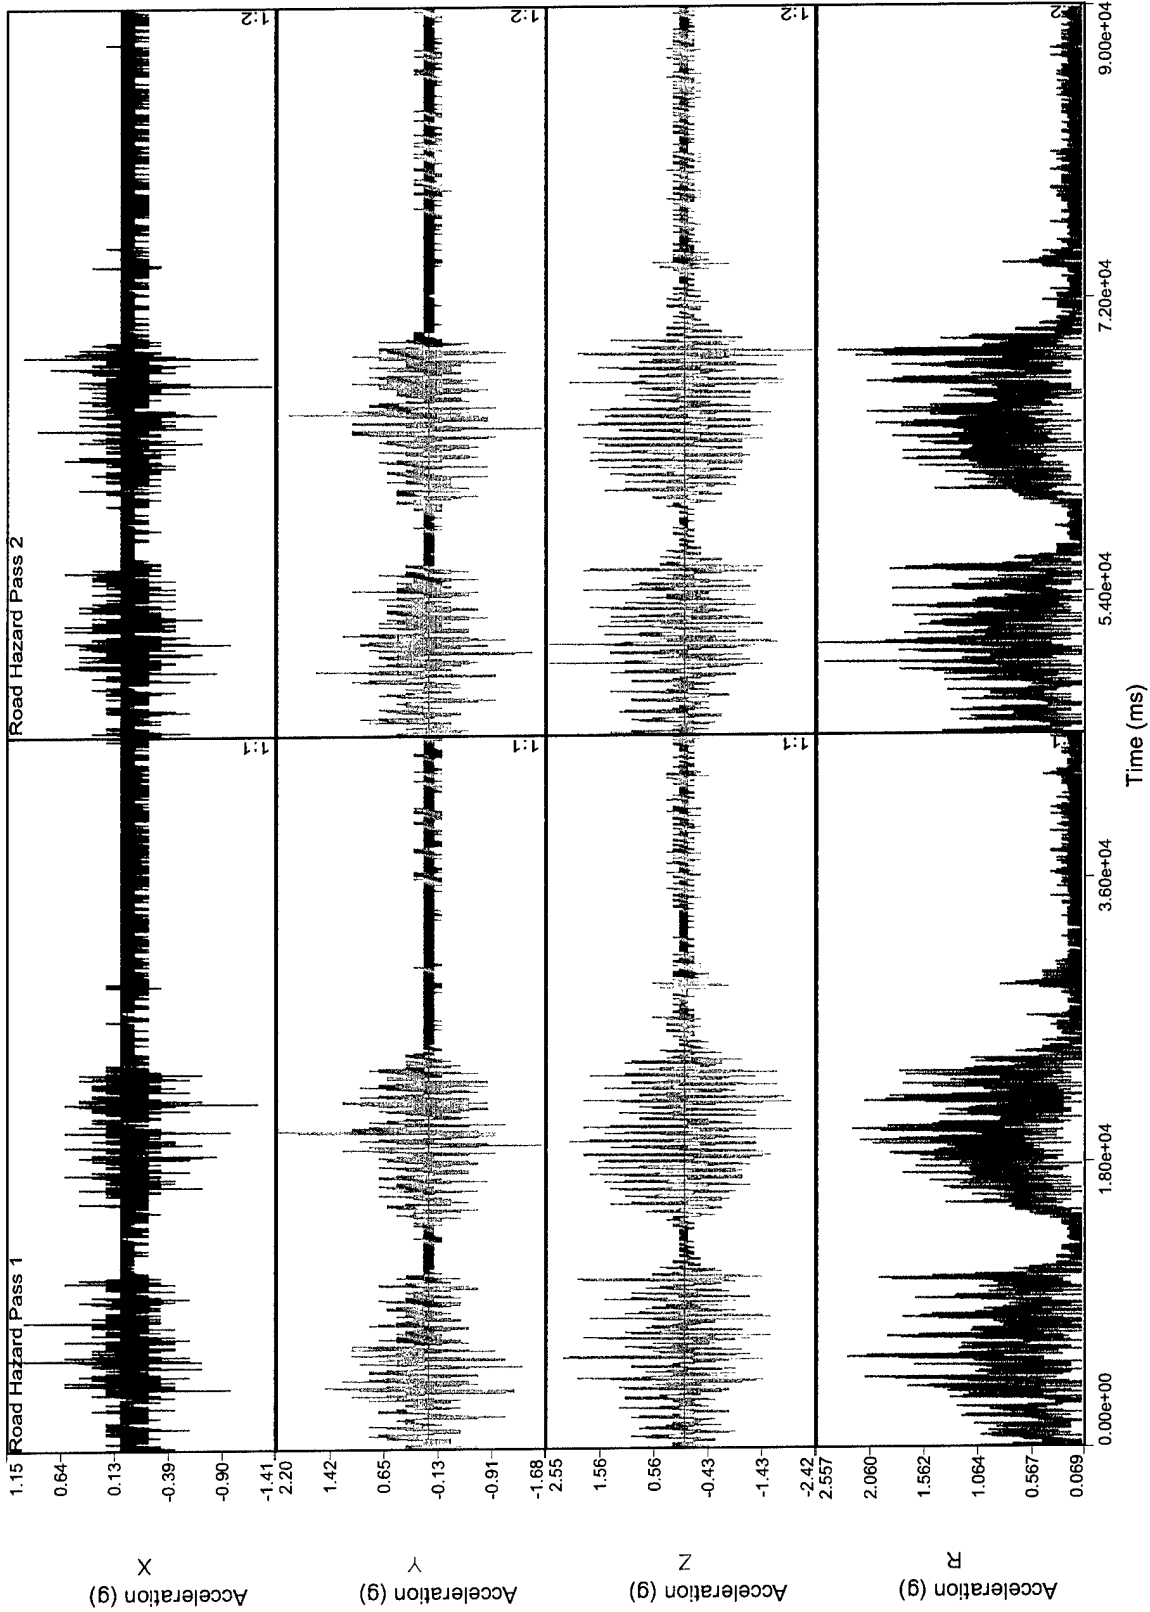
Hazard of M871A3 Trailer with 11,859-lb. Payload Sensor Location: Trailer Bulkhead

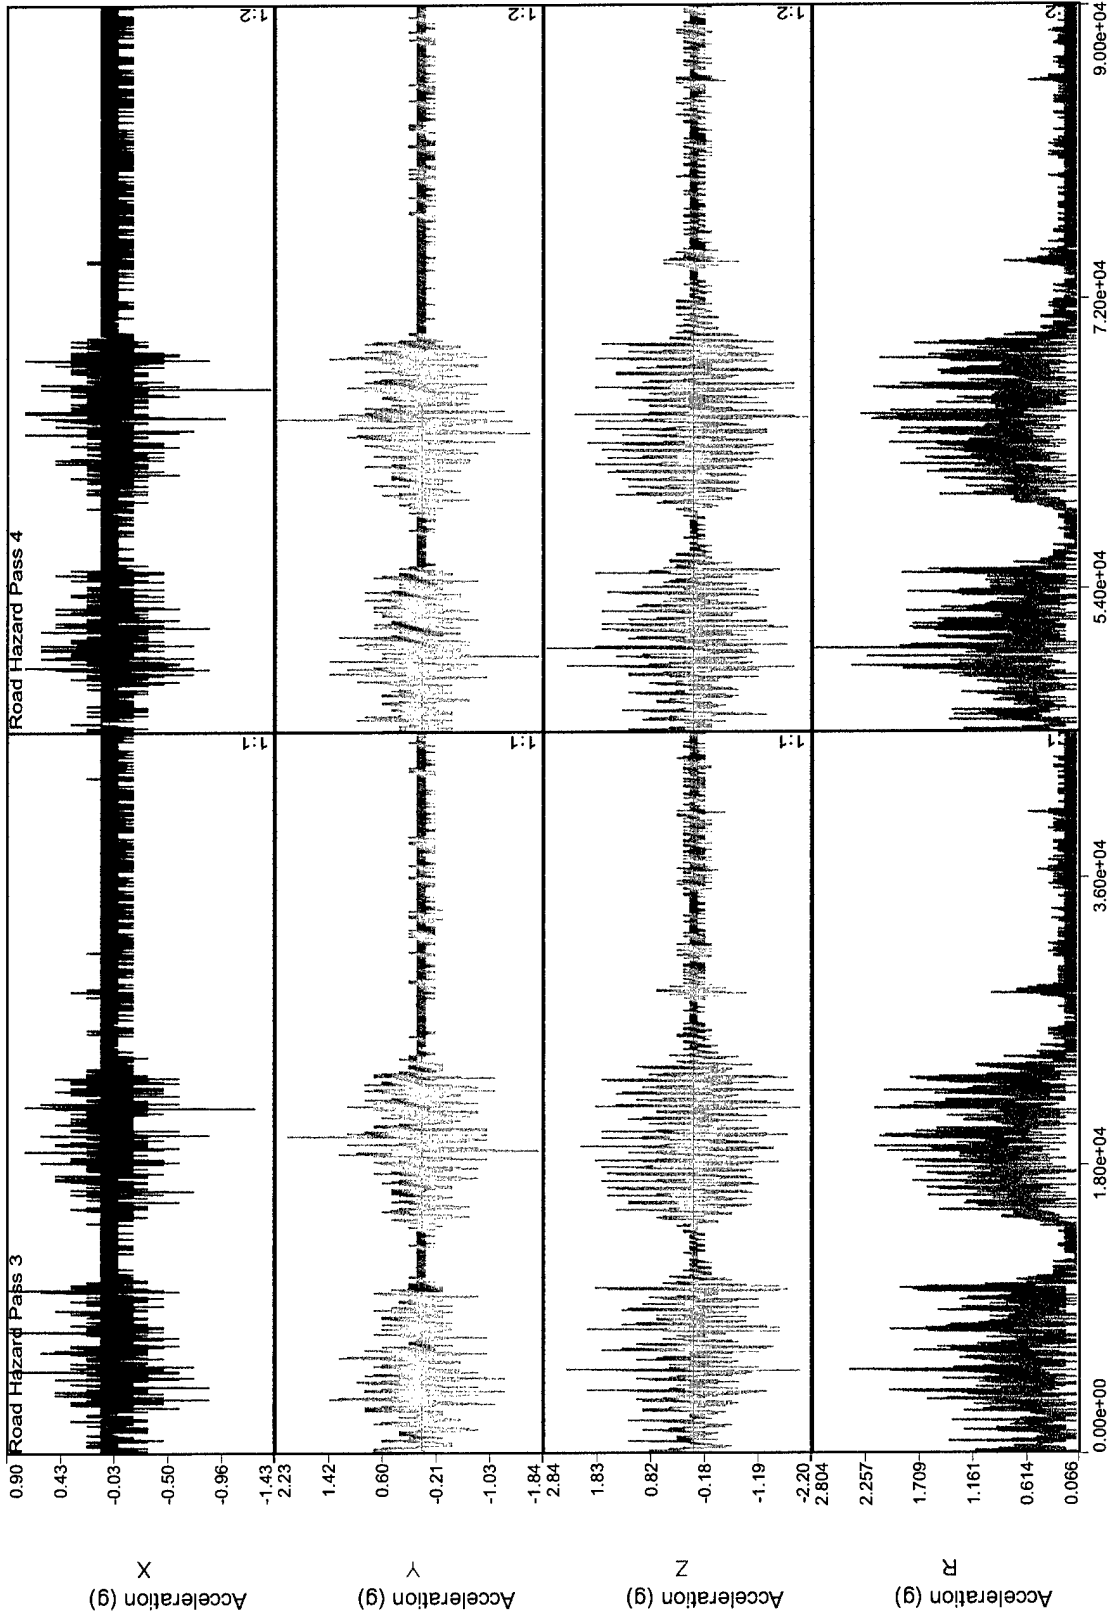
Hazard of M871A3 Trailer with 11,859-lb Payload Sensor Location: Trailer Bulkhead

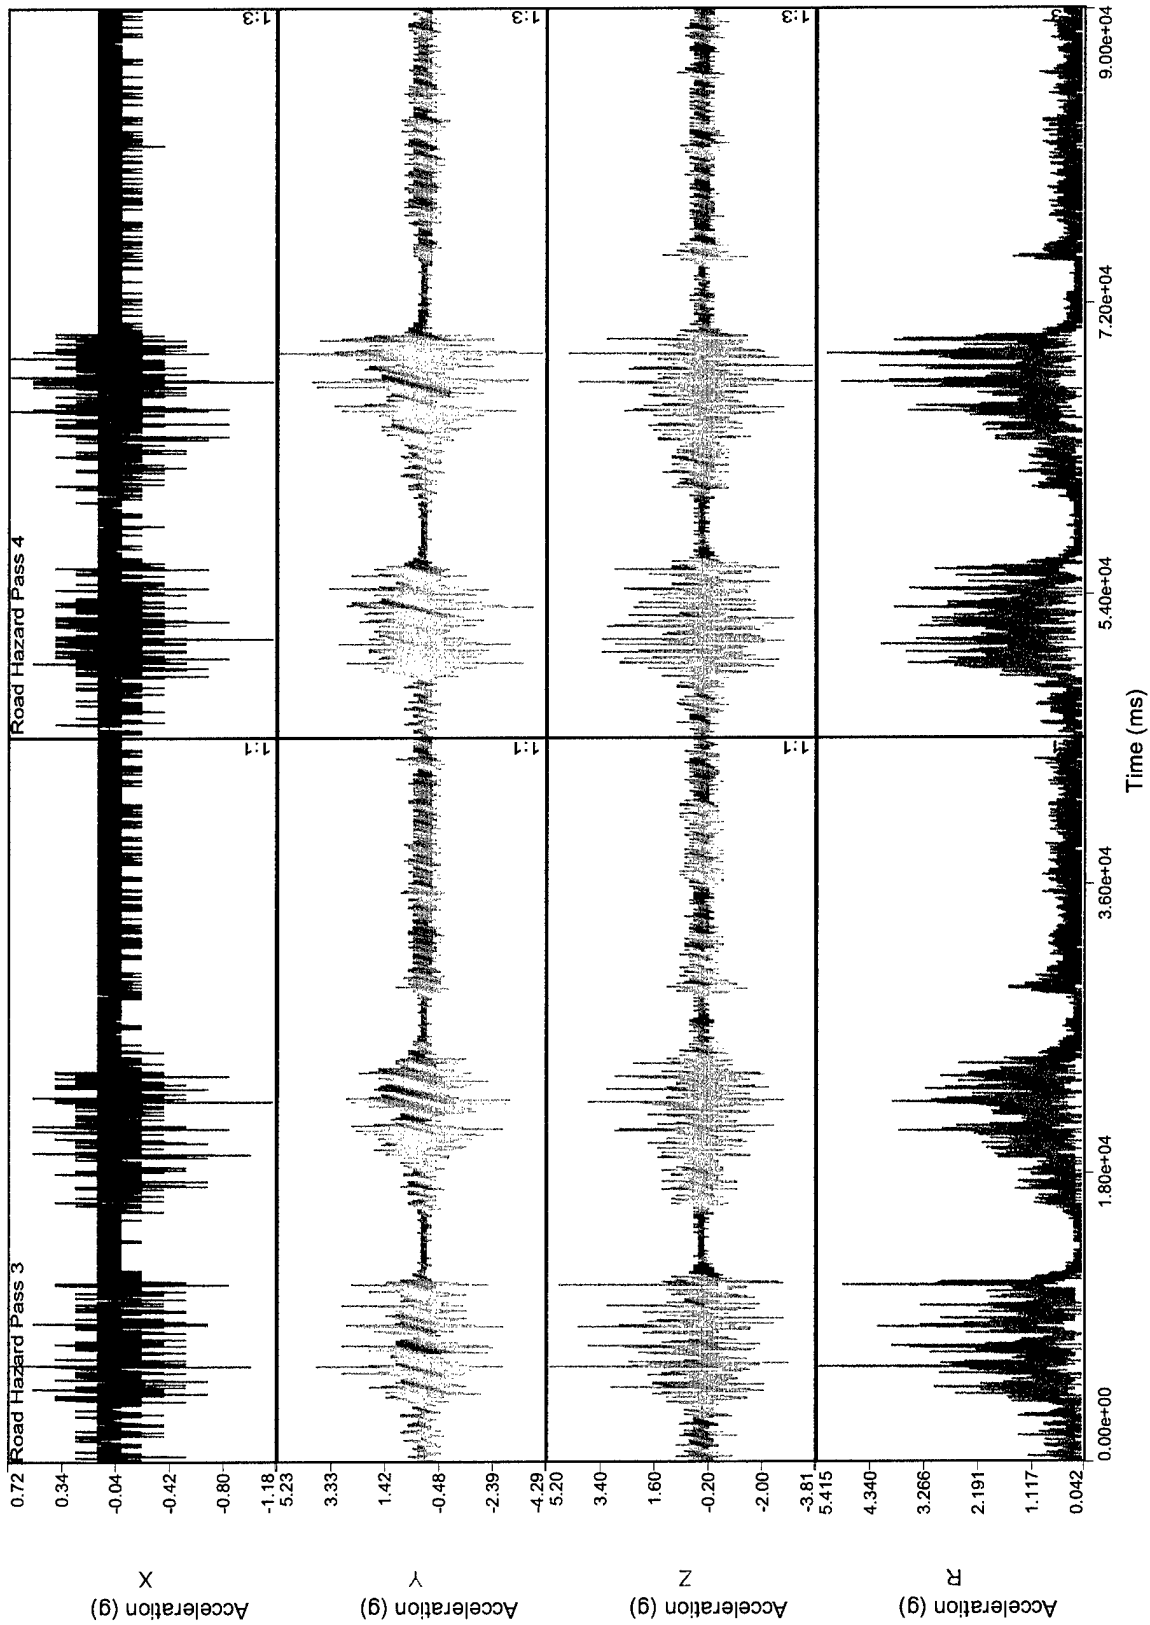
Hazard of M871A3 Trailer with 11,859-lb Payload Sensor Location: Trailer Rear

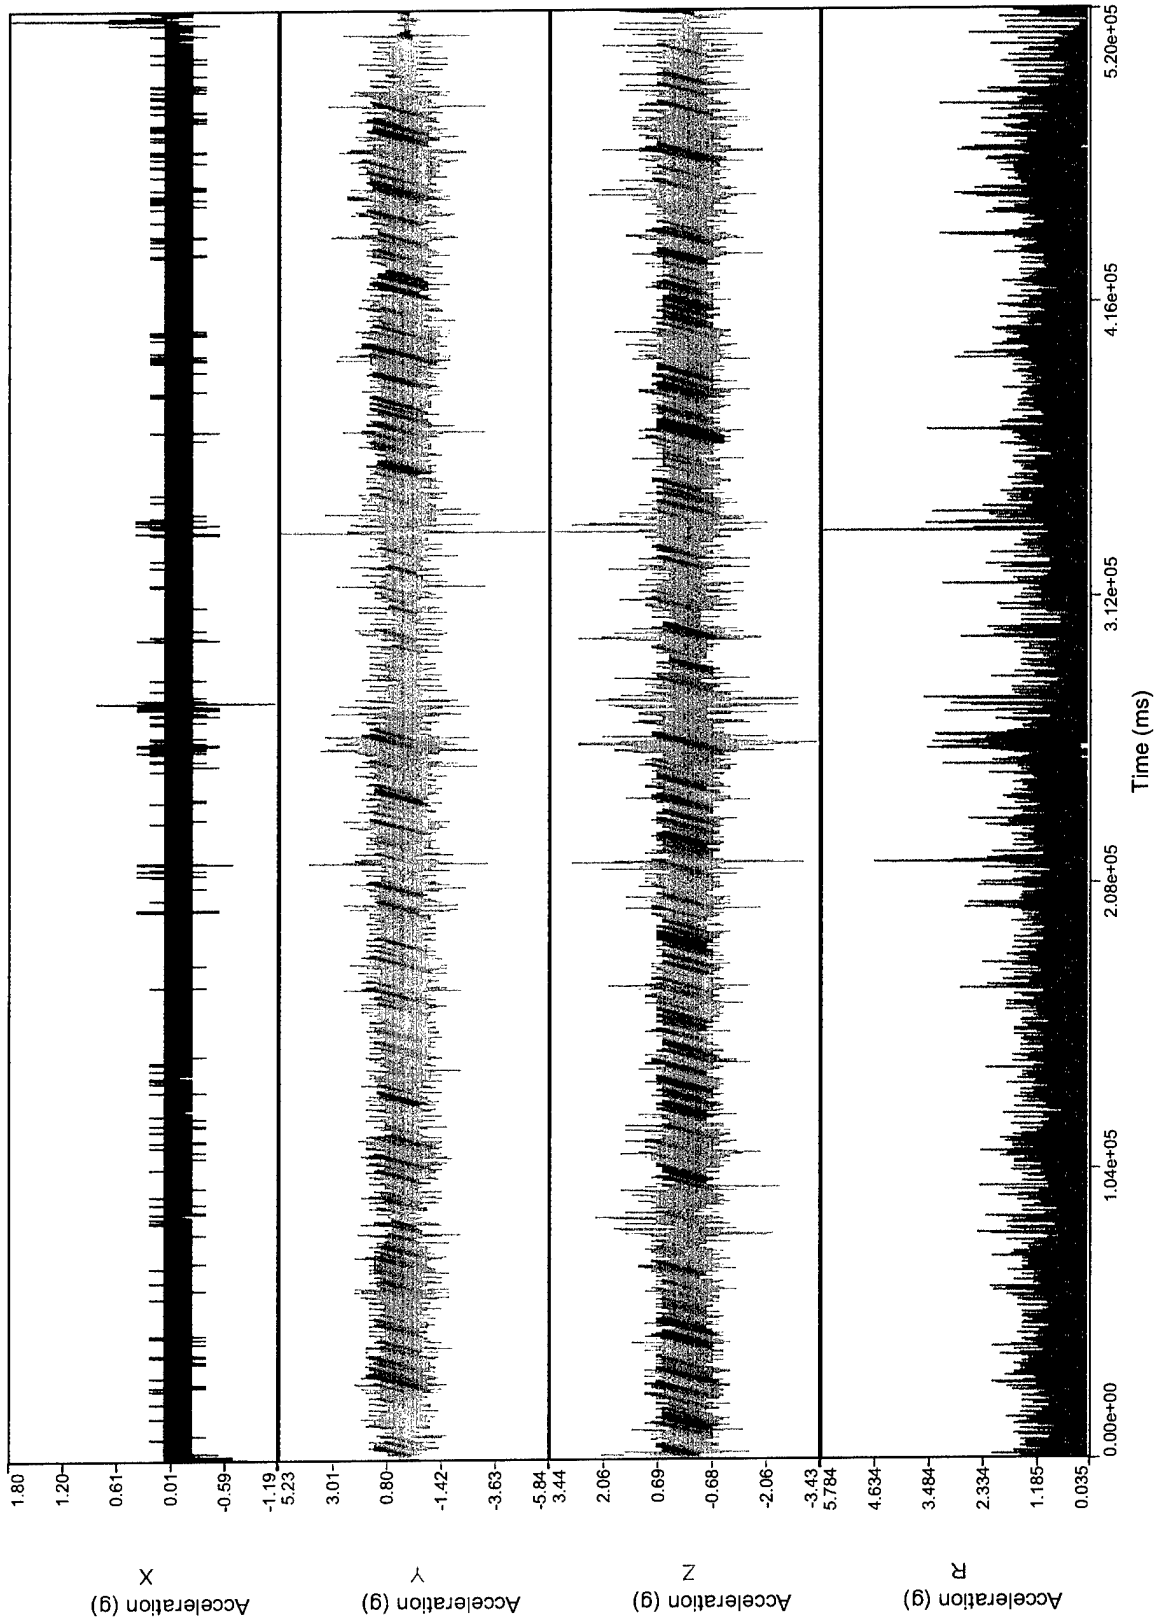
Road Trip of M871A3 Trailer with 11,859-lb Payload

Sensor Location: Trailer Rear
