**FINAL REPORT
January 2002**

REPORT NO. 01-16

**M871A3 TACTICAL TRAILER
22.5-TON PAYLOAD CAPACITY
TP-94-01,
“TRANSPORTABILITY TESTING PROCEDURES”**

**VALIDATION ENGINEERING DIVISION
MCALESTER, OKLAHOMA 74501-9053**

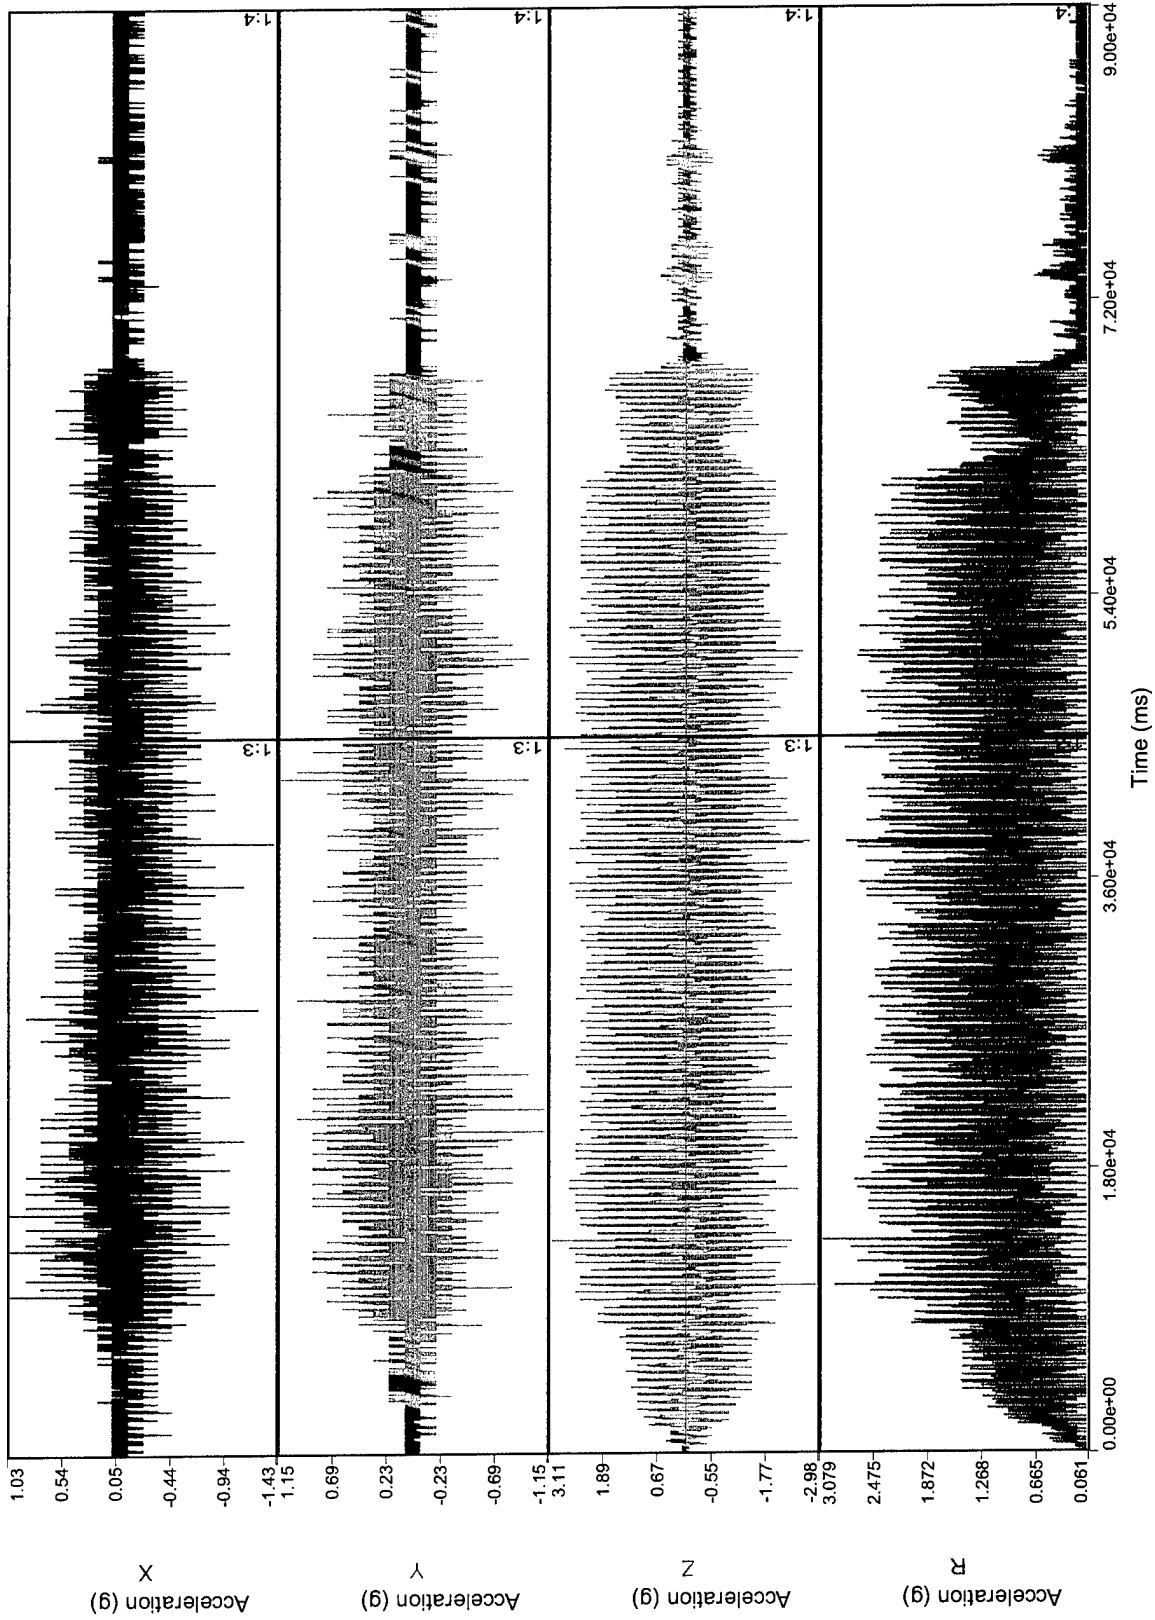
Washboard Course of M87/A3 Trailer with 11,859-lb Payload Sensor Location: Trailer Bulkhead

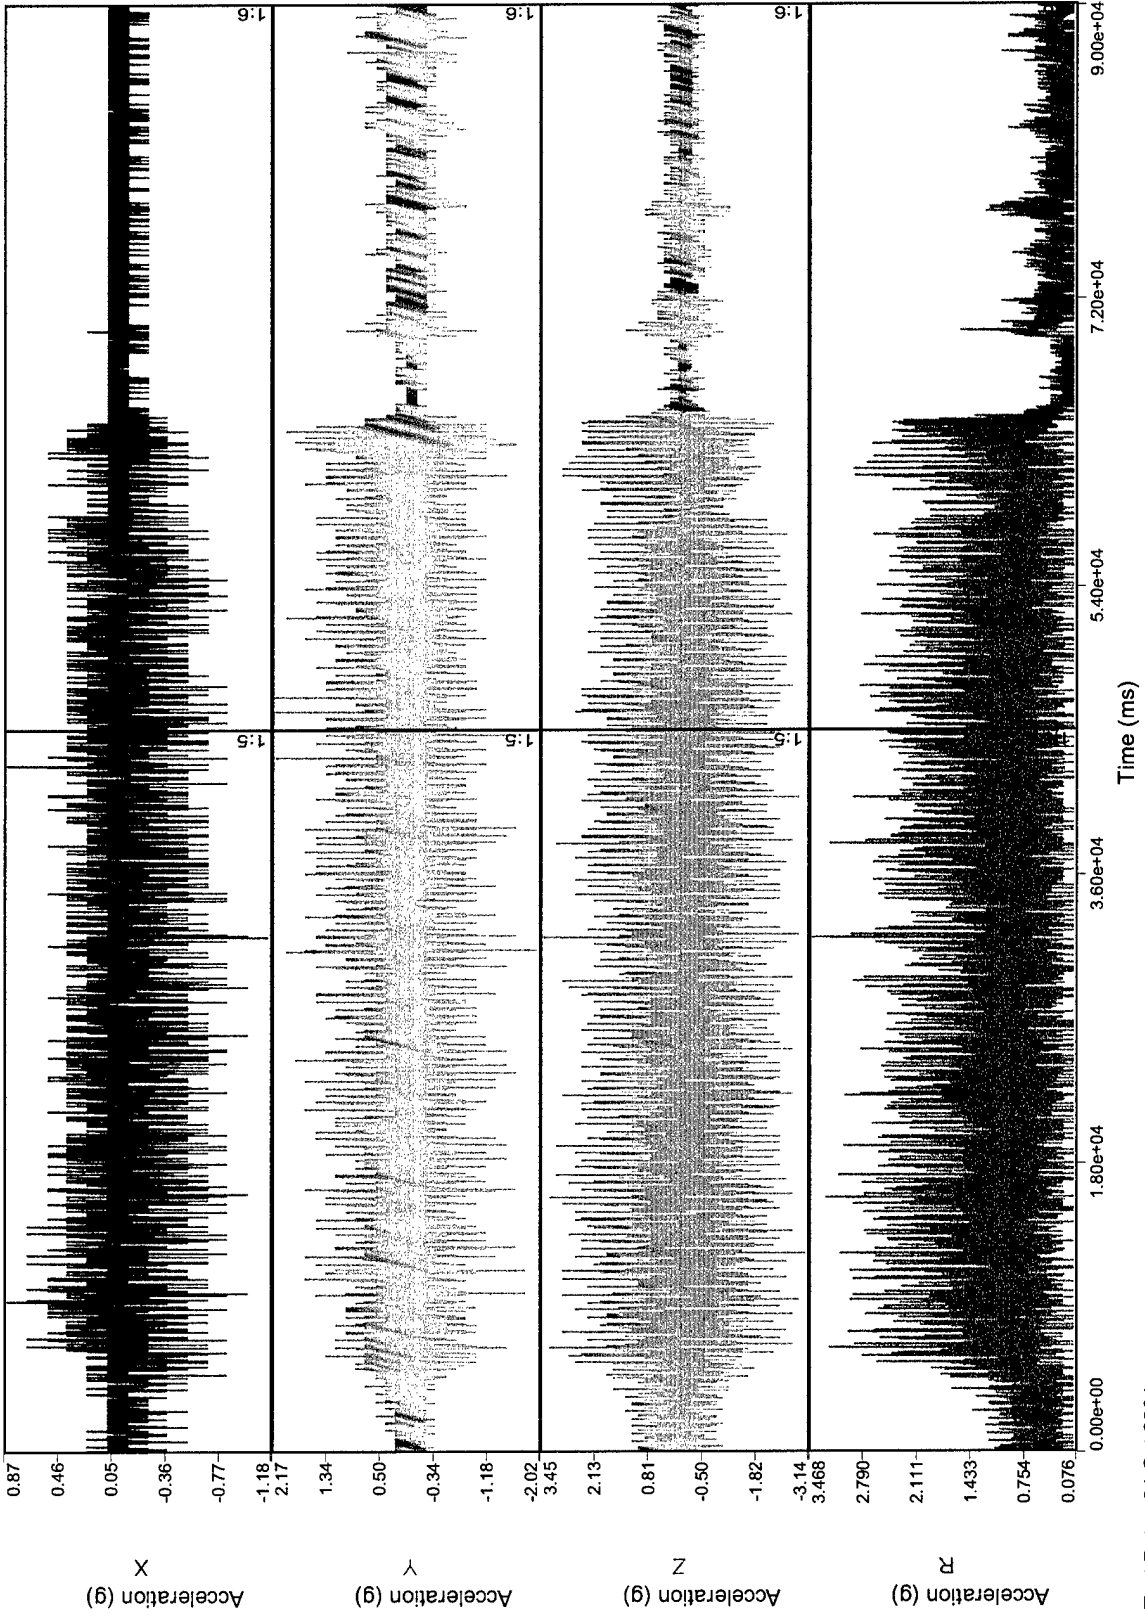
Washboard Course of M871A3 Trailer with 11,859-lb Payload

Sensor Location: Trailer Rear

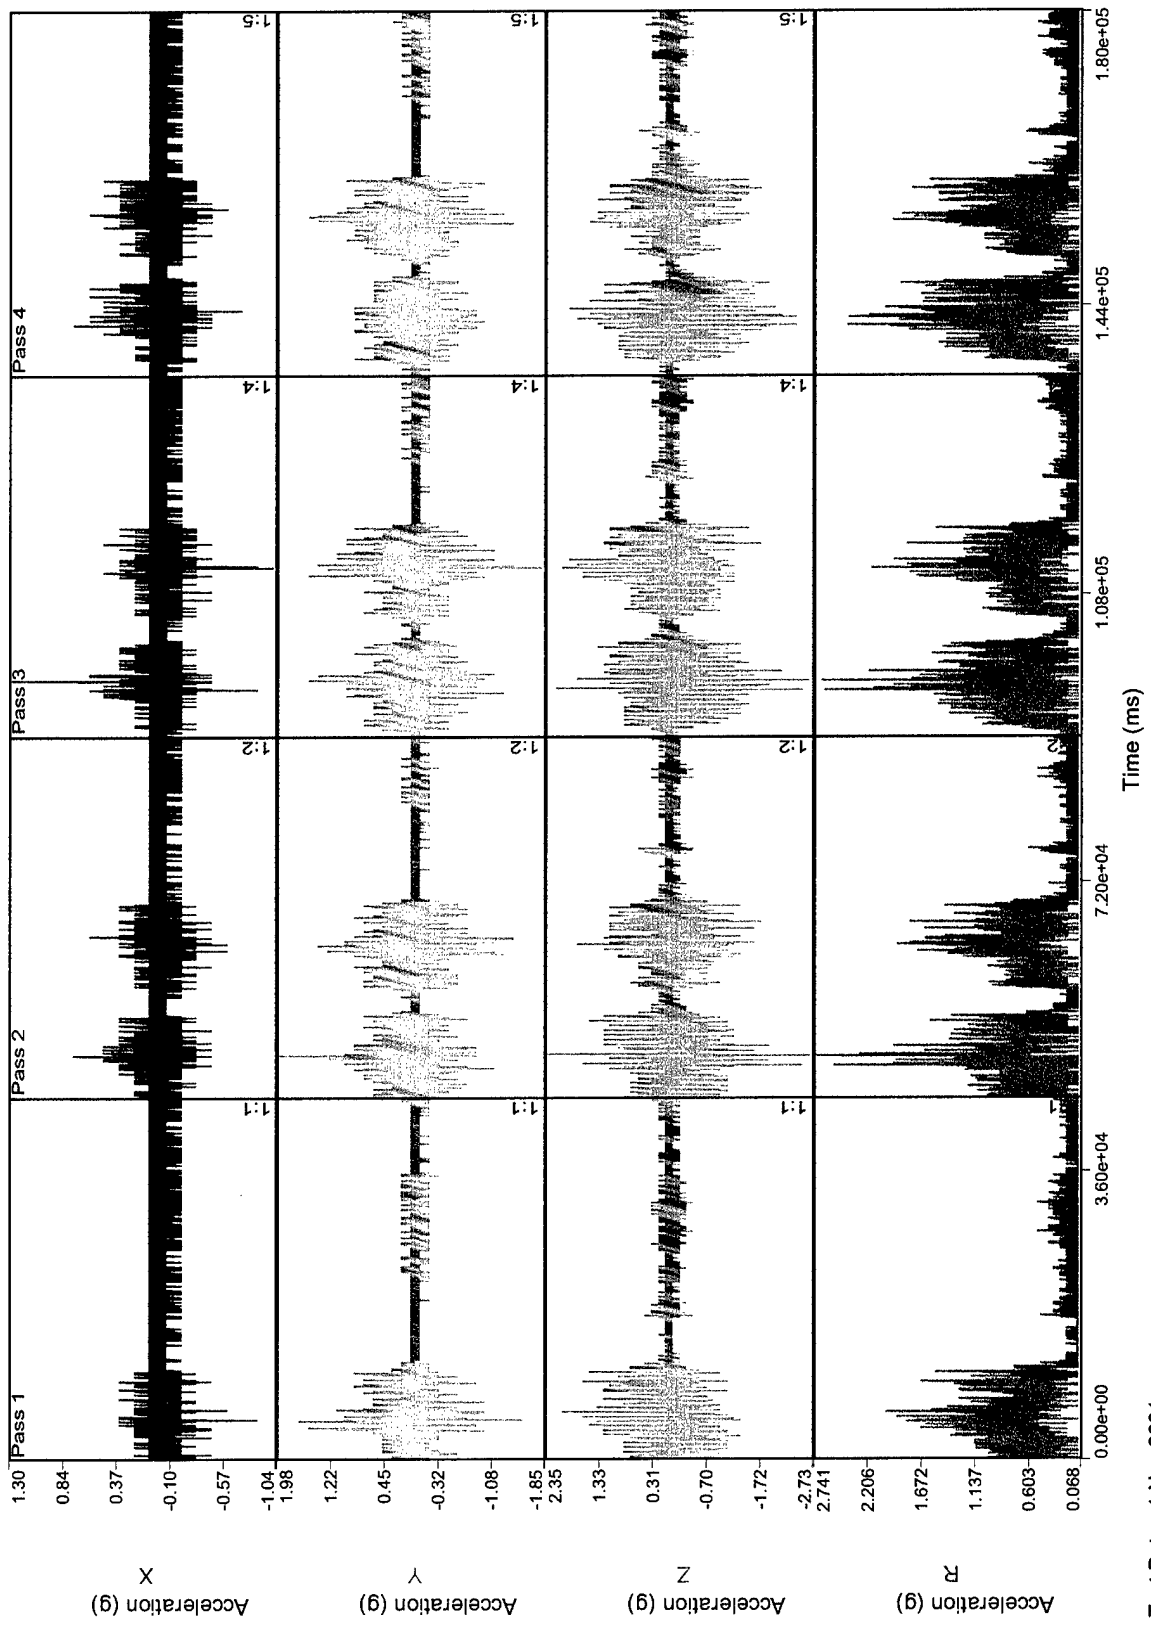
Hazard Course of M871A3 Trailer with 45,180-lb Payload Sensor Location: Trailer Bulkhead

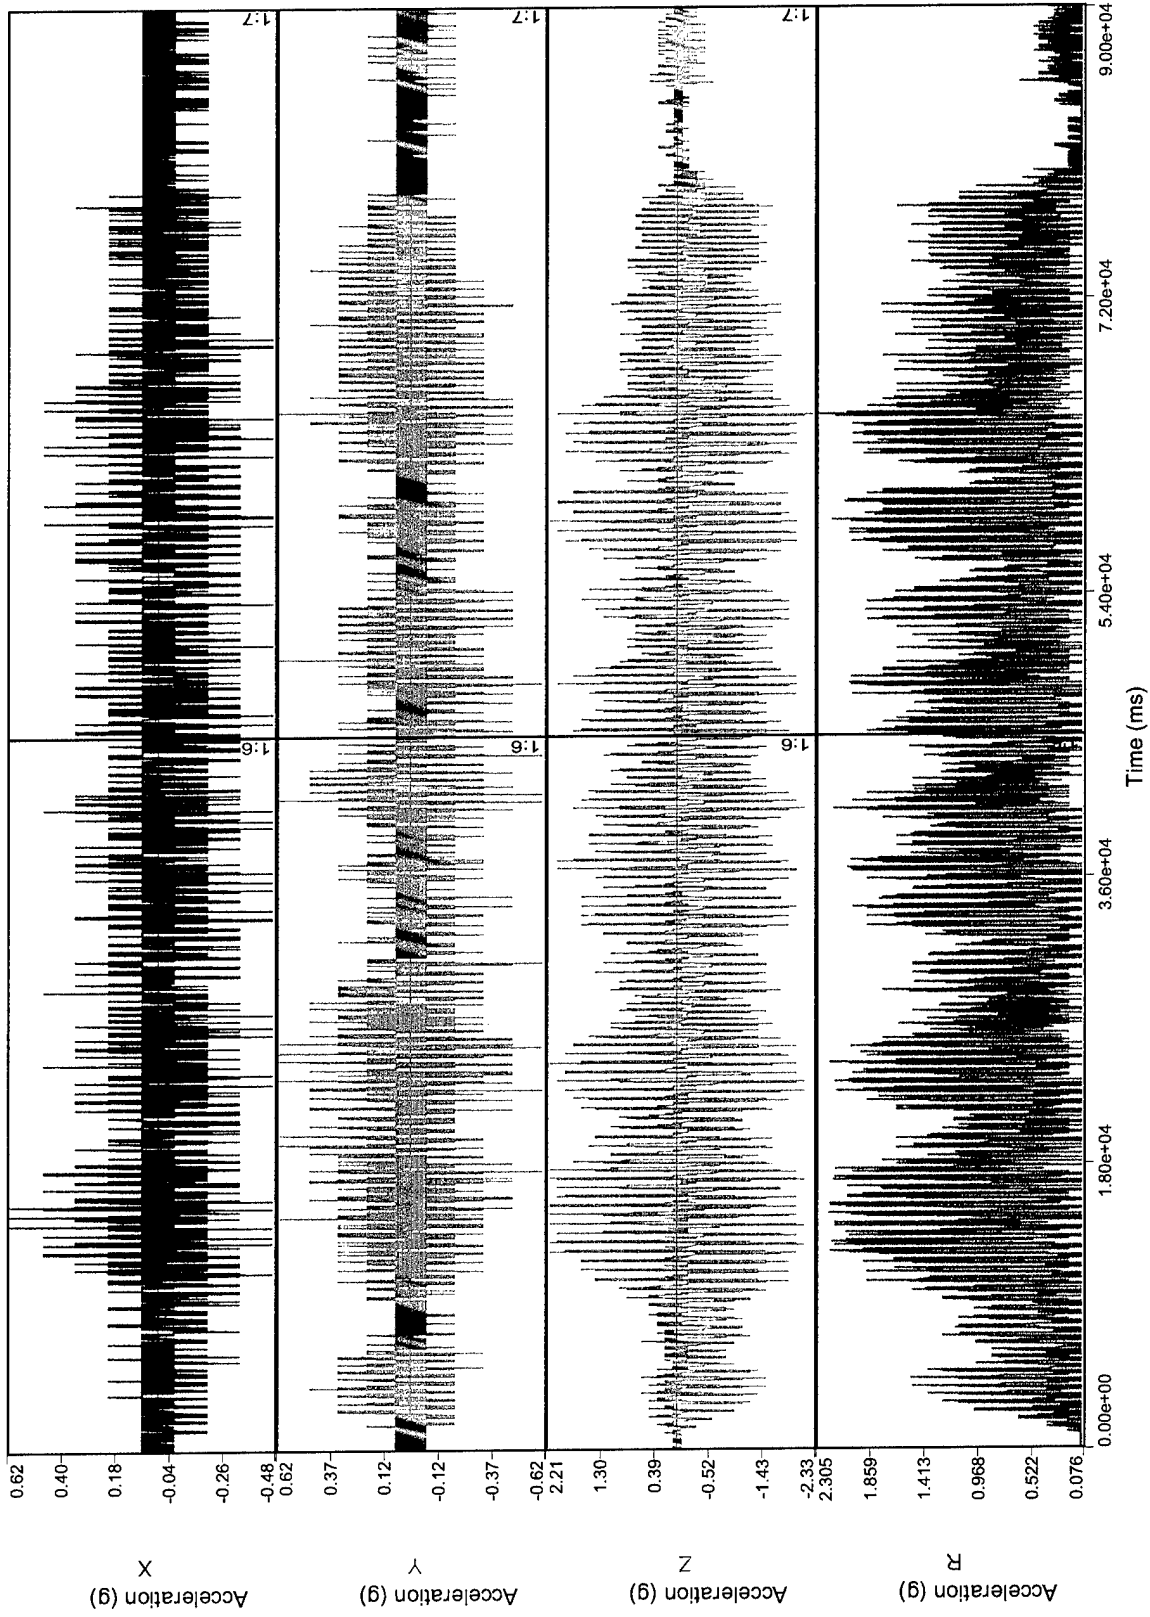
Washboard Course of M871A3 Trailer with 45,180-lb Payload

Sensor Location: Trailer Bulkhead

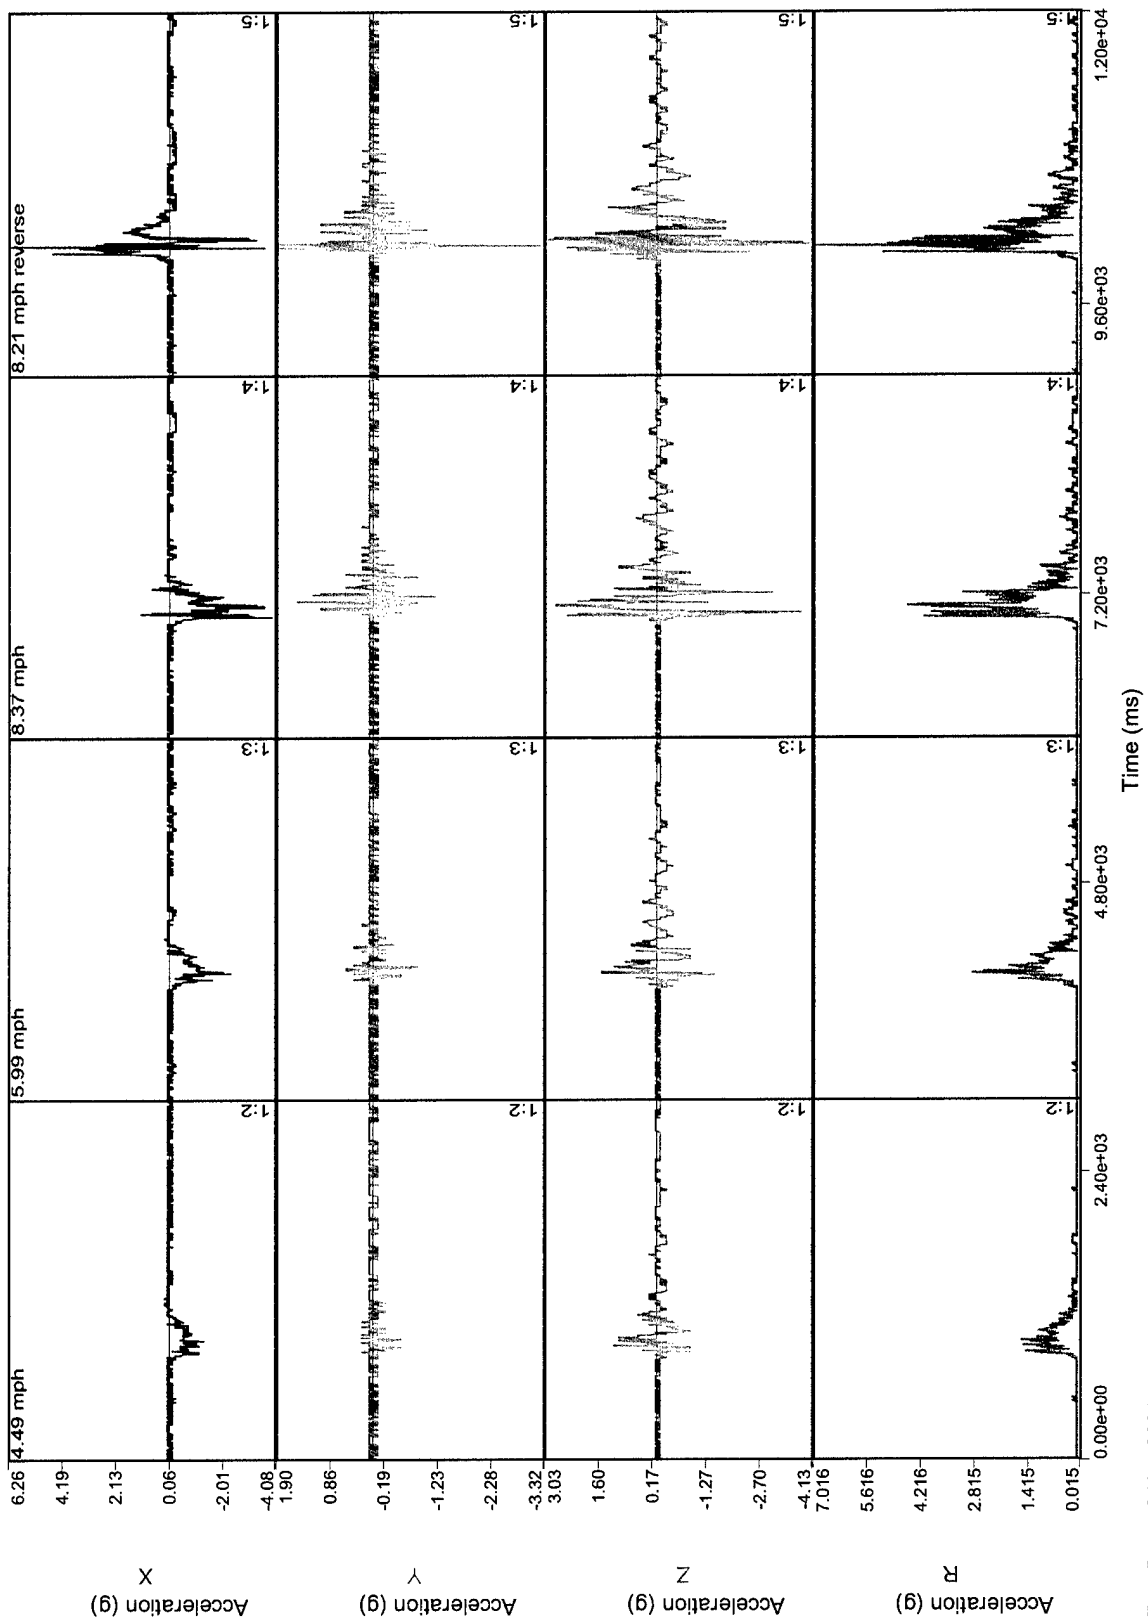
Retest Rail Impact of M871A3 Trailer with 45,180-lb Payload Sensor Location: Trailer Rear

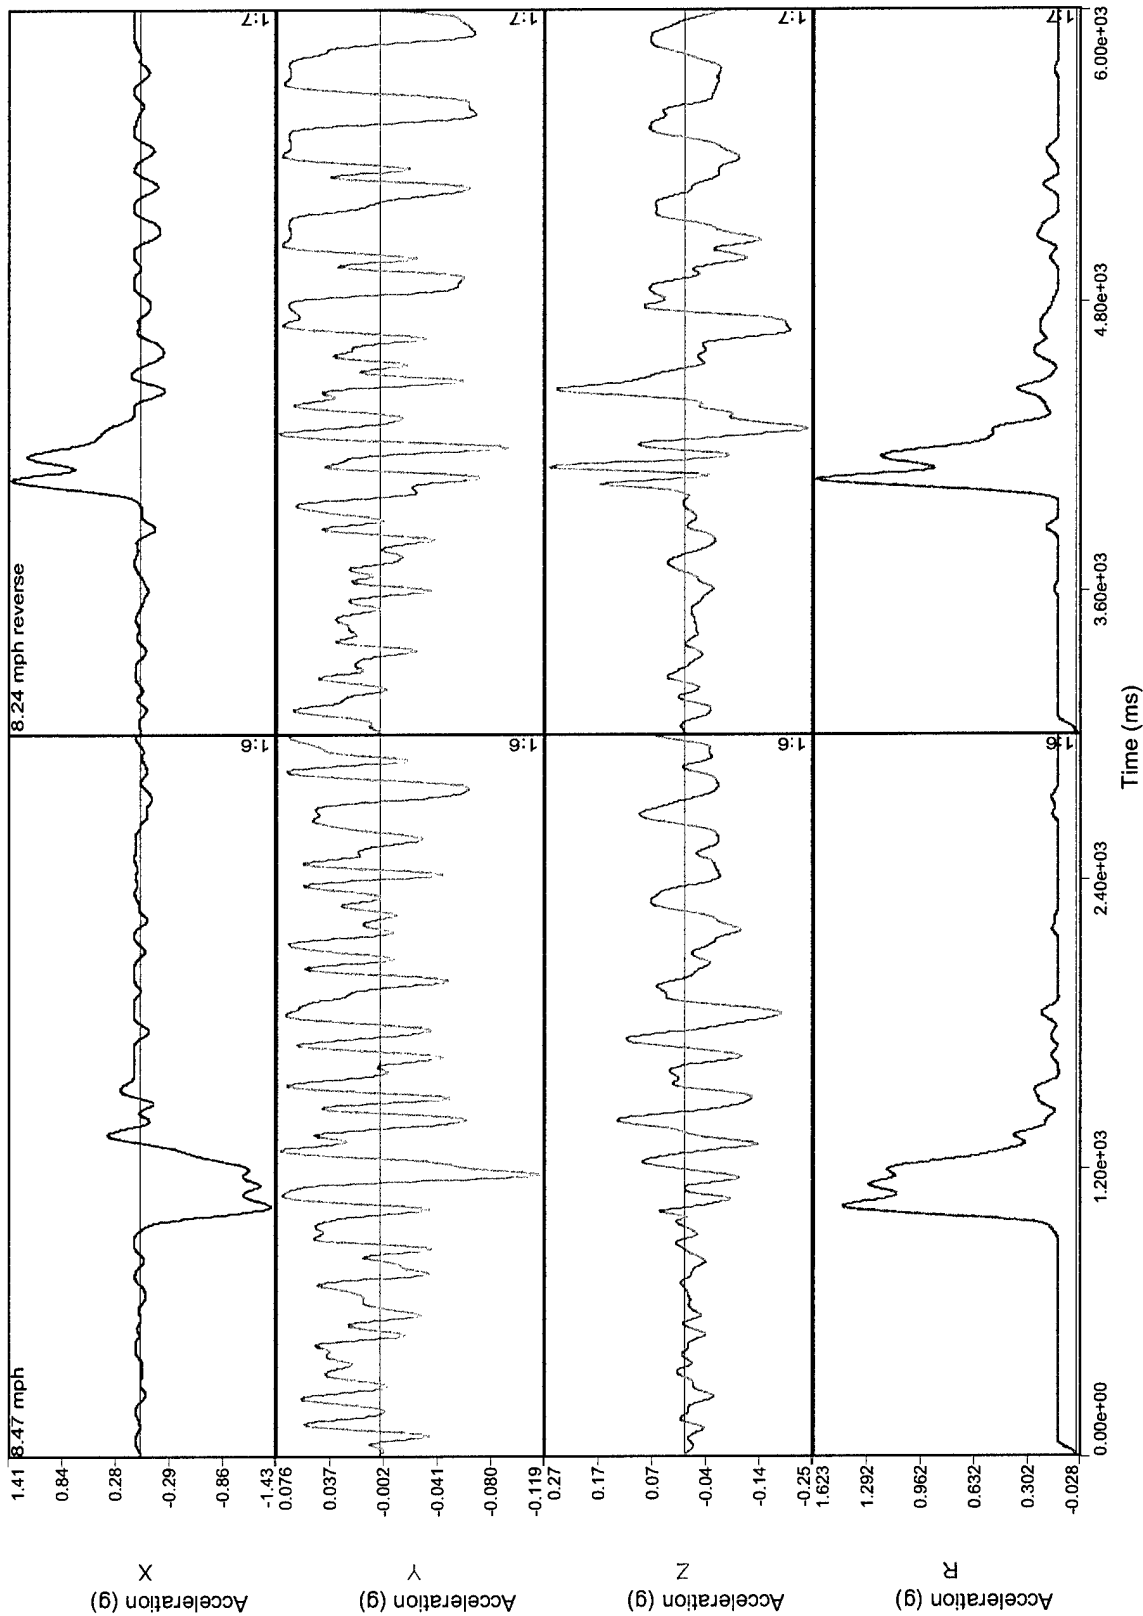
Rail Impact of M871A3 Trailer with 33,940-lb Payload Sensor Location: Trailer Bulkhead

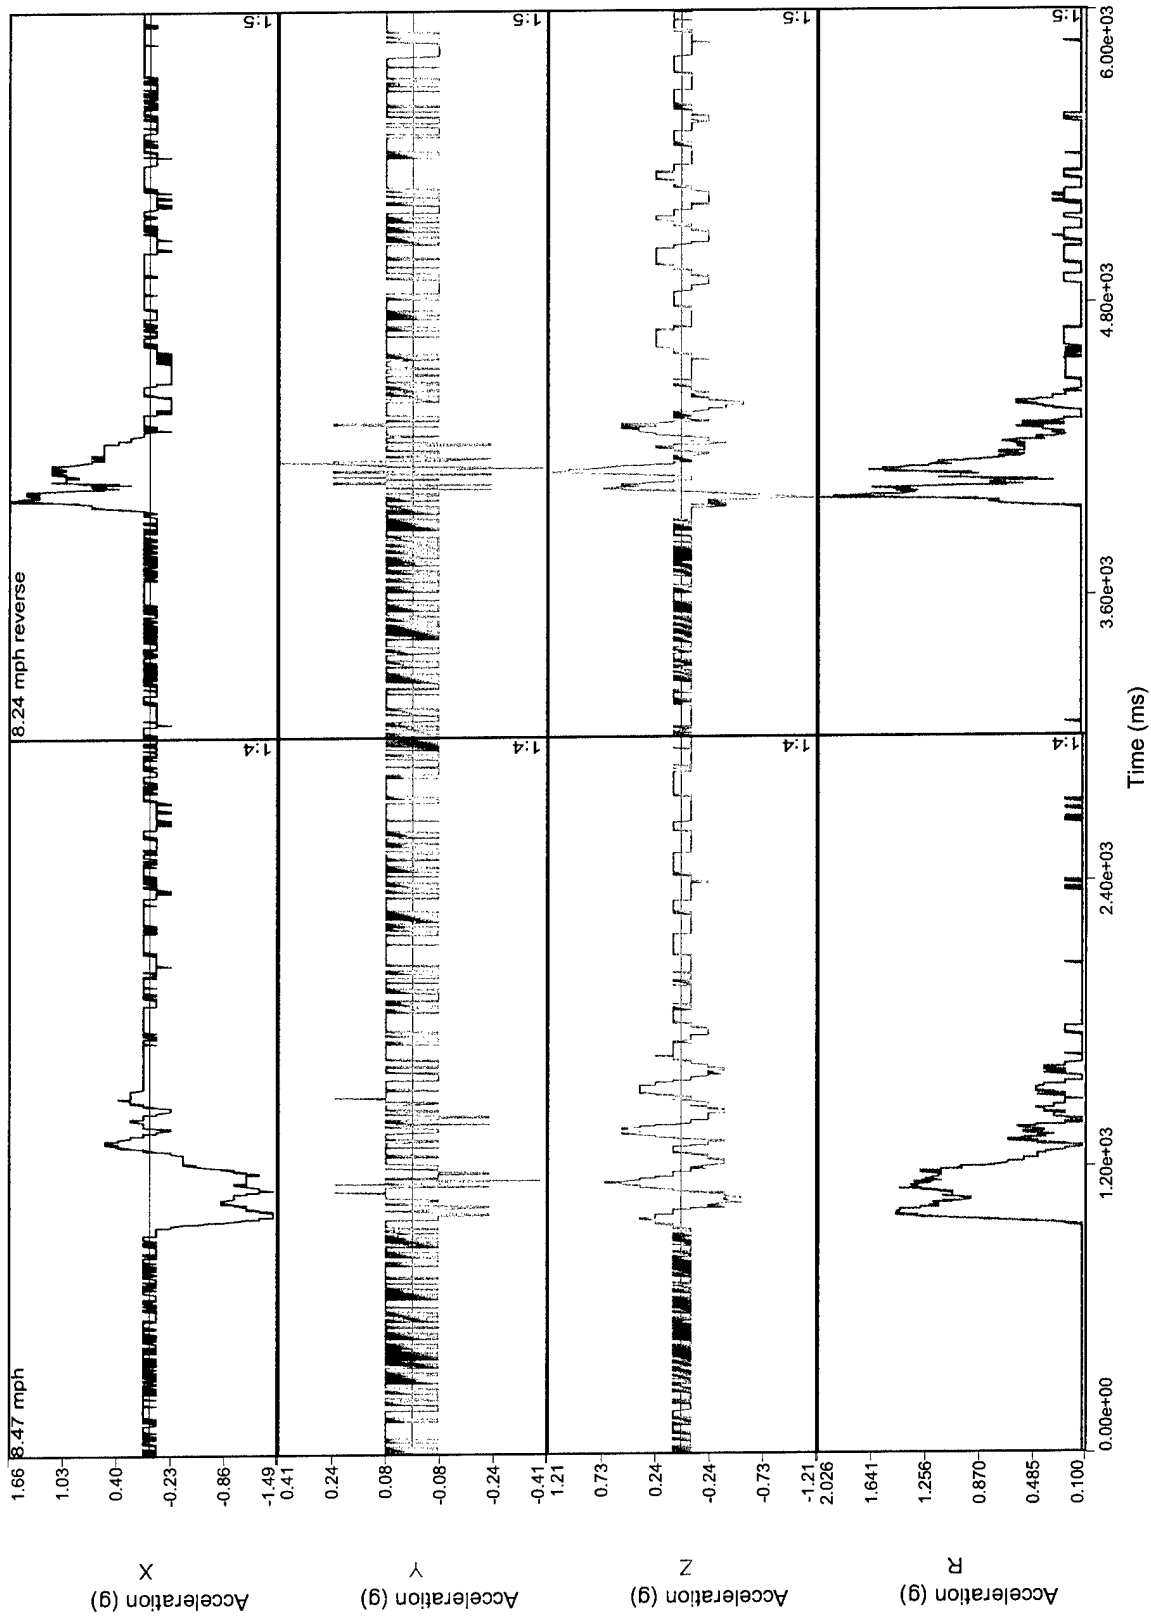
Rail Impact of M871A3 Trailer with 33,940-lb Payload Sensor Location: Trailer Rear

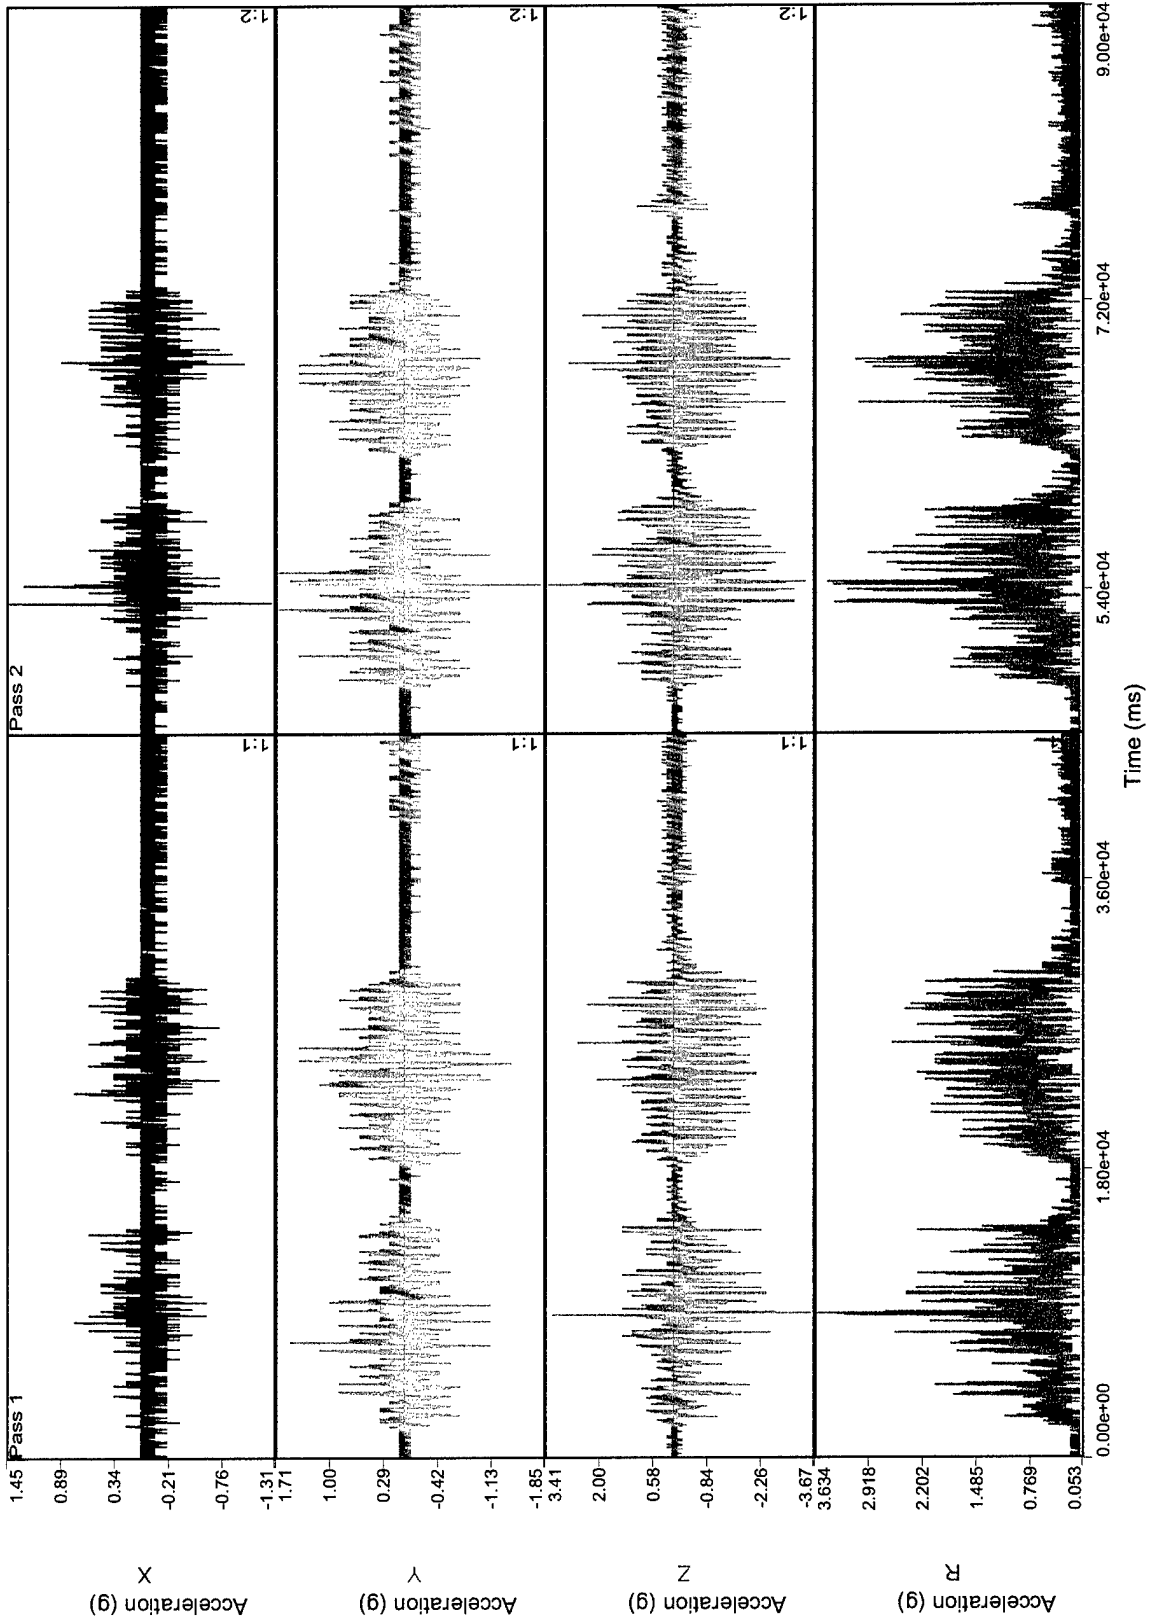
Sensor Location: Trailer Bulkhead

Hazard Course of M871A3 Trailer with 33,940-lb Payload

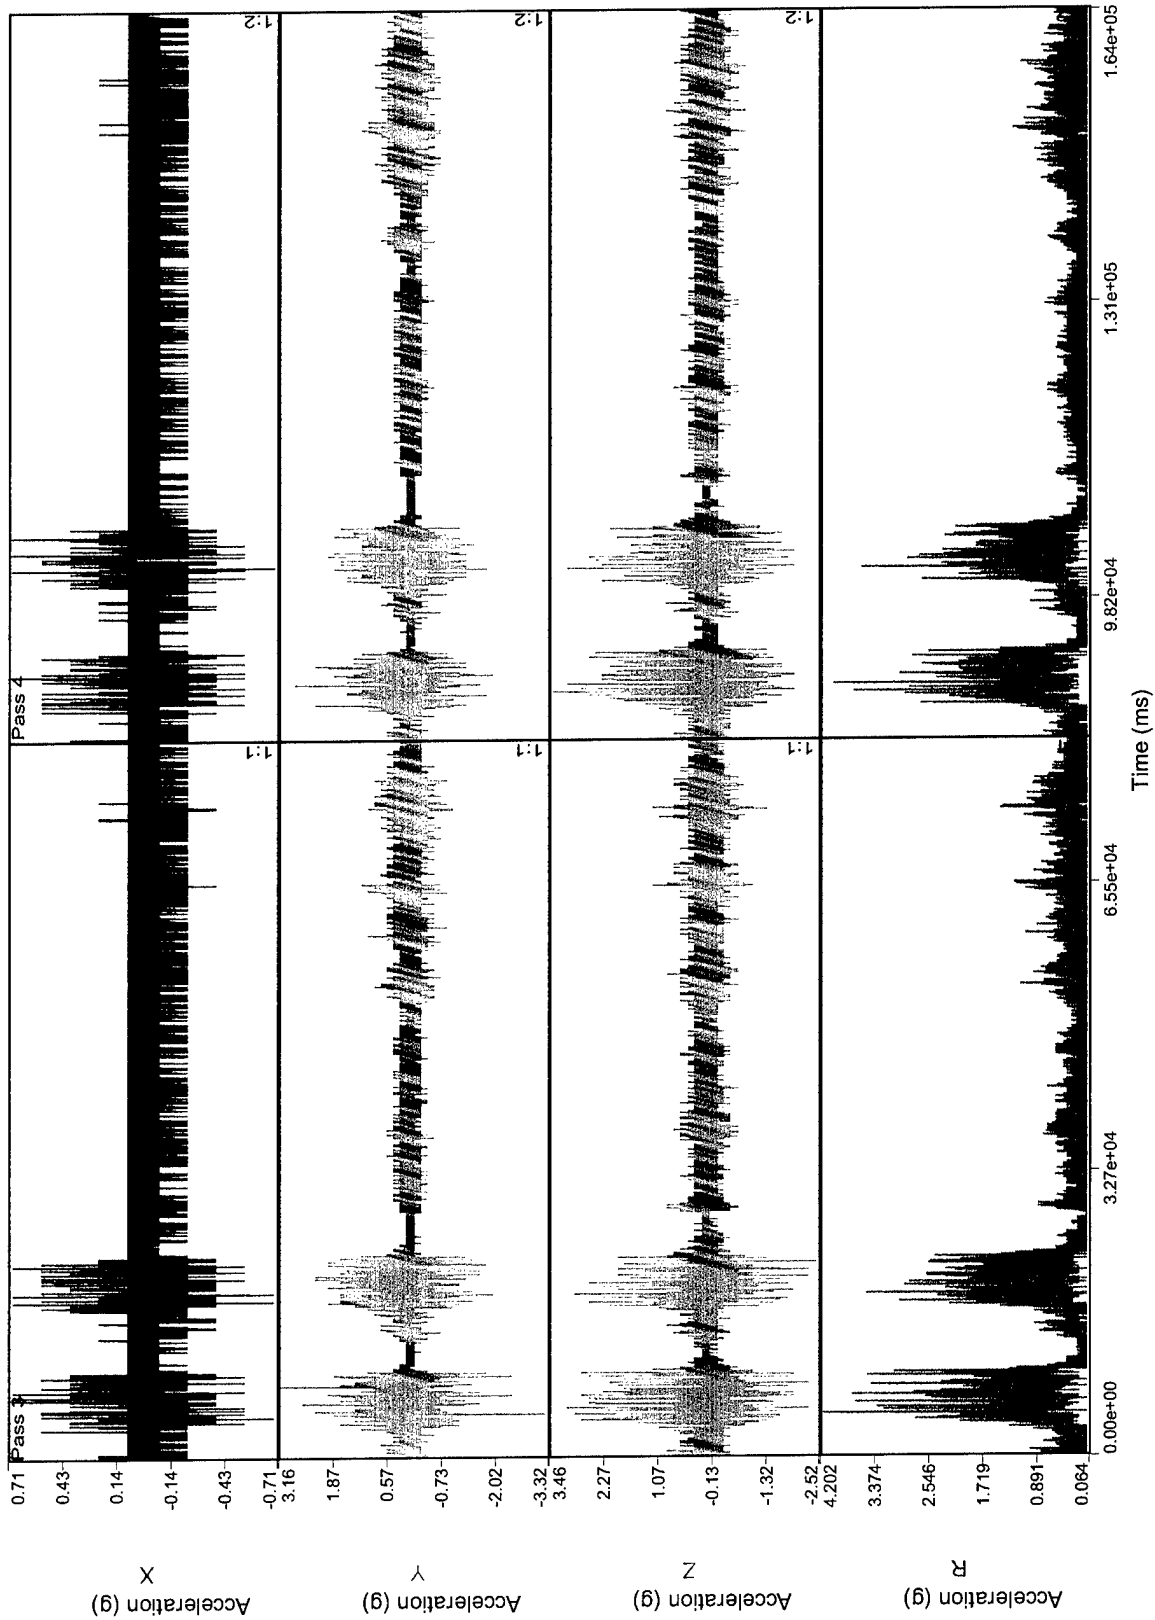
Hazard Course of M871A3 Trailer with 33,940-lb Payload Sensor Location: Trailer Bulkhead

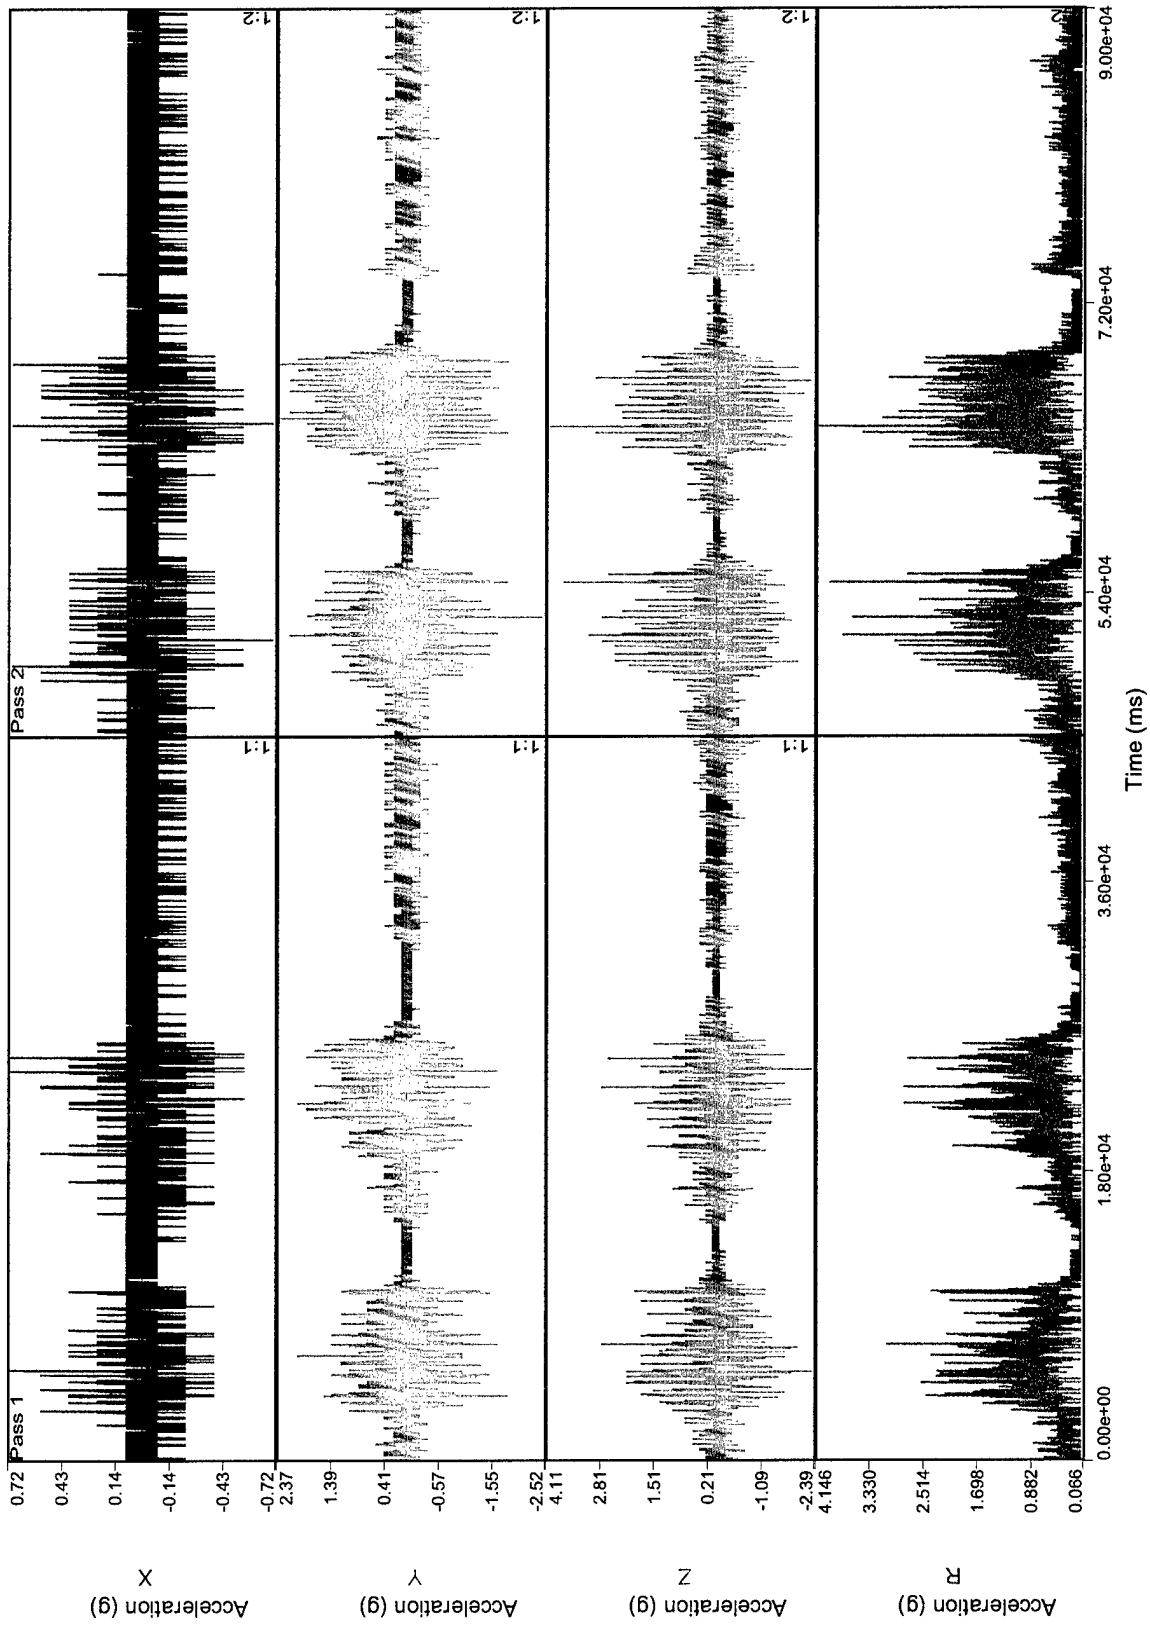
Hazard Course of M871A3 Trailer with 33,940-lb Payload Sensor Location: Trailer Rear

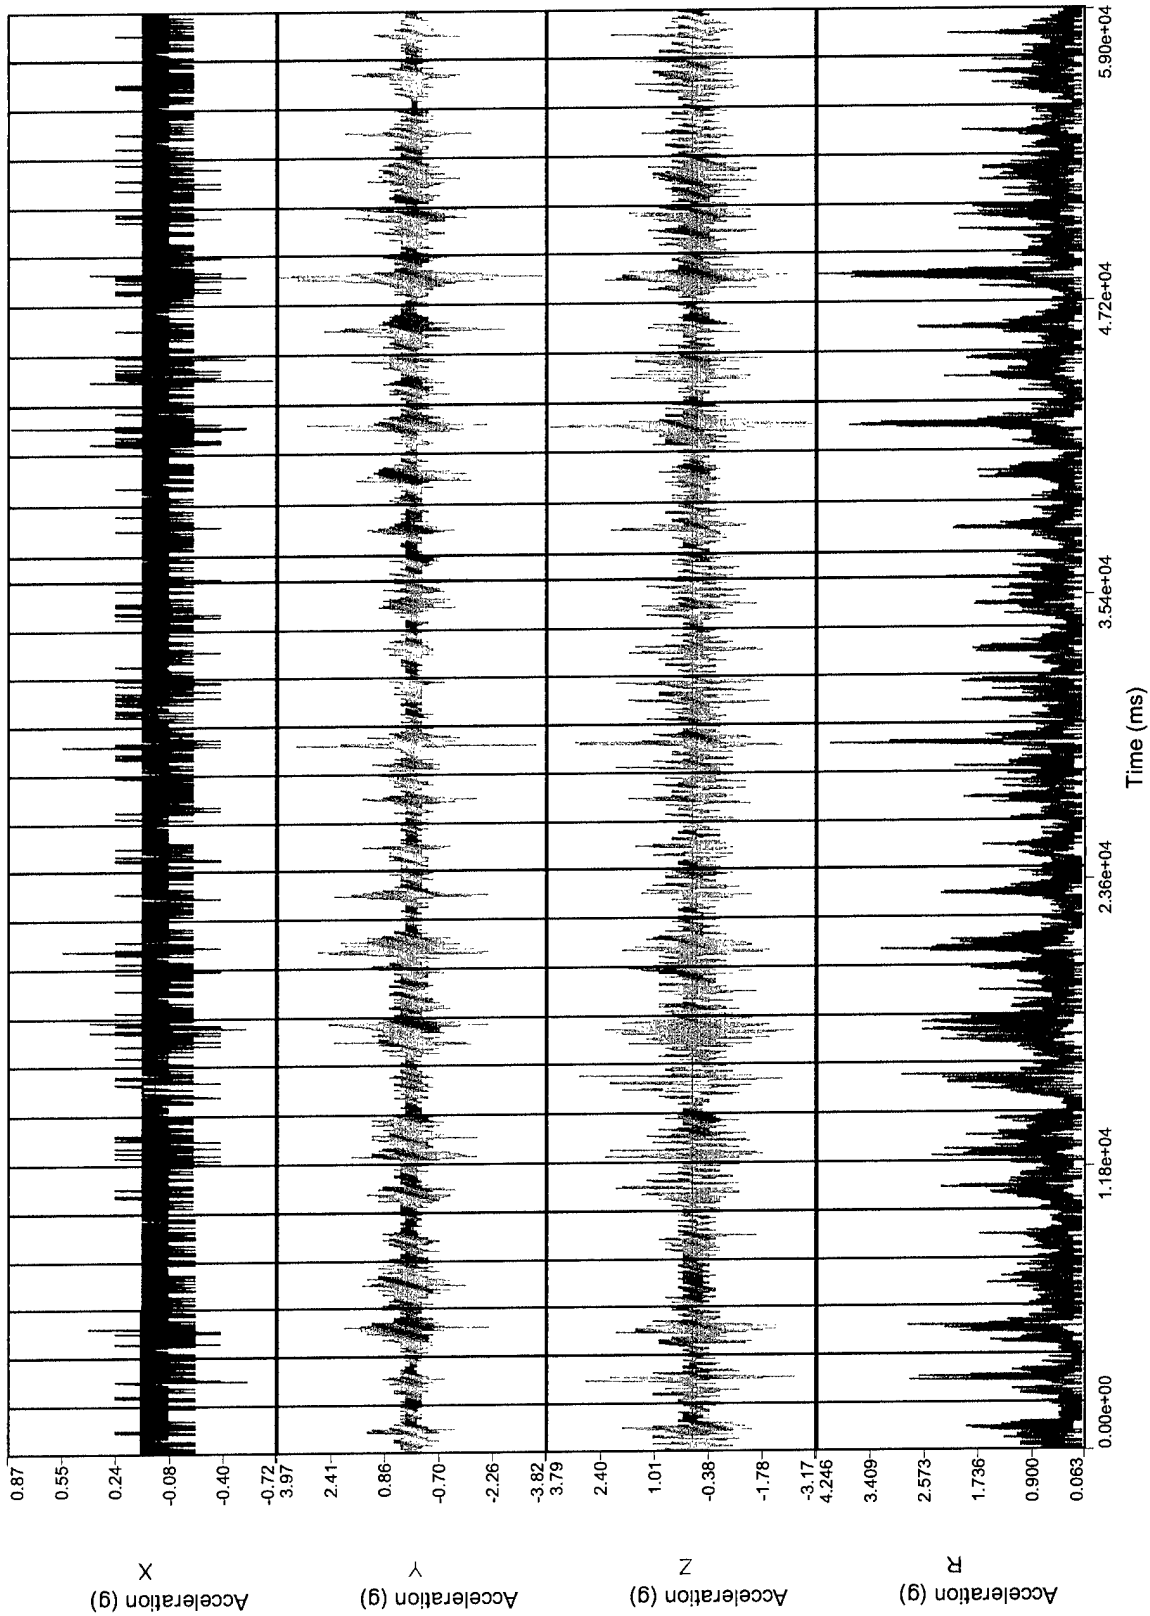
Road Trip of M87/A3 Trailer with 33,940-lb Payload Sensor Location: Trailer Rear

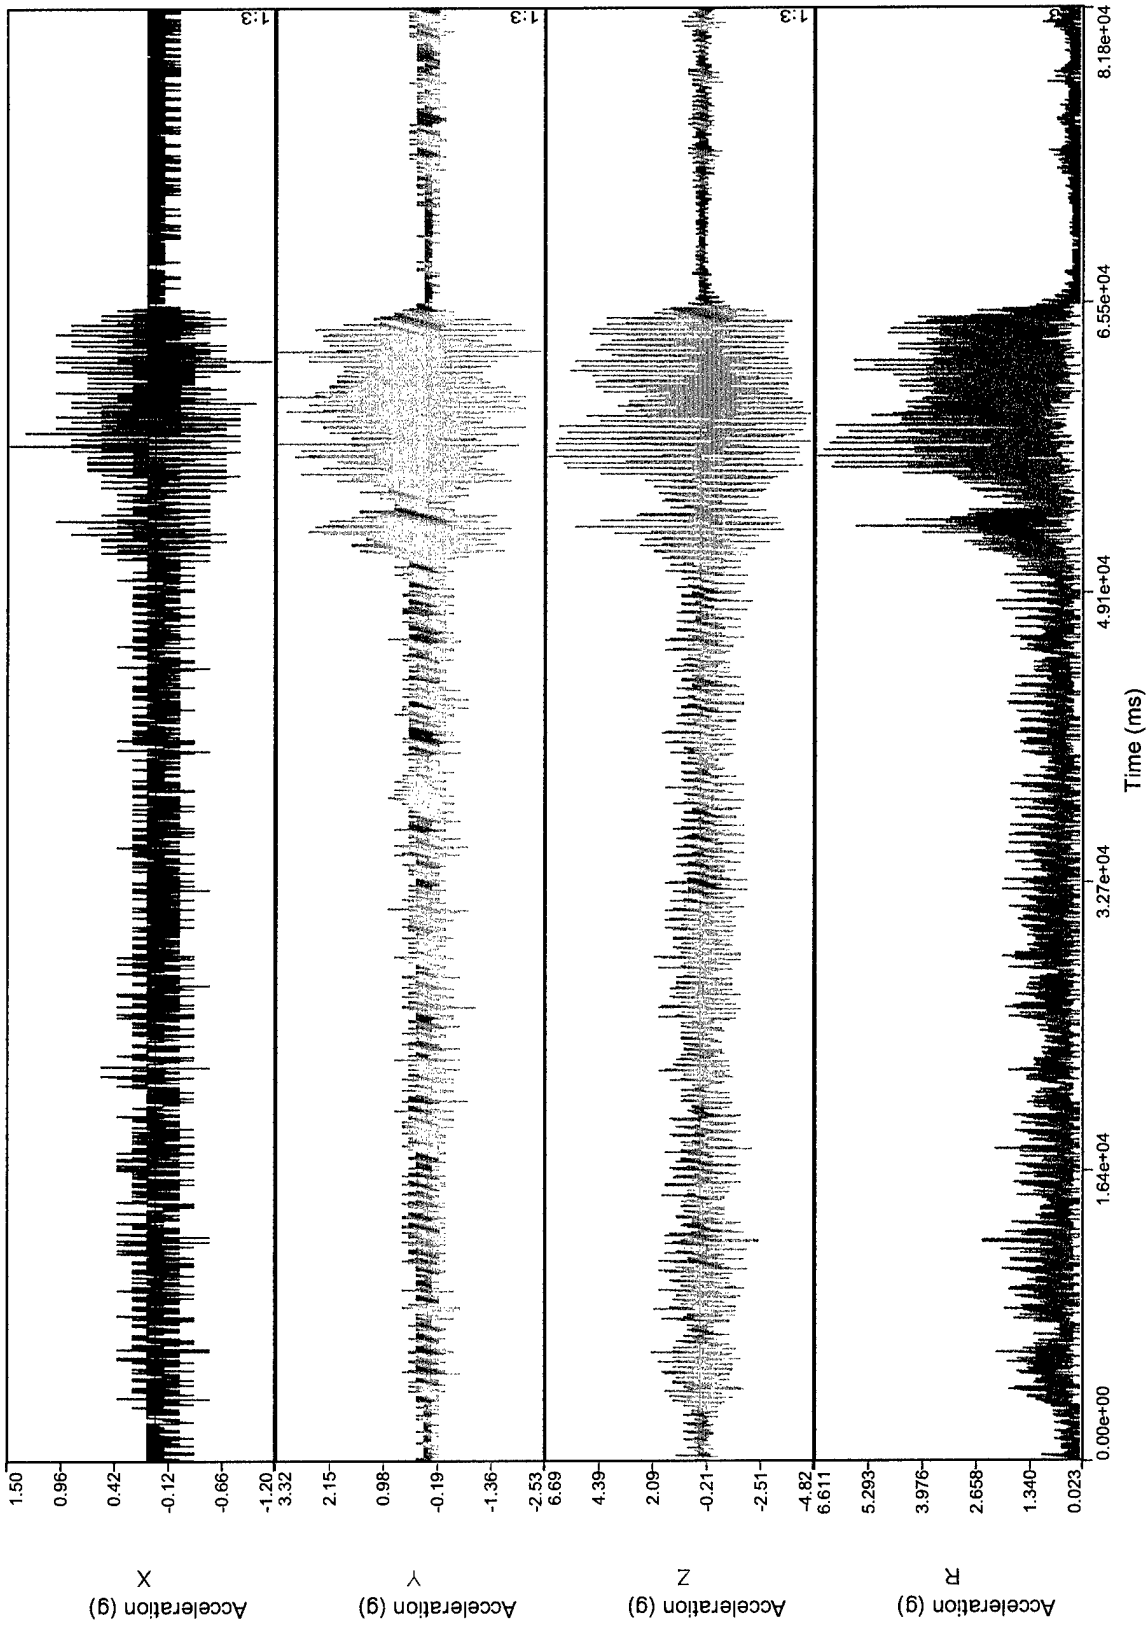
Dashboard Course of M871A3 Trailer with 33,940-lb Payload Sensor Location: Trailer Bulkhead
