**FINAL REPORT
January 2002**

REPORT NO. 01-16

**M871A3 TACTICAL TRAILER
22.5-TON PAYLOAD CAPACITY
TP-94-01,
“TRANSPORTABILITY TESTING PROCEDURES”**

**VALIDATION ENGINEERING DIVISION
MCALESTER, OKLAHOMA 74501-9053**

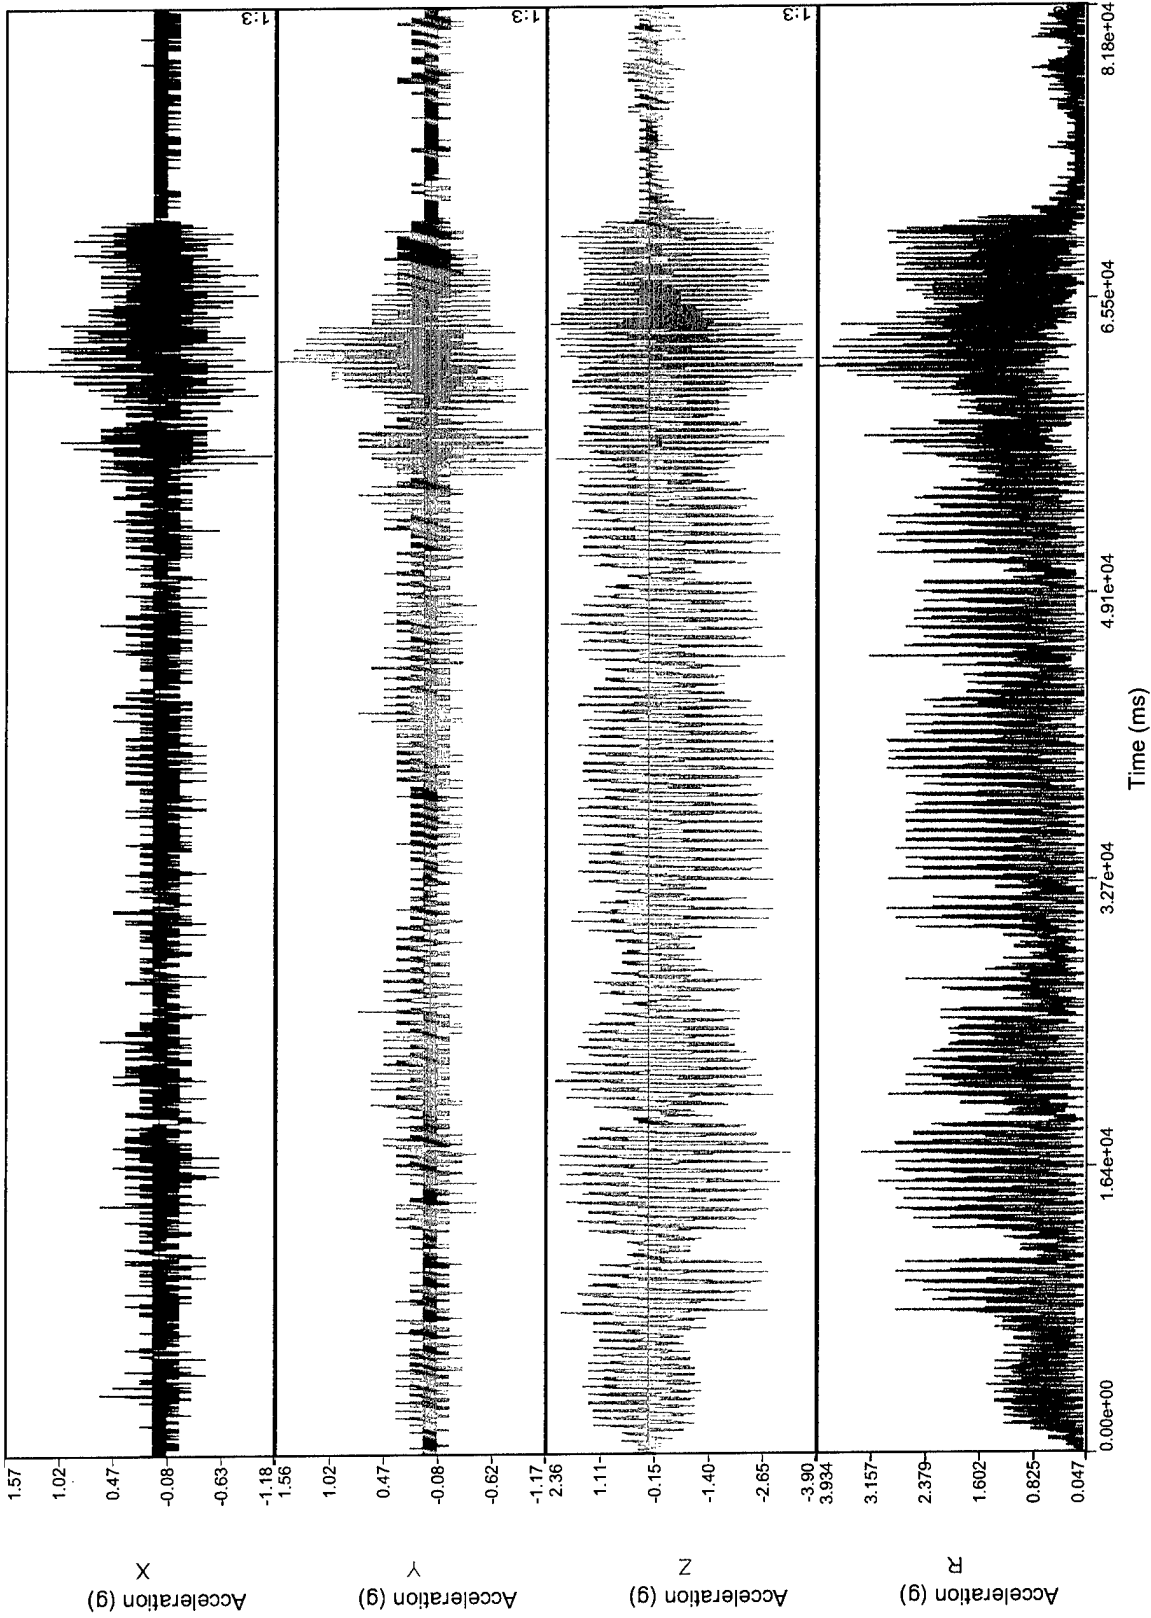
Washboard Course of M871A3 Trailer with 33,940-lb Payload Sensor Location: Trailer Rear

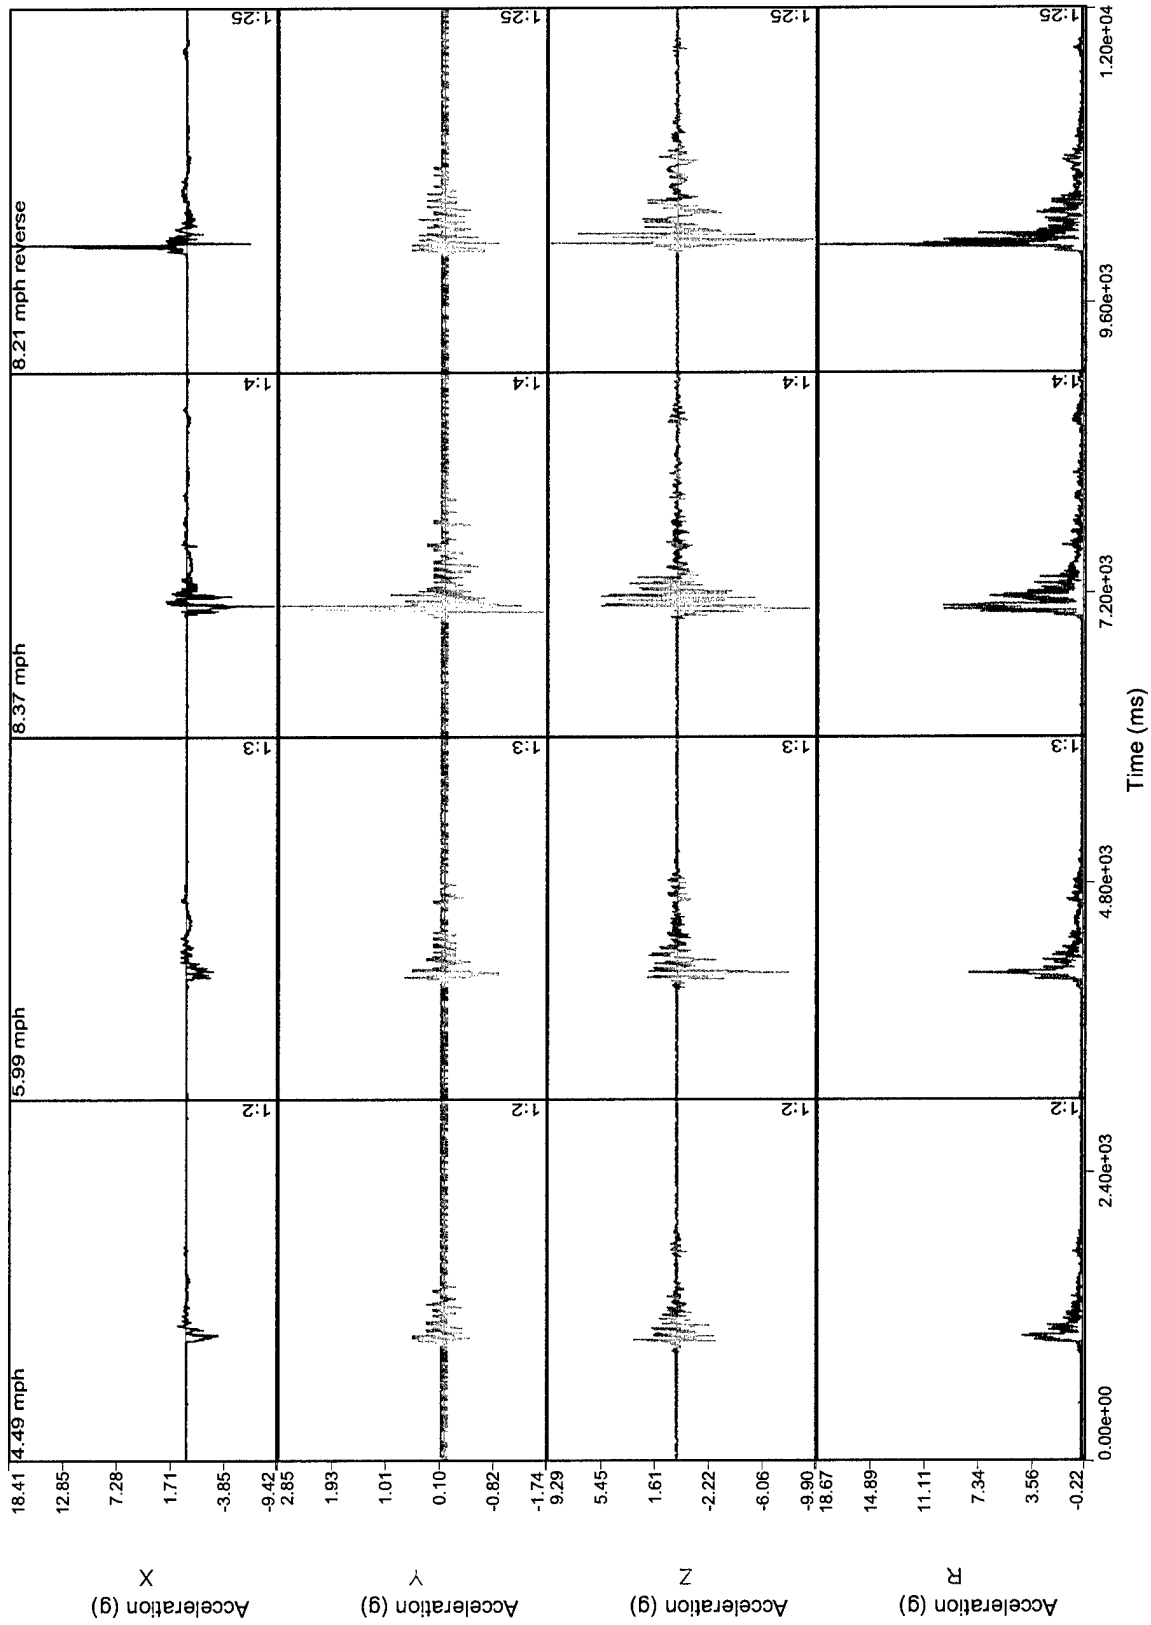
Rail Impact of M871A3 Trailer with 45,180-lb Payload - Sensor Location: Rear Railcar
