ERDC/CHL TR-04-3

**Demonstration Project on Dredging  
and Marsh Development Using a Flexible-  
Discharge Dustpan Dredge at Head  
of Passes/Southwest Pass Mississippi River**

June 2004

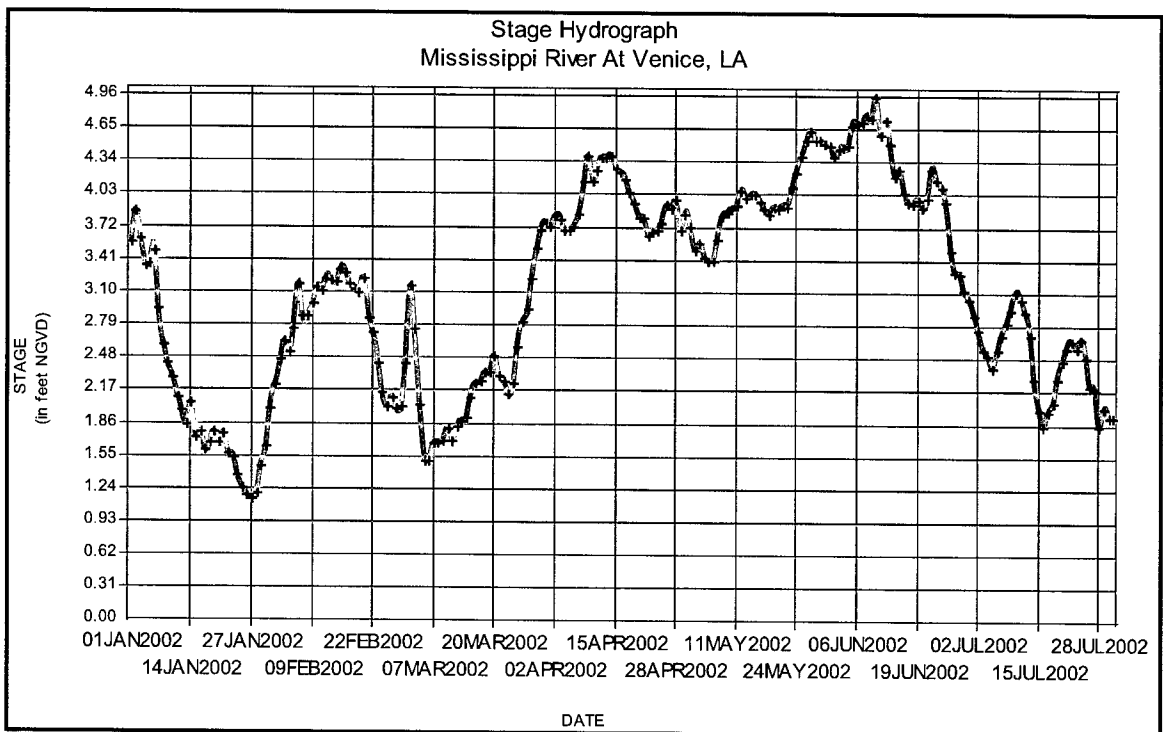
Figure 7. Venice Station stage hydrograph (January 2002 – July 2002)

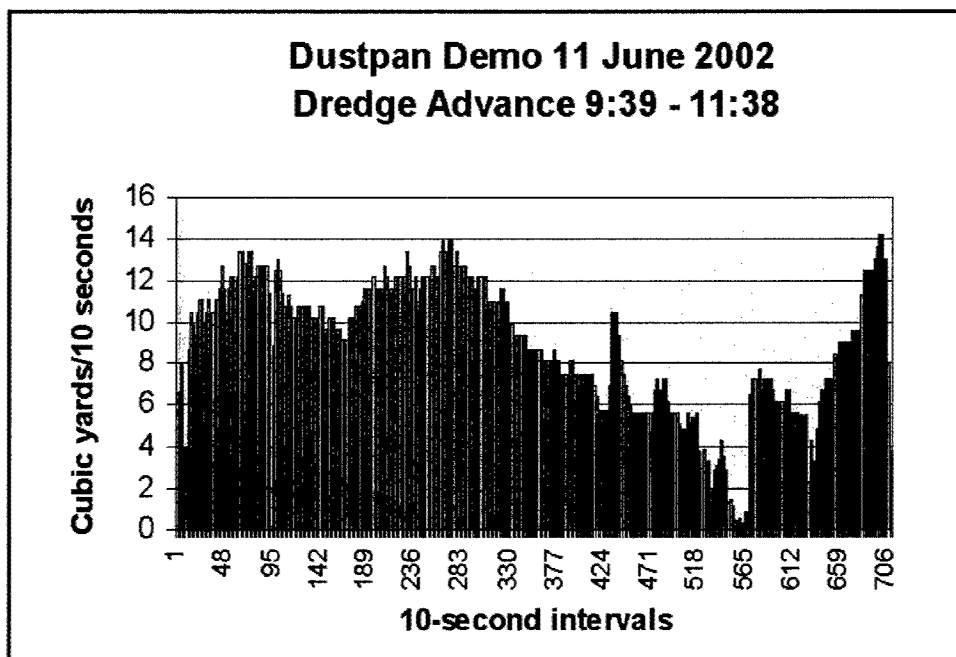
Figure 9. Example of a production time-series plot during a *Beachbuilder* advance

Two examples of the *Beachbuilder*'s time-series production data are given in Figures 9 and 10. Figure 9 illustrates a 486-ft advance made on 11 June 2002, with an average production rate of 2,411 cu yd/hr, which is fairly representative of the average production rate from all the advances in Table 3 at 2,346 cu yd/hr. The y-axis scale is in cubic yards per the dredge's advance every 10 sec. Figure 10 shows the *Beachbuilder*'s daily production on 13 June 2002, with the y-axis scale in cubic yards per hour, that was calculated and reported in (the x-axis) 10-sec increments.

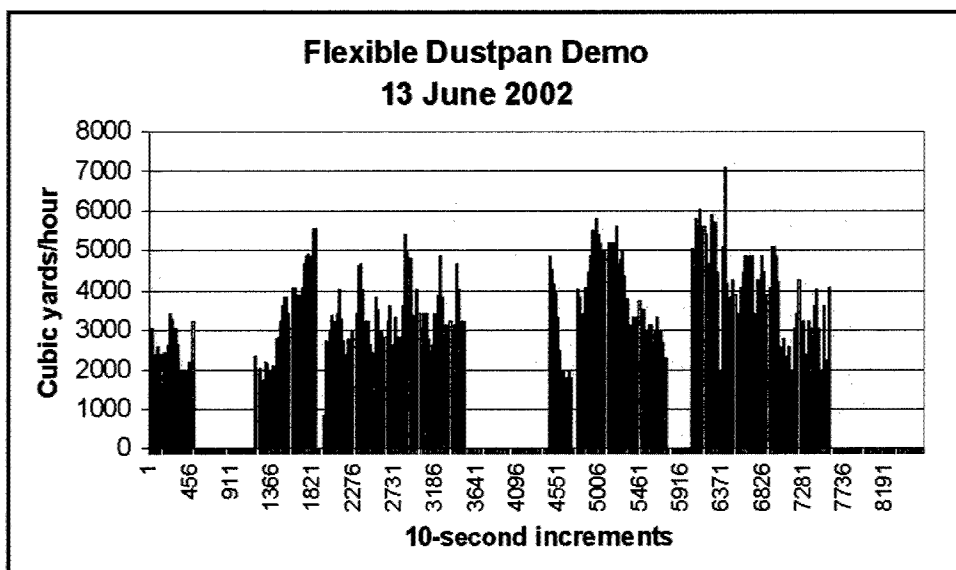
Figure 10. Time-series plot of *Beachbuilder's* production on 13 June 2002

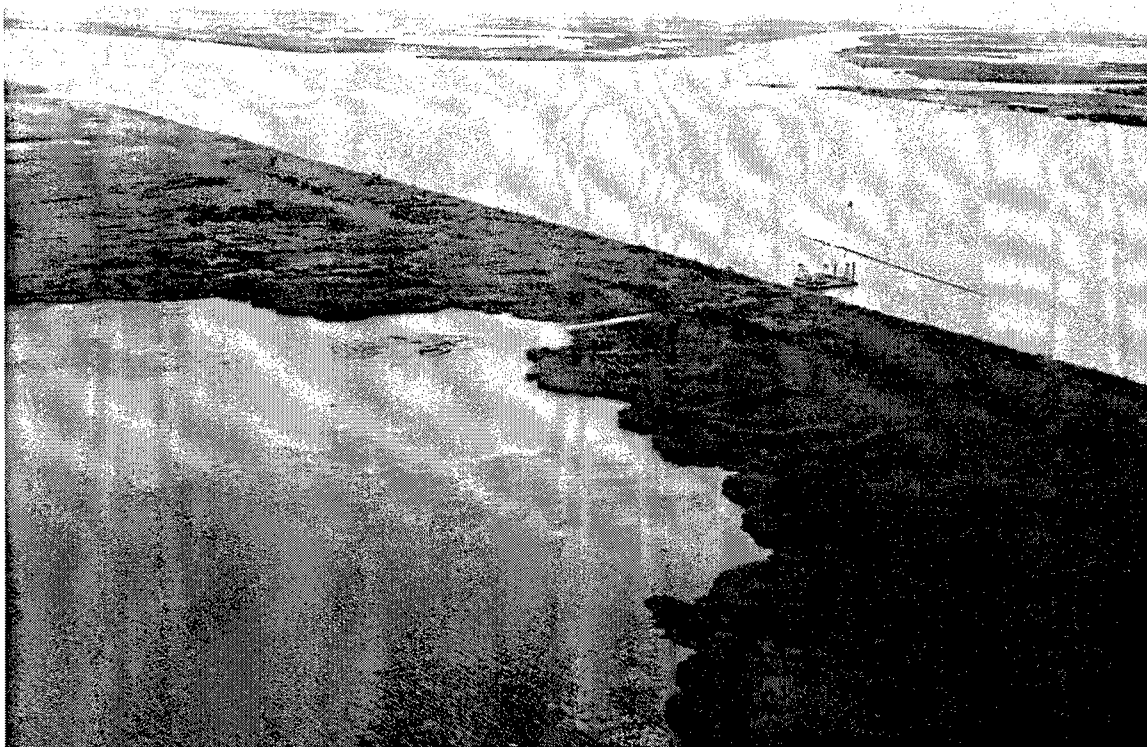
Photo 29. Before dredging aerial photo of placement site

Photographs of the BD and AD placement site are shown in Photos 29 and 30, respectively. BD and AD placement site surveys were conducted by the contractor's survey crew and inspected by MVN, using airboats, mobile DGPS for horizontal positioning, and spirit leveling for vertical control. The results from these surveys are plotted on Figures 11 and 12 (BD and AD surveys, respectively). The difference plot between the BD and AD surveys is shown in Figure 13. The dredged material deposit's footprint covers an area of approximately 20 acres. From the surveys, the contractor calculated a deposition volume of 177,700 cu yd. Assuming a 20 percent loss in fines in runoff, this volume was adjusted up to a gross volume of 222,000 cu yd. Contract specifications required that no dredged material exceed a vertical placement height of +3.5 ft MLG, but Figure 12 (referenced to the MLG datum) indicates elevations that exceed +3.5 ft. This resulted from the impact of an inspection conducted 13 June of the placement area, when USACE and OAS personnel discovered several least tern and American avocet nests containing eggs (Photo 31). The nests had been constructed some distance from the active placement point and were not being disturbed, but MVN decided to terminate the grading operations, along with the dredging operations, at 2100 hr on 13 June to preclude any damage to the nests. This rapid colonization by the least terns and American avocets, as well as other species, is an aspect that should be considered for future dredging projects of a similar nature.
