Descriptions of the Animas River-Cement Creek Confluence and Mixing Zone near Silverton, Colorado, during the Late Summers of 1996 and 1997

U.S. Geological Survey Open File Report 2005-1064

by Laurence E. Schemel and Marisa H. Cox

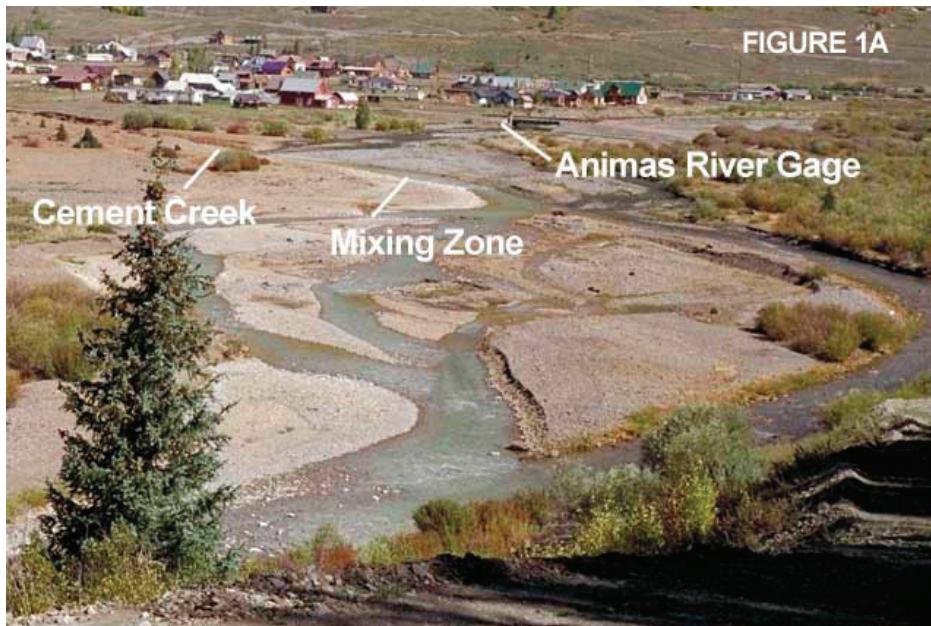
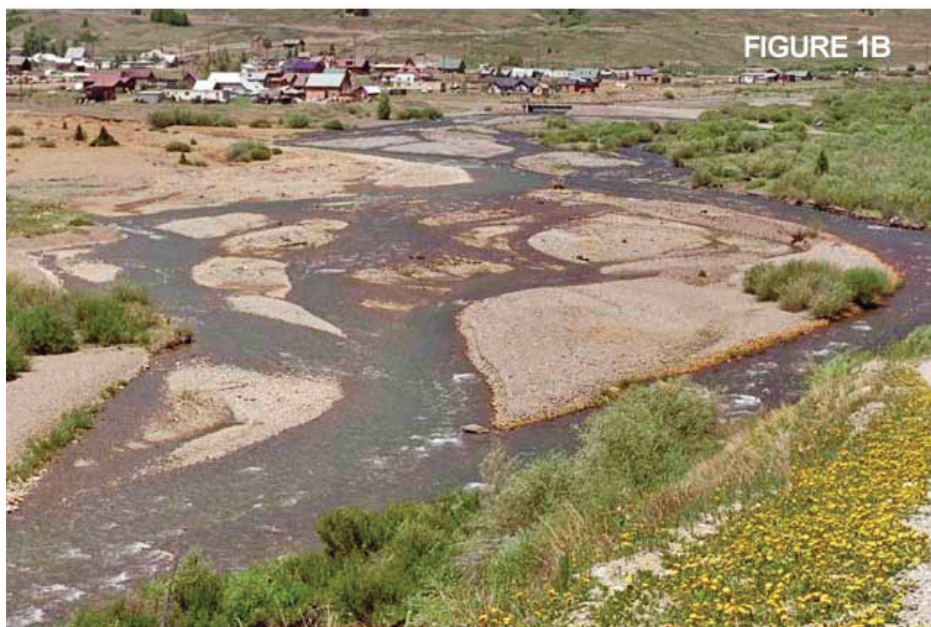
Figure 1 shows photographs of the Cement Creek-Animas River confluence and the network of channels downstream during late summer 1996 (A) and 1997 (B). Discharge from the upper Animas River flowed under the bridge at the location of the Animas River gage (shown in A). In both years, the river formed two main tributaries below the gage. The left-side (of the photograph) tributary discharged directly to the (primary) confluence with Cement Creek, and the right-side tributary flowed to locations downstream from the primary confluence. Most of the flow from the right-side tributary was carried by a channel (far right) around the area labeled “Mixing Zone” (Figure 1A) and the network of channels immediately downstream. Therefore, a secondary confluence of Animas River inflow with partially mixed waters from the Mixing Zone was located at bottom of the photographs shown in Figure 1. Consequently, complete mixing of Cement Creek with the Animas River occurred over several hundred meters in both years. In 1997, however, additional braiding of discharge from the Animas River was evident between the two main tributaries identified above. In addition to the left tributary, one braid discharged near the primary confluence with Cement Creek, and two additional braids discharged to the Mixing Zone downstream (Figure 1B). The distribution of inflow from the Animas River in 1997 neutralized inflow from Cement Creek in a more gradual fashion than had been the case in 1996, which preserved and intensified the across-channel gradients in the Mixing Zone that are described below.

The photographs presented in this report provide visible evidence of chemical gradients across the channel in the Mixing Zone and pH-dependent chemical reactions involving metals that were supplied to the confluence primarily by Cement Creek. In addition, they illustrate significant year-to-year differences in the ways these two streams mixed due to changes in the streambed and channel braiding.
