NRL/MR/6180--04-8737

# An Initial Evaluation of Video-based Fire Detection Technologies

January 9, 2004

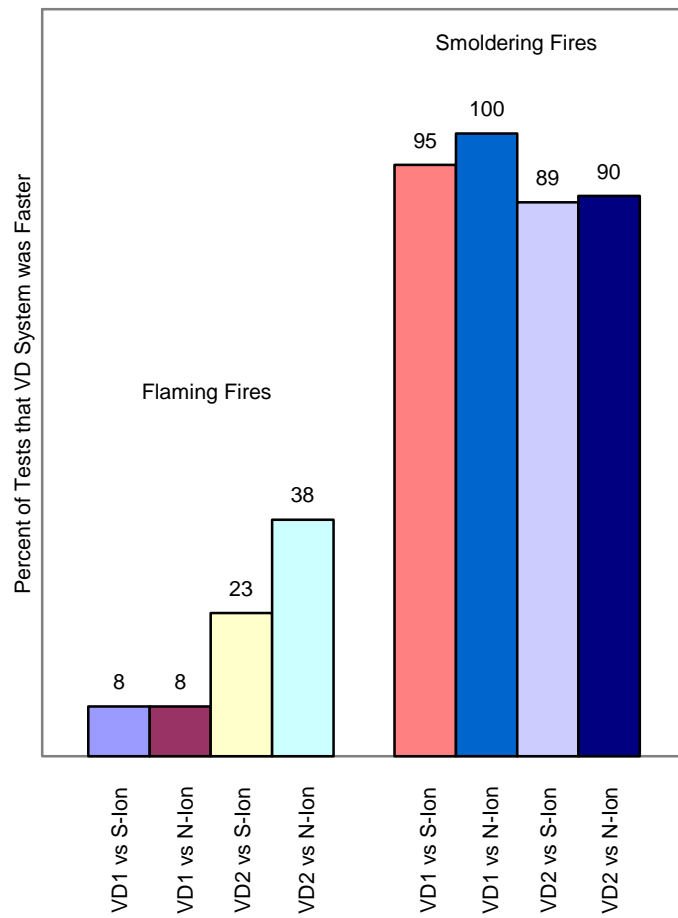
**Fig. 7 – The number of tests in which the video detection system was faster than the specified ionization smoke detection system**

For smoldering fires, the video-based detection systems outperformed both the ionization and photoelectric detectors in their ability to detect a larger range of smoldering sources and to alarm faster. For the tests conducted, the video-based systems showed similar overall nuisance alarm immunity. One of the video-based systems showed a tendency to alarm because of personnel working in the space; however, the manufacturer claims this can be rectified using standard configuration parameters. We look at this as a limitation of the algorithm and not a weakness of the sensor.

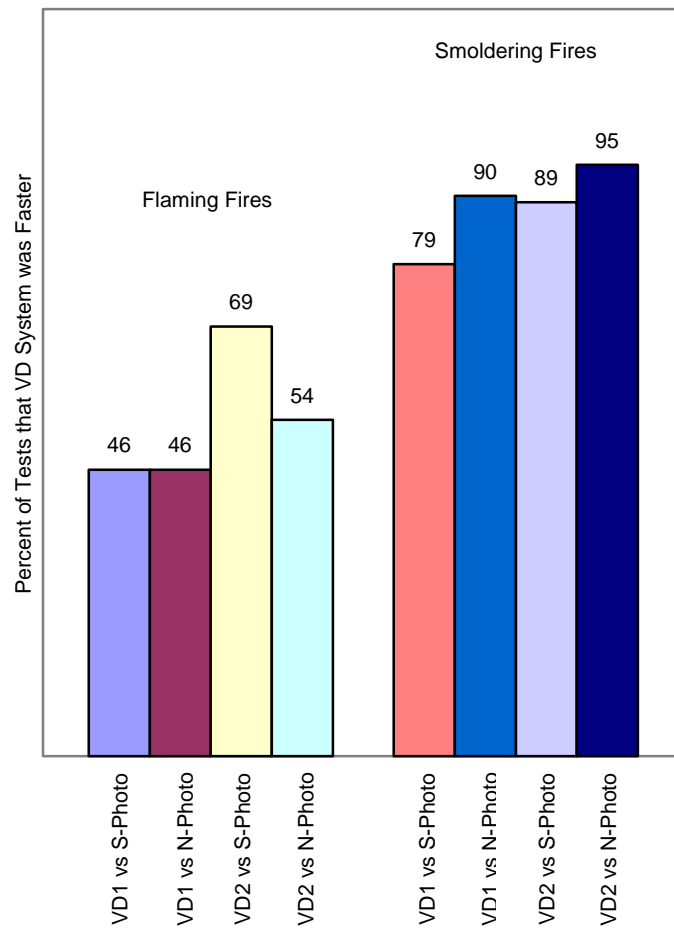
**Fig. 8 – The number of tests in which the video detection system was faster than the specified photoelectric smoke detection system**

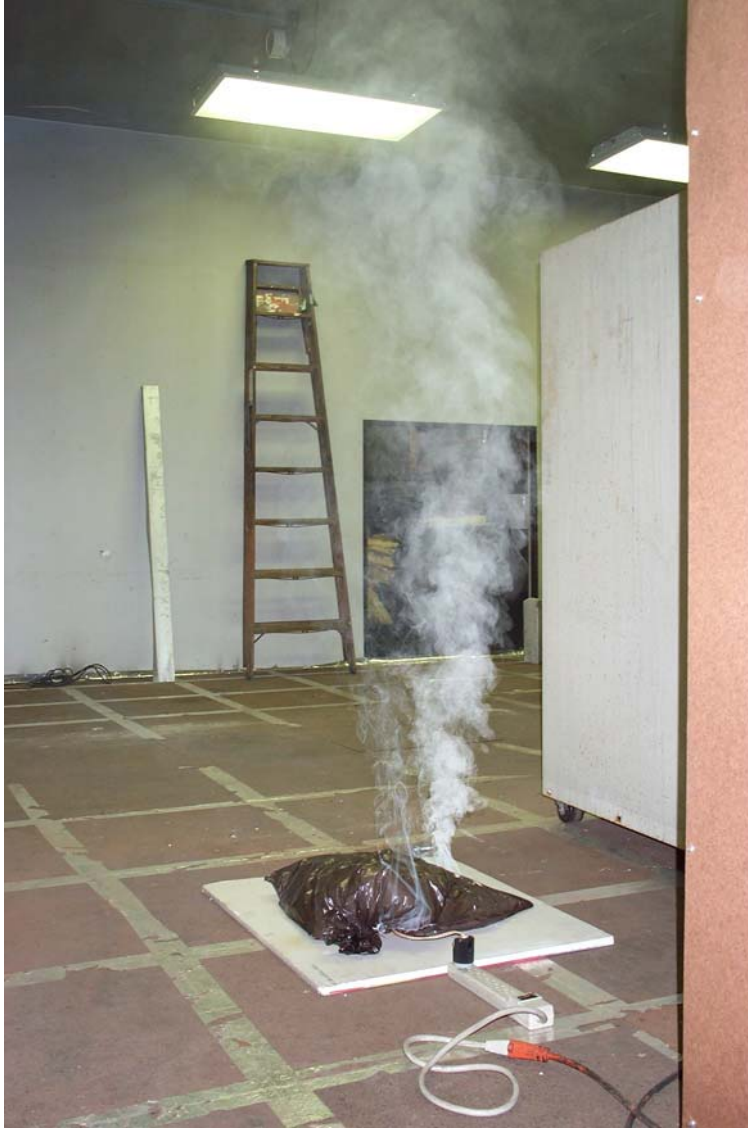
Photo 1. Test ADC001 – Smoldering bag of trash

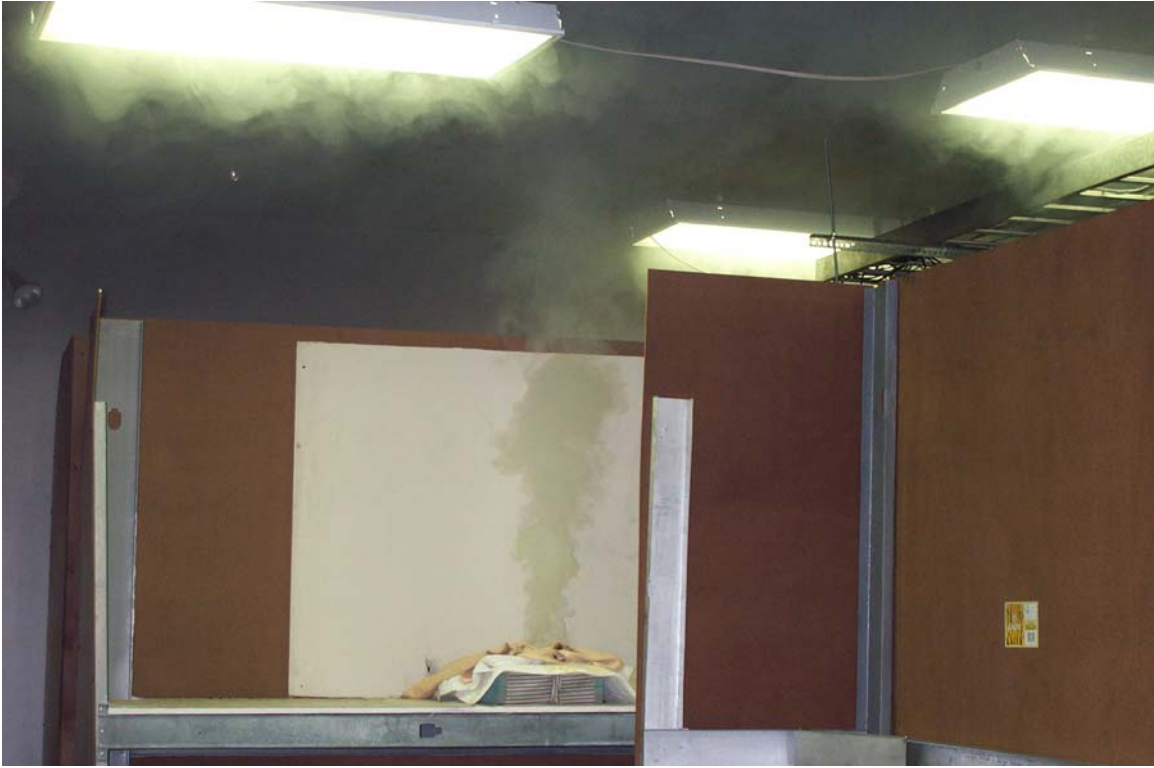
Photo 2. Test ADC008 – Smoldering/flaming mattress and bedding

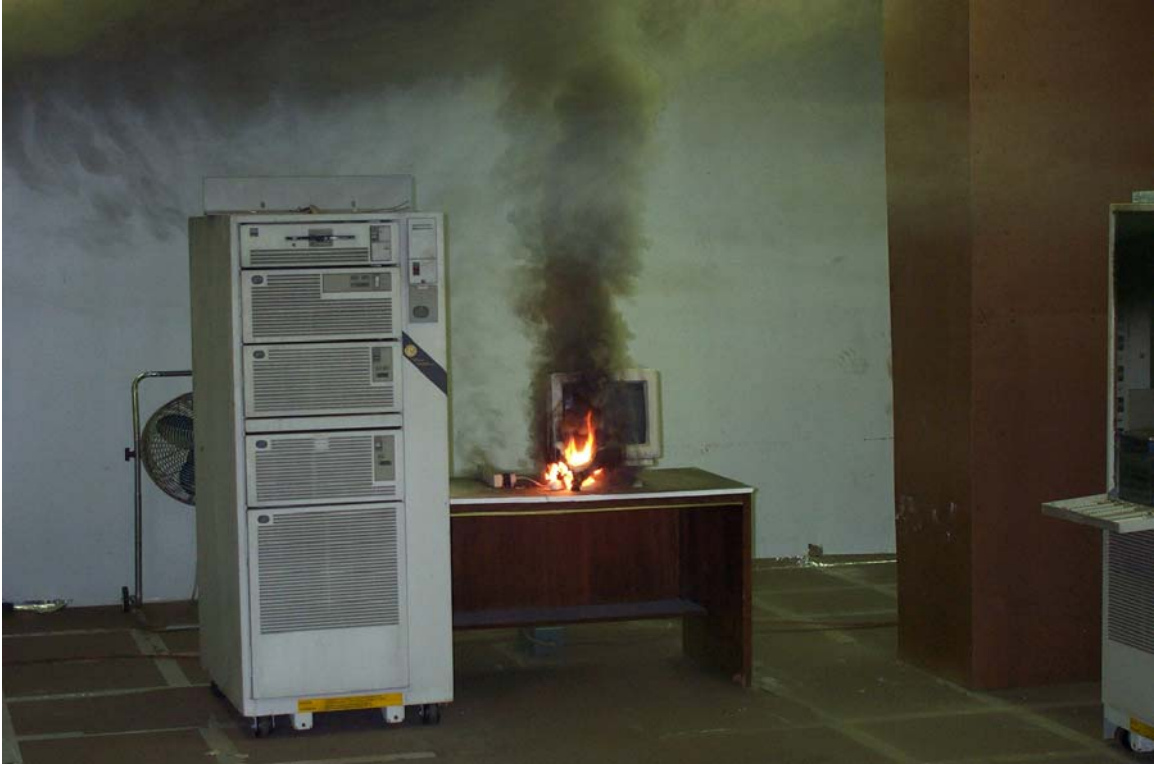
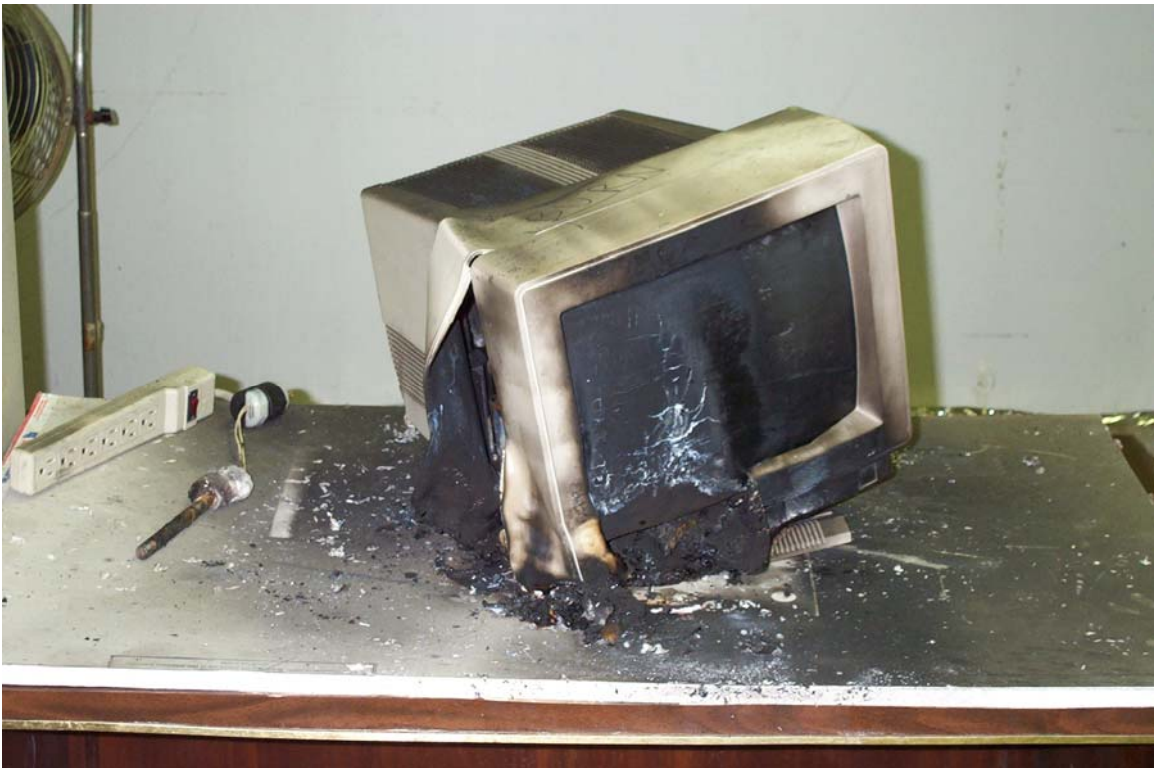
Photos 3 and 4. Test ADC015 – Smoldering/flaming computer monitor

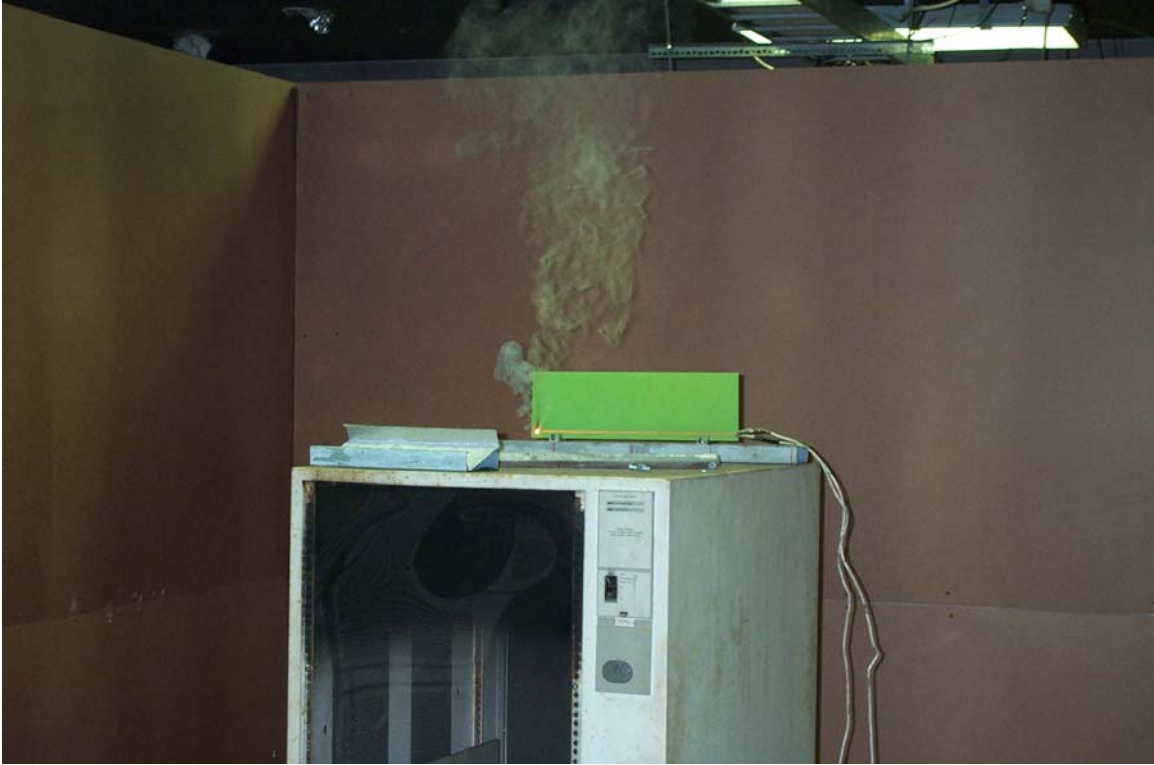
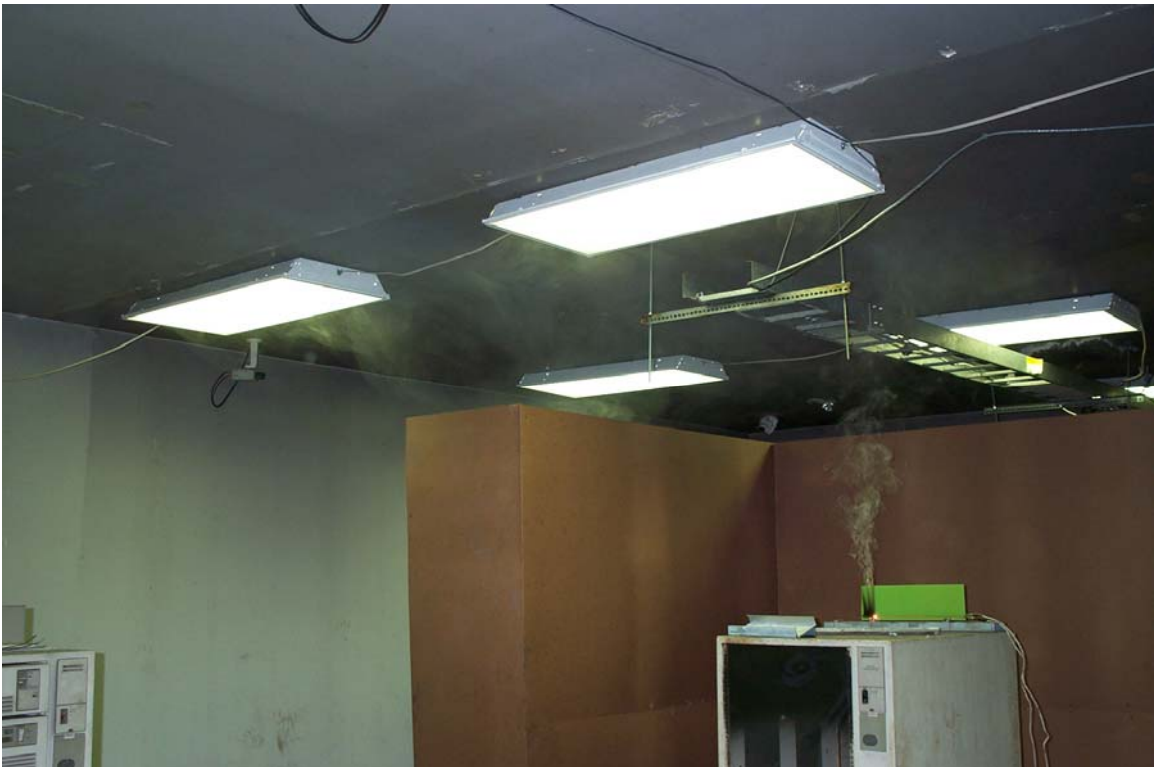
Photos 5 and 6. Test ADC016 – Printed wire board

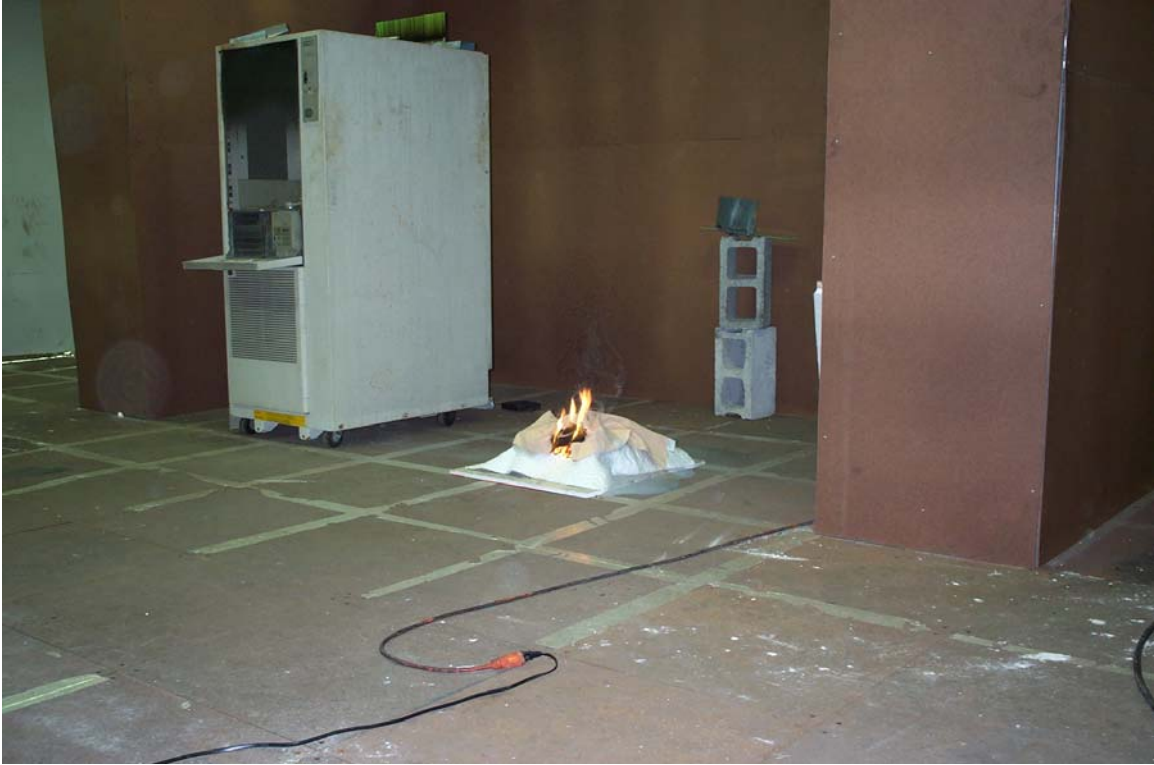
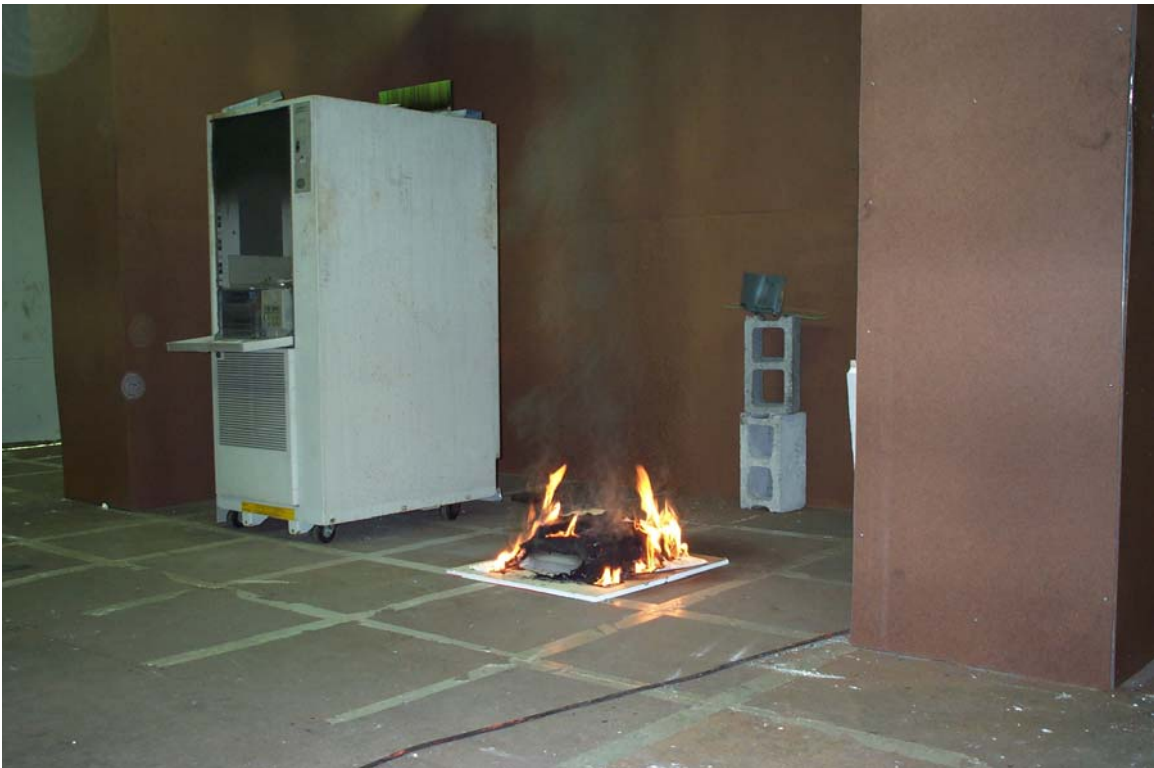
Photos 9 and 10. Test ADC024 – Flaming mattress and bedding

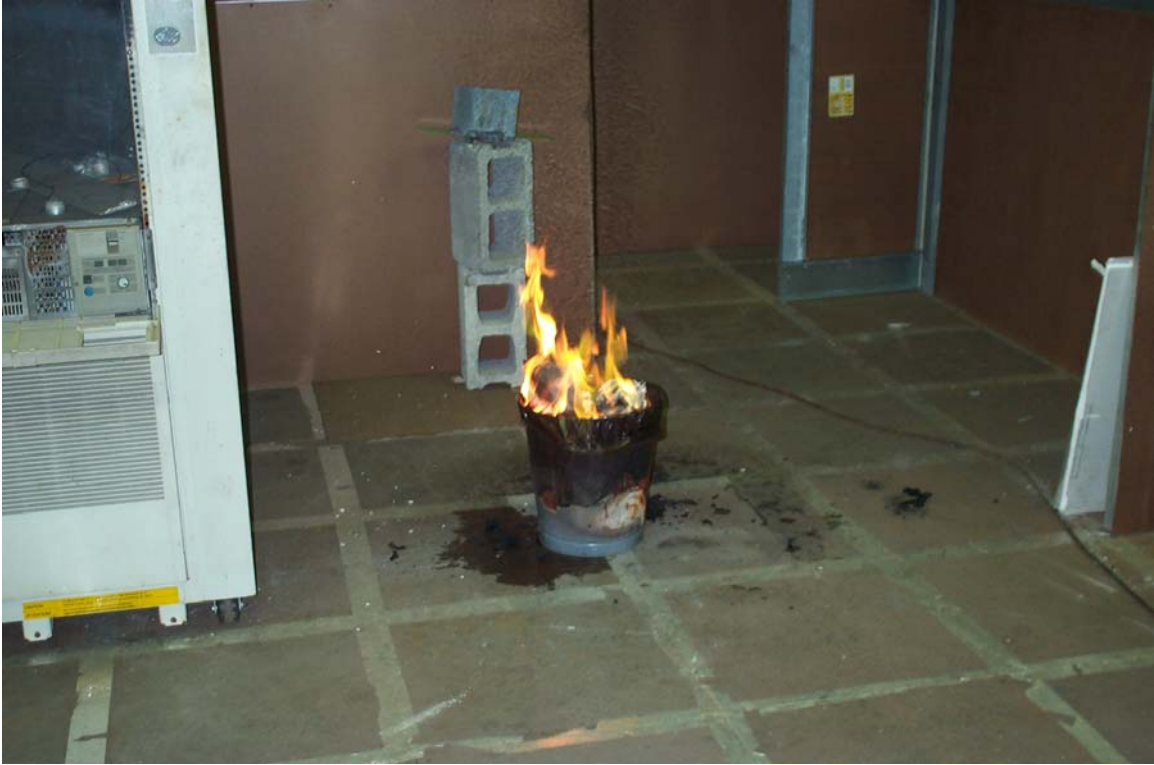
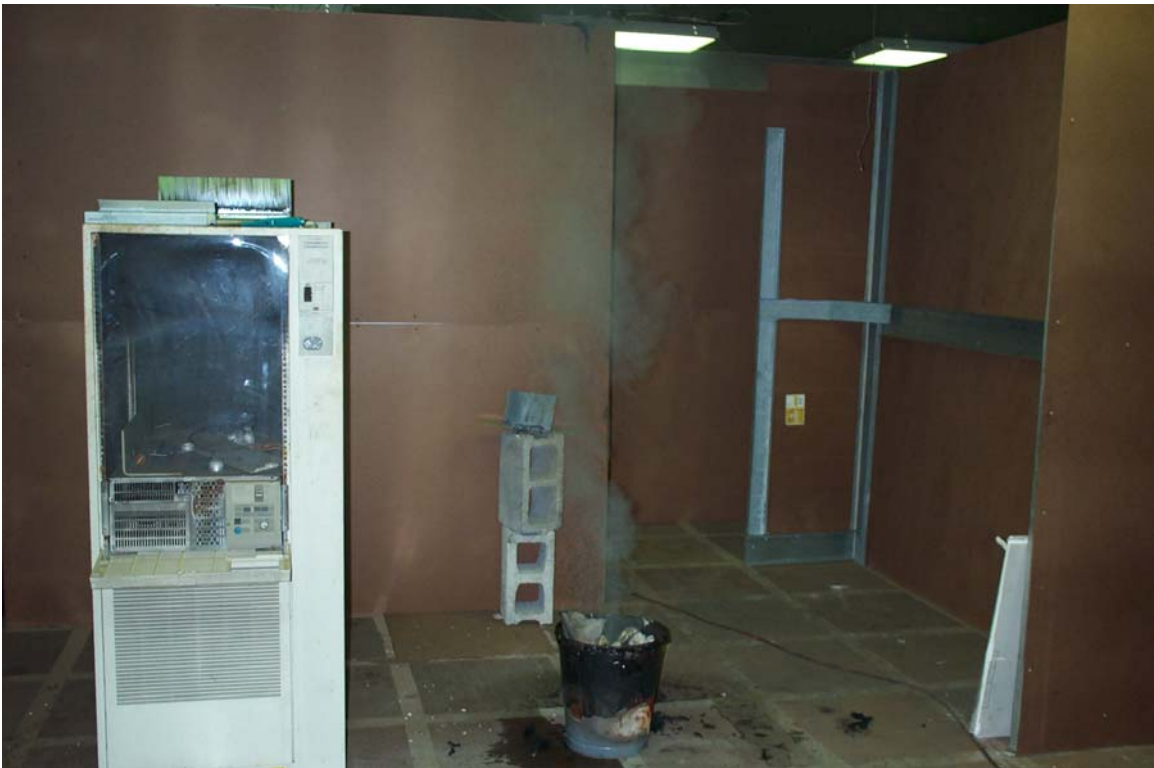
Photos 11 and 12. Test ADC025 – Flaming/smoldering trash can

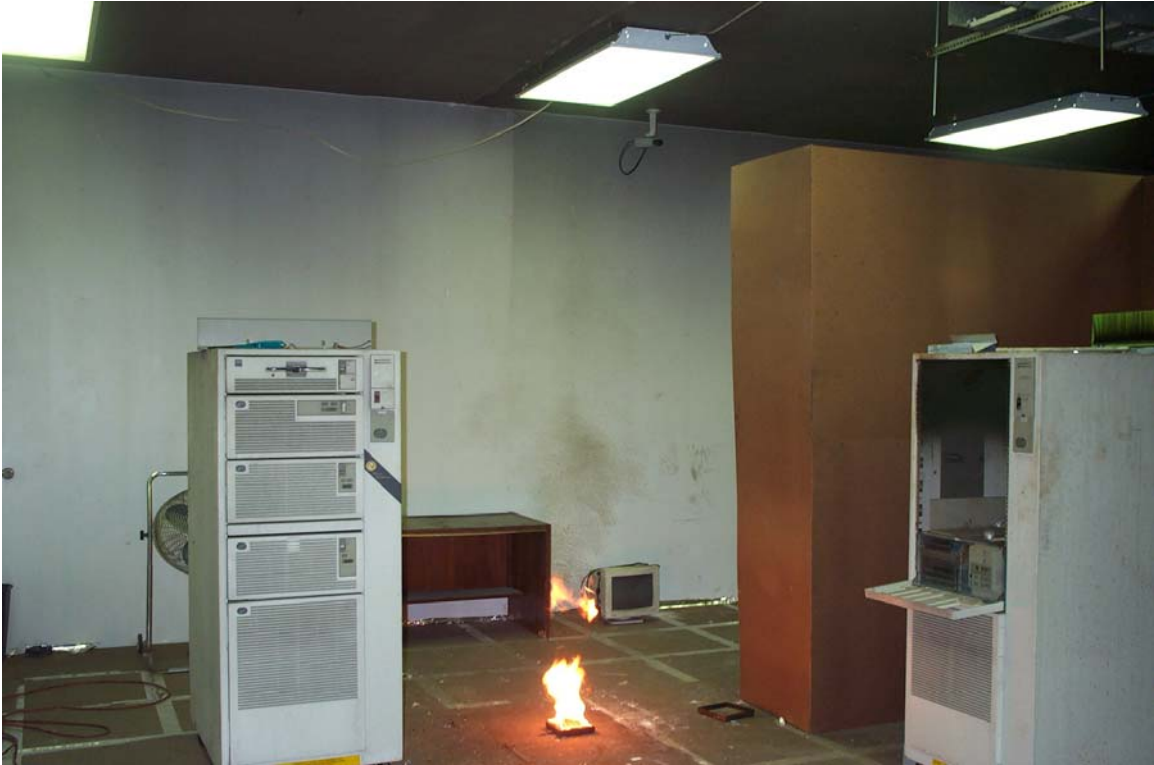
Photo 13. Test ADC027 – 0.15 x 0.15 m heptane pan fire

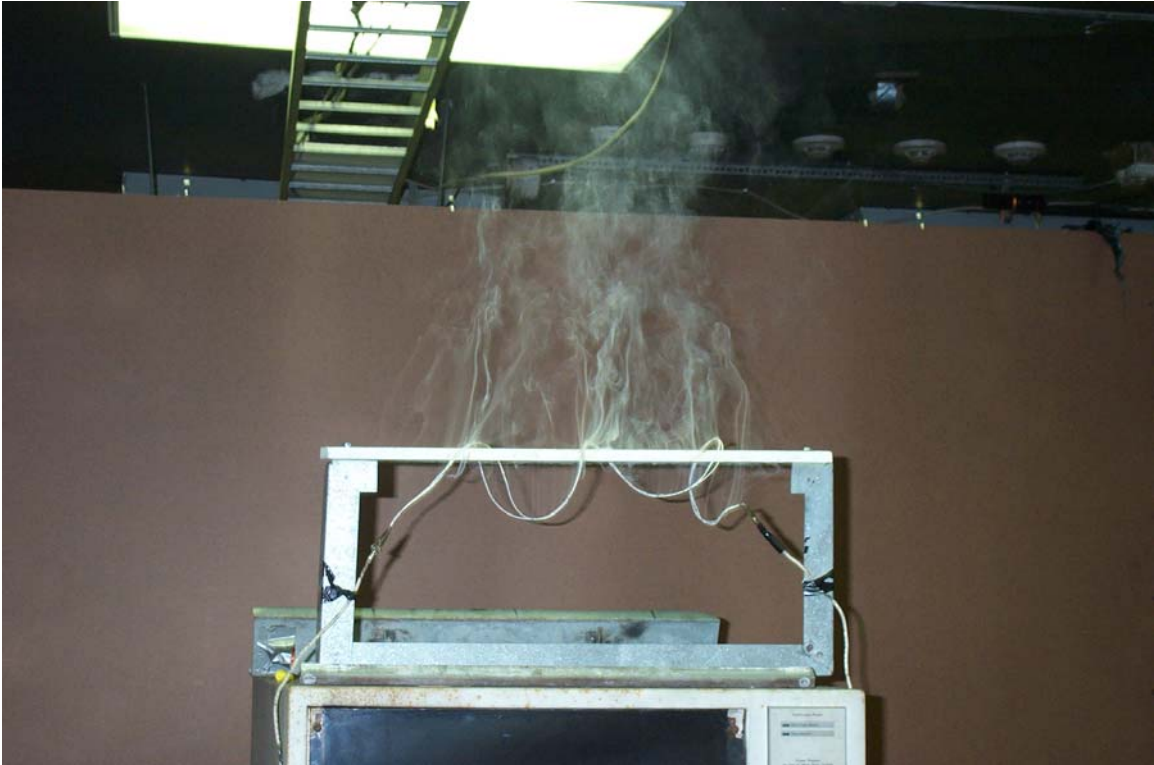
Photo 14. Test ADC033 – Smoldering wire

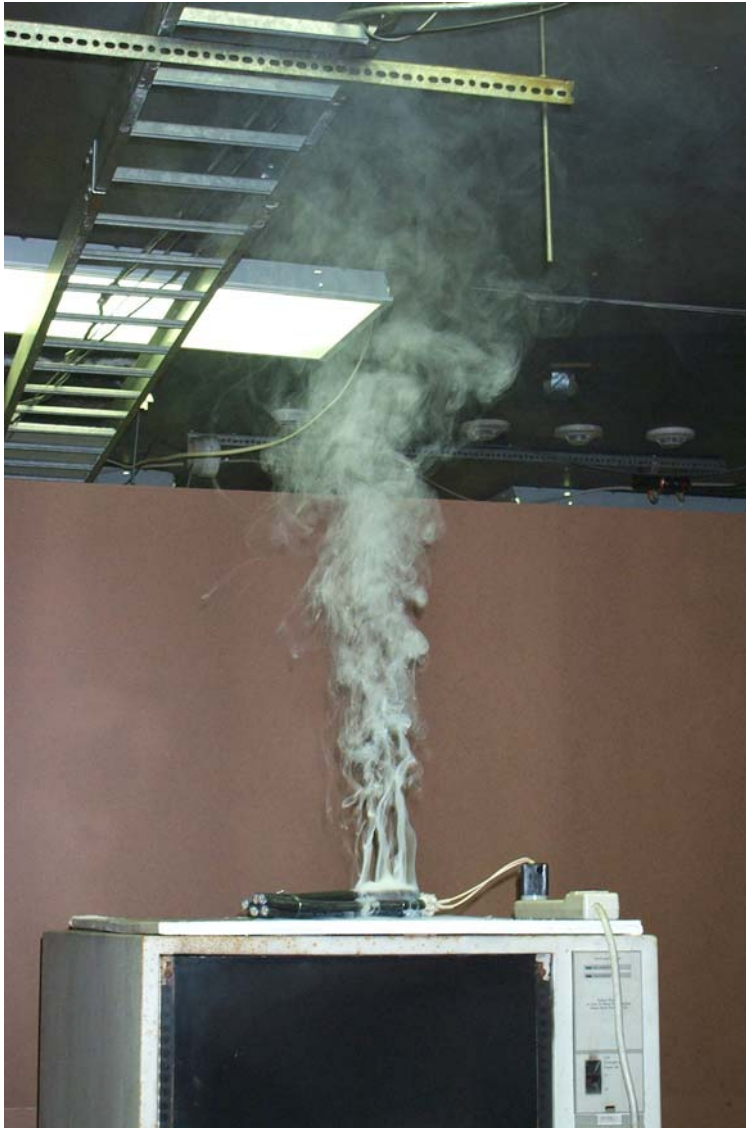
Photo 15. Test ADC034 – Smoldering/flaming cable bundle
