December 1995  
NSRP 0455

# **THE NATIONAL SHIPBUILDING RESEARCH PROGRAM**

## **Simultaneous 3-Edge Cleaning Methods and Tooling Evaluation**

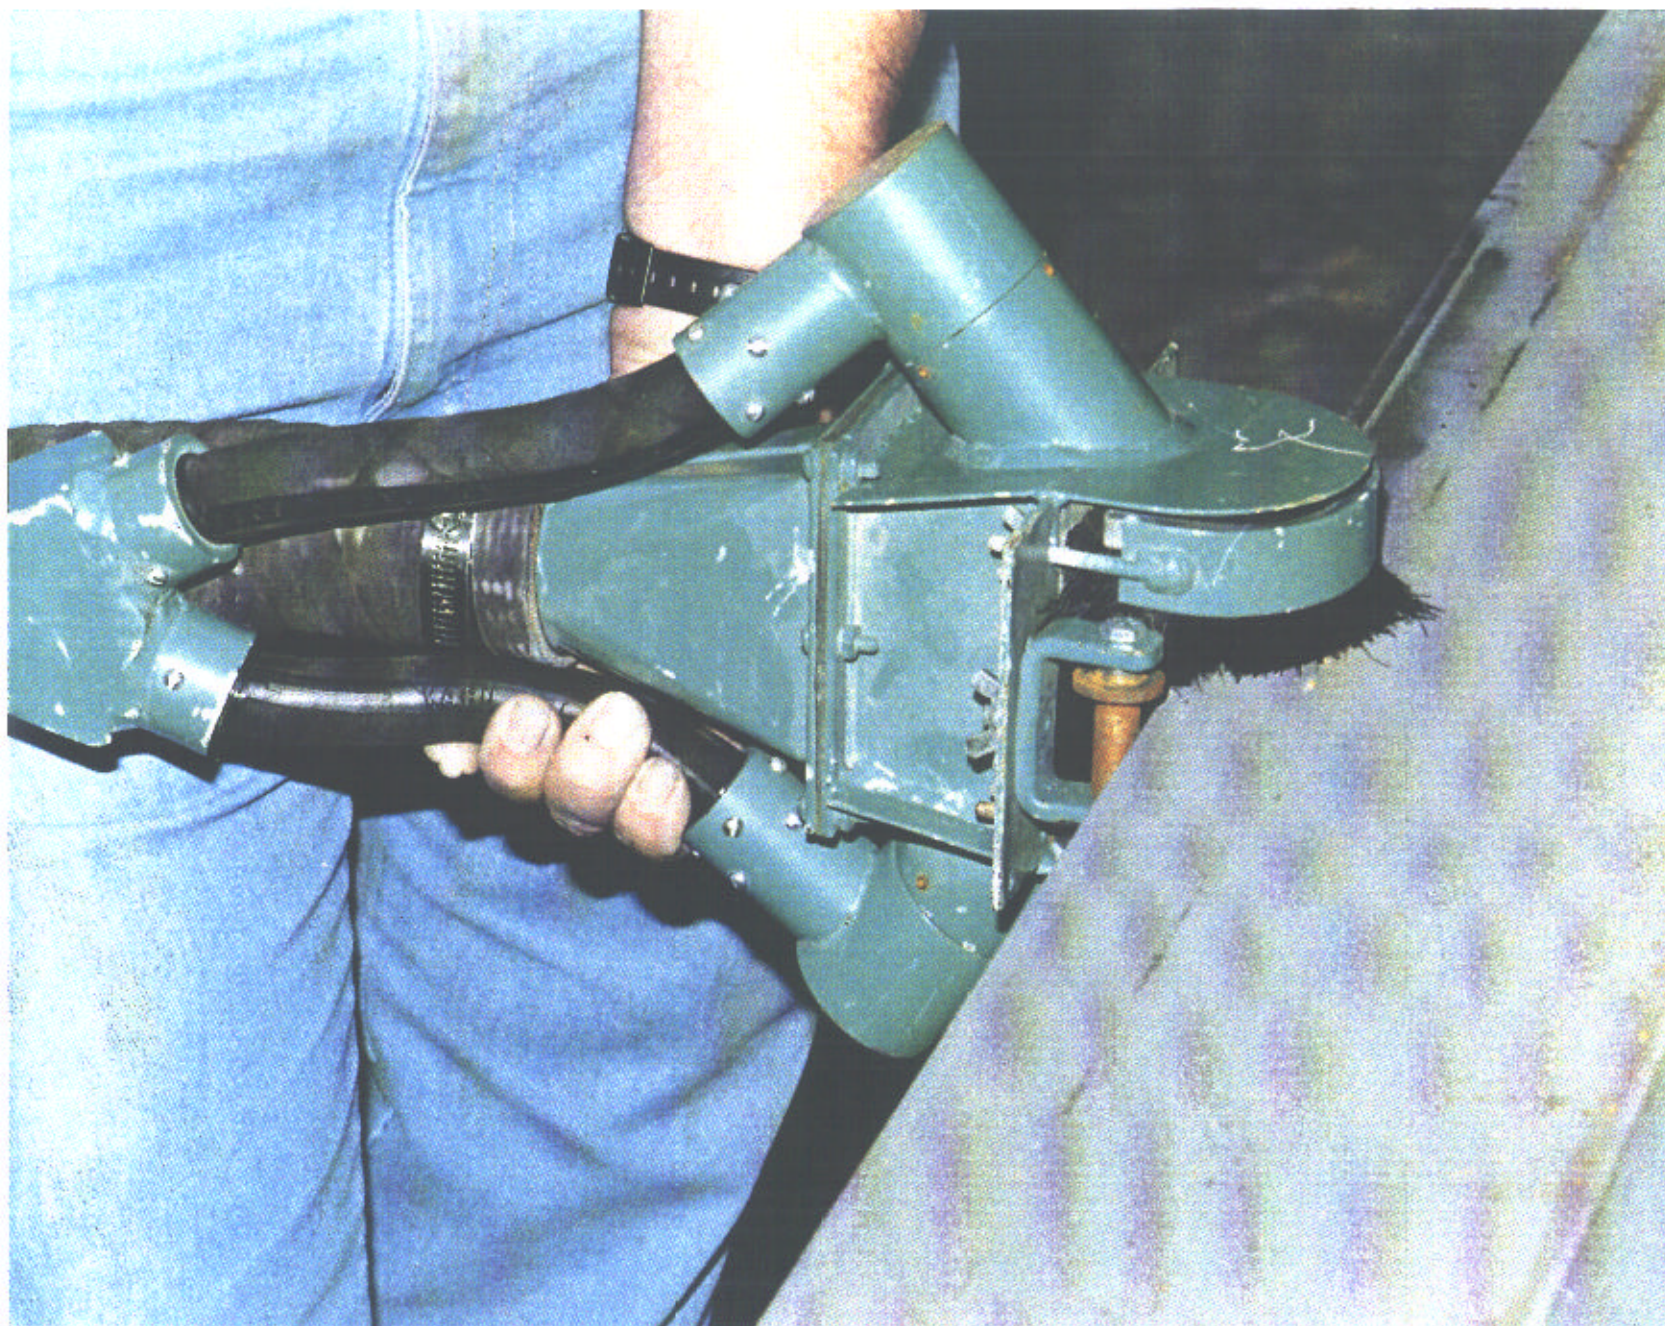
Figure 4. Three-edge head of vacuum recirculating grit blast system

After a survey of technologies and review of the equipment available, a suitable recirculating grit-blasting unit, (shown in Figure 4) was selected for an evaluation in a shipyard panel line.

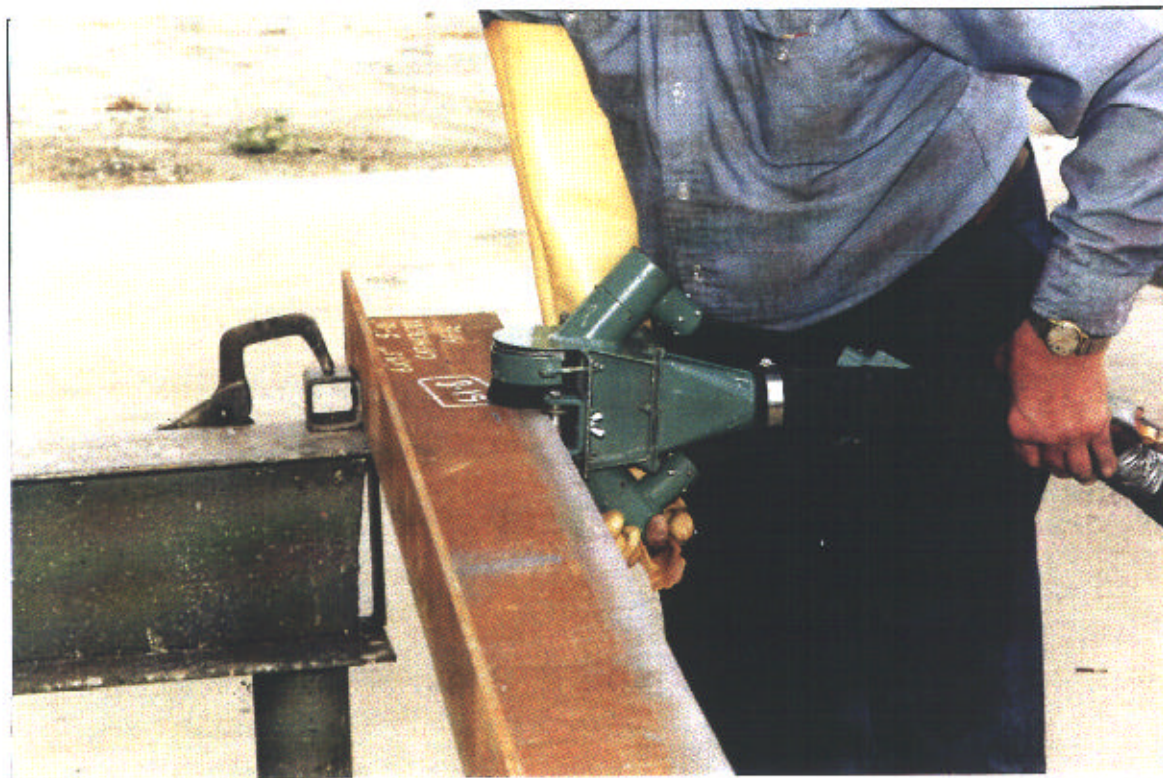
**Figure 9. Three-edge gun, removing rust and IZ-PCP from web of Tee.**

Three-edge blasting equipment is relatively simple grit from a holding tank is metered into a compressed air stream feeding the head. Near the head, the incoming grit is diverted into two nozzles which are aimed at the intersecting comers of the three surfaces. A powerful vacuum source connected to the head cleans up all the grit and swarf, transporting them to a “cyclone” chamber, which allows larger (re-usable) grit particles to be recycled, while smaller (worn) grit particles and other removal products are pulled out and dropped into a waste chamber. Filter bags capture fine dusts. In batch fed units, recycled grit is held until blasting stops, when a check valve opens to allow the grit to fall into the grit tank. Continuous-feed units are usually much larger, and the grit returns to the supply tank automatically. There are differences in total grit capacity, length of hoses, nozzle design, impingement angle, and vacuum systems, but the basic concept is the same. Choice of angle and nozzle shape are based on development work and experience. The unit rented from Kelco (see Figure 7) for these trials is typical. The arrangement of hoses, control valve and blast head is shown in Figure 8. Figure 9 shows the unit in operation.

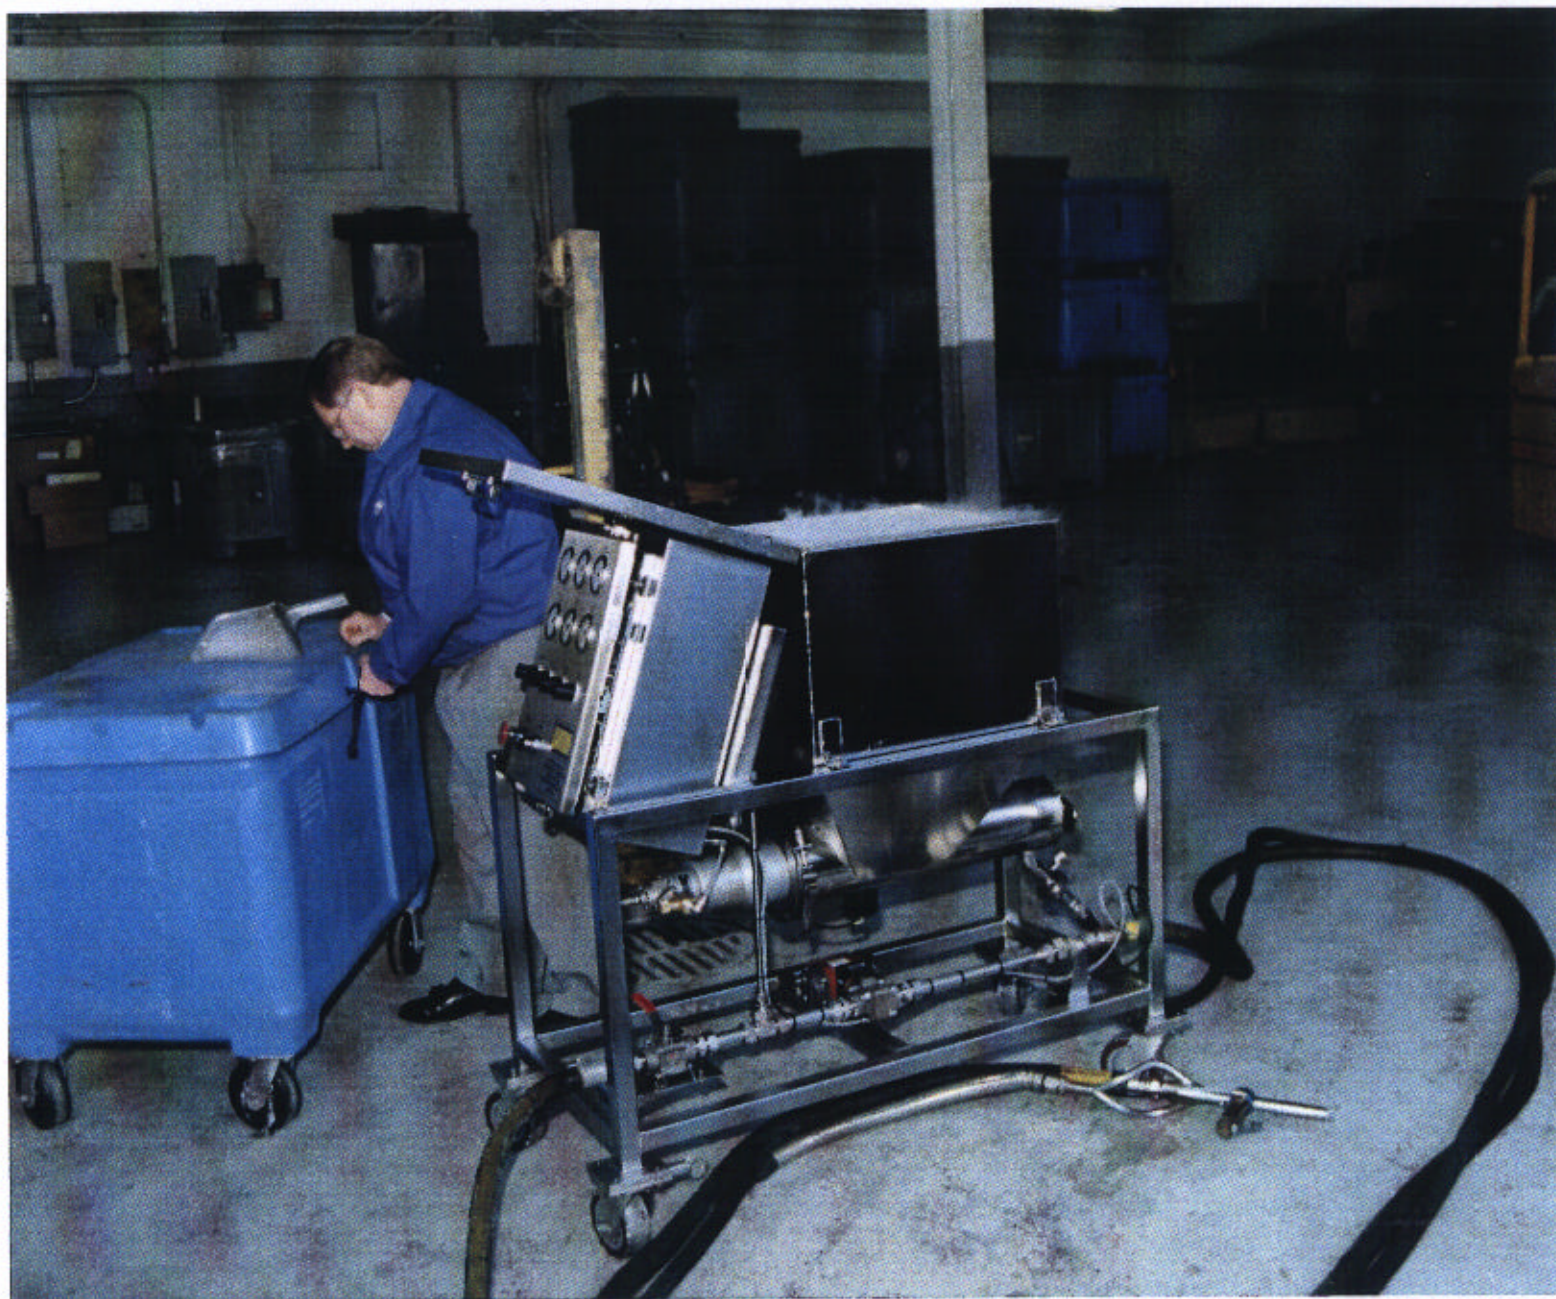
**Figure 22. CO2 pellet blasting equipment.**

Cryogenesis, of Cleveland, Ohio, provided equipment for this test, shown in Figure 19. Fabricated entirely of stainless steel, the equipment shown in the picture costs approximately \$28,000.00. A reservoir is filled with pellets, and operating parameters are set on the control console. As shown in Figure 20, the gun is a simple, rugged affair with a “dead-man” type trigger unit located on the handle.

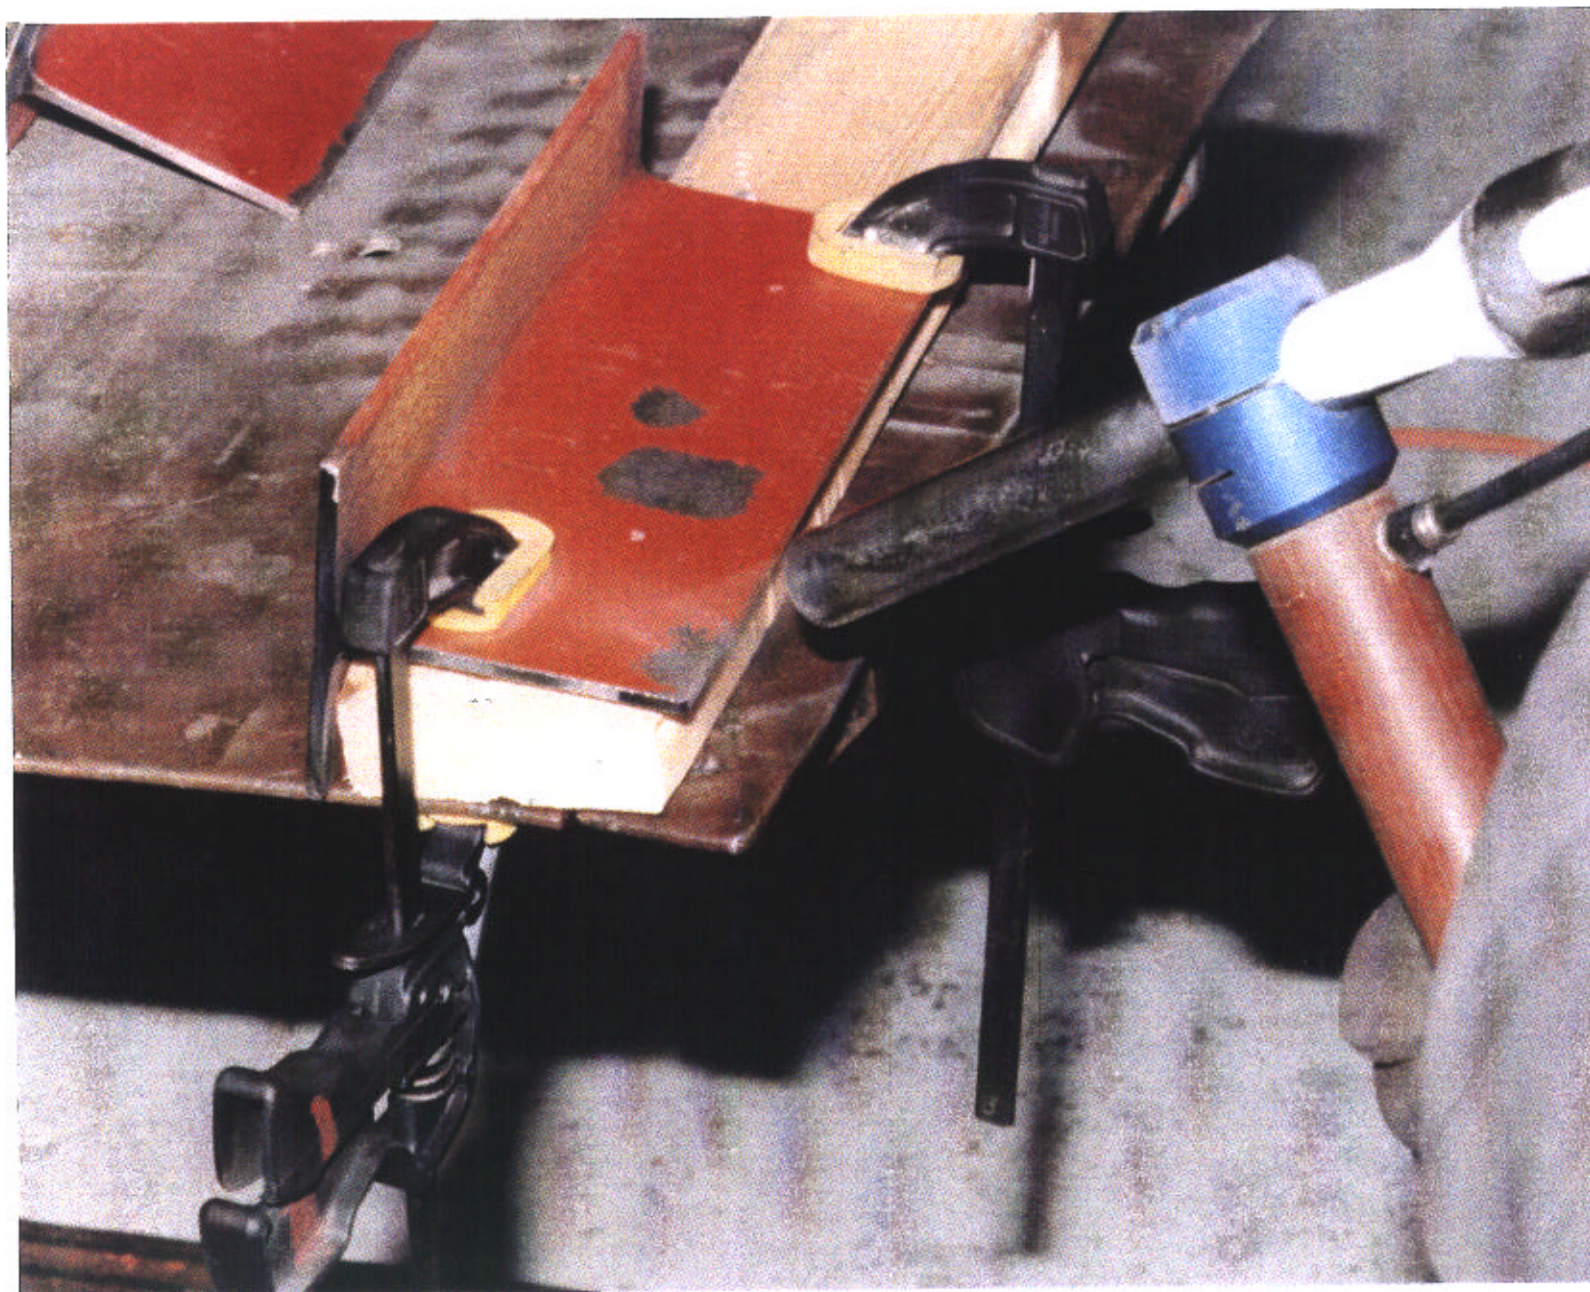
**Figure 26.** CO2 pellet blasting two edges of Tee primed with epoxy PCP.

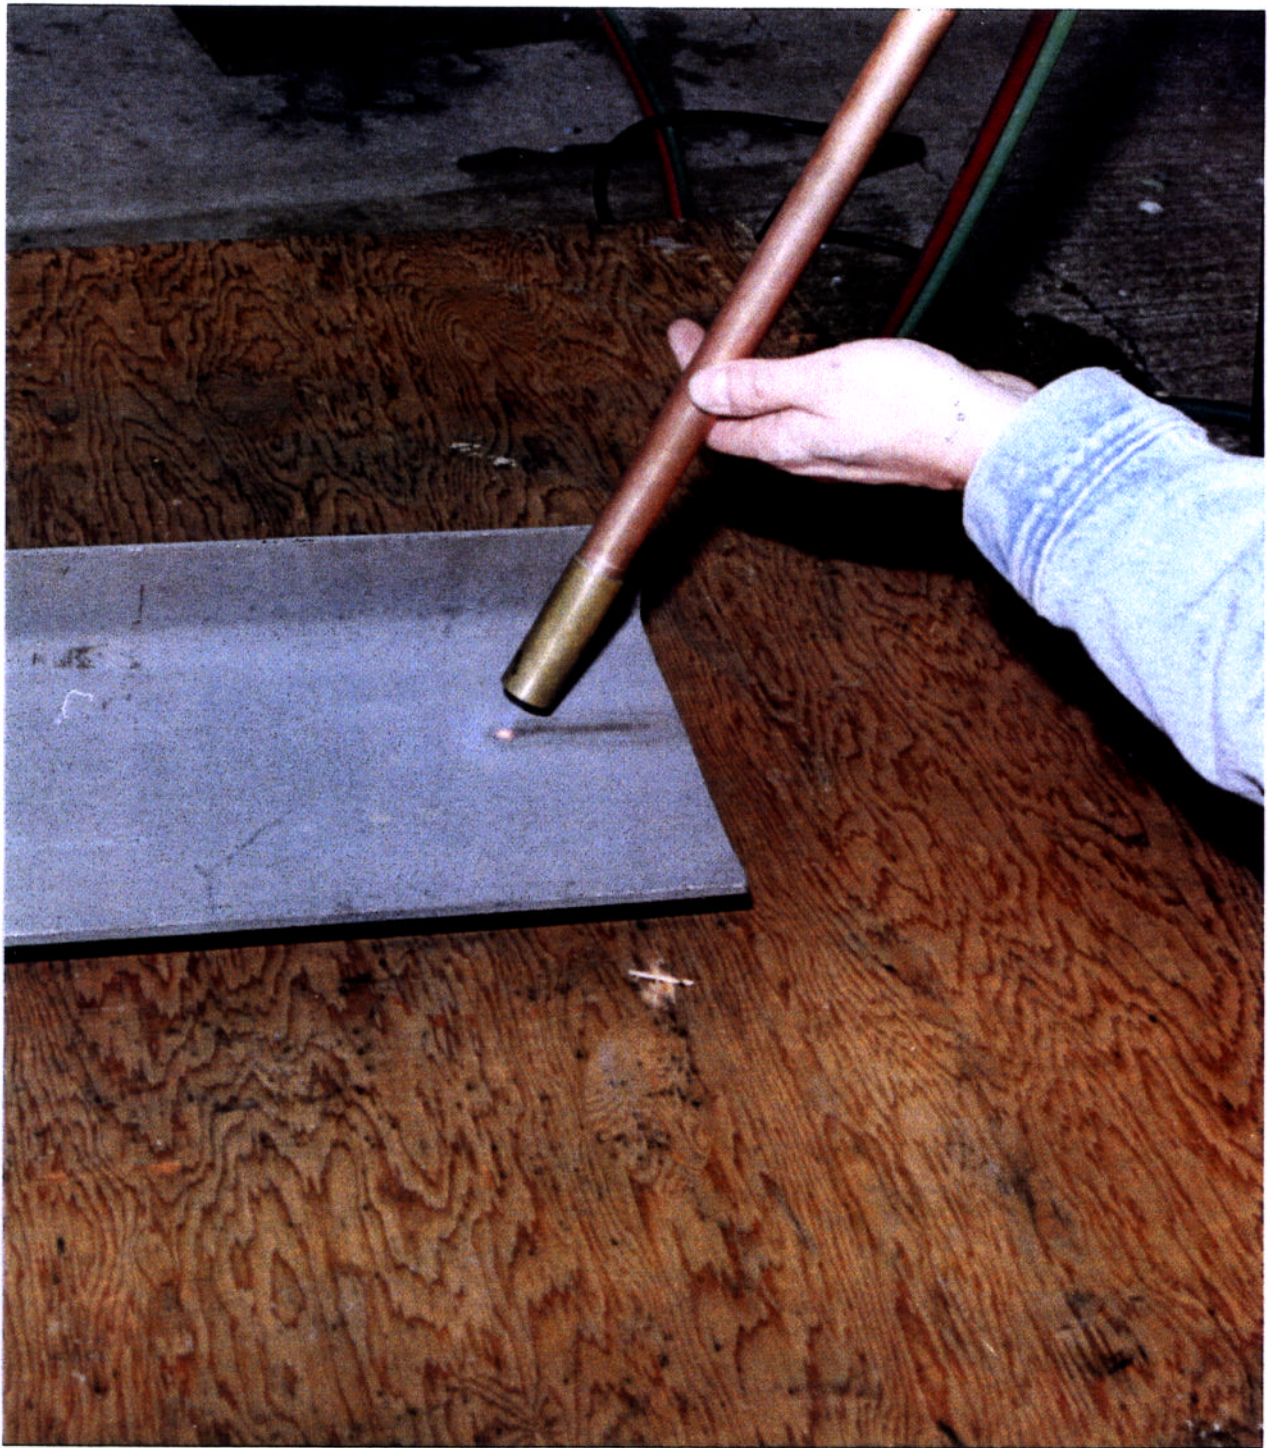
**Figure 30. HVOF stripping in progress on I/T test piece.**

Hanson Machine Company, located in Boscawen New Hampshire, provided an HVOF torch for testing, shown in Figure 29. In use, the flame was nearly invisible (see Figure 30), and, being a hand-held torch it was relatively easy to overheat the material. When travel speed slowed, the area under the flame quickly became red-hot. This would be a concern for heat-sensitive materials. The IZ coating was seen to discolor slightly, leaving a light brown residue, indicating that breakdown of the primer had occurred. There was no evidence of water of combustion condensing on the plate surface. Due to the high velocity of expanding gases, the device was inherently loud, and noise levels of nearly 95 dBA (details in Appendix B) were recorded. No testing for airborne contaminants was performed. In general, the same arguments regarding thermal breakdown products<sup>7</sup> of coatings would apply to the method as to laser beam stripping.

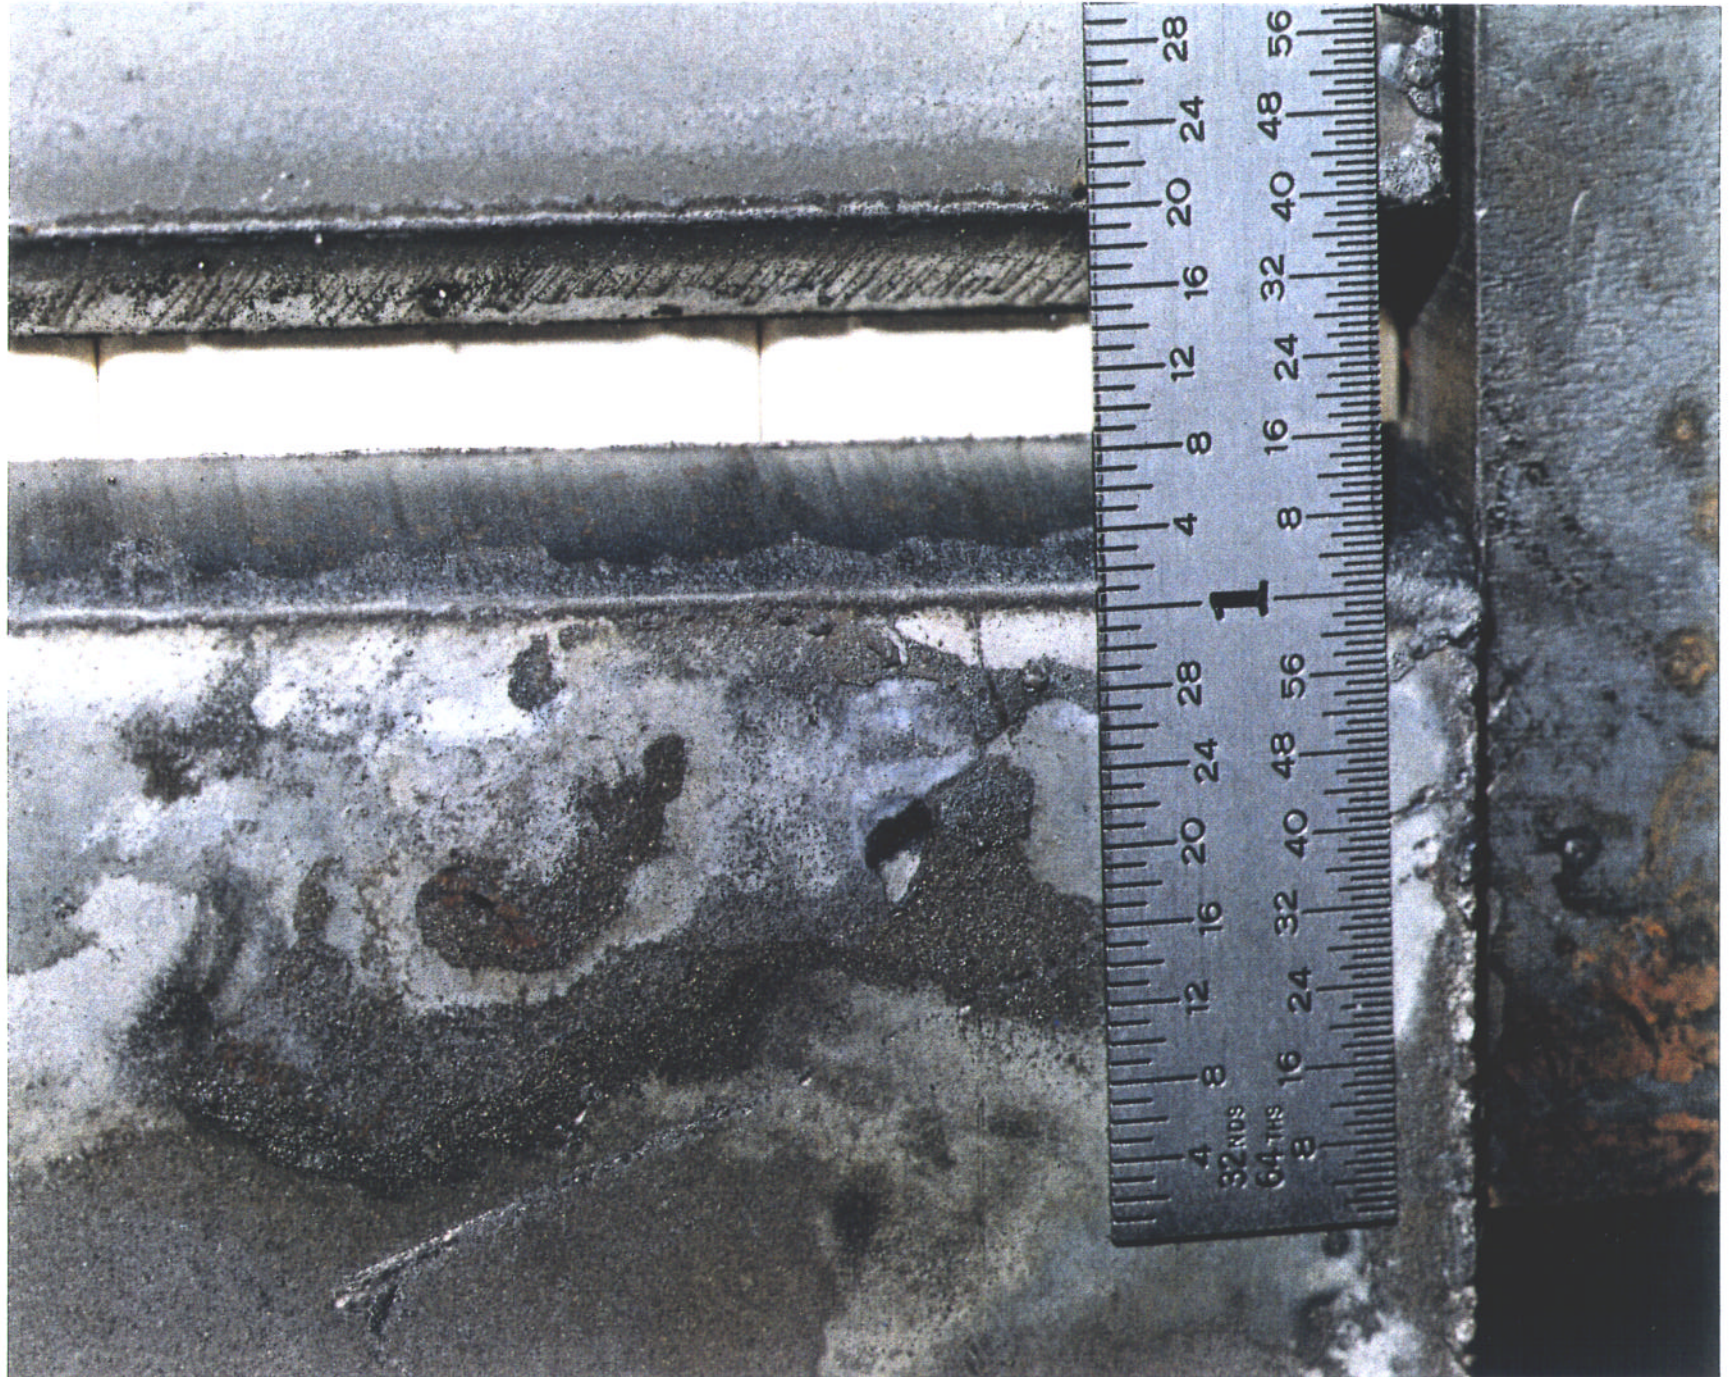
Figure 35. Close-up of ceramic backed assembly before blasting.

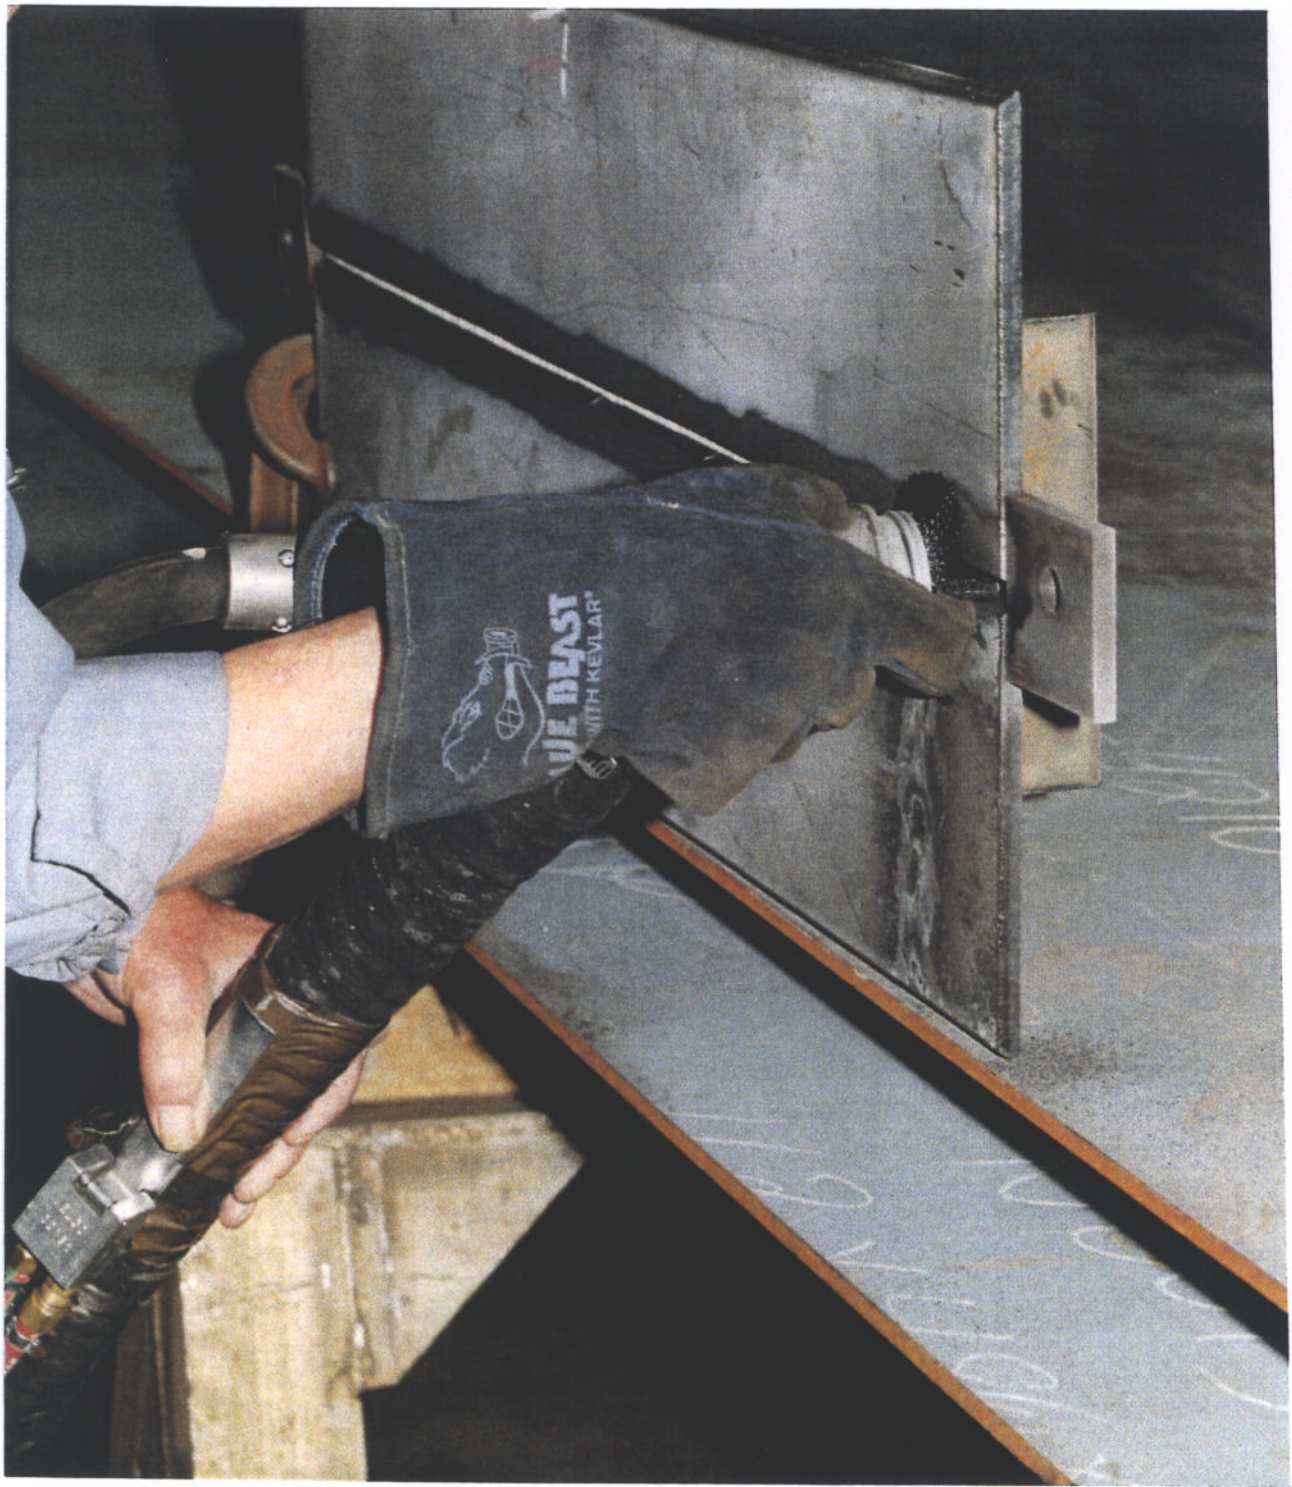
**Figure 36. Blasting in progress on assembly with ceramic backing.**
