**WEAR ANALYSIS OF CU-AL COATING ON
TI-6AL-4V UNDER FRETTING**

THESIS

AFIT/GAE/ENY/06-J12

AIR FORCE INSTITUTE OF TECHNOLOGY

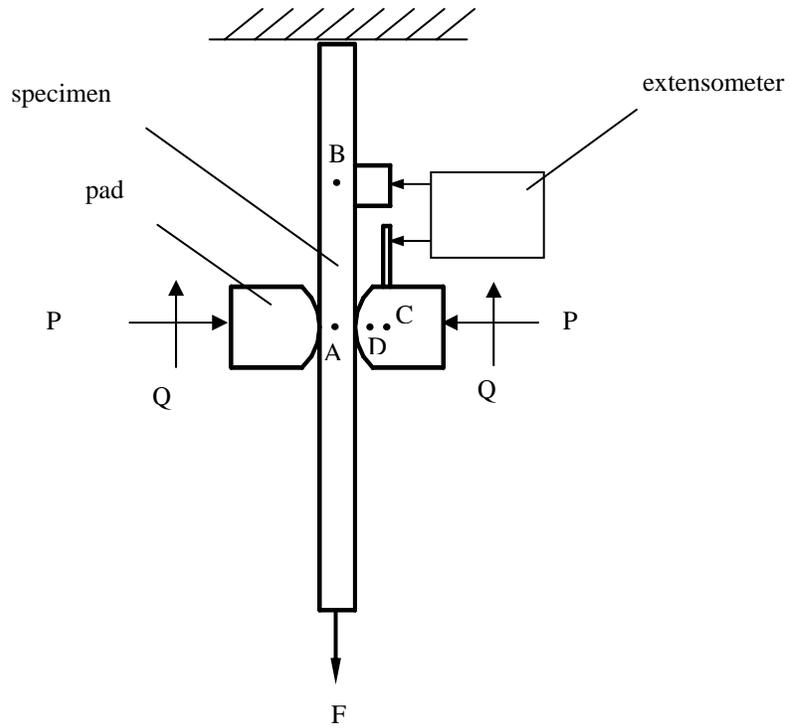
Figure 2.2 Extensometer Setup

The constant α is directly related to the compliance of the fretting fixture, and the value used in both this experiment and in Lee's work [12] was determined from previous experiments using the same test rig and fretting fixture; two quasi-static tests were conducted in which the value of l_{DC} was changed but the value of Q in both tests was kept constant [8]. The equation to calculate α is given below:

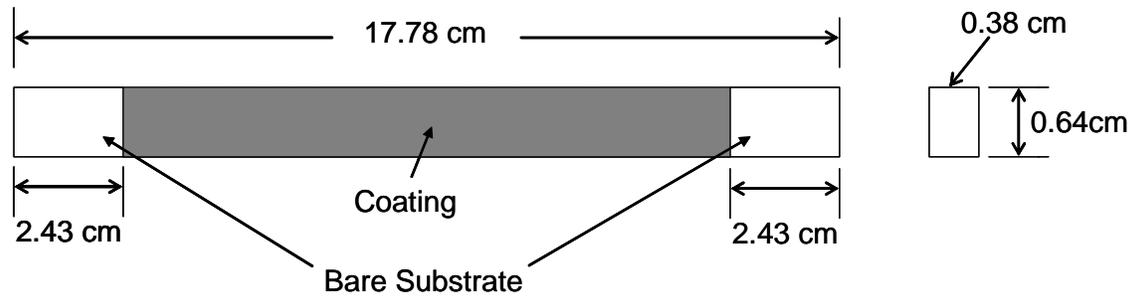
Figure 3.1 Specimen Dimensions

The specimen substrate was a titanium alloy, Ti-6Al-4V. Before the material was machined, it was preheated and solution treated at 935°C for 105 minutes, cooled in air, vacuum annealed at 705°C for 2 hours, and then cooled in argon. The microstructure of the material was comprised of two phases: 60% volume of α (HCP) and 40% of β (BCC), with the nucleation of the α plates in the β matrix. The grain size was approximately $10 \mu\text{m} \pm 2 \mu\text{m}$. The material has an elastic modulus of 126 GPa, yield strength of 930 MPa, and ultimate tensile strength of 978 MPa. The final dimensions of the specimen (see Figure 3.1) after cutting with the wire electrical discharge method and low stress grinding (to reduce residual machining stress) were a length of 17.78 cm, width of 0.64 cm, and thickness of 0.38 cm, which gave a cross-sectional area of 0.24 cm^2 . The cylindrical fretting pads were machined from the same Ti-6Al-4V material and had a radius of 0.3 cm. The Cu-Al coating was applied to the specimen by plasma spray method. The composition of the coating was 87 ~ 90 wt% of Cu, 9 ~ 11 wt% of Al, and 0.7 ~ 1.5 wt% of Fe. The average thickness of the Cu-Al coating was measured by profilometer and was determined to be 40 μm . The root mean square (RMS) surface roughness of both the specimen substrate and the pad was 0.2 μm .

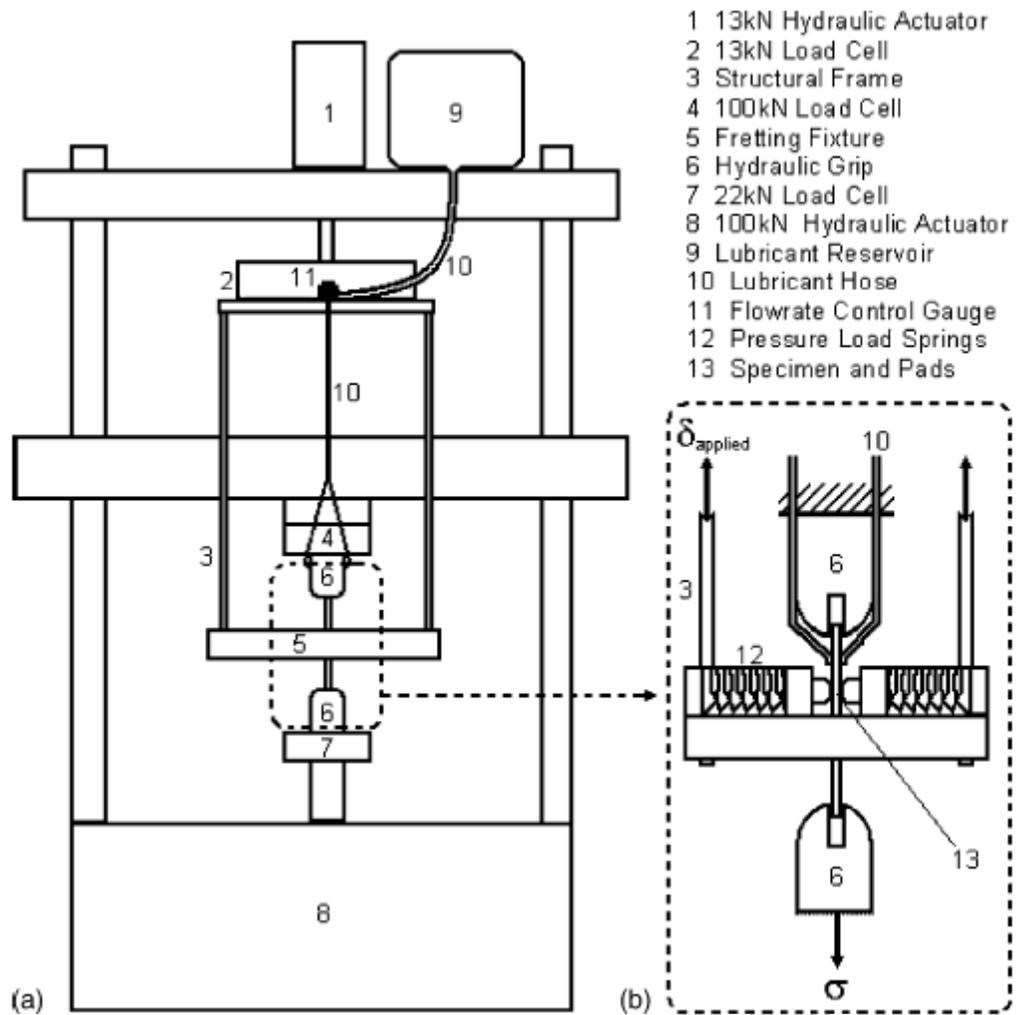
Figure 3.2 Test Setup with Lubricating System

To change the CoF, oil was applied to the specimen throughout the test cycles using a setup very similar to that used by Magaziner [14], as depicted in Figure 3.2. In actual turbine engines, a lubricating system is used to apply oil to the blades, which then reaches the dovetail joints; therefore, it was assumed that this would be a fairly accurate method to use to replicate real-life conditions. SAE 15W-40 Heavy Duty Motor Oil was

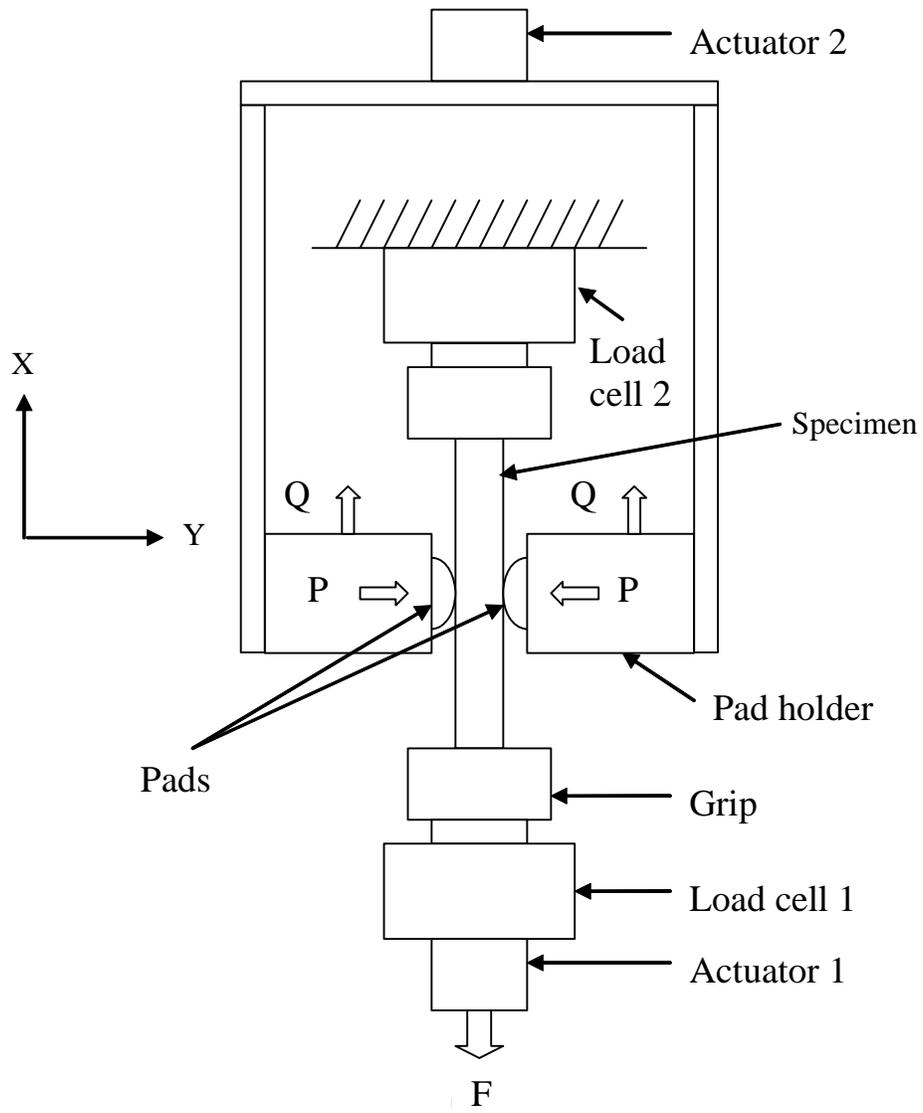
Figure 3.3 Fretting Machine Setup

Fretting tests were performed on a dual-actuator fretting machine located in the Air Force Institute of Technology Materials Laboratory. The machine was controlled using *MTS TestStar II* computer software on a basic desktop computer. All the tests were performed under room temperature and normal pressure conditions. For a portion of the tests, the specimen was put under a varying fatigue load, whereas, for some tests, the specimen was simply held in a fixed position. The testing apparatus allowed the specimen to be held in place by an upper grip while the lower grip could be moved to induce various fatigue loads on the specimen. At the same time that the lower grip actuator was moving, an upper actuator was used to move a fretting fixture placed about the specimen.

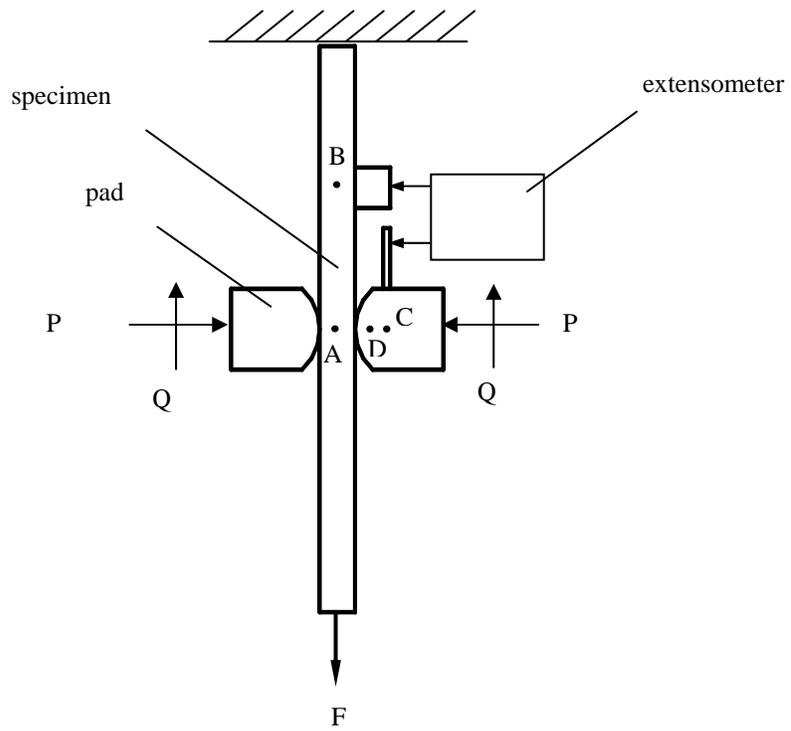
Figure 3.4 Extensometer Setup

the fretting pads—in this case, a contact force of 320 N was used. The extensometer was setup and attached in the same method as was used for the fretting tests. The upper grip was then released and a force was applied to the lower actuator until the specimen started to slip. The extensometer readings were used to determine exactly when slip started to occur. The force from the lower actuator used to induce slip was recorded. Several tests were conducted in each condition, and the CoF was determined from an average of these tests—the CoF was determined by dividing the average value of the tangential force during slip by the applied normal load to the fretting pad. The static CoF for the dry condition was determined to be ~ 0.24 , and the static CoF for the lubricated condition was ~ 0.13 .

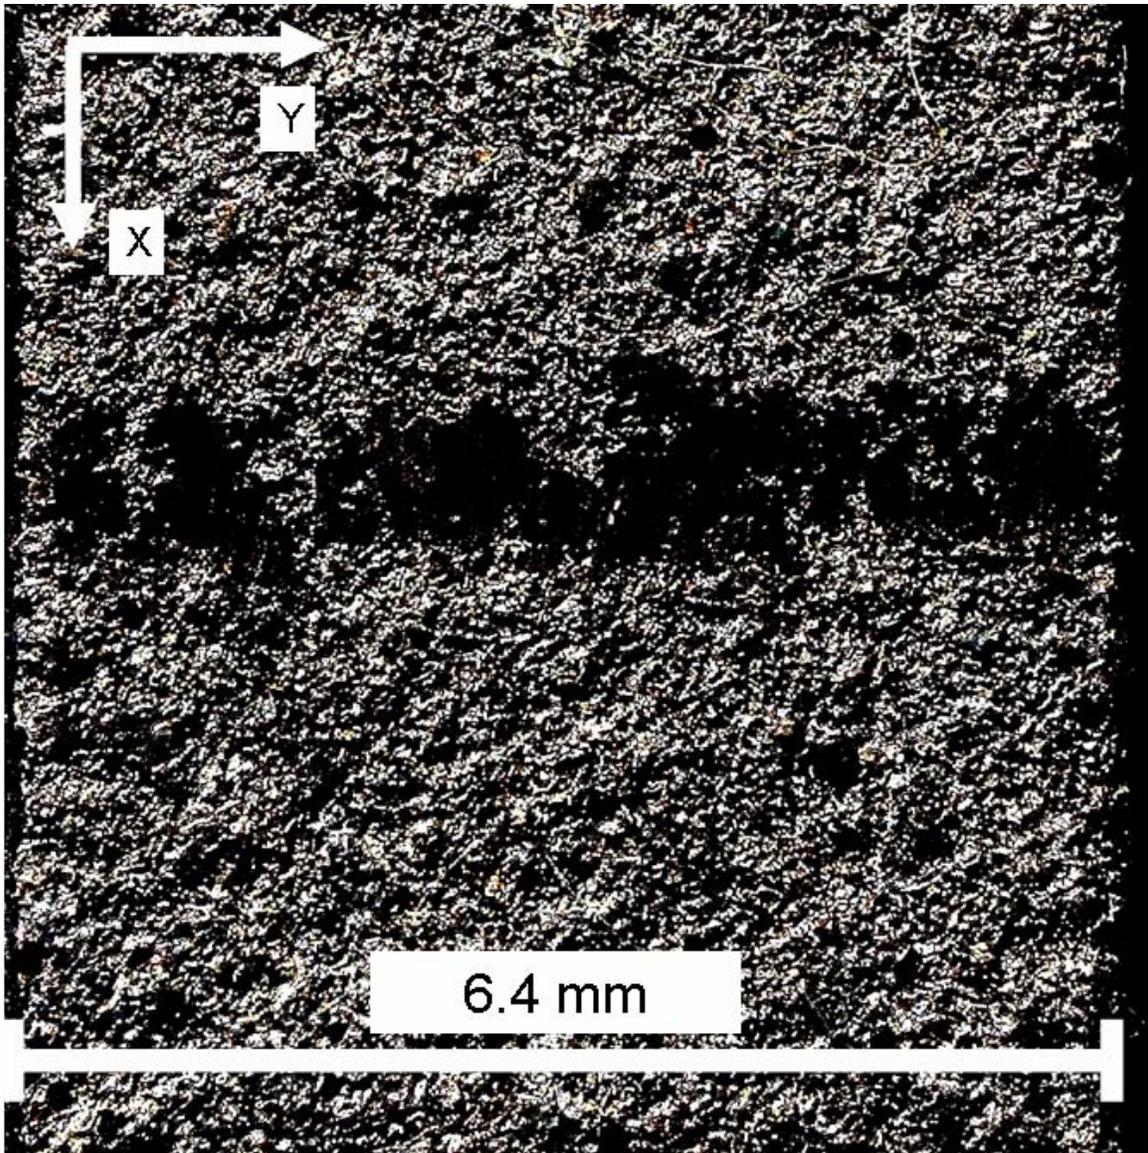
Figure 3.5 Typical Fretting Scar (Test 5)

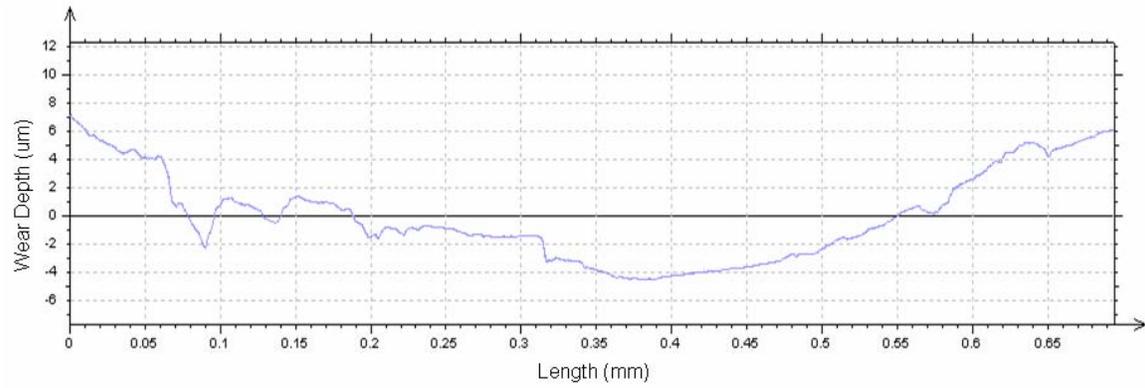
Figure 3.6 Profilometer Measurement of Surface (Test 1)

The wear area was calculated for each two-dimensional surface profile using *Taylor Hobson* computing software, knowing the wear length and depth (see Figure 3.6 and Figure 3.7). It was possible to numerically integrate the wear-area data for the seven

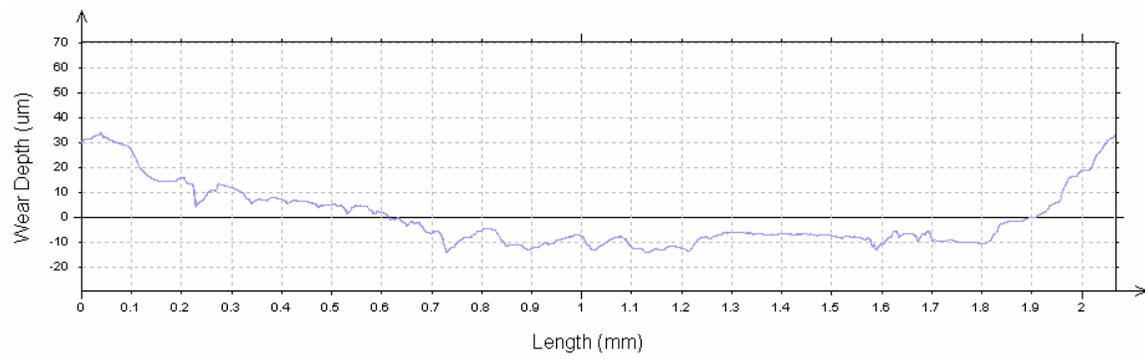
Figure 3.7 Profilometer Measurement of Surface (Test 7)

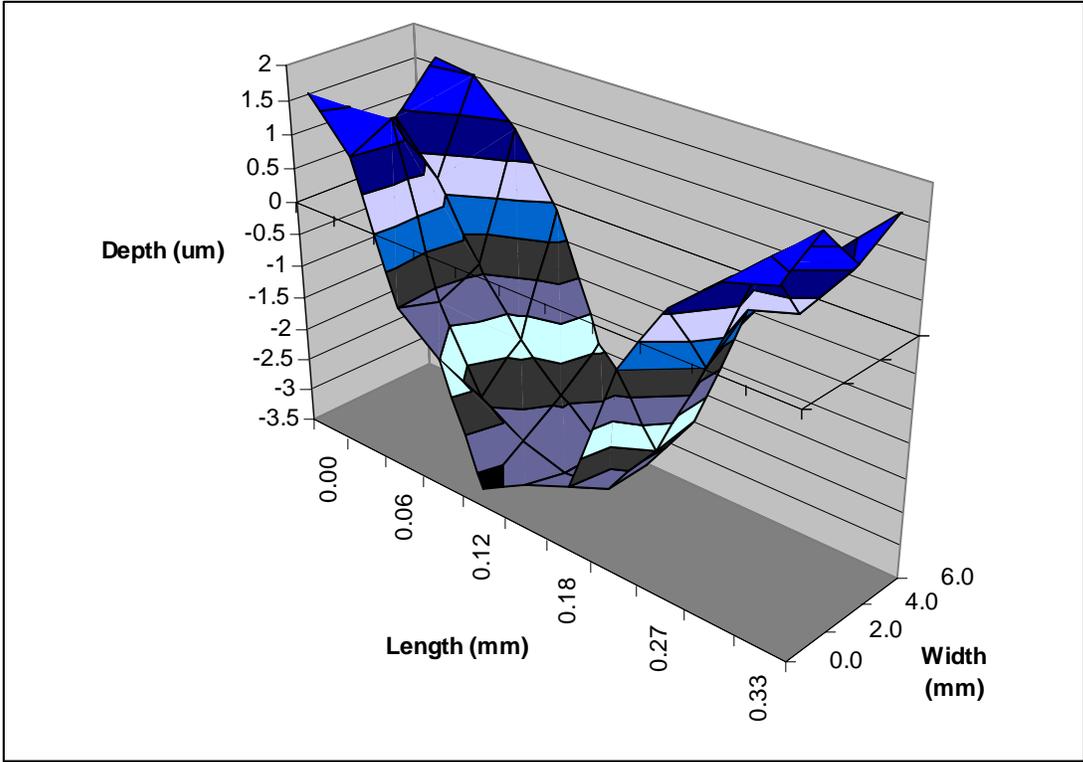
Figure 3.8 Three-Dimensional Surface Profile (Test 1)

different locations spaced evenly along the width of the scar to determine the total wear volume of the scar. From the two-dimensional data collected for each fretting scar, three-dimensional surface profiles were created that were a numerical approximation of the actual fretting scars (see Figure 3.8 and Figure 3.9). The wear volume was calculated using Simpson's Rule:

$$Volume = \int_a^b f(x)dx = \frac{h}{3} [f(x_0) + 4f(x_1) + 2f(x_2) + 4f(x_3) + 2f(x_4) + 4f(x_5) + f(x_6)] \quad (10)$$

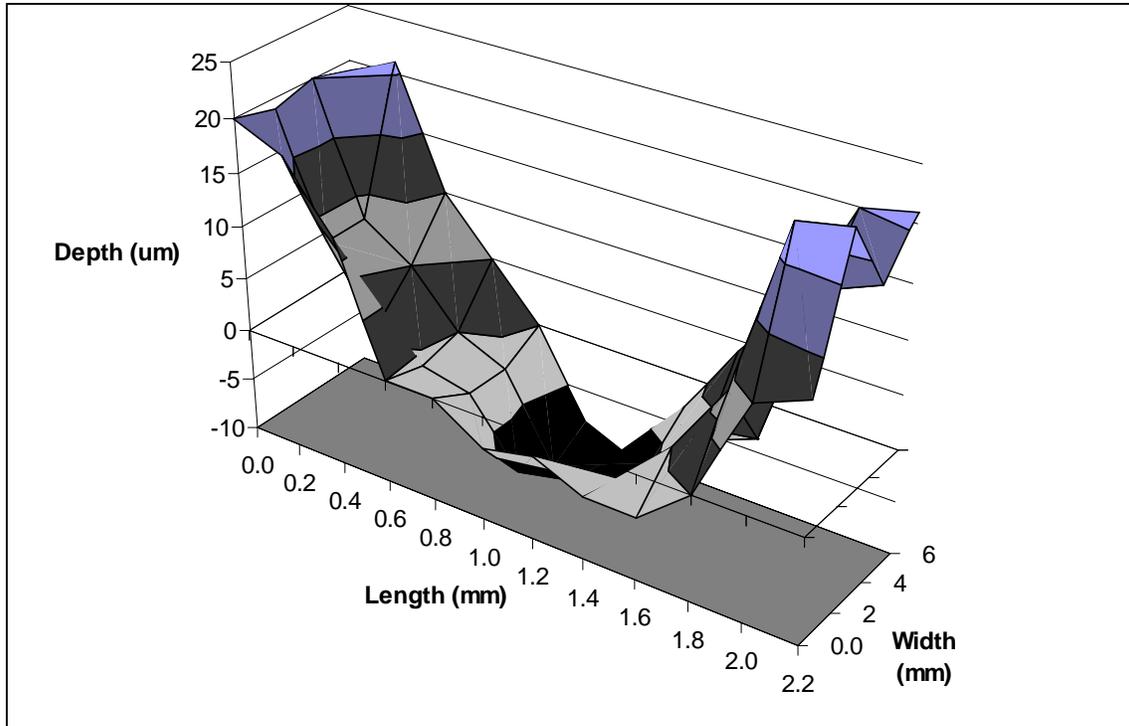
Figure 3.9 Three-Dimensional Surface Profile (Test 7)

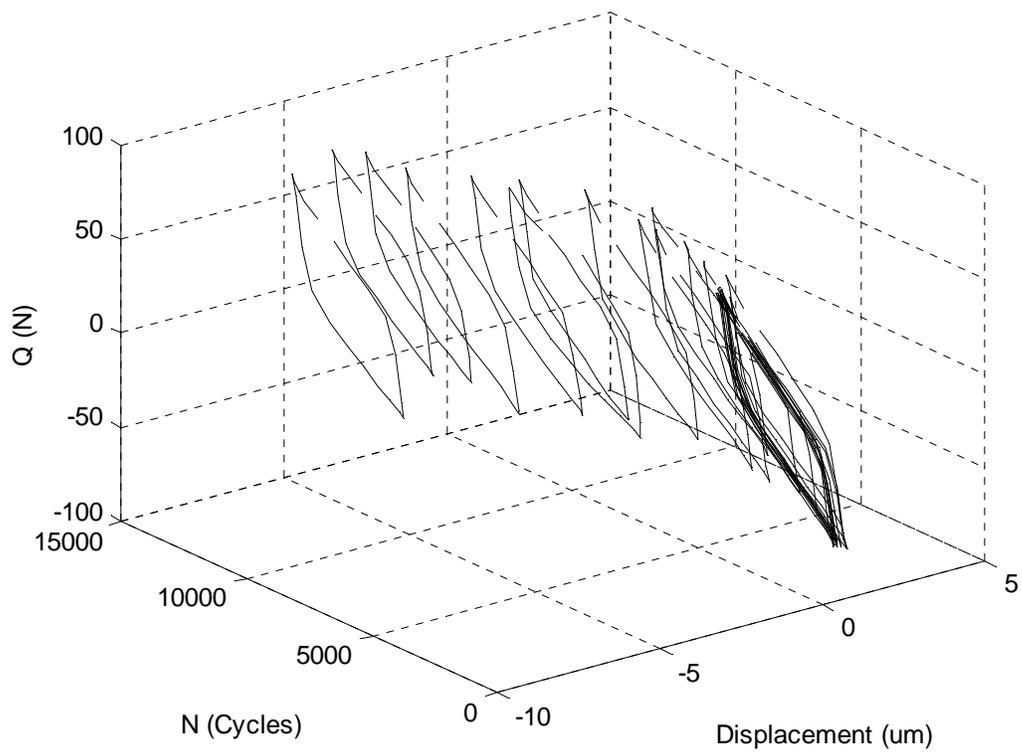
Figure 4.1 Typical Fretting Loops of Partial Slip (Test 1)

Fretting loops are a plot of tangential force, Q , versus relative displacement, δ , plotted for each cycle of a fretting test. An analysis of the fretting loops can give a great deal of information about the wear process. One of the main characteristics that can be defined by analysis of the fretting loops is the fretting regime, i.e., type of slip that was taking place during the test.

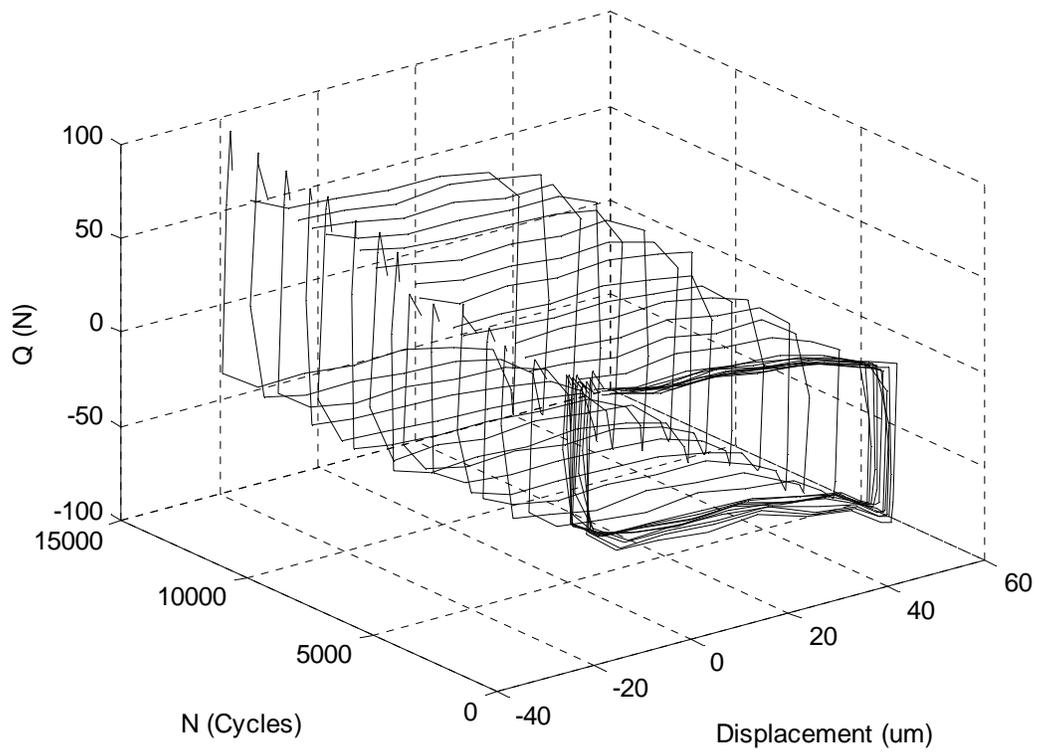
Figure 4.2 Typical Fretting Loops of Gross Slip (Test 4)

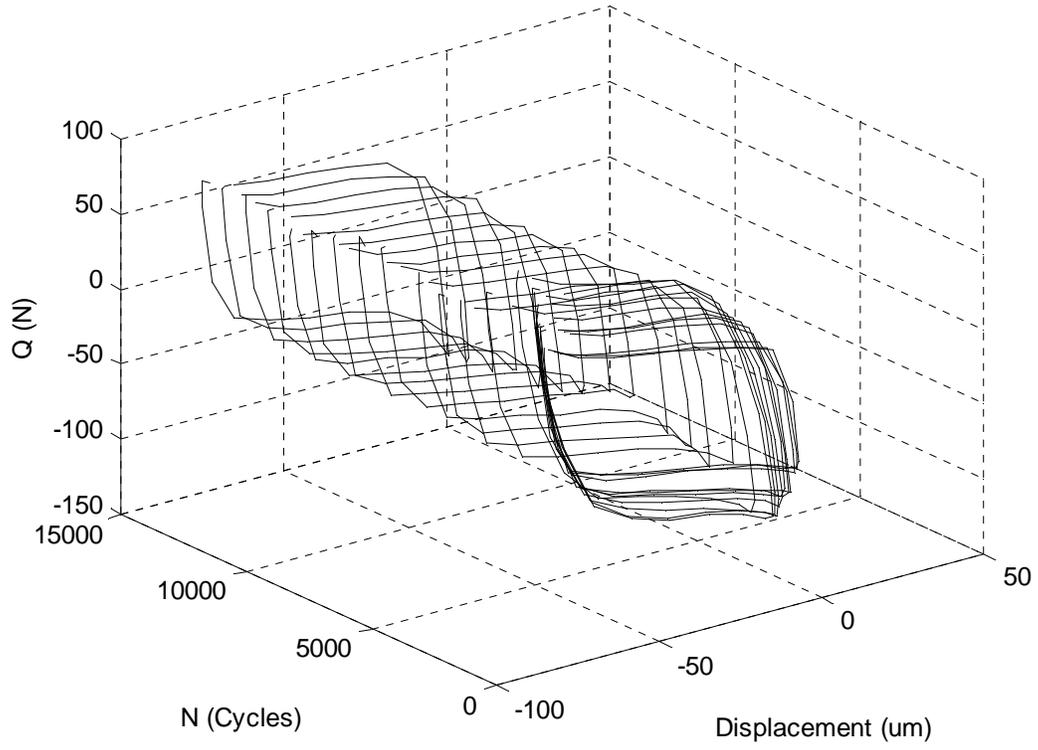
Figure 4.3 Typical Fretting Loops of Mixed-Mode (Test 5)

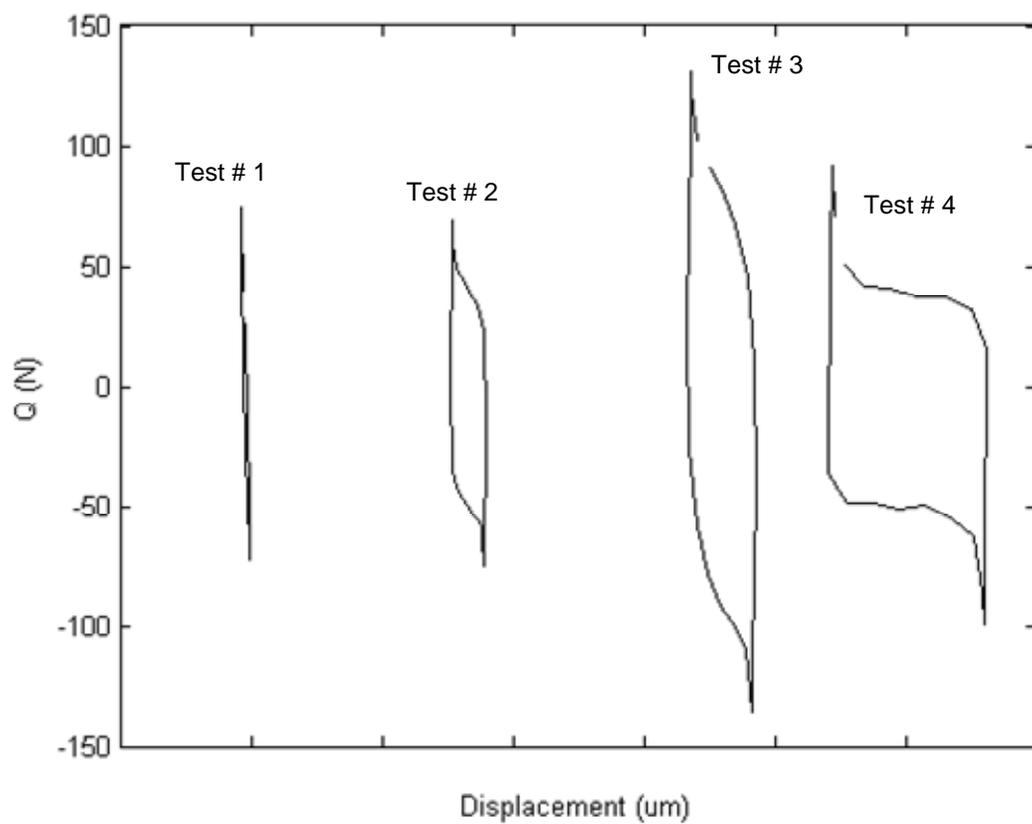
Figure 4.4 Fretting Loops at the 15,000th Cycle for Each Test (No Fatigue)

A comparison was made between the fretting loops of the tests conducted without a fatigue load and tests conducted with a fatigue load. The fretting loops generated at the end of testing (at the 15,000th cycle) can be seen for each test in Figure 4.4 and Figure 4.5. Partial slip only occurred for tests with no fatigue load. The areas inside the loops for the tests conducted with fatigue are much larger—the effect of the fatigue load essentially caused much greater displacements to occur.

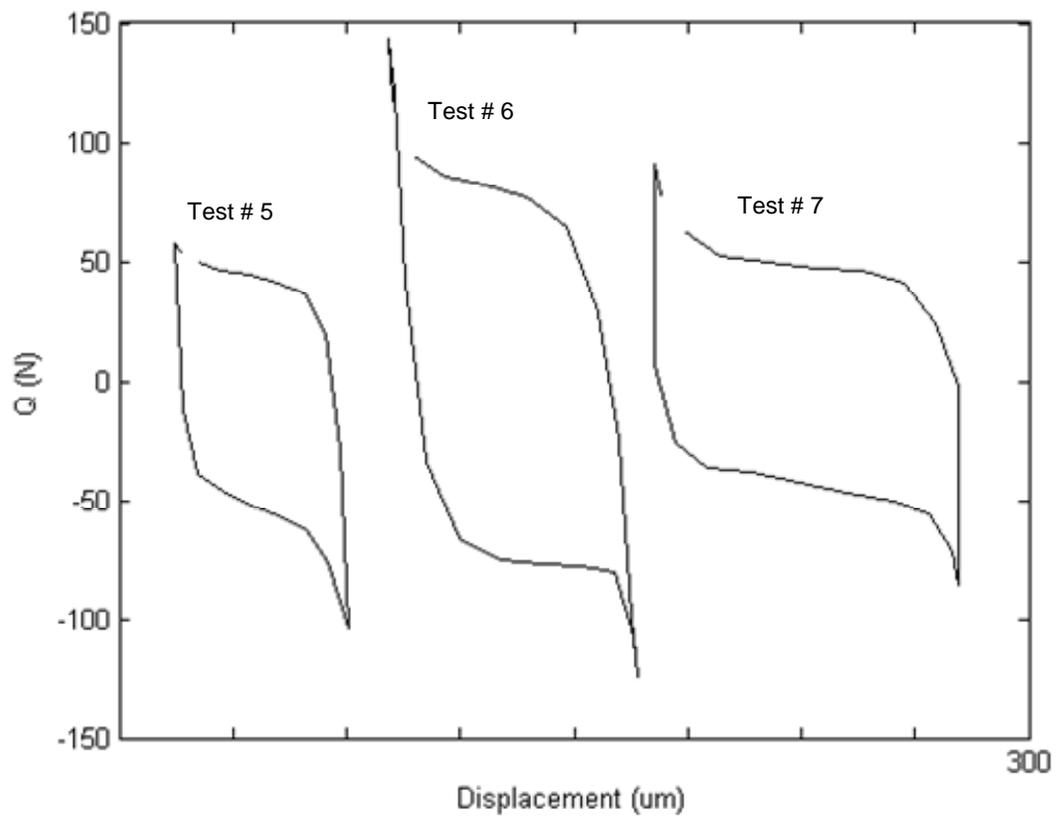
Figure 4.5 Fretting Loops at the 15,000th Cycle for Each Test (Fatigue)

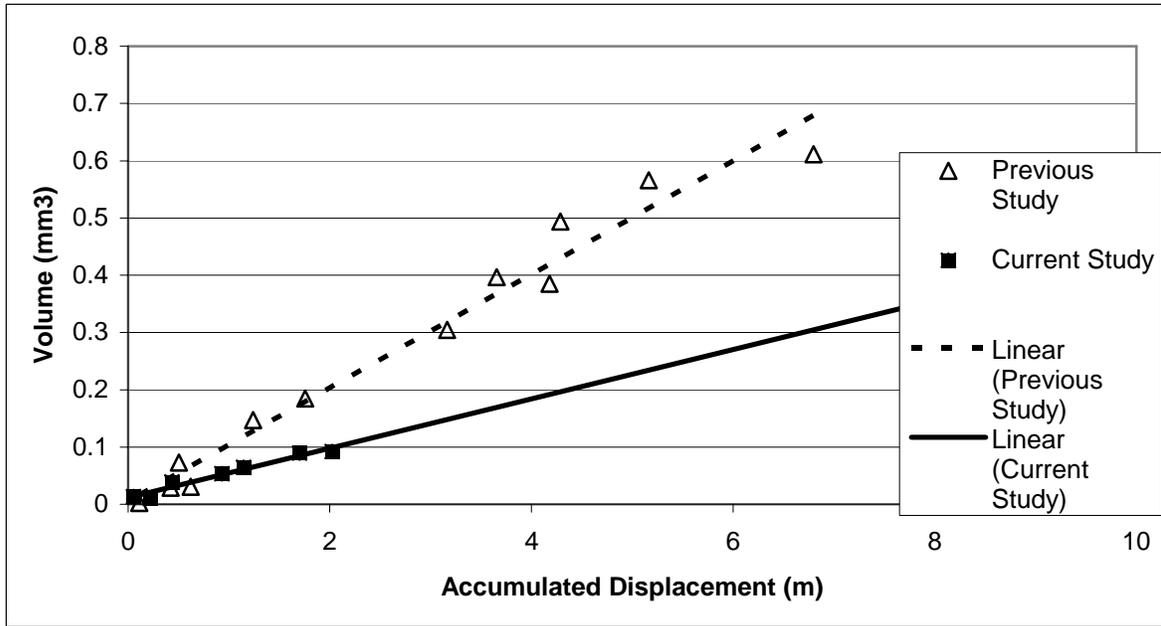
Figure 4.6 Accumulated Relative Displacement Range vs. Wear Volume

(Note: previous study data from Lee [12])

As can be seen in Figure 4.6, the relationship between wear volume and accumulated relative displacement is linear for all of the slip regimes and loading

conditions studied in both this study and that of Lee [12]. For a similar amount of accumulated displacement, the wear volumes measured for the tests conducted in the current study are much less than those measured in the Lee study. Wear is proportional not only to the contact load and relative displacement, but also to the surface conditions, and, thus, a change in the CoF at the contact surface will result in a change in the amount of wear. Unfortunately, tests conducted with greater wear volumes were unable to be conducted due to the limited range of the extensometer, so data on the higher end of the curve for the Lee study could not be compared in this study.

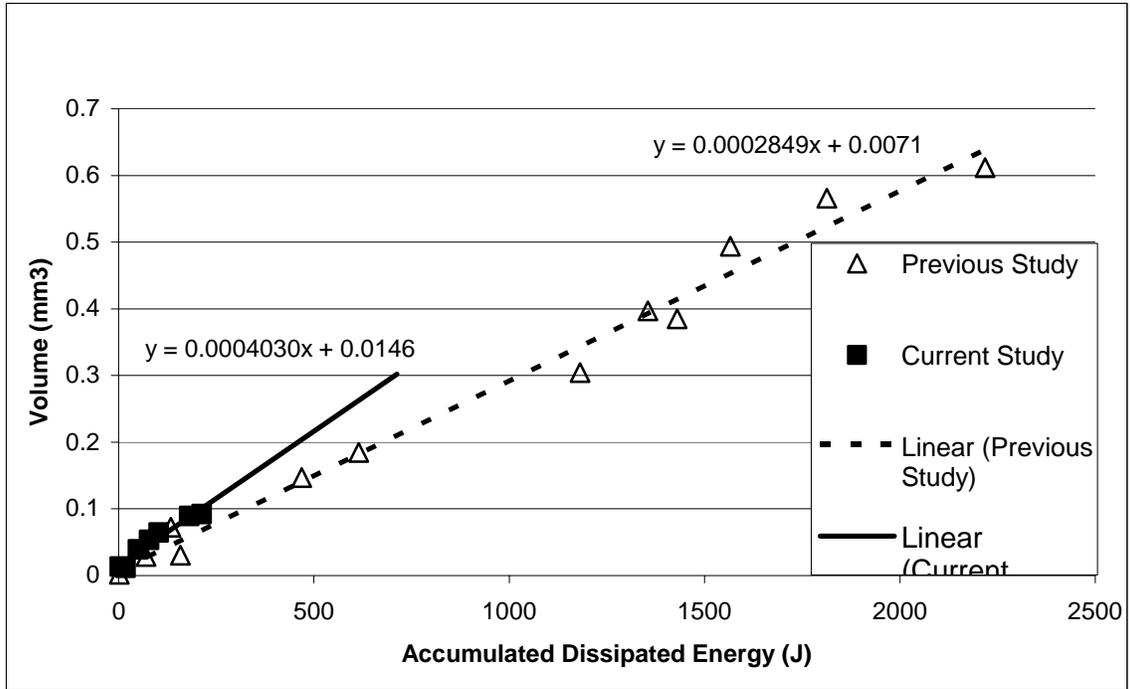
Figure 4.7 Accumulated Dissipated Energy vs. Wear Volume

(Note: previous study data from Lee [12])

Plots of wear volume versus accumulated dissipated energy for the tests conducted in this study and those of Lee [12] can be seen in Figure 4.7 and Figure 4.8—the relationship between wear volume and accumulated dissipated energy is also a linear one. It was expected that, due to a decrease in the CoF, the wear volume for a similar amount of dissipated energy would be less for tests conducted in this study, compared with those of Lee. Actual analysis shows that there is not much difference—the wear volume for tests conducted in this study are actually slightly higher for a similar amount of dissipated energy. This is most likely due to the ambiguity of the wear-volume measurements. Due to the relatively rough coating surface, it was sometimes difficult to accurately measure the wear areas from the surface profiles and thus determine a reliable wear volume for each test.

A linear regression line was calculated for the data of the Lee study and the current study, and, from this, the energy wear coefficient was determined. The energy wear coefficient is the slope of the regression line; for the Lee study it was about $2.85\text{E-}04 \text{ mm}^3/\text{J}$, and for the current study testing it was about $4.03\text{E-}4 \text{ mm}^3/\text{J}$.

In a previous study [3] that conducted fretting tests in a similar manner, there was a shift in the linear relationship from the origin on the energy axis. In fretting tests, it is possible that, during the incipient loading, the surface endures severe strain-hardening, which modifies the initial microstructure to a very hard phase called a tribologically transformed structure (TTS). When this TTS layer is formed, wear cannot occur until the TTS layer is fractured; this phenomenon can account for the shift on the energy axis. As found in Lee's results [12], the linear relationship in this study started very close to the origin on the energy axis. The y-intercept value determined from the regression line was only 0.015 mm^3 —a very minor shift; this signifies that a TTS layer was never formed during the testing in the current study.

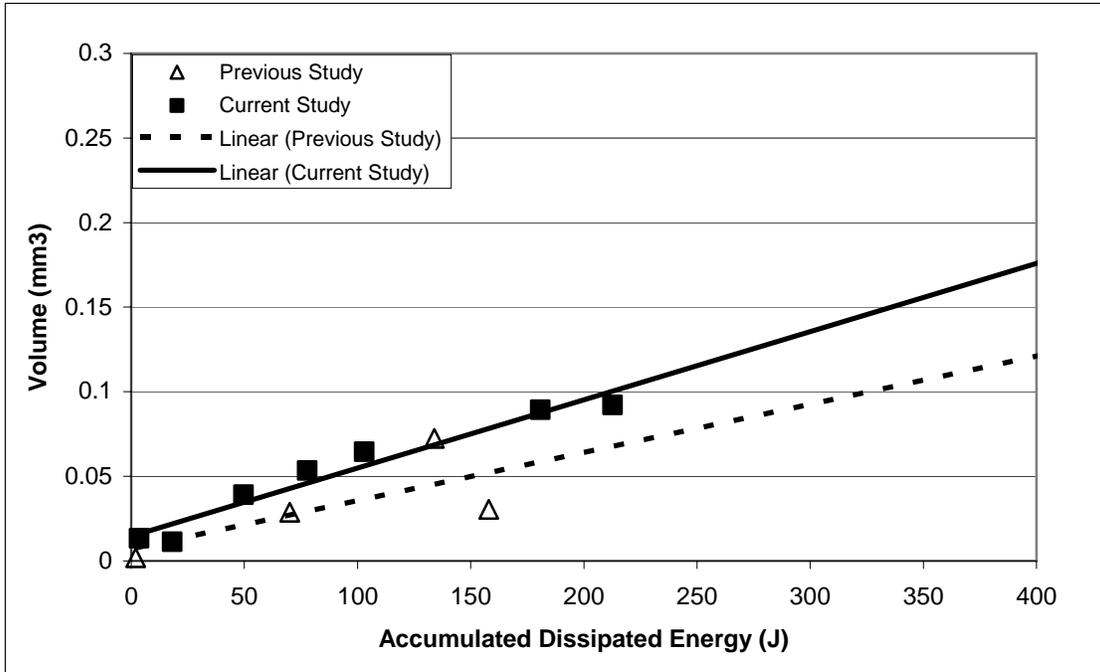
Figure 4.8 Close-in View of Accumulated Energy for Current Study

(Note: previous study data from Lee [12])

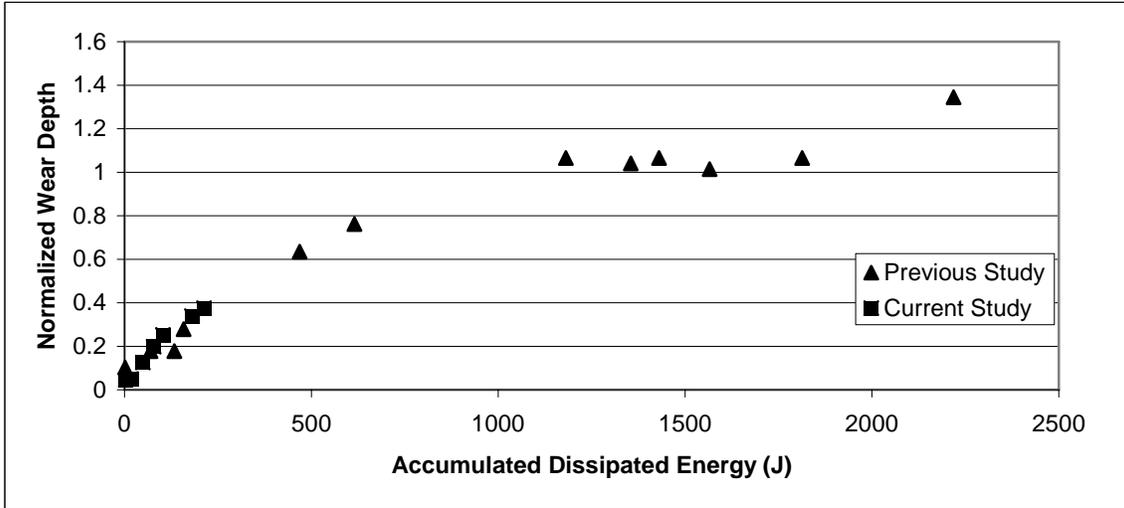
Figure 4.9 Normalized Wear Depth vs. Accumulated Dissipated Energy

(Note: previous study data from Lee [12])

The normalized wear depth as a function of the accumulated dissipated energy was also analyzed to further compare data from this study with those of Lee [12], and the depth can be seen in Figure 4.9. The normalized wear depth was calculated for each test as the ratio of the maximum wear depth to the initial thickness of the coating, which, in this study, was $40 \text{ }\mu\text{m}$.

As occurred when comparing wear volume to accumulated dissipated energy between the two studies, there were minor differences when comparing normalized wear depth, again most likely due to ambiguity in reading the surface profile measurements. In the Lee study, tests were conducted in which all of the coating was worn away and the normalized wear depth was 1.0 or greater. In the current study, there was a linear increase in wear depth with energy, but the normalized wear depth was never greater than

0.4 and the coating was never worn away—despite the large displacements that were applied in the current study.

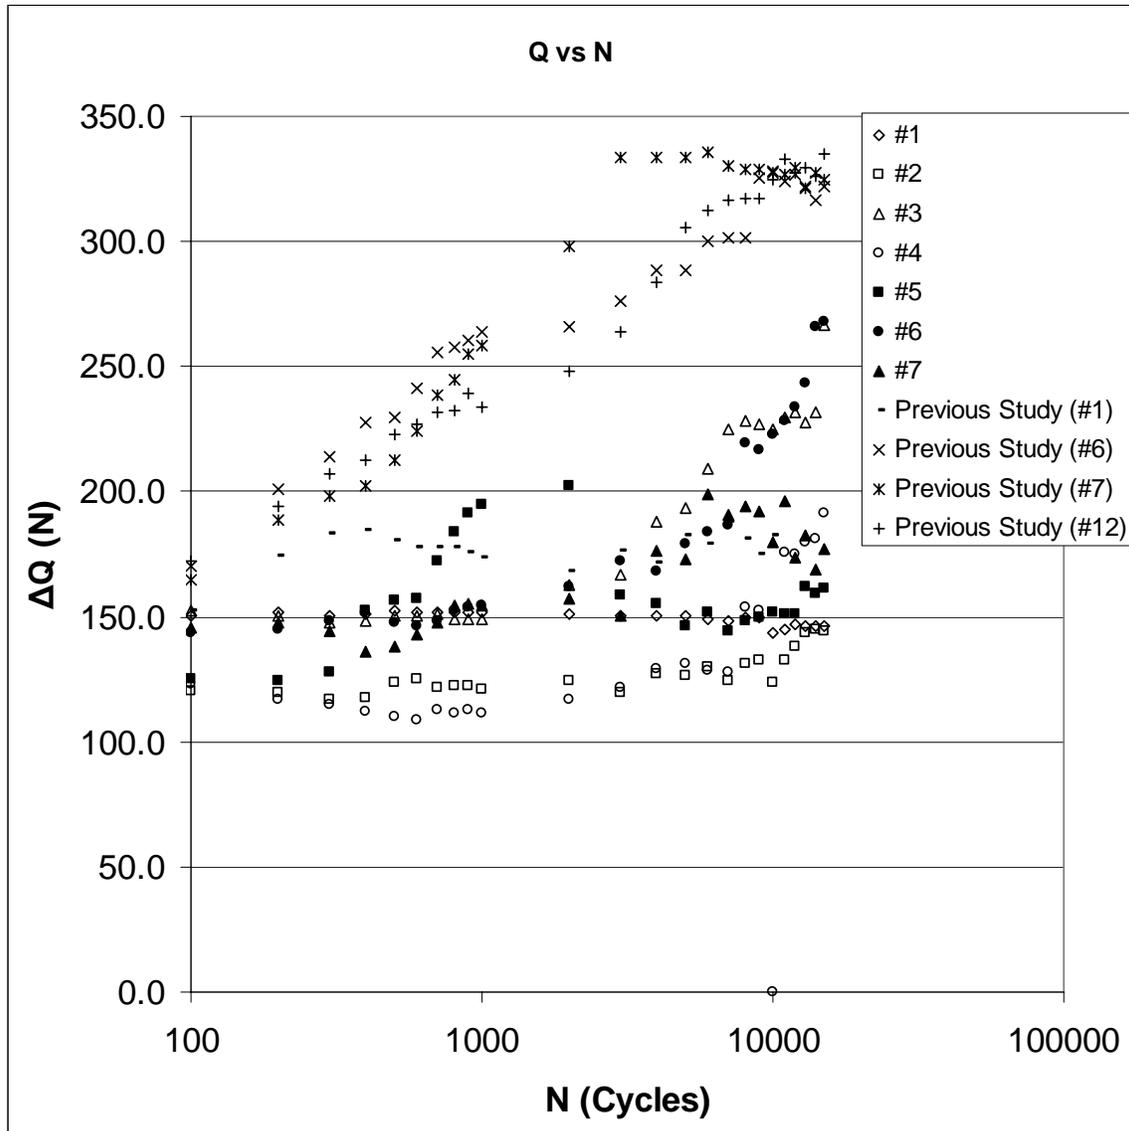
Figure 4.10 Tangential Force vs. Number of Cycles

(Note: previous study data from Lee [12])

The energy method takes into account both relative displacement and tangential force, and the results from analyzing the data from the two different studies with this method were similar. However, for a similar amount of wear volume, the relative displacements for the tests of this study were much greater than those of the previous study, so the tangential forces must be different as well. The differences in tangential force were then analyzed to help further characterize the fretting wear and contact conditions. Plots of tangential force ($Q_{\max} - Q_{\min}$, i.e., ΔQ) for each cycle can be seen in Figure 4.10.

The tangential forces measured in this study were significantly lower than those measured by Lee. Previous studies [18] have researched the relationship between the generation of wear debris and tangential force. An increase in the amount of wear debris participating in the friction process has been found to consequently result in an increase in the tangential force. Because the lubricant was entering the contact region and possibly helping to remove some of the wear debris, and because the CoF in the current study was lower than that of Lee, it was expected that the tangential force for the test cycles of the current study would be significantly lower.

tangential force stayed relatively constant, increased, or increased and then decreased. The tangential force in the current study never increased and then leveled off, as in Lee's study—this was because the tangential force never came close to reaching the applied contact load value. In this study, tests conducted under lower energy conditions had a tangential force that stayed mostly constant, as in Test 1, in which the contact condition was one of partial slip. Tests with higher energy conditions did show an increase in tangential force as the testing cycles went on became similar to those that occurred in the Lee study. There were two tests in which the tangential force actually decreased during the later part of cycling, which was not observed by Lee.

As can be seen in Figure 4.10, there is some decrease in the tangential force in the later part of the testing cycles for Tests 5 and 7; there are several possible reasons for this result. During the fretting tests, as the contact surfaces were worn due to material loss, the compressive springs that applied the normal contact load to the fretting pads were able to expand slightly and no longer provided the same initial contact force of 320 N—this was also observed by Magaziner [14]. Magaziner attributed this effect to the oscillations in Q , as plotted against N , and the reduction of the tangential force in value during the later part of cycling. This oscillation and reduction in tangential force were also observed in the current study for tests that resulted in high wear volumes (Tests 5 and 7), but not in all tests (Test 6), so this may not be a viable explanation for what occurred. In the Jin study [8], it was found that, for tests in the mixed-mode regime, there was some increase and decrease in Q —some variation of the tangential force with increasing fretting fatigue cycles. This characteristic of mix-mode contact conditions could explain the variation and decrease in tangential force for Tests 5 and 7. Analysis

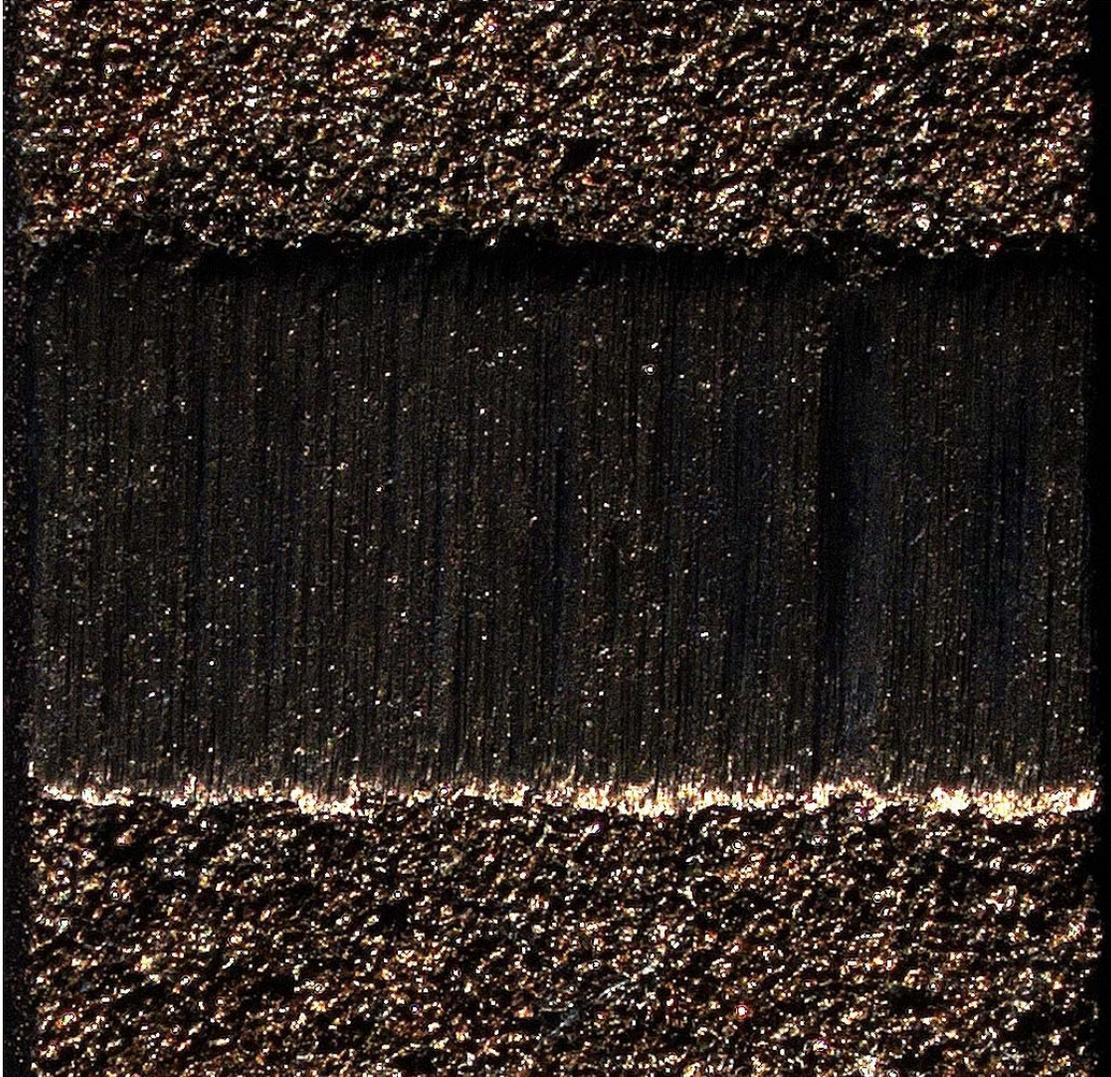
Figure A3.1 Scar with Complete Coating Wear (Test #8)

Tests were conducted with a higher level of applied displacement both with and without fatigue that resulted in a complete wear of the coating and much greater wear volumes (see Figure A3.1 and Table A3.1). Unfortunately, the 0.3-in. extensometer was pushed to its maximum range for these tests and did not record the relative displacement accurately, so these tests could not be included in analysis. Use of an extensometer with a larger gauge length would have eliminated this problem.
