DTRA-TR-03-41-V2

## *Smart Building Volume 2: System Description*

Prepared by:  
Northrop Grumman Corporation  
Defense Enterprise Solutions  
6940 South Kings Highway  
Alexandria, VA 22310

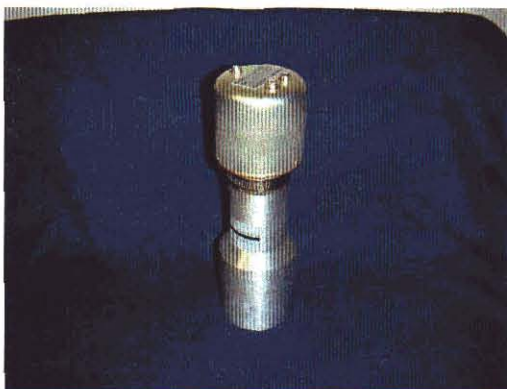
**Figure 9. Radiation Detector System**

<b>Component</b>	<b>Size</b>	<b>Weight</b>	<b>Power</b>	<b>Interface</b>
Detector assembly	10.25 inches long x 1.625 inch radius	3.81 lbs.	120 VAC, 50 mA max	LonWorks serial bus
Collimator	16.0 inches long x 2.5 inch radius	N/A	N/A	N/A
Detector with collimator	N/A	32 lbs.	N/A	N/A
Local Alarm Indicator	3.5 inches x 4.5 inches x 2.25 inches	1 lb.	N/A	N/A

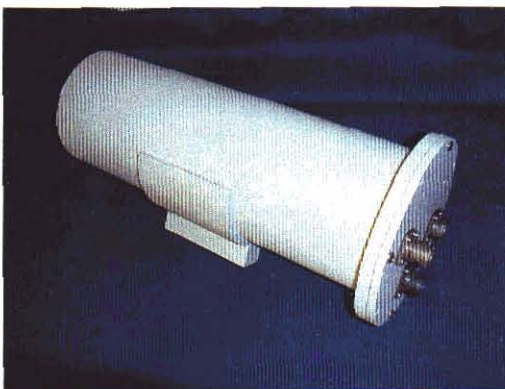
**Figure 10. Collimated Container**

The Lead Collimator would be used when the detector is installed in areas where shielding is necessary due to nearby x-ray machines. The Lead Collimator would also be used in applications where it is desirable to focus the radiation detection on a specific area. It was not used in the Smart Building application.

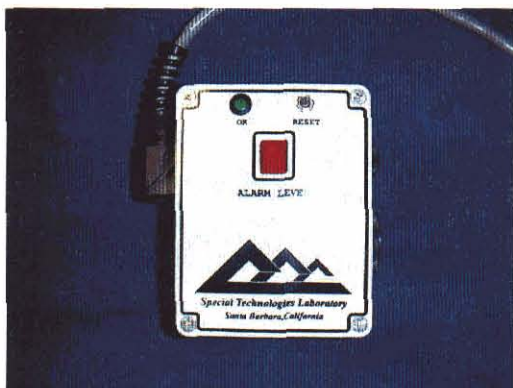
**Figure 11. Radiation Detector Local Alarm Indicator**

The Local Alarm Indicator is generally used in the immediate area where the radiation detector is located. The Local Alarm Indicator provides a guard or other operator with an audio warning when gamma radiation above normal background is detected. An alarm level indicator is also provided. The range of alarm levels is from 1 to 9 with nine indicating a high level of gamma radiation has been detected. A zero indicates no alarm. The local alarm indicators were used in the west lobby and parking garage by security personnel.

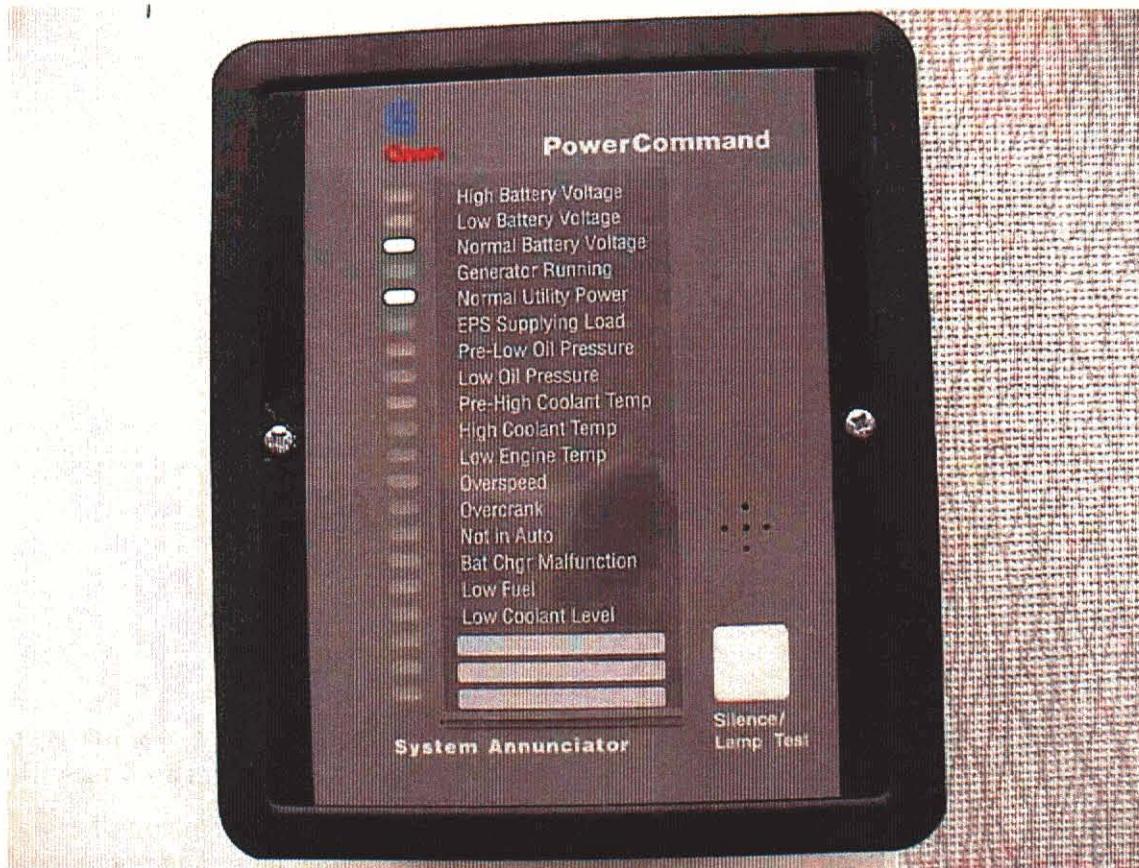
Figure 16. Remote Instrument Panel for Emergency Generator

The batteries used for starting the diesel engine were equipped with sensors that would report abnormal battery or battery charger voltage to the generator control system and remote monitoring panel located in the sixth floor control room (Figure 16).

The diesel engine and AC generator set was tested individually and as a complete system at the factory. Testing confirmed sustained functioning under partial, full, and overload conditions. The generator was tested using a portable load bank and under full building load after the CP system was operational. These tests confirmed that the Operator's Manual is correct and applicable, that the generator instruments and controls are fully functional, and that the remote panel displays the same readings as the local panel.

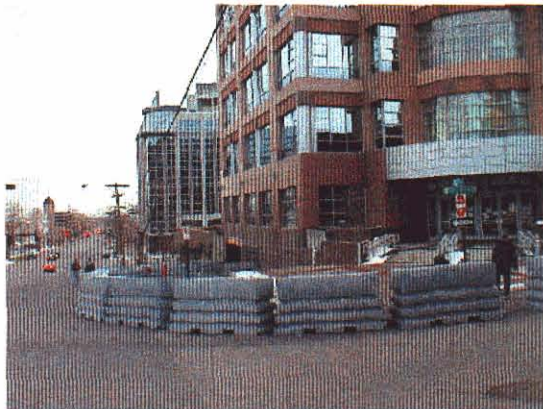
**Figure 17. Social Hall, Showing East Lobby Entrance and Barriers**

Physical security barriers were installed on Social Hall Avenue and 200 East in order to limit the access a potential terrorist may have close to the building. The barriers were installed in the traffic lane closest to the building, and Social Hall Avenue was turned into a one-way street with the traffic flow altered to allow vehicles to proceed from west to east. Barricades were also installed on 200 East to prevent vehicles from parking near the building on the west side of 200 East. These barriers extended past the south side of the building and blocked the opening near the gas main on the southeast corner.

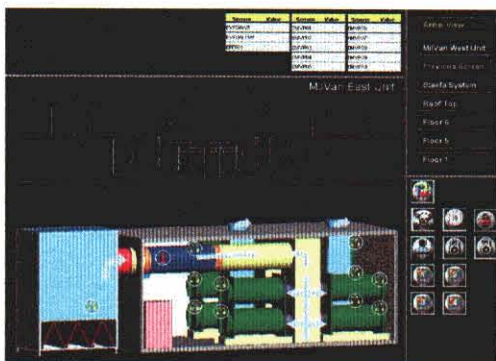
**Figure 20. MCPFS East Control Screen**

The control system utilized several screens to control the individual system components. Figure 20 and Figure 21 show the control screens for the MCPFS East and West units. Operators accessed the previously described interfaces through these screens.

In the graphical display of the MCPFS, the differential pressure transducers were shown in their approximate physical location by the icon shown in Figure 22. By touching the icon, the reading of the pressure transducer was displayed at the top left of the control screen. Similarly, the icon shown in Figure 23 graphically represented the operational state of the fan. By touching the icon, the state of the fan (either OFF or ON) was displayed at the top left of the control screen.

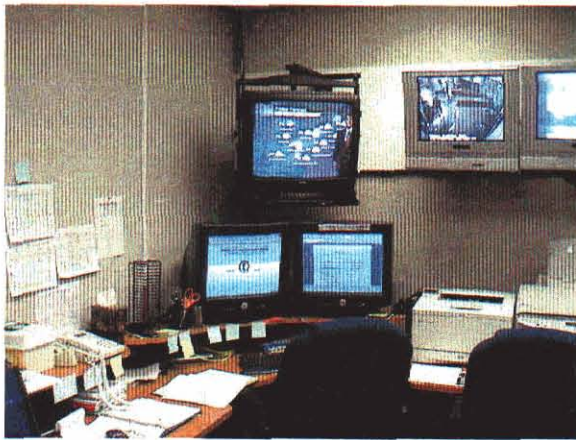
**Figure 24. Control Room, Showing Battelle PC Dual-Monitors and Broadcast/Cable TV Above**

The control room was located on the sixth floor in room 663. Figure 24 and Figure 25 show the layout of the control room. The CCTV monitors are shown mounted on the wall above the desks. Not visible are the control panels for the remote emergency generator panel, the remote fire alarm panel, server rack, a Staefa terminal and monitor, and a computer for receiving feedback and status from the JBPDS. The JBPDS status computer was not connected directly into the main server for the control system because the JBPDS operators manned the JBPDS satellite control room in the Key Bank Building on a 24/7 basis and logged all output data. The sixth floor control room also had fax and telephone message recording capability.
