**AFRL-ML-WP-TP-2006-507**

**CORROSION PROPERTIES OF Ca  
BASED BULK METALLIC GLASSES  
(PREPRINT)**

| <b>REPORT DOCUMENTATION PAGE</b> | | | | <i>Form Approved</i><br>OMB No. 0704-0188 | |
|---|---|---|---|---|---|
| <b>1. REPORT DATE (DD-MM-YY)</b><br>October 2006 | | <b>2. REPORT TYPE</b><br>Conference Paper Preprint | | <b>3. DATES COVERED (From - To)</b> | |

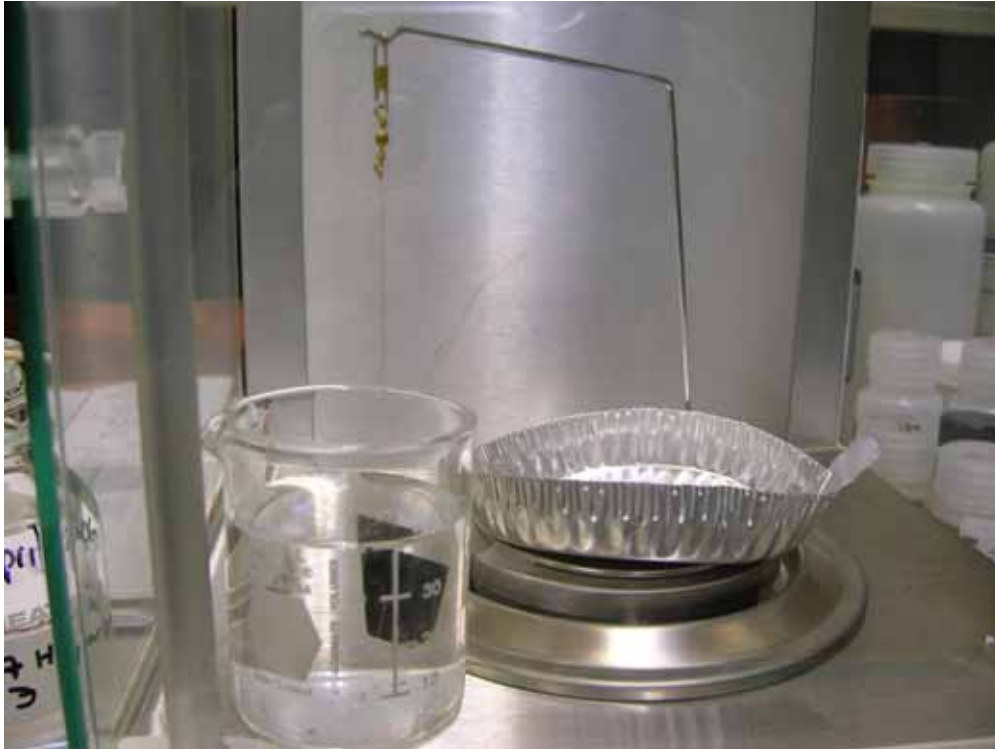
Figure 1. Experimental setup involved massing samples suspended in a distilled static aqueous environment.

The experiment evaluated the corrosion resistance in a static aqueous environment with a timeframe of ~700 hours. One sample from each alloy was attached to a nylon string and clasp with a mass of 0.1710 g. The sample was then suspended in 150 mL of distilled water ( $\text{D}_2\text{H}_2\text{O}$ ) by attaching the plastic line around a cylindrical piece of wood, and suspending the wood over the opening to a 250 mL beaker. An Al hook system was attached to a scale to measure the sample mass at selected times during the exposure. The sample weight change data points were collected while the sample was in distilled water (See Figure 1).

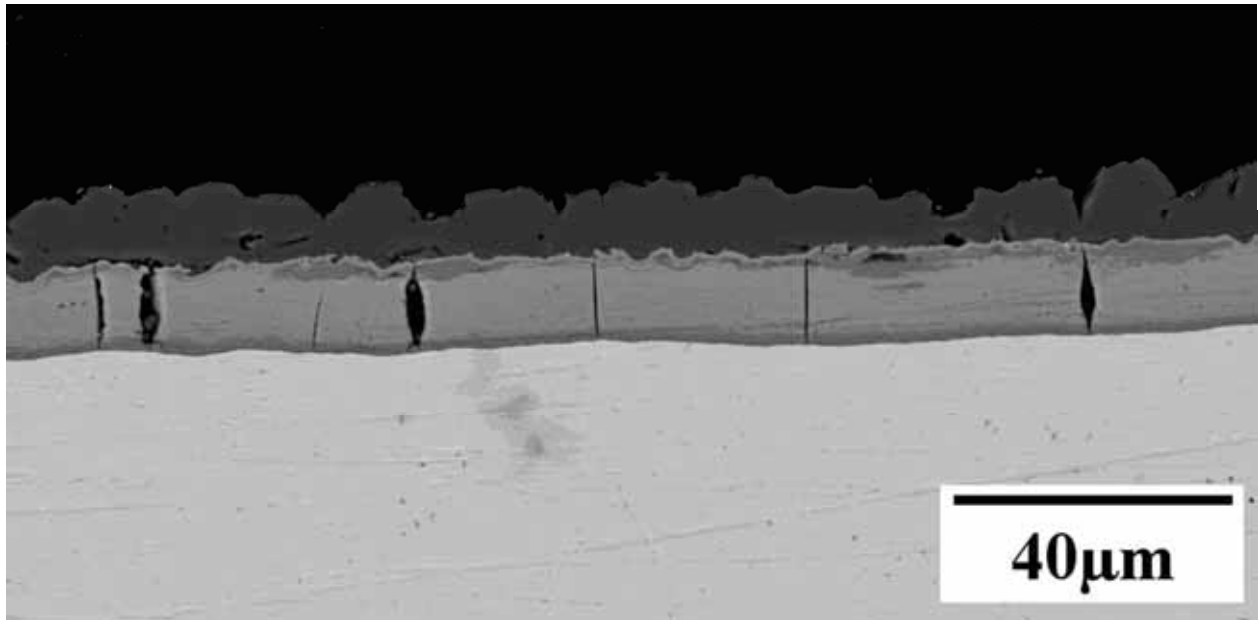
Figure 7. SEM backscatter image of a near surface region of a  $\text{Ca}_{55}\text{Mg}_{18}\text{Zn}_{11}\text{Cu}_{16}$  amorphous sample after corrosion in water for 2100 hours. A bright region at the bottom represents an image of a non-oxidized sample, above which three oxide layers are seen, which are identified by different gray levels. The darkest layer signifies the epoxy in which the sample was set.

where  $c = 1.45 \times 10^{-4} \text{ mg/cm}^2/\text{s}$  is the linear oxidation rate and  $d = 1.36 \text{ mg/cm}^2/\text{s}$ . Bubbles were present on the blackened specimen throughout the testing. After ~250 hours, a small amount of black spalled material formed on the bottom of the glass beaker. Once the spalled material was observed, the corrosion behavior changed from linear to a parabolic one (Figure 6), which can be described by Equation (1) with  $a_4 = 2.88 \times 10^{-4} \text{ mg/cm}^2/\text{s}^{0.5}$  and  $b_4 = 3.1 \text{ mg/cm}^2$ . After ~700 hours, the sample had increased 17.4 milligrams, or 1.636%. This large change in mass was verified by SEM analysis indicating an oxide film with a large thickness, roughly 30  $\mu\text{m}$  thick after corrosion in water for ~2100 hours (Figure 7). The film appeared to consist of three layers, with the majority of the structural defects occurring in the second layer. A bright region at the bottom of this picture represents an image of a non-oxidized sample, above which three oxide layers are seen, which are identified by different gray levels. The first oxide layer, which is adjacent to the non-oxidized sample region, is approximately 3  $\mu\text{m}$  thick and dark. It does not have any visible defects, except small cracks propagated from the second layer. The second,

intermediate, layer is much thicker, about 15  $\mu\text{m}$ , and has a lighter contrast and contains open cracks which are perpendicular to the sample surface. The third, external, layer is also thick and contains cracks, which are parallel to the sample surface; it has the darkest contrast and an uneven external surface. The different contrasts of the oxide layers in the backscatter electron imaging mode indicate different chemistry of these layers; in particular, the darker contrast indicates higher concentration of lighter elements. EDS analysis of the oxide layers indicate a very large presence of Ca, Mg and O in the outermost layer. This analysis also indicates that the first thin oxide layer mainly contains Ca, Zn and O, while the middle layer contains an increased concentration of Cu, Ca and O.
