**EFFECT OF PRIOR AGING ON FATIGUE BEHAVIOR OF IM7/BMI 5250-4
COMPOSITE AT 191°C**

THESIS

Christine G. Ladrido, Captain, USAF

AFIT/GAE/ENY/07-J10

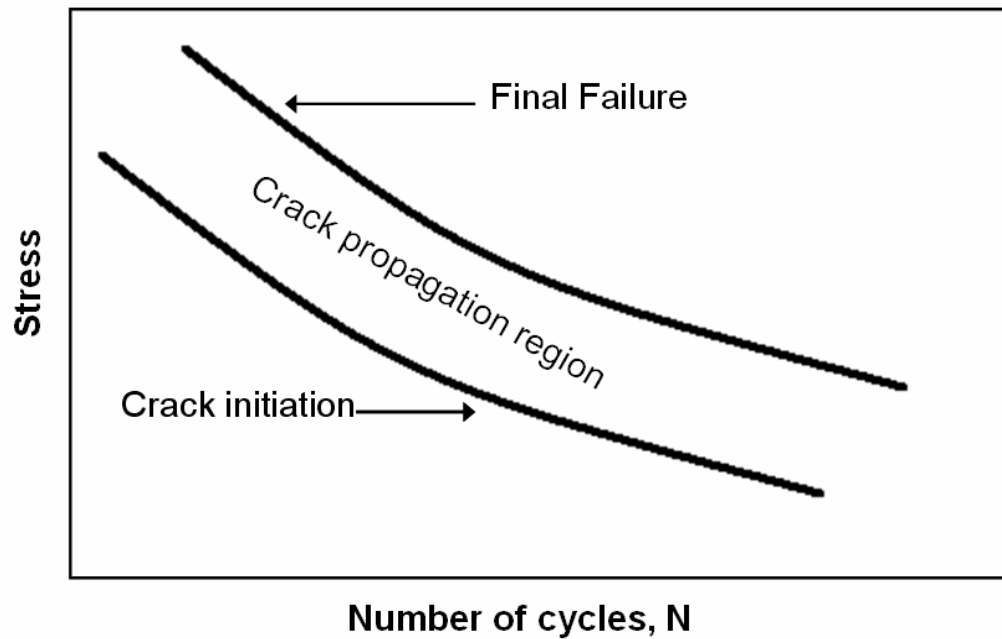
Figure 4. Three stages of fatigue life cycle for general material

was observed to be a three-stage process (Figure 4). Defects in fabrication or design caused the initiation stage to be shortened or nonexistent leading to shorter cycle life [12].

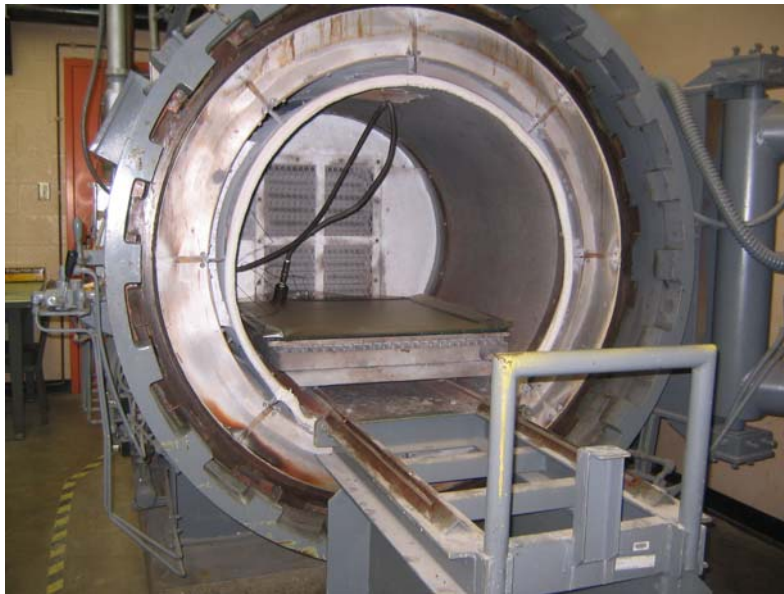
Figure 11. Autoclave setup which was used to fabricate the laminates (at AFRL facility)

A total of 8 plies from each fiber orientation were used to create a laminate of 16 plies. These stacked sheets of lamina were then placed in an autoclave which is pictured in Figure 11. Figure 12 shows an example of how the material is setup while inside the autoclave. The autoclave molding process is used for fabrication of high-performance advanced composites for military, aerospace, transportation, marine, and infrastructure applications. The bleeders (also called breathers) consist of dry glass fibers or mat. These are used to absorb the excess resin and allow for the escape of volatiles during the curing process. The entire assembly of prepreg layup and auxiliary materials is sealed

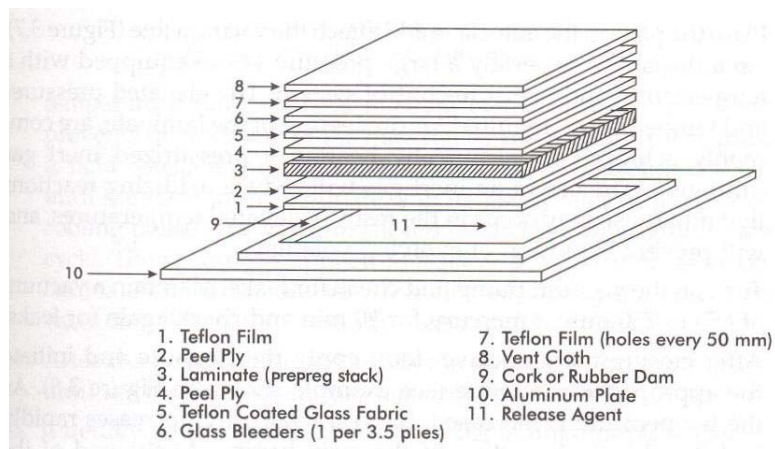
Figure 12. Vacuum bag preparation for autoclave cure of thermoset composite [10]

with a vacuum bag onto a tool plate (Aluminum plate) [10]. The curing process is essentially, the manufacturer prescribed temperature-pressure-vacuum-time cycle inside the autoclave chamber. Four laminate plates of IM7/BMI 5250-4 were created using the manufacturer suggested curing temperature and time of 375°F (191°C) for 6 hours and a 6 hour post-cure at 440°F (Figure 13).

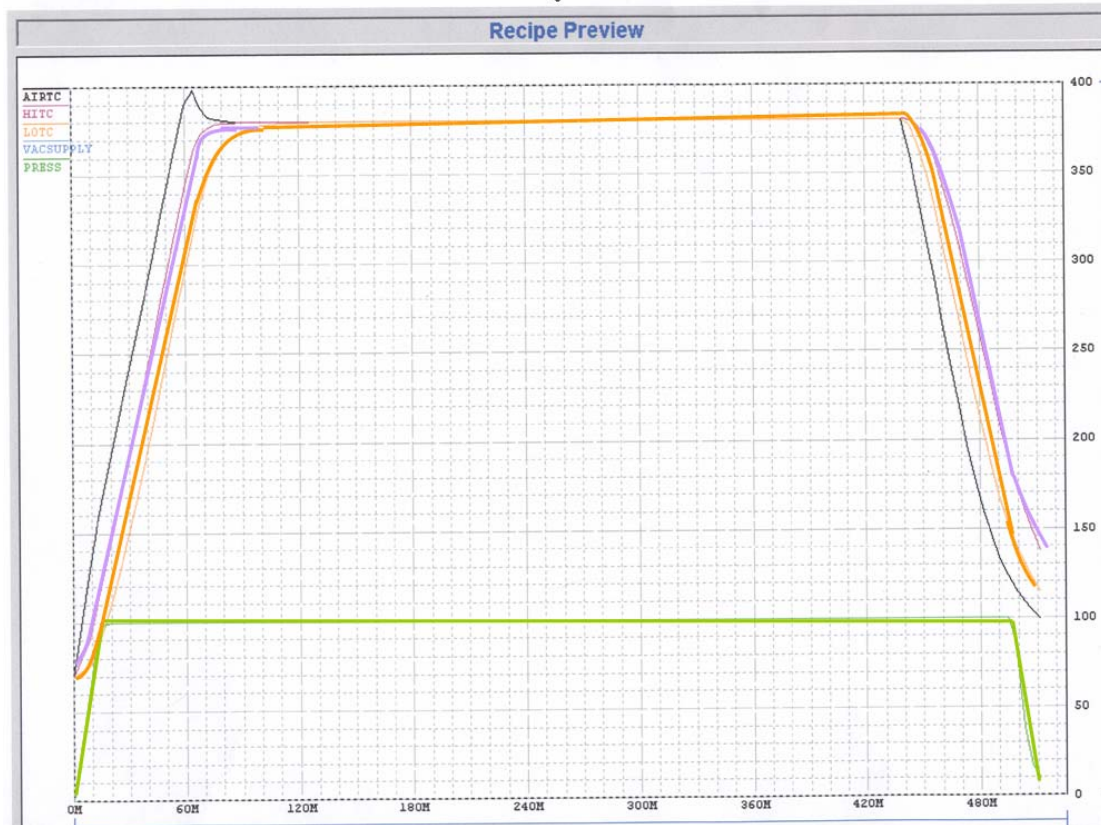
Figure 13. Plot of manufacturer’s suggested curing cycle for the IM7/BMI 5250-4 prepreg in the autoclave

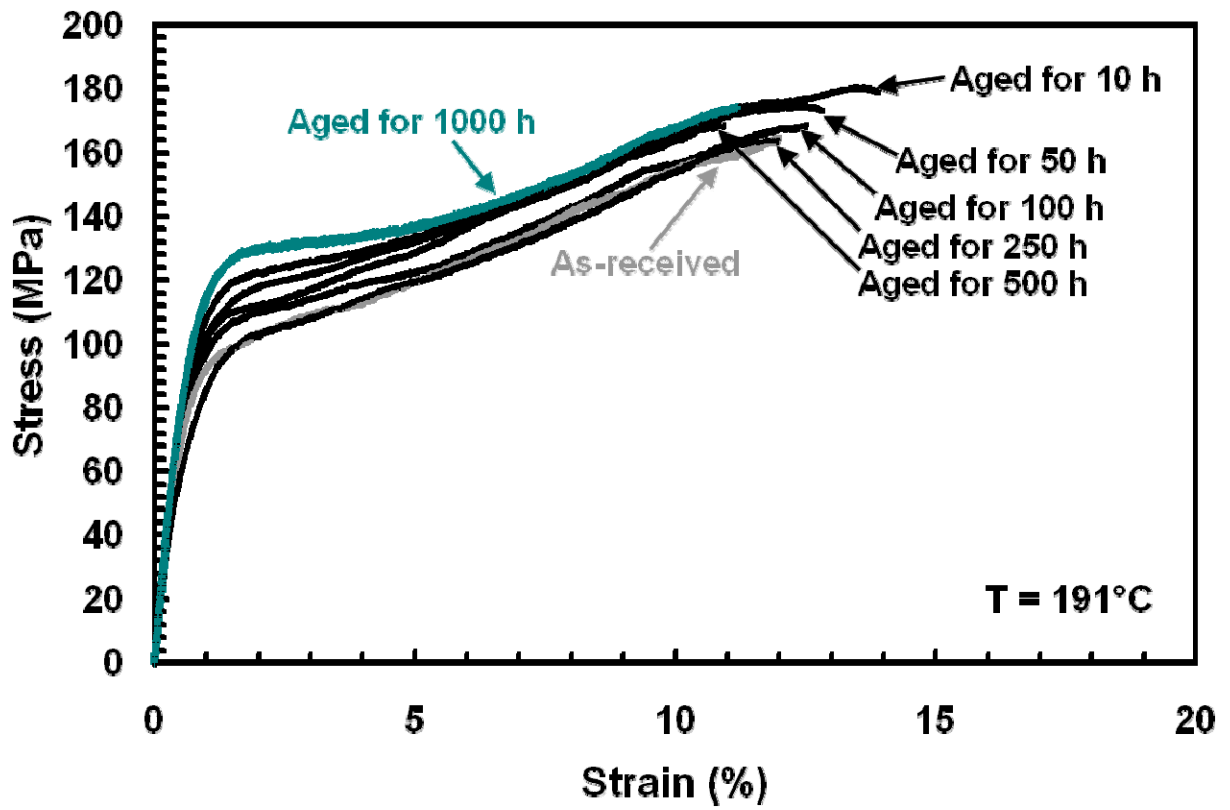
Figure 23. Stress-strain curve of all the [+45] specimens after tensile to failure test

In addition to the as received (virgin) specimen, tensile to failure tests were also conducted on the aged material. Figure 23 shows a plot of the $[\pm 45]$ aged specimens compared to that of the unaged virgin specimen.

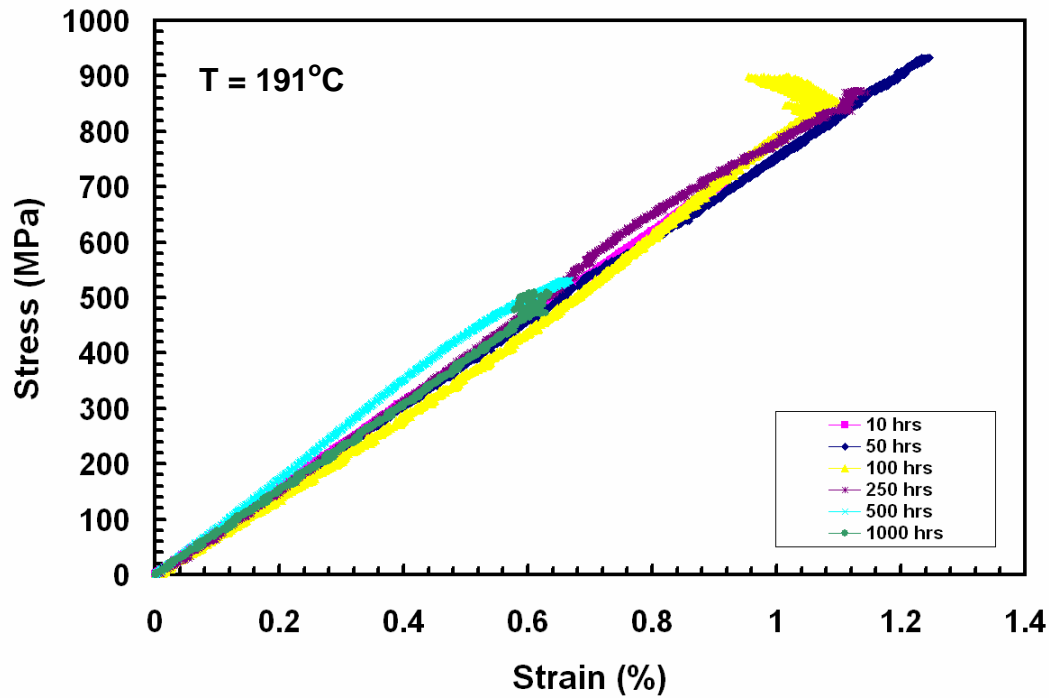
Figure 24. Stress-Strain curve of all the [0/90] specimens after tensile to failure

Table 4 shows the values for all of the aged [0/90] tests. As with the unaged virgin specimen, the strain at failure reached 0.7 to 1%, the UTS decreased but still remained within the range of the unaged virgin specimen, and the modulus stayed close to the initial values as well.

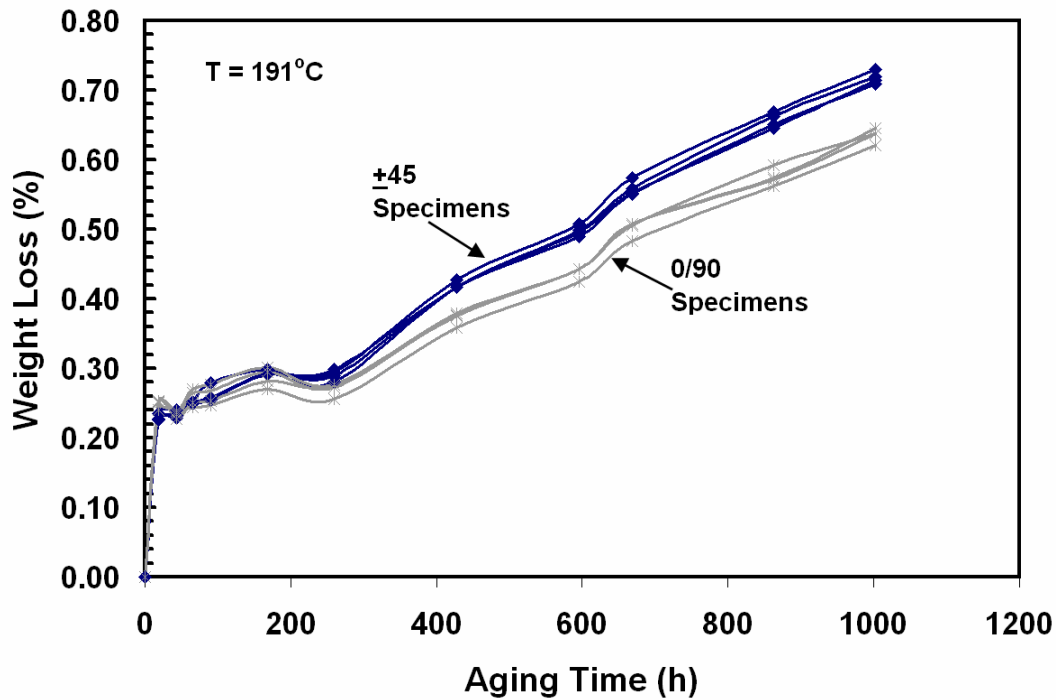
Figure 28. Weight loss (in percentage) of [± 45] specimens aged for 1000 hours

Figure 27 illustrates that there was a steady decrease in weight over the 1000 hours of aging which was similarly experienced by both fiber orientations. Figure 28 provided a percentage form of the weight loss for all the specimens in both fiber orientations. This plot shows that there is actually a difference between the weight losses of the two fiber orientations. From this figure, it can be seen that the percent weight loss during the first 250 hours of aging were similar. For the hours following this, the $[\pm 45]$ specimens lost much more of their weight as compared to the $[0/90]$ specimens. This is thought to stem from the fact more fiber ends were exposed on the edge of the $[\pm 45]$ specimens causing more matrix degradation at these points where oxygen could enter into composite. The oxidation within the composites causes the degradation of the matrix. The weight loss (in grams) of the four specimens aged for 1000 hours for each fiber orientation is presented in Table 6 with respect to the number of hours of aging. It also shows that the average weight of the $[0/90]$ specimens was higher than the $[\pm 45]$ specimens.

Figure 27 and 28 are plots that take into account only the weights from placement into the aging oven. As discussed in Chapter III, the specimens were placed in a vacuum oven prior to being placed in the aging oven to remove any extra moisture it may have contained. The percent weight loss of all the specimens from the vacuum oven resulted in about 0.3%. Much of this weight loss is thought to be attributed by the release of moisture from the specimen that was collected after fabrication in the autoclave as well as during machining and transportation of the materials through ambient air as well as from the people handling them without wearing gloves.

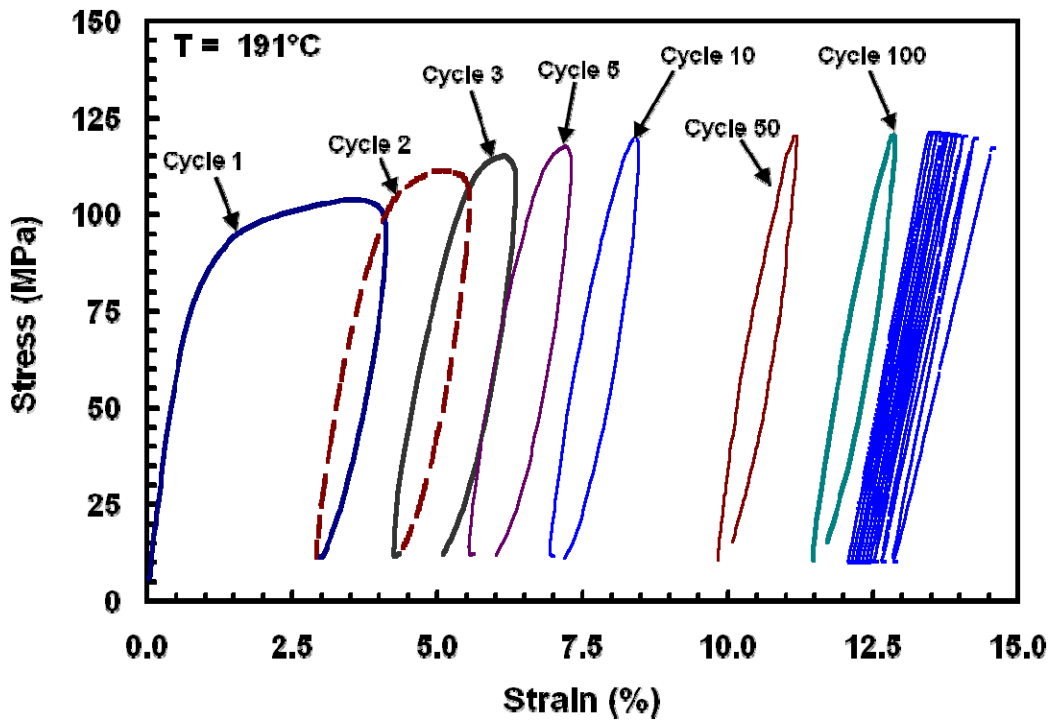
Figure 29. Hysteresis of an unaged $[\pm 45]$ specimen loaded at 132 MPa (80% UTS)

Using the UTS and modulus from the tension to failure tests, the specimens were tested at varying ranges of fatigue at 191°C. The unaged (as received) specimens were tested at 80%, 70%, 60%, and 40% of the UTS. Figures 29 through 32 show the evolution of hysteresis loops for each of these tests. The evolution of hysteresis loop is a plot of the stress versus the strain during the tension-tension cyclic load fatigue test. Each “loop” in these plots represents a cycle during testing. From these figures it can be seen that the specimen accumulate strain as the number of cycles increased. For the unaged specimen loaded at 80% UTS, the specimen failed after 120 cycles of loading. The plots are presented with similar axes ranges for ease of comparison. It appears that as the percent of UTS decreases, the stress as well as the strain accumulation decreases as well.

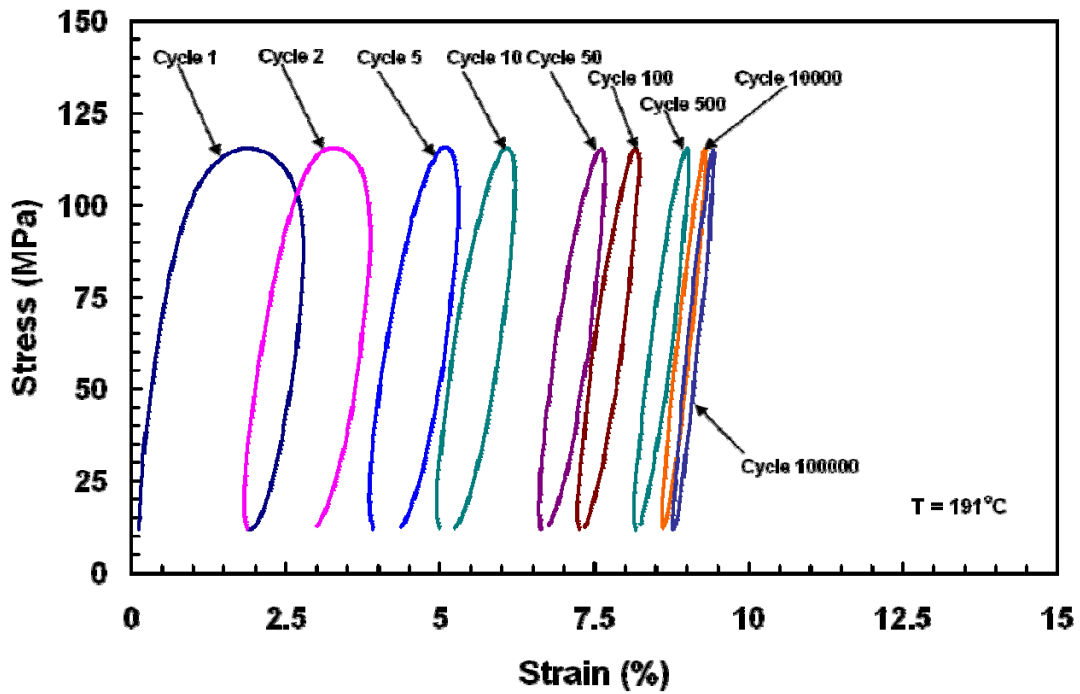
Figure 30. Hysteresis of an unaged $[\pm 45]$ specimen loaded at 115.5 MPa (70% UTS)

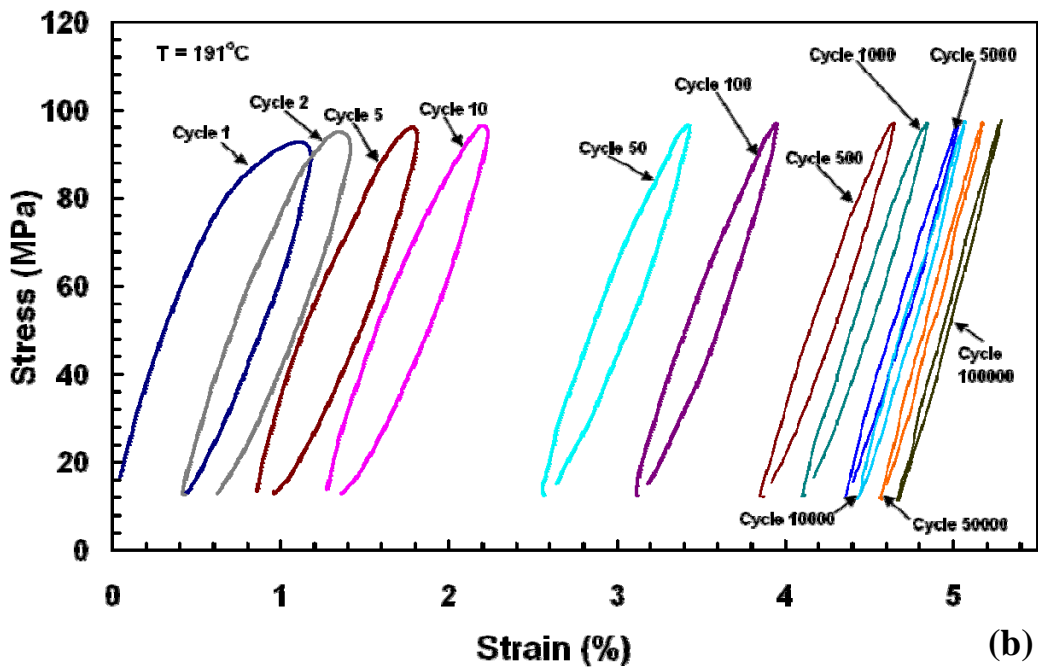
Figure 31. Typical evolution of hysteresis for an unaged $[\pm 45]$ specimen loaded at 99 MPa (60% UTS) (a) for comparison with other hysteresis plots (b) shows more detail

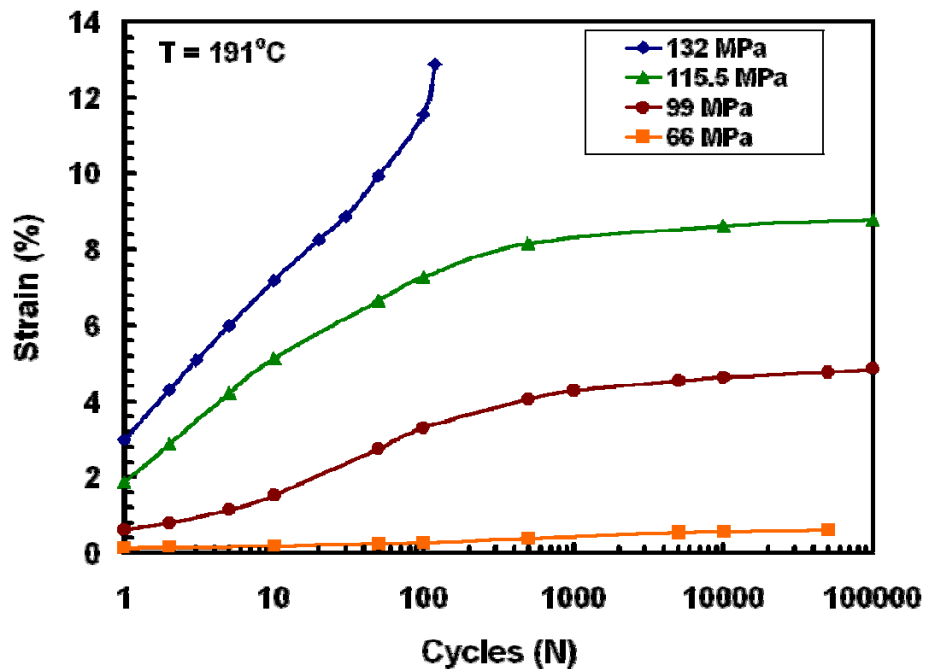
Figure 34. Ratchetting of the unaged $[\pm 45]$ specimen for all of the stress levels

Figure 34 is a plot of how much strain was accumulated at the end of each cycle and is plotted as a function of cycle number for each of the four fatigue load levels. From this plot, it shows that the strain increased drastically prior to failing in the 80% UTS fatigue test. The reason for this could stem from the fact that matrix fracture had already occurred and the final stages of strain accumulation were from the “scissoring” of the fibers.

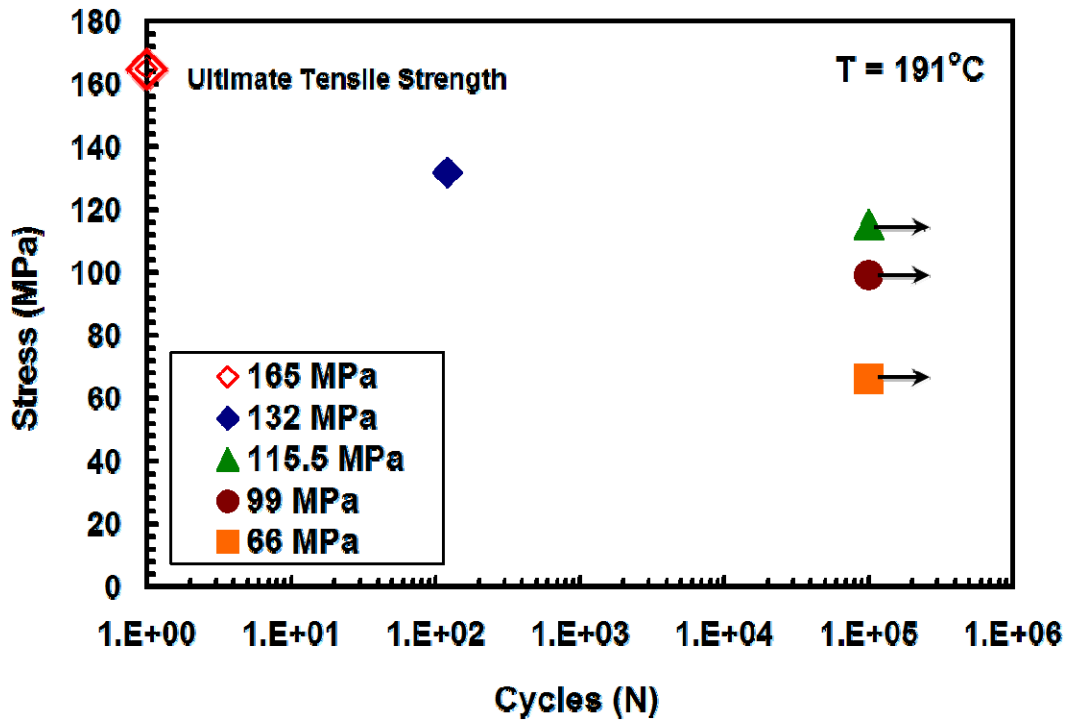
Figure 35. Fatigue S-N Curve for $[\pm 45]$ unaged specimens

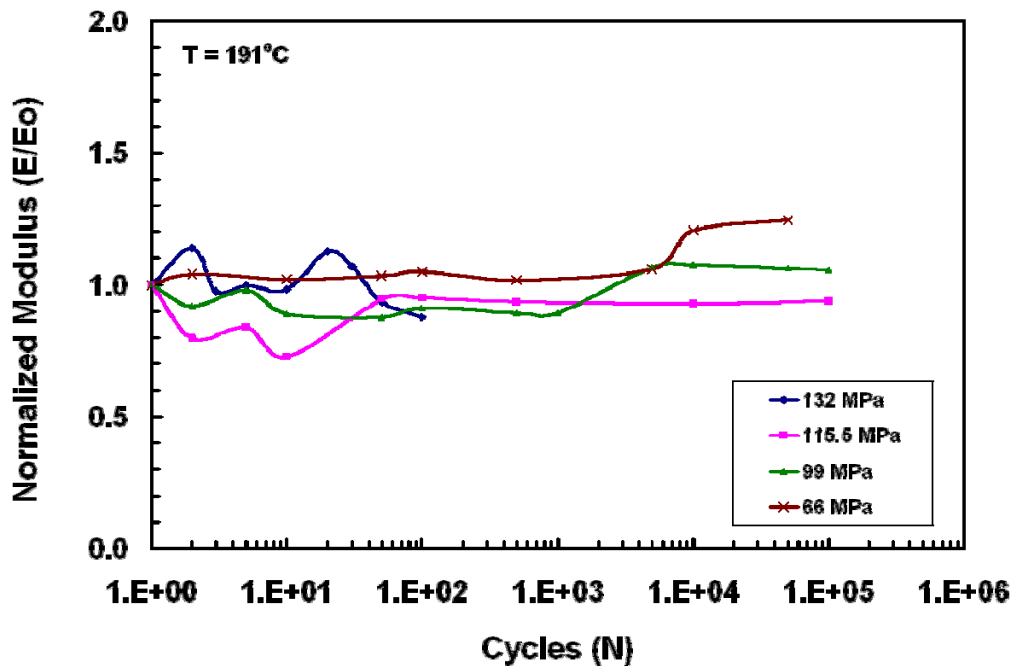
Figure 36. Normalized modulus vs fatigue cycles of $[\pm 45]$ unaged specimen

The normalized modulus as a function of cycle number is plotted in Figure 36. These plots were created by taking the modulus from the initial linear portion of the cycle “loop”. For consistency, a range of 10 to 40 MPa was selected to obtain the modulus at each cycle that the material survived. This plot shows that the modulus decreases at the beginning of loading and then at some point starts to increase. This means that through cyclic fatigue loading the composite gets stiffer. This is probably caused by the realigning of the fibers in the load direction. In addition the point at which the specimen starts to increase becomes later in the number of cycles as the load level is decreased. There are some relatively high peaks in these plots that are attributed to noise in the data acquisition.

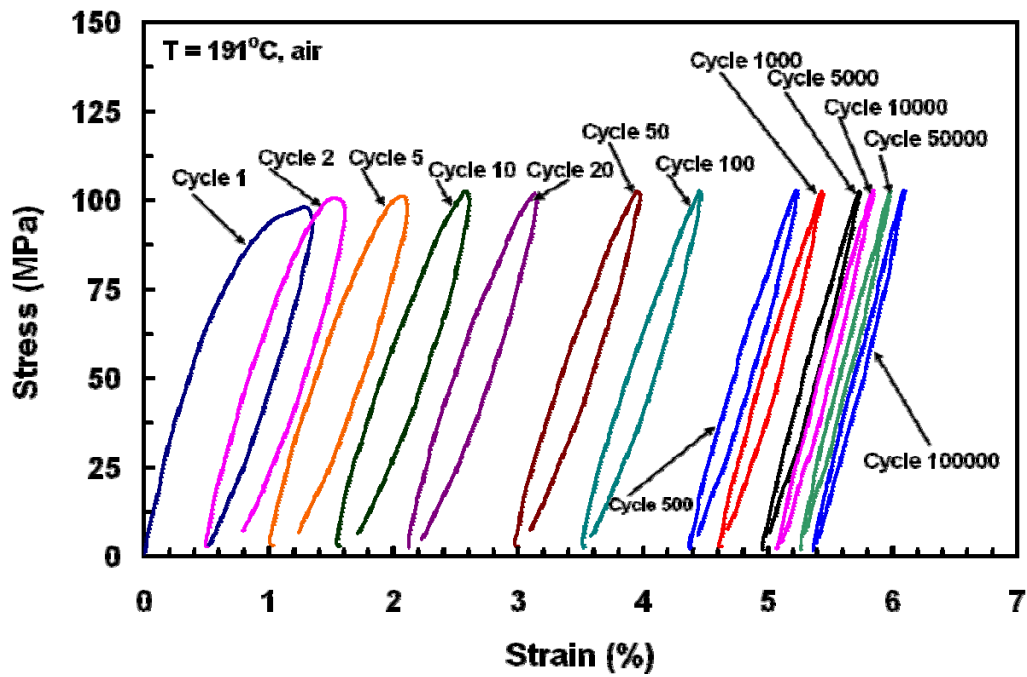
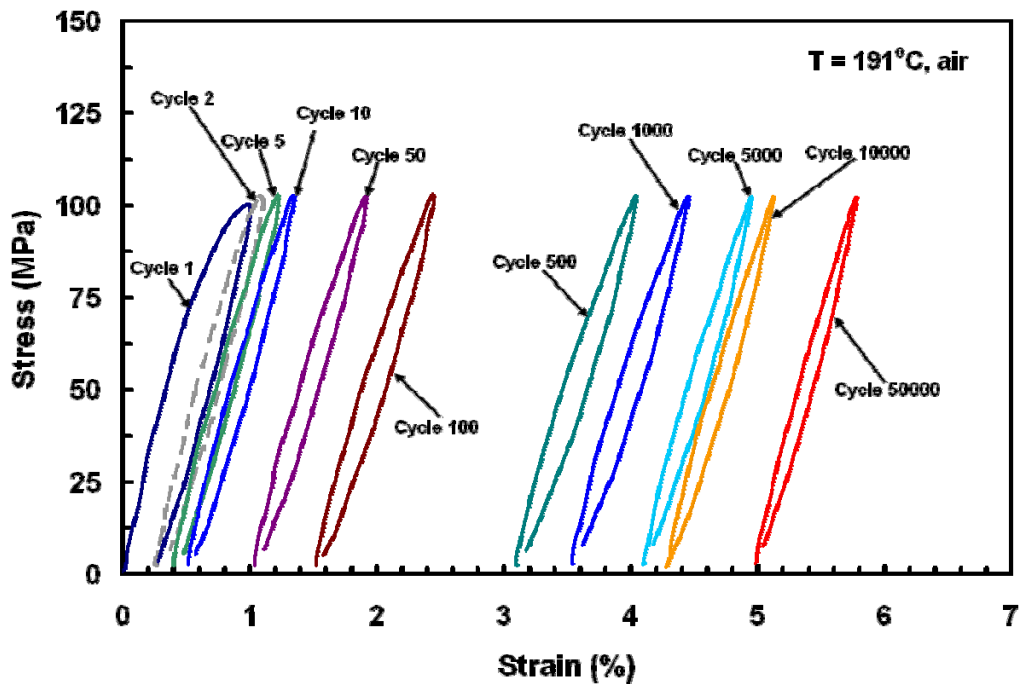
Figure 37. Hysteresis loop for $[\pm 45]$ specimen aged for 10 h

Figure 38. Hysteresis loop for $[\pm 45]$ specimen aged for 50 h

Figure 39. Hysteresis loop for $[\pm 45]$ specimen aged for 100 h

Figure 40. Hysteresis loop for $[\pm 45]$ specimen aged for 250 h

Figure 41. Hysteresis loop for $[\pm 45]$ specimen aged for 500 h

Figure 42. Hysteresis loop for $[\pm 45]$ specimen aged for 1000 h

Figures 37 through 42 are evolution of hysteresis loops for the specimens aged at 10, 50, 100, 250, 500, and 1000 hours at stress and temperature levels of 70% UTS and 191°C. The same or similar axis ranges have been used on these plots for ease of comparison. It is interesting to see from these graphs at which strain percentage the cycle falls. These results show that tension-tension fatigue life cycle decreases with increasing prior aging time.

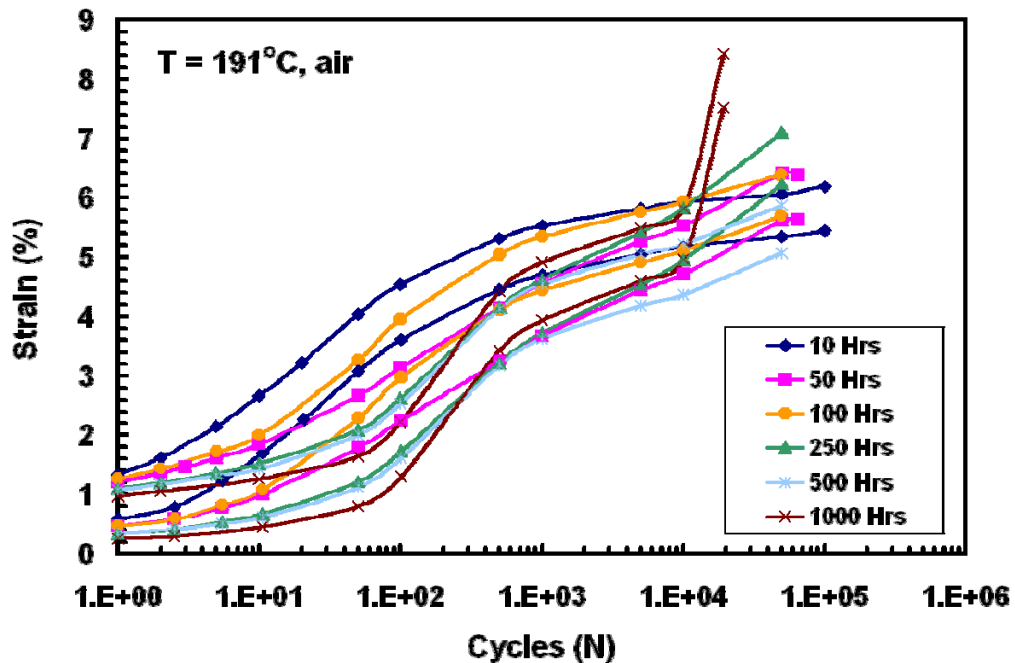
Figure 43. Maximum and minimum strains as functions of cycle number for aged $[\pm 45]$ specimen

Figure 43 shows the maximum and minimum strain curves as a function of aging time for the aged $[\pm 45]$ specimens. It shows that the specimens followed a similar rate of increase without too much variation among the different aging times. The rapid increase in the 1000 h specimen prior to failure could be attributed to the fact that there was already a crack in the matrix prior to complete separation of the specimen into two pieces.

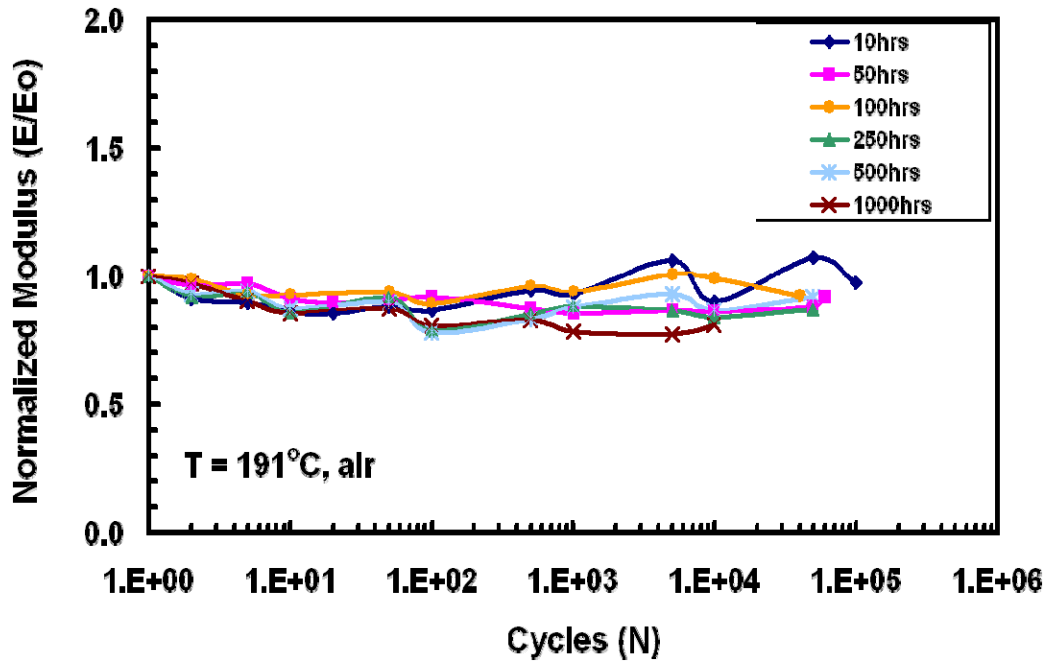
Figure 45. Normalized modulus vs fatigue cycles of $[\pm 45]$ aged specimens

Figure 45 shows that as the fatigue cycling increases, the normalized modulus decreases with increasing cycles. For most of the aging times, the modulus decreases between 3 to 13%, but for the 500 and 1000 h specimens, the final decrease reaches up to almost 20%.

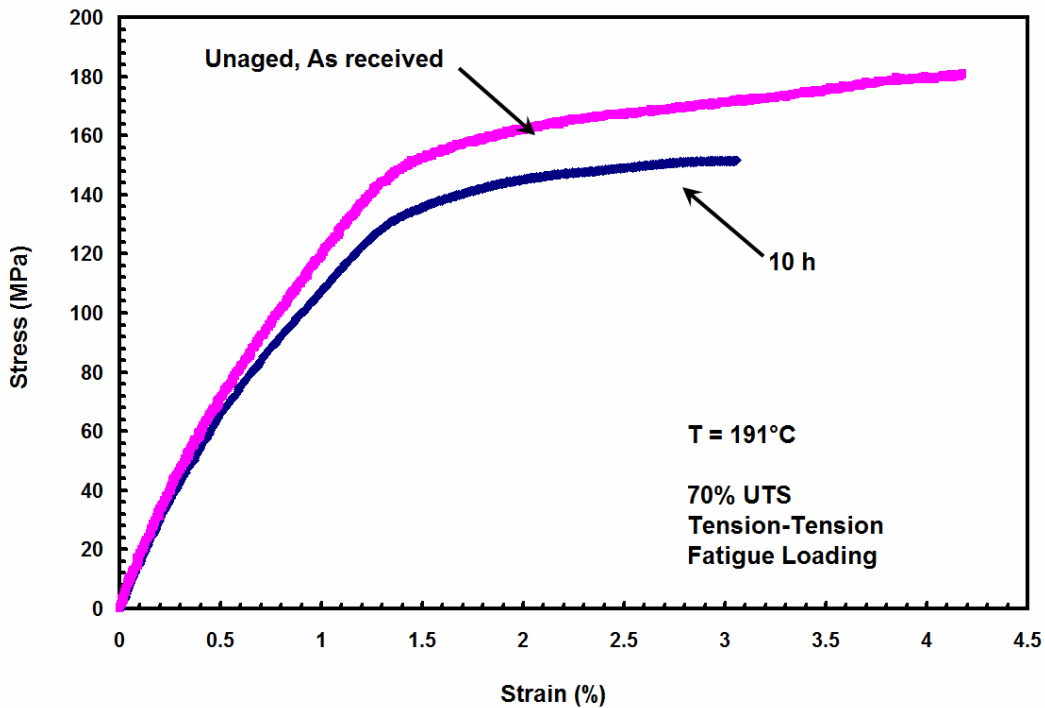
Figure 46. Retained stress-strain curve of the 10 h specimen compared to the unaged specimen at the same load level

Figure 46 shows a comparison between the stress-strain curves of the unaged and 10 h aged $[\pm 45]$ specimens that underwent 70% UTS cyclic fatigue loading at 191°C.
