## The Use of Sand Fences in Barrier Island Restoration: Experience on the Louisiana Coast

*By Syed M. Khalil*

**PURPOSE:** This System-Wide Water Resources (SWWRP) technical note describes experiences with sand fences to reduce losses by wind-blown sand transport on restored barrier islands in Louisiana. Seven installations of sand fences with various plan view orientations and cross-sectional designs are reviewed. Recommendations are given for use of sand fences in conjunction with restoration of barrier island systems.

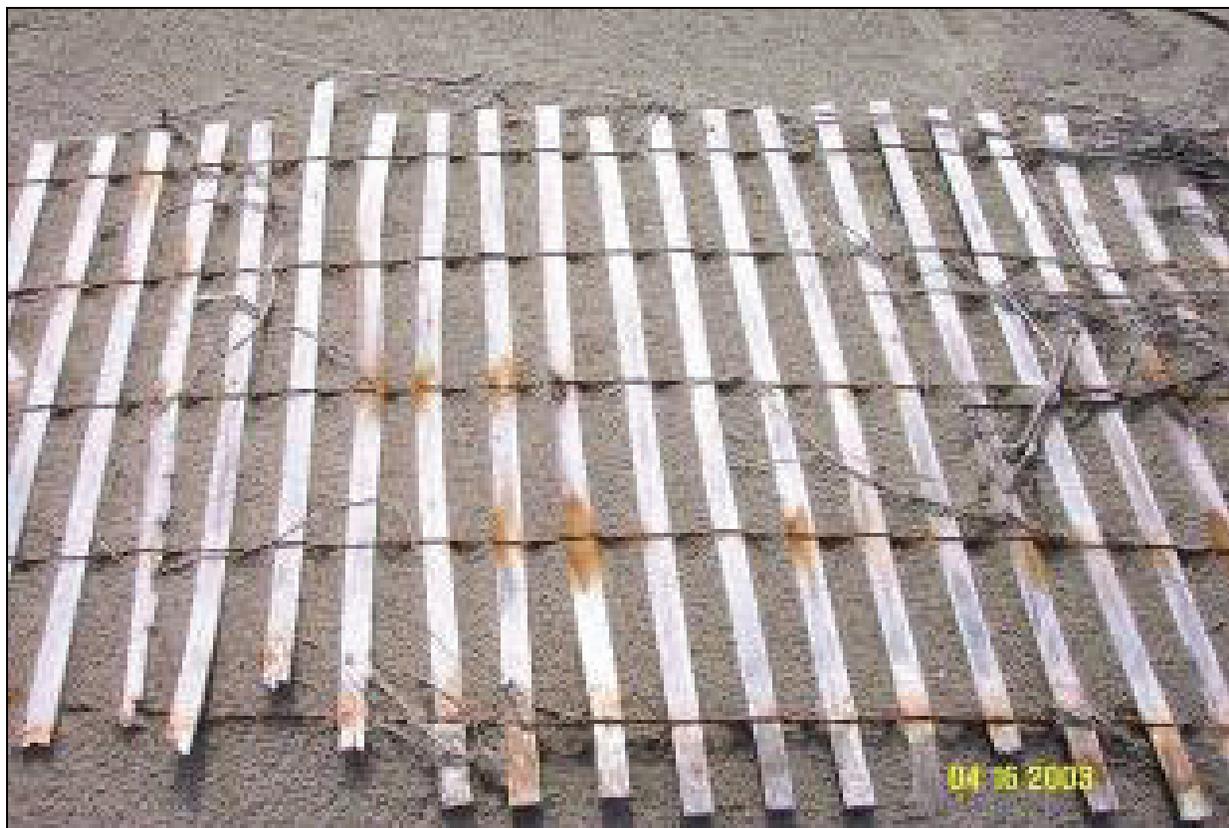
Figure 2. Sand fence nearly 3 years after installation; shrinkage and breaking of wooden slats have increased porosity through time.

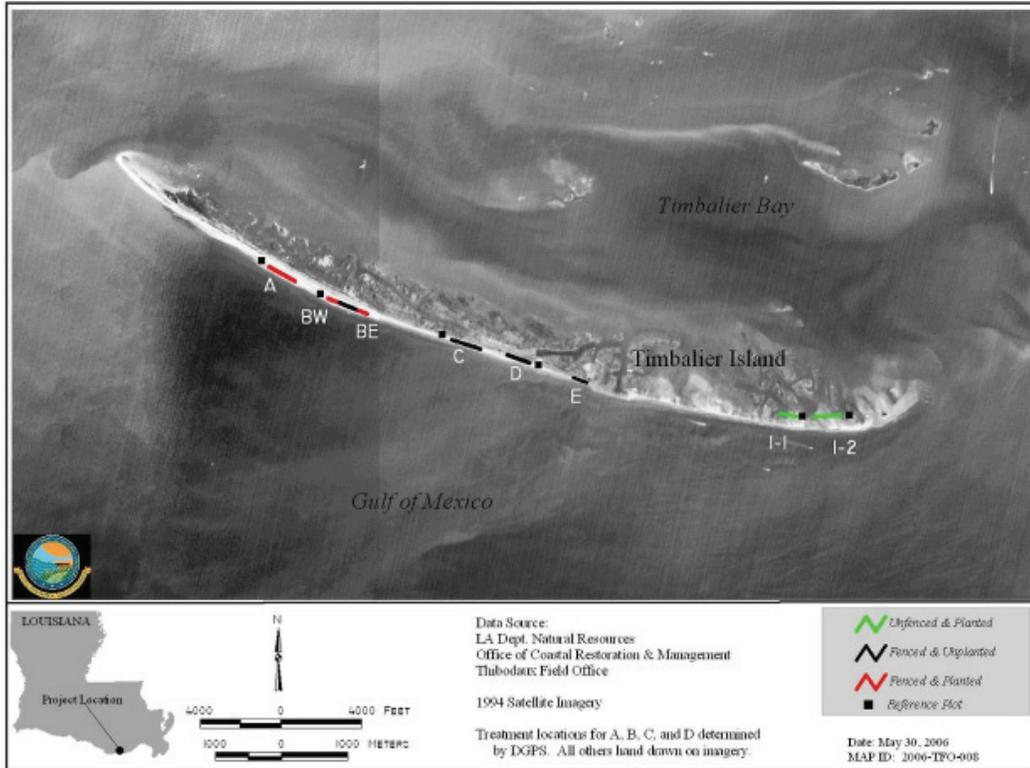
Figure 7. Timbalier Island Plantings Demonstration project features.

**Timbalier Island Plantings Demonstration (TE-18).** The first sand fence in Louisiana was installed on the western side of Timbalier Island during the Timbalier Island Plantings Demonstration Project. This project was initiated in May 1995 and consisted of fences with vegetative plantings. Project goals were to be accomplished by the construction of approximately 2,300 m of sand fences at seven sites along the length of the island (Lee et al. 2006). Each site had a primary fence oriented parallel to the gulf shoreline with perpendicular spurs every 15.2 m that extended 7.6 m bayward from the primary fence (Figures 7 and 8). Fence construction was completed in July 1995. Numerous tropical storms impacted the fences, and repairs were conducted in October 1995 to sections A through D (see Figure 7 for locations). Fence sections E, I-1, and I -2 were damaged beyond repair and abandoned. Fence sections B through D were repaired again in July 1996 immediately prior to planting due to additional storm damage (Lee et al. 2006).

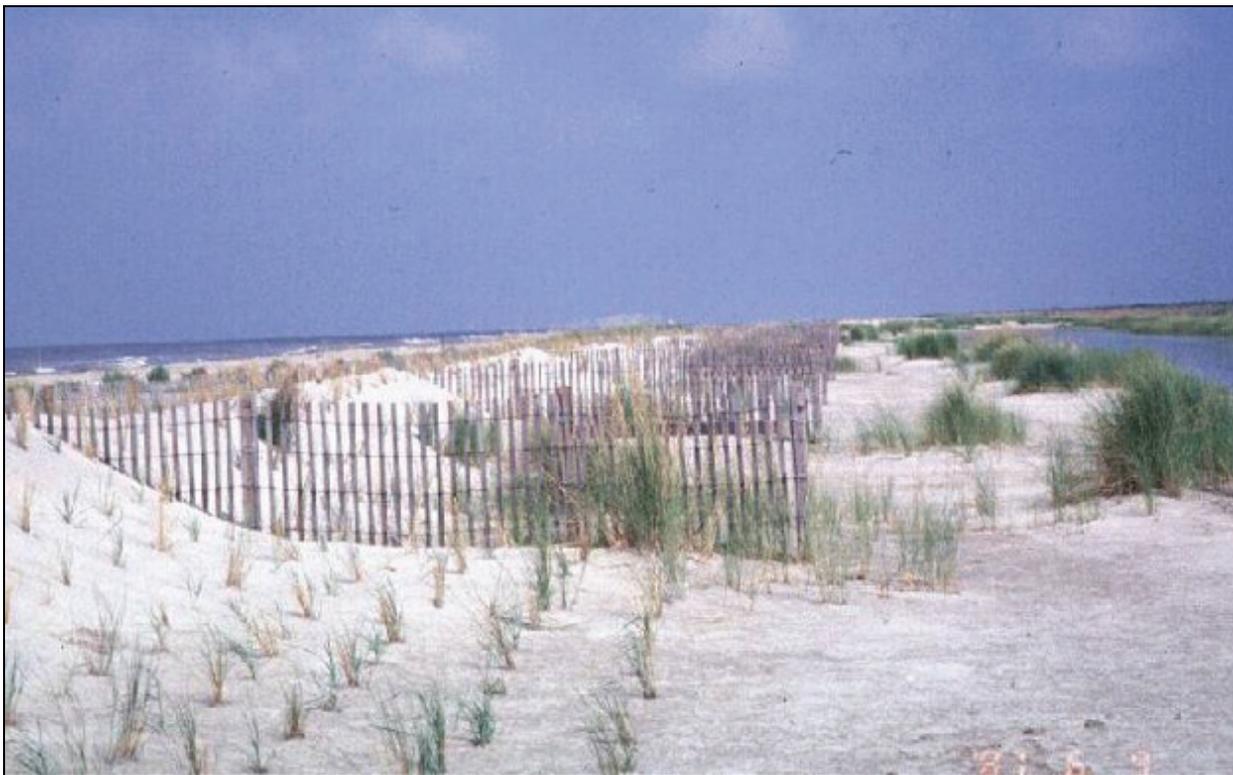
Figure 8. Sand fences (parallel to gulf shoreline) with perpendicular spurs (extending towards bay) at Timbalier Island Plantings Demonstration Project (Site A July 1996, looking northwest).

The specific goals of the project were to increase the elevation of areas enclosed by the fences and to increase the percent cover of emergent vegetation behind them. To evaluate meeting these goals, aerial photography, surveys, and vegetation sampling were conducted to determine changes in habitat, acreage, elevation, volume, and vegetation cover and composition. The sand fences and plantings created dunes (Lee et al. 2006). These results indicated that initial filling of the fences was rapid, followed by a decline in sand accumulation. However, a decrease in the accumulation rates in the reference (nonfenced) areas seemed to indicate other factors were involved, such as reduced sand availability and shore erosion. Townson et al. (2000) reported much lower volume accumulations per linear meter of beach for this project than had been measured in previous studies for other parts of the country (Savage and Woodhouse 1969; Dahl et al. 1975; Myer and Chester 1977; Woodhouse et al. 1976; Knutson 1980). However, all but one site experienced erosion throughout the project life. Dunes grew in elevation at an annual rate of 12.2 cm/year, whereas associated nonfenced reference plots grew at an average rate of 9.1 cm/year over the 5-year period (Lee et al. 2006). Even well established dunes could not prevent the natural transgression of the shoreline that eventually eroded as the shoreline receded landward. This is evidenced by the fact that all treatments, other than site A, eroded from east to west, as the barrier island's natural process of northwestward migration occurred. One-time applications of fences and plantings cannot stabilize the beach, which will continue to exhibit similar migrational behavior on Louisiana's highly transgressive shorelines.

Based on observations at this site, Mendelssohn and Hester (1988) reported that sand fences with spurs accumulated more sand during the first year of construction compared to other designs tested. However, after 3 years, a straight fence design collected approximately 160 percent more sand than the fence with spurs (Mendelssohn and Hester 1988).

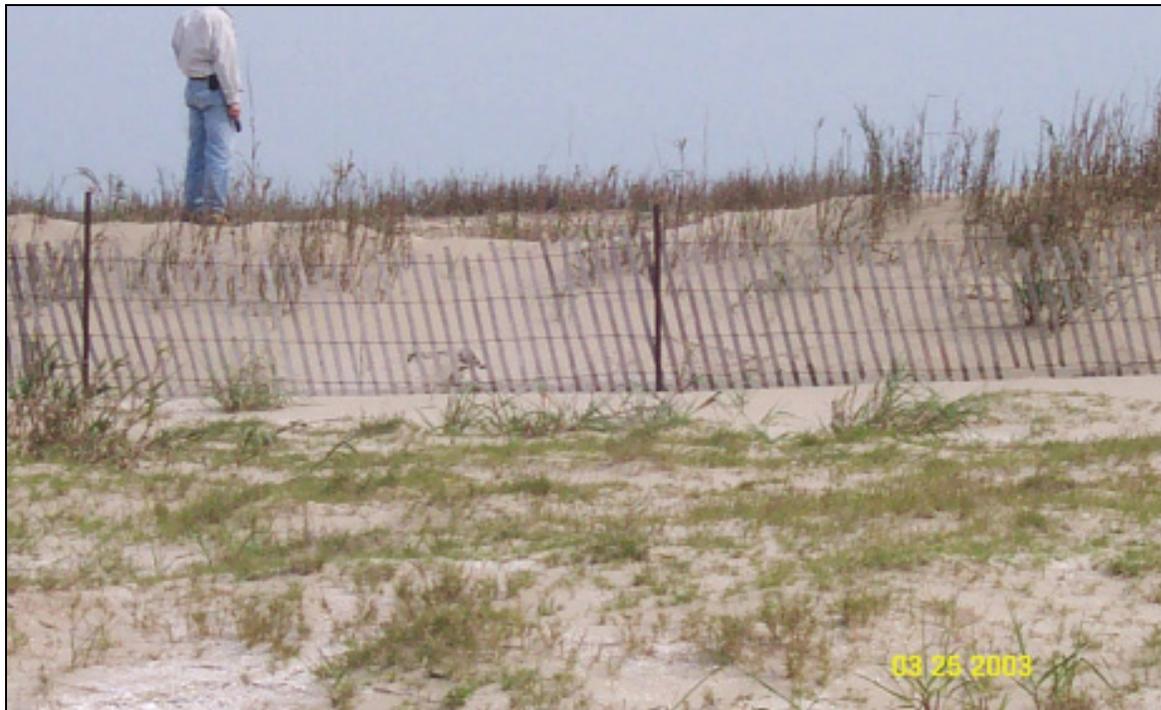
Figure 10. Sand fence with dune created on East Island. Dune is on southeast side of fence indicating northerly winds moving sand and depositing on southeastern side.

These fences trapped sand to create almost NE-SW trending dunes of higher relief (1.8-2.1 m). At places these dunes attained 2.5 m in relief (Figure 10). Thus, these fences were able to trap and redistribute the sediment in their lee side to form several parallel dunes.

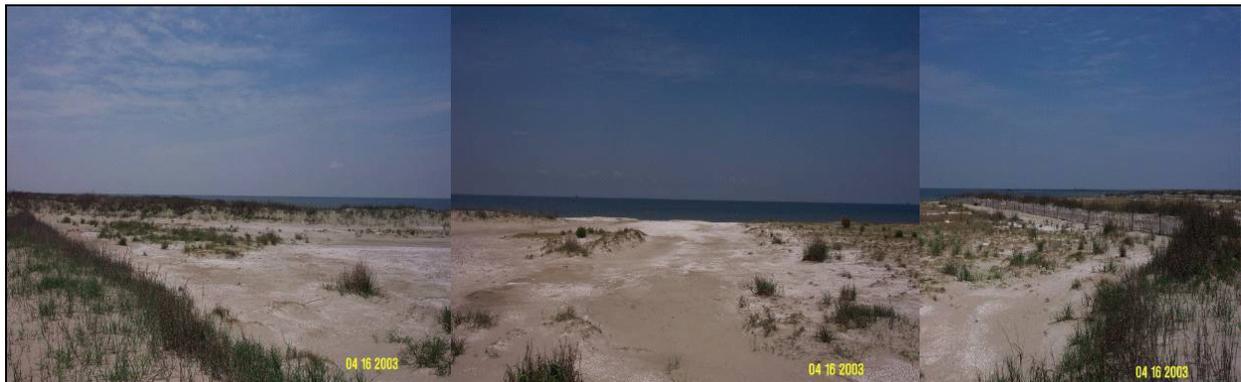
Figure 12. Scour between two dunes at East Island indicates focusing of water due to orientation of dunes.

However, because the orientation of the sand fences was diagonal to the trend of the shoreline, the dunes formed in a morphology that tended to funnel water and create scour on the beach during overwash (Khalil and Lee 2004) (Figure 12).

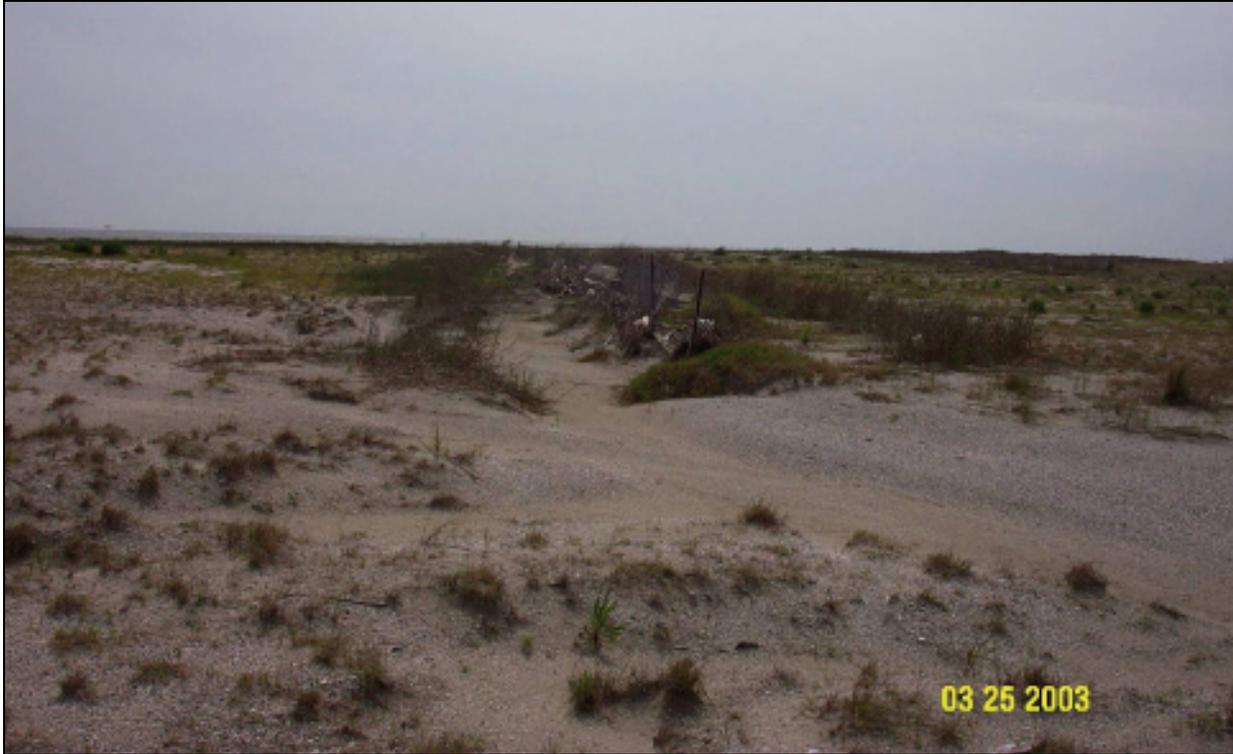
Figure 14. Looking south on Trinity Island (note scour at rear of fence spur indicating focusing of water during overwash).

A similar phenomenon occurred on Trinity Island. The diagonal orientation of the sand fences and, ultimately, the dunes that formed funneled water in-between these relatively high-relief morphologic forms, created scour on the subaerial beach (Figure 14). In addition, dunes in this diagonal alignment will not function as levees to backshore areas nor will they provide a source of sediment for the foreshore.

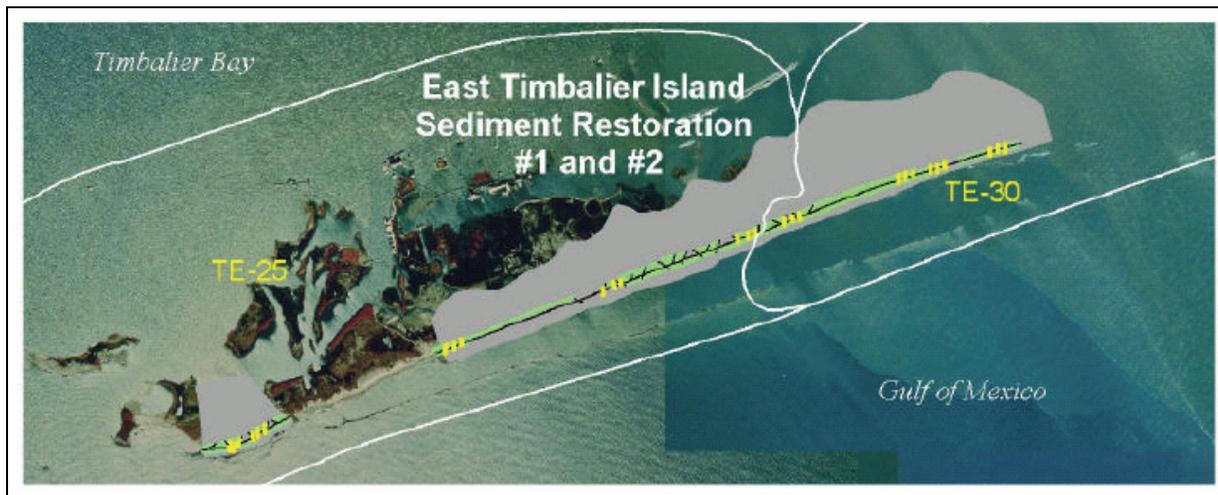
Figure 15. Location of sediment fences and vegetative plantings along East Timbalier Island, showing various orientations (A-configurations, V-configurations, and linear shore-parallel).

**East Timbalier Island (TE-25, TE-30).** East Timbalier Island is approximately 6.5 km long and 0.9 km wide, and it is located at the mouth of Timbalier Bay. This island was restored in 2000 by placing approximately 2 million cu m of dredged sediment to create a 61-m-wide dune to an elevation of 1.5 m National Geodetic Vertical Datum 1929 (NGVD29) and a back-barrier marsh platform at 0.6 m NGVD29 (West et al. 2005). Shoreline rock revetment placed upon an earthen dike and sand fences with vegetative plantings were placed to stabilize the constructed dune. The sand fence was placed in a shore-parallel position with varying orientations of spurs to trap windblown sand and to aid in the development of dune habitat (Figure 15). In some areas of the island, spur fences either intersected or crossed the linear shore-parallel fence at near -45-deg

angles and resulted in fences segments that resembled an “A” or “V” alignment. Approximately 4,000 m of sand fence was installed by the end of September 2000 (West et al. 2005).

No sand fences were found completely intact during the inspection in 2005 (West et al. 2005). The late 2002 storms appeared to have removed the sand fences from the project area. Fill sediment had a higher percentage of fines considered too great and unsuitable as beach fill. Initially, the sand fences on the western end of the island trapped sand and built dunes on both sides of the fence. However, in the central and eastern portions of the island, sand fences were ineffective in trapping and redistributing sand.

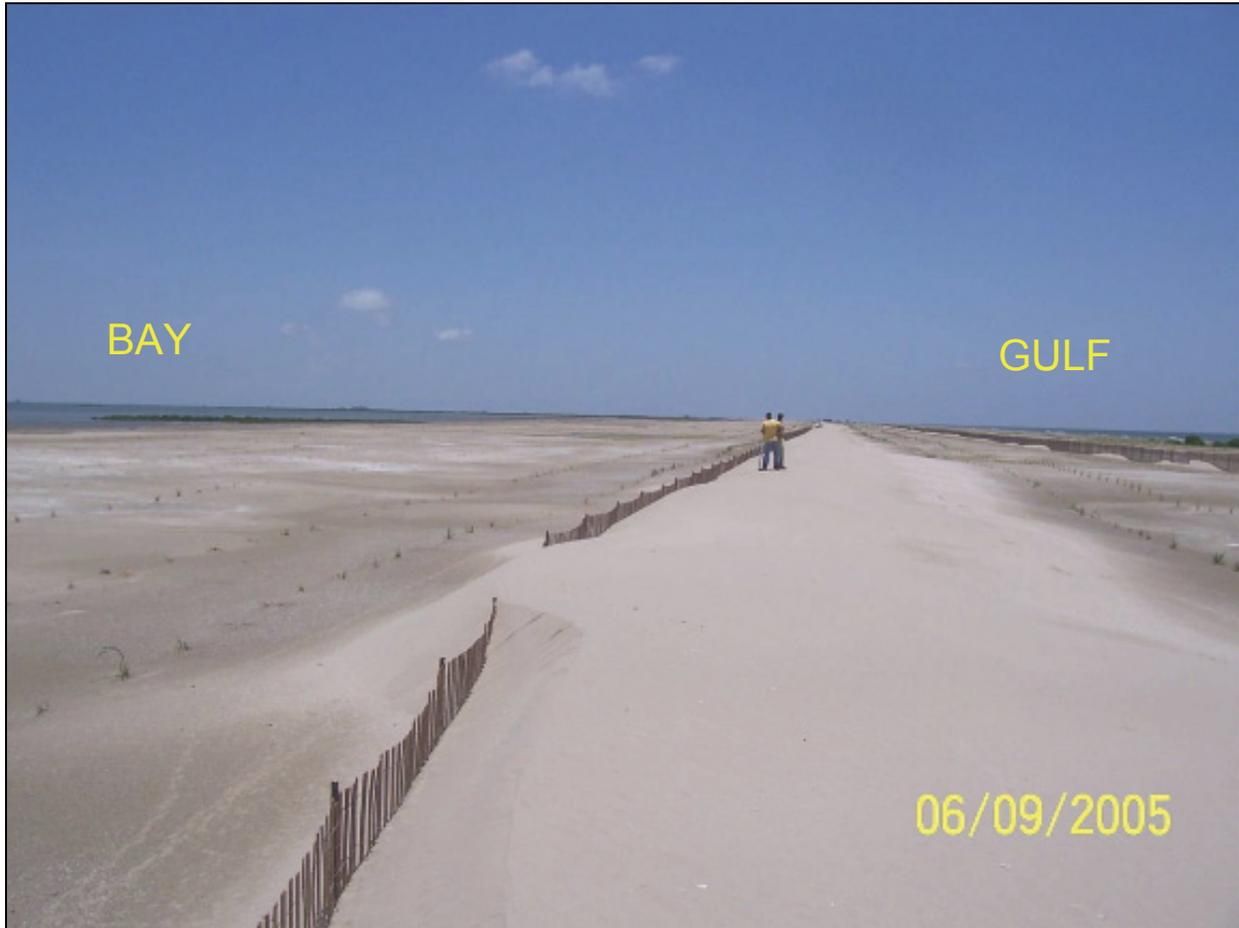
Figure 16. Looking east, formation of dunes towards south of northern sand fence at Timbalier Island.

After observing the efficacy of sand fences on the Isle Dernieres projects, two rows of shore-parallel straight sand fences totaling approximately 10,600 m were installed immediately after the restoration of the island. These rows were 30 m apart. The fences trapped sand and built extensive dunes within a few months after their installation (Figure 16). The fences were installed in December 2004 and by April 2005 a dune higher than the fence had formed around the northern fence. The northern sand fence had accumulated more sand than the southern fence. Sand dunes were built on the lee (south) side of this northern fence, indicating the influence of the wind from the north. Sand accumulation was so great on the north fences that at places the dunes reached >1.5 m in elevation and overtopped the fences to the extent that the fences were completely buried. The dune-base built in the lee of the north fence ranged in average around 15 m in width and 1.7 m in height with a crest width of ~4 m. Because it was buried, the northern fence was no longer capable of trapping sand. The southern fence also trapped sand, but to a lesser degree. The average height of the dune was 0.6 m, located on both sides of the fence. The

width of the base of the dune ranged from 7.5 to 9 m and the crest width averaged 3 m. Obviously, the northern fence performed better and trapped more sand.

It appears that the southern fence could not perform well because of the presence of northern fence. The sediment supply for the southern fence from the north was restricted by the presence of the northern sand fence and dunes that formed. This reaffirms the conclusion that wind capable of transporting sand on Louisiana islands during nonsaturated conditions is from north to south (or northeast to southwest).

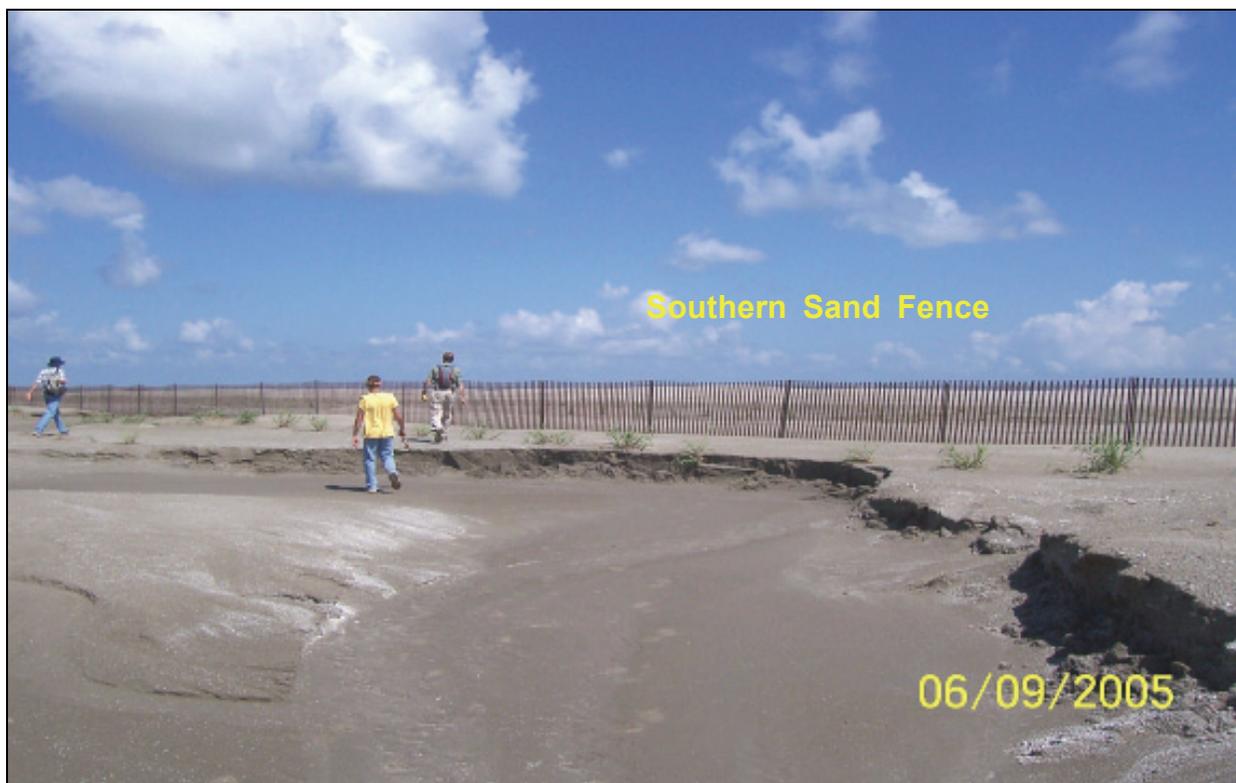
Figure 17. Rainwater that accumulated between dunes flowed towards gulf through southern dunes, which was lower in elevation, creating breaching in dune and on beach berm (looking north).

Because of the difference in elevation of the two adjacent dunes, rainwater accumulated within the trough of the two dunes and flowed gulfward, towards the southern dune, which was lower in elevation. This flow created three breaches in the southern dune as well on the beach-berm (Figure 17). If the sand fences had instead been installed sequentially, then the development of a swale between dunes could have been avoided. Sequencing of fences is necessary if more than one sand fence will be installed. The distance between rows of fencing should not exceed more than four times the height of the fence (Savage 1963), which in this case would be 4.8 m. For Louisiana, fences should be installed in sequence starting from gulf side to build larger foredunes on the gulf side of the island.
