THE EFFECT OF ELEVATED TEMPERATURE ON THE
FRETTING FATIGUE BEHAVIOR OF NICKEL ALLOY IN-100

THESIS

AFIT/GA/ENY/08-M04

AIR FORCE INSTITUTE OF TECHNOLOGY

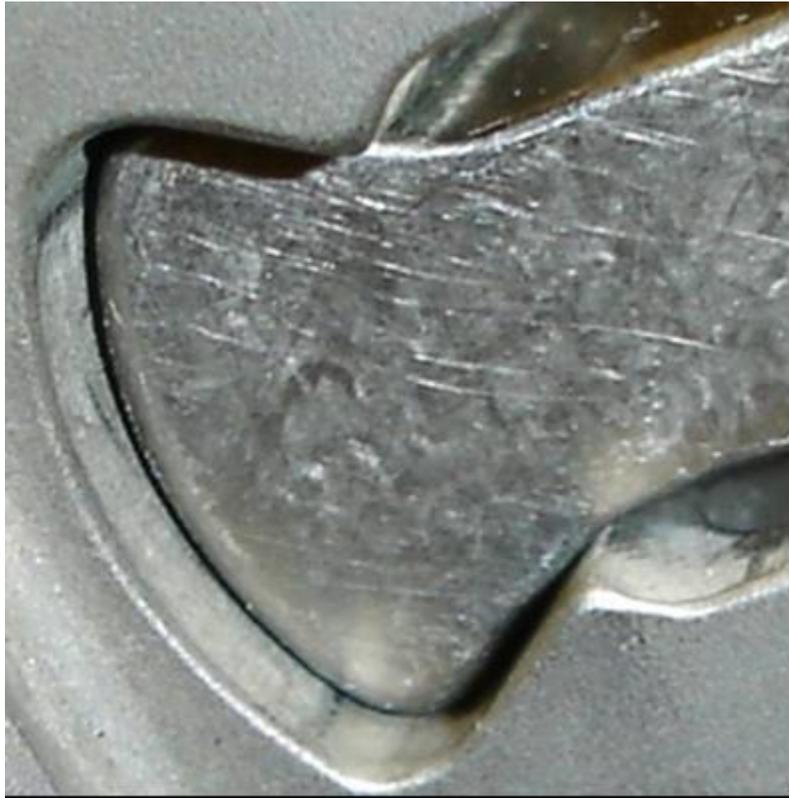
Figure 1.1 - Photograph of a typical dovetail joint [10]

In the case of dovetail connections found in modern turbine engines the surface to surface interface is found between the numerous individual turbine blades and the collar that is mounted around the rotor that constitutes the centerline of the entire engine (Figure 1.1). These connections, blade and collar shapes and materials have all been optimized for various engineering and operational concerns. Due to the intricate way in which modern engines are assembled it is extremely difficult and time consuming to routinely inspect and repair or replace broken components. As such it is highly desirable to design components that are more resistant to fretting damage and thus could serve for longer periods of time between inspections. To accomplish this objective the fundamentals of the fretting phenomenon need to be better understood and, to the extent possible, predicted before an engine is ever put into service. This study will attempt to further the fundamental knowledge of the fretting fatigue phenomenon so that future efforts may employ this knowledge to improve the design and maintenance schedules of modern turbine engines.

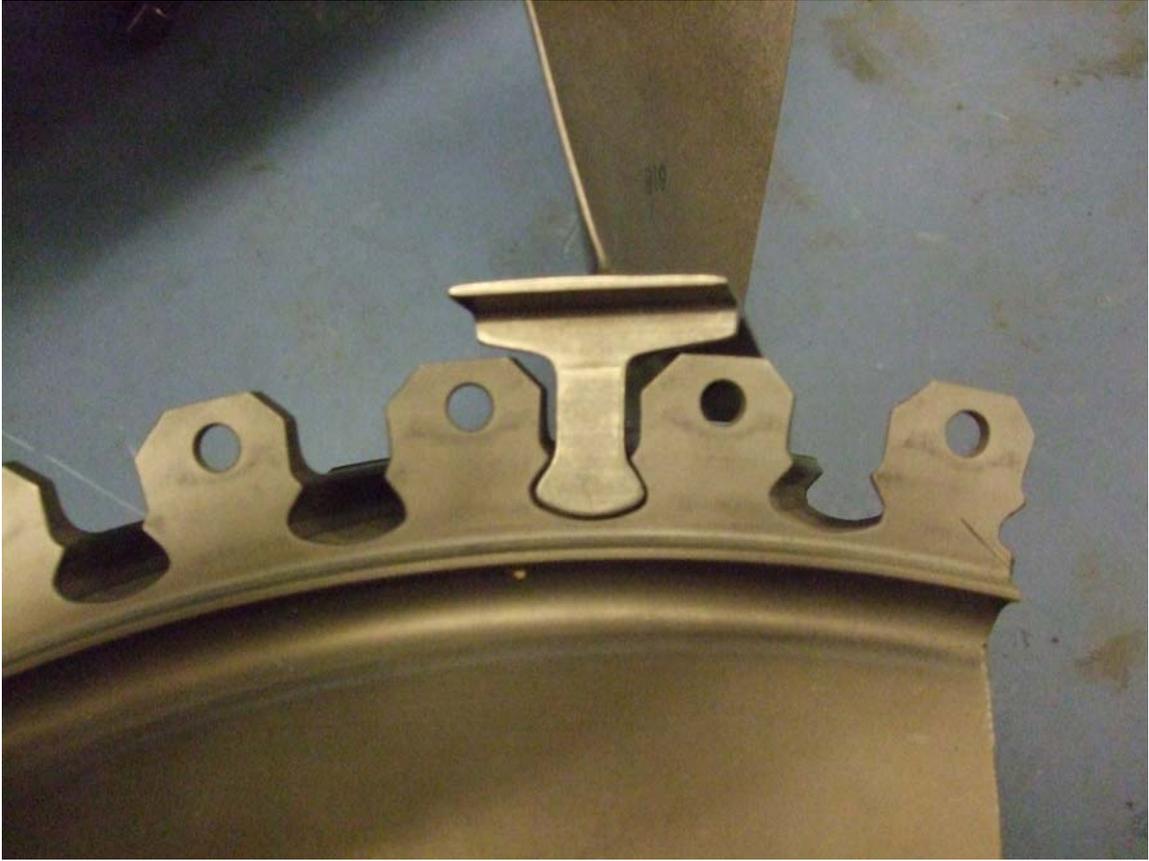
Figure 1.2 - Photograph of turbine collar and turbine blade

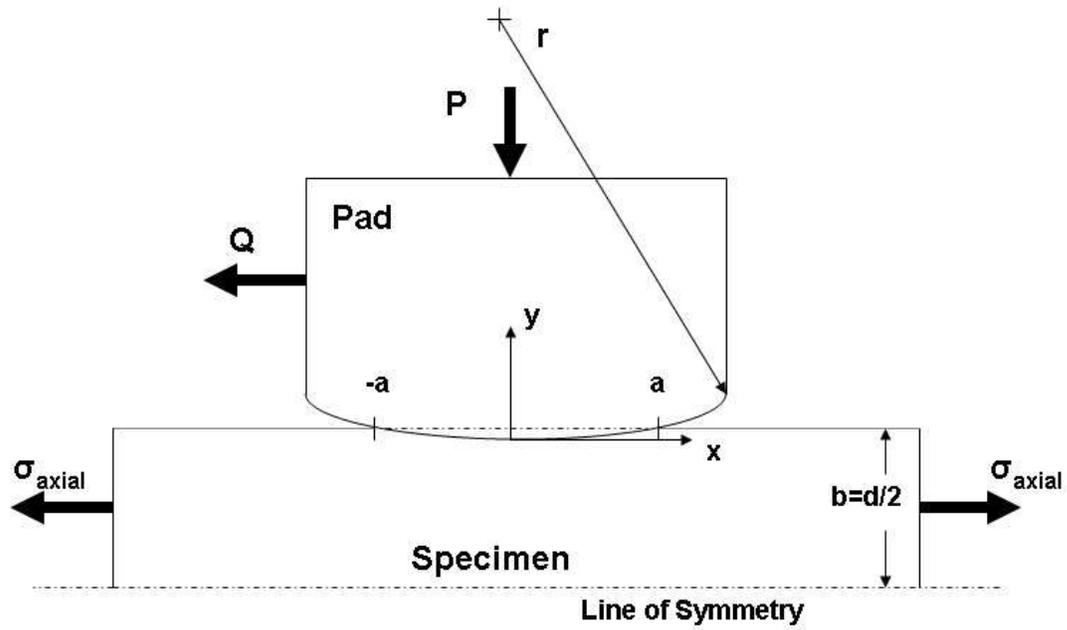
Figure 2.1 Diagram of cylinder on flat fretting fatigue configuration [11]

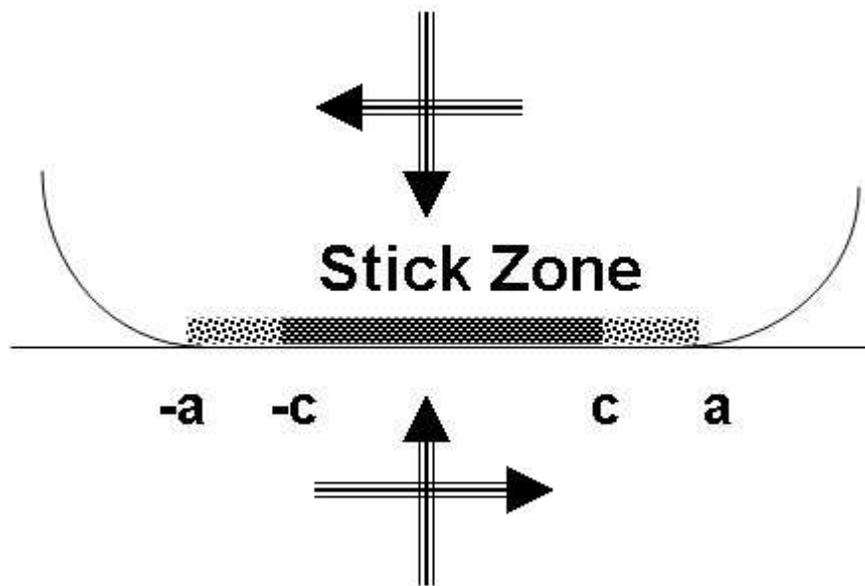
Figure 2.2 Diagram of stick zone [11]

The second type of slippage is partial slip and it is the opposite of gross slip. Under partial slip conditions the two surfaces will begin to stick to one another and are only undergoing slip near the edges of the contact zone. There are no large relative displacements between the two contacting surfaces as the substrate and contacting surface are essentially being welded together. In this study the fretting pads and the tensile specimen are initially able to slip against one another freely. This initial gross slip persists until the pads and the specimen begin to stick together thus inhibiting large displacements. This region of the contact zone which is no longer moving with respect to both the pads and the specimen due to the surface welding is called the stick zone. The region immediately outside of the stick zone but still in the contact zone is called the slip zone (Figure 2.2). Under ideal fretting conditions the stick zone will form exactly in the center of the contact zone and the slip zone on each side will be symmetrical.

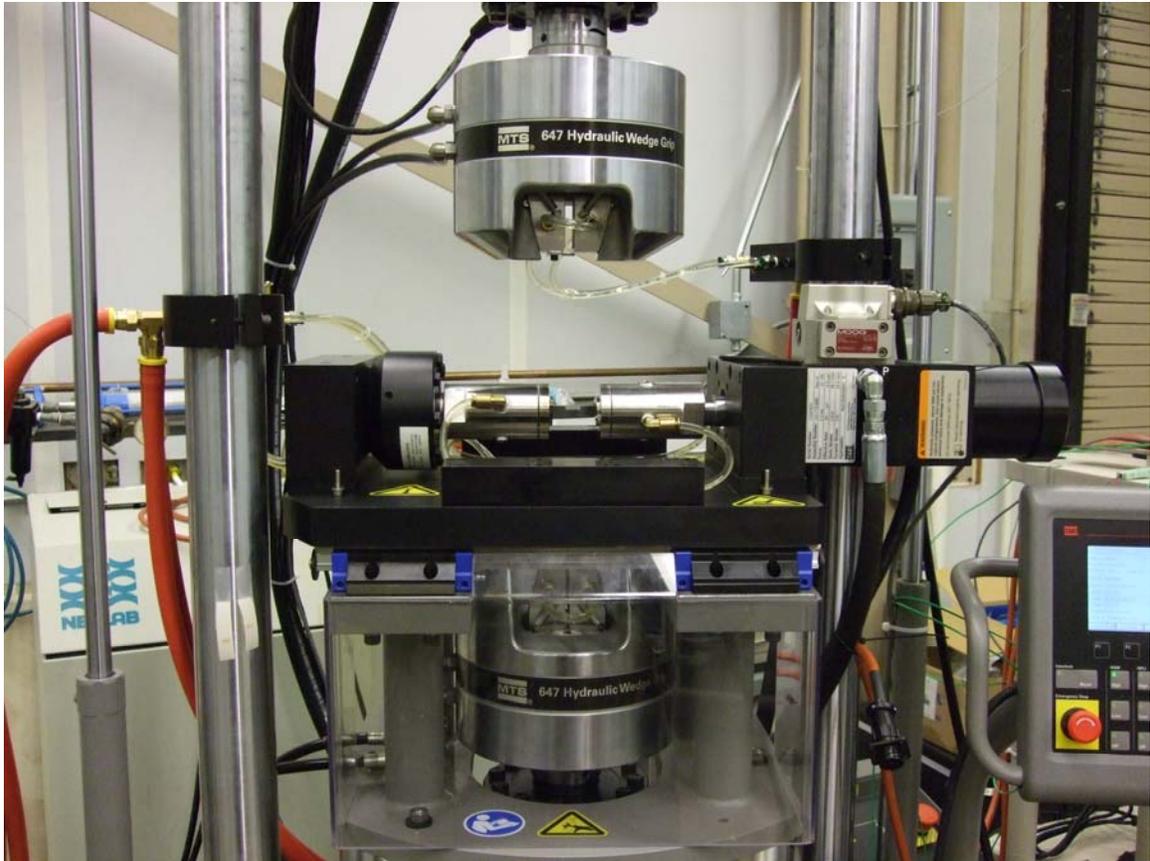
Figure 3.1 - MTS Machine

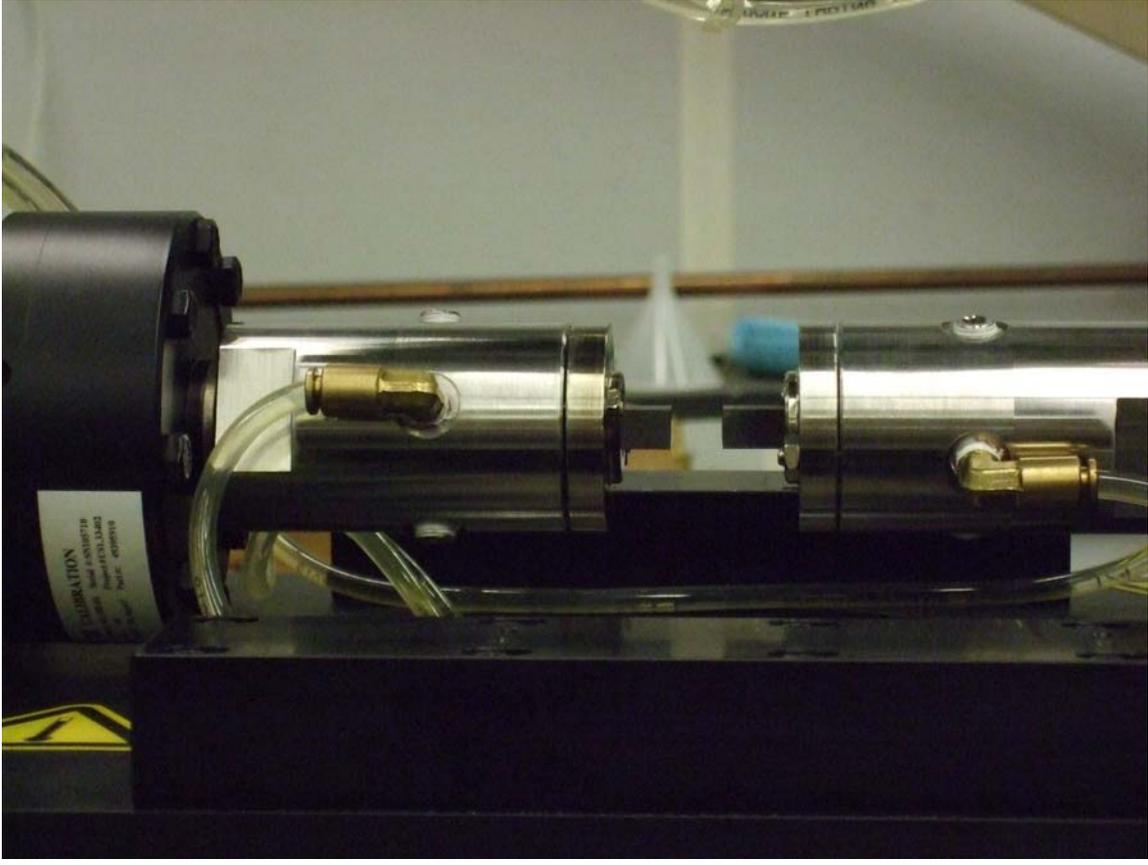
Figure 3.2 - Close up of fretting actuator

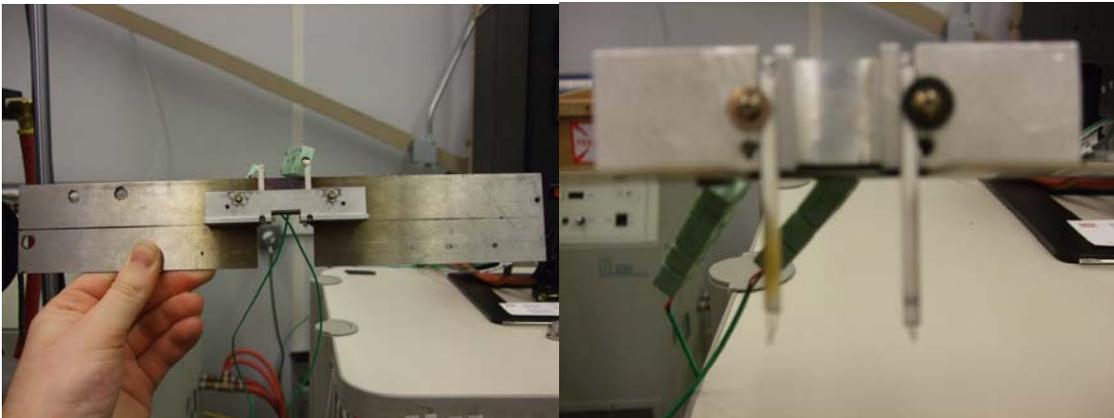
Figure 3.3 - Thermocouple apparatus

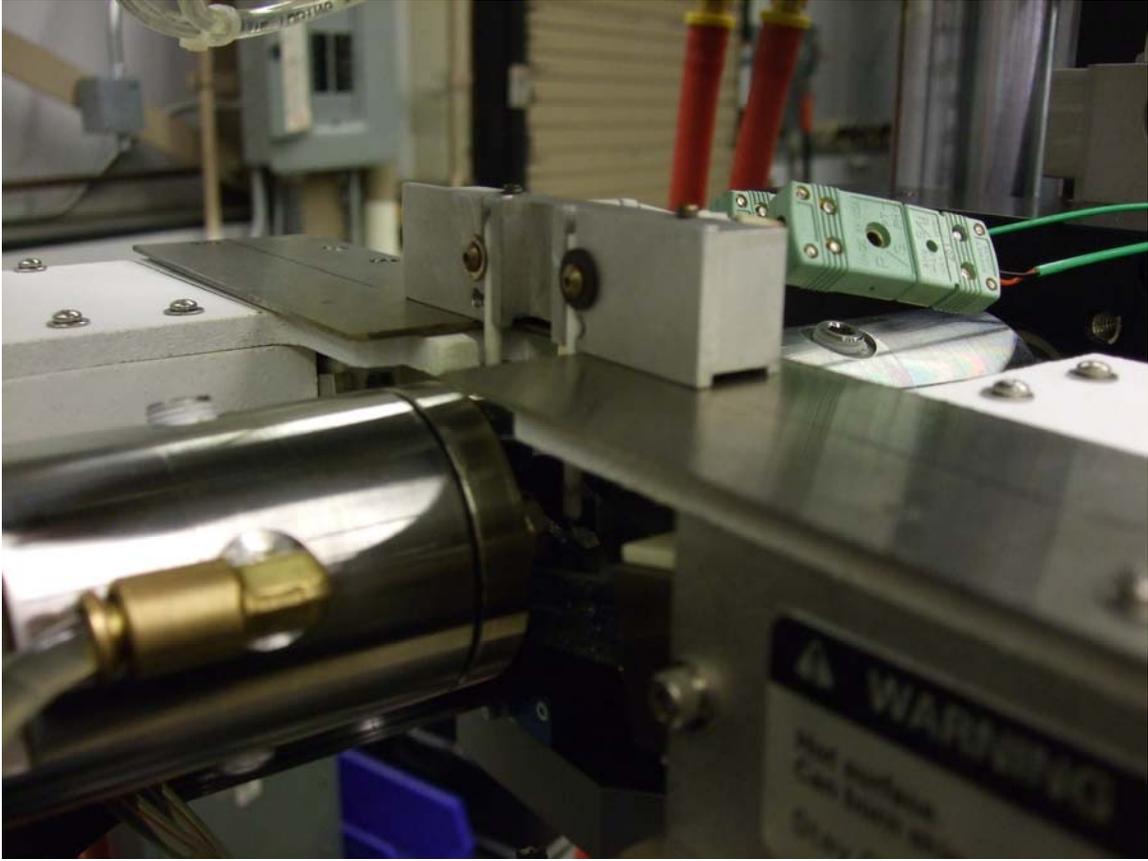
Figure 3.4 - Thermocouple apparatus as placed in normal test position

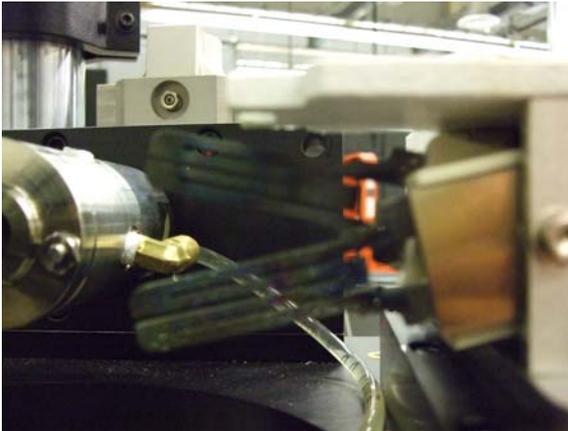
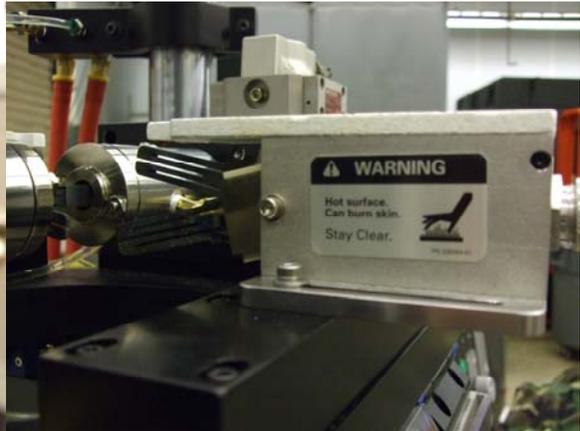
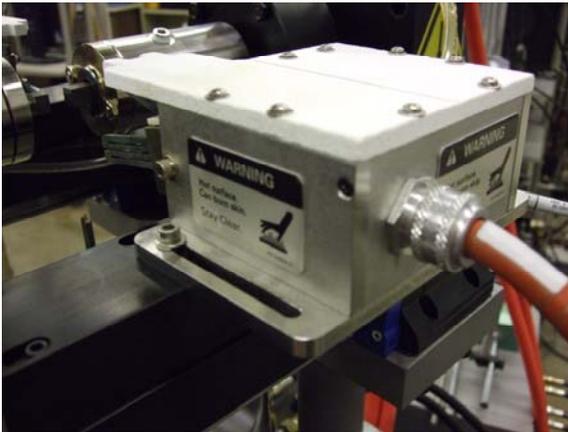
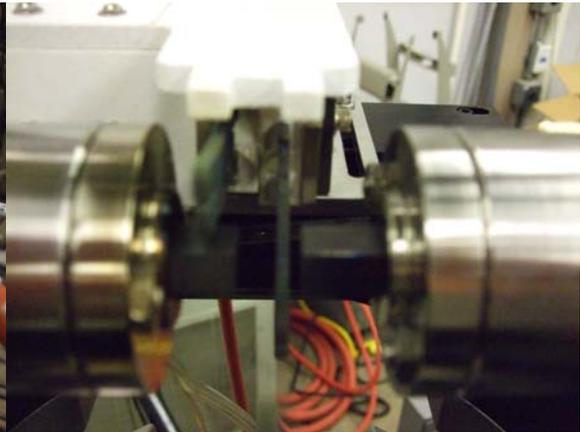
Figure 3.5 - Heating elements and heater boxes

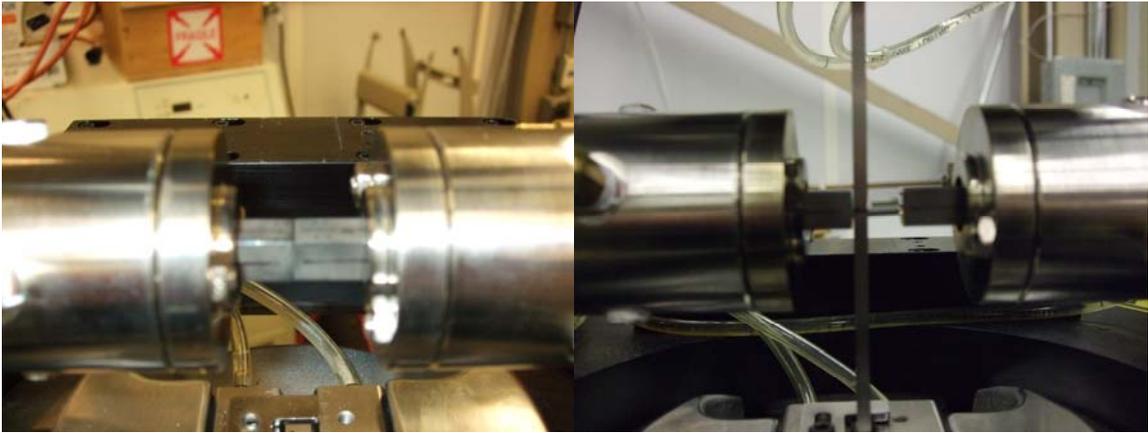
Figure 3.6 - Guideline markings on fretting pads and specimen

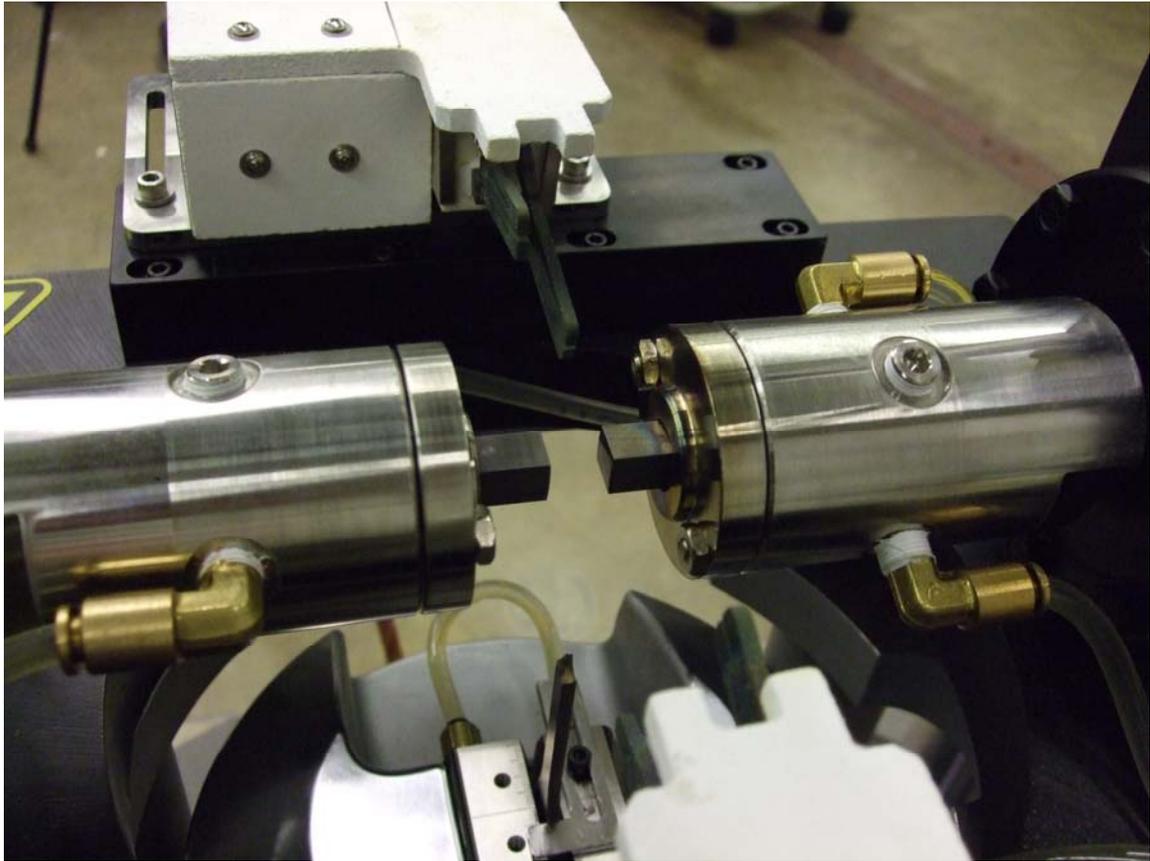
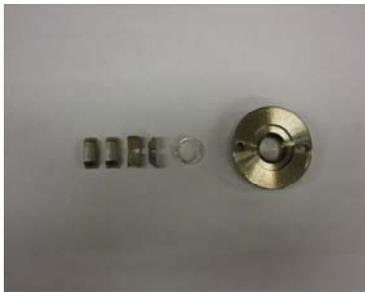
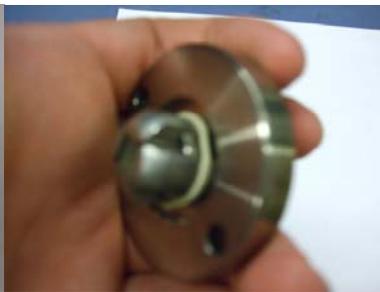
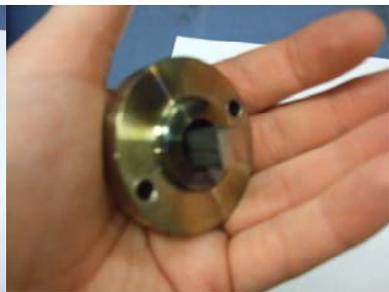
Figure 3.7 - Fretting pad holders

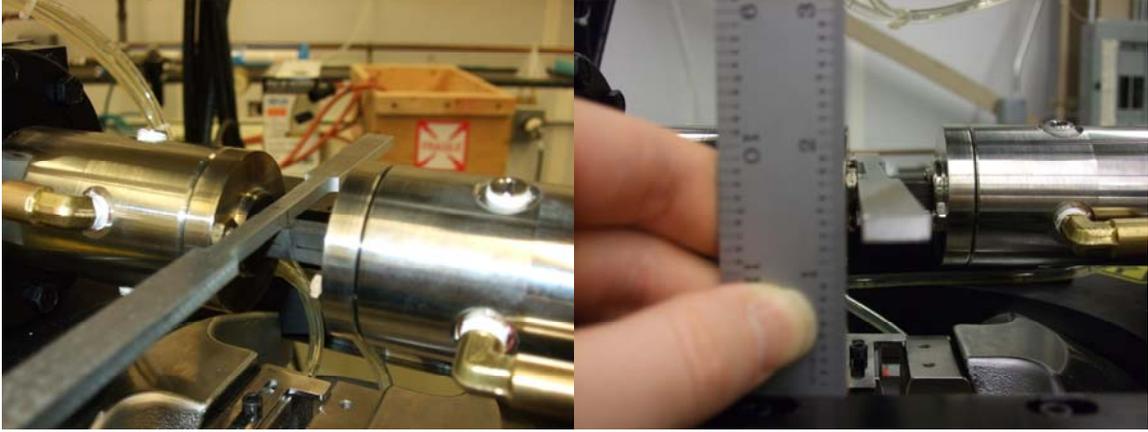
Figure 3.8 - Leveling technique

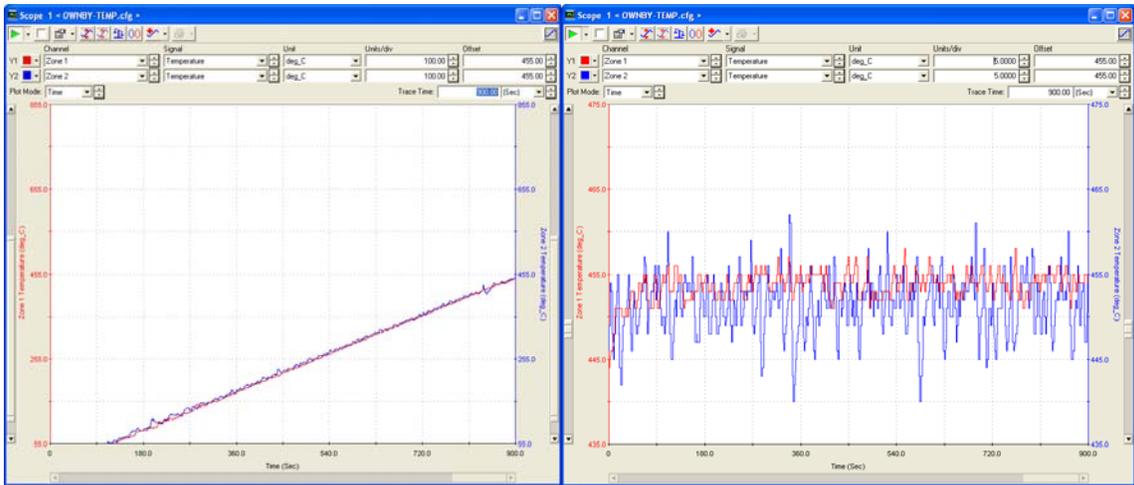
Figure 3.9 - Temperature ramp up period and temperature stabilization period

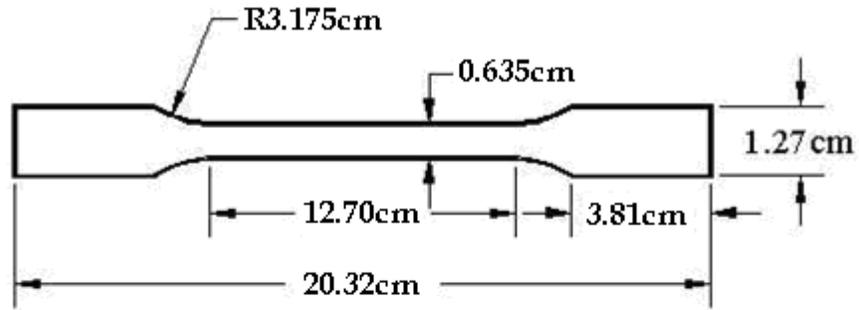
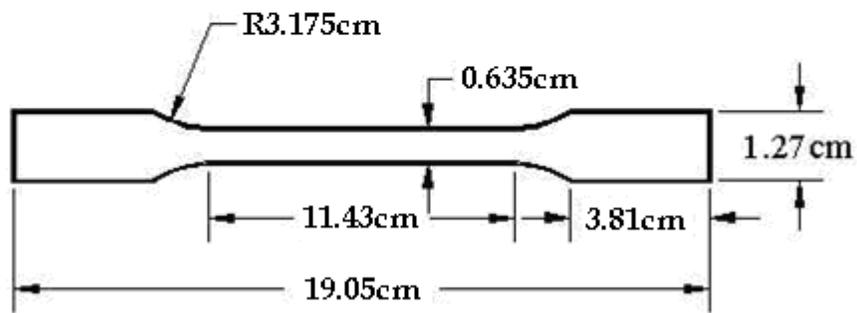
thickness = 3.81mm

Figure 3.10 - Dog bone dimensions (a) 8 inch specimen (b) 7.5 inch specimen

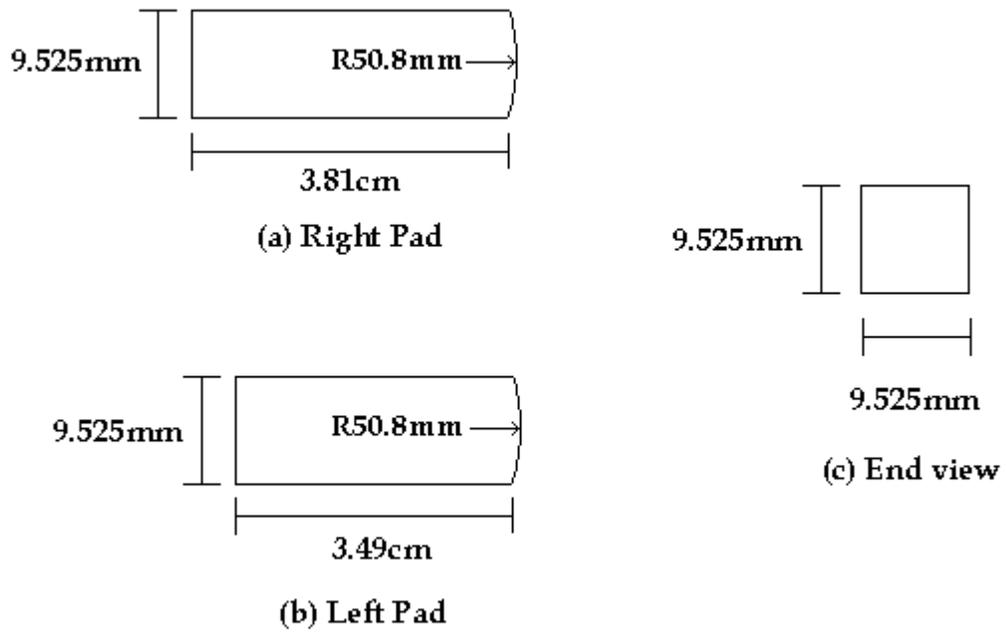
Figure 3.11 - Fretting pad dimensions (a) right pad (b) left pad (c) end view

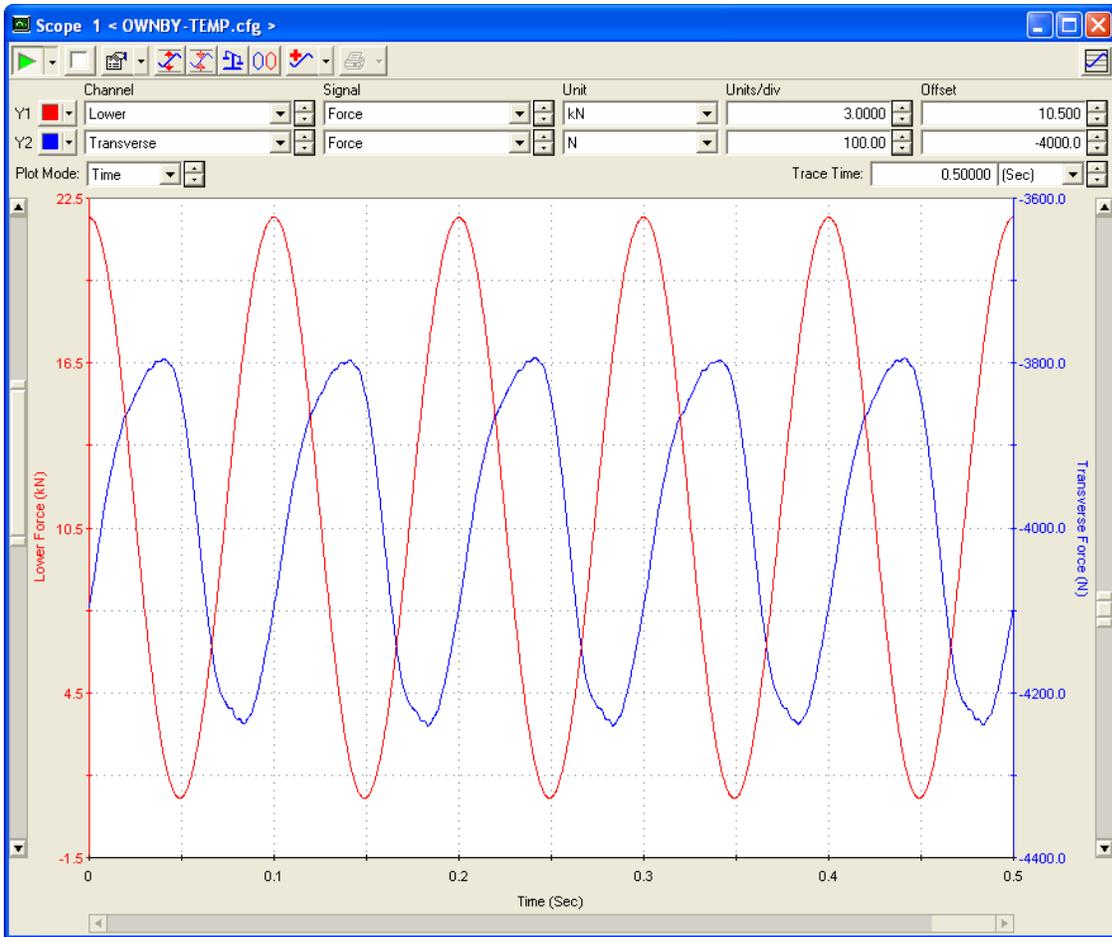
Figure 3.12 - MTS screen capture of observed axial and fretting loads from test #7

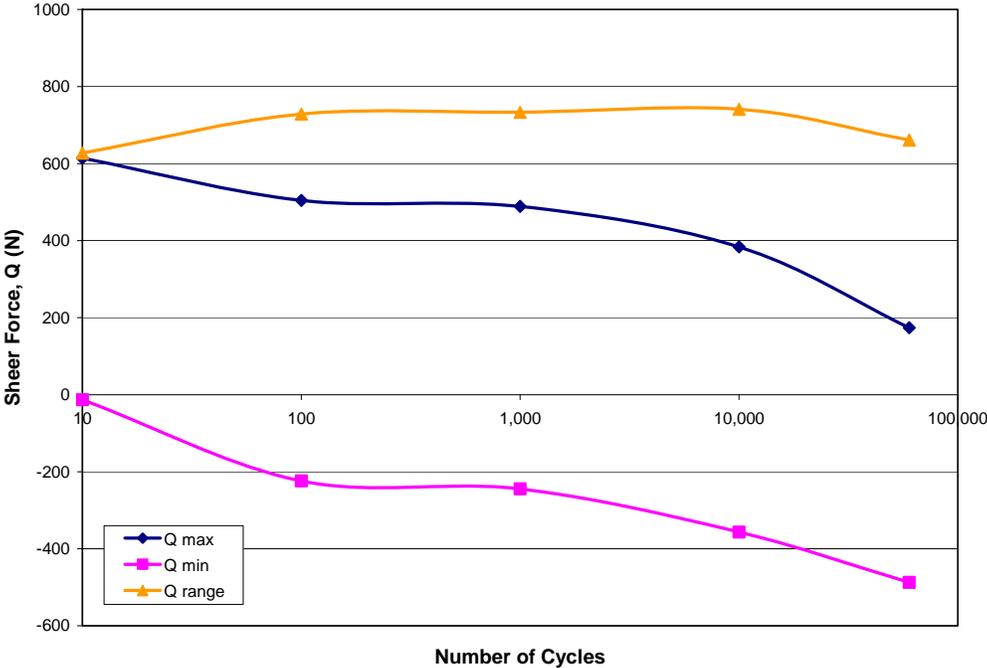
Figure 3.13 - Shear stress range plot (Q vs N) for test #16

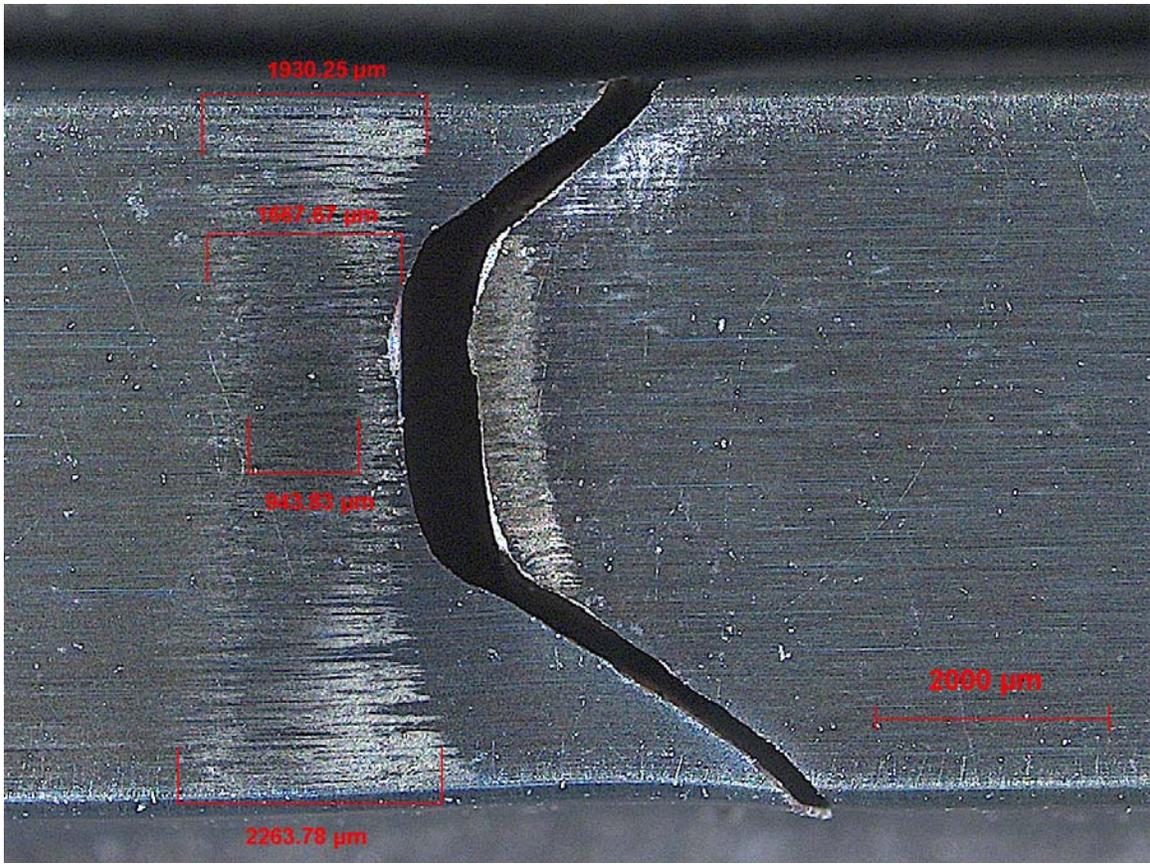
Figure 3.14 - Fretting scar on specimen used in test #5 (right side pictured)

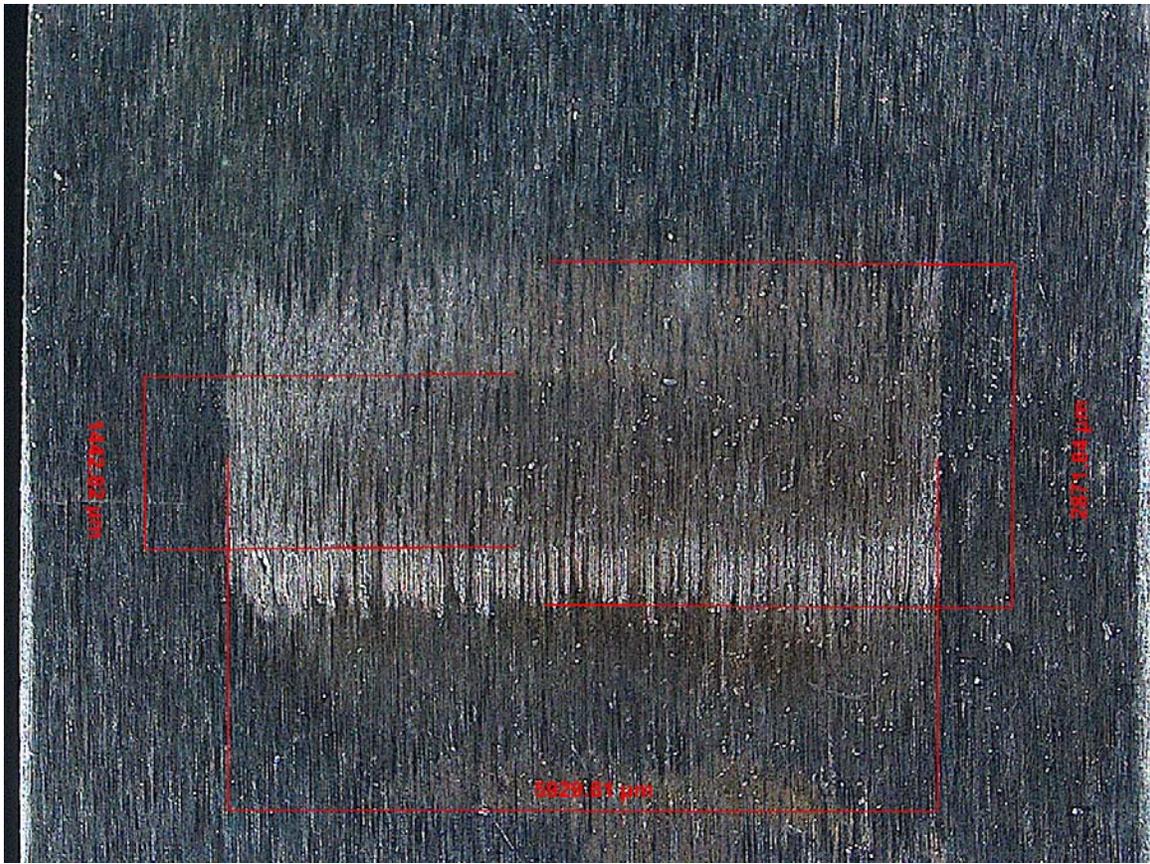
Figure 3.15 - Fretting scar on test #5 left fretting pad

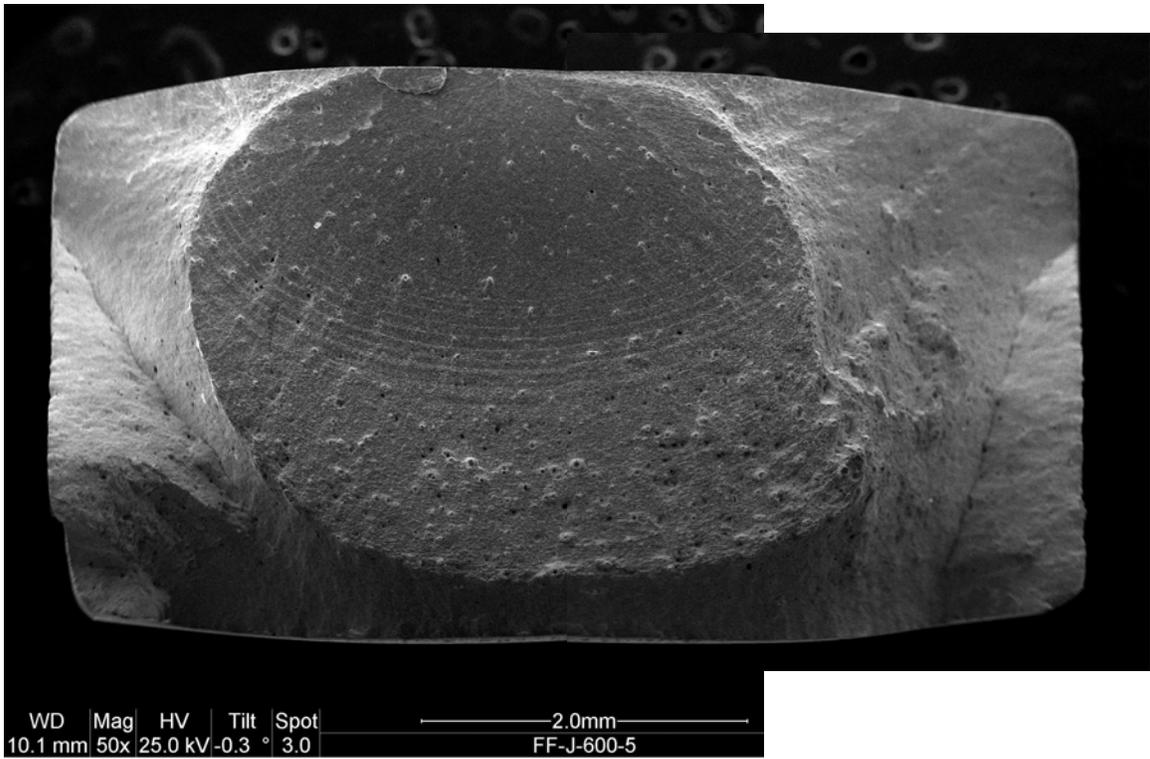
Figure 3.16 - Fracture surface of test #5 taken with SEM

Crack initiation location, orientation and the various stages of its growth are all crucial to understanding fretting fatigue. A fretting fatigue specimen can be analyzed under a microscope after it has failed to determine the manner in which it failed and what was physically occurring during the test. The fretting pads leave clear markings on the specimen that can be observed and measured to determine the actual contact half width and contact shape of the test. These markings are often referred to as fretting scars because the material surface is permanently damaged by the fretting process. Figure 3.14 is an example of such a fretting scar taken by an optical microscope of test #5. One can also examine the fretting scars left on the fretting pads as well (Figure 3.15). From analyzing these fretting scars from each of the tests one can determine where the crack initiated. It is expected that the cracks will initiate near the edge of the contact region. Often the cracks initiate near the longitudinal edges of the specimens but this is not always the case. A Scanning Electron Microscope (SEM) can also be used to observe in great detail the fracture surfaces of the specimens. The images of the fracture surface can then be analyzed for the points where cracks initiate and their orientations as well as the different stages or regions of the cracks growth as discussed earlier in Chapters I and II. Figure 3.16 is an image of a fracture surface taken from test #5.

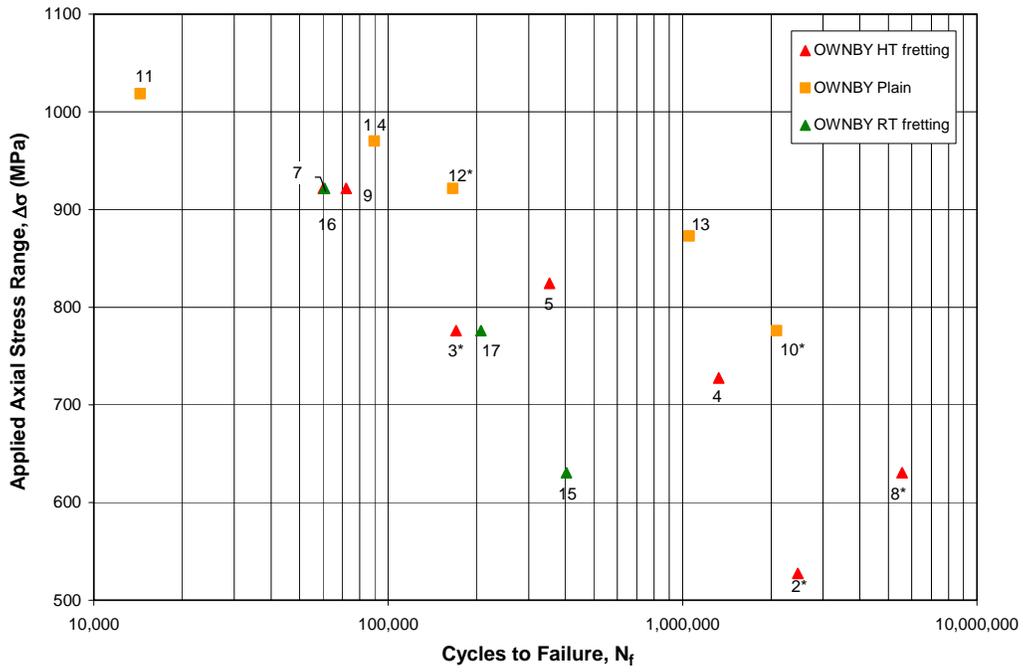
Figure 4.1 S-N data points for all tests in this study

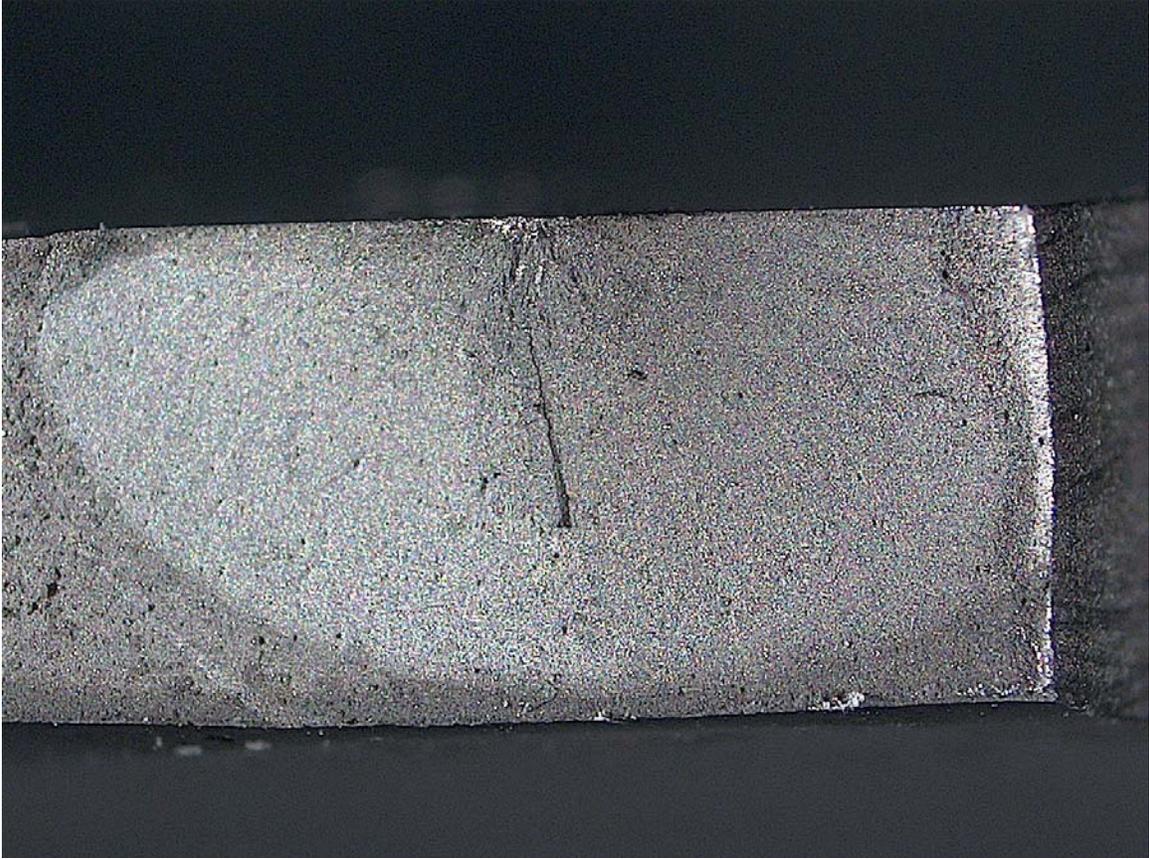
Figure 4.2 Optical Micrograph of internal flow in specimen 10

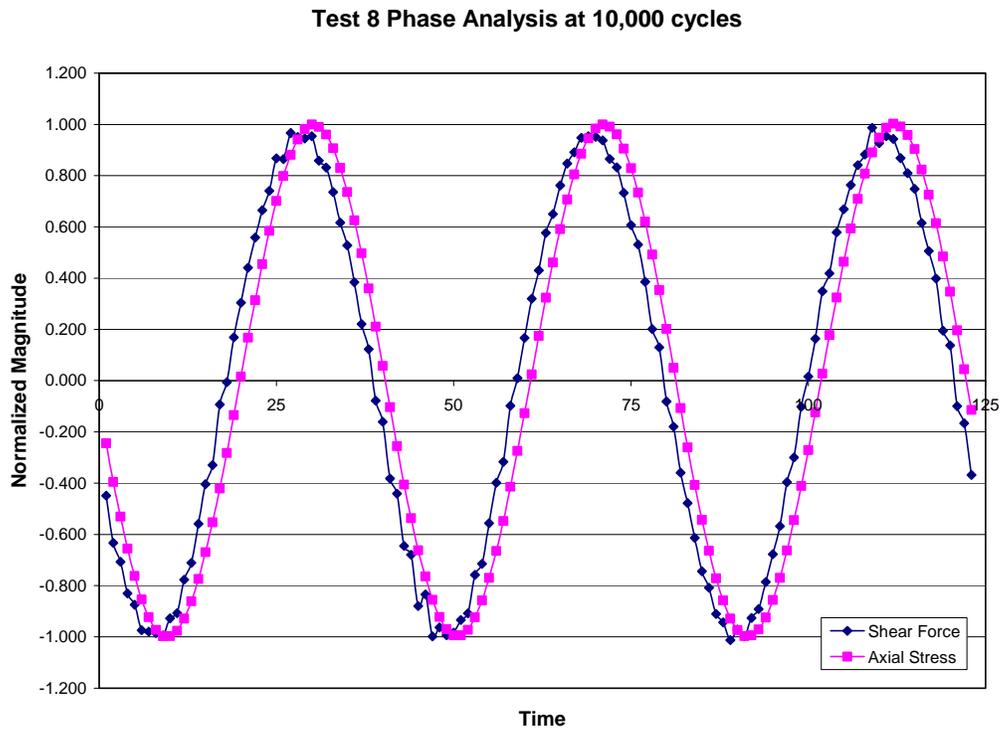
Figure 4.3 Phase of shear force and axial stress signals test #8 10,000th cycle

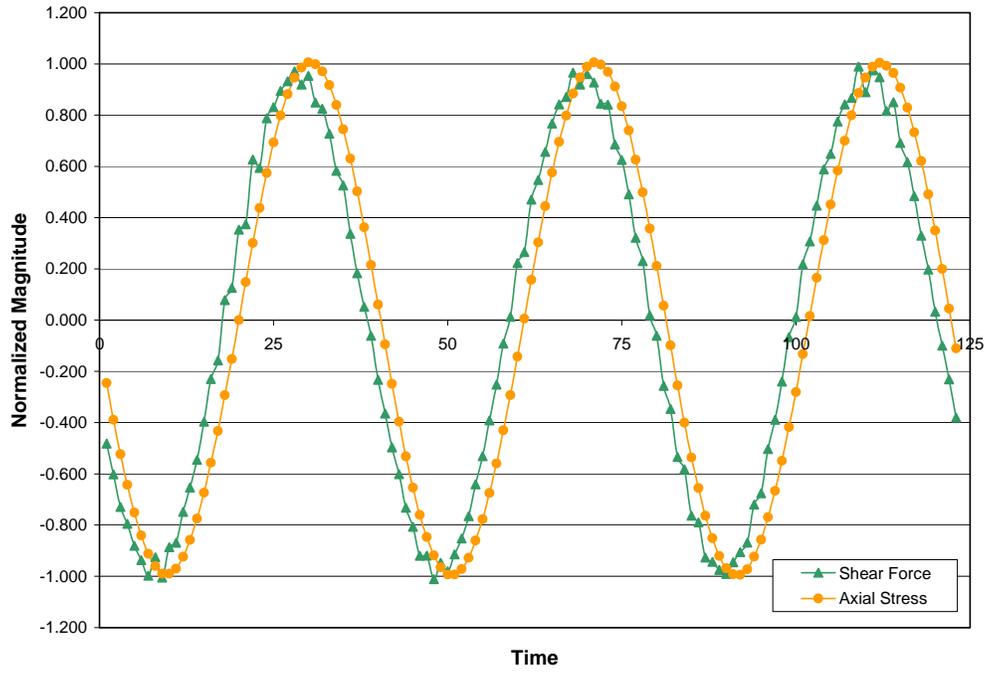
Figure 4.4 Phase of shear force and axial stress signals test #8 100,000th cycle

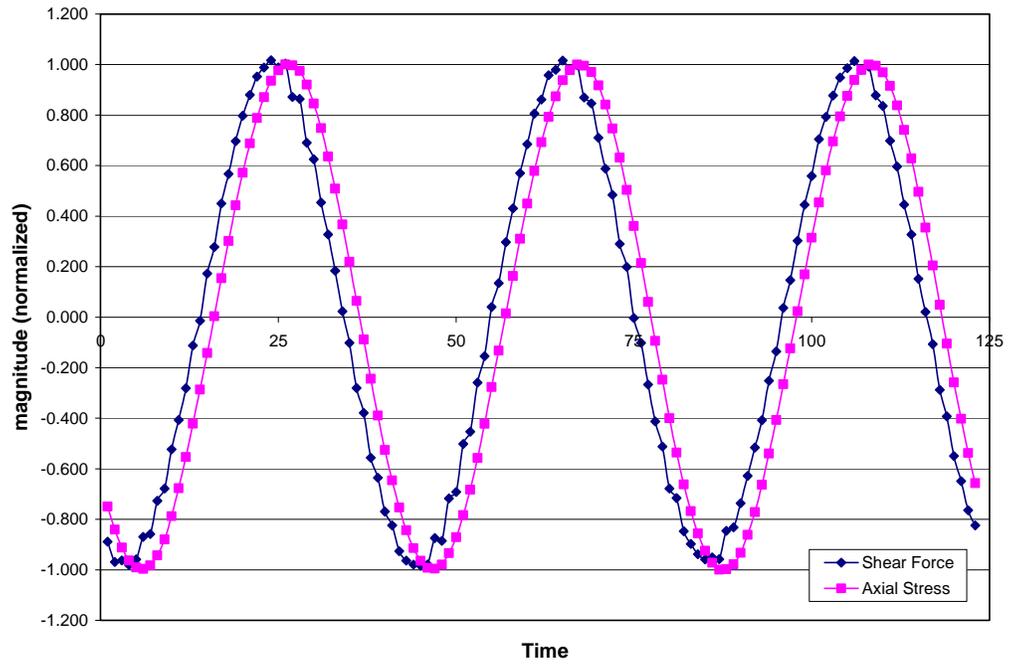
Figure 4.5 Phase of shear force and axial stress signals test #15 10,000th cycle

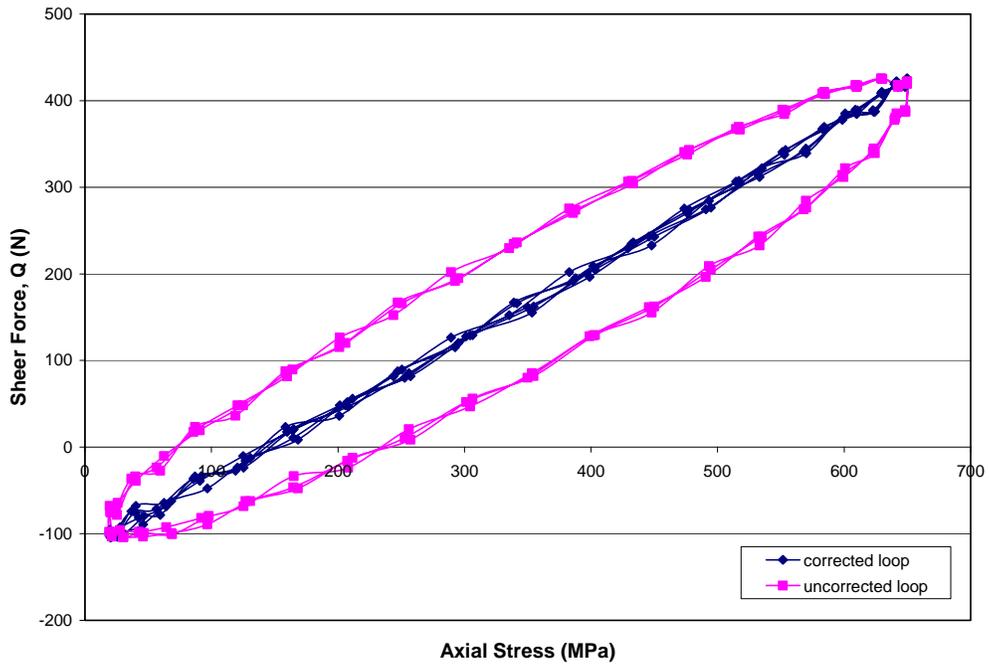
Figure 4.6 Hysteresis loops with and with out phase correction

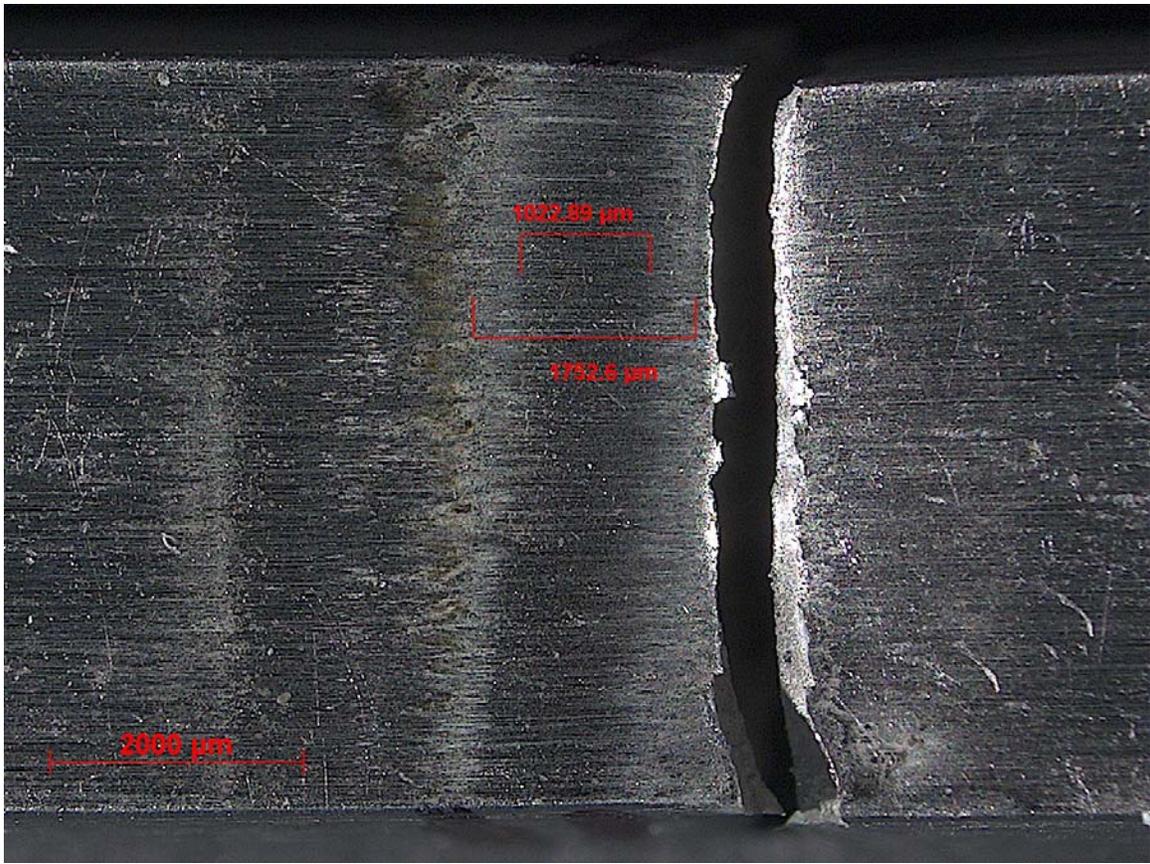
Figure 4.7 – Fretting scar from test #16
