THE EFFECT OF ELEVATED TEMPERATURE ON THE
FRETTING FATIGUE BEHAVIOR OF NICKEL ALLOY IN-100

THESIS

AFIT/GA/ENY/08-M04

AIR FORCE INSTITUTE OF TECHNOLOGY

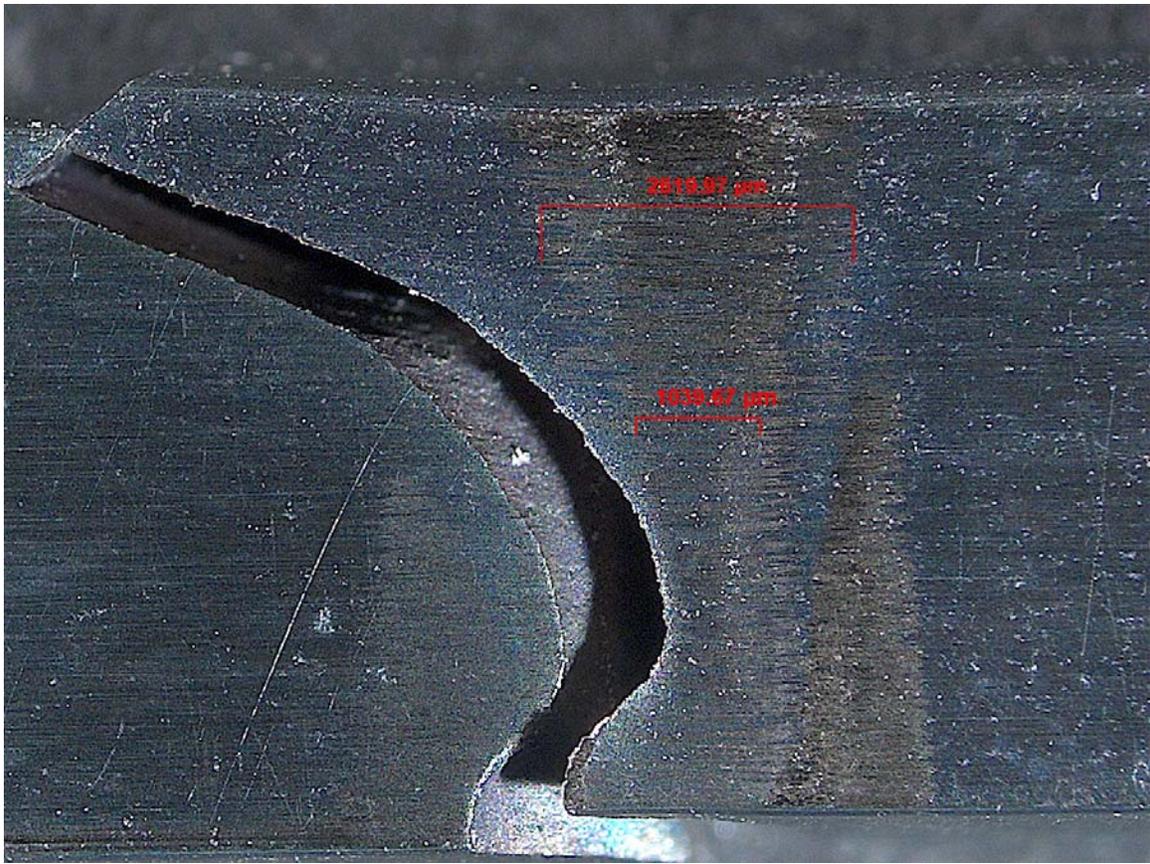
Figure 4.8 – Fretting scar from test #4

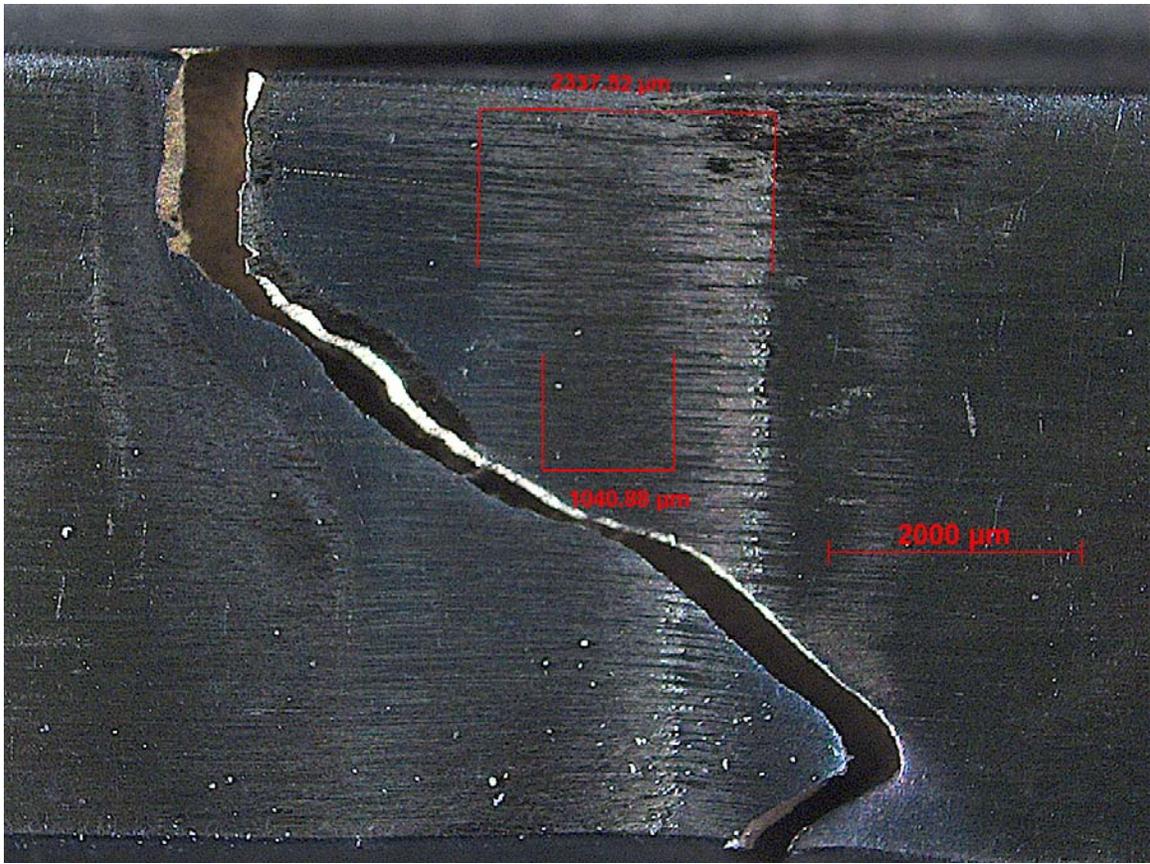
Figure 4.9 – Fretting scar from test #9

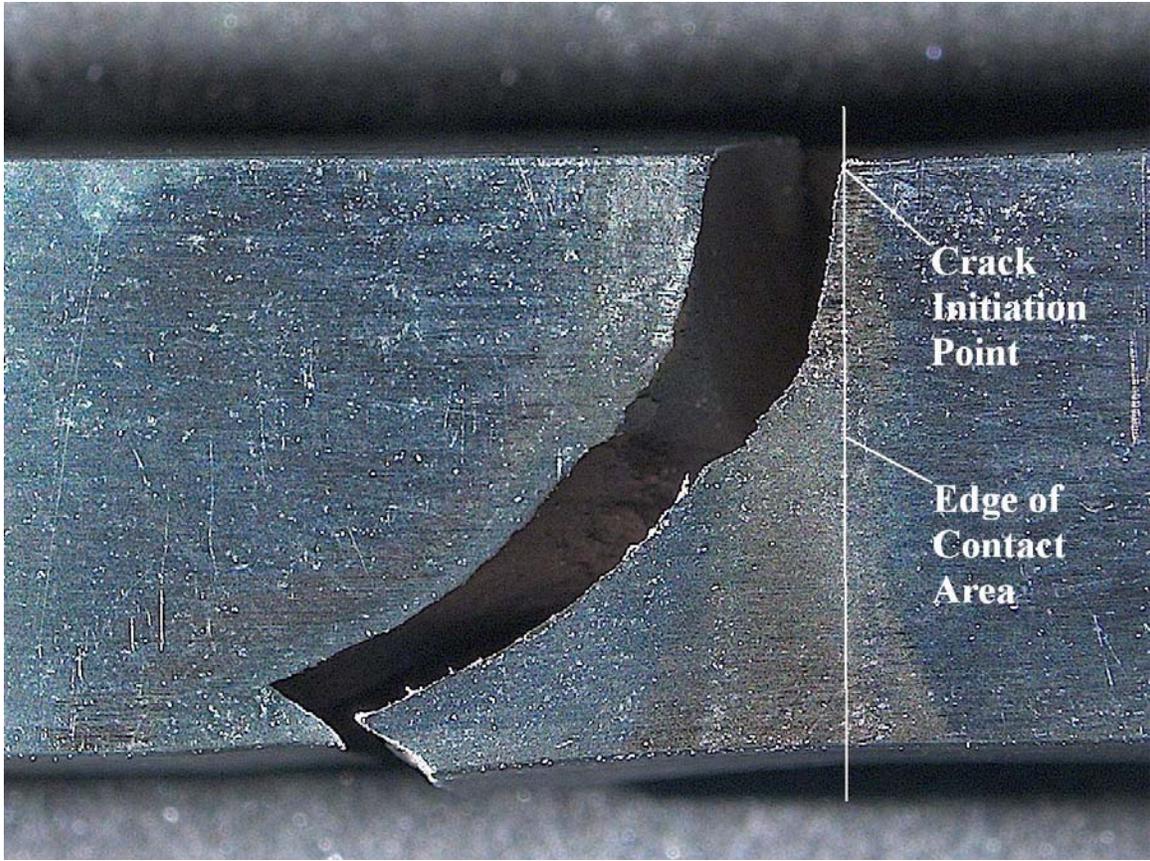
Figure 4.10 Optical microscope image of specimen from test #4

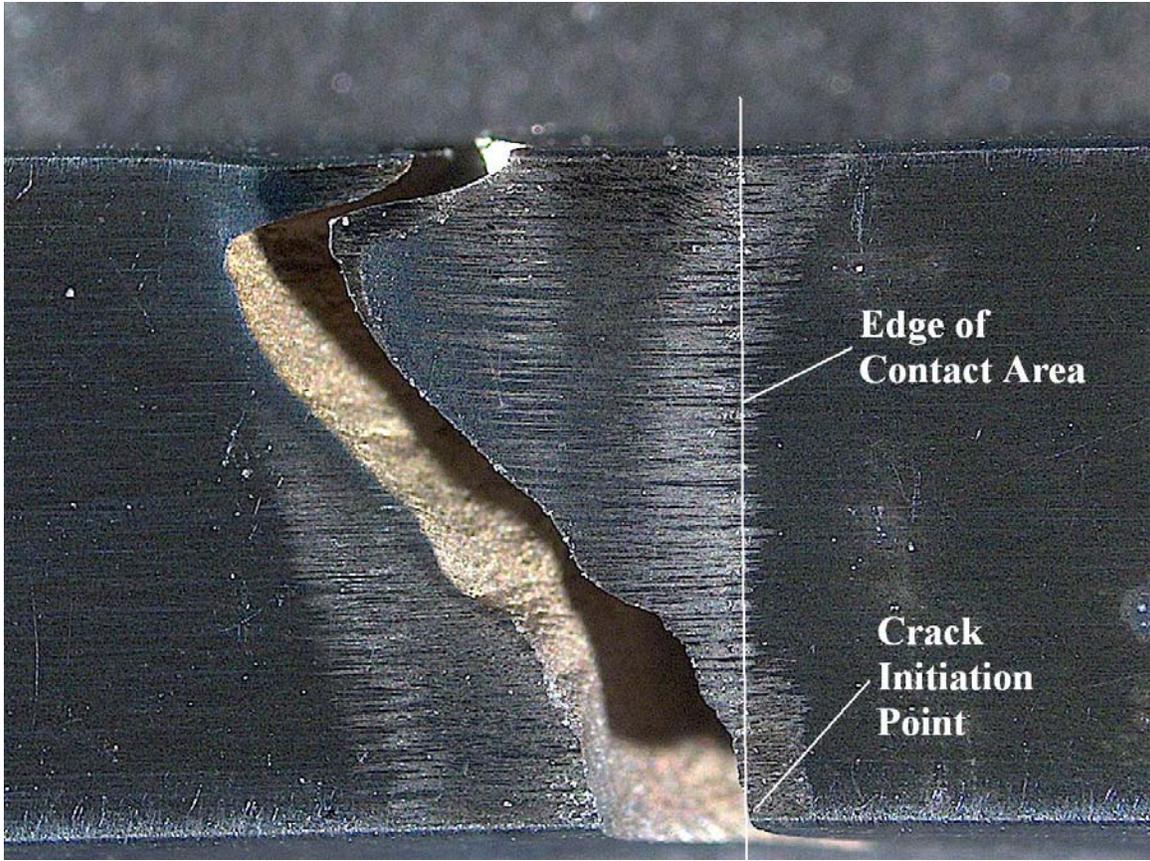
Figure 4.11 Optical microscope image of specimen from test #7

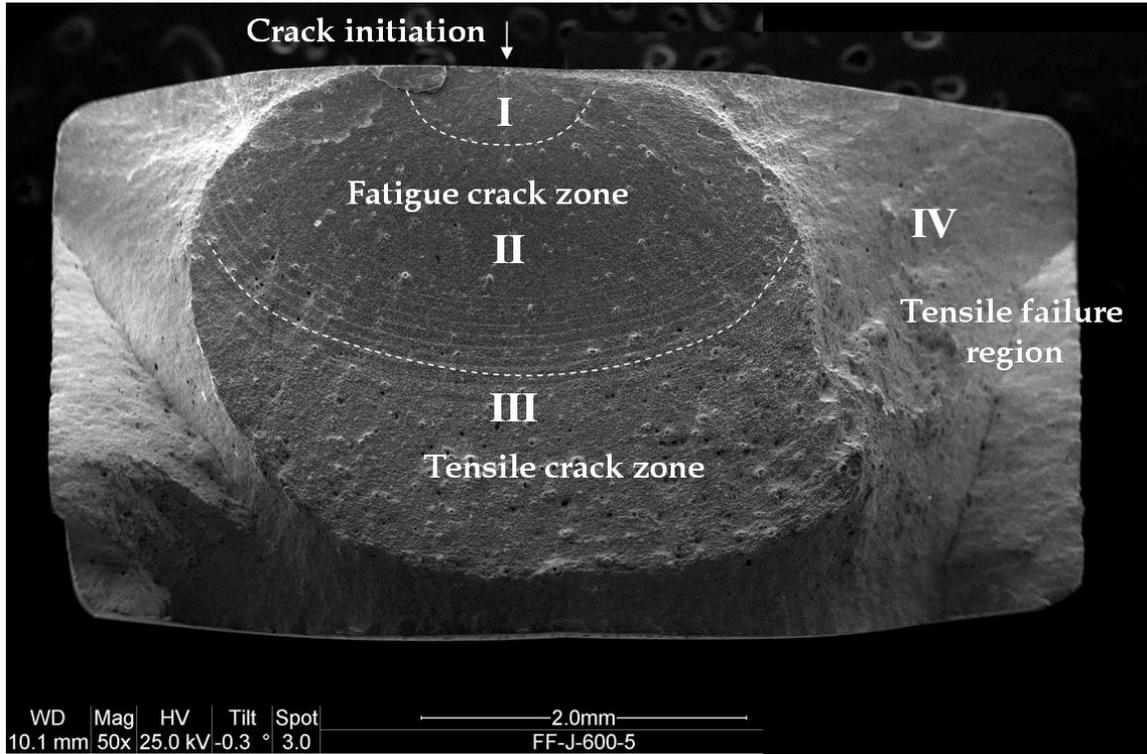
Figure 4.12 SEM micrograph of specimen from test #5

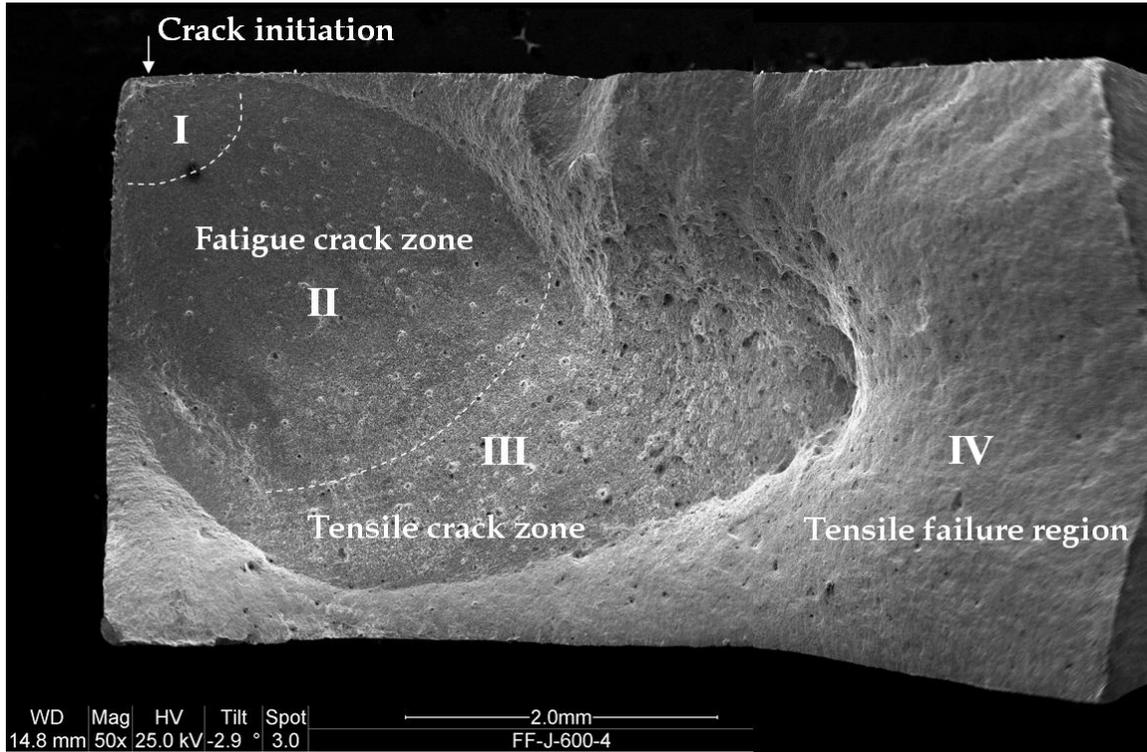
Figure 4.13 SEM micrograph of specimen from test #4

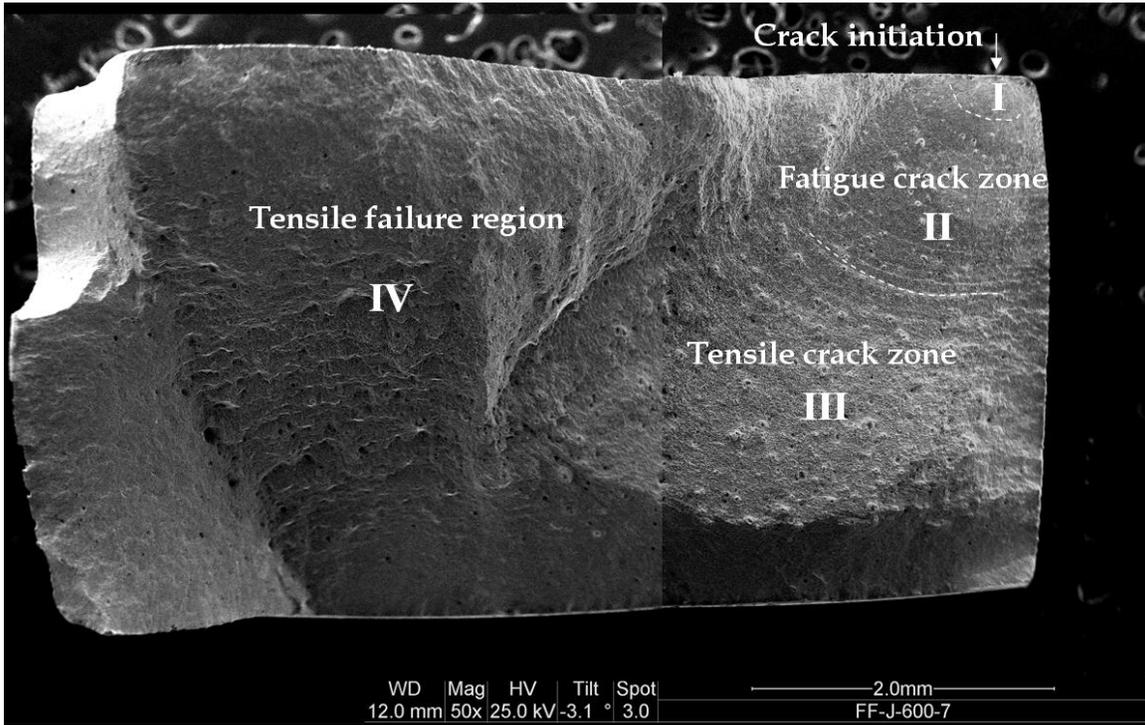
Figure 4.14 SEM micrograph of specimen from test #7

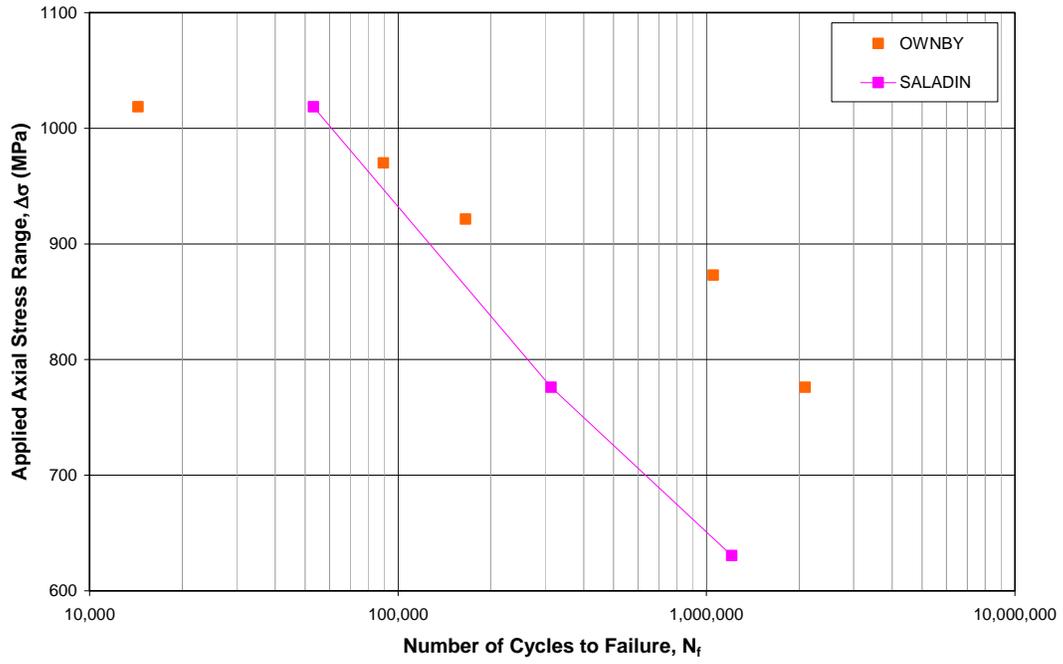
Figure 4.15 Comparison of Ownby and Saladin S-N data points for plain fatigue

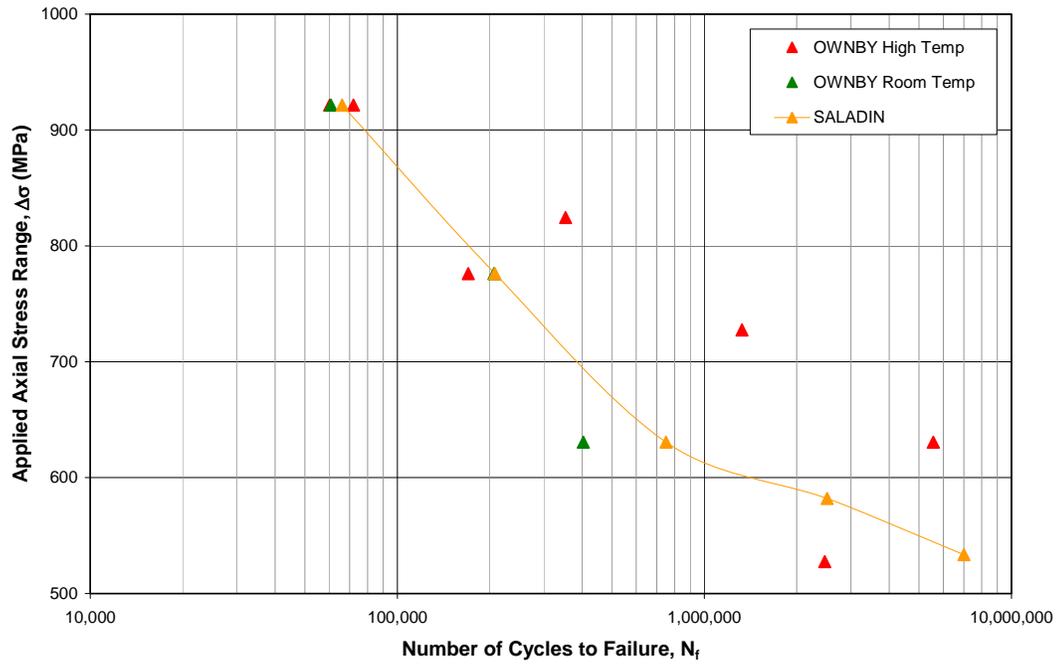
Figure 4.16 Comparison of Ownby and Saladin S-N data points for fretting fatigue

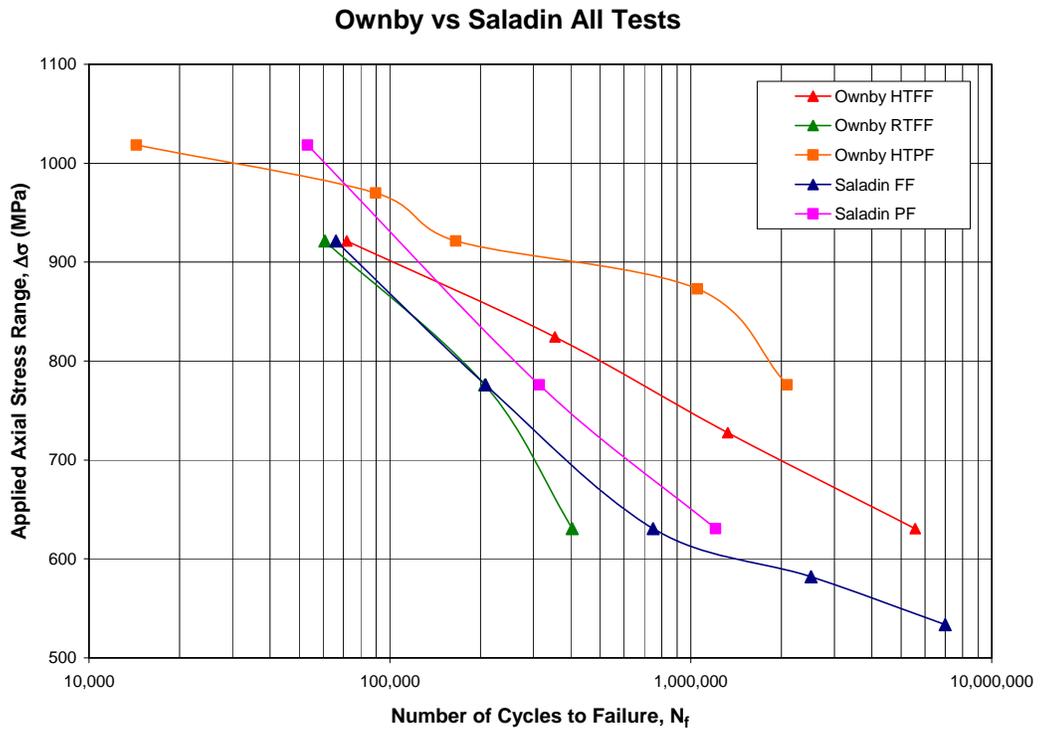
Figure 4.17 Comparison of Ownby and Saladin S-N data for all tests

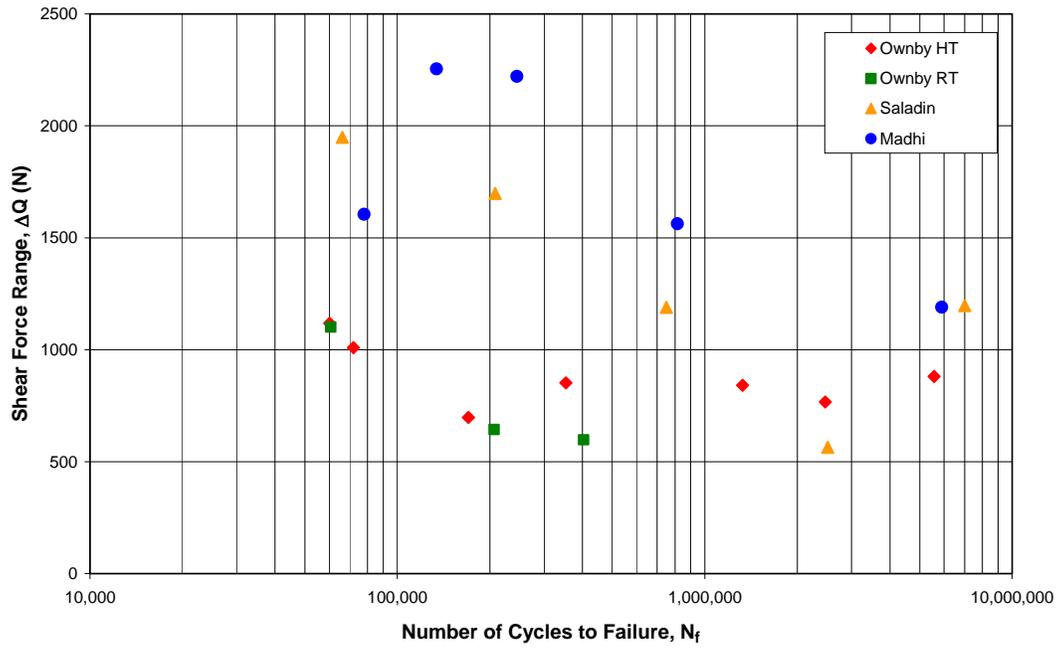
Figure 4.18 Plot comparing ΔQ vs N_f from Ownby, Saladin & Madhi data points

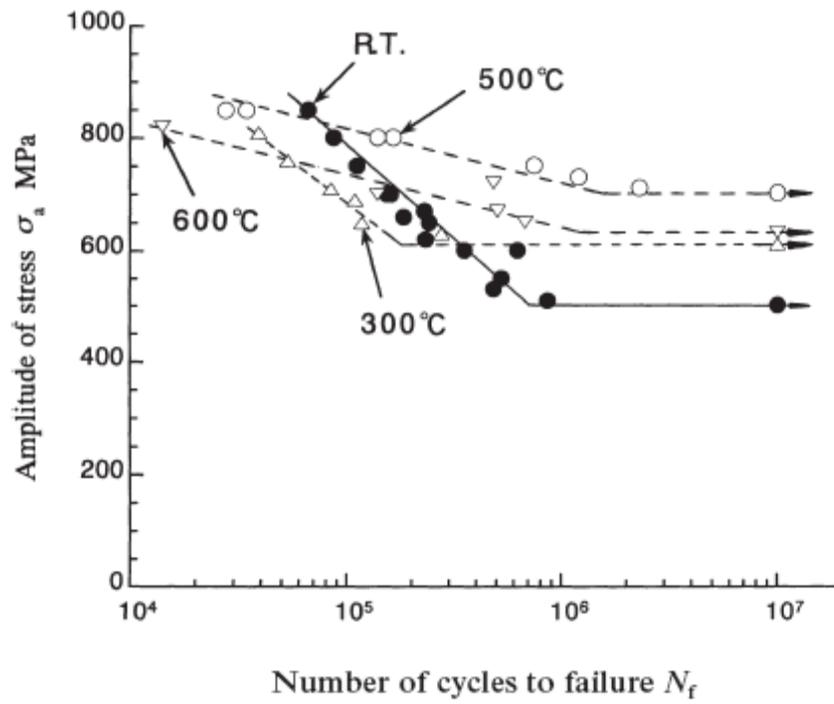
Figure 4.19 Plot from Kawagoishi et al. [21] of IN-718 at various temperatures, $R = -1$, $\nu = 55$ Hz under rotary bending fatigue

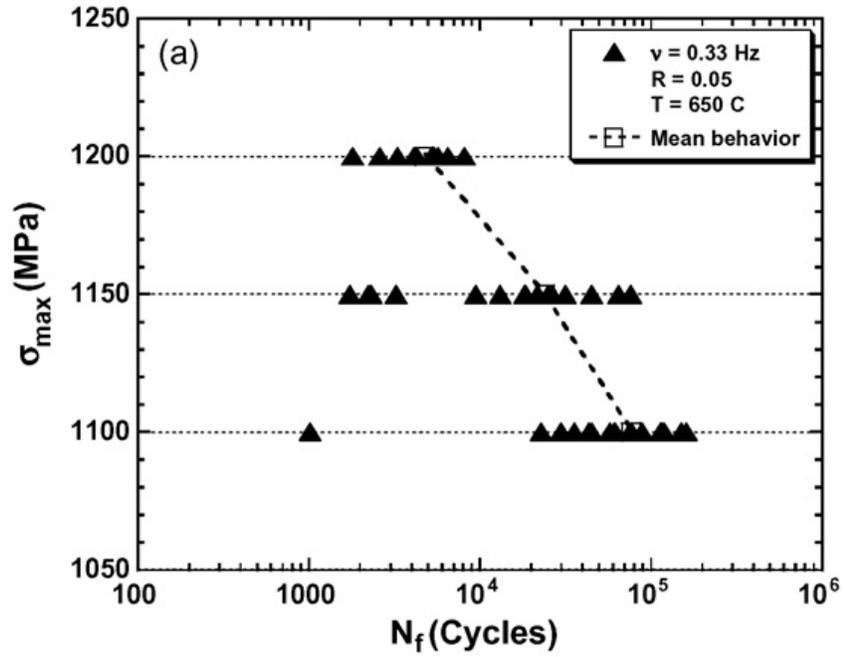
Figure 4.20 Plot from Jha et al [48] of P/M nickel-based alloy at 650 C, R=0.05 and $\nu = 0.33$ Hz

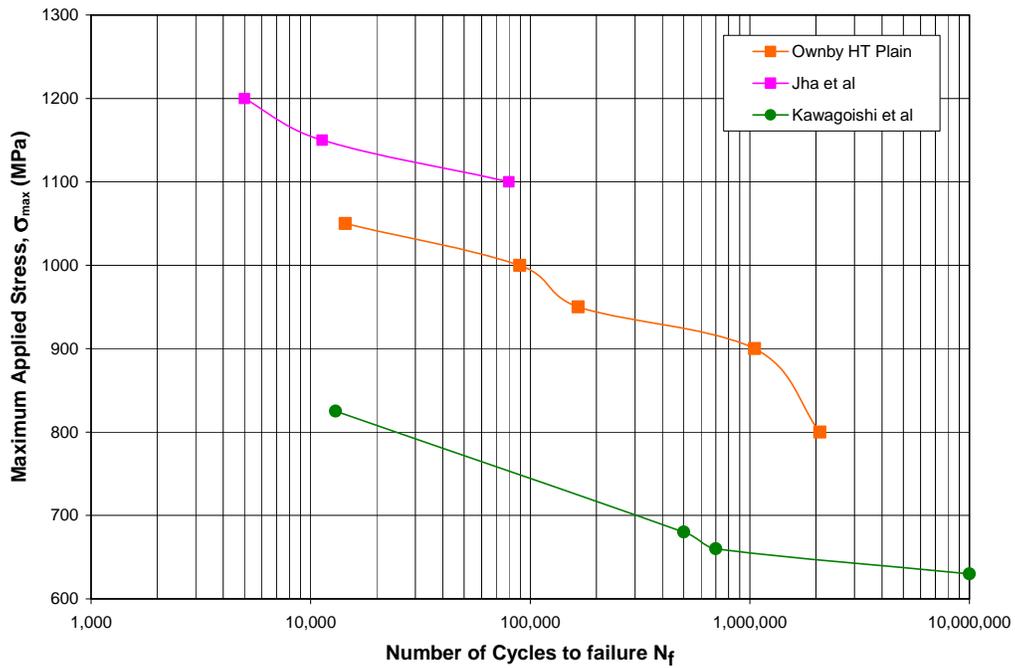
Comparison of High Temperature Plain Fatigue Study Trends

Notes: 1. Jha study was conducted at 650 C, R = 0.05 and $\nu = 0.33$ Hz

2. Kawagoishi study was a rotary bending test at 600 C, R = -1, $\nu = 55$ Hz

[21] studies. From this figure it is clear the overall trend in high temperature fatigue in each study was similar. The vertical placement of the three curves is related to the stress ratio from each study with the highest ratio, 0.05, on top and the lowest ratio, -1, on bottom with the trend line from this study falling in between the two other lines as expected considering the stress ratio, 0.03, also fell in between these two studies. Ultimately, the high temperature fatigue behavior of nickel-based superalloys, whether IN-718 or IN-100, appear to be relatively similar to one another and exhibit increased fatigue life at elevated temperatures.

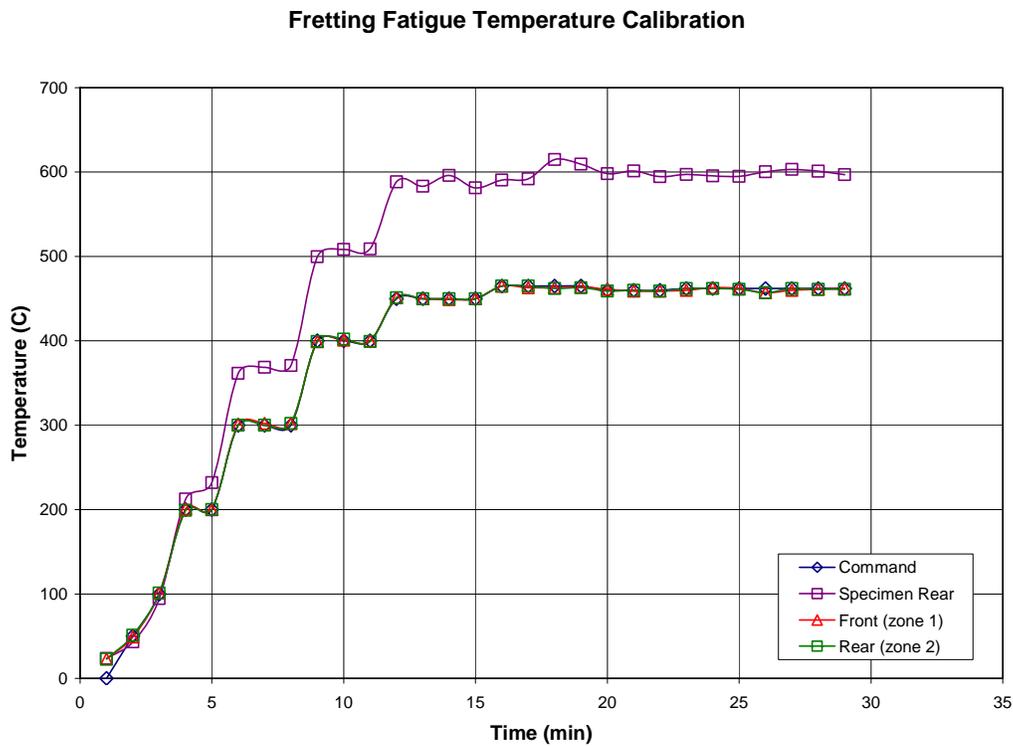
Figure A.1 Fretting fatigue condition calibration data from 6 Dec 07

Note the close correlation of the commanded temperature and the front and rear thermocouple observed temperatures thus indicating good control feedback.

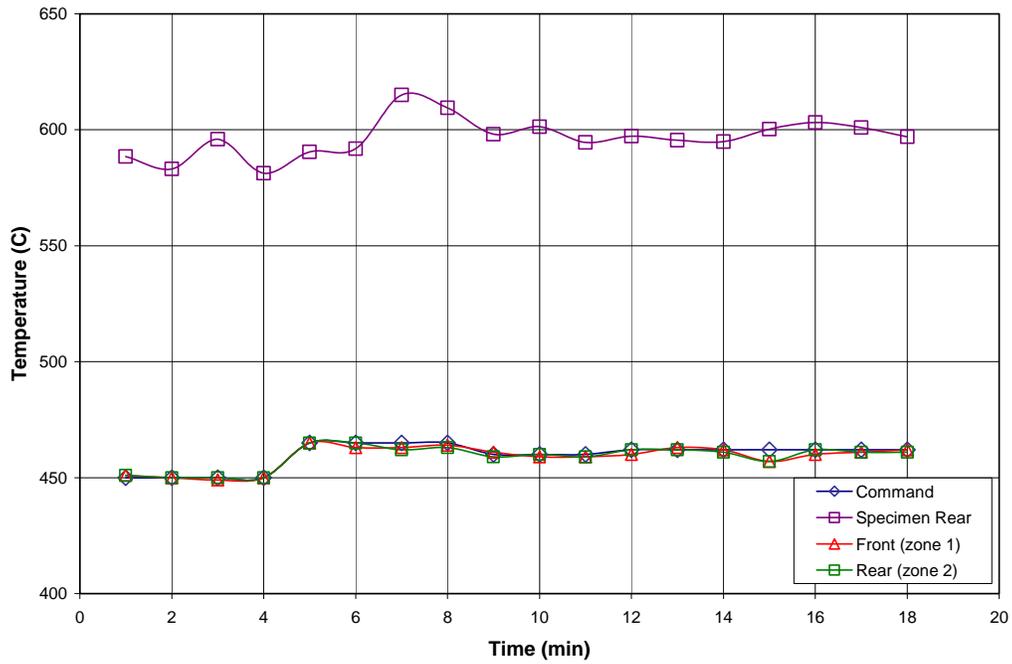
Figure A.2 Fretting fatigue condition calibration data from 6 Dec 07

In this figure the scale has been focused on the high temperature region. The specimen's observed temperature clearly stabilizes at the desired 600 C and maintains this temperature over time with a high degree of fidelity.

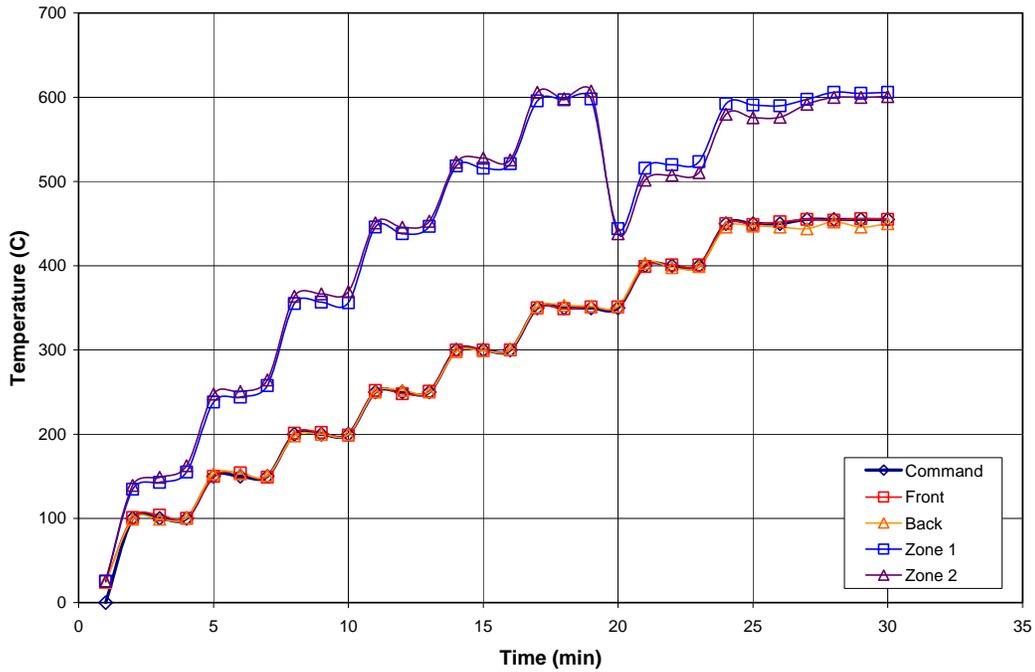
Figure A.3 Fretting fatigue condition calibration data from 30 Jan 08

Note the sudden change in observed temperature of the specimen, Zone 1 and Zone 2, in the 20th minute. This was due to the application of the fretting pads to the test specimen. This indicates the magnitude of the heat sink from the fretting pads.

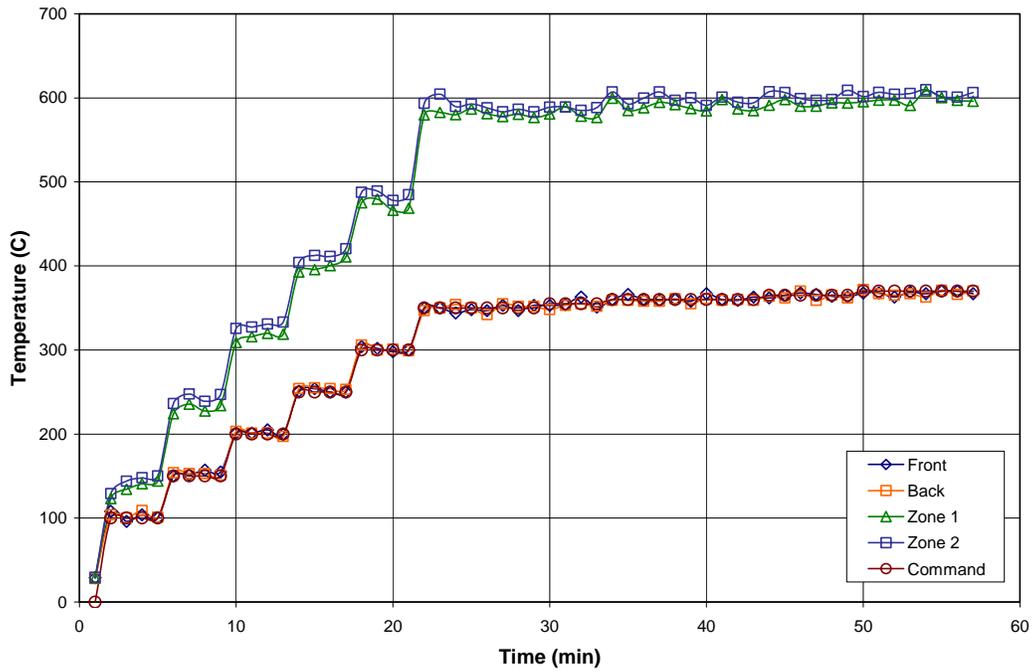
Figure A.4 Plain fatigue condition calibration data from 30 Jan 08

Notice that the commanded temperature for the plain fatigue configuration is much lower than in the fretting fatigue configuration. This difference is attributable to the heat sink from the fretting pads which are not applied in the plain fatigue configuration.
