DAMAGE DETECTION ANALYSIS USING LAMB WAVES
IN RESTRICTED GEOMETRY
FOR AEROSPACE APPLICATIONS

THESIS

AFIT/GAE/ENY/08-M29

March 2008

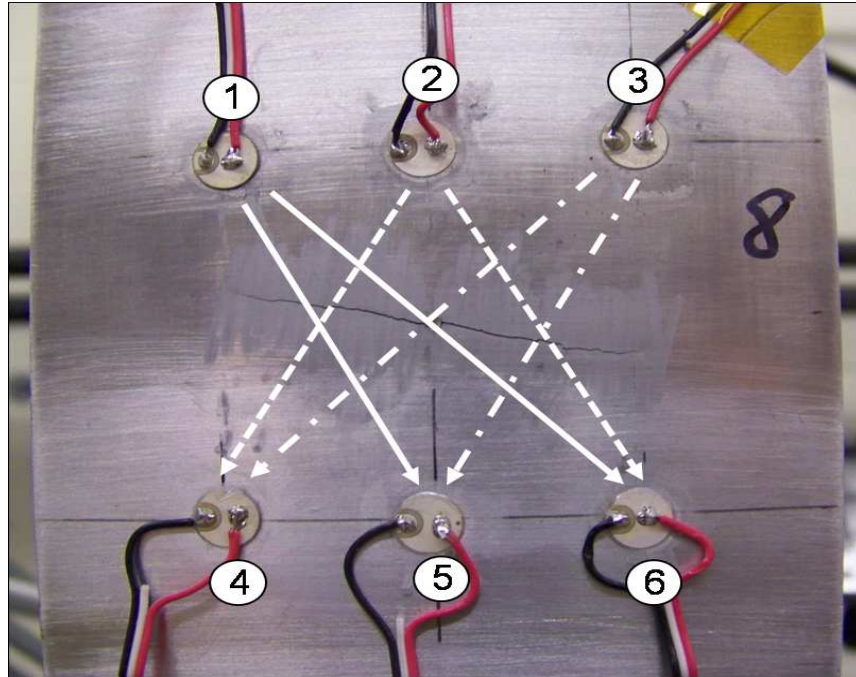
Figure 4.9: Bulkhead-webbing PZT setup with wave propagation paths indicated (shown with 36 mm crack).

Since we use a “pitch-catch” approach to detect damage in the plate, PZT pairs and wave propagation paths are selected that minimize the interference of the first reflected S_0 mode and increase the probability of crack detection. The path between PZT pairs 2-5 and 2-5B include the rivet hole (see Figure 4.9, and therefore once a crack is present, the propagation path between PZTs 2-5 and 2-5B is always completely interrupted by the fatigue crack. Conversely, the paths between PZT pairs 1-4, 1-4B, 3-6, and 3-6B are the farthest from the rivet hole, and are never completely interrupted by the crack. The data from the paths between 1-4, 1-4B, 2-5, 2-5B, 3-6, and 3-6B can be used as a control to better understand the effects of continued fatigue loading on the PZTs. Figure 4.9 shows the PZT pairs that have propagation paths interrupted by the growing crack. It is the paths between these PZT pairs where we look for decreases in the response amplitude due to damage.
