# Performance Evaluation Test of the Rapid Area Preparation Tool (RAPTOR)

**December 2008**

Prepared by  
Institute for Defense Analyses  
4850 Mark Center Drive  
Alexandria, VA 22311-1882

**Humanitarian Demining Program**  
Night Vision and Electronic Sensors Directorate  
Attn: AMSRD-CER-NV-CM-HD  
10221 Burbeck Road  
Fort Belvoir, VA 22060

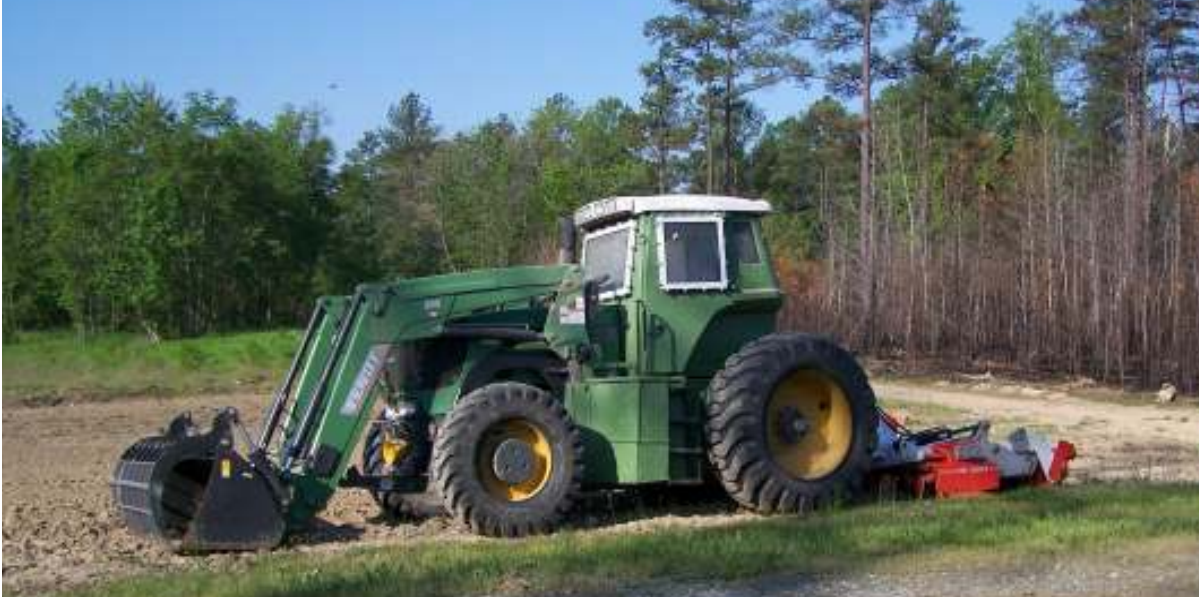
**Figure 1: Rapid Area Preparation Tool (RAPTOR)**

The objective of the RAPTOR program is to provide area-preparation and mine-clearance capability on a mine-survivable vehicle. Figure 1 shows the RAPTOR, a modified and armored Fendt 918 farm tractor capable of operating a number of specialized and off-the-shelf commercial attachments to address challenges when performing vegetation clearance, soil preparation, area reduction, mine removal and neutralization, and quality assurance during humanitarian demining.

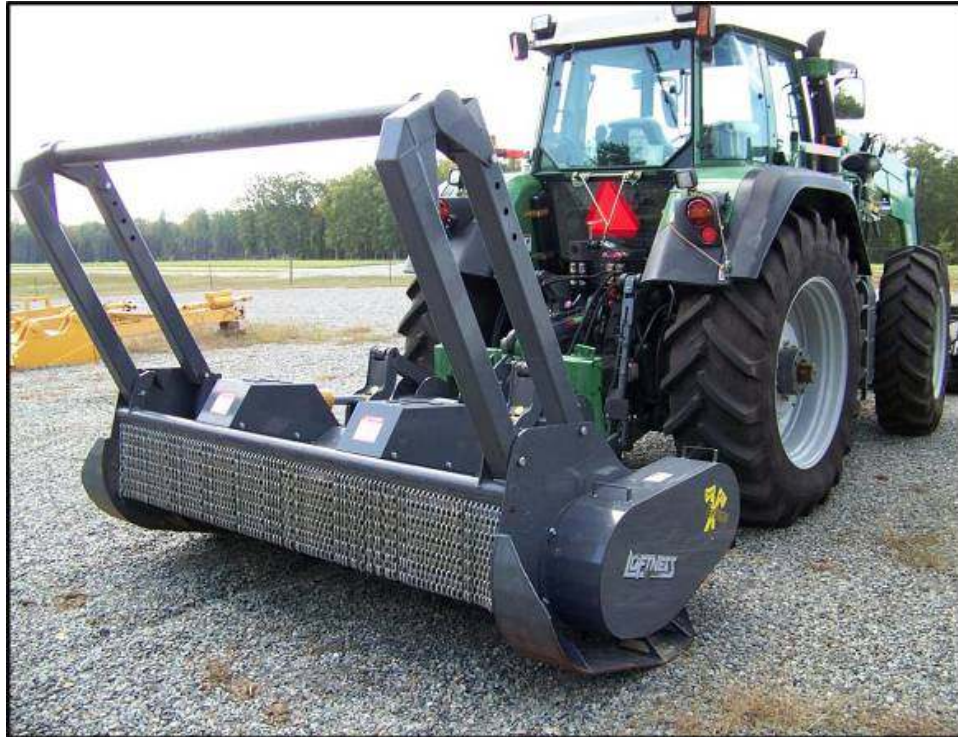
**Figure 2: Loftness Vegetation Cutter**

<b>Item</b>	<b>Measurement / Dimension</b>
Width	117 in / 2,972 mm
Cutter fielded weight	4,980 lb / 2,259 kg
Width of cut	93 in / 2,362 mm
Number of knives	20

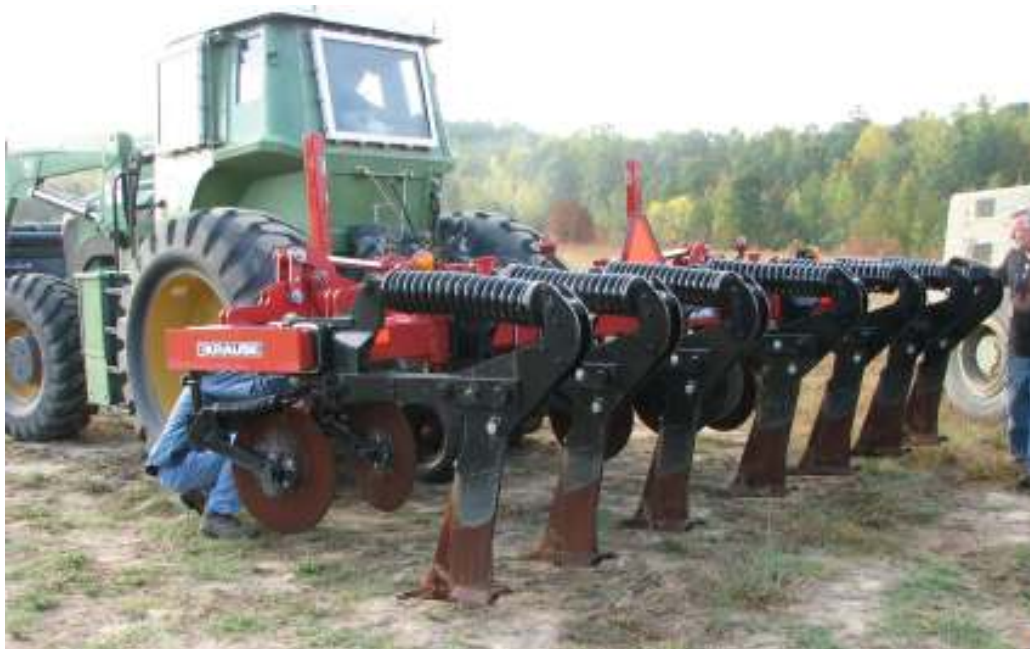
**Figure 3: Krause 4830 Chisel Plow**

<b>Krause Chisel (Ripper) Plow 4830-730F</b>	<b>Measurement / Dimension</b>
Number of shanks	7
Spacing between rows	30 in / 14.2 cm
Swath width	232 in / 91.3 cm
Spring reset shank shipping Weight	5,364 lb / 2,438 kg
Transport width	138 in / 350.5 cm
Transport depth	93 in / 236 cm

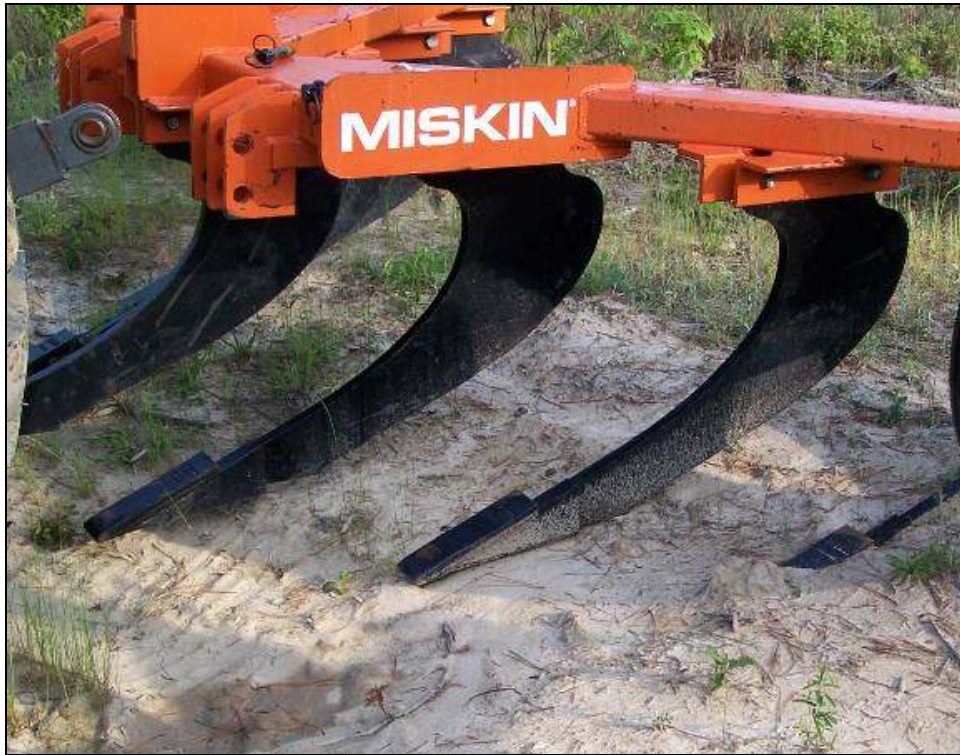
**Figure 4: Miskin Parabolic Subsoiler Plow**

<b>Miskin Parabolic Subsoiler</b>	<b>Measurement / Dimension</b>
Number of shanks	7
Spacing	20 in / 7.9 cm
Shank height (point to frame)	32 in / 12.6 cm
Plow shipping weight	2,068 lb / 940 kg
Width	11 ft 8 in / 3.55 m

According to the manufacturer, “the Subsoiler frame...is angled back 45 degrees so that it requires less horsepower and fuel, and allows travel at a faster speed. The first parabolic shank cracks and lifts the ground. The second shanks break up the ground partly cracked by the first shank. The third shanks break up the ground that was cracked by the second shanks, and so on.” Before operations, the height of the plow’s tires is adjusted to ensure optimal ground-engaging depth of the digging shanks. This adjustment took approximately 7 minutes to complete and was set to give a shank digging depth of approximately 12 in. Images of the adjustment are shown in Figures 18 and 19.

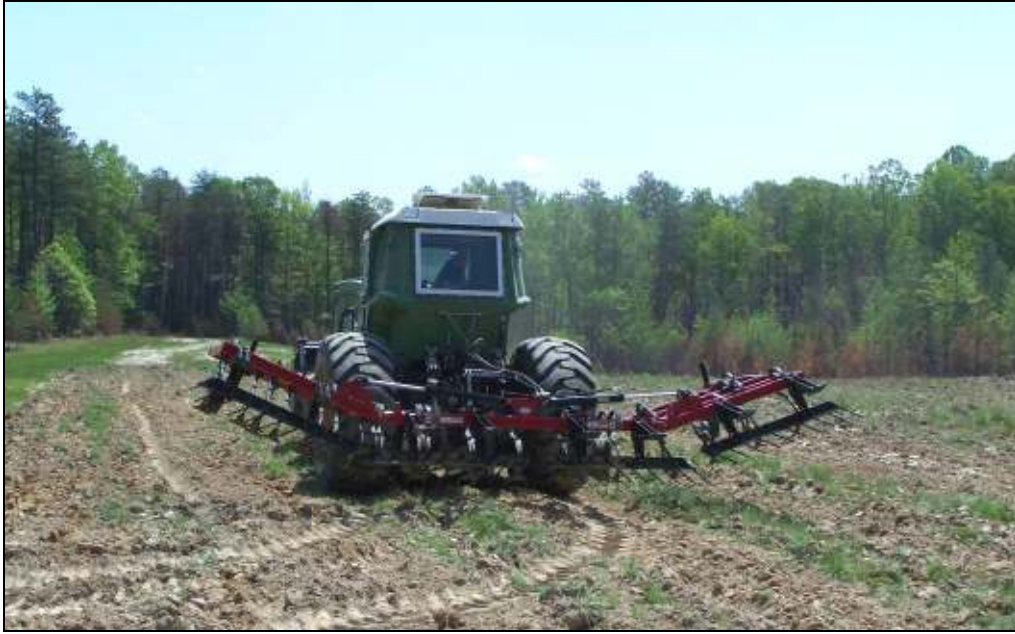
**Figure 5: Unverferth Spring Cultivator Being Extended**

<b>Unverferth Spring Cultivator</b>	<b>Measurement / Dimension</b>
Width (collapsed)	150 in / 3,810 mm
Width (extended)	240 in / 6,096 mm
Folded height	87 in / 2,210 mm
Cultivator fielded weight	2,545 lb / 1,154.4 kg
Number of S-tines	37
Number of leveling bar teeth	40

The Unverferth cultivator has two hydraulically operated hinge points that allow the cultivator to be transported with a reduced width (see Figures 24–26). The cultivation configuration has the sides fully extended, allowing each tine to contact the ground.

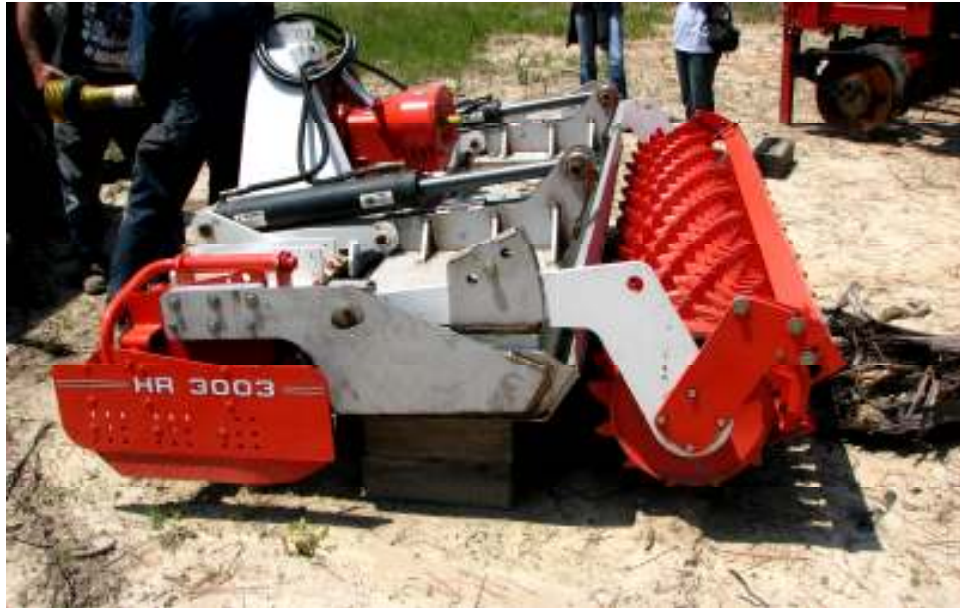
**Figure 6: Power Harrow with Magnet**

<b>Power Harrow with Magnet</b>	<b>Measurement / Dimension</b>
Width	10.1 ft / 3,087 mm
Number of two-bladed harrow tines	121.5 in / 10
Distance between harrow tines axis	11.8 in / 300 mm
Weight—harrow and magnet	8,300 lb / 3,765 kg
Weight—magnet installation	5,666 lb / 2,571 kg

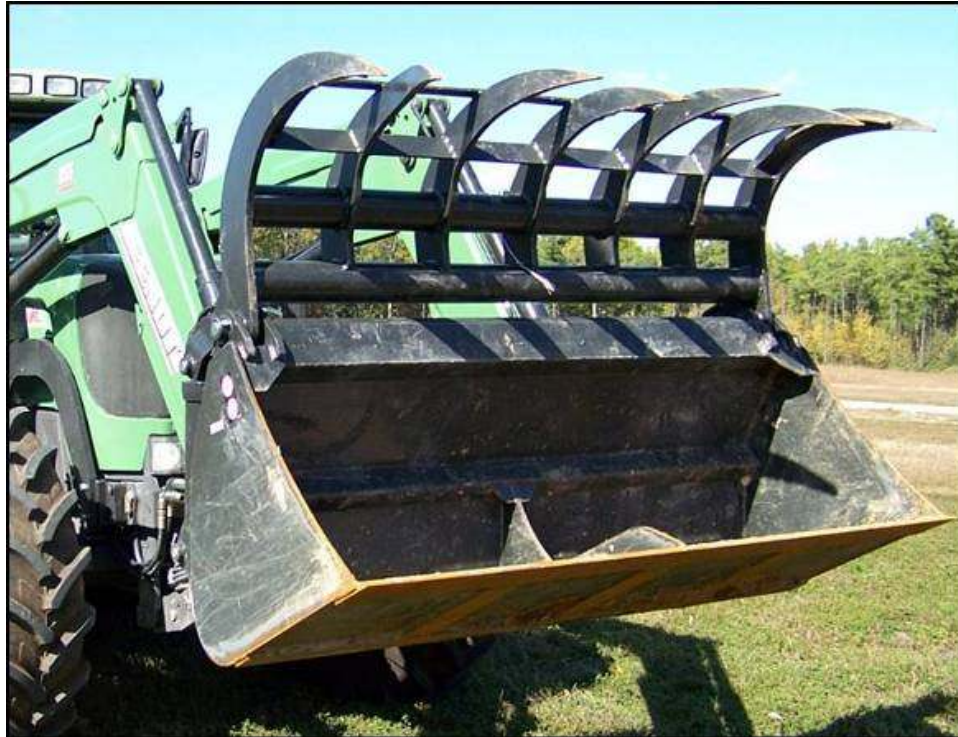
**Figure 8: Quicke Grapnel Bucket**

<b>Quicke Grapnel Bucket</b>	<b>Measurement / Dimension</b>
Weight	1,215 lb / 655 kg
Width	79 in / 200 cm
Depth	31.5 in / 80 cm
Volume	40 ft <sup>3</sup> / 1.14 m <sup>3</sup>

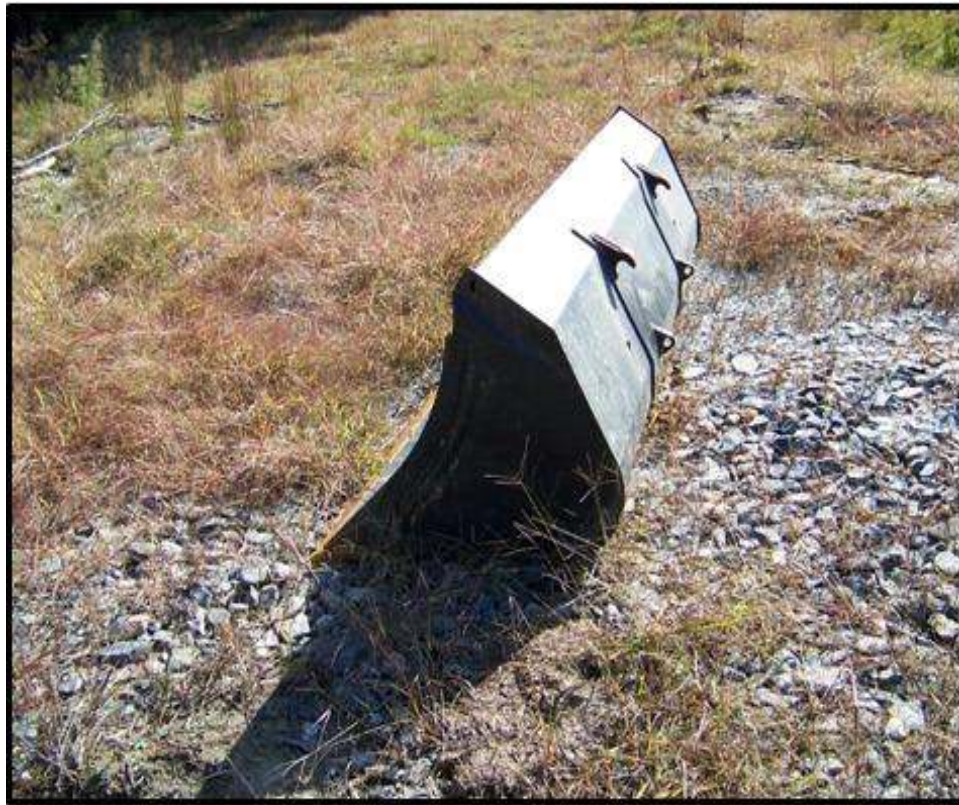
**Figure 9: Quicke Utility Bucket**

<b>Quicke Utility Bucket</b>	<b>Measurement / Dimension</b>
Weight	520 lb / 235 kg
Width	73 in / 185 cm
Depth	31.9 in / 81 cm
Volume	25.8 ft <sup>3</sup> / .72 m <sup>3</sup>

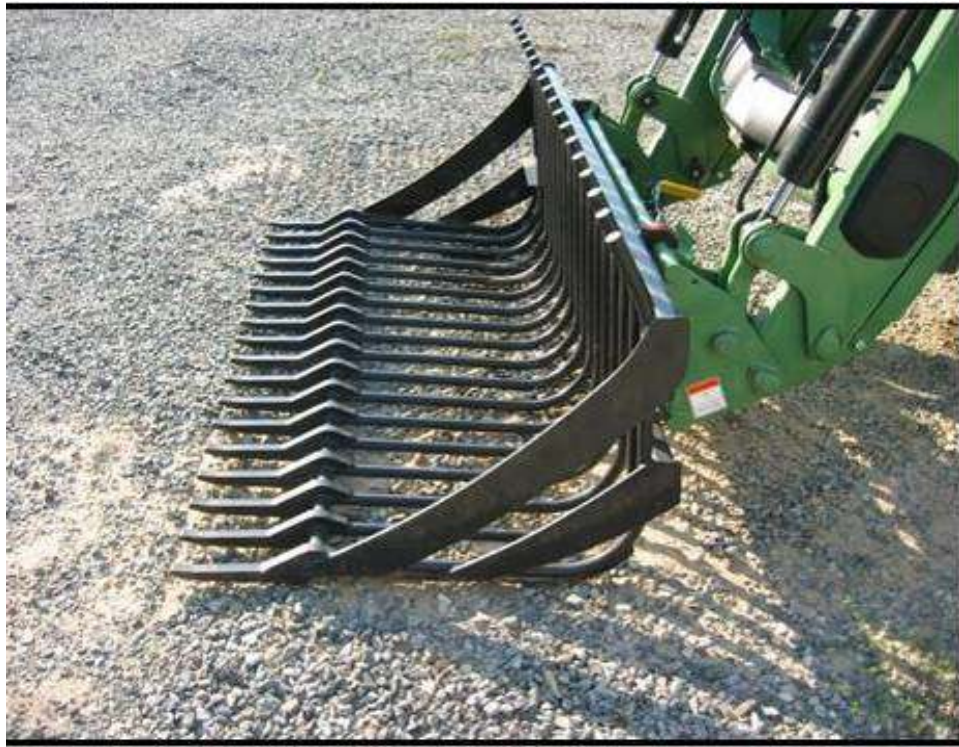
**Figure 10: Quicke Rock Bucket (Stone Fork, Model 180)**

<b>Quicke Stone Fork</b>	<b>Measurement / Dimension</b>
Weight	630 lb / 286 kg
Width	74.8 in / 2.0 m
Depth	39.4 in / 1.0 m
Height	29 in / 73 cm
Number of times	18

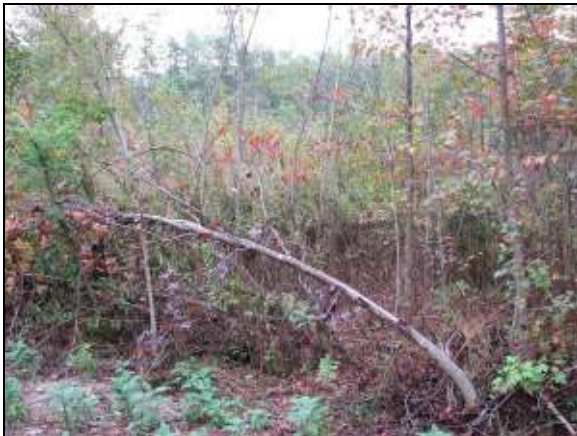
**Figure 11: Test Site A (Category 3)**

Test Site A consists of both Category 1 vegetation on level terrain and Category 3 vegetation over gently rolling terrain. Table 11 describes the four categories of vegetation, and Figures 11 and 12 provide images of Test Site A.

vegetation cutter, the first step was to determine how much ground clearance was needed to avoid ground scalping during cutting operations. The first pass of the cutter over Category 1–2 vegetation (at the bottom of Figure 11) left a debris layer measuring 3–4 in. (7.5–10 cm) above the ground. A subsequent pass (performed in the opposite direction to that of the first pass) further reduced the debris and brush height to about 2 in. (5 cm). At times, small trees cut during the first pass of the vegetation cutter fell onto the ground parallel to the cutting track and were not further cut or mulched during the second pass of the cutter because of the ground-clearance allowance. (See the result in Figure 17.)

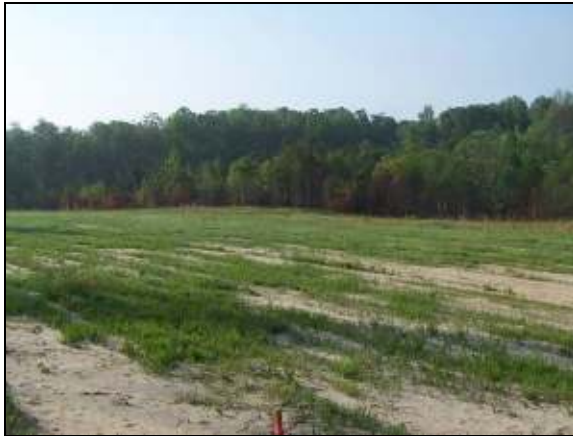
Figure 13: Test Site B

Test Site B is a 100 m × 50 m area with little vegetation over flat to gently rolling terrain. The soil contains root systems within a sandy loam soil. Figures 13 and 14 show images of Test Site B.

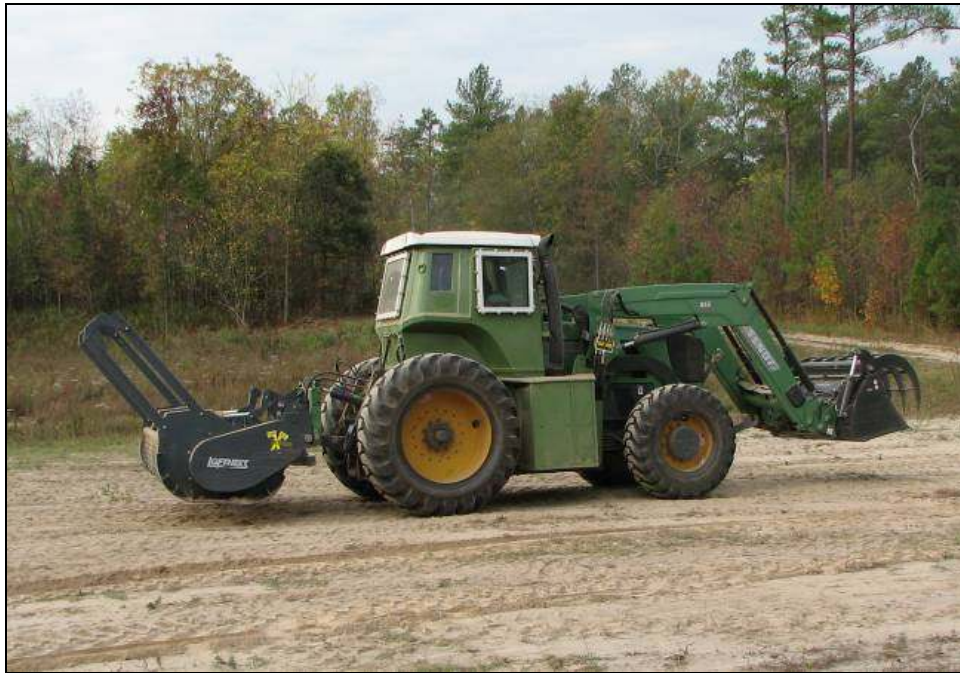
Figure 15: Loftness Vegetation Cutter

The Loftness vegetation cutter, shown in Figure 15 attached to the rear of the RAPTOR, is best operated at a forward speed of 1.5–3 kph. Operating speed depends on terrain (e.g., flat, rolling, etc.) and the category of vegetation being cut, where Category 1 vegetation allows for faster forward-moving speeds and Category 3–4 requires slower forward movement. For Category 3–4 vegetation cutting, it is recommended that the

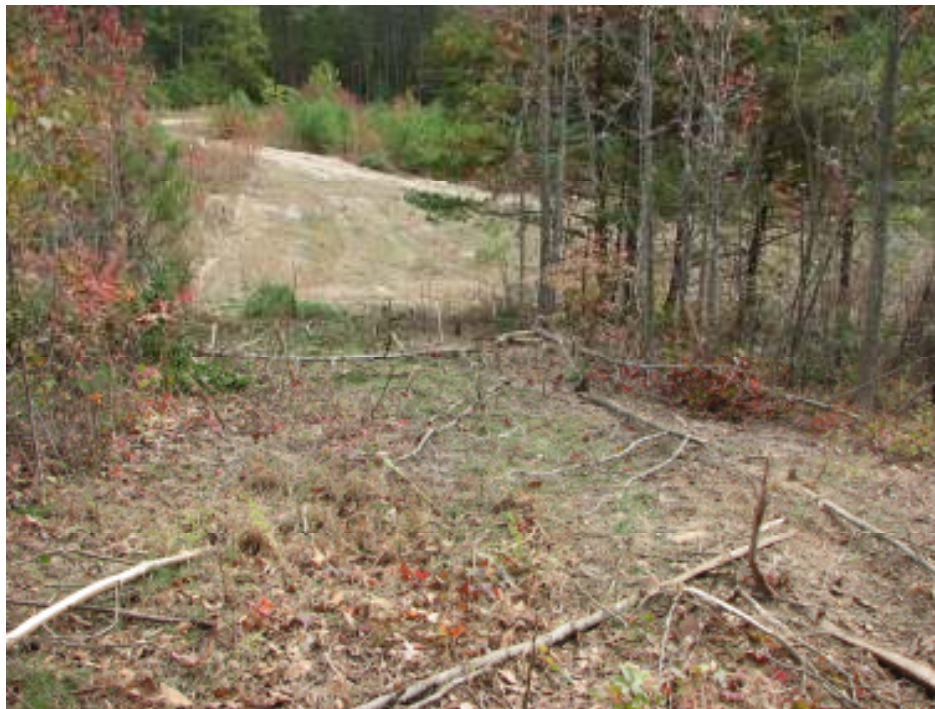
**Figure 17: Debris Remaining after Vegetation Cutting**

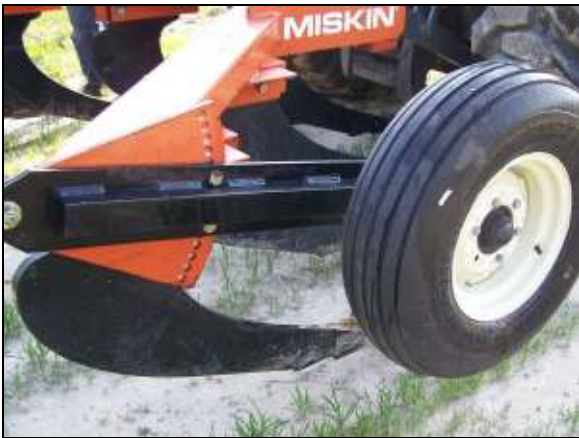
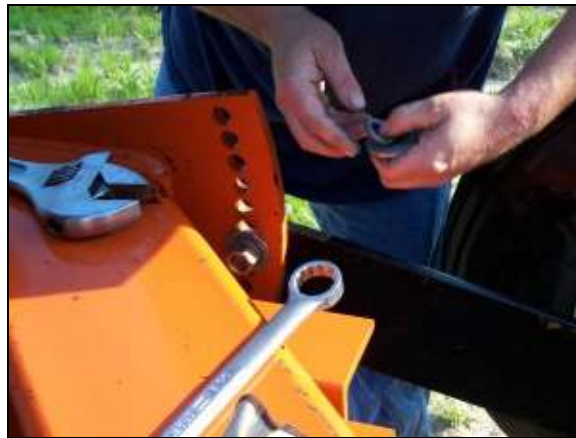
Figure 18: Height Adjustment, Miskin Subsoiler

Figure 19: Height Adjustment, Miskin Subsoiler

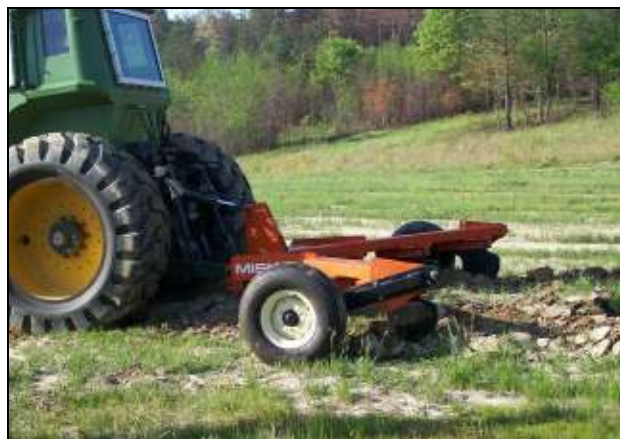
Figure 20: Operating Position, Miskin Parabolic Subsoiler

Plowing depth was set by driving the RAPTOR forward to force the plow shanks to engage the soil until the depth wheels rode on the ground (see Figure 20).

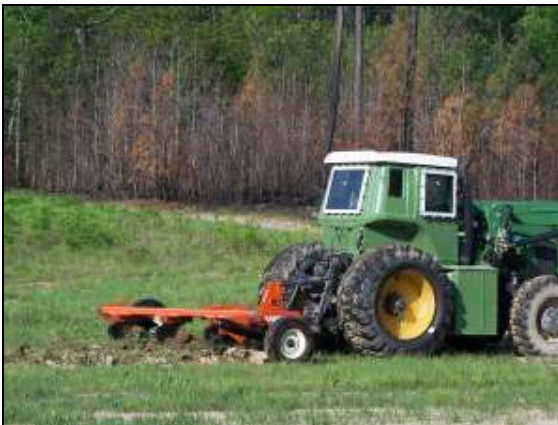
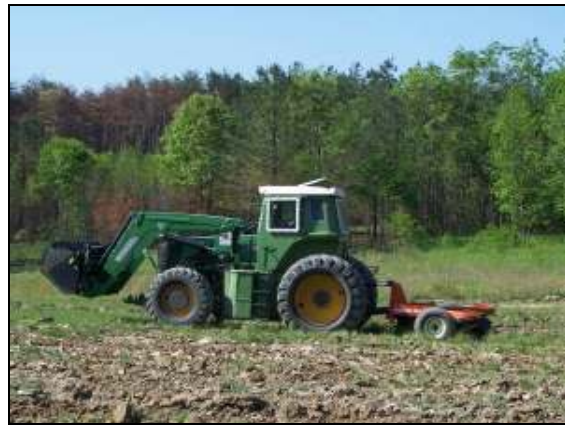
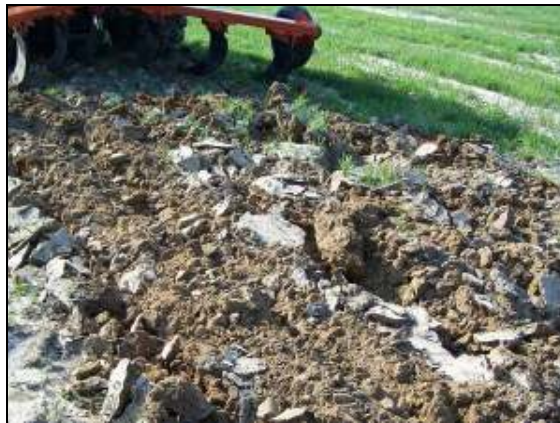
In total, the 5,000 m<sup>2</sup> area was plowed in 116 minutes. This time includes two full passes of the plow over the test area and does not include any stopped times for replacing shear bolts or freeing the plow from roots. The resulting plowing rate is 2,586.2 m<sup>2</sup>/hr. Figures 21–23 are images of plowing operations.

**Figure 21: Miskin Subsoiler Operations**

**Figure 22: Miskin Subsoiler Operations**

**Figure 23: Ground After Plowing Operations, Miskin Subsoiler**

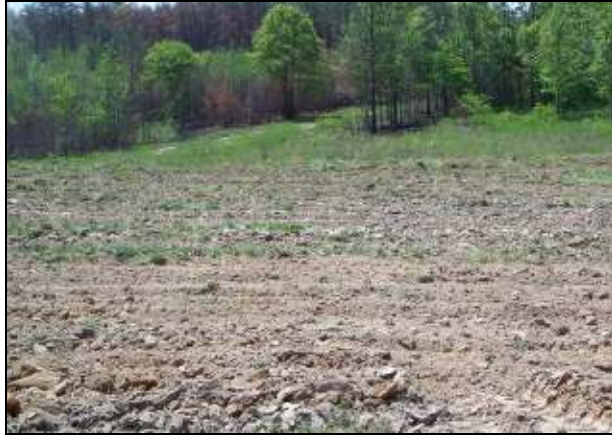
Testing of the cultivator was conducted in Test Site A after the completion of plowing operations with the parabolic subsoiler. The parabolic subsoiler left the soil well plowed, and there were no bogging or other operational issues during cultivation. The cultivator completed two passes of the 5,000 m<sup>2</sup> in 37 minutes, for a cultivating rate of 8108.1 m<sup>2</sup>/hr. Figure 27 is an image of the ground after cultivating operations.

**Figure 27: Ground After Cultivation, Unverferth Cultivator**

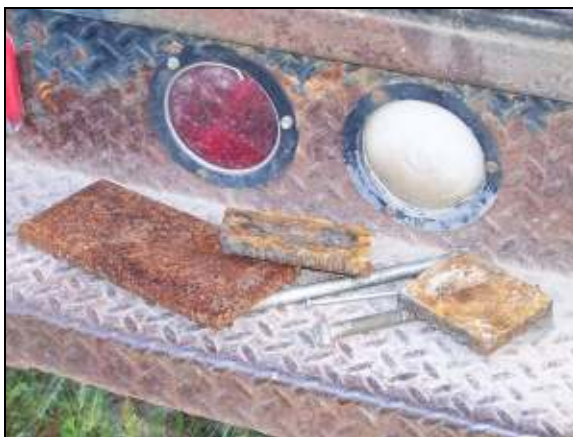
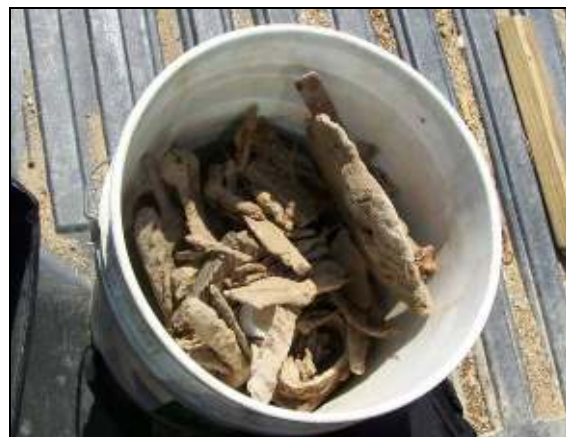
Figure 29 shows various metal objects (three steel plates, five metal bolts, two spikes), that were placed randomly on the surface or up to two inches below the surface of the soil in the test area in front of the RAPTOR's path to gauge the effectiveness of the harrow/magnet. After one emplacement of these items, all items recovered. In a second emplacement, all items except two bolts and one spike were recovered. Additional metal pieces were recovered from the test area. Before becoming a military installation, the test site was a privately owned farm and has since been used for training and testing. Additional metal recovered was mostly corroded metal scrap and objects that ranged in size from a few millimeters to several centimeters. One pass of the power harrow with magnet over the 5000 m<sup>2</sup> test area removed 402 pieces of metal clutter from the ground (see Figure 30). The test was completed in 158 minutes, a clearance rate of 1,898.7 m<sup>2</sup>/hr. Figures 31–34 are images of harrow/magnet operations.

**Figure 29: Recovered Metal**

**Figure 30: Emplaced Metal Objects**

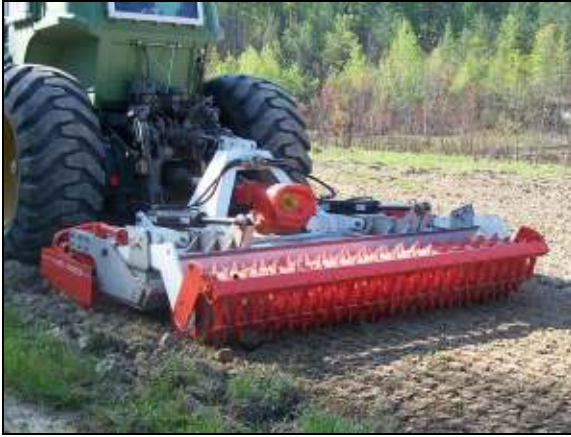
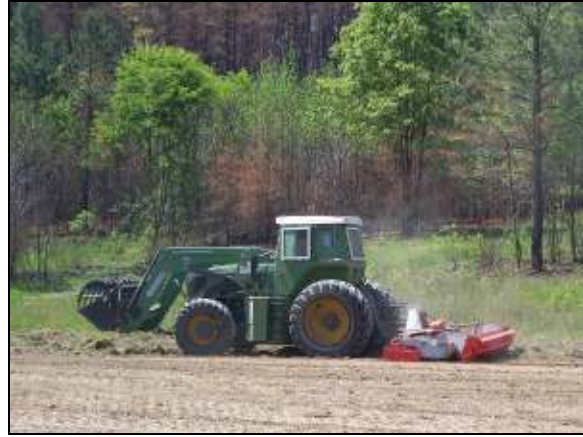
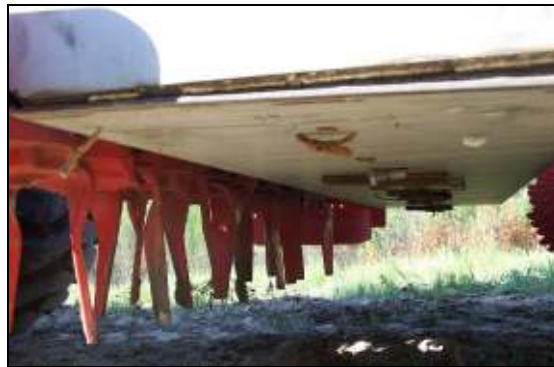
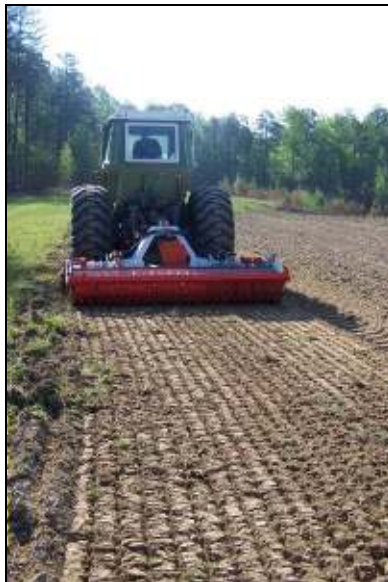
**Figure 31: Power Harrow with Magnet Operations**

**Figure 32: Power Harrow with Magnet Operations**

**Figure 33: Metal Attracted to Magnet**

**Figure 34: Ground After Harrow/Magnet Operations**
