ECBC-TR-661

EFFECTS OF VAPORIZED DECONTAMINATION SYSTEMS ON SELECTED BUILDING INTERIOR MATERIALS: VAPORIZED HYDROGEN PEROXIDE

January 2009

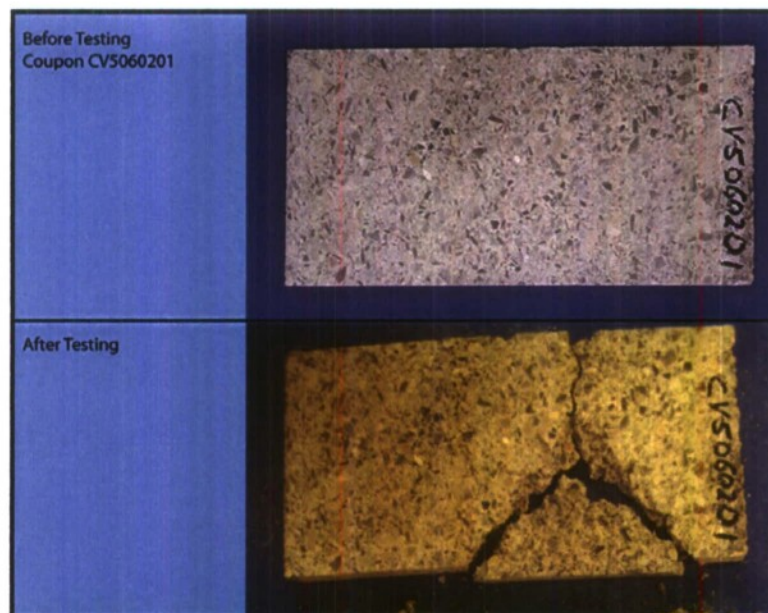
Figure 9. Representative concrete cinder block coupon before and after testing.

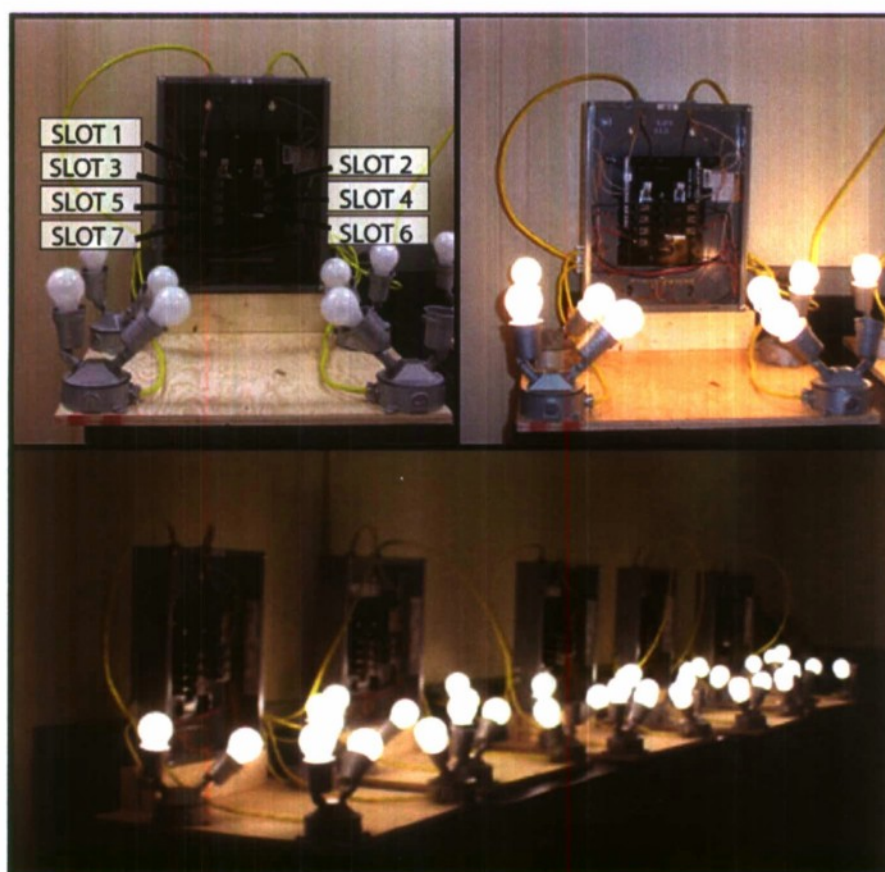
Figure 12. Circuit breaker test station photograph.

After visual inspection, the breakers were installed in the testing station and observed for 90 days under load (Figure 12). The testing station is an electrical box containing 8 spaces, 16 circuits, 100 amp max from square D (Home Depot No. 577-340). The circuit breaker box was wired with 12 gauge, 20 amp wire into the 120 V outlet. Each circuit breaker was wired in series with an electrical lamp (s513e) with an outlet box (s110e) manufactured by Thomas & Betts (Home Depot Nos. c214477 and b214426, respectively). Each lamp contained a Phillips 40 watt light bulb (Home Depot No. a356140). The test or control circuit breakers were installed into slots 1–7, and the baseline circuit breaker was installed in slot 8 (Figure 12, upper left corner).

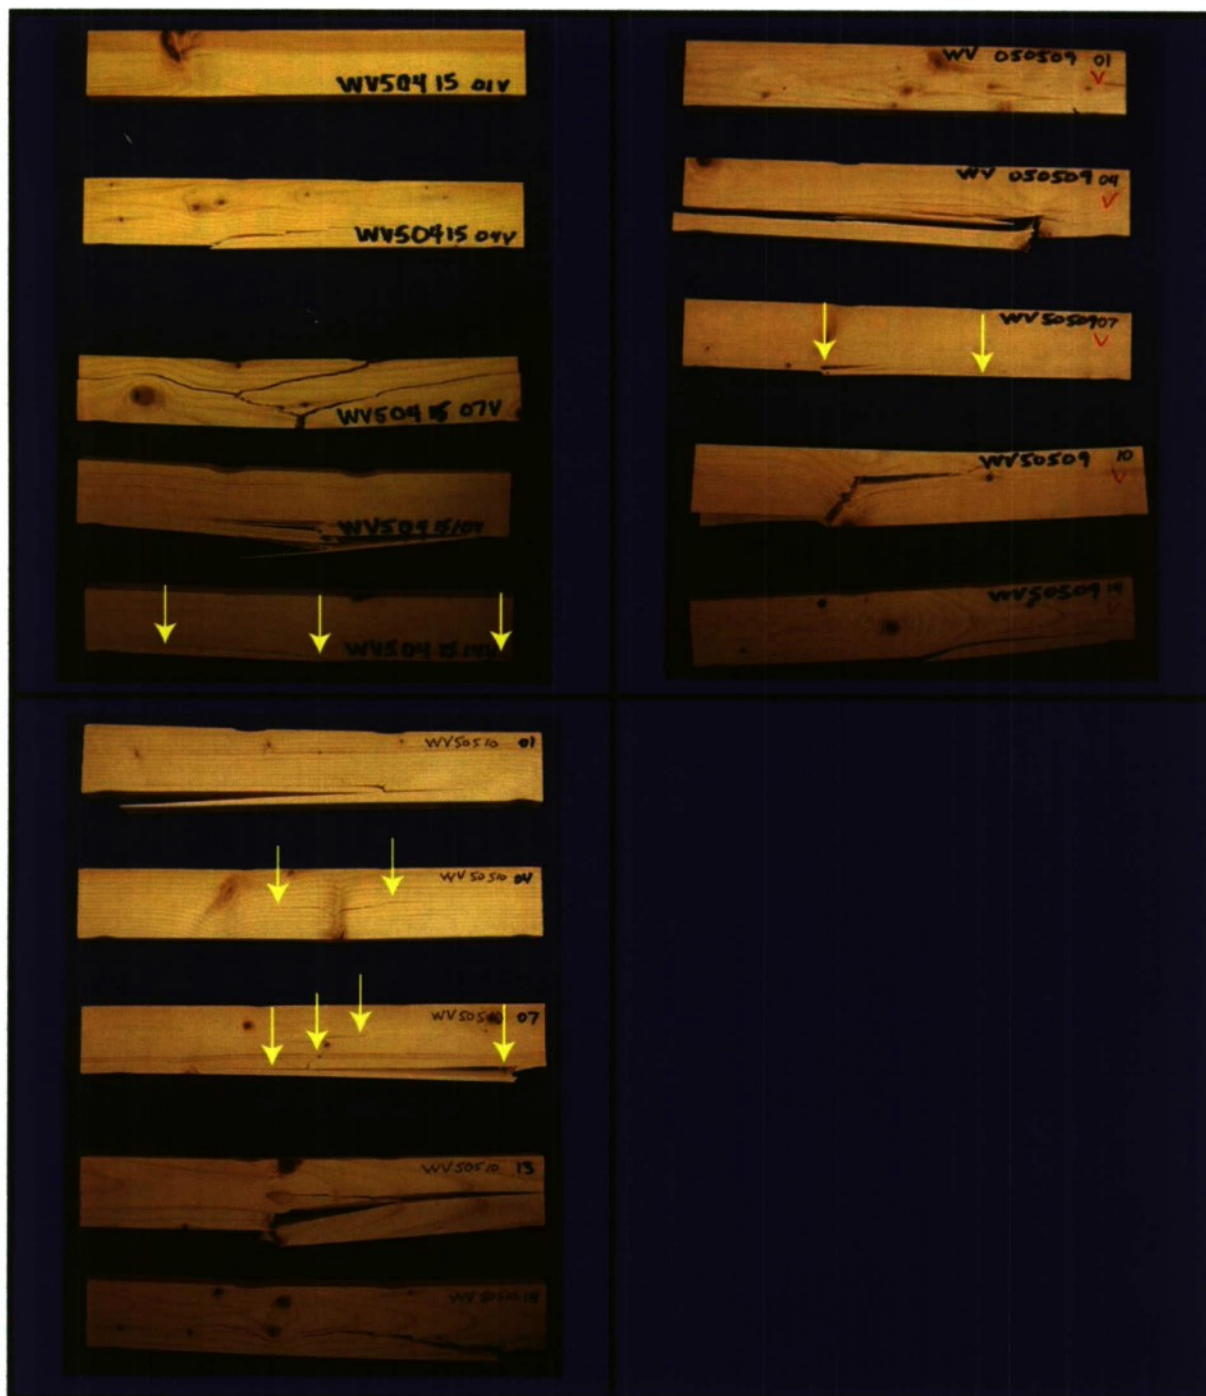
Wood coupon location of break: VHP 125 ppm set.

The ASTM test method requires reporting the location of the break for each wood sample. The purpose of this appendix is to provide this reporting information in pictorial form. Yellow arrows are used on samples where the photograph contract may not clearly show the location of the break.

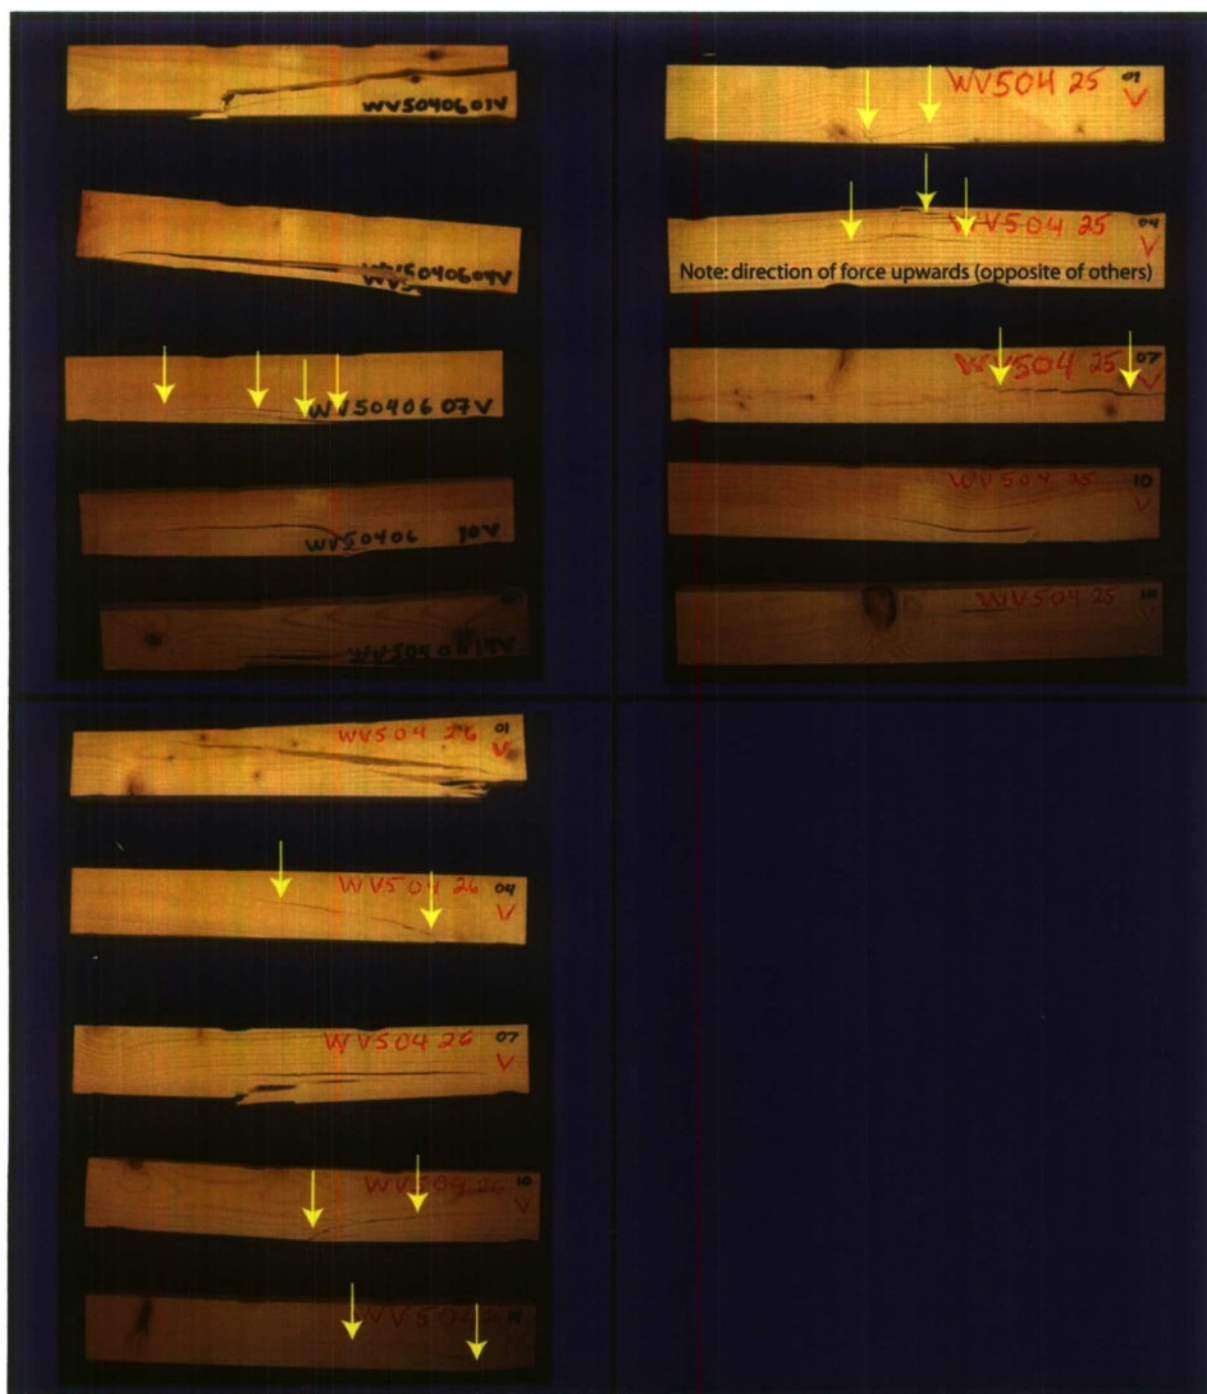
Wood coupon location of break: VHP 250 ppm set.

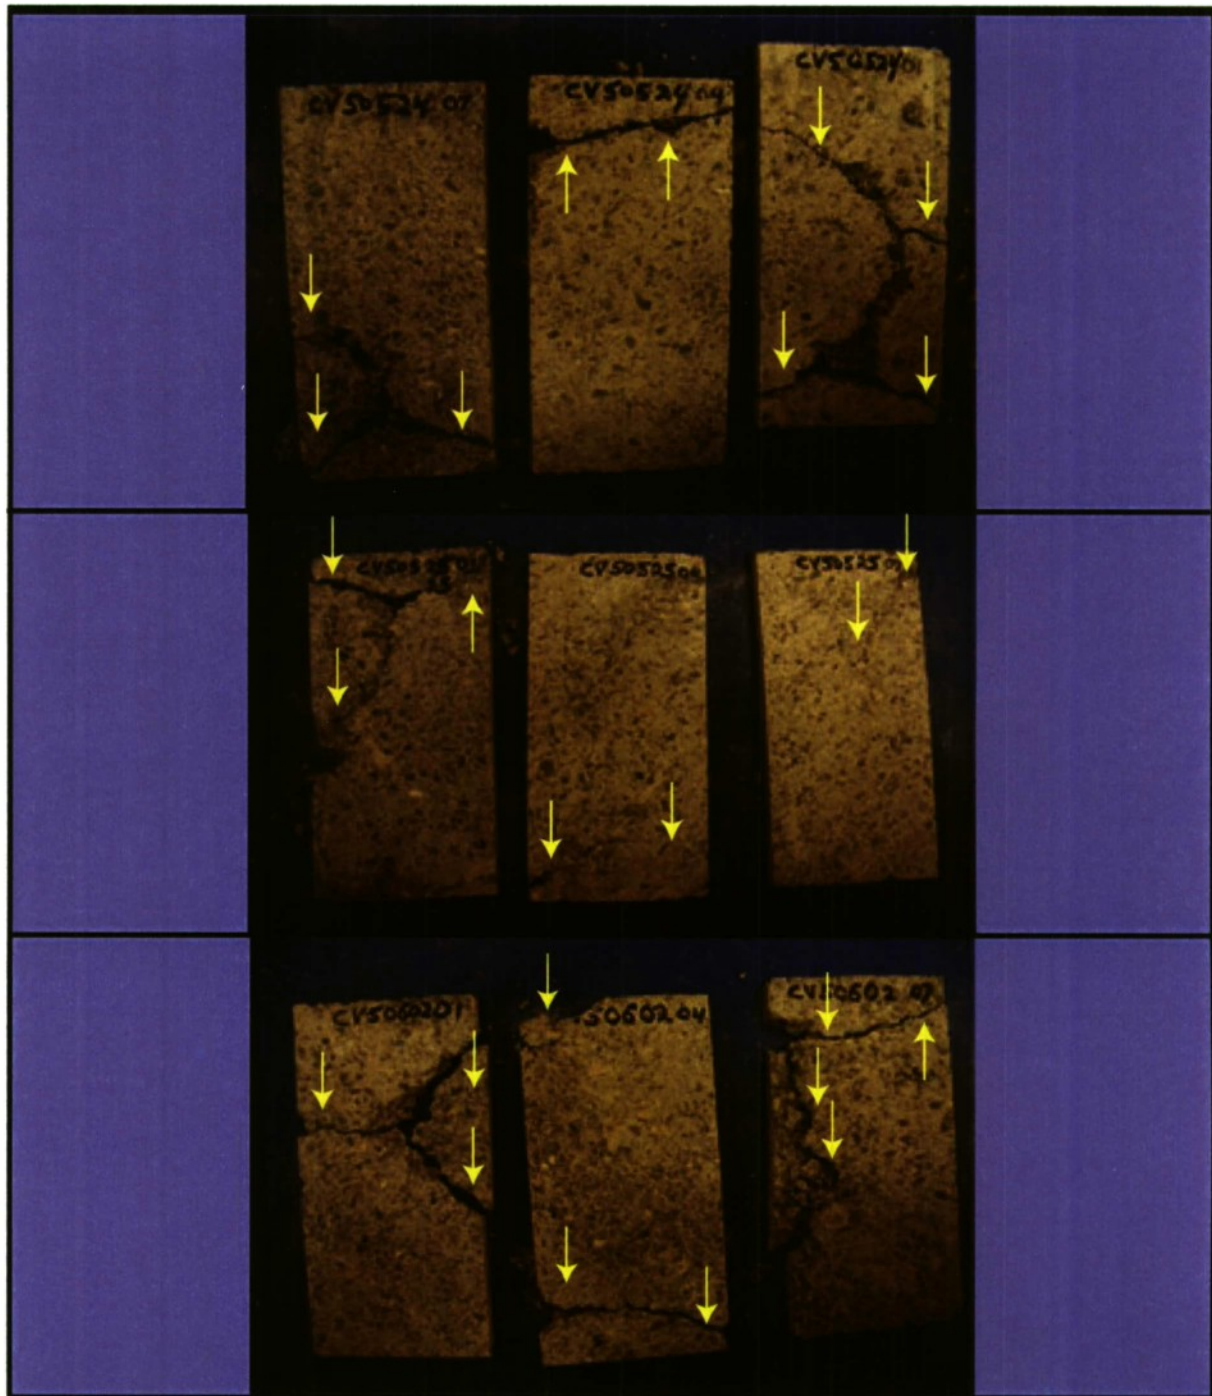
Concrete cinder block coupon location of break: VHP 125 ppm set.

There is no requirement for reporting the location of the break; however, concrete block is a variable material and differences in location were observed. The purpose of this appendix is to provide additional information through test photographs. Yellow arrows are used on samples where the photograph contract may not clearly show the location of the break.
