# ESTCP Cost and Performance Report

(ER-0426)

## Treatment of RDX and/or HMX Using Mulch Biowalls

April 2008

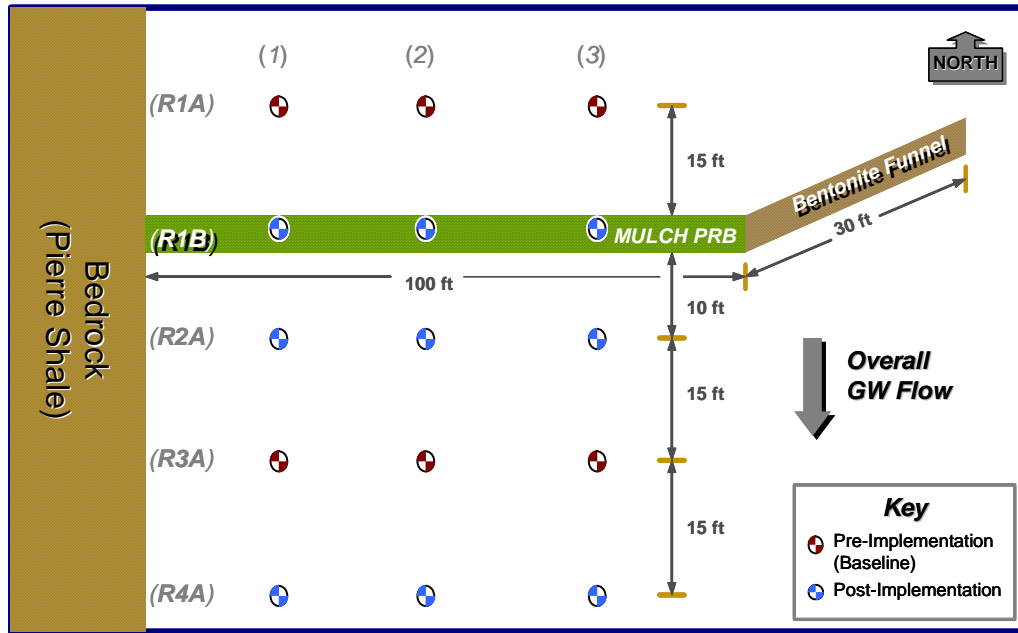
**Figure 5. PRB and Well Network Plan View Implementation Schematic (not to scale).**

(Well row designations are shown. Row R1A and R3A wells [red color symbols] were installed prior to the PRB installation, and row R1B, R2A, and R4A wells [blue color symbols] were installed after the PRB installation. The PRB and funnel trench installation began at the easternmost point away from the shale bedrock unsaturated zone and progressed westward.)

Implementation of the mulch/gravel PRB and the associated performance monitoring wells shown in the plan view in Figure 5 was completed in three phases. In the first phase, two rows of three monitoring wells each were installed, developed, and sampled. Prior to the mulch/gravel PRB installation, groundwater was collected from the six wells installed in the first phase. These samples established the baseline distribution of target contaminants in the field demonstration area.

1. *Technology Effectiveness.* Groundwater samples collected upgradient (Row R1A, Figure 5), immediately downgradient (Row R2A), and further downgradient (Rows R3A and R4A) of the PRB were analyzed for RDX and HMX. Analyzed concentrations allowed the calculation of RDX removal across the PRB and in the treatment zone. Concentrations of geochemical parameters such as inorganic anions (i.e., sulfate and nitrate) and cations (i.e., ferrous iron and arsenic) were also determined because these species can potentially divert electron flow away from the reduction of the target contaminants.

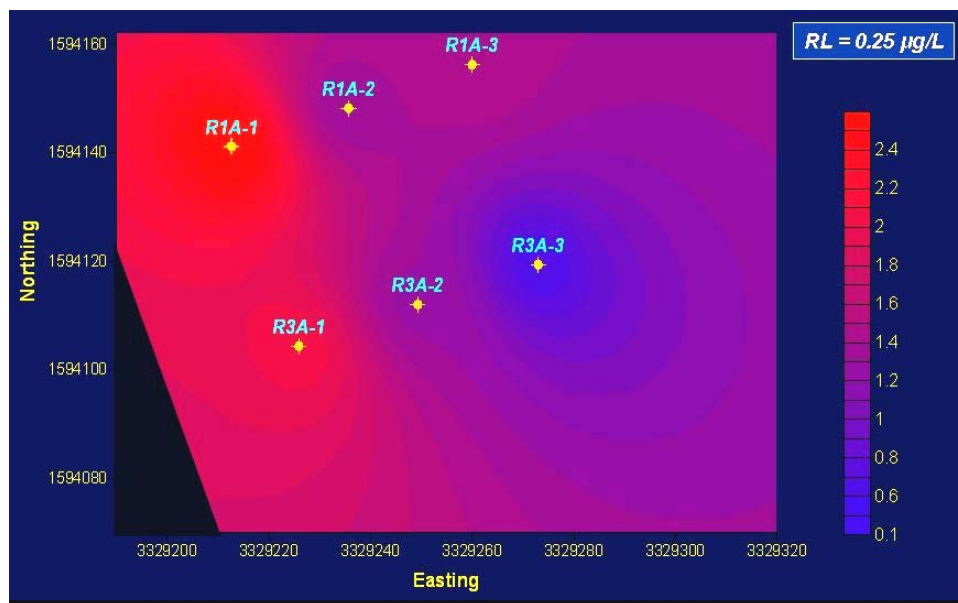
**Figure 8. Baseline RDX Concentration Measured on 11/10/2005, Prior to Technology Implementation.**

(Concentrations ranged from 2.68 ppb to 1.30 ppb in the Row R1A wells, and 2.08 to 0.61 ppb in the Row R3A wells. All RDX concentrations were above the CDPHE regulatory threshold of 0.55 ppb.)

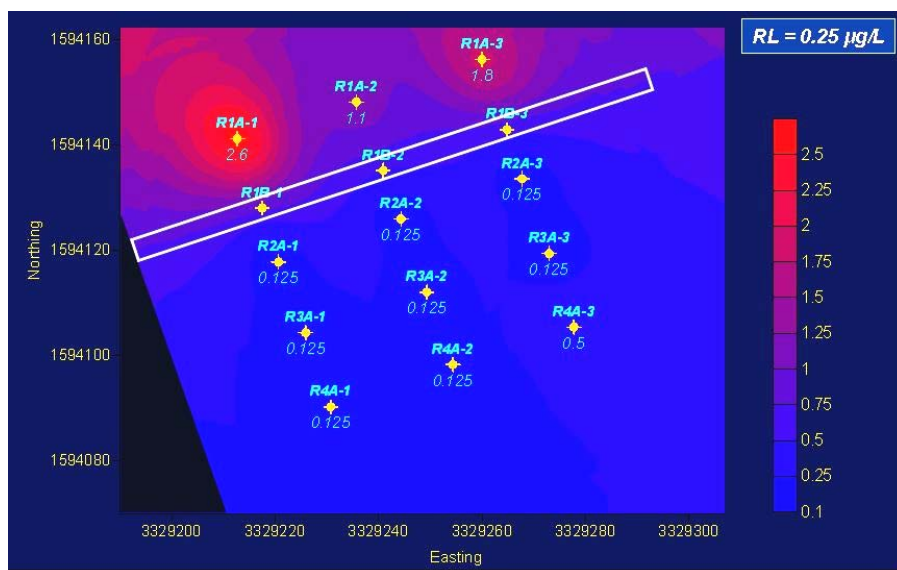
**Figure 9. RDX Concentrations Measured on 06/20/2006, 7 Months After Mulch PRB Installation.**

By the second post-installation monitoring event on June 20, 2006, almost 31 weeks after the PRB installation, approximately six system pore volumes had been displaced. By this time, the system appeared to be approaching a steady state when compared to the baseline case (Figure 8), and RDX could not be detected in any of the wells except well R4A-3, where it was below the regulatory threshold of 0.55 ppb (Figure 9).

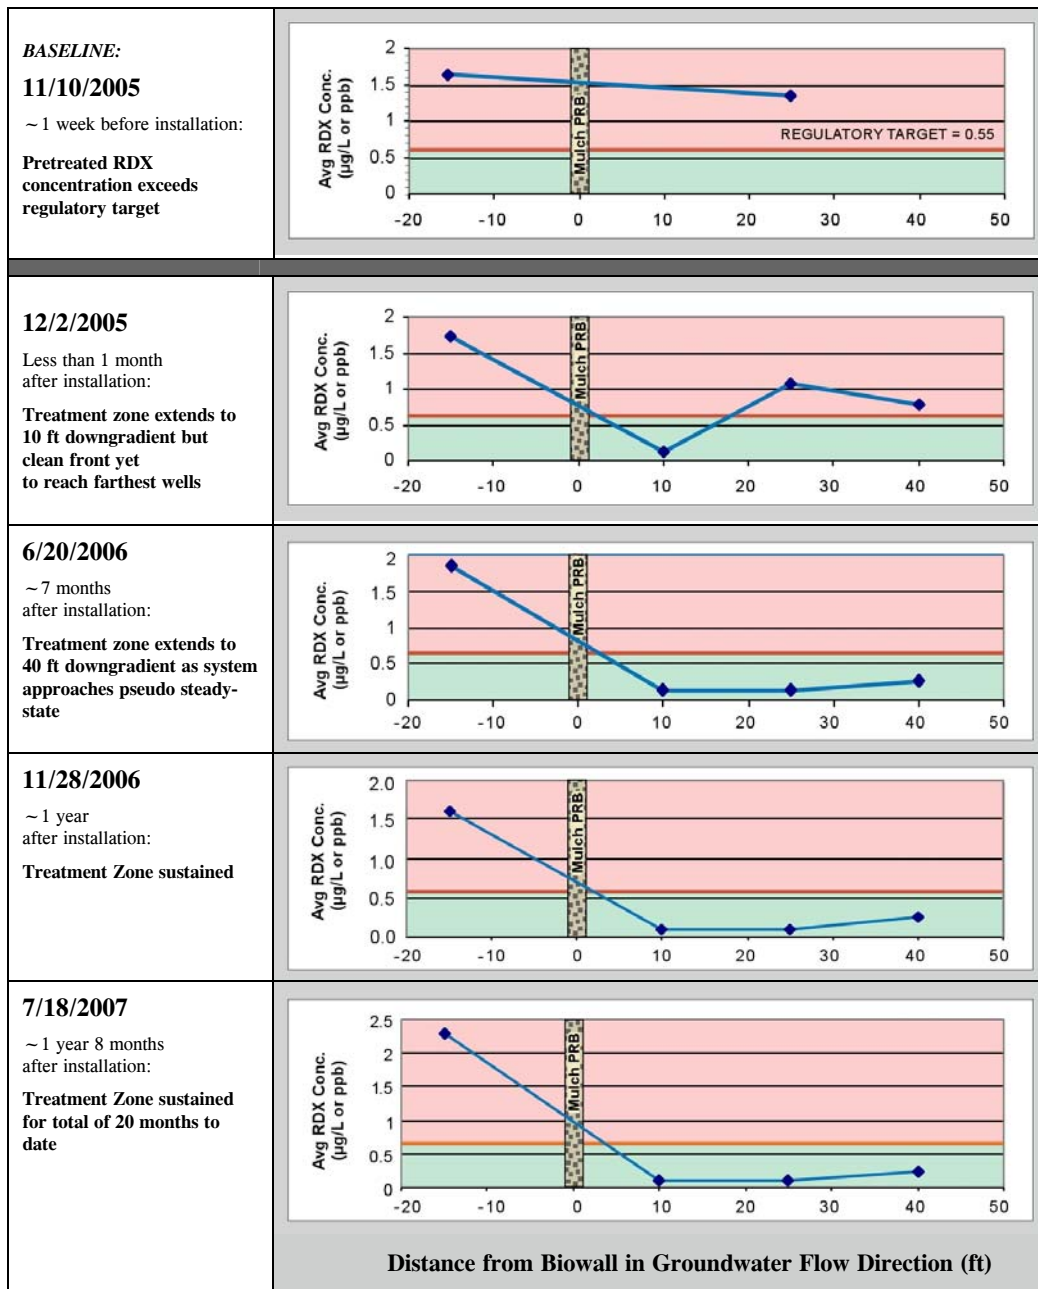
**Figure 10. Row-Averaged RDX Concentrations over the Course of the Field Demonstration.**

No RDX was detected in the treatment zone (i.e., Row R2A and R3A wells) once the system approached steady state in the June 2006 monitoring event (Figure 10 and Table 5). Detections of RDX did occur in R4A wells outside the treatment zone, but these were generally below the regulatory threshold of 0.55 ppb, except for one detection in well R4A-1 in the November 2006 monitoring event (Table 5). The definitive identity of this detection could not be confirmed using mass spectrometry as these services were not available at USACE/ERDC Vicksburg, which was handling the explosives analysis work for the project after the closure of the USACE/ERDC Omaha facility.

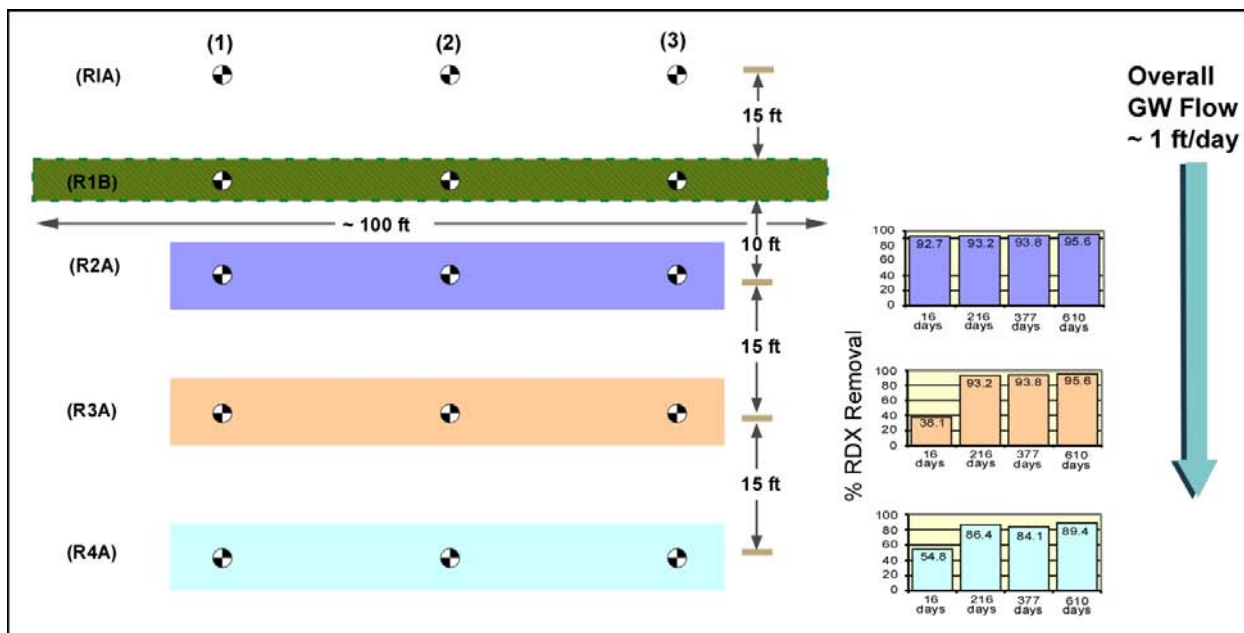
**Figure 11. Row-Averaged RDX Removal over the Course of the Field Demonstration.**
