# Aquatic Nuisance Species Research Program

ANSRP Bulletin, Vol-09-1

## Non-Native Suckermouth Armored Catfishes in Florida: Description of Nest Burrows and Burrow Colonies with Assessment of Shoreline Conditions

by Leo G. Nico, Howard L. Jelks, and Travis Tuten

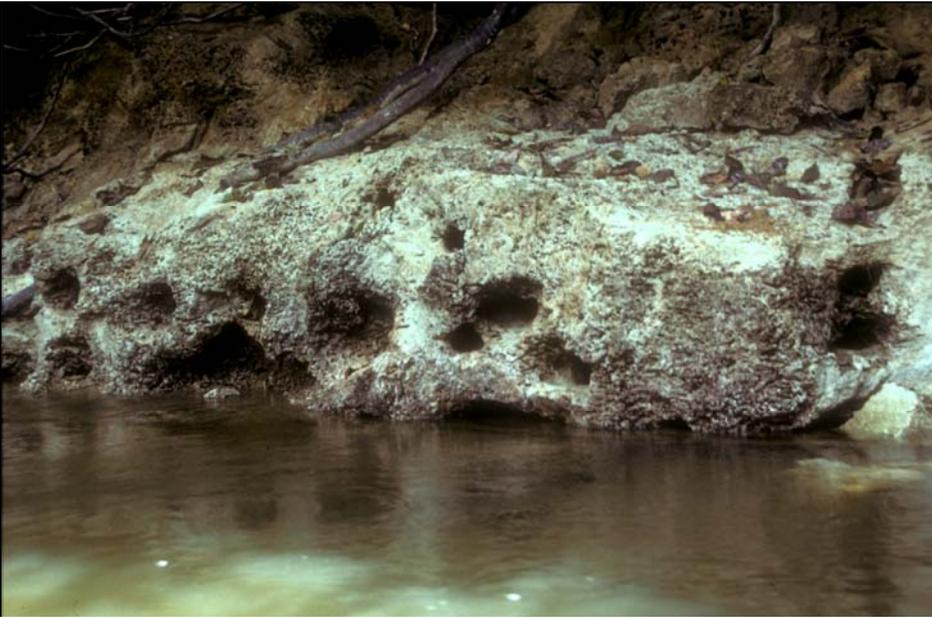
Figure 2. Nest burrows of loricariid catfishes in their native range in South America: Cano Mavaquita, upper Orinoco River basin, Venezuela. Type locality for *Leporacanthicus triactis* (Isbrücker et al. 1992). (Photograph by L. G. Nico)

burrows in shoreline slopes for use as spawning and nesting sites (Figure 2). The burrows are reportedly excavated and maintained by adult males. In places where these catfish are abundant and the shore habitat suitable, burrows are common. Burrows typically occur in aggregates with individual colonies consisting of a few to perhaps dozens of burrows. In larger

*Leporacanthicus triactis*, has been found to occupy burrows (Figure 2; Isbrücker et al. 1992). Adults of this species are likely

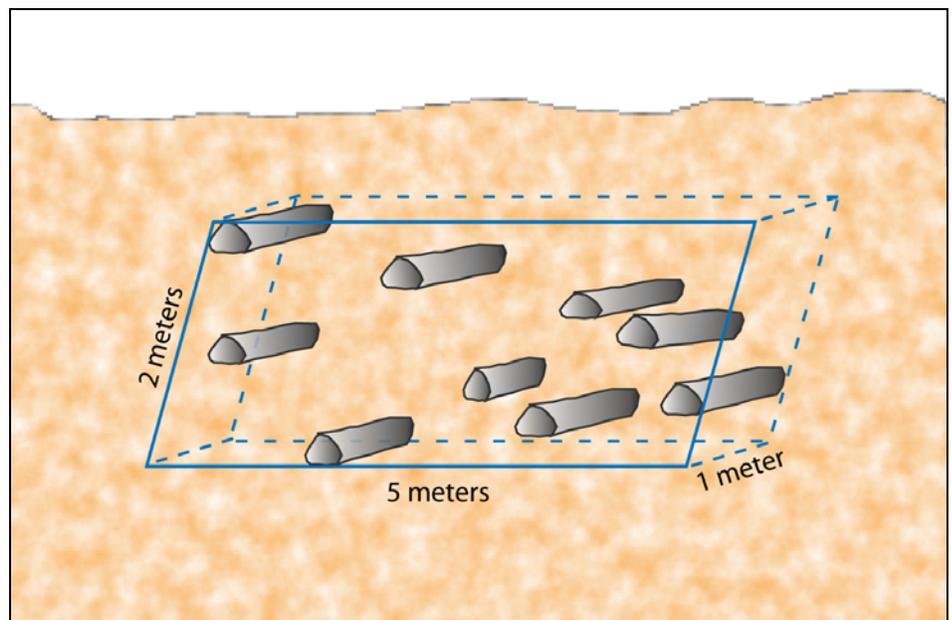
Figure 4. Diagram of a burrow colony showing the three-dimensional portion of the shoreline used to calculate the relative amount of sediment removed by *Pterygoplichthys*.

multiplied by 1-m depth. For example, if the lowest and highest burrow openings were 2 m apart, and the most upstream and most downstream burrows in the colony were 5 m apart, then the rectangular area was  $2 \times 5$  m and the total volume of the involved bank would equal  $10 \text{ m}^3$  (Figure 4).

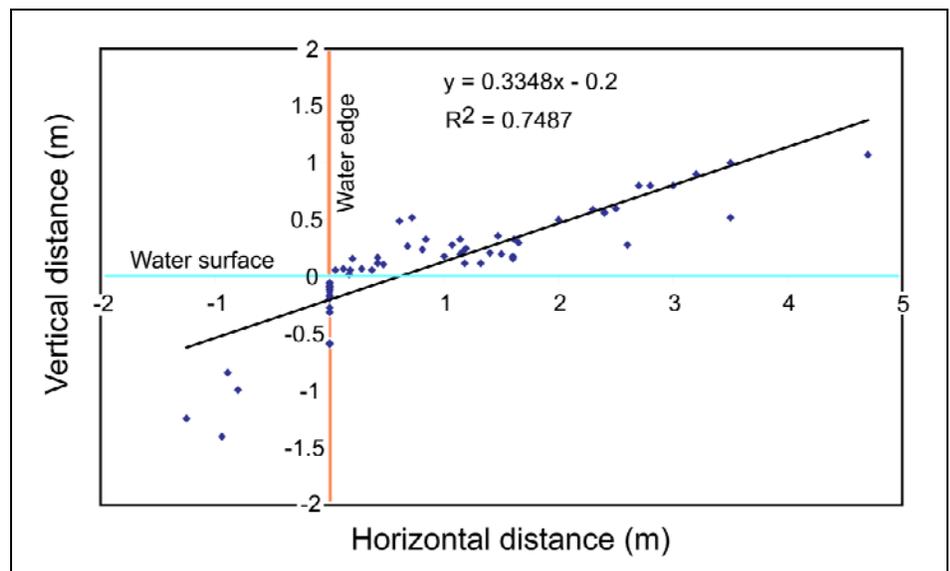
Figure 5. Relationship between vertical and horizontal distances from *Pterygoplichthys* burrows to waterline (adjusted  $R^2 = 0.74$ ,  $p < 0.001$ ). The 0-horizontal line represents the waterline. Burrow points above this line were those whose entrance was completely above the water. The 0-vertical represents the water's edge. As shown in this figure, most of the observed nest burrows were exposed because of low water and most of these were within 2 m out from the water's edge, but less than 0.5 m above water surface.

In most colonies, some burrows were grouped together. Among these clumped burrows, the distance between adjacent burrow openings was typically less than 1 m. In some cases only about 25 cm of soil separated adjacent burrow openings. In terms of vertical distribution, the lowest burrow opening was typically never less than about 1.5 m below the highest burrow within a colony. Due to the water level at the time sampled, exposed burrows were located up to 1.35 m above and 4.7 m horizontally out from the water's edge. These two parameters were positively correlated and largely described the overall bank slope at sampling sites (Figure 5).

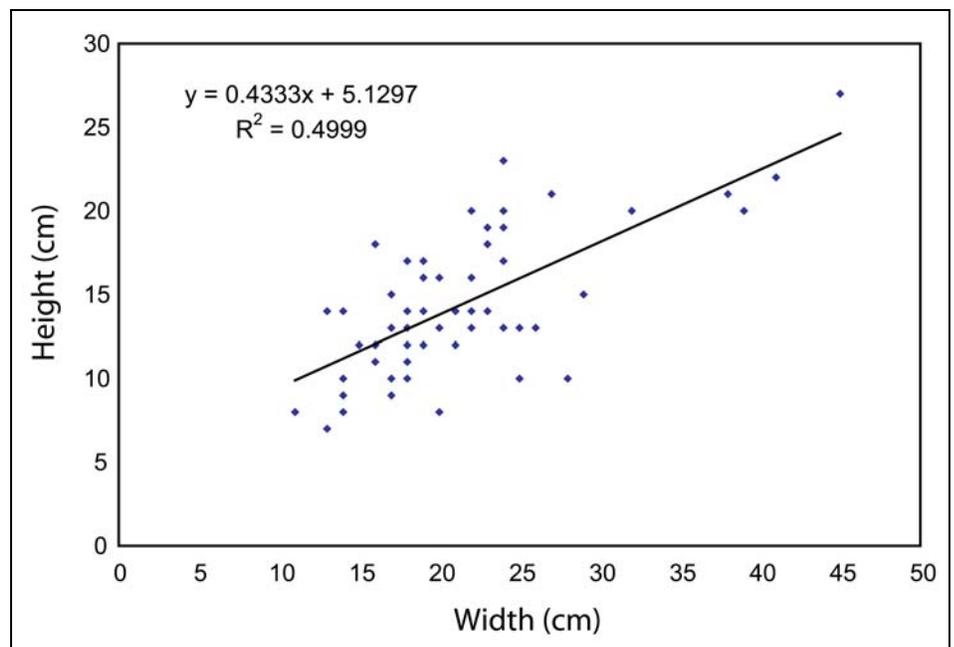
Figure 6. Relationship between *Pterygoplichthys* burrow entrance height and width (adjusted  $R^2 = 0.49$ ,  $p < 0.001$ ).

130 cm (mean = 77 cm) in length, and the dimensions of the entrance ranged from 11 to 45 cm (mean = 21 cm) in width, and 7 to 27 cm (mean = 14 cm) in height (Table 2). Heights of burrow entrances were consistently less than entrance widths, with height averaging 66 percent of width. Burrow height and width were positively correlated (Figure 6).

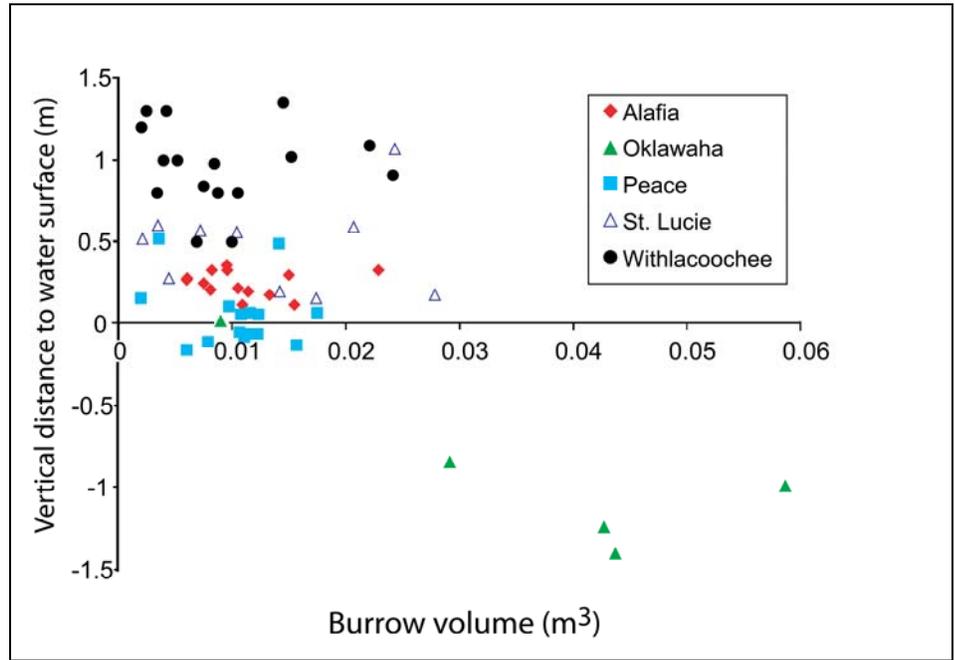
Figure 7. Relationship between burrow volume and vertical distance to water surface. Note that the three Oklawaha burrows with the largest volumes were active with catfish tending nests.

between burrow volume and distance (vertical) to water surface, a possible explanation for differences in observed volumes of active versus abandoned or even exposed burrows is provided in Figure 12. The assumption is that burrows above the water and other abandoned burrows were, prior to erosion, as large as the active burrows discovered in the Oklawaha River.

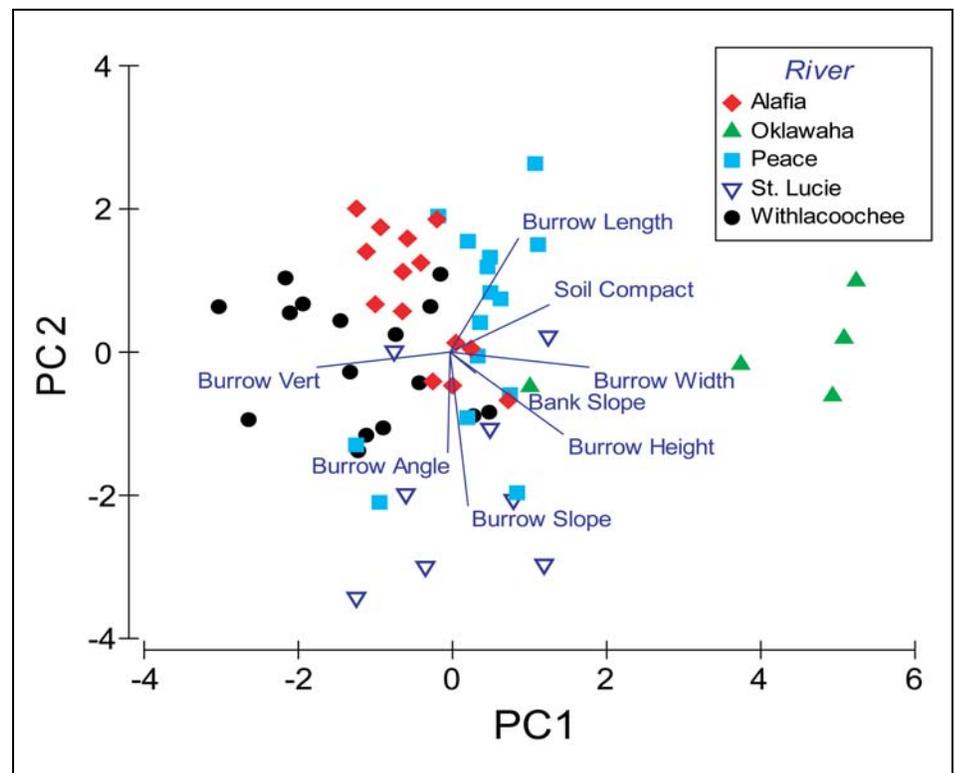
Figure 8. Principal component analysis plot of *Pterygoplichthys* burrow dimensions from Table 2 (excluding volume) measured at 58 burrows in five river and canal systems in Florida with principal component vectors superimposed. PC1 is associated with height and width of burrows and vertical distance to water surface. PC2 was associated with burrow length, burrow slope, and angle relative to flowing water.

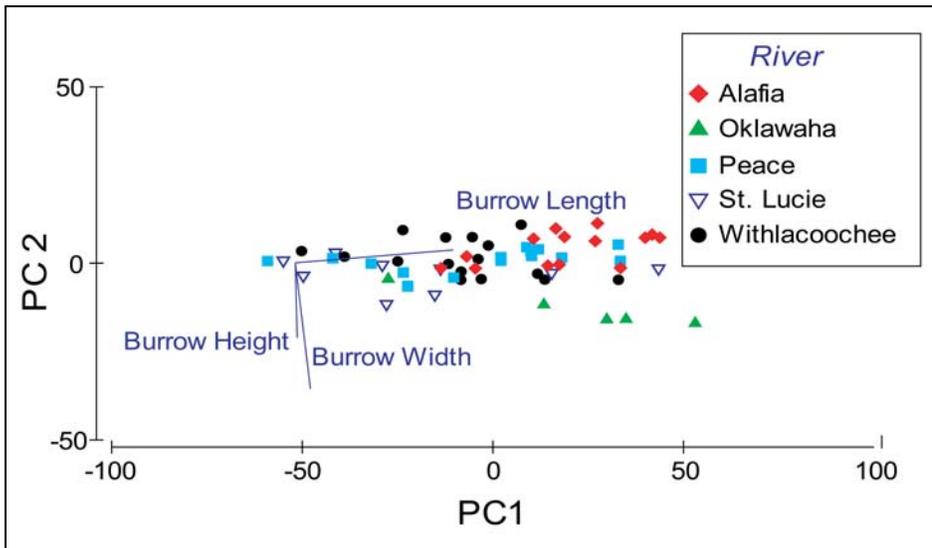
Figure 9. Principal components analysis of burrow height, width, and length among 58 burrows in five Florida river systems. PC1 is associated with increasing length, while PC2 is associated with increasing height and width.

When the PCA was limited to burrow height, width, and length, the first two principal components accounted for 99 percent of the variation (Figure 9). PC1 was

associated with increasing length, while PC2 was associated with increasing height and width. Again, the active Oklawaha burrows separated from other sites.

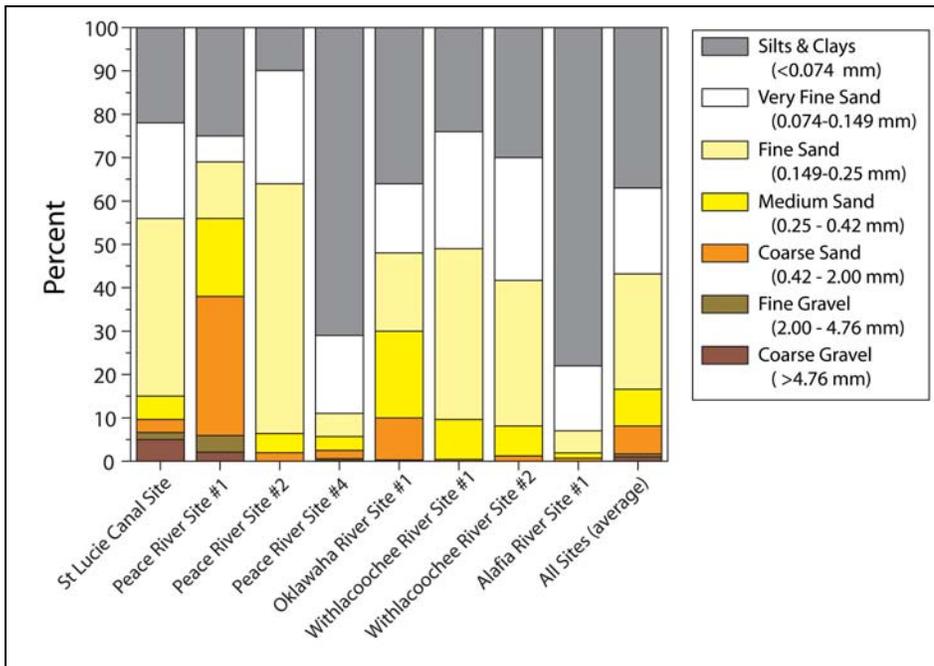
Figure 10. Soil composition of samples taken from eight different *Pterygoplichthys* burrow sites in five river and canal systems in Florida.

Analysis of particle sizes indicated that the soil composition among the eight colonies sampled was largely a mixture of fine and very fine sands and silts-clay (Figure 10). Based on the classification of the Soil Science Society of America, soil textures were sandy-clay-loams (four sites), clays (two), sandy-clay (one), and sand (one). Soil composition PCA showed that sites varied considerably (Figure 11). Alafia River and Peace River Site 4 both had large amounts of clay, Oklawaha River and Peace River Site 1 had medium and coarse sand, while the other sites had mostly fine and very fine sands. PC1 accounted for 76 percent of variation and was

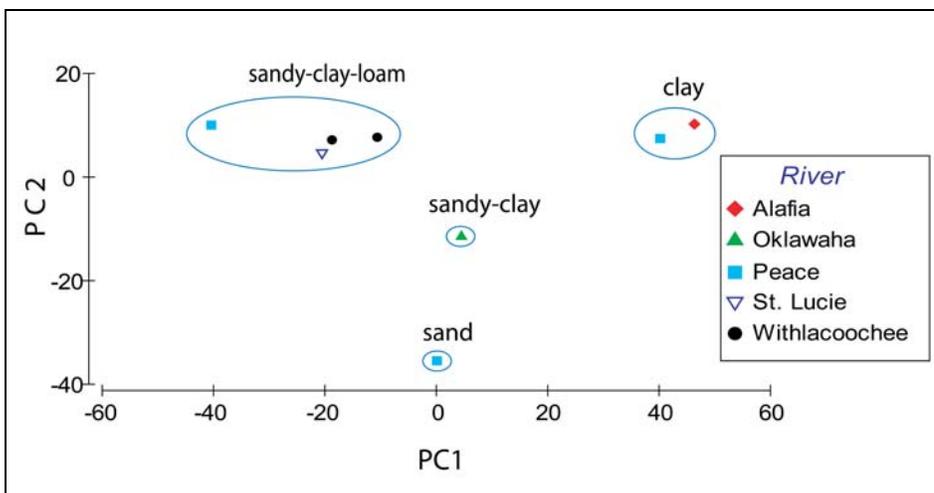
Figure 11. Principal component analysis plot of soil composition associated with *Pterygoplichthys* burrows in five river and canal systems in Florida with component vectors superimposed. PC1 is associated with increasing silt/clay and decreasing fine sand proportions. PC2 is associated with decreasing proportions of coarse sand and accounted for an additional 22 percent of variation. Soil texture designations follow the classification of the Soil Science Society of America.

associated with increasing silt-clay and decreasing fine sand proportions. PC2 was associated with decreasing proportions of coarse sand and accounted for an additional 22 percent of variation. Despite differences in soil composition among sites, there appeared to be little difference in the dimen-

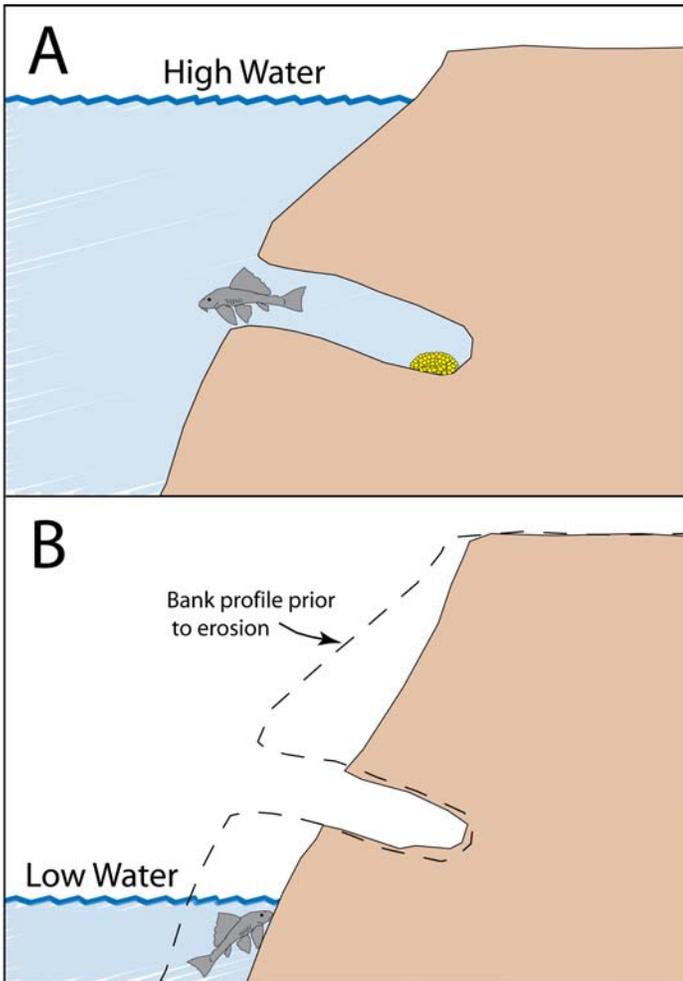
Figure 12. Bank profile and longitudinal section of a *Pterygoplichthys* burrow. Drawing shows possible sequence of events over time as water levels drop and bank erodes: a) high water period showing active burrow with eggs being guarded and burrow structure maintained by adult catfish; and b) same site during low water, after nest has been abandoned and exposed to air. As a result of lack of maintenance by catfish and continued exposure of burrow to wave wash and other forces, the bank has eroded, causing the burrow structure to degrade and its length to become reduced.

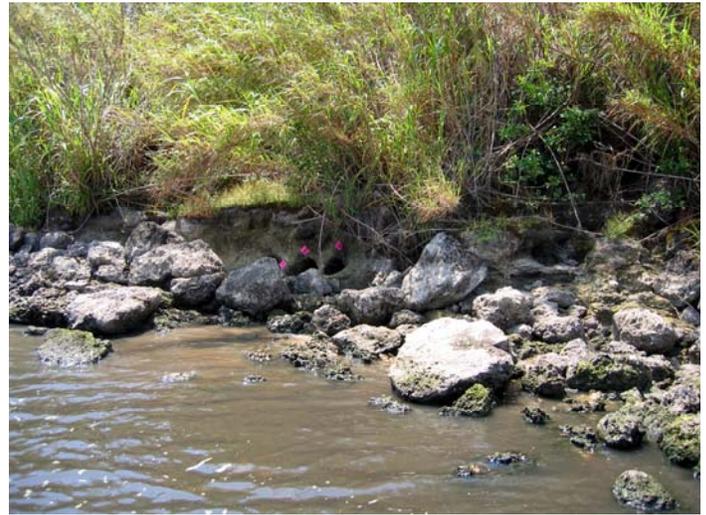
Figure 13. Portion of a burrow colony on the St. Lucie Canal showing three exposed burrows, indicated by red flags (Field # LGN 06-41). Here burrows are closely associated with rip-rap revetment and the rock apparently affords burrows protection from the heavy wave wash of passing boats. (Photograph by L. G. Nico)

the base of steep banks within or just above existing rip-rap revetment (Figure 13). The upper portions of much of the shoreline, unprotected by rip-rap, appeared highly unstable. Although the burrows probably were contributing to bank instability, their contribution almost certainly was low relative to erosion caused by wave action, in particular, the incredibly forceful waves that strike the shore whenever high-speed boats and yachts pass (a common event). Burrows in high-traffic waterways could act synergistically to increase erosion. Two burrow colonies were discovered during the survey. All detected burrows were exposed, although some of the burrows in the larger colony were near the water's edge and subject to waves.

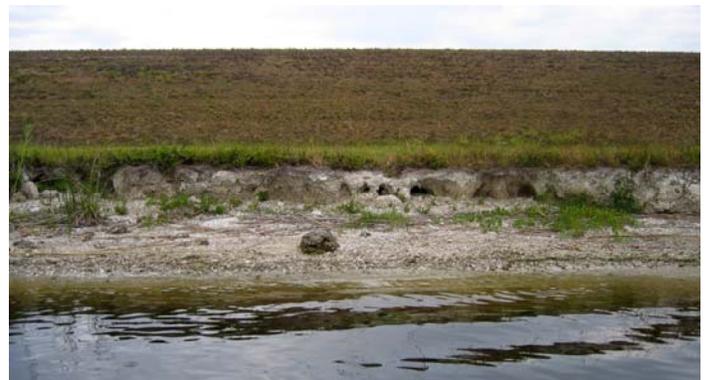
Figure 14. Photograph of a portion of the west shore of the Lake Okeechobee Rim Canal just north of the St. Lucie Canal. Many highly eroded holes such as these were scattered above the waterline and could not be definitively attributed to the work of *Pterygoplichthys*. A portion of the levee surrounding the lake is in the background. (Photograph by L. G. Nico)

- **Lake Okeechobee Rim Canal.** This artificial waterway, composed of a number of unconnected segments, extends along large sections of the outer border of the 230-km long, high earthen levee that surrounds Lake Okeechobee. Besides the occasional small-boat wake, these canals are very low-energy systems, more similar to lake habitats than riverine environments. In the area that was sampled, along a northeast side of the lake, the canal is separated from the toe of the levee by a wide and flat open shore area. Water levels at the time were moderately low, exposing undercuts and fissures along the upper part of the low bank on the levee side of the canal (Figure 14). However, the

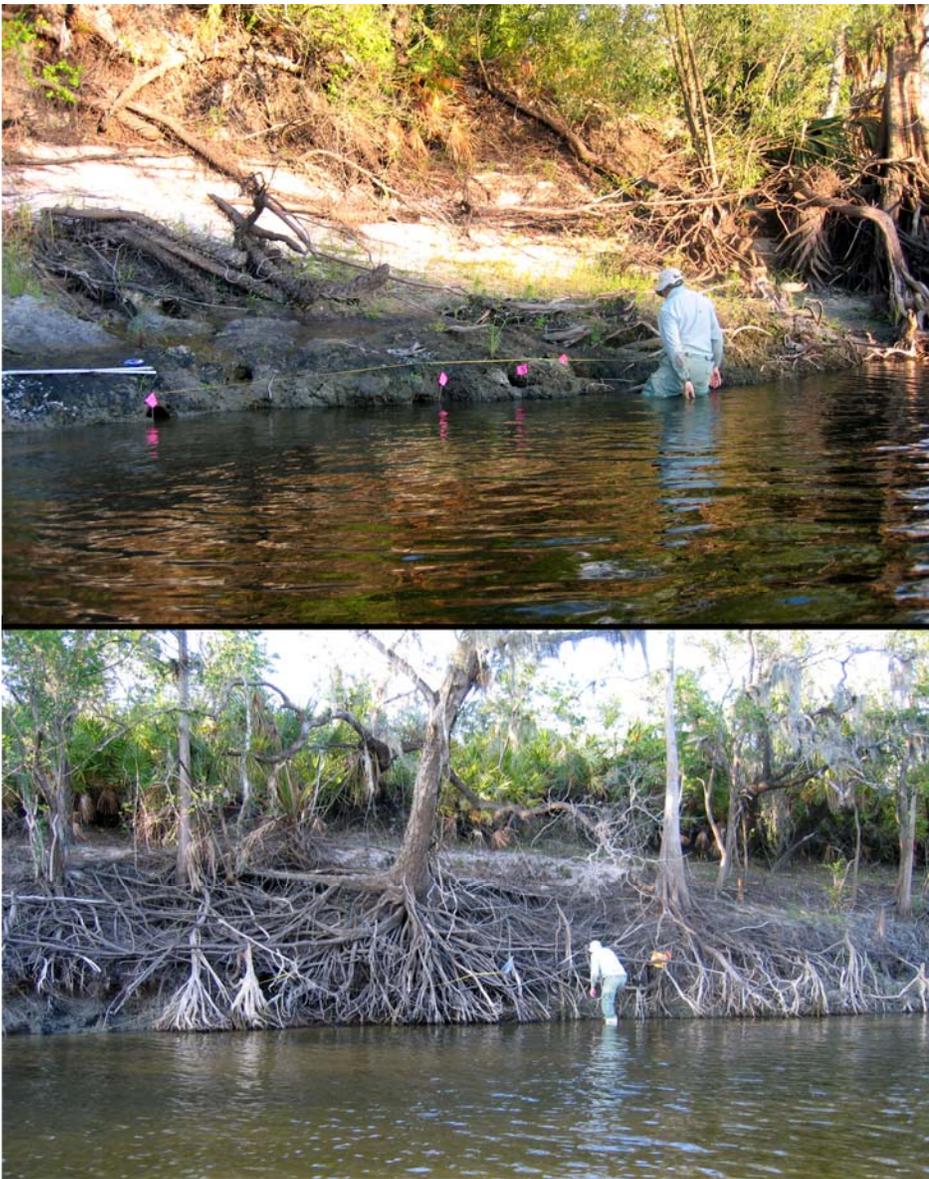
Figure 15. Burrow colonies on the Peace River. Upper photograph: Portion of colony showing four exposed burrows indicated by red flags. This colony includes exposed and submerged burrows, although the submerged burrows did not appear to be active nests. Lower photograph: Portion of this colony encompassed tree roots and some burrows were hidden among the large roots. Such burrows would likely pass undetected if the river was surveyed during higher water and the burrows were submerged. (Photographs by L. G. Nico)

burrows, the river was at very low water stage and large numbers of *Pterygoplichthys* were seen in shallow portions of the river. The low water also enabled documentation that the nest burrows of this species are common in the system (Figure 15).

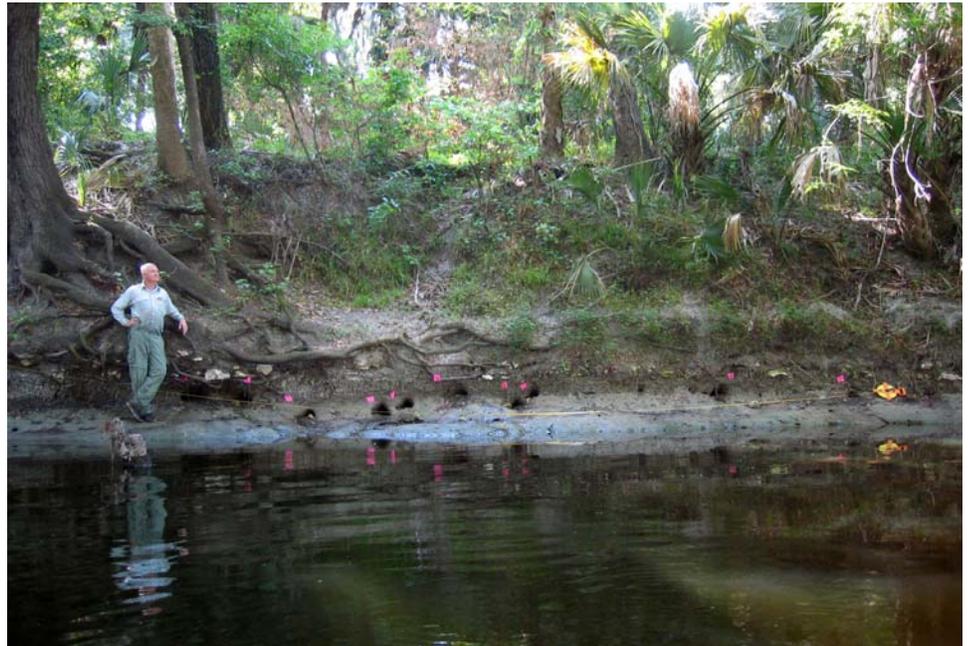
Figure 16. A portion of a large burrow colony on the Alafia River showing 10 exposed burrows indicated by red flags. This colony was constructed in soil of high clay content and the shore seemed to be relatively stable. (Photograph by L. G. Nico)

- **Alafia River.** The 40-km long Alafia is a small meandering stream with tannin-stained water and moderate water clarity. Some tributaries, such as Buck Creek, are spring fed with clear water. During the survey, the Alafia was at low water stage. *Pterygoplichthys* were common and easily sighted in most shallow sections of the river. Interestingly, another herbivorous fish, the native striped mullet *Mugil cephalus* was also common. Although a few isolated cavities were observed, some possibly nest burrows of *Pterygoplichthys*, the first burrow colony was located upstream in an area with steep banks (Figure 16).

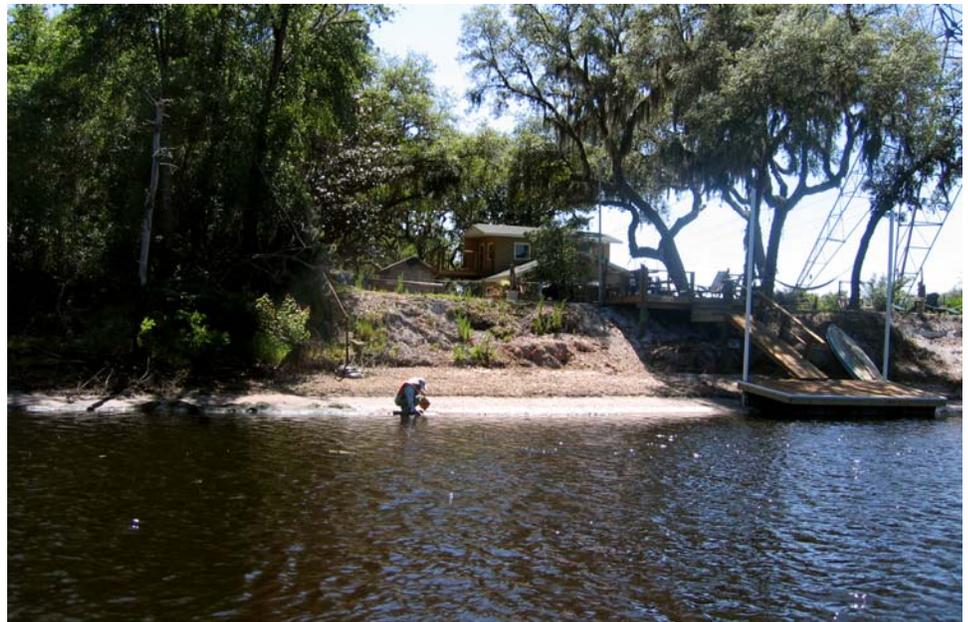
Figure 17. Burrow Site #1 on the Withlacoochee River (Field # LGN 06-34). This colony included exposed burrows, some located upstream and others downstream of the private boat dock. Eleven burrows were measured, but additional burrows were later seen immediately downstream and it was suspected that the colony also included a few burrows still submerged (Photograph by L. G. Nico)

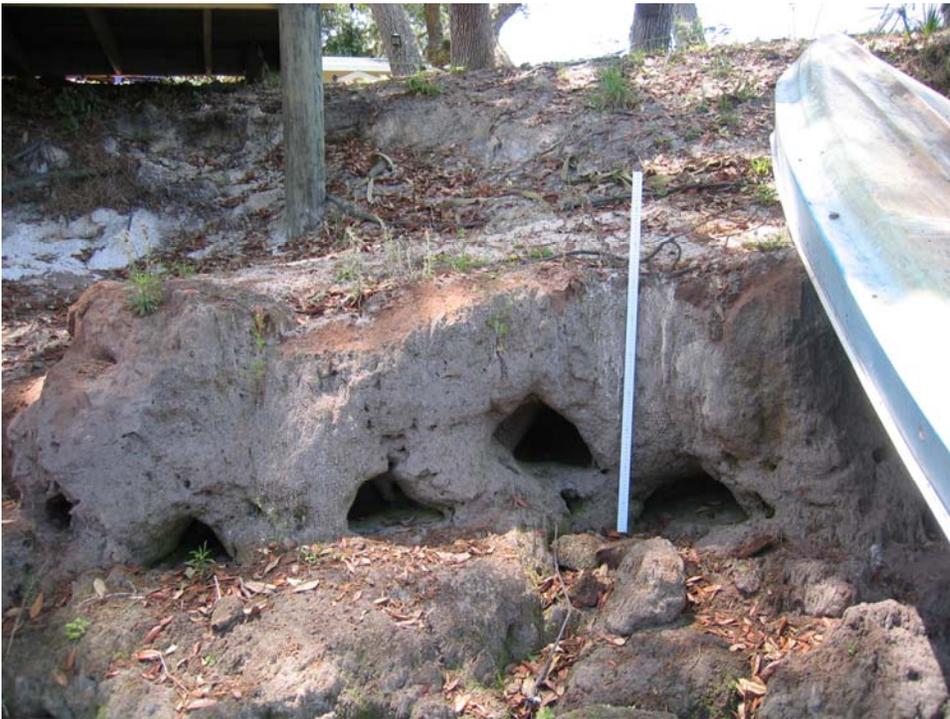
Figure 18. A portion of Burrow Site #1 on the Withlacoochee River showing five of the 11 exposed burrows actually measured (Field # LGN 06-34). Typical of many *Pterygoplichthys* colonies, the burrow openings are triangular and some burrows are closely grouped. (Photograph by L. G. Nico)

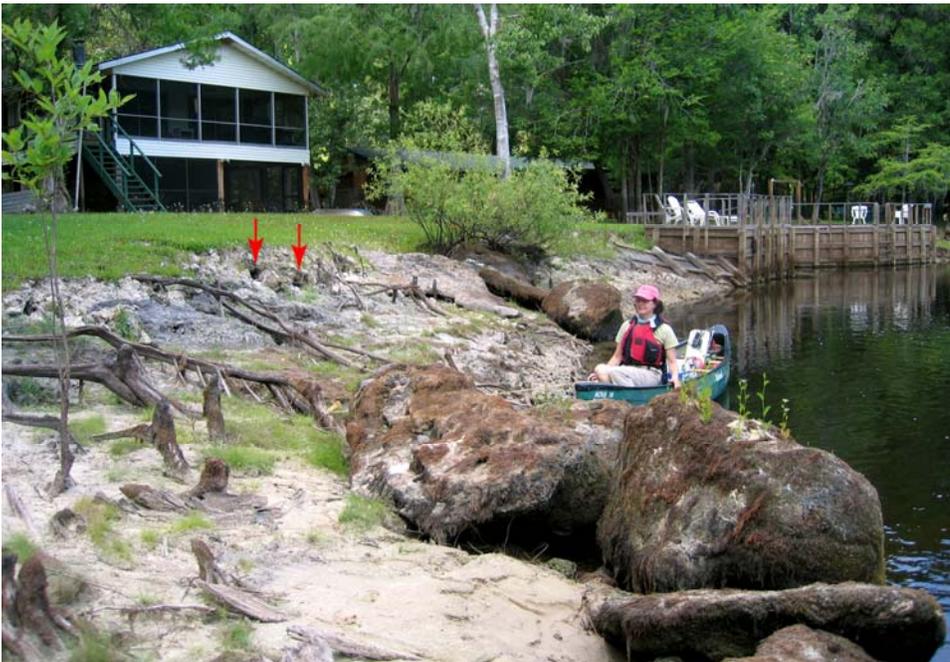
Figure 19. Photograph showing upstream portion of Burrow Site #2 on the Withlacoochee River (Field # LGN 06-35). This burrow colony was situated on the outside of a sharp bend near decks and boat ramps of private residences. The eight burrows detected at this site were degraded, most had partially filled with silt and some had already collapsed (red arrows indicate location of two of the eight burrows). Two active burrows submerged and guarded by adult catfish were observed at this site by LGN during a visit in June 1997, indicating that the same colony sites are used over multiple years. (Photograph by L. G. Nico)

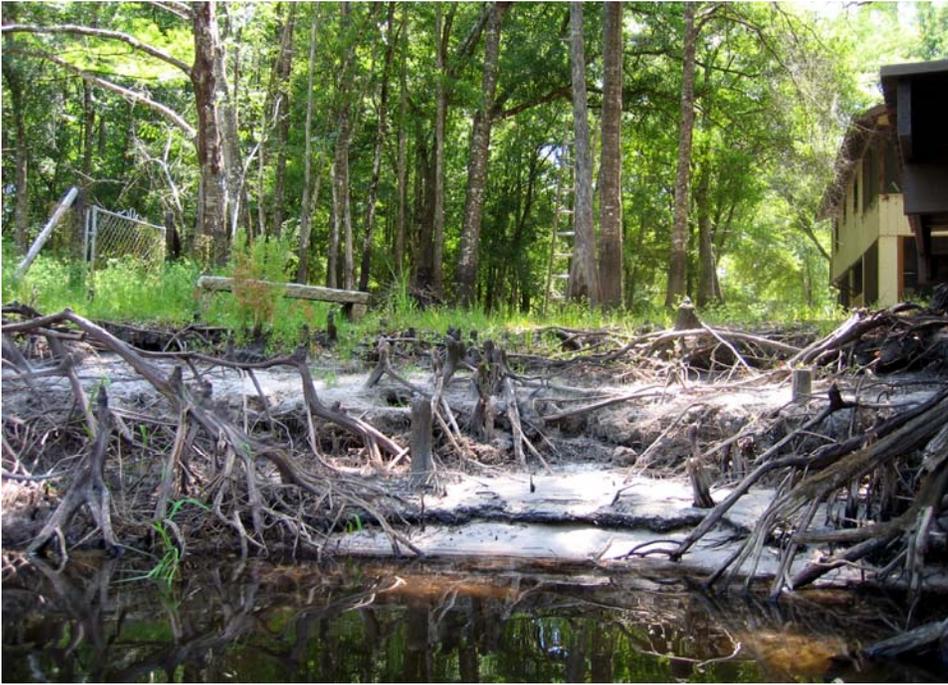
Figure 20. Small burrow colony, highly degraded, on the Withlacoochee River (Field # LGN 06-36). This site was within a reach of live and dead cypress. The site with burrows was one of the few areas in this part of the river with exposed bank. If any burrows were within the reaches with dense cypress roots, they would have been difficult or impossible to detect. (Photograph by L. G. Nico)

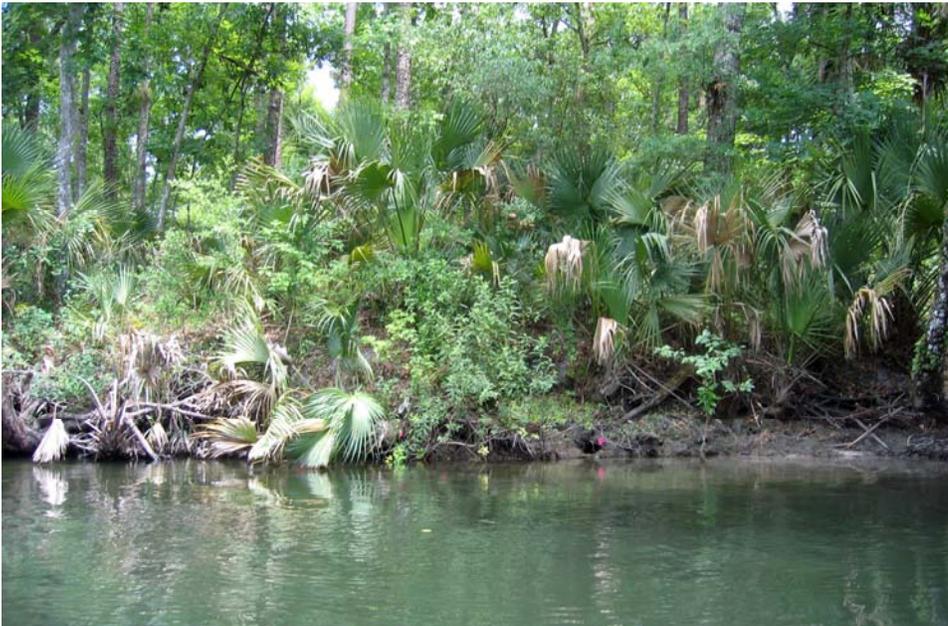
Figure 21. A portion of a small burrow colony in the Oklawaha River drainage consisting of one exposed burrow (see red flag, center right) and four submerged burrows containing eggs and guarding adults (Field # LGN06-59). (Photograph by L. G. Nico)

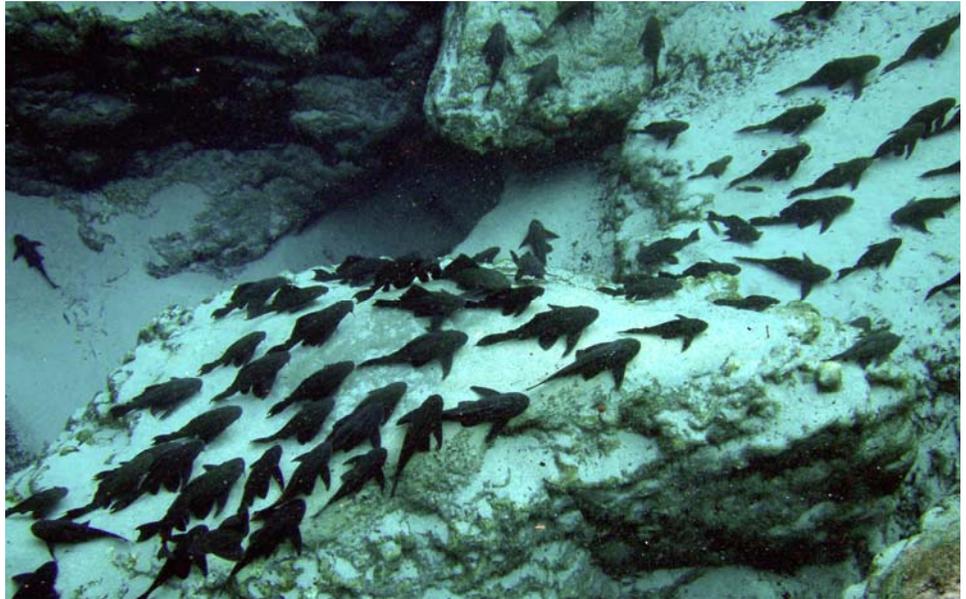
Figure 24. *Pterygoplichthys* have become abundant in many Florida waterways but their impacts are difficult to quantify, especially in complex natural systems. In February 2007 a large number of these non-native catfish were observed massed in Alexander Spring, Florida. (Photograph by Brian MacGregor)

(Figures 24 and 25). Their environmental threat is a combination of distinctive life history attributes, especially feeding and reproductive behaviors, coupled with their large size and high population densities (Fuller et al. 1999, Hoover et al. 2004).
