**COMMANDER'S EMERGENCY
RESPONSE PROGRAM: MUHALLA 312
ELECTRICAL DISTRIBUTION PROJECT
LARGELY SUCCESSFUL**

**SIGIR 09-025
JULY 26, 2009**

COMMANDER'S EMERGENCY RESPONSE PROGRAM: MUHALLA 312 ELECTRICAL DISTRIBUTION PROJECT LARGELY SUCCESSFUL

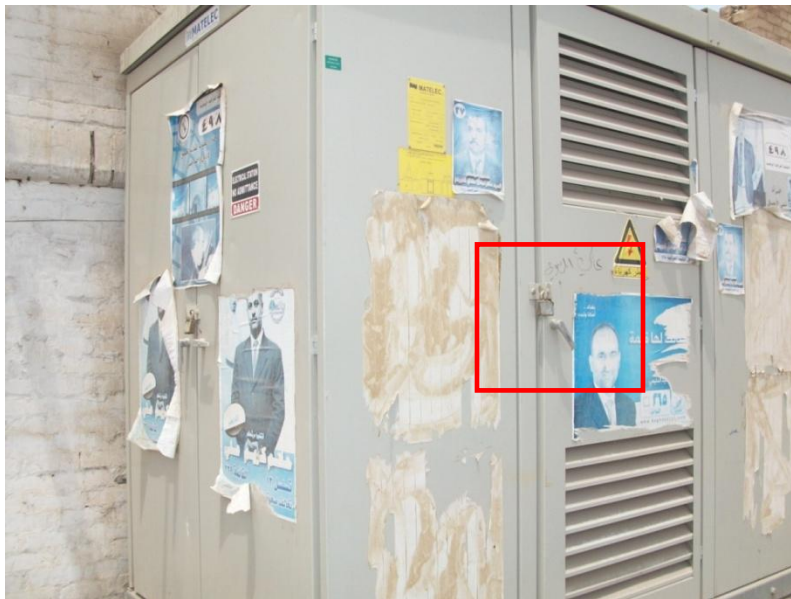
Figure 2—Locked Kiosk

On May 20, 2009, SIGIR visited Muhalla 312 and observed that the GOI was sustaining the electrical distribution grid project. While visiting the project, SIGIR observed several of the installed kiosks and pillars and confirmed that power lines from the distribution project were not visible. The cables from the kiosks were buried to prevent tapping into the power source. Further, SIGIR observed that the contractor had secured each of the kiosks and pillars with padlocks and metal bands. SIGIR observed that none of the kiosks or pillars appeared to have been tampered with (see Figures 2 and 3). According to an MND-B official, the project included the installation of 469 high-pressure mercury street lamps connected to the new distribution lines; cables from the kiosks and pillars are underground at least one meter to deter residents and shop owners from illegally tapping into the distribution lines. As shown in figures 4 and 5, the neighborhood appears to have a large amount of resident-installed electrical lines strung from building to building, which increases the risk of electrocution and disruption of power.
