1. REPORT DATE DEC 2004	2. REPORT TYPE	3. DATES COVERED 00-10-2004 to 00-12-2004			
4. TITLE AND SUBTITLE 'One-Stop' Waste Disposal - Enhancing Force Protection in Afghanistan (Engineer, Volume 34, PB 5-04-4, October-December 2004)		5a. CONTRACT NUMBER			
		5b. GRANT NUMBER			
		5c. PROGRAM ELEMENT NUMBER

“One-Stop” Waste Disposal – Enhancing Force Protection in Afghanistan

By Lieutenant Colonel Garth Anderson and Lieutenant Colonel Whitney Wolf

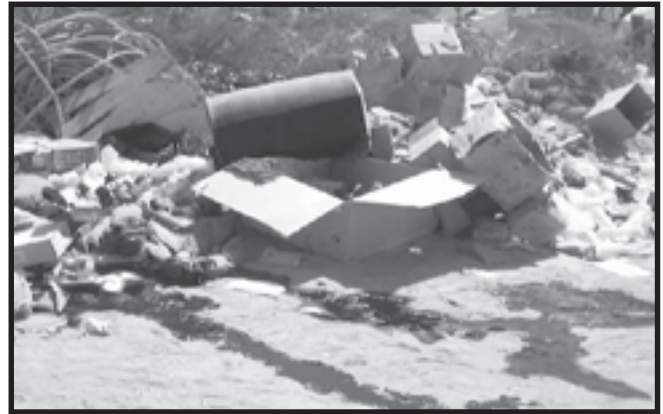
Hazardous waste disposal at the old burn pit

items—regardless of their potential hazard or reuse value—were thrown into or around the burn pit. The uncontrolled nature of the disposal area created a number of unacceptable conditions:

- Soldiers entering the area to dispose of waste were at risk for potential exposure to smoke from burning debris, exploding aerosol cans and food containers, and unknown hazardous waste.

- The burn pit’s proximity to the center of the camp allowed smoke to drift over living and work areas, creating a potential risk to soldier health.
- Hazardous waste (primarily petroleum, oil, and lubricant [POL] products) was uncontained, allowing the possible leaching of contaminants into the groundwater. Since the airfield depended on a single well to supply all of its nonpotable and most of its potable water, this threat was unacceptable.

- Soldiers threw nonburnable debris into the burn pit, causing it to fill up quickly and resulting in the need to dig a new emergency pit.
- Units discarded and destroyed large amounts of reusable or recyclable material (such as lumber, vehicle parts, equipment, metals, and concertina wire).

- The area was used for improper disposal of medical waste.

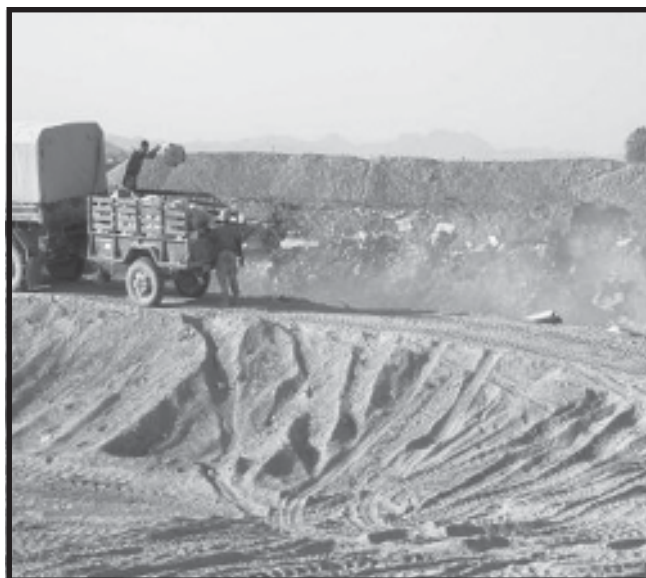
Soldiers dumping at the old burn pit were exposed to hazards of burning trash.

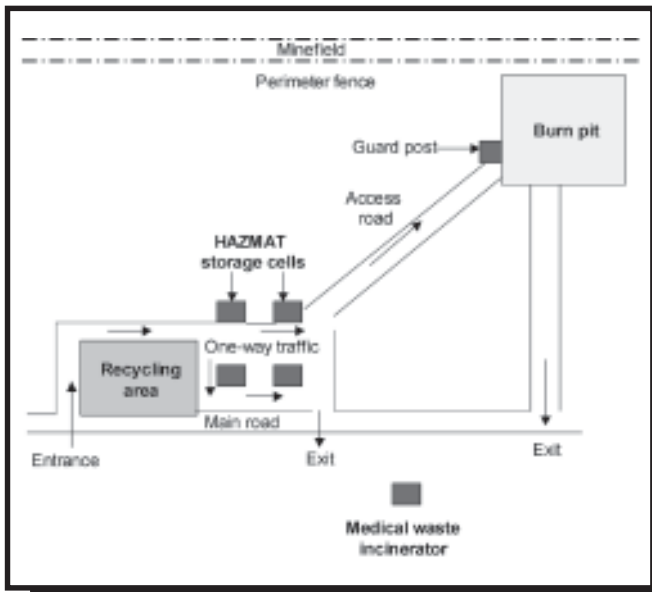
Layout of the one-stop waste disposal area

The environmental officers on the FET developed a plan that effectively balanced simplicity with effectiveness. First, the new disposal area needed to be as far away from the main part of the camp as possible to minimize exposure to smoke. Second, sound waste disposal needed to be easy. If it is too difficult and complex to comply with the requirements, then midnight dumping occurs, making the problem even worse. The basic concept became “one-stop shopping” for all disposal requirements—all forms of waste disposal located in one spot. This allowed a logical and controlled process that made it easy for units to comply. This facility, with easy access from the road, consisted of a recycling area, hazardous waste storage cells, a medical waste incinerator, and a large burn pit with controlled access.

The first stop at the facility was the recycling area where units dropped off potentially usable materials, especially lumber and scrap metal. This provided numerous benefits to the camp—units could reuse these materials for building furniture, packing for shipping, fabricating parts, and repairing equipment. Lumber was scarce and expensive, and this was a great cost saving and a relief on resupply channels. And keeping the nonburnable material out of the burn pit greatly extended the life of the pit.
