**THESIS**

**AN EXPERIMENTAL STUDY OF FIBERGLASS  
COMPOSITES CONTAINING METAL WIRE  
JOINTS**

Joseph E. Klopfer

September 2009

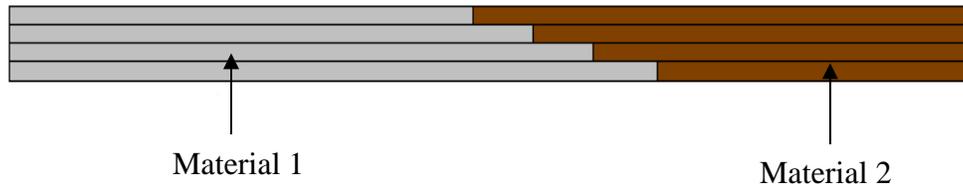
Figure 1. Stepped-lap joint

Ship superstructures and submarine sails are very large; therefore, construction of these items in one piece is impossible. The resulting joints are the weakest part of the structures, so it could be said that the strength of the structure is dependent on the strength of the joints. The weakest of these joints are the ones that join the composite to the hull. There are two types of joints in use today: mechanical and adhesive joints [1]. The structural property and efficiency of materials that are adhesively bonded is highly dependent on the adhesive used, as well as the joining configuration. Compared to mechanical fasteners, adhesively-bonded joints have many advantages. They distribute the load more evenly over a larger area without needing holes drilled. In addition, stress concentrations on bonded joints are much lower, and occur at the edge of an overlap instead of at a hole. The primary adhesive joint types in use today are the stepped-lap joint and the scarf joint, shown in Figures 1 and 2. The stepped-lap joint is several lap joints staggered by layer to form a joining surface with a large surface area. The increased surface area increases adhesion strength, but it also promotes stress concentrations at the ends of the overlap. The scarf joint provides less surface area for the adhesive to bond, but is considered superior to the lap joint because it is free of stress concentrations [3]. The mechanical joint has several advantages over adhesively bonded joints. These advantages are that mechanical joints need little surface preparation, are not affected by the service environment when properly maintained, and can be dismantled and inspected when in need of repair. However, because the mechanical joint requires

holes to be drilled to allow for connectors, there is significant stress concentration around the hole once loaded, as well as a weight penalty due to the connectors [1].

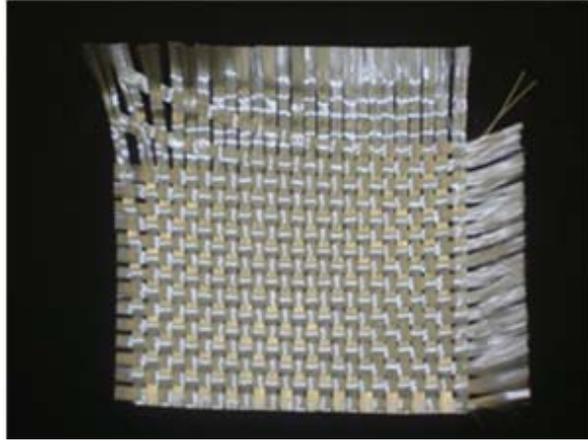
Figure 4. E-Glass (From [9])

The co-cured composite samples were fabricated from E-glass, Derakane 510A vinyl ester resin, and 3SX Hardwire© metal mat. E-glass used for this study is a 24 oz per square yard, bidirectional fiberglass woven roving (Figure 4). The metal wire mat seen in Figure 5 was used in all of the samples containing metal. It was a 3SX metal wire mat with 12 bundles, or cords, per linear inch fabricated by Hardwire LLC. Each metal cord consists of three individual wires wrapped by a fourth smaller wire.

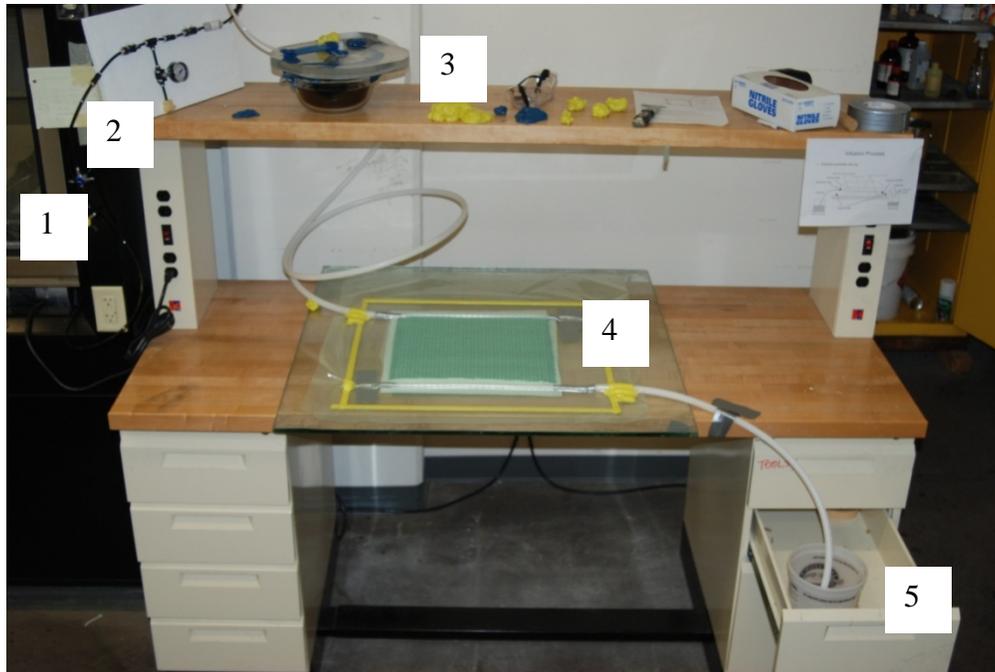
Figure 6. Vacuum Assisted Resin Transfer Molding Apparatus (After [9])

Knowledge concerning the Vacuum Assisted Resin Transfer Molding (VARTM) technique for fabricating composite materials was provided by Naval Surface Warfare Center Carderock Division (NSWCCD). The VARTM apparatus consists of five major components. They are a vacuum pump, gauge board, resin trap, glass surface, and resin reservoir (Figure 6).

1. Vacuum Pump
2. Gauge Board
3. Resin Trap
4. Glass sheet, vacuum bag assembly and composite
5. Resin reservoir

1. Place the resin reservoir in position 5, as shown in Figure 6.
2. Plug the end of the plastic tubing with a ball of AT-200Y sealant tape, start the vacuum pump, and draw a full 25 inches of vacuum. Ensure that the vacuum bag is free of wrinkles and air leaks.
3. Remove the AT-200Y sealant tape plug from the vacuum tubing and quickly submerge into the resin reservoir, ensuring it touches the bottom of the reservoir.
4. Observe proper flow across the coupon, as shown in Figures 14 and 15.
5. Once the coupon is visibly saturated with resin, secure the vacuum pump and break vacuum down to 10 inches by opening the bottom valve on the gauge board (Figure 7).

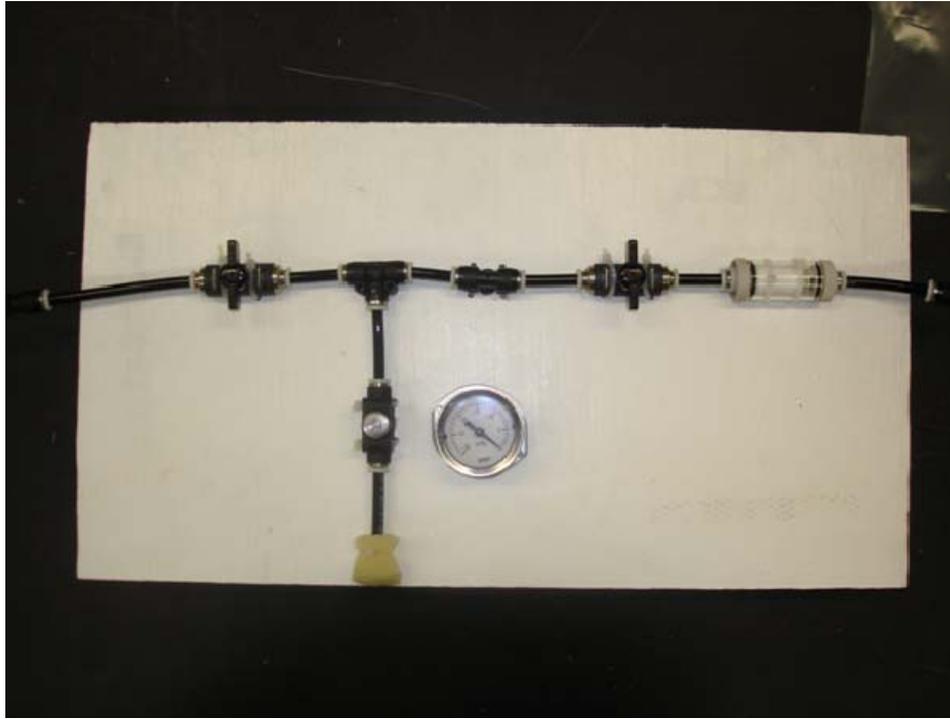
Figure 7. Gauge Board (From [9])

The gauge board, shown in Figure 7, was used to measure and regulate the vacuum pressure in the apparatus. This board was essential to detecting air leaks in the vacuum bag which would lead to bubble formation in the coupon if not corrected immediately. It was made from two ball valves, for isolation, one needle valve, to regulate the vacuum, and a vacuum gauge for observation of the vacuum. The vacuum

was connected to the fitting of the right side of the gauge board, measured by the gauge in the center and regulated by the needle valve at the bottom center (Figure 7).

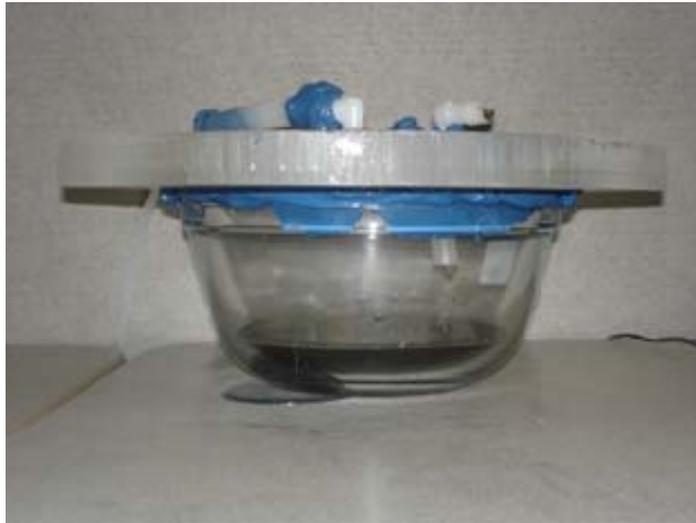
Figure 8. Resin Trap (From [9])

The resin trap, shown in Figure 8, is made from a glass bowl topped with a glass lid and sealed with AT200Y vacuum sealant tape. Inlet and outlet holes were drilled into the glass lid where plastic tubing connections were inserted and sealed with AT200Y vacuum sealant tape. The purpose of the resin trap is to allow air from the coupon to pass freely to the gauge board and vacuum pump while simultaneously preventing the resin from contaminating these sensitive components by providing collection reservoir.

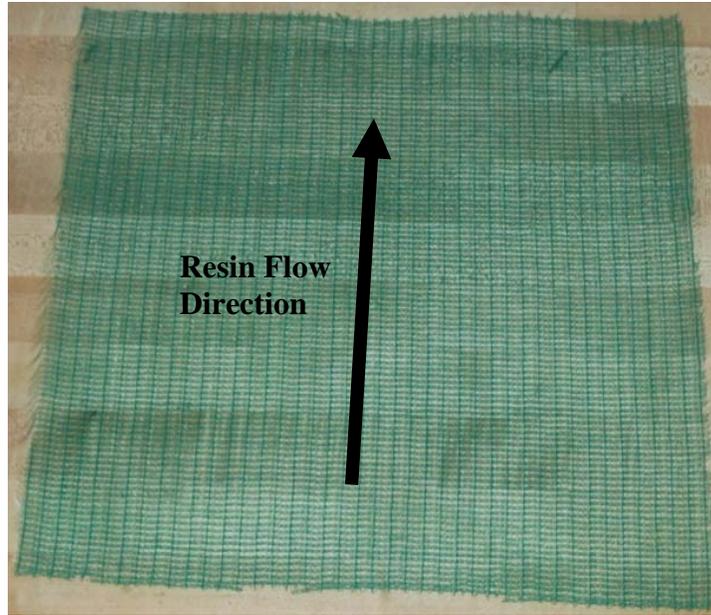
Figure 9. Resin Infusion Flow Netting

1. Inspect glass curing surface to ensure it is clean and free of chips or cracks.
2. Place the larger of the two pieces of resin infusion flow netting on the glass curing surface, as shown in Figure 9.

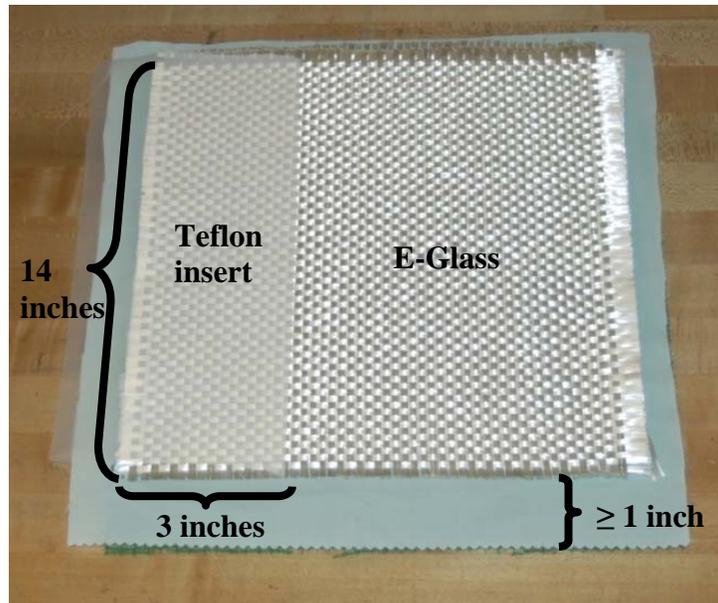
Figure 11. Bottom Half Coupon Set-up

- Place one-half of the coupon to be cured on top of the release ply, as shown in Figure 11, with the Teflon de-lamination insert placed along the left edge of the coupon (Sample shown is E-Glass only, Case V). Ensure that the infusion flow netting underneath the release ply extends at least one inch below the bottom edge of the coupon.

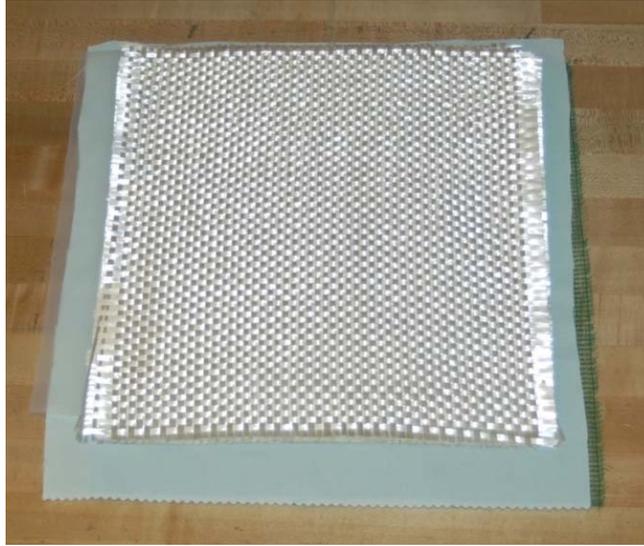
Figure 12. Top Half of Coupon in Place

- Place top half of the coupon on top of the bottom half, taking extra care to ensure that the de-lamination insert does not move (Figure 12).

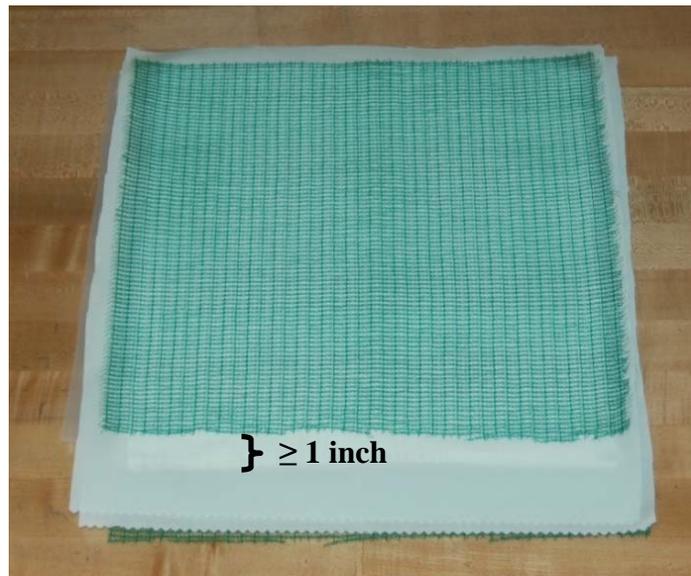
Figure 13. Coupon Ready for Vacuum Bag

6. Place the other piece of release ply on top of the coupon and the remaining piece of infusion flow netting over the release ply, ensuring that the top edge of the netting lines up with the top edge of the coupon as shown in Figure 13.

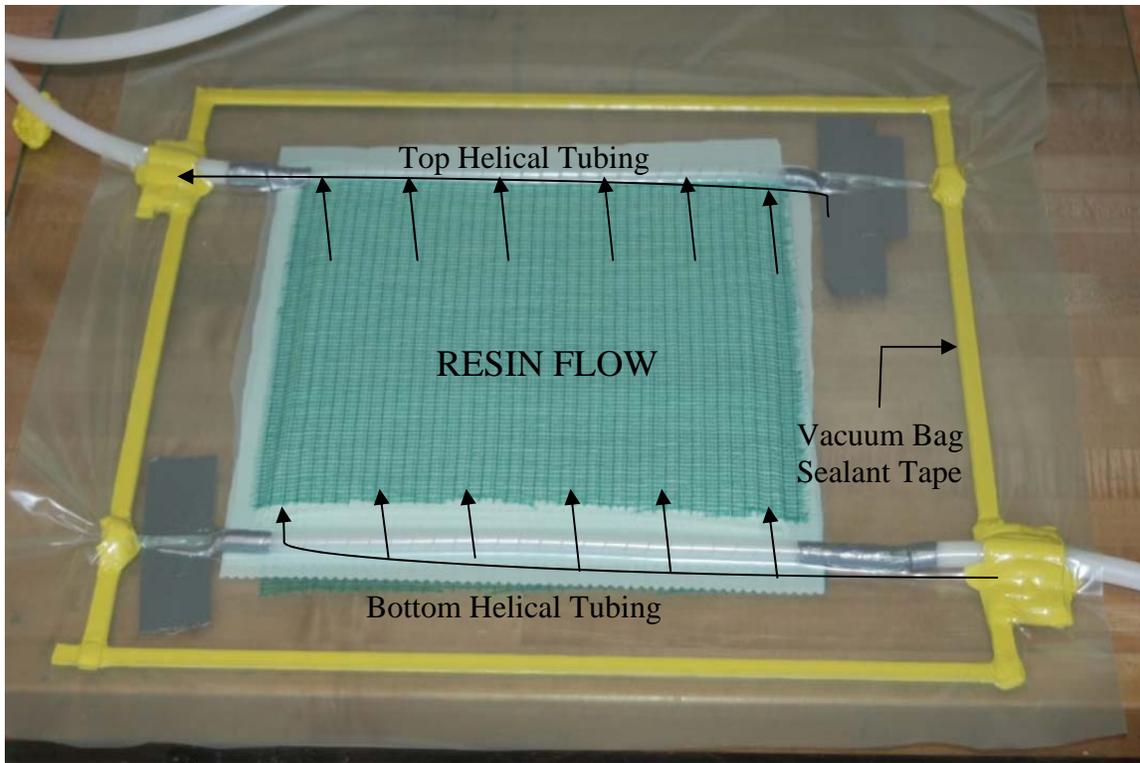
Figure 14. Vacuum Bag Assembly

7. Create a rectangular shape around the coupon, using the AT-200Y vacuum bag sealant tape, as seen in Figure 14.
8. Place the end of the polyethylene tube extending from the resin trap at the top left corner of the coupon, and press the portion of the tube crossing over the sealant tape down firmly so it adheres to the tape. Do the same at the bottom right corner of the coupon with the tubing extending from the resin reservoir (Figure 14).

10. Affix the vacuum bag to the sealant tape ensuring that the bag stays unwrinkled (Figure 14).
11. Plug the end of the tubing that goes in the resin reservoir with vacuum sealant tape. Turn on the vacuum pump. Once 25 inches of vacuum have been established, secure the vacuum pump. Carefully listen for air leaks in the vacuum bag. Fix leaks using sealant tape. If the vacuum bag leak check is satisfactory, break the vacuum by removing the AT-200Y sealant tape plug from the end of the polyethylene tubing.

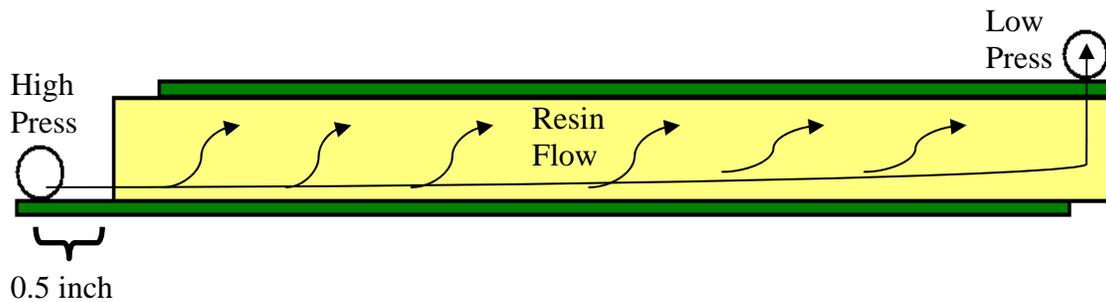
Figure 15. Pressure Difference Across Coupon

9. Place one end of the helical polyethylene tubing into the end of the top tube and adhere it with duct tape. Stretch the tubing across the top edge of the sample, ensuring that it rests on top of the coupon and infusion flow netting. Duct tape the end of the helical tube and tape that end to the glass curing surface so the tube is held firmly in place. Do the same at the bottom edge of the coupon, ensuring that there is a 0.5-inch gap between the edge of the coupon and the helical tubing, but that it is still lying across the bottom layer of infusion flow netting (Figure 14). This setup ensures that the negative pressure point will occur on the top surface and edge of the coupon while the atmospheric pressure point will occur on the bottom surface and edge. Therefore, the resin will be drawn from the bottom edge to the top edge and bottom surface to top surface of the coupon ensuring full resin saturation, as shown in Figure 15.

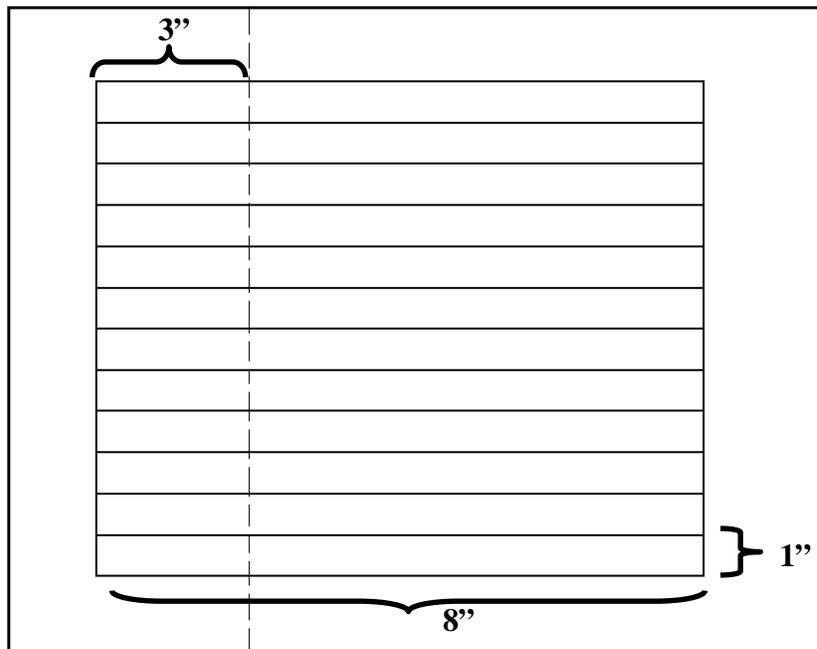
Figure 16. Mode 1 Sample Preparation

1. Use permanent marker to draw on coupon. Mark coupon into twelve, 8-inch long by 1-inch wide Mode 1 testing samples, as shown in Figure 16. Ensure that 3 inches of the sample contains the de-lamination insert.
2. Cut samples along marked lines using Jet Edge water jet cutter.
3. Final samples are configured as seen in Figure 17.

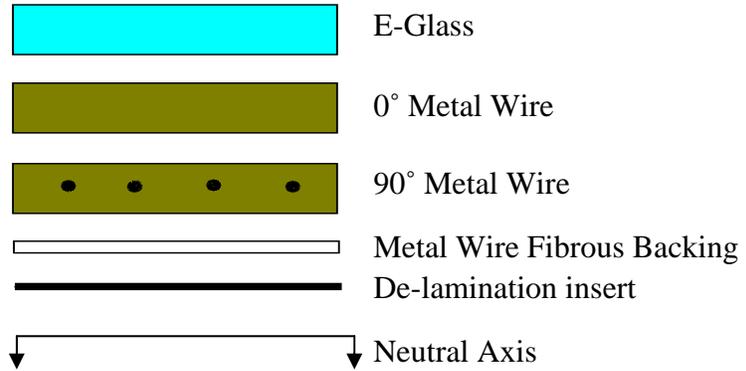
Figure 19. Configuration Legend

The following figures and descriptions represent the specific configurations investigated during this study. Figure 19 is a legend corresponding to the materials used for the coupons. This study builds on research performed during LT William Shultz's thesis [9], therefore, case numbering follows his format and is not sequential.

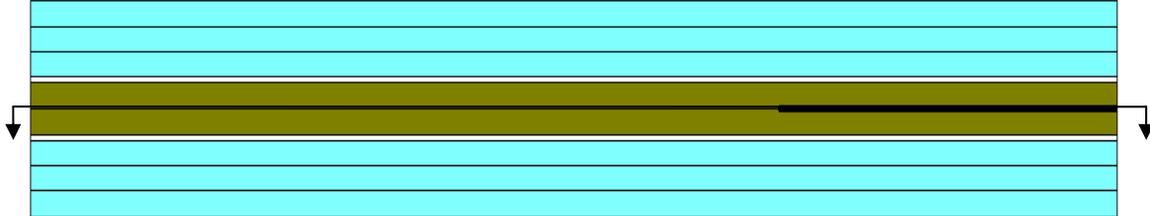
Figure 20. Case I

Case I, Figure 20, consisted of two identical halves of three layers of E-glass woven roving, followed by one layer of hardwire mat, oriented  $90^\circ$  to the crack face or parallel to the longest edge (Figure 10), with the fibrous backing between the fiberglass and the wire mat, which now will be referred to as the “ $0^\circ$  layer.”

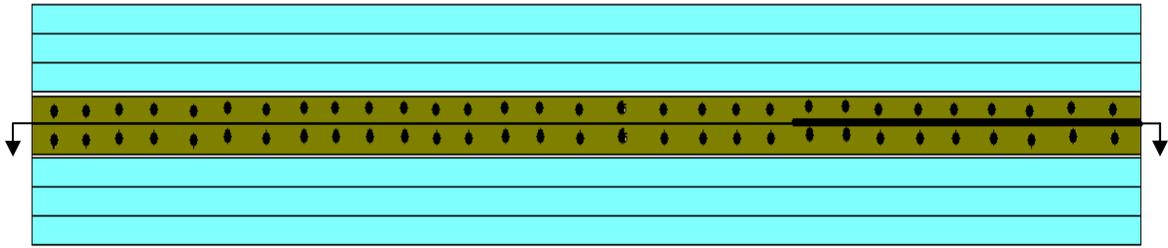
Figure 21. Case IV

Case IV, Figure 21, was identical to Case I, Figure 20, except the metal wire mat was a  $90^\circ$  layer instead of the  $0^\circ$  layer.

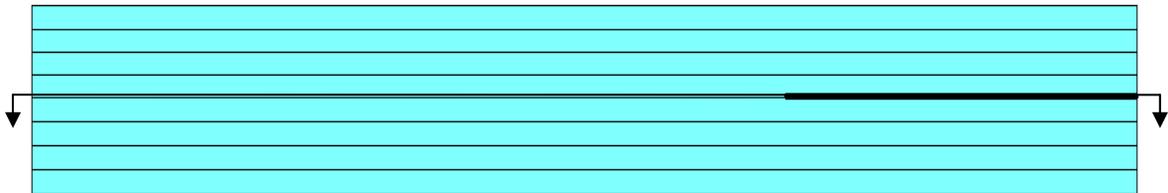
Figure 22. Case V

Case V consisted of four layers of fiberglass, followed by the de-lamination insert and then four more layers of fiberglass (Figure 22).

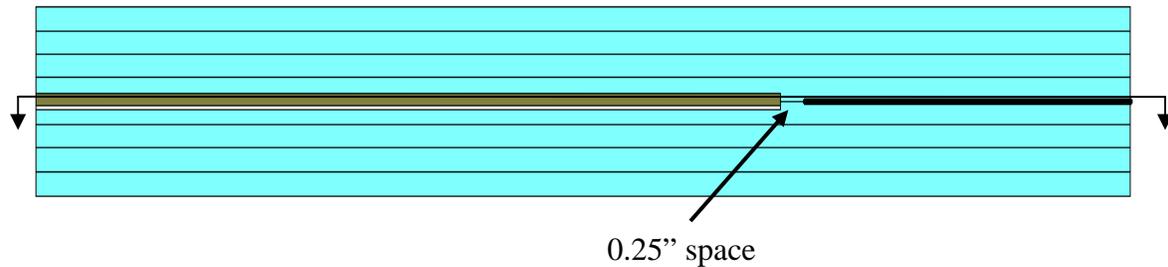
Figure 23. Case VII

Case VII investigated how a crack would propagate into the tip of the co-cured joint. It consists of four layers of fiberglass followed by a  $0^\circ$  layer metal wire mat with the fibrous backing side down and four more layers of fiberglass. Notice that the wire mat is oriented 0.24 inches from the de-lamination insert, Figure 23.

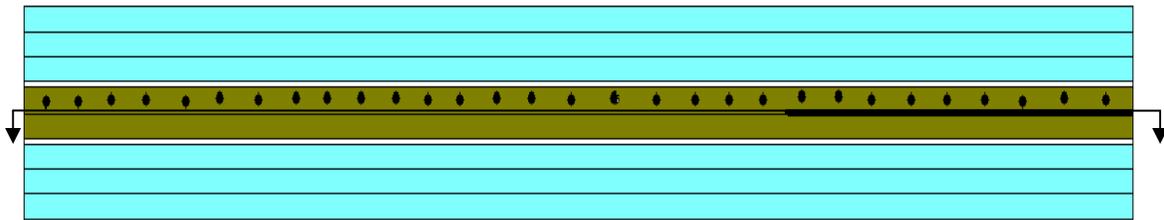
Figure 24. Case VIII

Case VIII contains two sheets of wire mat, aligned at  $90^\circ$  to each other. The top wire mat was set with fibrous backing facing up, with the wire bundles at a  $90^\circ$  orientation. The second layer of wire mat was set with the fibrous backing side down, and with the wire mat in a  $0^\circ$  layer orientation (Figure 24). The Metal wire layers are surrounded by three layers of E-glass on top and bottom, as in Case I, Figure 20.

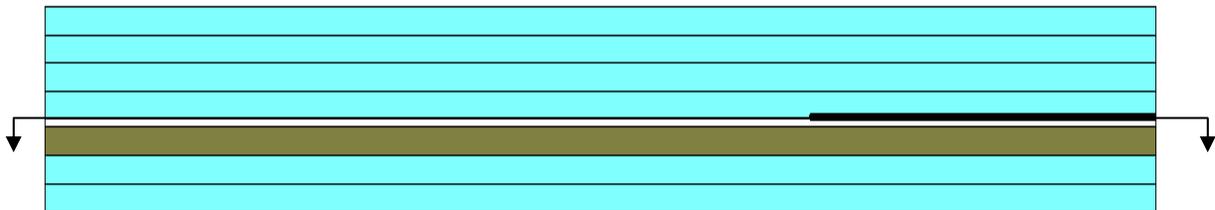
Figure 25. Case IX

Case IX was the only asymmetric case tested. It had four layers of fiberglass followed by the de-lamination insert, then a layer of  $0^\circ$  layer wire mat, with the fibrous backing facing up, and followed by two more layers of fiberglass (Figure 25).

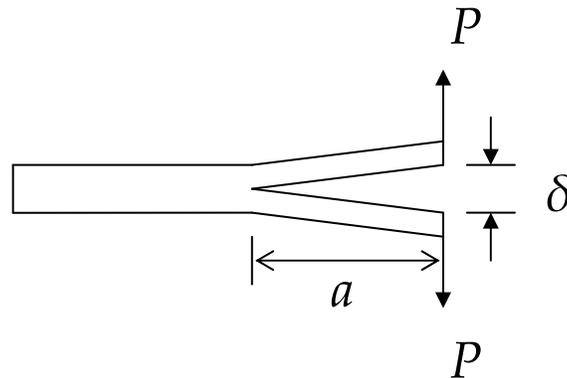
Figure 26. Double cantilever beam test for Mode I (i.e., crack opening) fracture

The applicable ASTM Standard was followed for Mode I testing. Mode I testing consisted of a double cantilever beam (DCB) test, as shown in Figure [26]. Piano hinges, used to apply the load, were attached to each sample using a commercially-available adhesive. The following equation was used to determine interlaminar fracture toughness,  $G_I$ , through the Modified Beam Theory method [7]:

$$G_I (J / m^2) = \frac{3P\delta}{2ba}$$

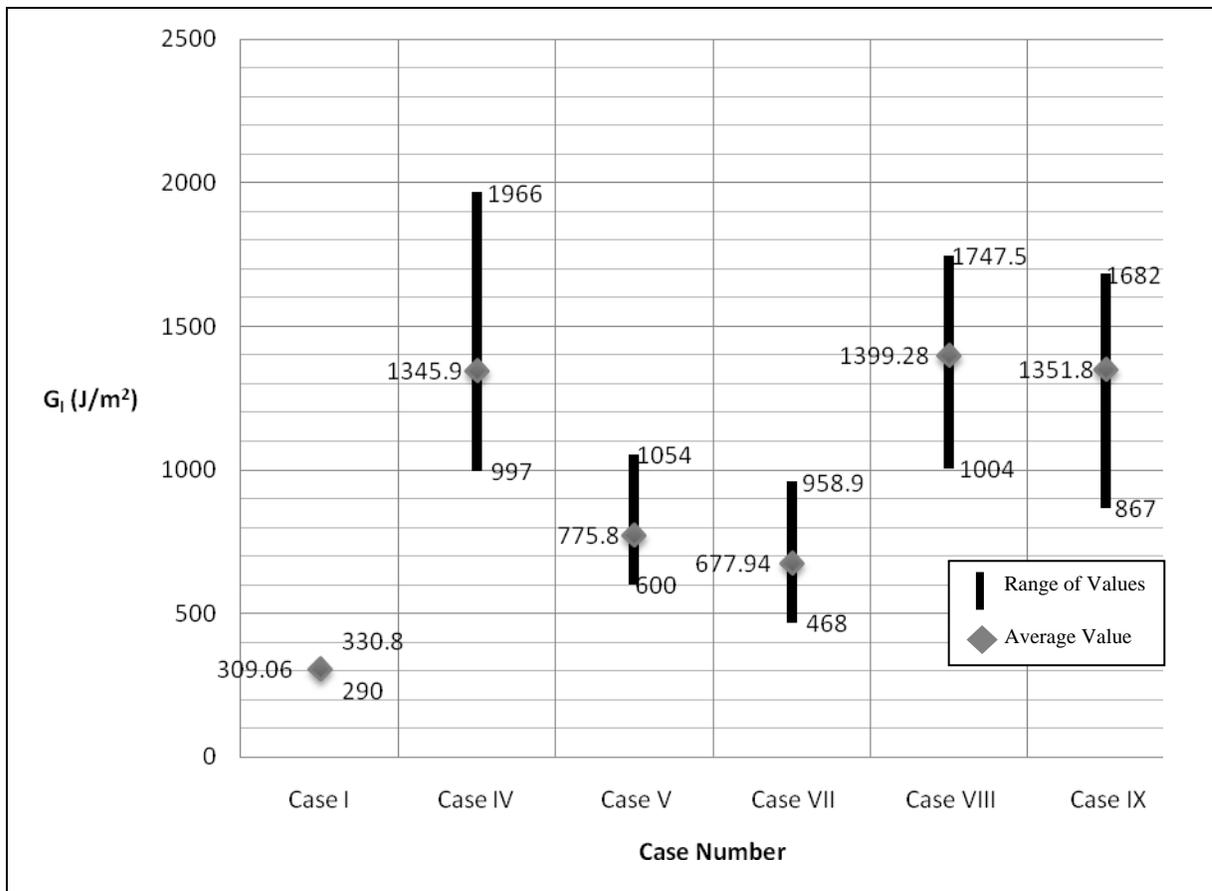
Figure 27. Mode I Interlaminar Fracture Toughness

Several different subjoins of the co-cured E-glass/metal-wire hybrid interface were investigated. Each sample was evaluated for mode I interlaminar fracture toughness ( $G_I$ ), and failure mode (Figure 27). Seven samples were tested for each case and the fracture toughness values represent an average of at least five samples.

Figure 27 shows that Cases IV, VIII, and IX had significantly higher interlaminar fracture toughness values than the other three subjoin orientations. On the other hand, Case I,  $0^\circ/0^\circ$  metal-wire orientation, resulted in the lowest value of interlaminar fracture toughness. It is important to note that for all follow-on discussion and comparisons, only the average values of interlaminar fracture toughness will be considered.

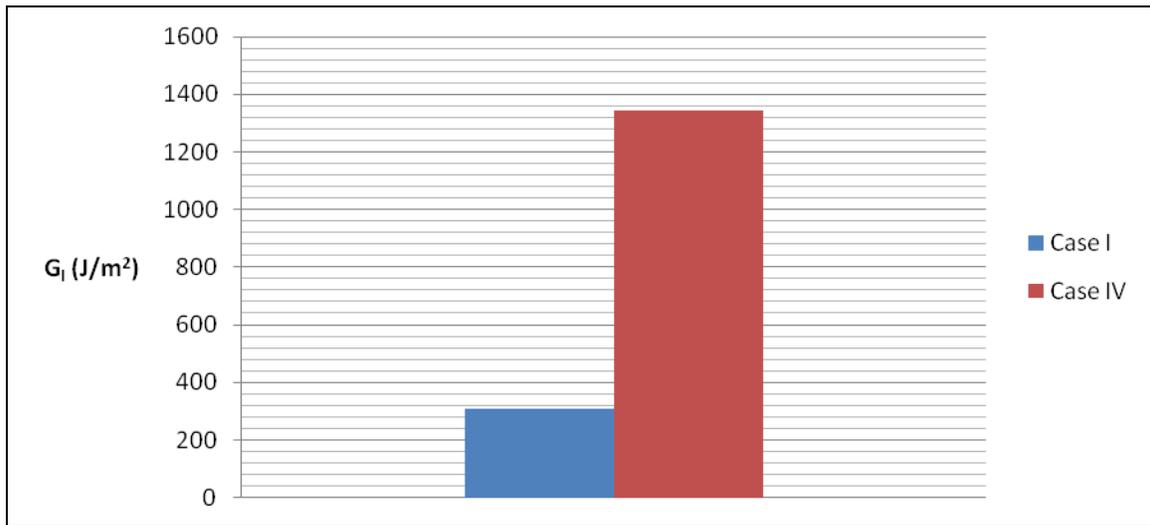
Figure 28. Average Fracture Toughness Cases I and IV

Comparison of Case I, 0°/0° metal-wire orientation, to Case IV, 90°/90° metal-wire orientation, shows that when loaded in mode I, the subjoint interface with 90°/90° metal-wire orientation has a much higher interlaminar fracture toughness (Figure 28). Case IX was the only other sample tested in which all the metal-wire mating was oriented at 0° and traversed the entire length of the sample, although only one metal-wire layer was used and the fibrous backing was facing the neutral axis. This case had significantly higher fracture toughness than Case I (Figure 29). These results indicate that hybrid composites with a 90°/90° metal-wire subjoint orientation have a significantly higher mode I fracture toughness than those with a 0°/0° metal-wire orientation, and that a higher interlaminar fracture toughness may be achieved if metal-wire mats are oriented such that their interface along the neutral axis contains the metal-wire mat's fibrous backing.

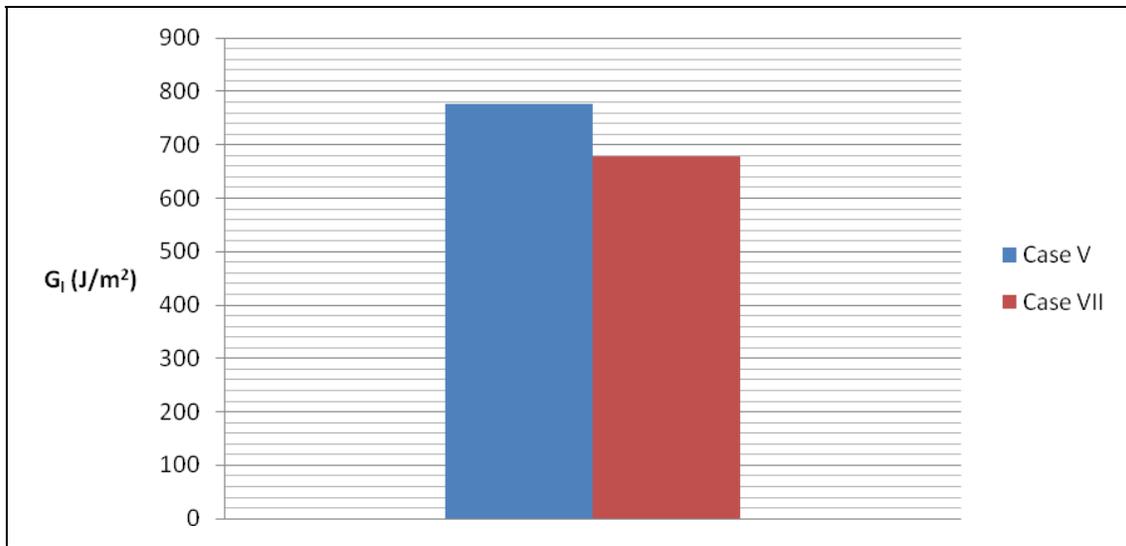
Figure 30. Average Fracture Toughness Cases V and VII

Testing showed that Cases V and VII demonstrated similar interlaminar fracture toughness (Figure 28). Both of these cases had an E-glass only crack tip interface, although Case VII had a layer of 0° wire-metal one-quarter of an inch away from the crack tip and running along the de-lamination plane. This indicates that mode I interlaminar fracture toughness of the bulk composite material being joined to a metal hull via a hybrid joint is affected minimally by the presence of metal-wire matting co-cured in the joint.

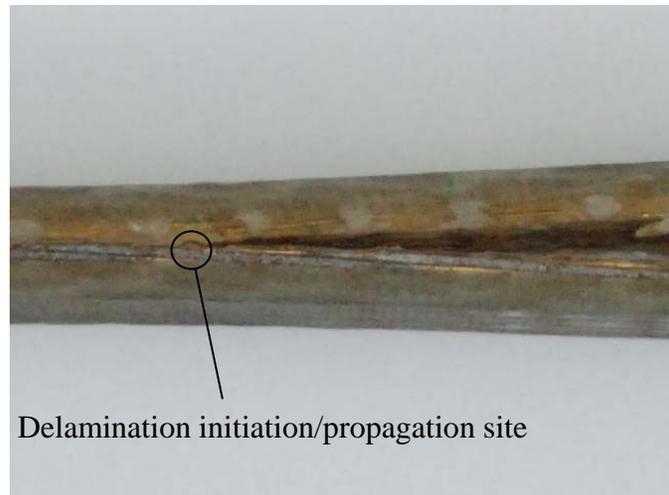
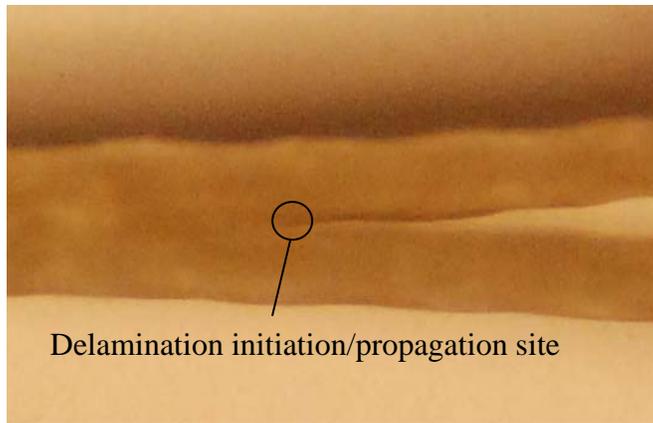
In Cases I, V, and VII, (Figures 31, 33, and 34) the primary failure mode was delamination caused by tensile forces concentrated at the fabricated crack tip. These failures occurred along the neutral axis and in Case I delamination occurred along the metal-wire/resin interface (Figure 31). This differs from Cases IV and VIII (Figures 32 and 34) which failed in tension along a crack that propagated normal to the neutral axis due to the orientation of the 90° metal-wire layers and their close proximity to the initial crack tip (Figure 36). Since this type of failure was unexpected, a finite element model was created in ANSYS to verify the experimental results.

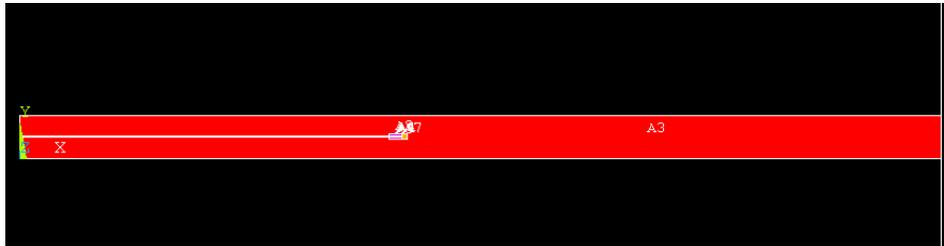
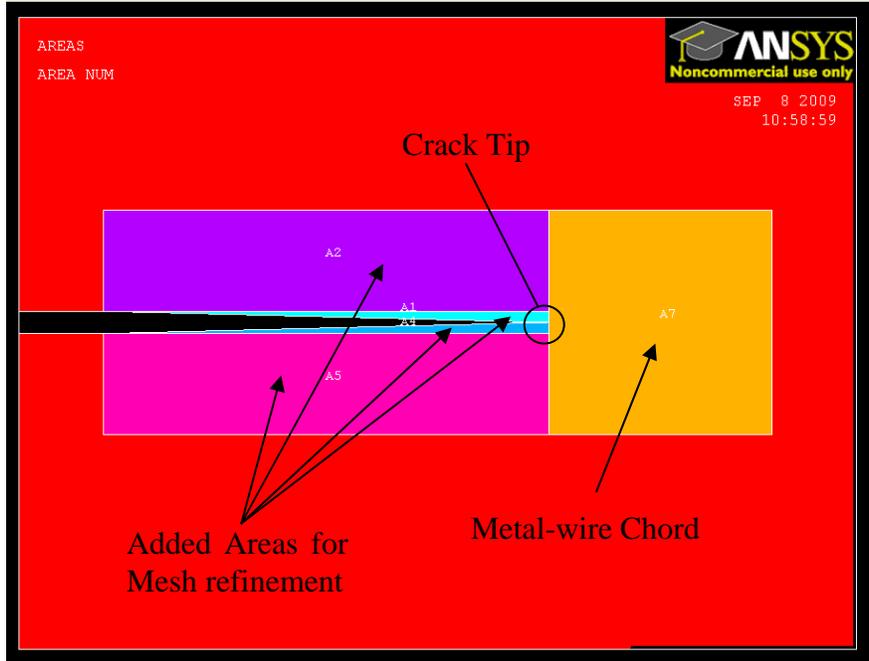
The finite element ANSYS model was created with dimensions of a typical sample and a 90° metal-wire chord inserted at the crack tip (Figures 36 and 37). Properties of both E-glass and the metal-wire were defined and the model was meshed using triangular shapes. The mesh in areas 1, 2, 4, 5, and 7 were refined in order to obtain more accurate results in the vicinity of the crack tip because force analysis is being conducted in this area. The right edge was fixed and a displacement force of 0.015m and -0.015m was applied to the nodes at the top and bottom left corners of the model respectively. The model was solved under plane strain conditions, and then Von Mises forces were calculated and displayed on contour plots (Figures 38, 39 and 40). Analysis of the forces in the x and y directions at the two nodes of concern along the crack propagation route (Figures 39 and 40) show that the sample must have failed in tension due to forces in the x-direction. This failure occurred as the sample delaminated in a direction perpendicular to the neutral axis and along the resin/metal-wire chord interface. This analysis showed that the sample was able to withstand higher loading than those without a 90° metal-wire chord because the forces in the y-direction, that cause tensile failure in along the neutral axis in cases I, V, and VII, were not high enough to cause a tensile failure in the metal-wire chord. Therefore tensile failure occurred normal to the neutral axis as the bending caused by the applied load caused the forces in the x-direction to increase above the tensile strength of the resin/wire-mat interface.

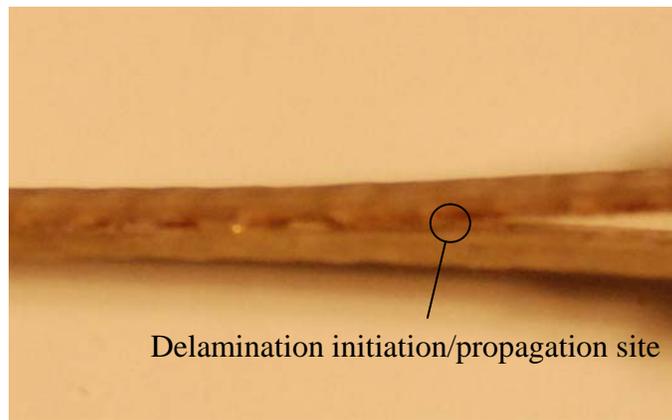
Figure 41. Case XI Delamination Initiation/Propagation

Case IX (Figure 41) was of particular interest because it demonstrated high values for interlaminar fracture toughness, but its metal-wire layer was oriented at 0°. The difference between this case and Case I is that, its metal-wire mat was oriented such that the fibrous backing was positioned along the neutral axis. This orientation provided the same stiffness increase as in a sample oriented with the wire chords along the neutral axis, but forced de-lamination to occur in a direction nearly perpendicular to the neutral axis. This caused failure due to tension in a direction normal to the neutral axis. This shows from Figure 27 that, particularly with 0° layer oriented metal-wire, mode I interlaminar fracture toughness can be increased dramatically if the metal-wire layers are oriented such that the fibrous backing is along the neutral axis.
