Comparison of Relocatable Commercial Vehicle Washing Systems

SERDP Project SI-1545

Joe Fleming, Mechanical Engineering Technician,

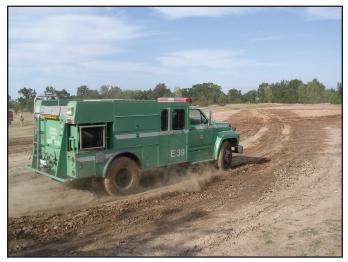
Figure 2—Wildland fire engines.

Vehicle Type 1. Wildland fire engines (three; only two were used for test cycles).

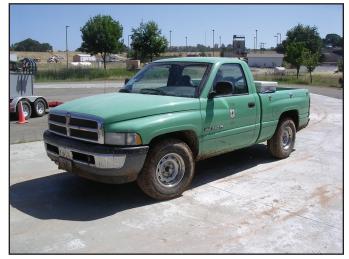
Figure 3—Light-duty trucks and sport utility vehicle.

Vehicle Type 2. Light-duty trucks (two) and sport utility vehicle (one).

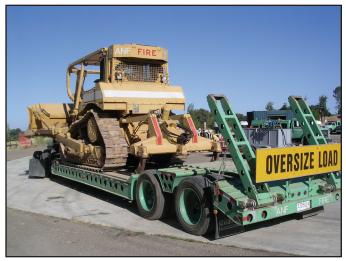
Figure 4—Caterpillar D6.

Vehicle Type 3. Caterpillar D6 High-Track bulldozer (one).
