# The Lead Crack Fatigue Lifting Framework

DSTO-RR-0353

A fatigue lifting framework using a lead crack concept has been developed by the DSTO for metallic primary airframe components. The framework is based on years of detailed inspection and analysis of fatigue cracks in many specimens and airframe components, and is an important additional tool for determining aircraft component fatigue lives in the Royal Australian Air Force (RAAF) fleet. Like the original Damage Tolerance (DT) concept developed by the United States Air Force (USAF), this framework assumes that fatigue cracking begins as soon as an aircraft enters service. However, there are major and fundamental differences. Instead of assuming initial crack sizes and deriving early crack growth behaviour from back-extrapolation of growth data for long cracks, the DSTO framework uses data for real cracks growing from small discontinuities inherent to the material and the production of the component. Furthermore, these data, particularly for lead cracks, are characterized by exponential crack growth behaviour. Because of this common characteristic, the DSTO framework can use lead crack growth data to provide reasonable (i.e. n

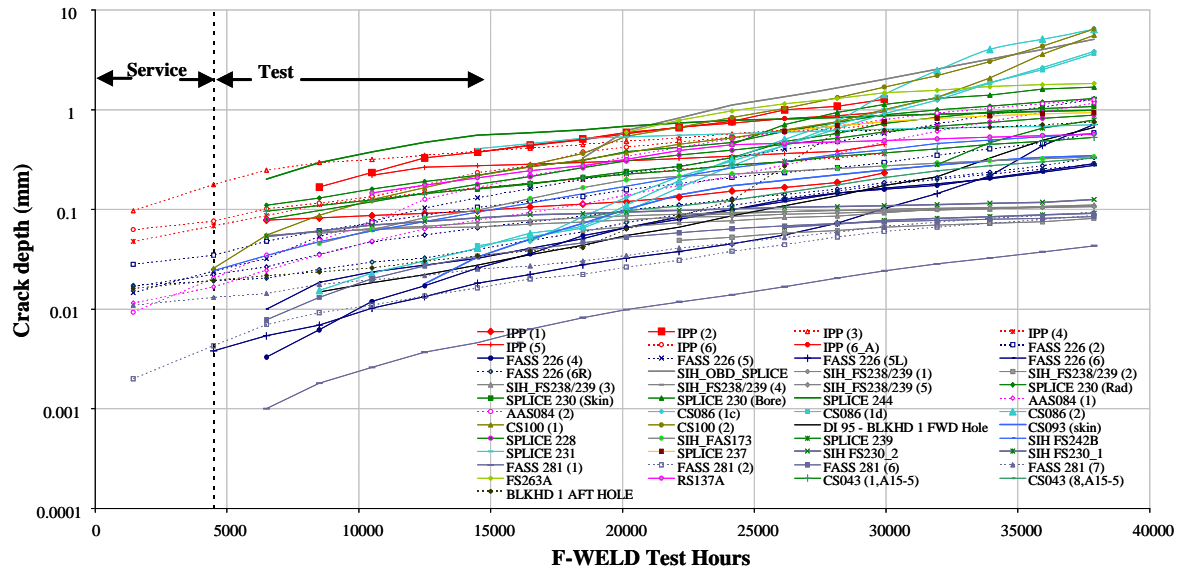
Figure 1: Sample of FCG curves from different locations in the aluminium alloy (AA) 2024-T851 lower wing skin of an F-111 test article removed from service [17]. CS = central spar, BLKHD = bulkhead, FASS = Forward Auxiliary Spar Station inches, IPP = Inner Pivoting Pylon, RS = Rear Spar.

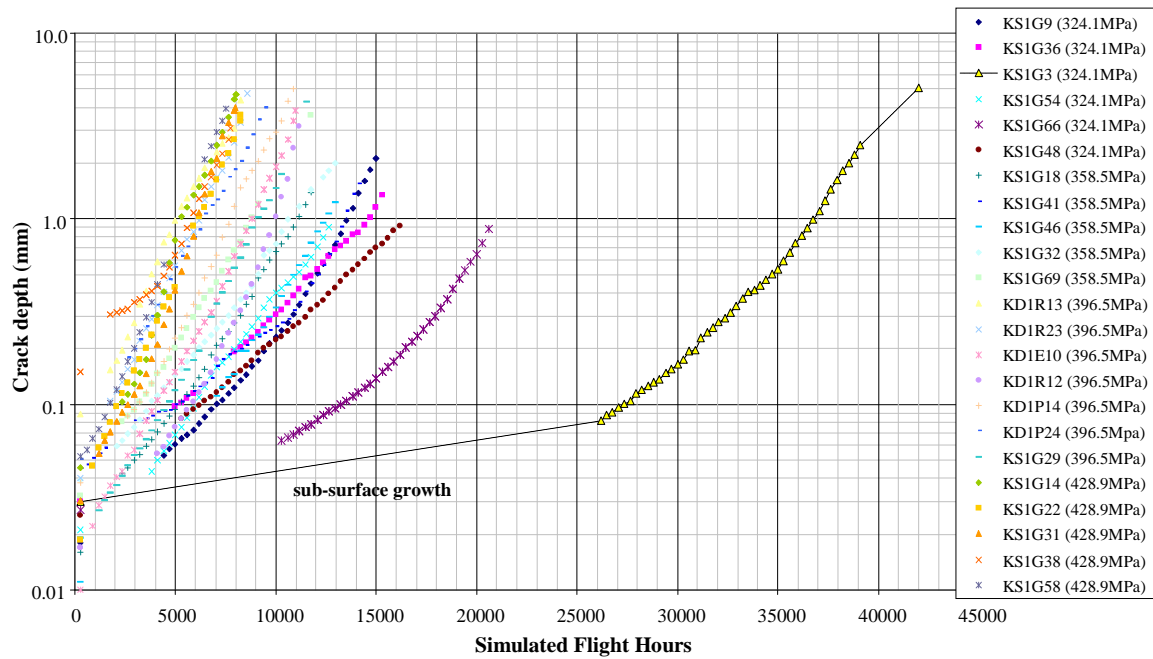
Figure 3: FCG data for highly stressed AA7050-T7451 aluminium alloy specimens tested under combat aircraft flight-by-flight block loading at four stress levels. One block represents about 300 airframe hours (AFHRS) and each data point represents the crack growth increment per block.

To illustrate these points and their interrelation, Figure 3 shows QF data for flight simulation FCG from surface-connected and (slightly) subsurface discontinuities in highly stressed aluminium alloy specimens. Most of the FCG-initiating discontinuities were smaller than 0.05 mm and crack growth began effectively immediately when they were surface-connected. However, for specimens KS1G3 and KS1G66 the FCG-initiating discontinuities were subsurface and there were apparent delays of 10,000 and 26,000 flight blocks before crack growth began. The reason for these apparent delays is that subsurface crack growth would have occurred *in vacuo* at much slower rates than in air [23]. Once the cracks contacted the surface (and thus the environment) their FCG rates became similar to those for other specimens tested at the same stress levels.

N.B: although differentiation to obtain Figure 4 reveals data scatter, comparison with Figure 3 shows that the log crack size *versus* linear life plots for each crack are stable. This is a common observation, see for example Figures 6 and 16 in [26]. Differentiation to obtain FCG rates accentuates quite small differences in the progression of crack growth. This can be useful for detailed analyses of crack growth but is not relevant to the DSTO lead crack lifing method, which uses log crack size *versus* linear life plots.

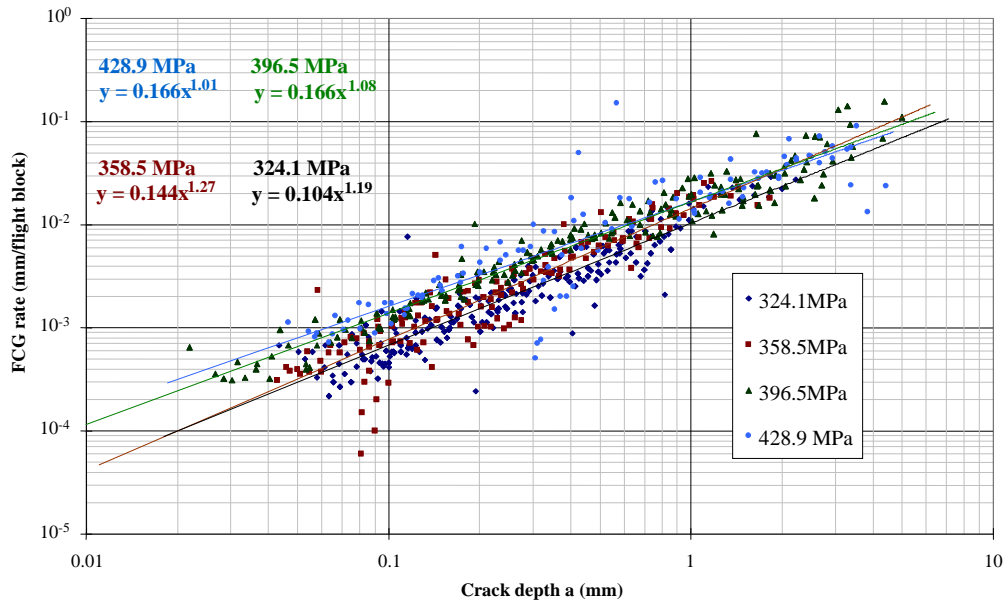
Figure 4: FCG rate data from Figure 3

These relationships mean that the FCG data appear to be well represented by straight lines on plots of  $\ln$  (log) crack size *versus* life and  $\ln$  (log) FCG rate *versus*  $\ln$  (log) crack size. Figures 1 and 3 are examples of the first type of plot, and Figure 4 is an example of the second type.

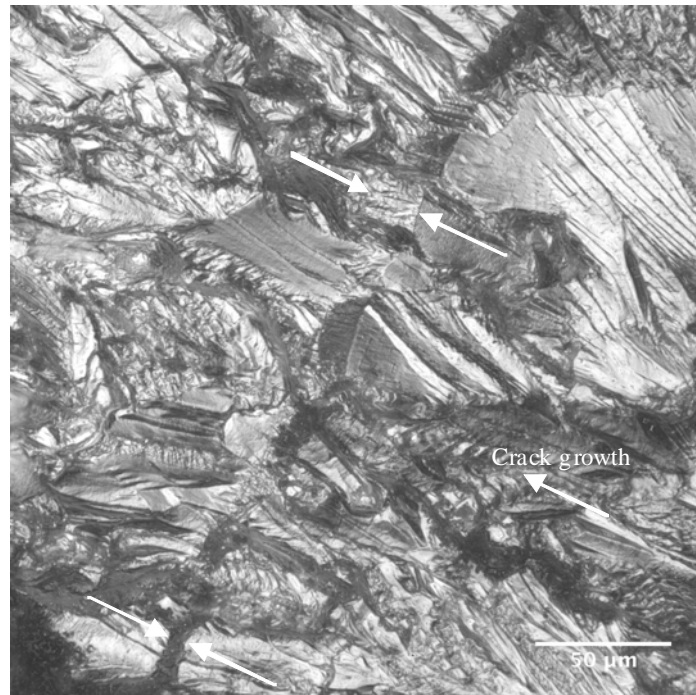
Figure 5: An example of material-related FCG rate variability from the fracture surface of an AA7050-T7451 aluminium alloy specimen at about 1mm in depth. The band from lower left to top right was formed by a block of CA R = 0.7 cycles applied between blocks of 5000 CA R = 0.1 cycles, all with the same maximum load. Note the width variation of the band at the two arrowed positions.

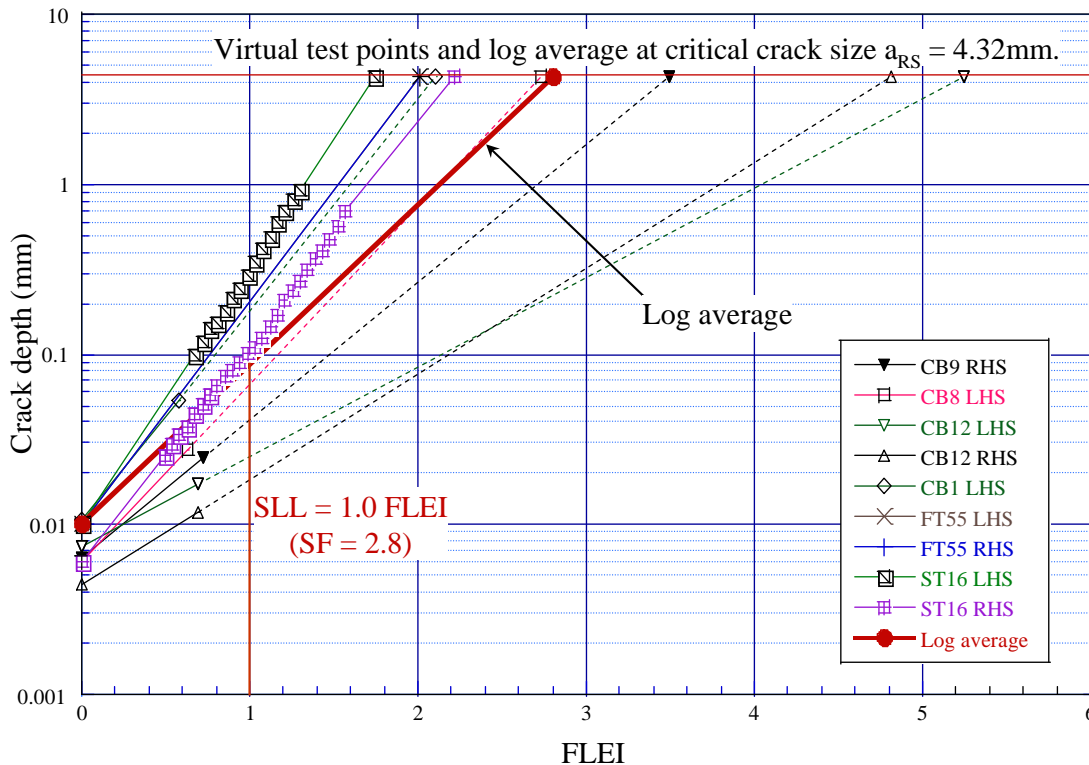
Figure 6: Pooled estimates of exponential FCG for several lead cracks, their virtual test points, the logarithmic average of these virtual test points, and the re-assessed SLL for the web of a fuselage bulkhead in a combat aircraft, using an experience-based scatter factor (SF) of 2.8 [38]. FT55 & ST16 = Full Scale Fatigue Test; CBxx = in-service aircraft. Crack depths at zero SFH = EPS; crack depths at approximately 4000 SFH = measured in-service crack depth from tear-down; dashed lines are extrapolations to the web thickness.

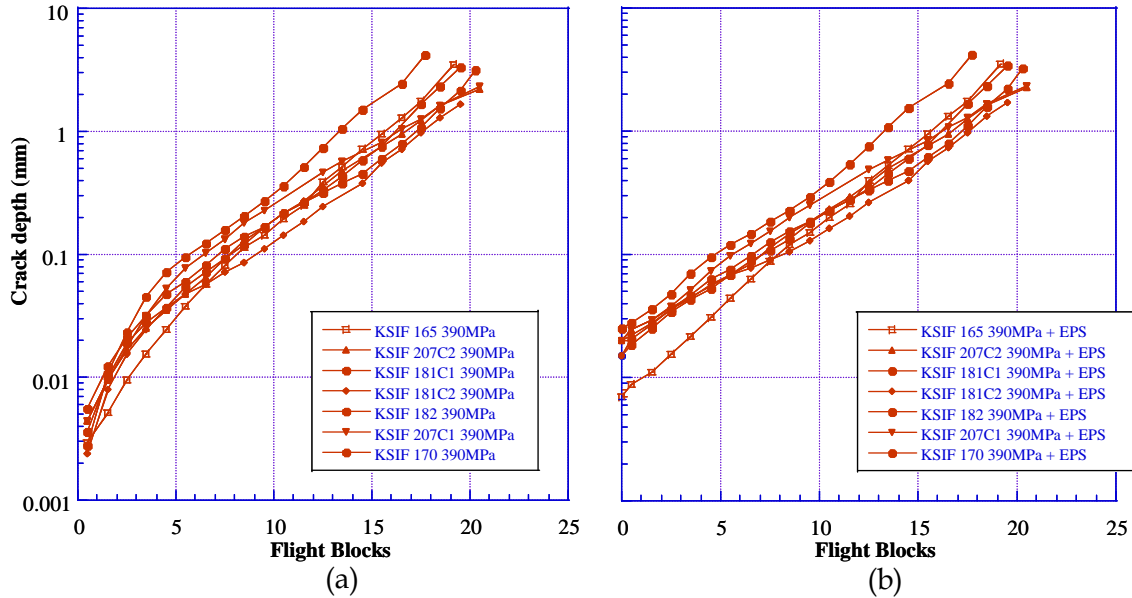
Figure A.1: FCG data for AA7050-T7451 aluminium alloy coupons tested under combat aircraft flight-by-flight block loading: (a) without and (b) with corrections to the effective crack depths by adding the initial discontinuity depths at zero lifetime and for all subsequent crack depths [A.2]

flight block. The early FCG data clearly do not follow the later exponential trend. However, when the best estimates of the discontinuity depths are added to the plots at zero lifetime and for all subsequent crack depths, Figure A.1b, an approximately exponential FCG trend is found over the whole range of crack sizes.

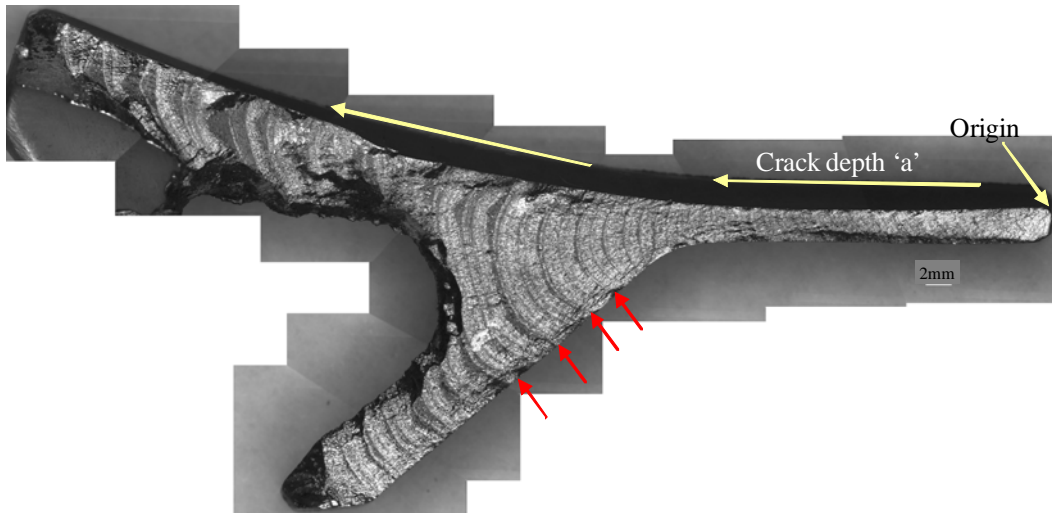
Figure A.2: Optical fractograph of a fatigue crack growing through a major change in geometry, known as the FT46 (AA7050-T7451) Y557 kick-point, under combat aircraft (F/A-18) flight-by-flight block loading [A.3,A.4]. The pattern of the block repeats (some marked by red arrows) was used to generate the FCG curve in Figure A.3. The large arrows indicate the direction of crack measurement.

Figure A.2 shows an example of a crack growing through a significantly changing geometry, known as the FT46 Y557 kick-point, a location on the upper longeron of an aft fuselage full-scale test article [A.3]. QF measurements resulted in the FCG curve shown in Figure A.3. This plot is exponential until the crack enters the 'Y' junction, whereupon the FCG rate decreased for about 8000 simulated flight hours (SFH). Since exponential FCG pertained over most of the crack growth life, this behaviour was used to provide a conservative estimate of the FCG life for the kick-point location.

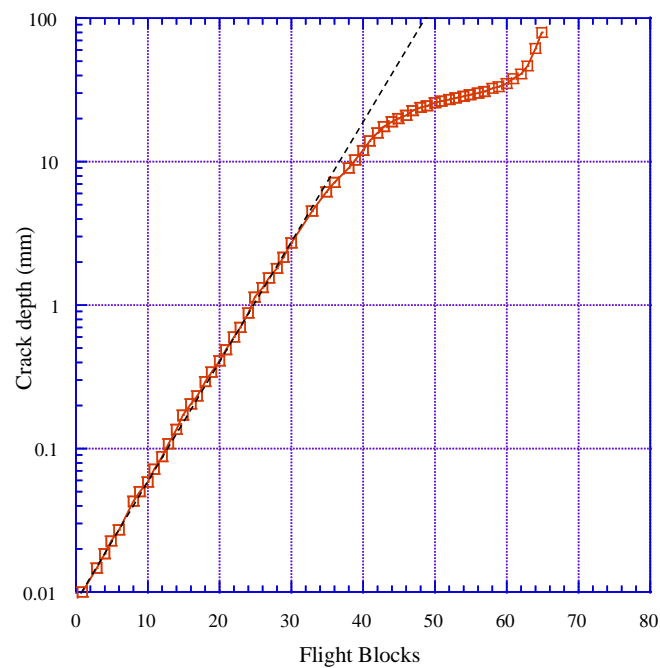
Figure A.3: FCG curve derived for the FT46 Y557 kick-point [A.4]. The commencement of decreasing FCG rates corresponds to the crack entering the 'Y' junction, see Figure A.2. The dashed line represents exponential FCG and would give a conservative estimate of the FCG life.

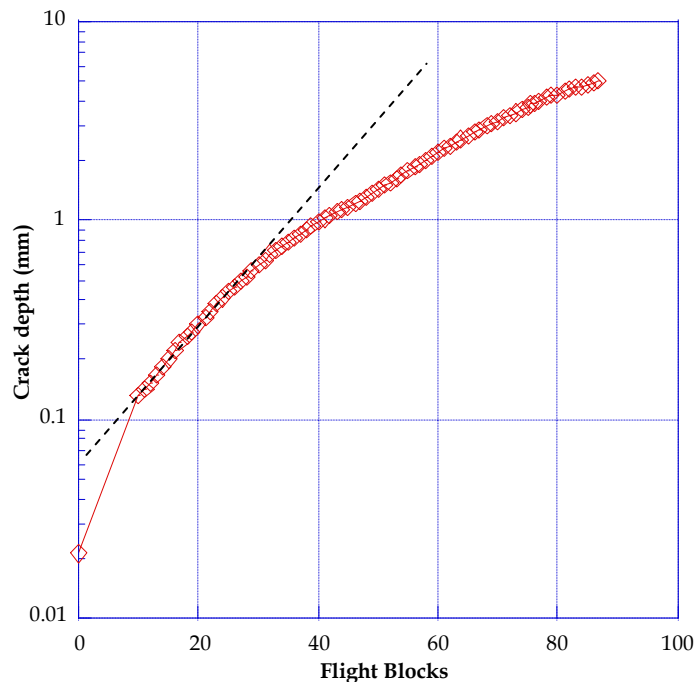
Figure A.4: FCG for an attachment lug of a wing leading edge device from a full-scale F/A-18 wing test [A.5]. Load shedding caused decreased FCG rates after about 32 blocks of simulated flights. The dashed line represents exponential FCG and would give a conservative estimate of the FCG life.

Figure A.4 shows QF FCG data for one of the lugs of a wing leading edge lift device from an F/A-18 full-scale wing test [A.5]. The FCG behaviour was approximately exponential for about 32 blocks of simulated flights. The cracked lug then began to shed load, most probably to adjacent lugs, resulting in a decrease in FCG rates. Exponential FCG could still be used to provide a conservative estimate of the FCG life, as is indicated by the dashed line. However, in this case the estimate would be over-conservative, since load shedding prevented the lug from failing during the test.

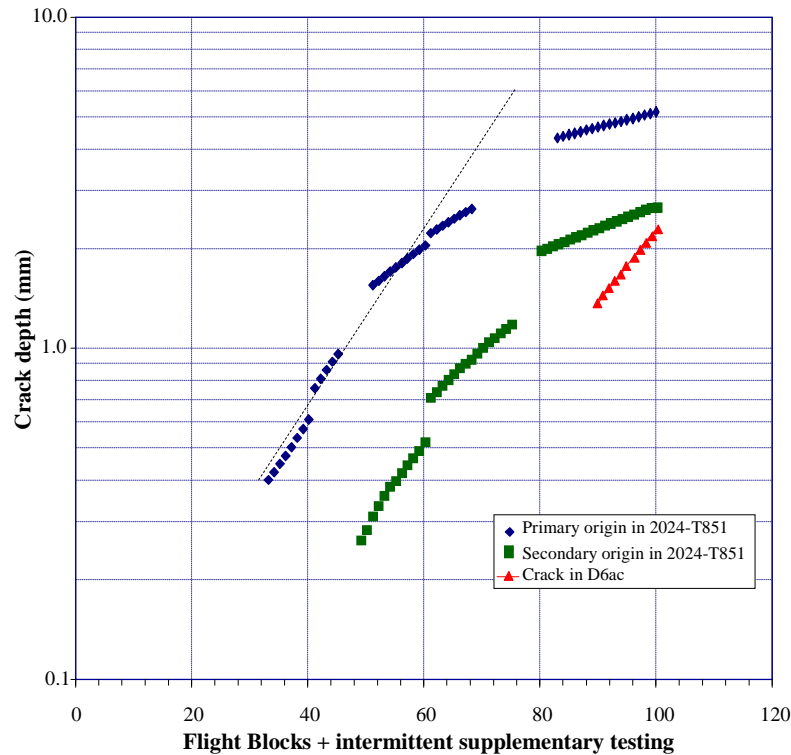
Figure A.5: FCG from fastener hole 182 in the wing pivot splice produced during an F-111A full-scale fatigue test: adapted from [A.1.6]. Step changes in the plots are due to intermittent short-term supplementary testing. The dashed line represents exponential FCG for the crack growing from the primary origin in the AA2024-T851 wing skin would give a conservative estimate of the FCG life.

Figure A.5 shows a more complicated example of load shedding. This is from a full-scale fatigue test for the General Dynamics F-111A aircraft, specifically the wing splice area. The splice consisted of a D6ac steel plate fastened to a 2024-T851 aluminium alloy plate.

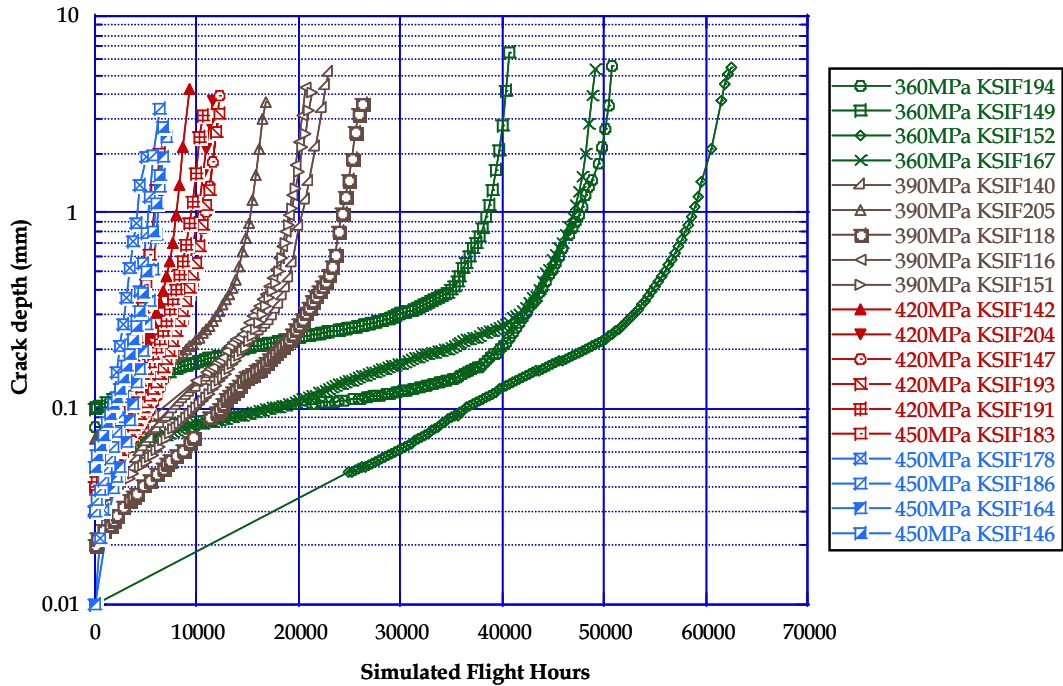
Figure A.7: FCG data for shot peened AA7050-T7451 coupons tested under combat aircraft flight-by-flight block loading at several stress levels [A.8].

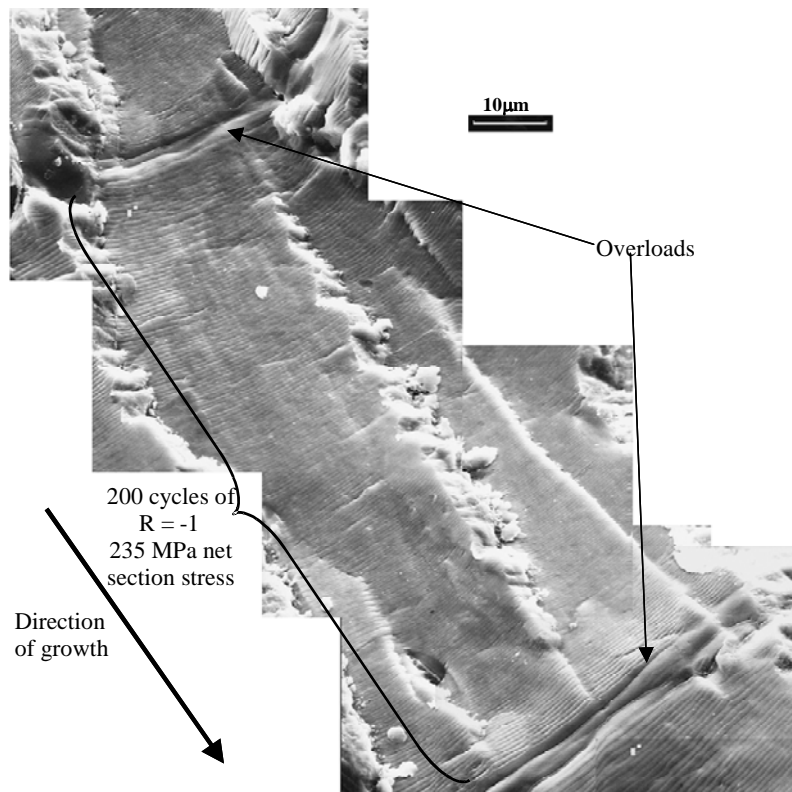
Figure A.9: QF view of part of the fatigue fracture surface of the specimen illustrated in Figure A.8.

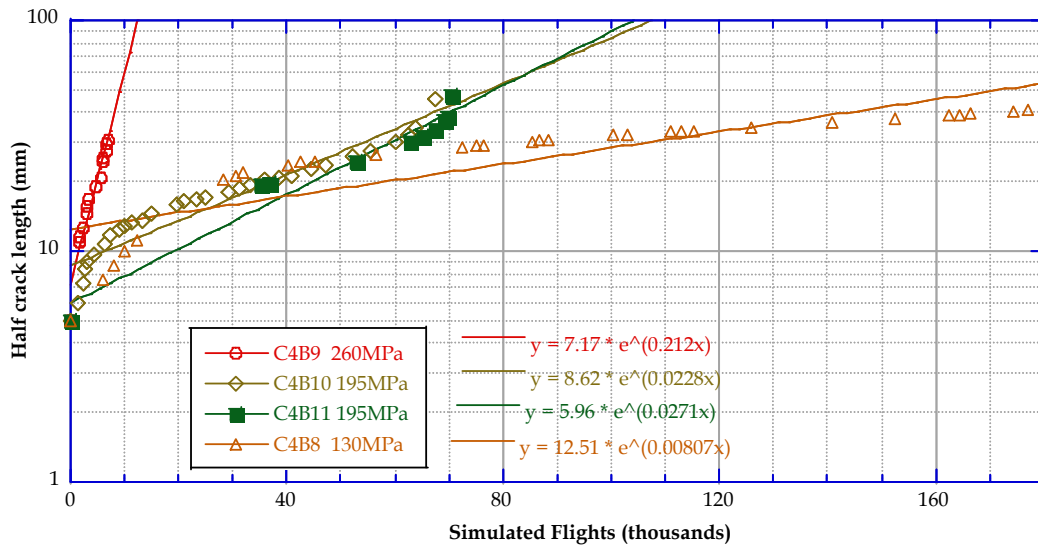
Figure A.10:FCG data for AA2024-T3 panels subjected to the standard gust spectrum loading, TWIST [A.12]. The data are replotted from [A.13].

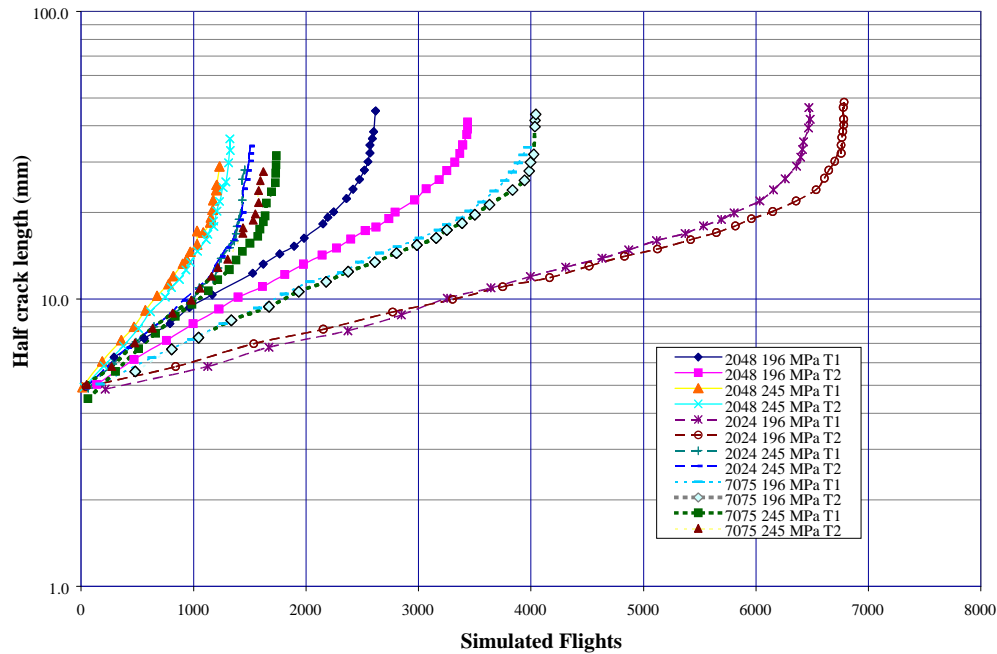
Figure A.11:FCG data for AA2048-T851, AA2024-T3 and AA7075-T6 aluminium alloy panels subjected to the standard manoeuvre spectrum loading, FALSTAFF [A.14]. The data are replotted from [A.10].

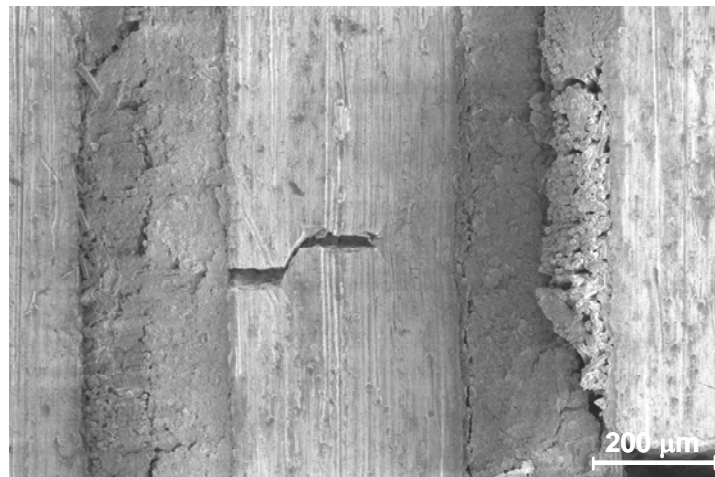
Figure B.2: Example of fatigue cracking initiating from scoring in the bore of a fastener hole in the MLB GLARE door beam [B.2]. The cracking is in one of the AA2024-T3 sheets of the GLARE laminate.

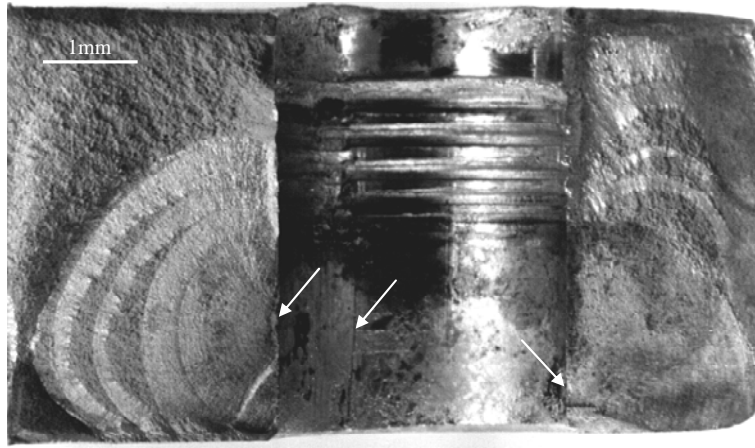
*Figure B.3: Example of a hole that was damaged by fastener insertion in a main wing spar made from an AA7075-T6 extrusion. Service fatigue cracks have initiated from surface scores produced during insertion of a blind fastener. The middle arrow (bore of the hole) indicates one of the scores.*

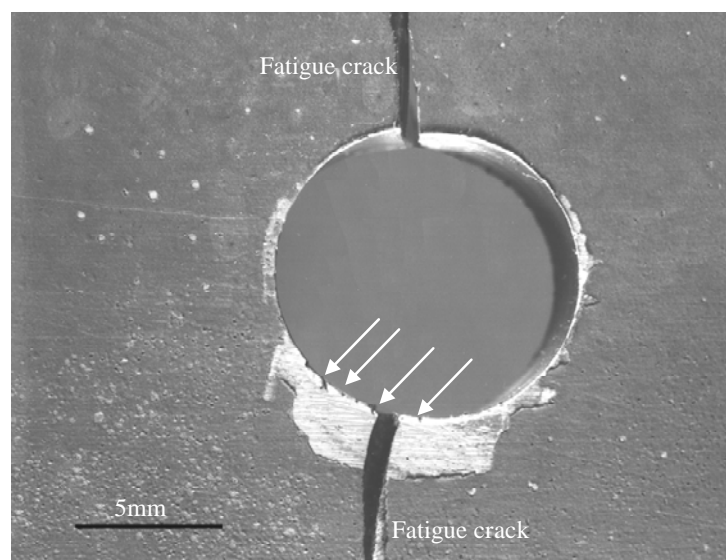
*Figure B.4: Example of a hole that was poorly finished in a main wing spar made from an AA7075-T6 extrusion. The upper fatigue crack initiated from a split in a burr at the edge of the hole. The lower fatigue crack initiated from a nick on the edge of the hole: other nicks are indicated by the small arrows.*

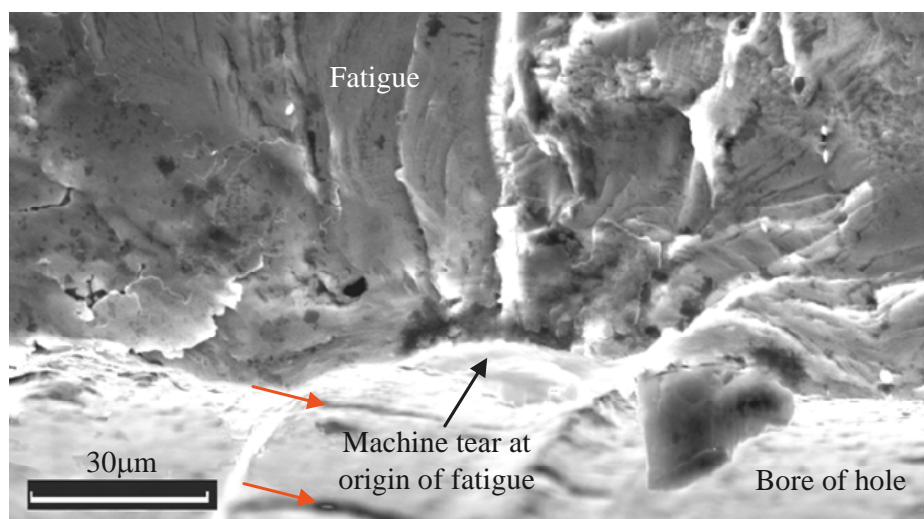
Figure B.7: Fatigue cracking initiating from a shallow long surface groove combined with a machining tear in an AA7050-T7451 coupon.

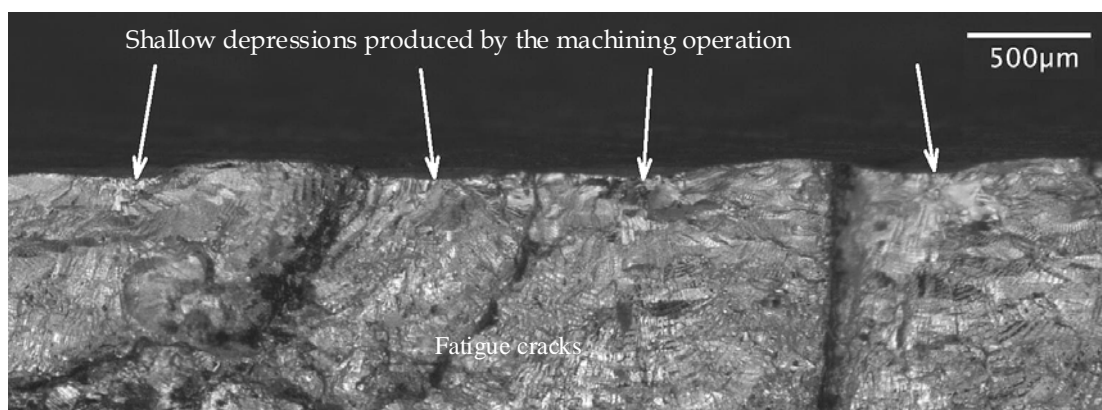
Figure B.10: Example of a fatigue test failure in a full-scale fatigue test article. Multiple fatigue cracking started from small etch pits at the base of coarse machining grooves. The material was AA7050-T7451 plate.

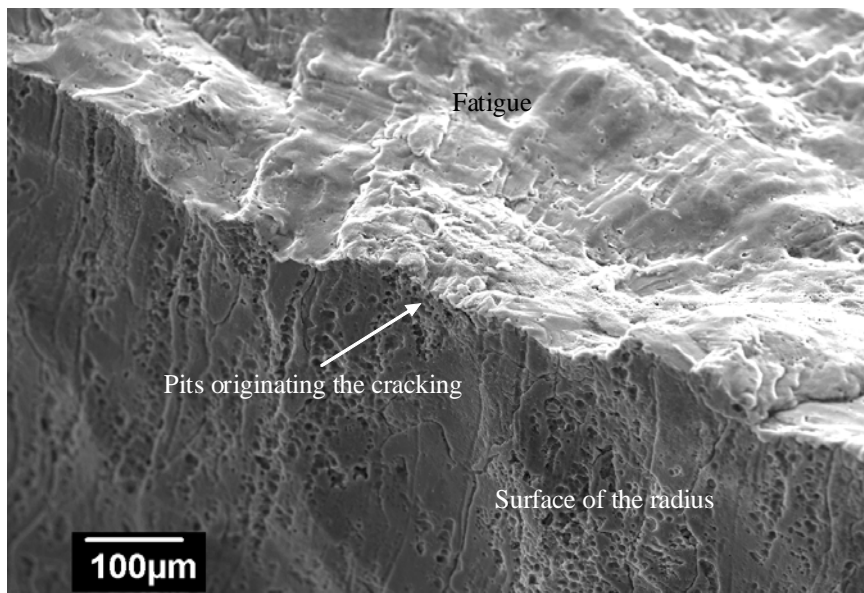
*Figure B.12: Example of fatigue cracking from small etch pits during the FSFT of an AA2024-T851 wing lower skin. Cracking from the etch pits may have been facilitated by a shallow radius in the skin.*

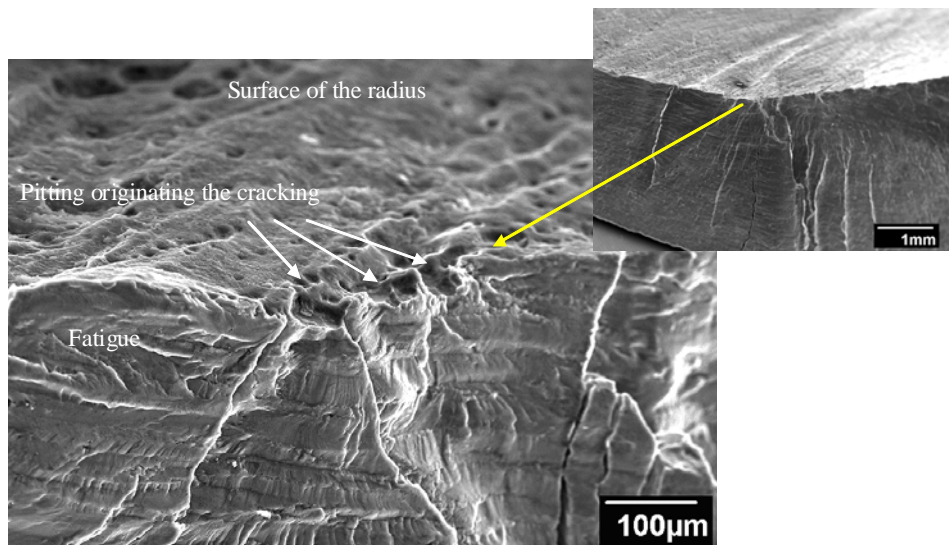
*Figure B13: Example of a fatigue crack initiating from etch pits on the surface of a P3C empennage component that had been deoxidised prior to anodising, as part of the production process. The component was an AA7075-T6 extrusion. Note the many other etch pits on the surface.*

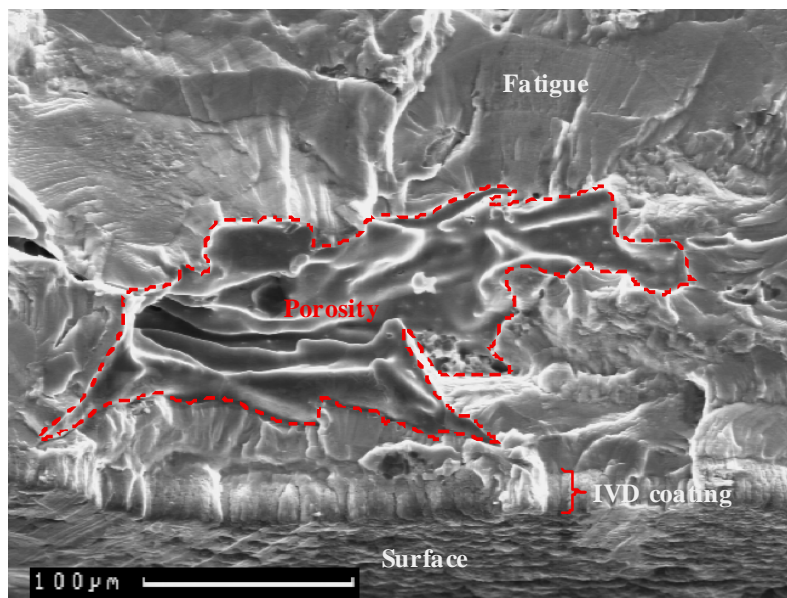
Figure B.15: Example of fatigue growing from many closely spaced origins around a large pore (outlined) in thick plate made from AA7050-T7451.

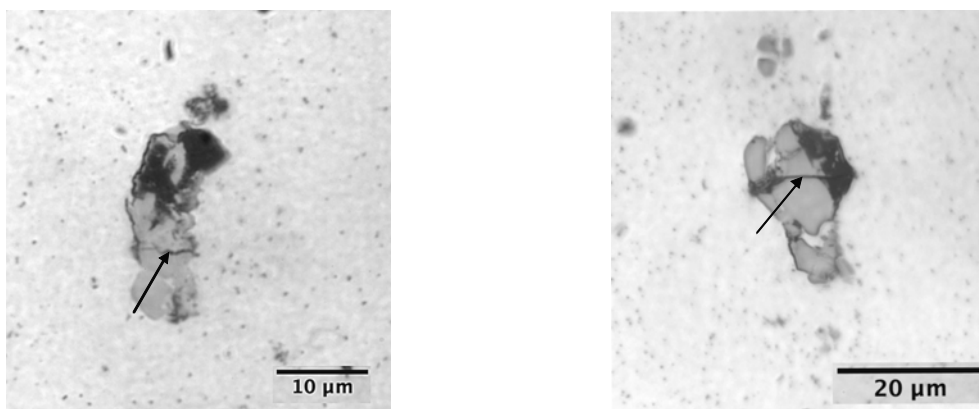
*Figure B.16: AA7075-T6 constituent particles that cracked (arrows) during abrasion with 600# SiC paper. The abraded surfaces were electropolished to reveal the cracks.*

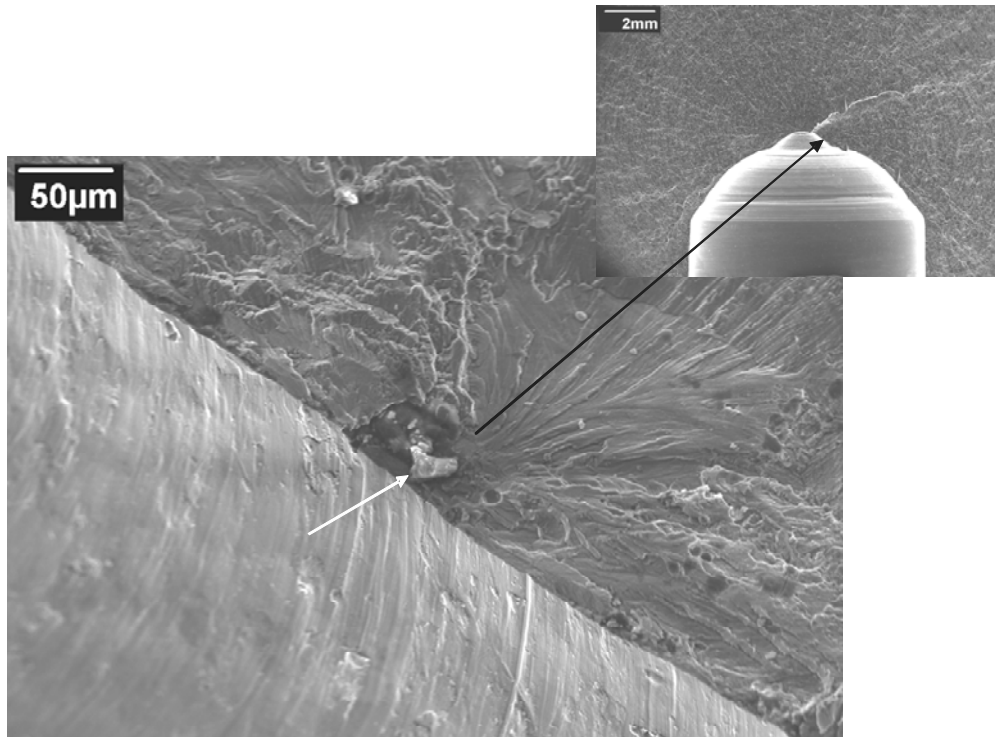
*Figure B.18: Example of fatigue cracking from a large constituent particle at the bottom of a blind fastener hole in a wing main spar made from AU4SG aluminium alloy and subjected to an FSFT. Although the hole had a good machined surface, the particle's fatigue-initiating severity was most probably increased by a stress concentration due to the poor shape of the hole tip.*

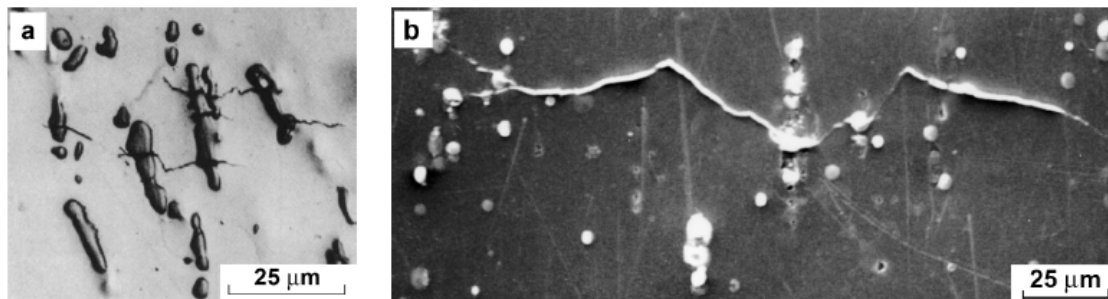
Figure B.19: Fatigue crack initiation at (a) cracked inclusions in a smooth specimen of D.T.D. 5014 aluminium alloy (equivalent to AA2618-T6) tested under CA loading, and (b) uncracked particles in a notched specimen of AA2024-T3 tested under flight-by-flight gust spectrum loading [B.22,B.27].

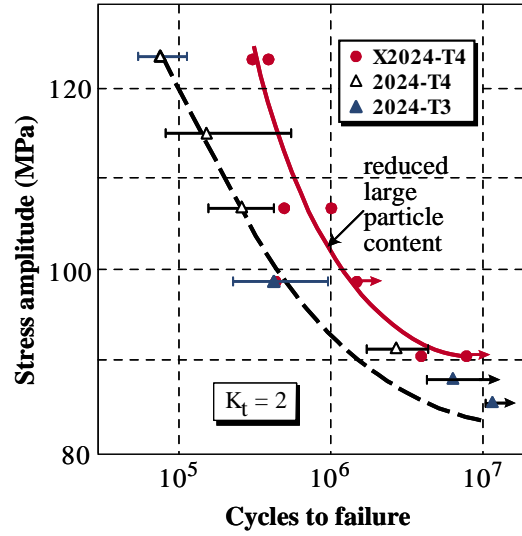
Figure B.21: Effect of reduced large constituent particle (inclusion) content on notched ( $K_t = 2$ ) fatigue of experimental (X) and commercial naturally aged AA2024 [B.19].

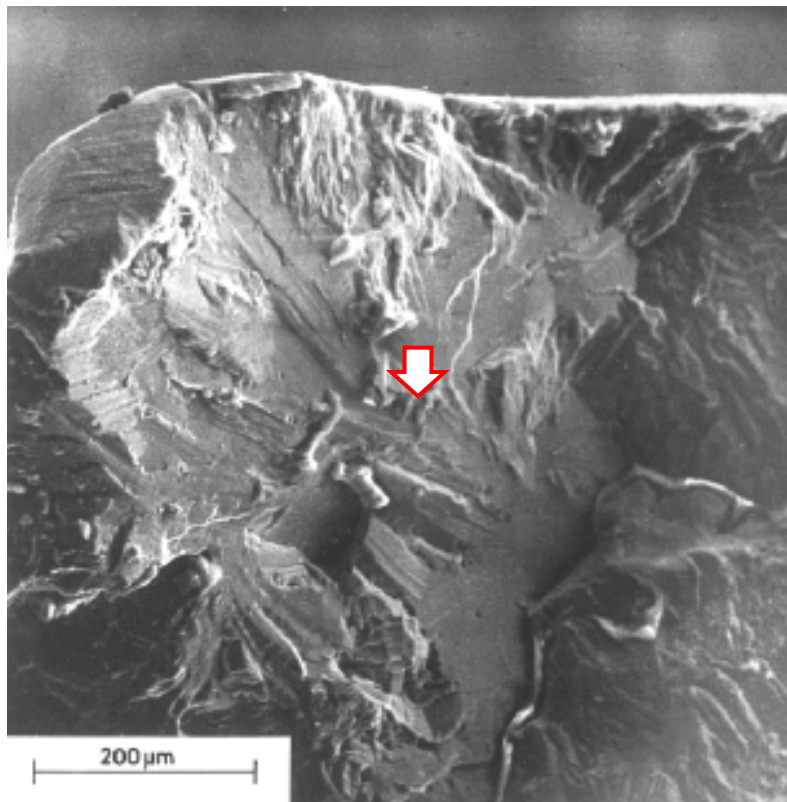
Figure B.23: Subsurface high-cycle fatigue crack initiation in a shot-peened unnotched coupon machined from an AA7079-T652 forging [B.16]. The arrow indicates the approximate location of the fatigue origin.

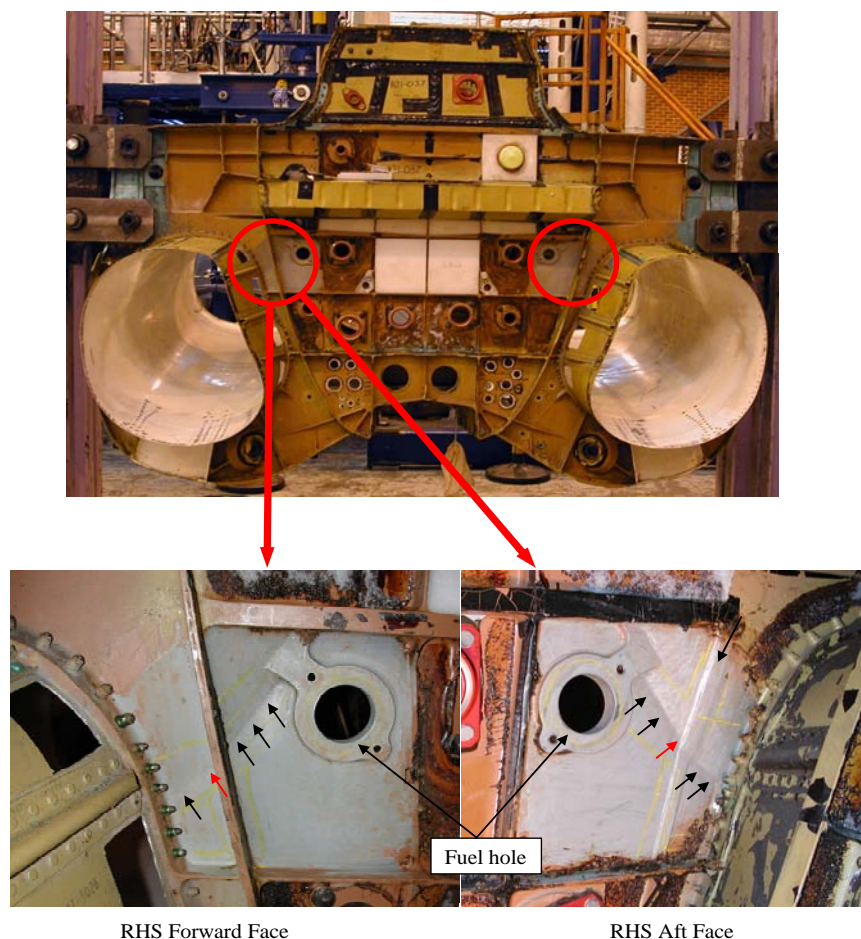
Figure C.1: A centre barrel removed from an F/A-18A showing the two web taper areas (circled) and details of one of them in the front bulkhead of the tested assembly. The small arrows in the lower photographs indicate the fatigue-critical location, with the red arrows pointing to the most critical position along the taper.

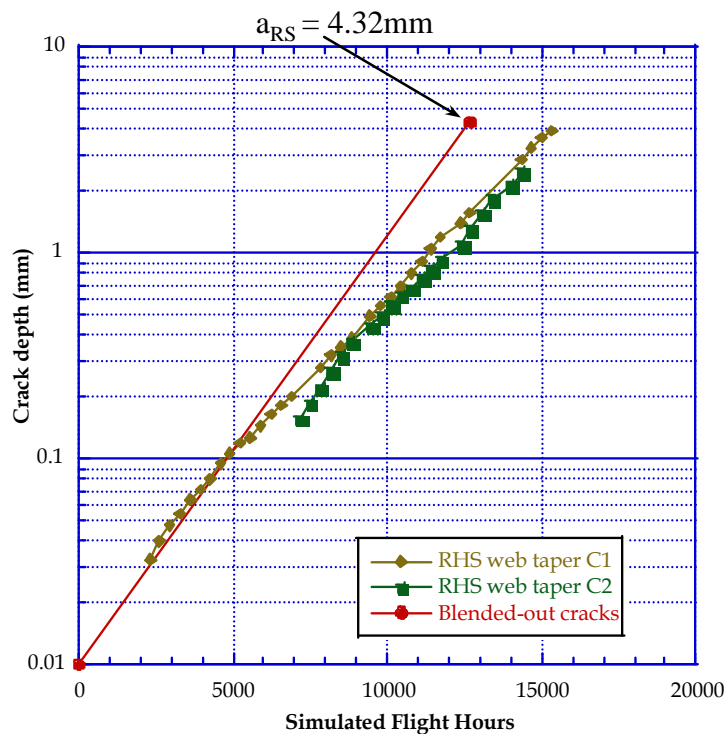
Figure C.2: FCG data and a predicted lead crack FCG plot (FSFT blended-out cracks) for the RHS web taper area of an F/A-18A/B production CB [C.2].

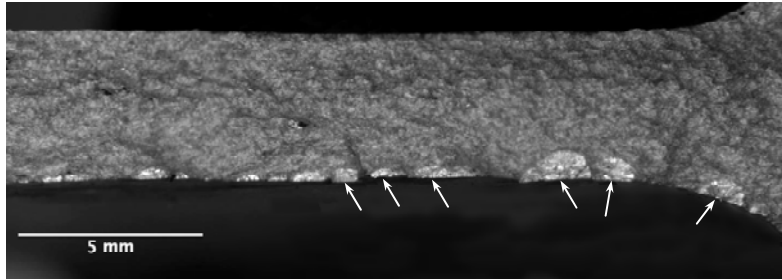
Figure C.3: Fracture surface of the broken-open fatigue cracked area in the LHS web taper from an ex-service CB tested until cracking was detected. Some of the exposed fatigue cracks are marked.

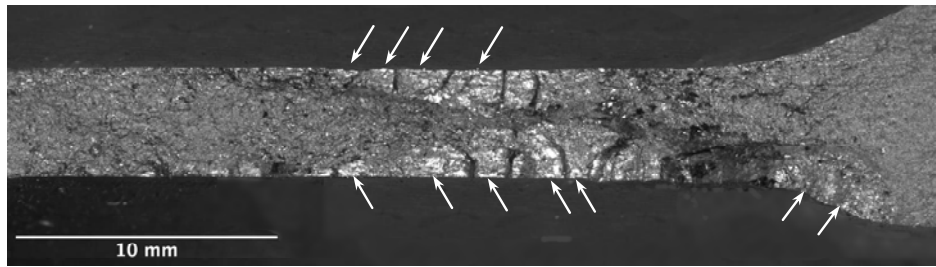
Figure C.4: Fracture surface of the broken-open fatigue cracked area in the RHS web taper from an ex-service CB tested until cracking was detected. Some of the exposed fatigue cracks are marked.

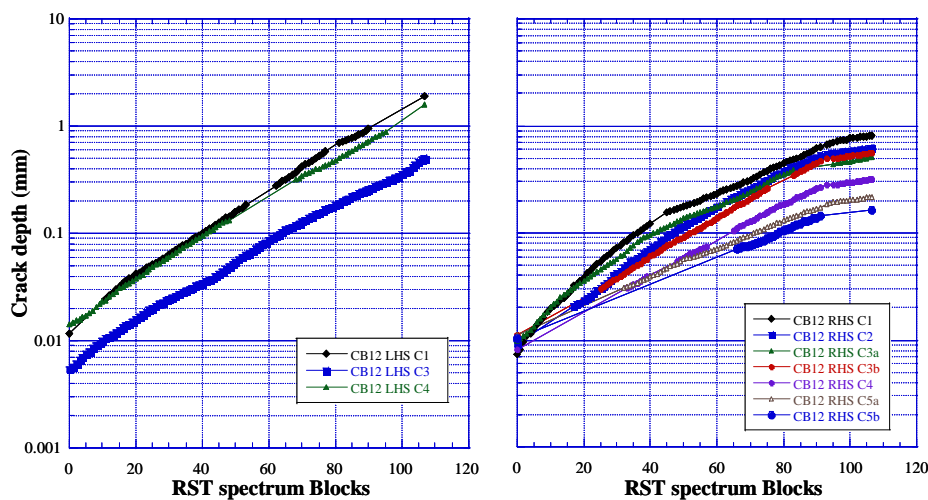
Figure C.5: FCG test data for selected cracks from the web taper areas of an F/A-18A/B ex-service CB. The CB was tested with an RST spectrum developed principally to test other structural areas [C.2].

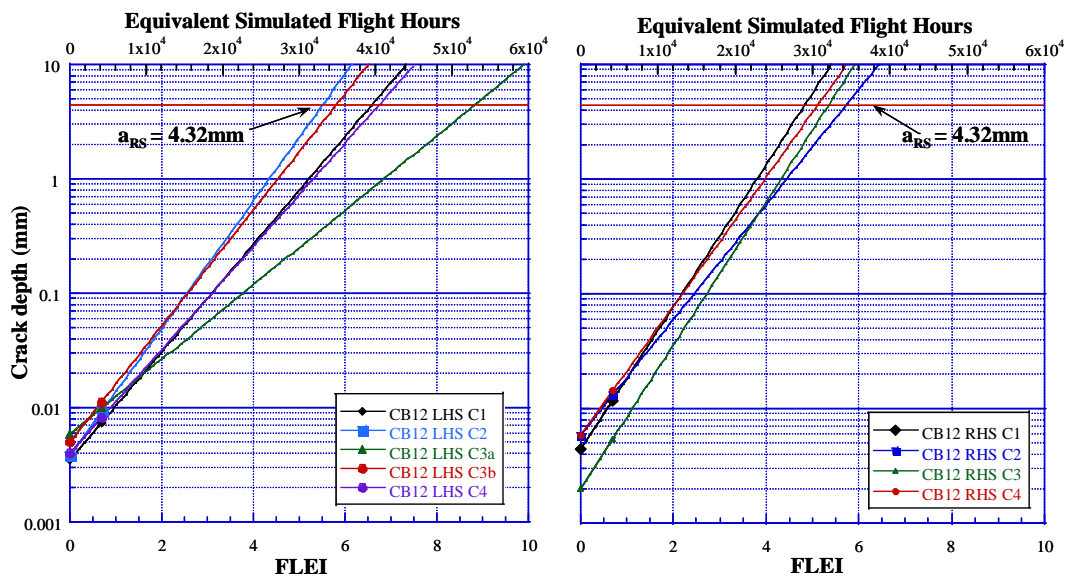
Figure C.6: In-service FCG data points and conservatively-predicted FCG plots for the cracks whose test data are shown in Figure C.5. The equivalent lives in terms of the FSFT are given at the tops of the graphs.
