# Puget Sound Naval Shipyard & Intermediate Maintenance Facility

# **Dry Dock Discharge Dye Study**

# September 2004

C.N. Katz and A. Blake Environmental and Applied Sciences Branch, Code 2375 Space and Naval Warfare Systems Center, U.S. Navy San Diego, CA

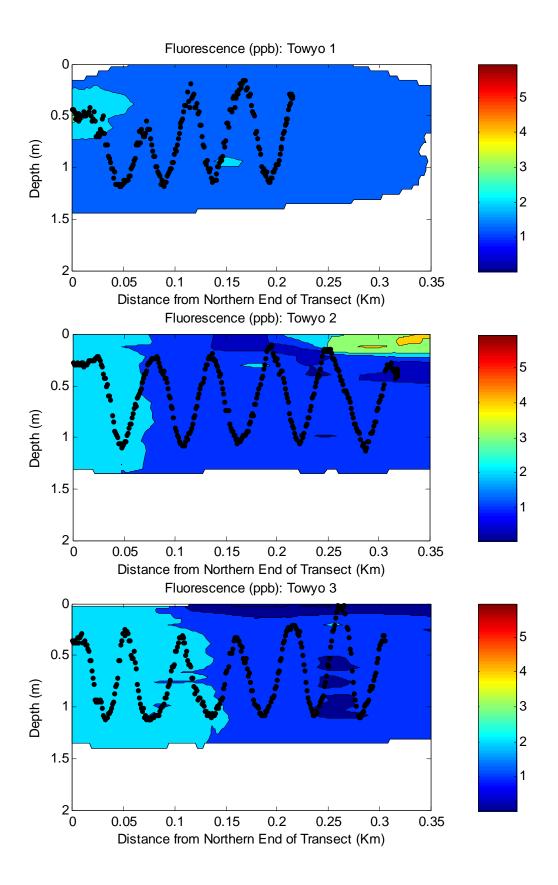
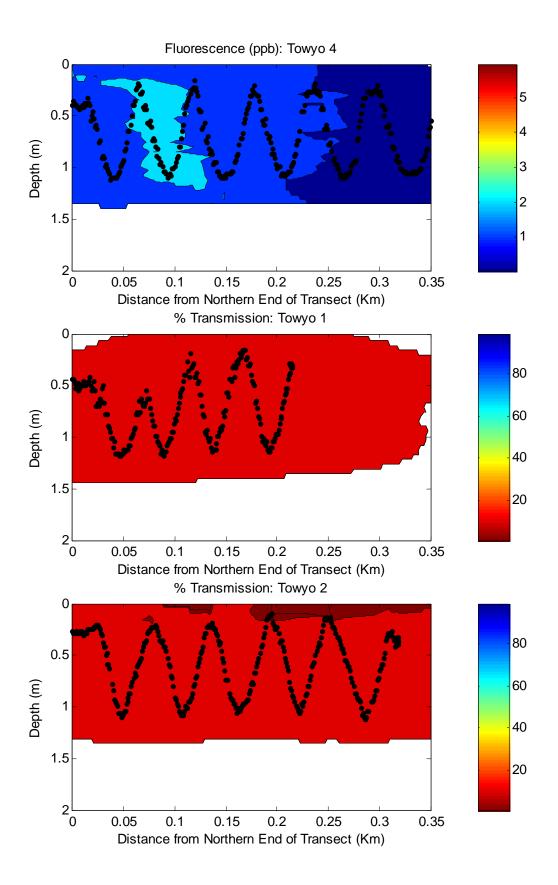
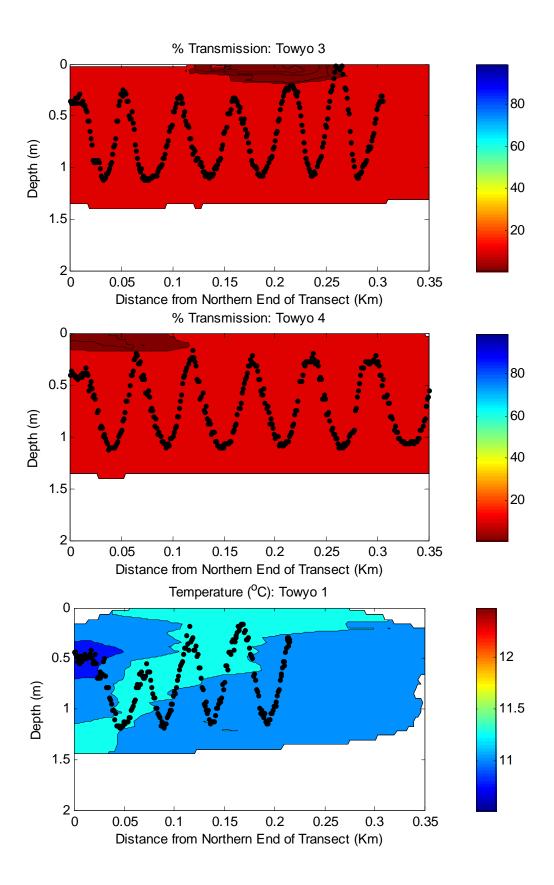
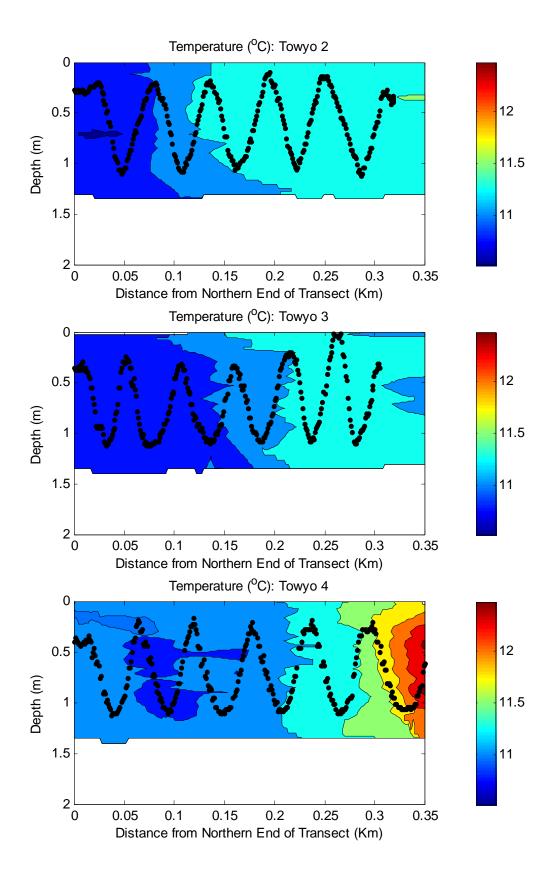
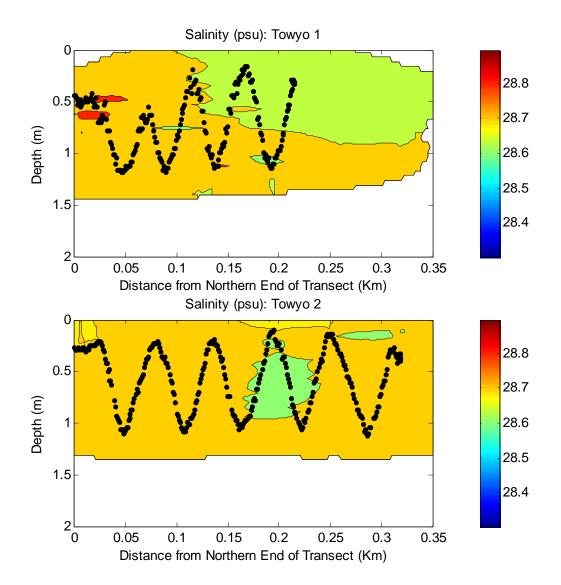
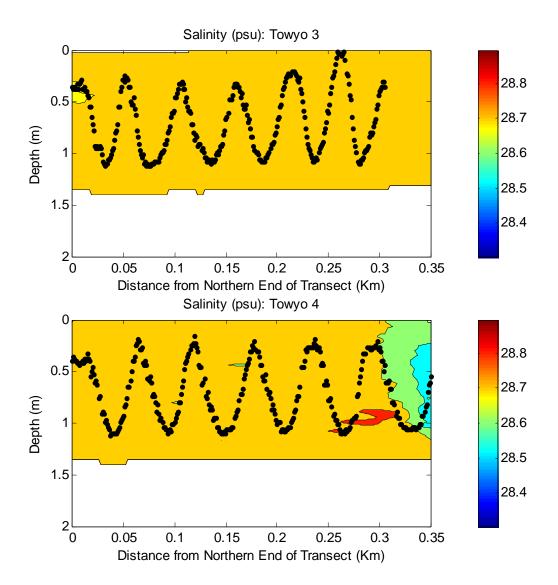
## **APPENDIX I- RUN 3A TOW YO DATA**

TOWYO	Start	End	Tide (cm)
1	27.2528	27.2555	225.6
2	27.2738	27.2775	225.6
3	27.2989	27.3024	225.6
4	27.3270	27.3308	228.6
