Technical Report ARMET-TR-09049

**M228 FUZE IGNITER PRESSURE MEASUREMENT
PART 1**

July 2010

U.S. ARMY ARMAMENT RESEARCH, DEVELOPMENT AND
ENGINEERING CENTER

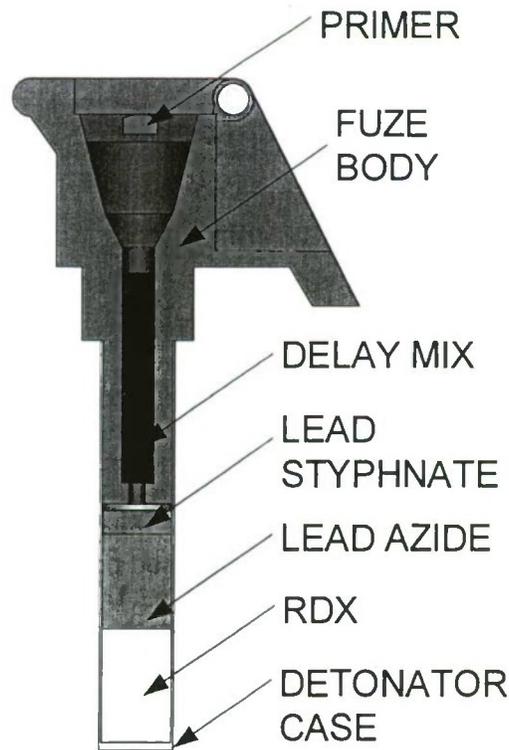
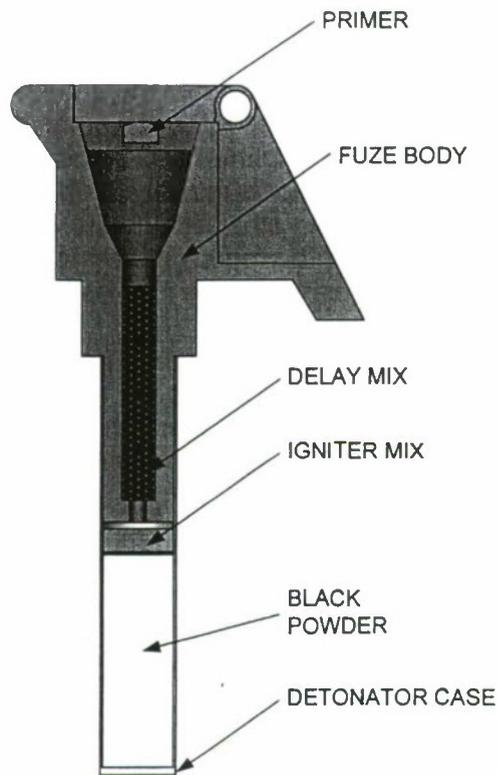
a) M213 fuze

Figure 1
M213 and M228 grenade fuze
(spoon and hammer not pictured)

b) M228 fuze

The M67 fragmentation hand grenade is a traditional pull-pin grenade, widely used by the U.S. Army and Marine Corps. Pulling the pin in the grenade's fuze (the M213) releases the spoon and the hammer, which hits the primer at the top of the fuze body (fig. 1), initiating the firing train. The delay mix is ignited by the primer and burns several seconds before initiating the attached C70 detonator. This detonator is massive, containing approximately 10 times more lead styphnate, lead azide, and RDX than other detonators. This size is not simply a case of over engineering; the length is required to properly initiate the grenade's explosive fill for good fragmentation, while its diameter is dictated by the dimensions of the fuze body.

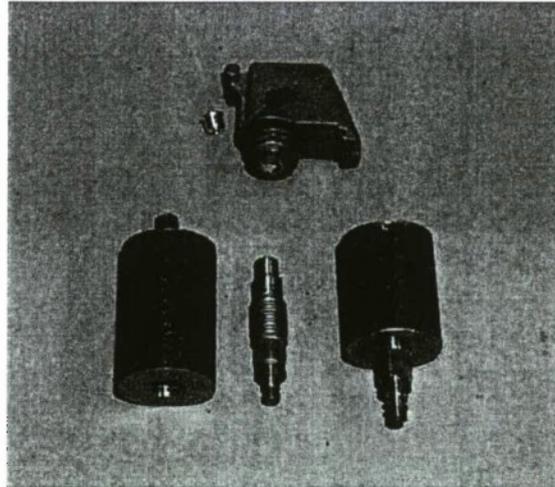
Figure 2
Fuze igniter head, fixtures, pressure sensor

The M228 fuze igniter head and the two fixtures used to conduct pressure tests on the head are shown in figure 2. The head, which was modified by removing the delay tube, contains only the filled primer cup. It was screwed into the top of the fixture until it contacted a flat surface machined into the fixture. Teflon tape was wrapped around the head threads to seal against pressure leakage. Below the flat surface, the fixture was machined to accept a PCB model P119B12 pressure sensor. The first fixture had a recessed pressure sensor with a 5/16 in. gap between the igniter head and the sensor's active surface. This gap was filled by a steel pellet that was included to protect the sensor against heat from the burning igniter. The sensor is shown in figure 2 and the block diagram of the measurement system is shown in figure 3. Figures 4 through 8 show the assembled test unit, the test chamber, and instrumentation used to measure pressure. The test was conducted with the item in the small containment chamber (fig. 7). A string was tied to the safety pin. This string was drawn outside of one of the chamber ports so it could initiate in the closed chamber and it's safe. The string was pulled from outside, which pulled the pin to strike and hit the primer. Pulling the pin allowed the striker to hit the primer, igniting it, and generating pressure. The pressure was sensed by the pressure sensor, which sent a signal to a PCB model 402M186 inline amplifier and PCB model 482A22 signal

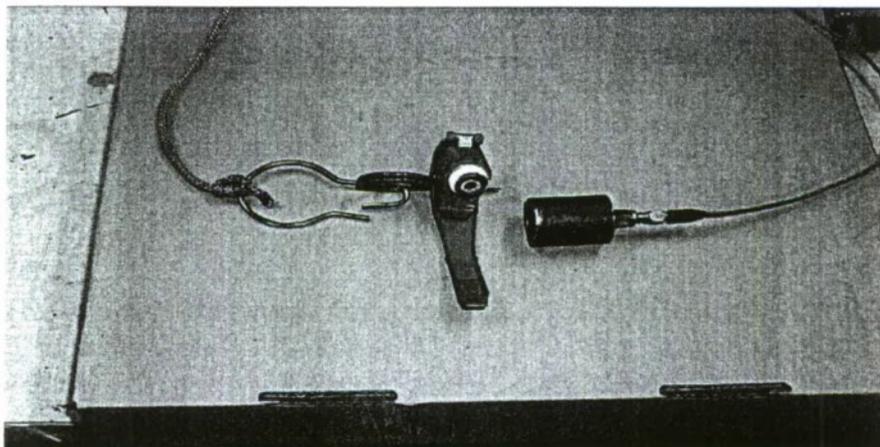
Figure 4
Preassembled components

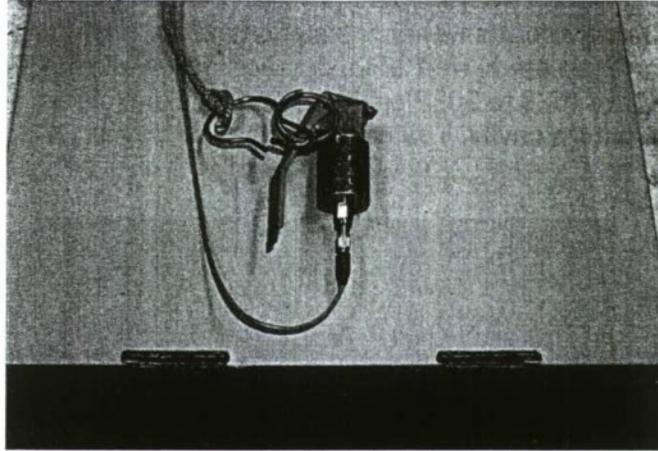
Figure 5
Assembled components

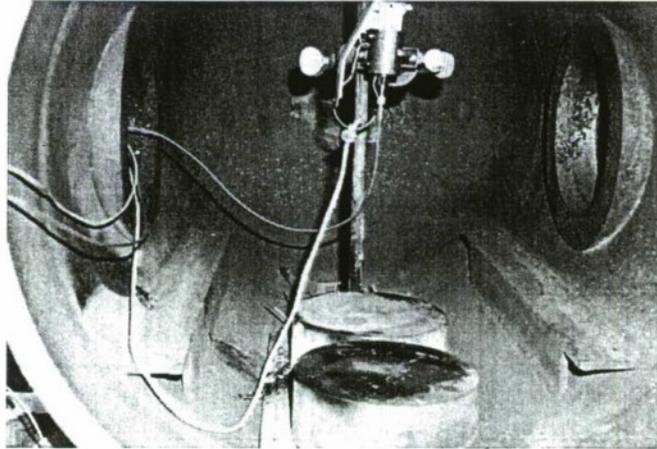
Figure 6
Test assembly in chamber

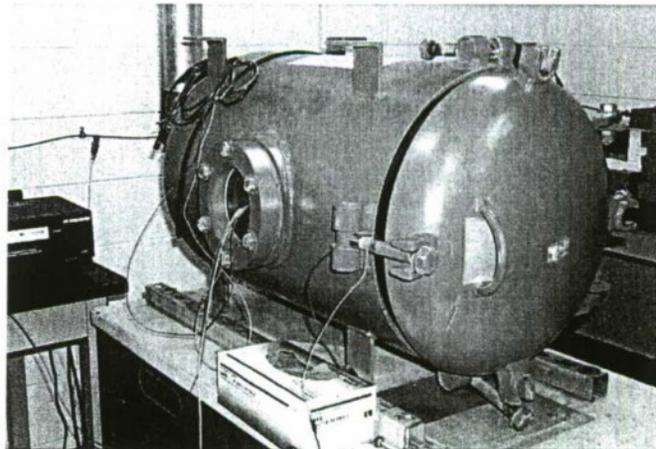
Figure 7
Test chamber

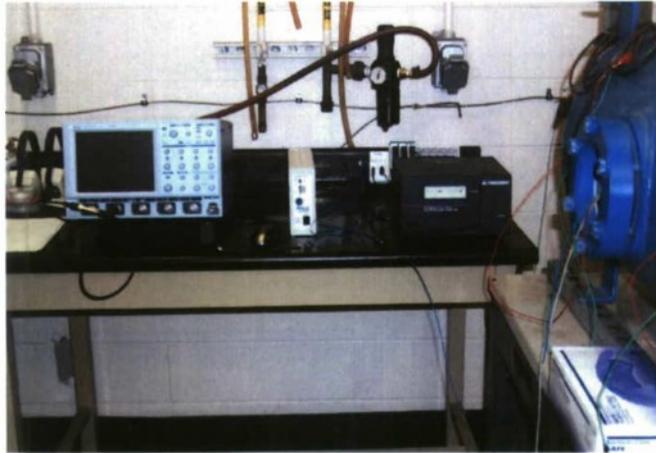
Figure 8
Test instrumentation

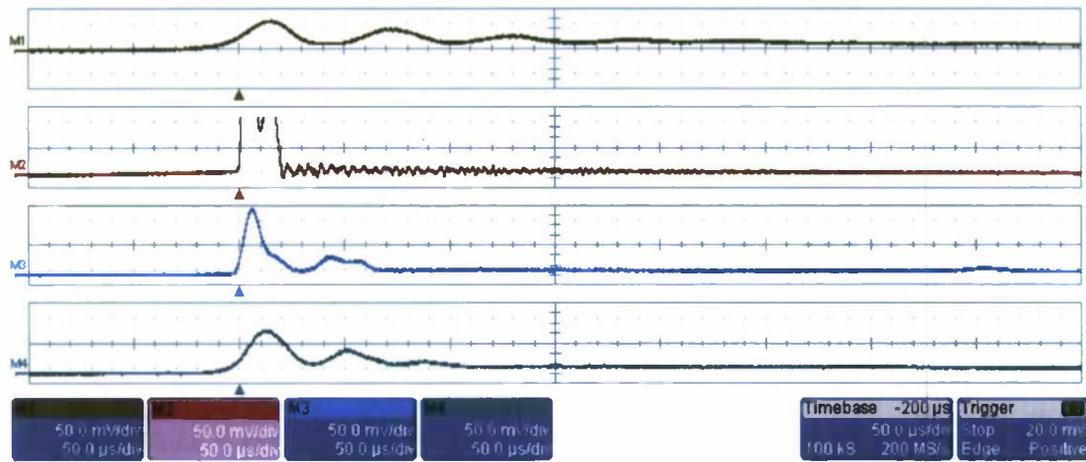
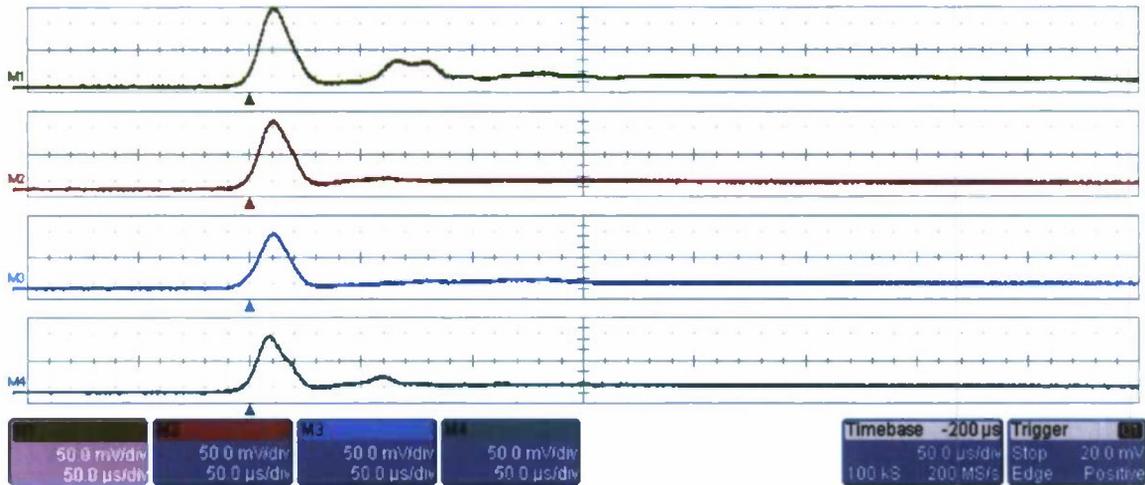
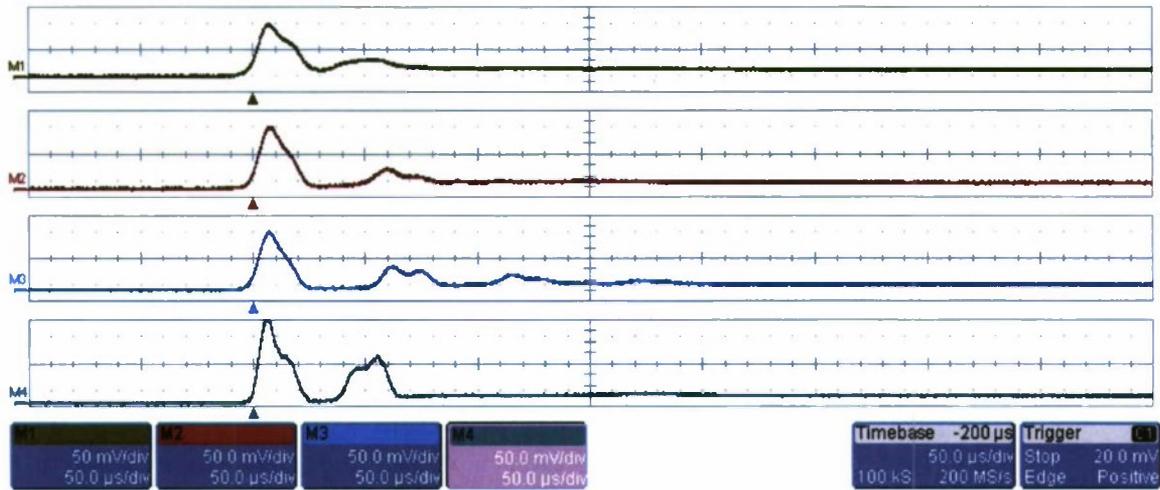
conditioner. The signal was then sent to a LeCroy model 6050A digital storage oscilloscope where it was captured and stored. Waveforms from the 12 tests conducted with the first fixture are shown in figure 9. The waveforms were consistent, typically having an initial pulse of 220 to 390 mV peak (5326 to 9442 psi peak) and 20 μ s duration, followed by a smaller step signal with an initial peak of 26 to 86 mV (629 to 2082 psi) that gradually diminished towards zero as the pressure leaked from the fixture cavity. The calibration factor for this PCB system was 24.21 psi/mV.

Figure 9
Pressure signals, recessed fixture

Signal	Conditions	Peak pressure (psi)
Fig. 9, M1	Recessed fixture w/steel pellet	1210
M2	Recessed fixture w/steel pellet	629
M3	Recessed fixture w/steel pellet	2082
M4	Recessed fixture w/steel pellet	920
M1	Recessed fixture w/steel pellet	1501
M2	Recessed fixture w/steel pellet	1210
M3	Recessed fixture w/steel pellet	1017
M4	Recessed fixture w/steel pellet	968
M1	Recessed fixture w/steel pellet	1017
M2	Recessed fixture w/steel pellet	872
M3	Recessed fixture w/steel pellet	920
M4	Recessed fixture w/steel pellet	920
Fig. 10, M1	Flush fixture w/vinyl tape	1840
M2	Flush fixture w/vinyl tape	1767
M3	Flush Fixture w/vinyl tape	1307
M4	Flush fixture w/vinyl tape	1549
Fig. 11, M1	Recessed fixture w/steel pellet	944
M2	Flush fixture w/grease	993
M3	Flush fixture w/grease	1961
M4	Flush fixture w/grease	1210
M1	Flush fixture w/grease	1501
M2	Flush fixture w /2x grease	944
M3	Flush fixture w/2x grease	2687
M4	Flush fixture w/2x grease	1743

There was a considerable variation in the test results from both fixtures. The fixture with the recessed pressure gauge and steel pellet produced a large initial pulse the cause of which could not be determined. The fixture with the flush pressure gauge was better suited to make the pressure measurements. Peak pressures generated by the primer composition in the flush fixture ranged from 944 psi to 2687 psi. Tests with the vinyl tape gave higher pressures with less variation. There was too much variation in the length of the truncated head.

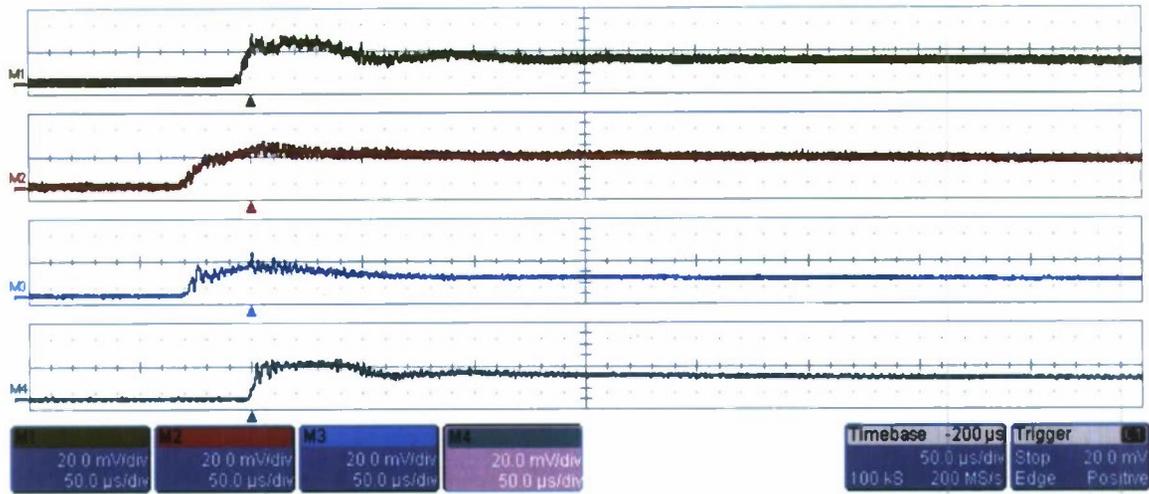
Figure 10
Pressure signals, flush fixture, vinyl tape

Eleven tests were conducted with the second fixture which was designed to eliminate the large gap between the ignition head and sensor diaphragm. This fixture was machined so that the sensor diaphragm was almost flush with the flat surface in contact with the fuze head. The head diaphragm gap was approximately 0.010 in. Temperature protection was provided by vinyl tape for four tests and silicone grease for seven tests. The test methodology was the same for the second fixture as for the first fixture. Figure 10 shows the waveforms obtained for the tests conducted with vinyl tape placed across the sensor diaphragm. Those signals were not the same as the signals obtained with the first fixture. The second fixture signals did not have a pulse initially, but were step waveforms that were 54 to 76 mV peak (1307 to 1840 psi peak), which were similar to the step signals obtained with the first fixture that occurred after the first large pulse. PCB Engineers were asked if they could explain the presence of the first pulse in the first fixture tests. They were unable to come up with an explanation and no one involved with these tests could explain it either. However, the PCB engineers thought that the second fixture, with the flush diaphragm, should give the most accurate signals and they recommended using silicone grease or vinyl tape to protect the sensor. This was done for the next four tests where grease was placed in the airspace from the bottom of the truncated igniter head to the top of the channel where the delay composition normally goes (the delay composition was removed from the heads for all the tests to be conducted in this series). The waveforms obtained from these tests (fig. 11) are very similar to the three vinyl tape waveforms with peaks of 41 to 81 mV (993 to 1961 psi). The first signal (fig. 11) was obtained using the recessed fixture as a check on the sensor operation. The last three tests were made using twice the amount of grease to fill the head cavity. This was done to see if it would produce twice the signal peak, but results were inconclusive. However, the waveforms were similar with peaks of 39 to 111 mV (944 to 2687 psi). Table 1 summarizes the peak pressures obtained with fixture 1, which discounted the initial pulses, and fixture 2. These tests completed the exploratory phase of this project.

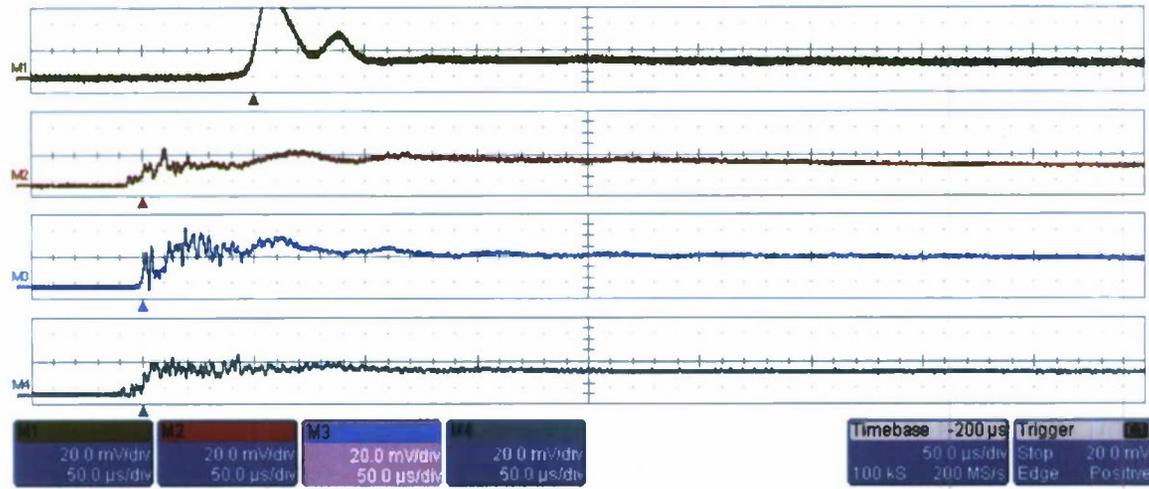
Figure 11
Pressure signals, flush fixture, grease

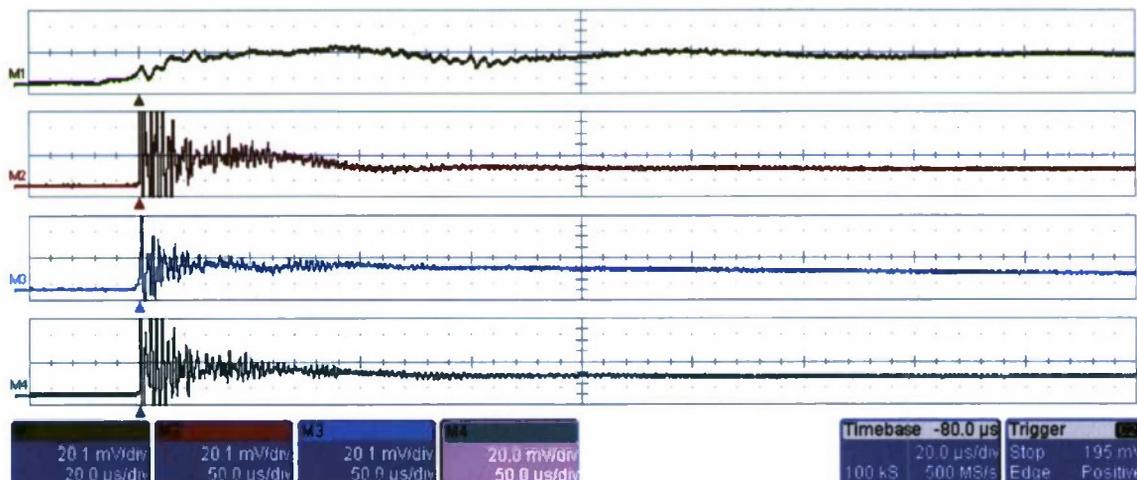
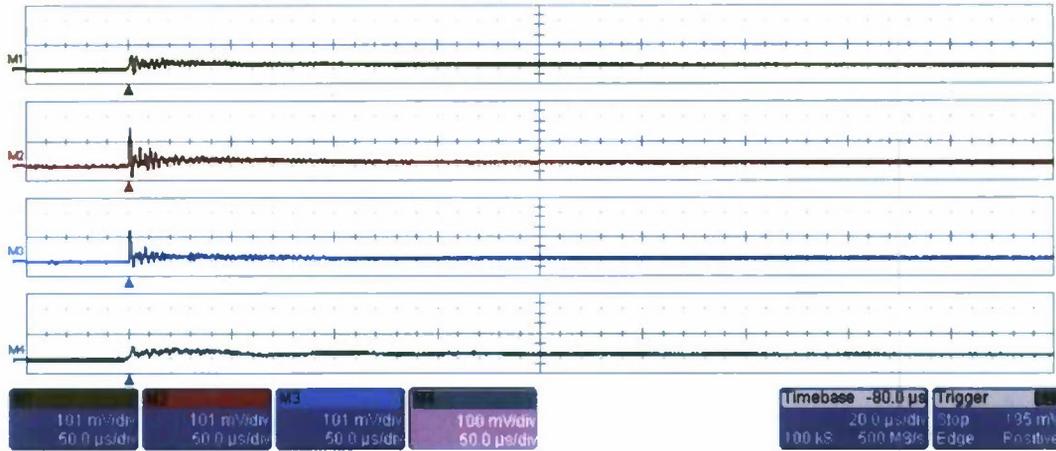
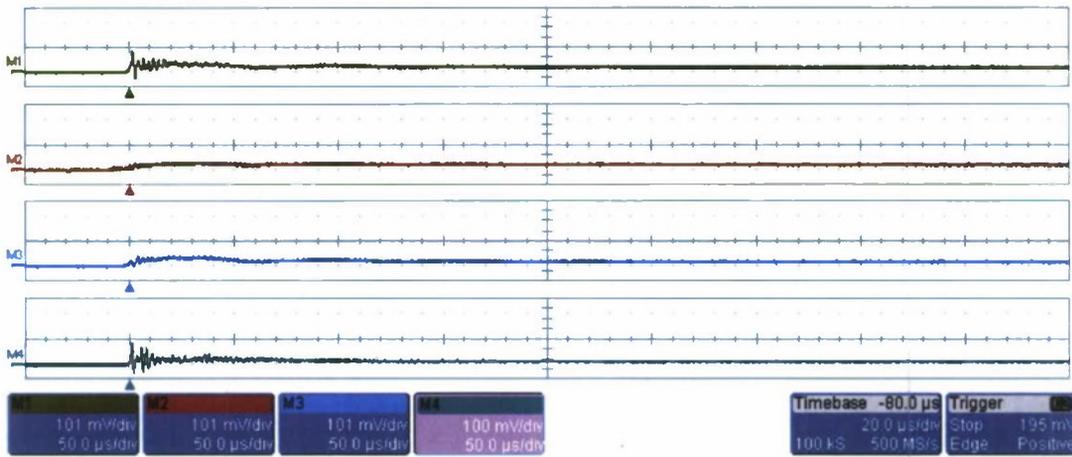
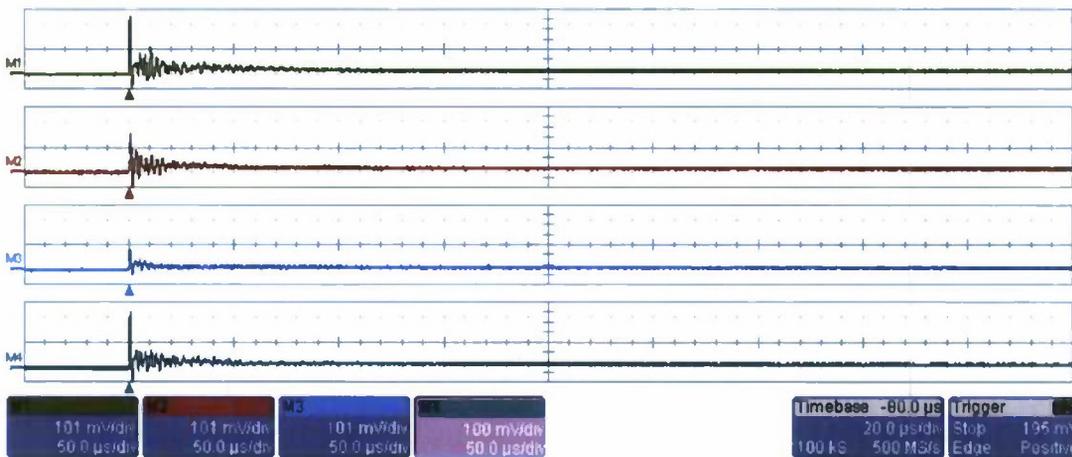
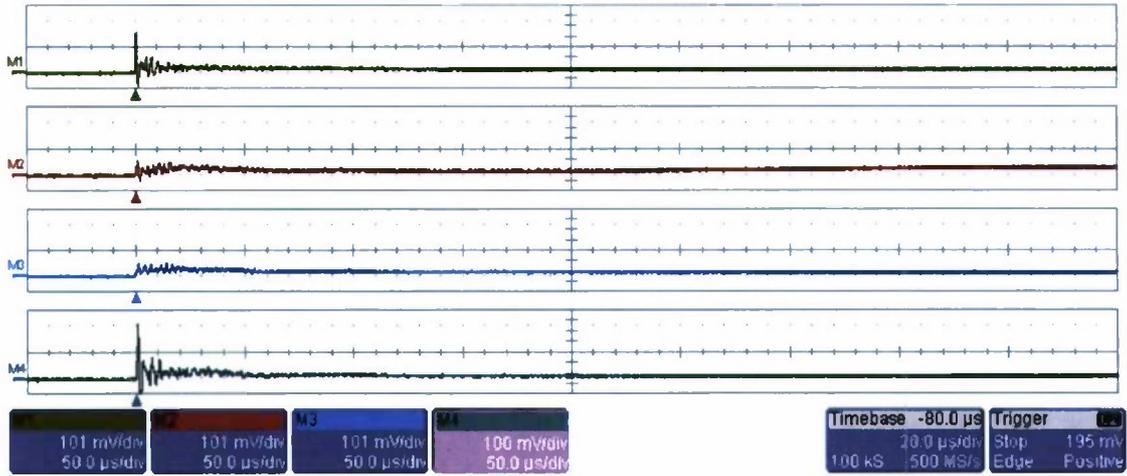
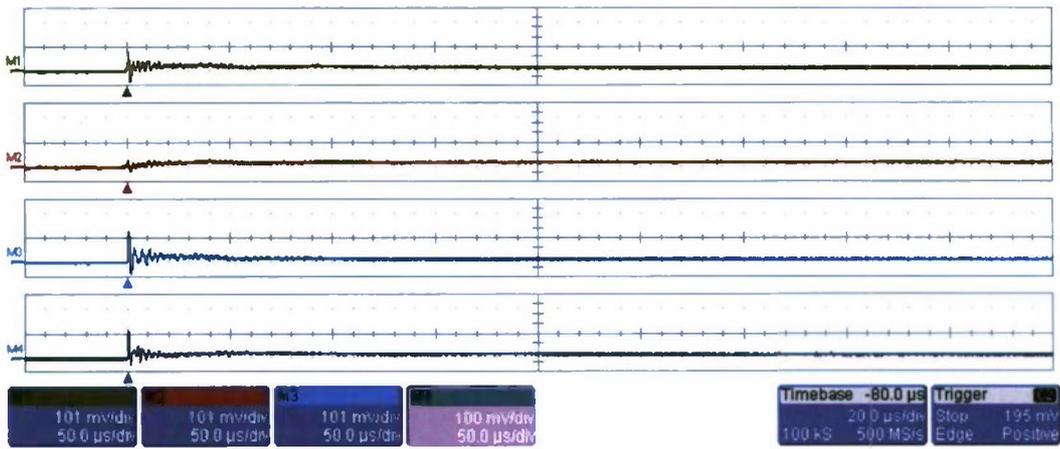
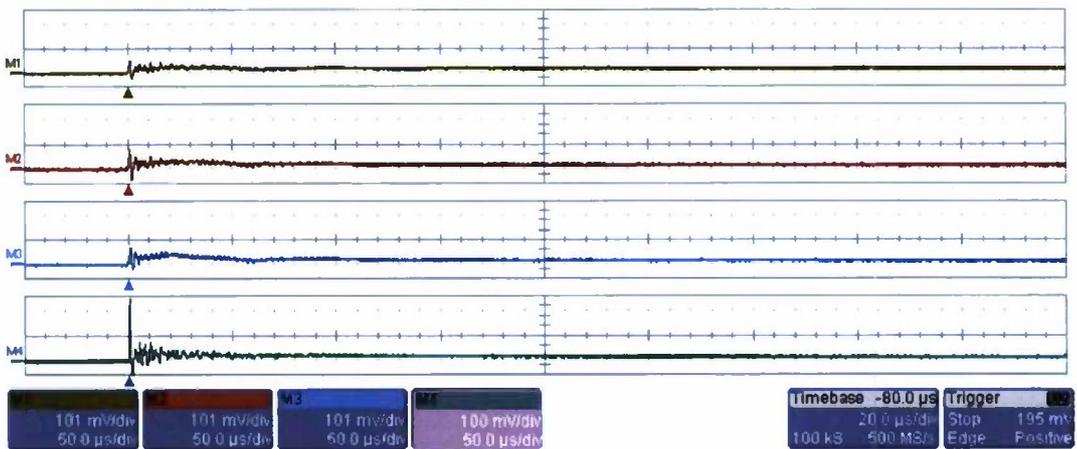
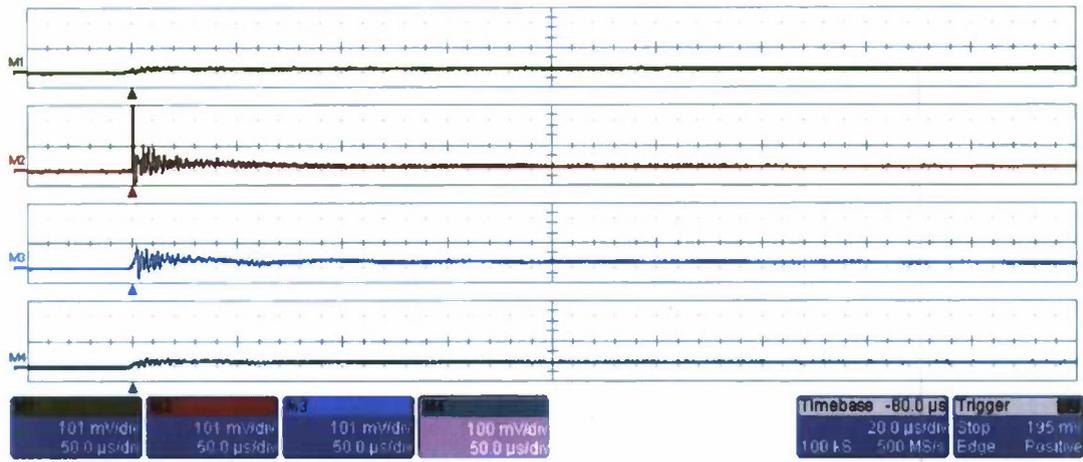
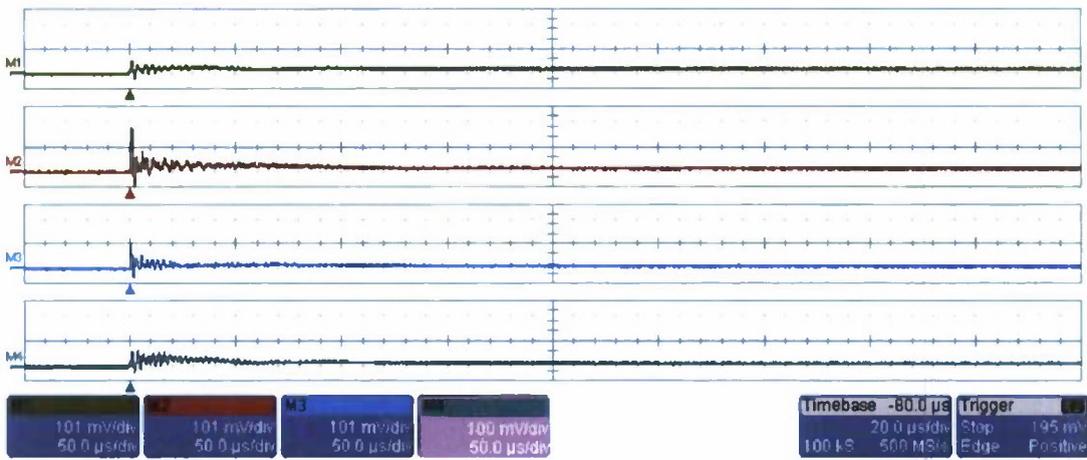
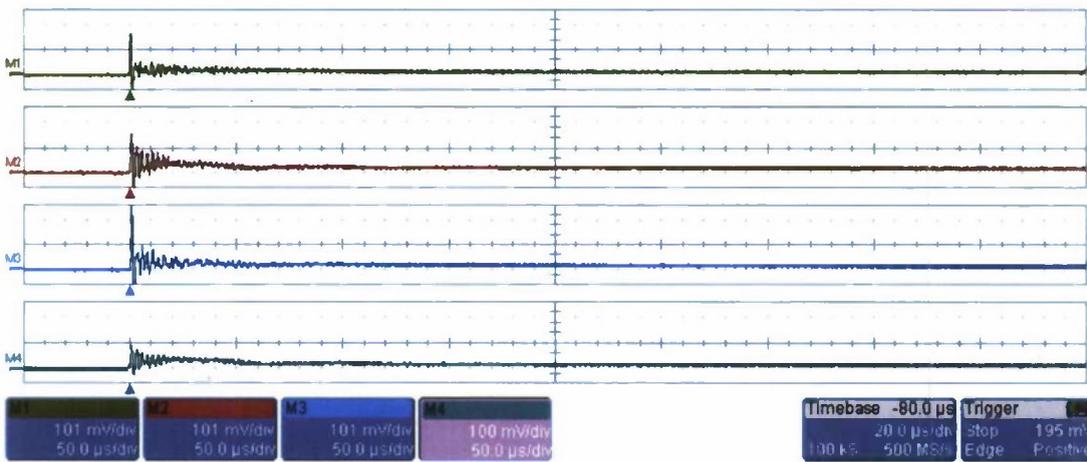
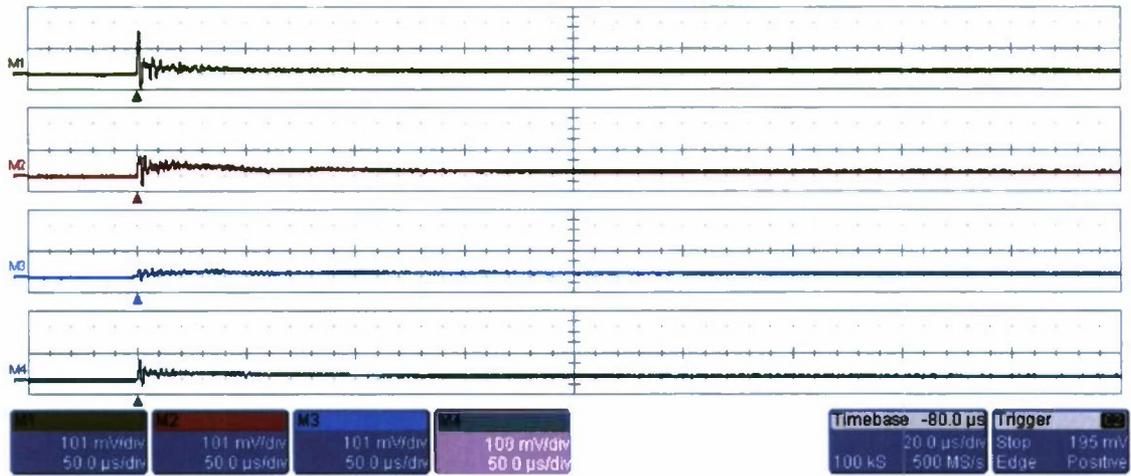
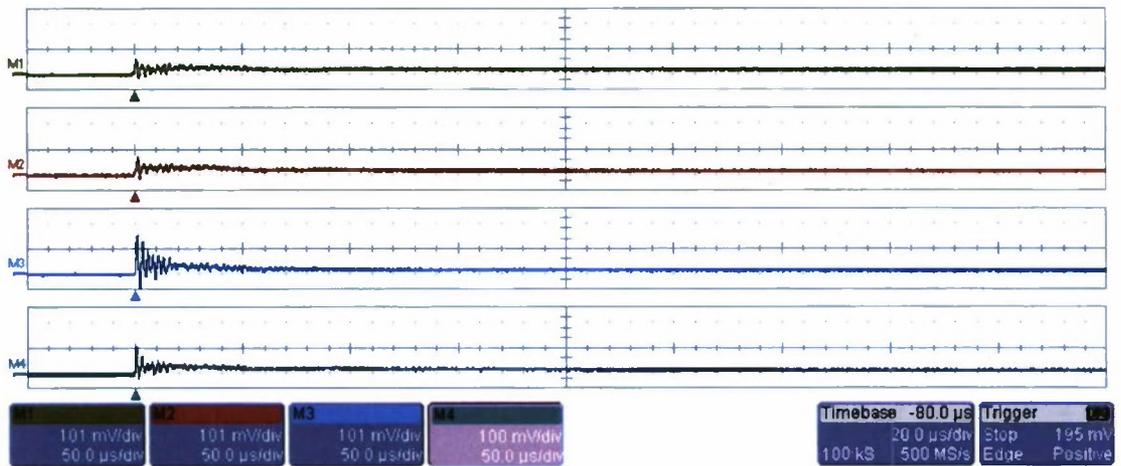
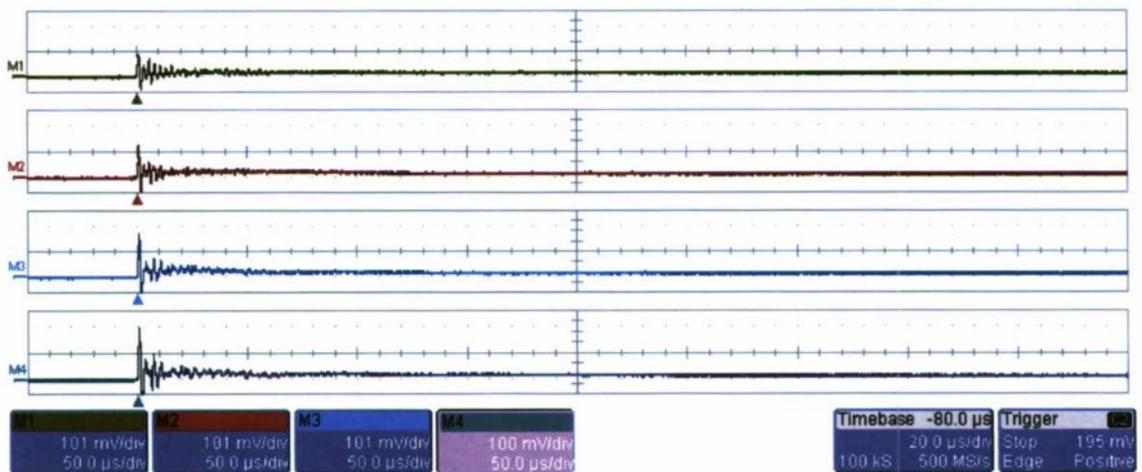
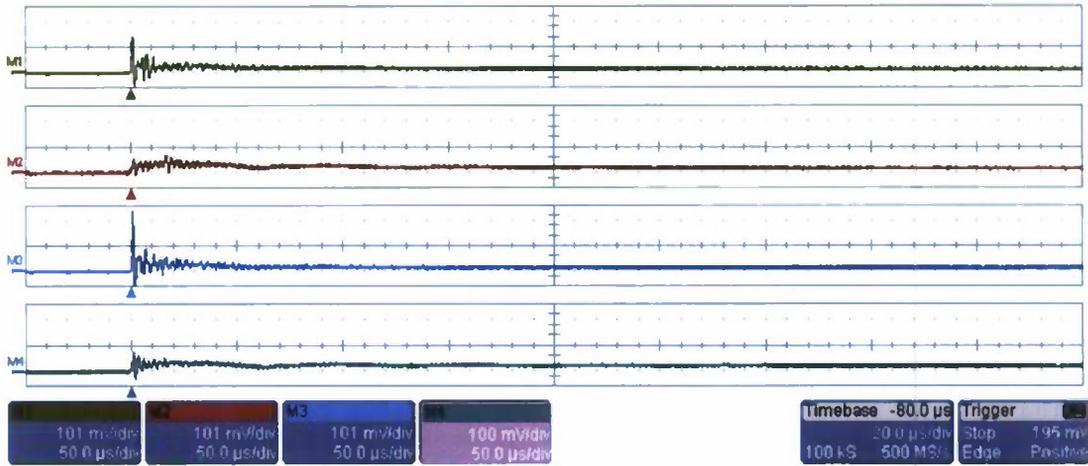
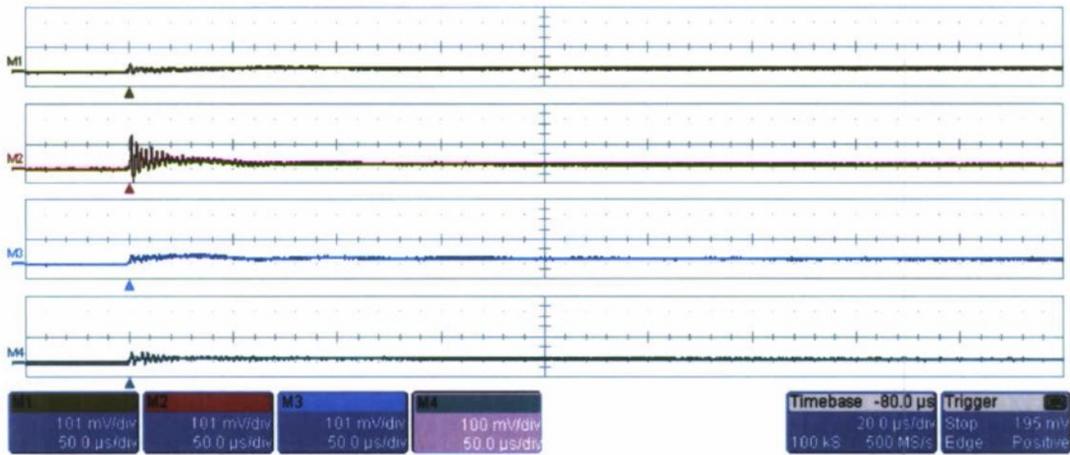
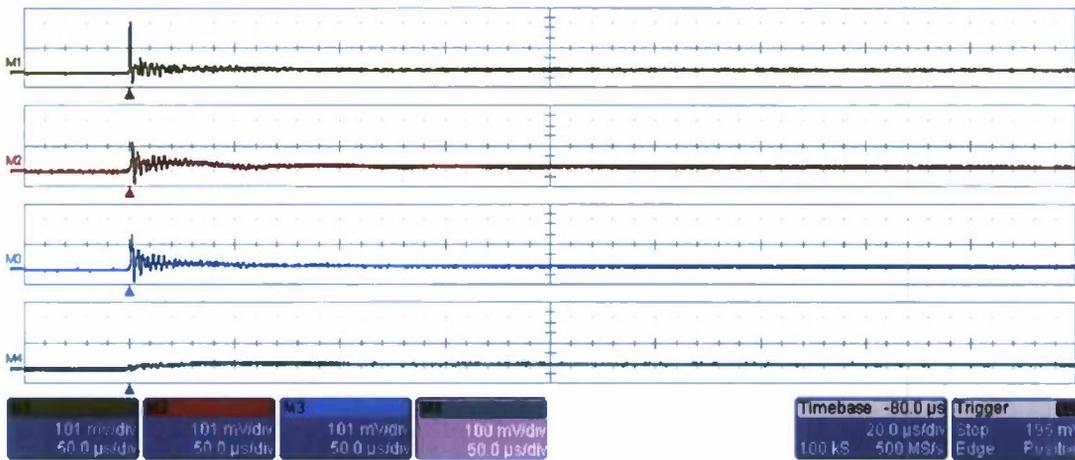
Sixty-four tests were then performed using the flush fixture with vinyl tape over the sensor surface. Figures 12 through 28 show the pressure waveforms obtained from the 64 test items of this second group. Table 2 lists the peak pressures and rise times of the waveforms.

Most of the waveforms have an exponentially damped oscillation of about 500 KHz at the start of the signal. It is believed the oscillations were caused by the resonance of the pressure sensor that distorts the signal in that fashion. Future tests should be conducted with a 100 KHz low pass filter inserted at the output of the signal chain. As far as the 64 tests already conducted are concerned, an arbitrary function generator can be used to reproduce the original signals and pass them through the 100 KHz filter before capturing them with an oscilloscope. Figure 28 shows a pressure signal before and after filtering. The signal was obtained from a different type of explosive reaction using the 119B pressure sensor. An arbitrary function generator is currently on order for this group.

Test number	Initial peak pressure (psi)	Initial peak rise time (μ s)
1	1700	31
2	4100	0.6
3	4100	1.5
4	Off Scale	na
5	3500	1.0
6	3500	2.0
7	3500	2.0
8	7500	0.4
9	3200	2.8
10	1500	20
11	2200	5.0
12	5200	1.0
13	13800	0.38
14	9000	0.65
15	4600	0.54
16	1400	0.45
17	9200	0.36
18	3200	0.98
19	2700	1.5
20	12100	0.73
21	4600	0.94
22	1700	0.68
23	7500	0.78
24	6500	0.44
25	2900	1.2
26	4400	0.84
27	4200	1.2
28	15000	0.38
29	970	2.7
30	16500	0.3
31	5300	2.4
32	1500	3.3
33	2800	1.2
34	10300	0.95
35	6100	0.58
36	3600	1.7
37	9800	0.3
38	9000	0.7
39	15300	0.68
40	5200	0.82
41	9900	0.89
42	4200	0.94
43	1700	1.6
44	4400	0.91
45	3500	0.94
46	4000	1.4
47	9200	0.96
48	6300	0.48
49	5200	0.9

Test number	Initial peak pressure (psi)	Initial peak rise time (μ s)
50	7500	0.78
51	10000	0.82
52	11700	0.72
53	8200	0.89
54	3000	1.7
55	14400	0.63
56	4500	0.92
57	1900	1.3
58	8000	1.1
59	2100	1.6
60	2400	1.2
61	12100	0.4
62	7000	1.6
63	8500	1.4
64	1500	28

Peak pressures ranged from 970 psi to 16,500 psi. Rise times were from 0.3 μ s to 28 μ s. There was considerable variation in pressures for the final tests also. The test method did not address the cause of this variation.

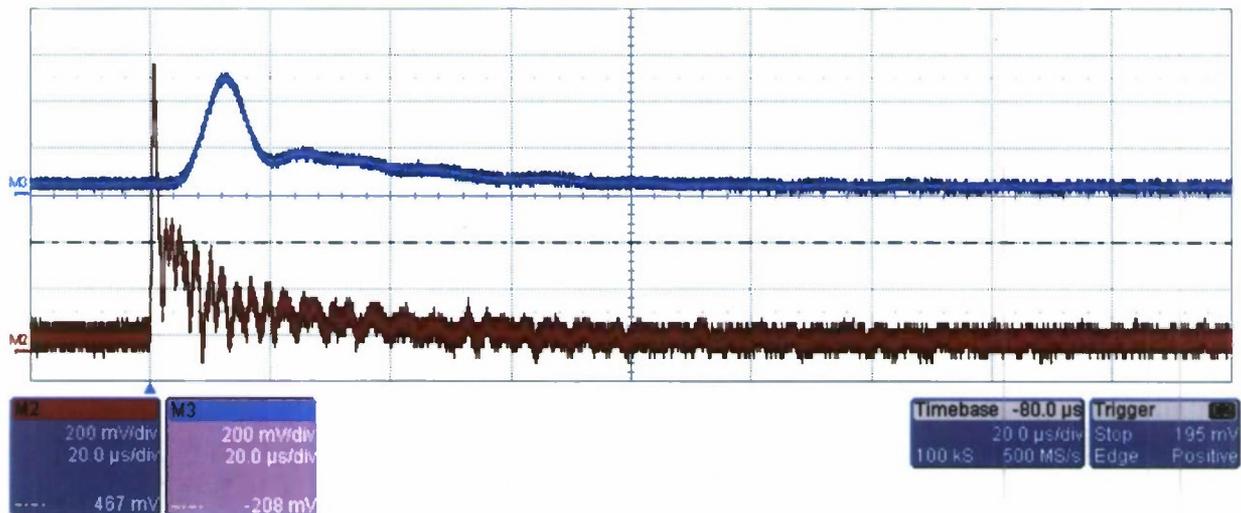
Figure 28
Milliwell pressure test, filtered and unfiltered signal
