AATD TR10-D-95

# Composite Universal Weapons Pylon Damage Tolerance Test Report

29 October 2010

## **Composite Universal Weapons Pylon Fatigue Test Plan**

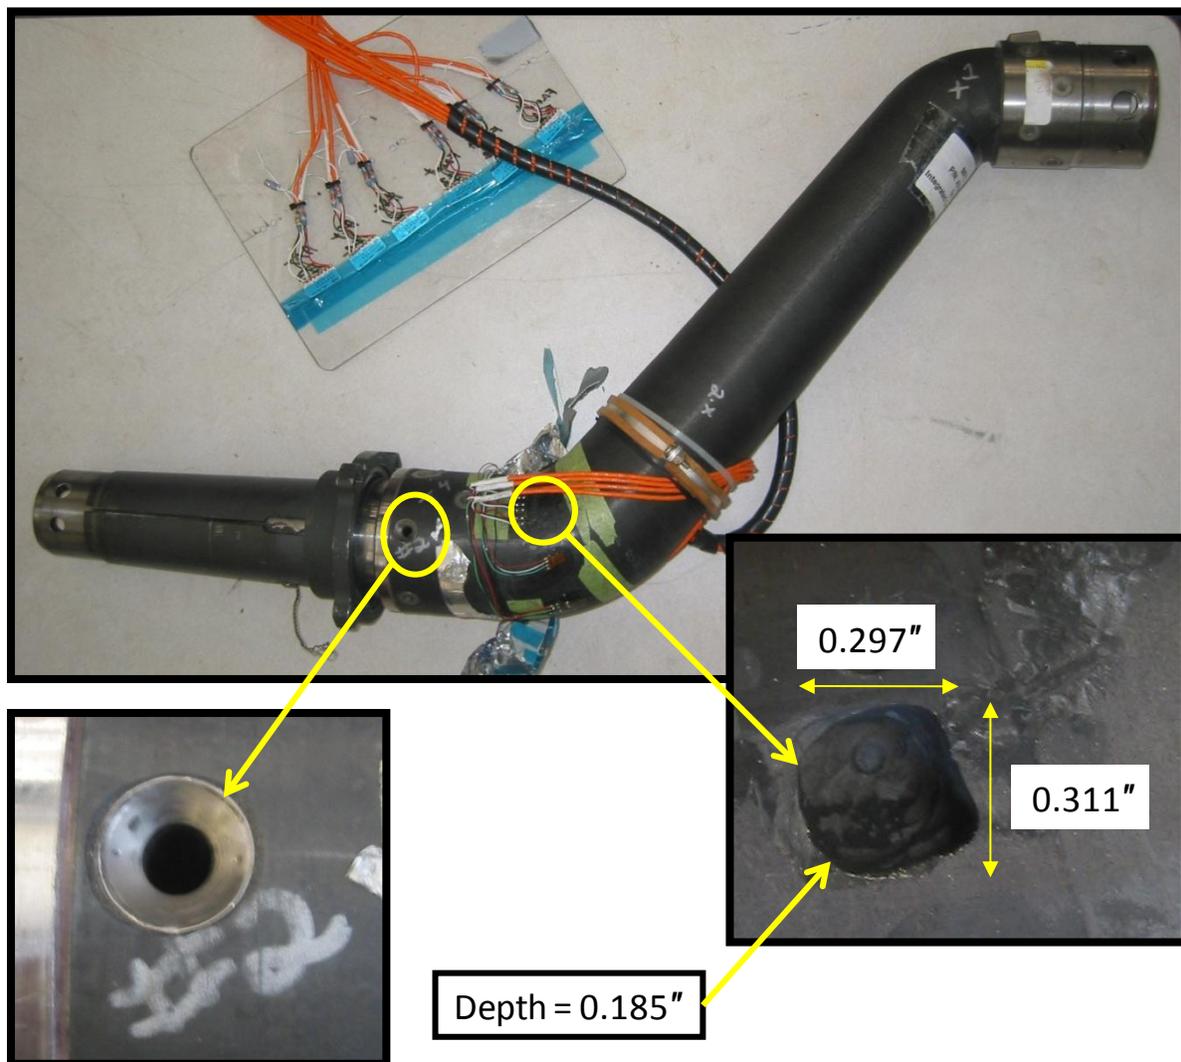
**Figure 1. CUWP Test Article with Bore and #2 Fastener Removed**

The CUWP test article that was used in the fatigue test (Reference a) was also used for this sequence of damage tolerance testing. The test article was modified by introducing damage into the composite tube and also removing the #2 fastener (Figure 1). The damage introduced into the test article consisted of a bore drilled approximately halfway into the composite tube using a tungsten carbide drill bit. The drilling of a round hole through the entire 0.40" thick tube was not performed since the unsymmetrical bore provided a higher stress concentration factor. The location of the bore was chosen at the maximum principle strain due to the .50 caliber gun cyclic loading based upon the OEM analysis. The effect of the bore simulates a delamination in the composite structure. The #2 fastener was removed since this fastener exhibited the highest bearing load into the titanium fitting based upon the OEM analysis. The removal of the #2 fastener causes the load to be transferred to adjacent fasteners.

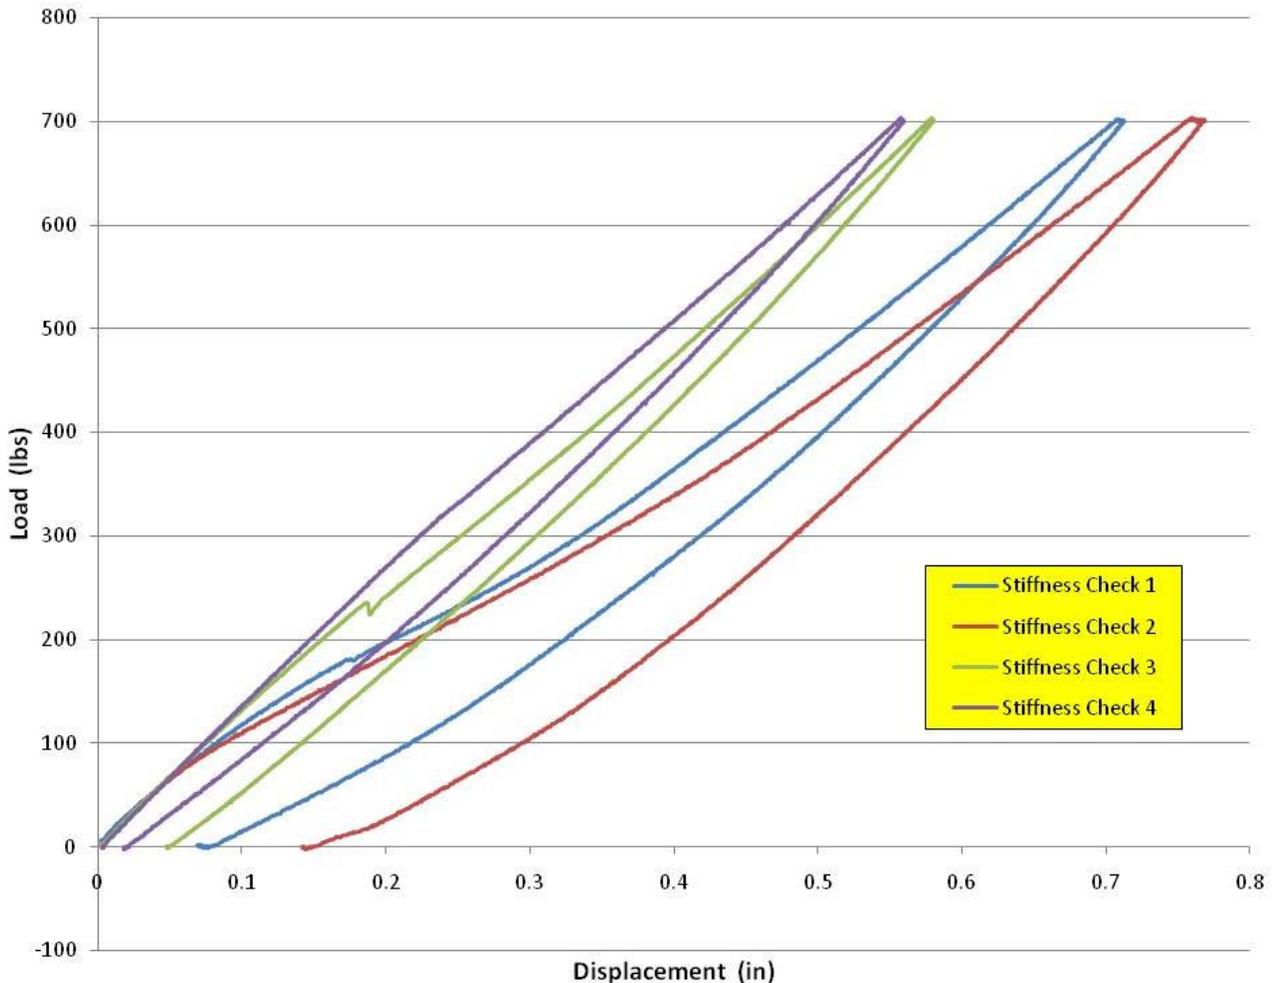
**Figure 2. Load vs. Displacement for Stiffness Checks 1-4**

Prior to each load case, the CUWP test article was subjected to a stiffness check in order to determine if any variations in stiffness occurred during the cyclic loading. The stiffness checks consisted of one stroke up to a load limit of 700-lbs. Load as a function of displacement was recorded for each of the first four stiffness checks (Figure 2). The stiffness of the test setup generally increased as more stiffness checks were performed. This was likely due to the interface of the collet assembly and the lower test fixture. Tightening the collet nut expanded the collet providing a frictional interface between the collet and the test fixture. When the test article was subjected to cyclic loading, the collet had the tendency to seat into the fixture. As more cyclic loading was performed, more seating took place. Since the collet nut was re-torqued to the required 250-260 ft-lbs prior to each stiffness check, it is logical to conclude that the changing stiffness of the test setup was the result of the increased seating of the collet.

As evidenced by the stiffness checks, the collet had the tendency to seat into the fixture when the test article was subjected to cyclic loading. As more cyclic loading was performed, more seating took place. In order to maintain consistent torque, the collet nut was re-torqued to the required 250-260 ft·lbs prior to each stiffness check. It is possible that a CUWP installed on an aircraft for an extended period of time could potentially become sufficiently loose to have a negative impact on the function of the weapon system. Therefore, it is recommended that a torque check be performed on the CUWP if installed for an extended period of time.

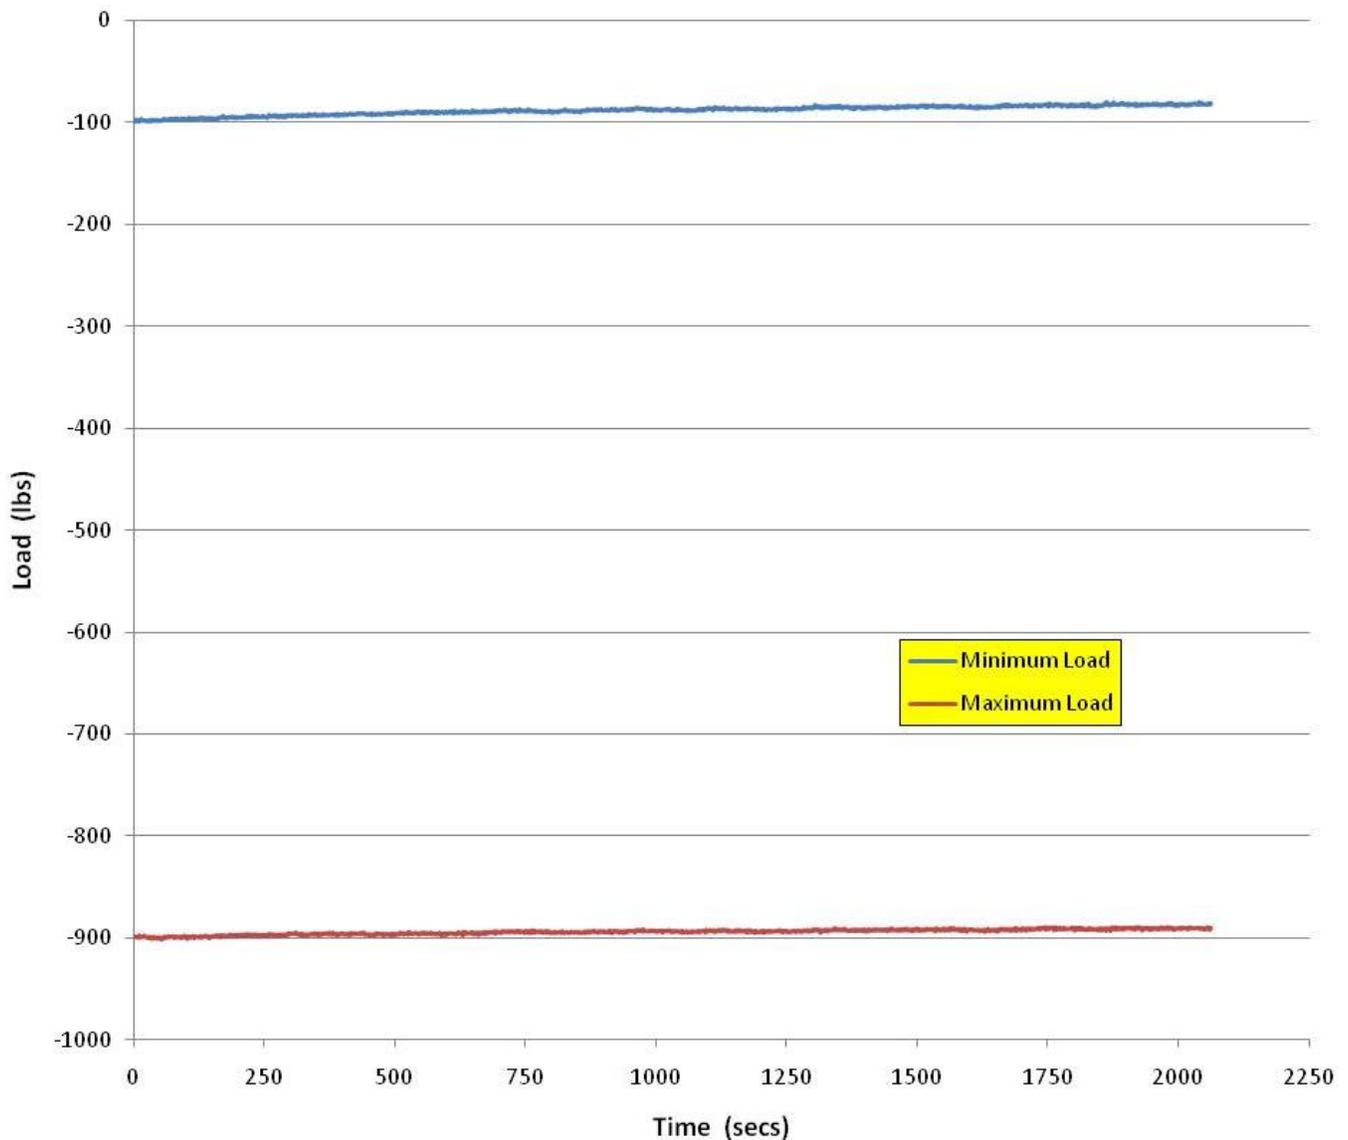
**Figure 3. Cyclic Load vs. Time, Case #1a**

Cyclic Load Case #1a simulated the firing of HELLFIRE missiles for 4,200 cycles. Load as a function of time for Cyclic Load Case #1a was recorded (Figure 3). The cyclic loading was performed at two hertz. The hydraulic actuator and load cell was subjected to displacement control thus the maximum and minimum displacement values were -0.96" and -0.18", respectively. The load curves are smooth indicating that no anomalies were recorded.

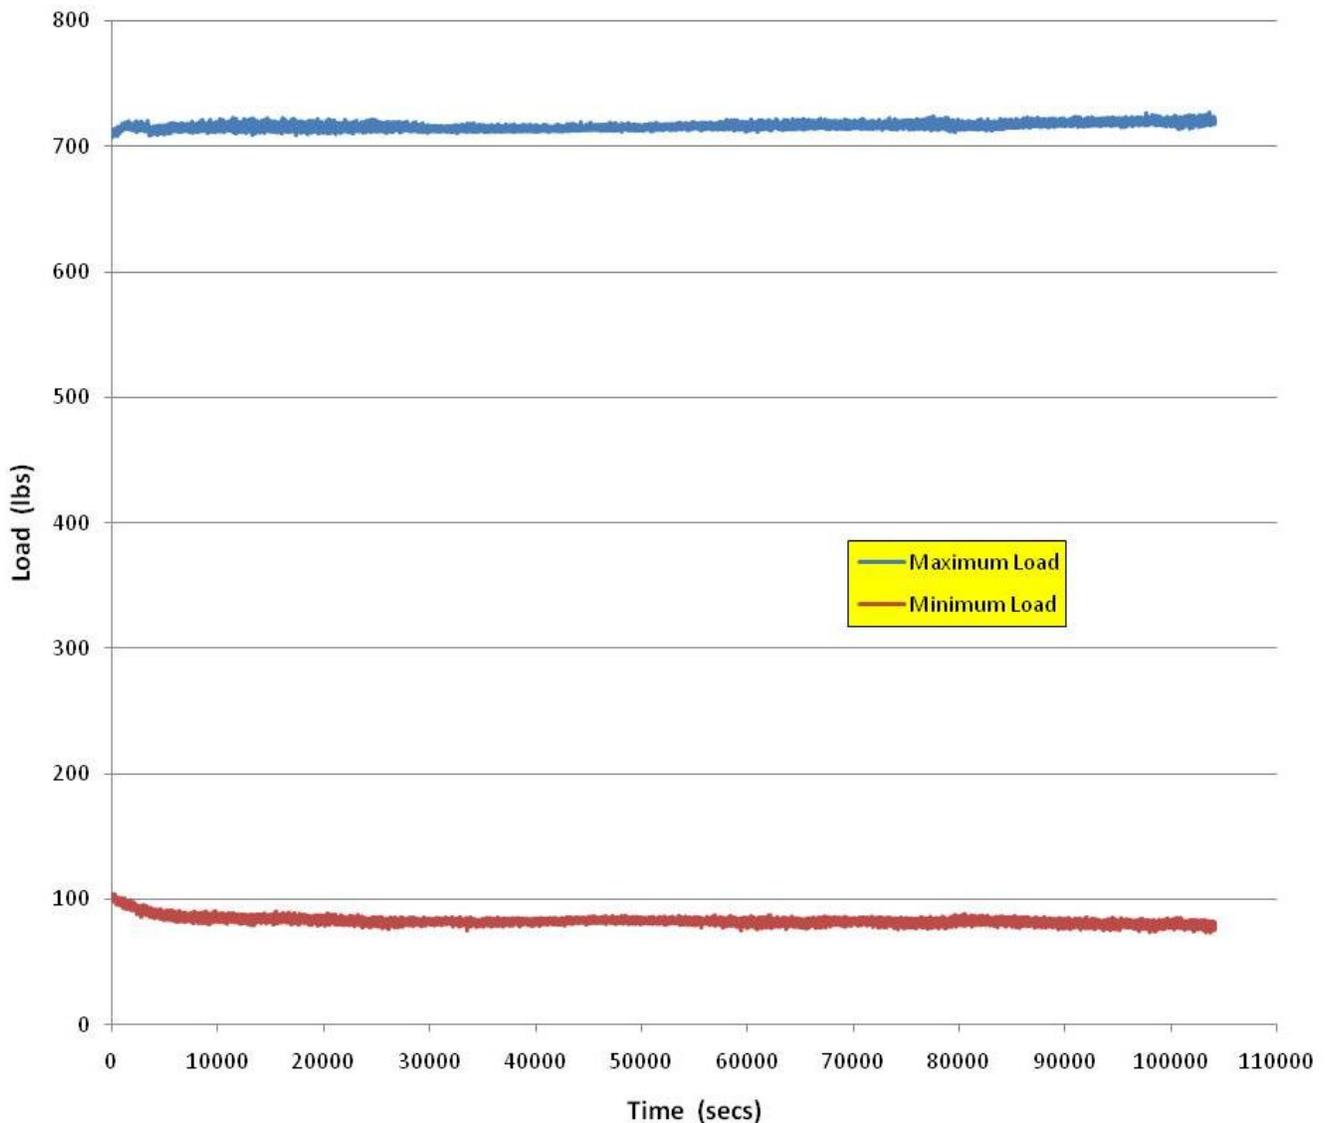
**Figure 4. Cyclic Load vs. Time, Case #2a**

Cyclic Load Case #2a simulated the firing of a .50 caliber machine gun for 420,000 cycles. Load as a function of time for Cyclic Load Case #2a was recorded (Figure 4). The cyclic loading was performed at four hertz. The hydraulic actuator and load cell was subjected to displacement control thus the maximum and minimum displacement values were 0.70" and 0.23", respectively. The load curves are smooth indicating that no anomalies were recorded.

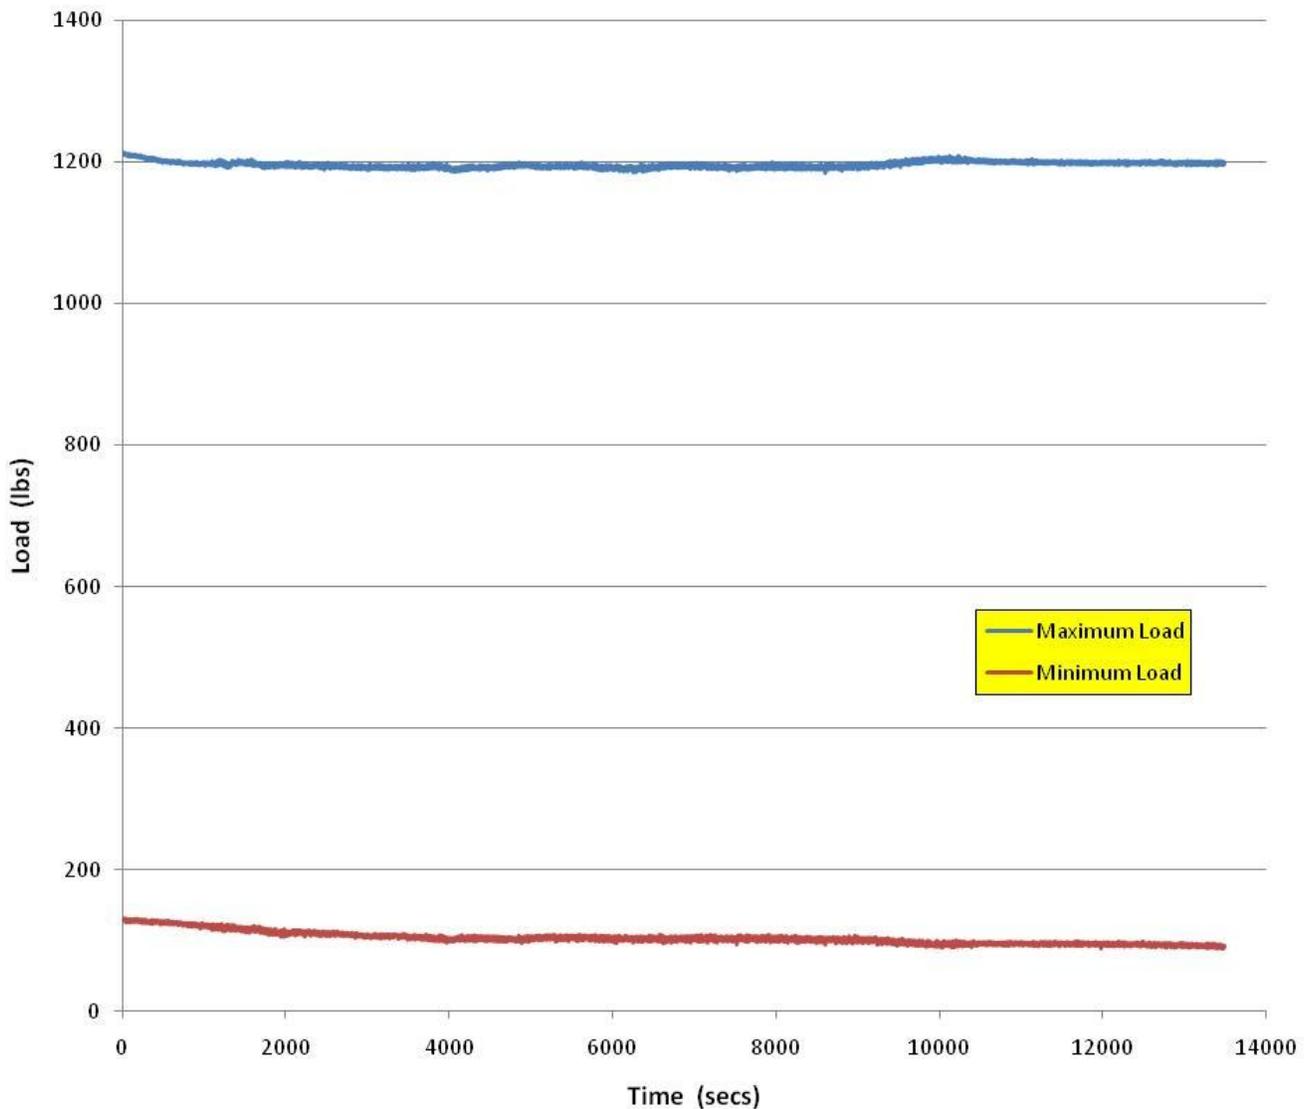
**Figure 5. Cyclic Load vs. Time, Case #3a**

Cyclic Load Case #3a simulated the firing of Hydra rockets for 42,000 cycles. Load as a function of time for Cyclic Load Case #3a was recorded (Figure 5). The cyclic loading was performed at three hertz. The hydraulic actuator and load cell was subjected to displacement control thus the maximum and minimum displacement values were 0.97" and 0.17", respectively. The load curves are smooth indicating that no anomalies were recorded. This completed the first block of cyclic testing.

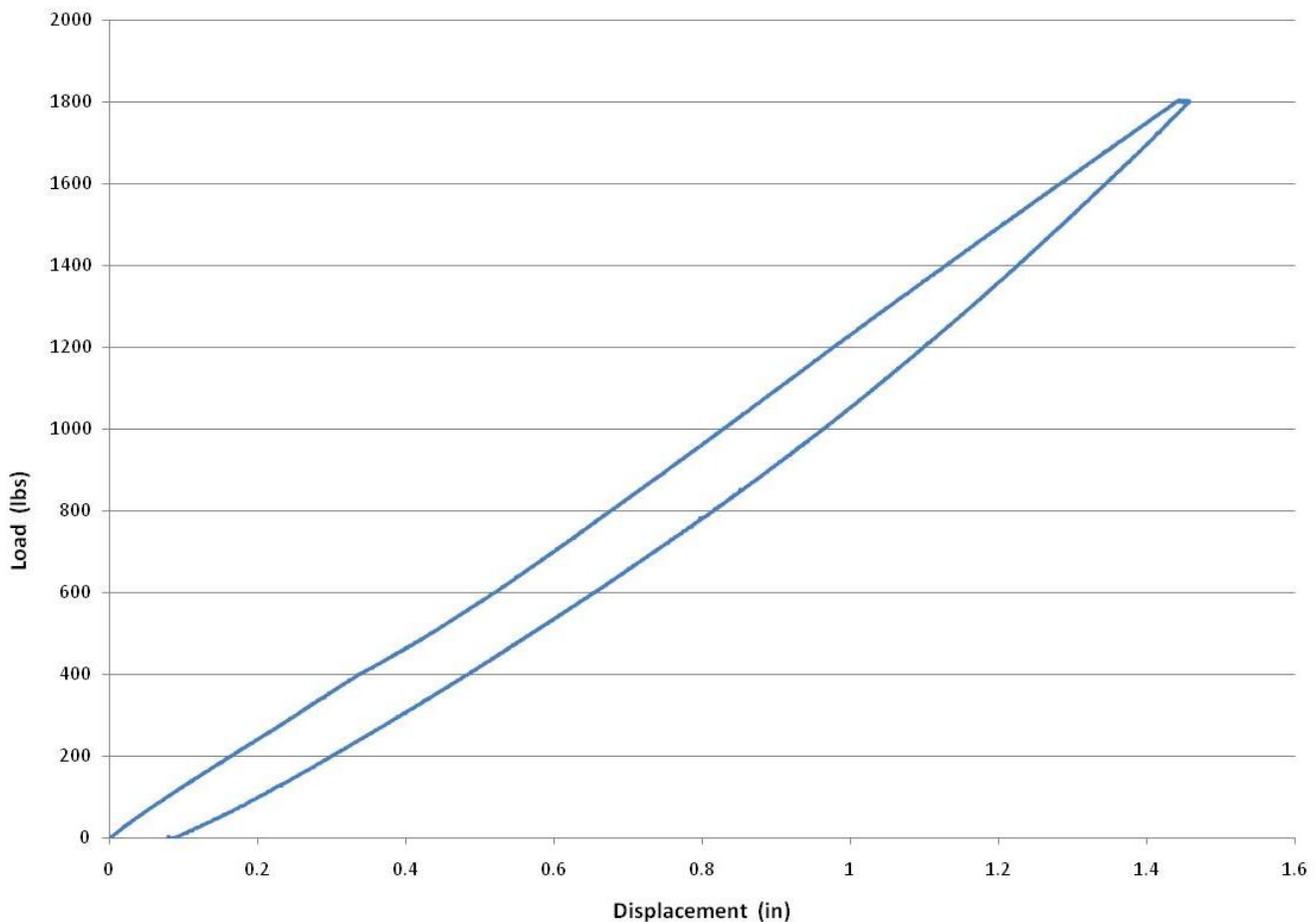
**Figure 6. Load vs. Displacement, Proof Load Case #1a**

Proof Load Case #1a simulates Hydra rocket loading and was conducted to demonstrate no stiffness or strength reduction occurred in the test article after the completion of the of the first block of cyclic loading. Load as a function of displacement was recorded for Proof Load Case #1a (Figure 6). The load was applied with a 120 second ramp up duration, held constant for 30 seconds, and then released with a 120 second ramp down duration. The test article underwent elastic hysteresis but did not return to exactly zero displacement. In addition, there was a slight increase in displacement during the 30 second duration when the load was held constant. This may have been the result of the test article experiencing slip, a slippage of the support structure, and/or the collet seating. Regardless, the displacement variations can be considered negligible for the purposes of this test since the 1800-lbs proof load was conducted to show that the test article could hold 1.5 times the Hydra rocket load after cyclic loading without structural failure.

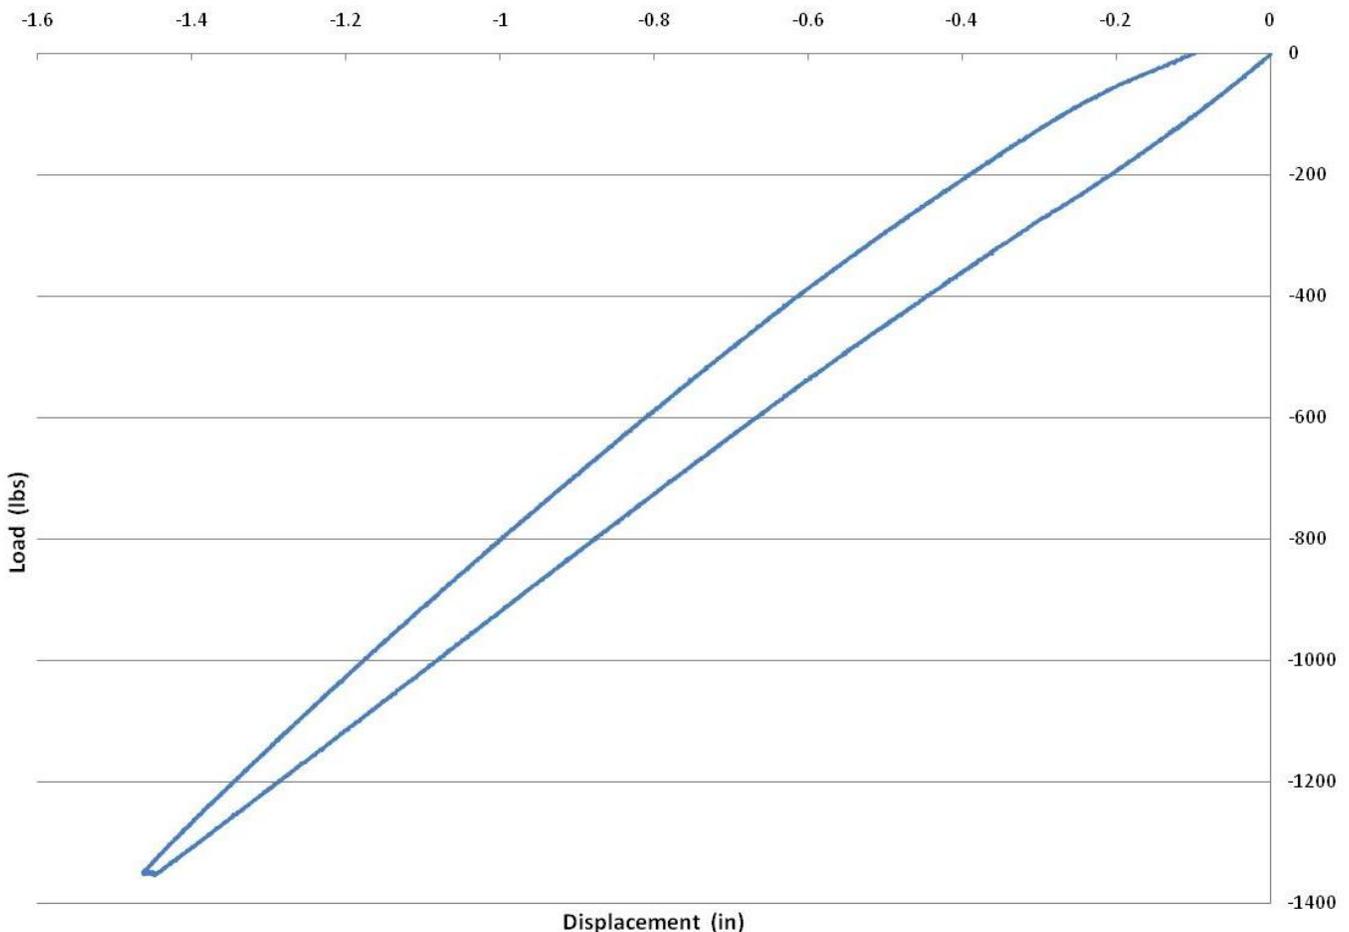
**Figure 7. Load vs. Displacement, Proof Load Case #2a**

Proof Load Case #2a simulates HELLFIRE missile loading and was conducted to demonstrate no stiffness or strength reduction occurred in the test article after the completion of the of the first block of cyclic loading. Load as a function of displacement was recorded for Proof Load Case #2a (Figure 7). The load was applied with a 120 second ramp up duration, held constant for 30 seconds, and then released with a 120 second ramp down duration. The test article underwent elastic hysteresis but did not return to exactly zero displacement. In addition, there was a slight increase in displacement during the 30 second duration when the load was held constant. This may have been the result of the test article experiencing slip, a slippage of the support structure, and/or the collet seating. Regardless, the displacement variations can be considered negligible for the purposes of this test since the -1350 lbs proof load was conducted to show that the test article could hold 1.5 times the HELLFIRE missile load after cyclic loading without structural failure.

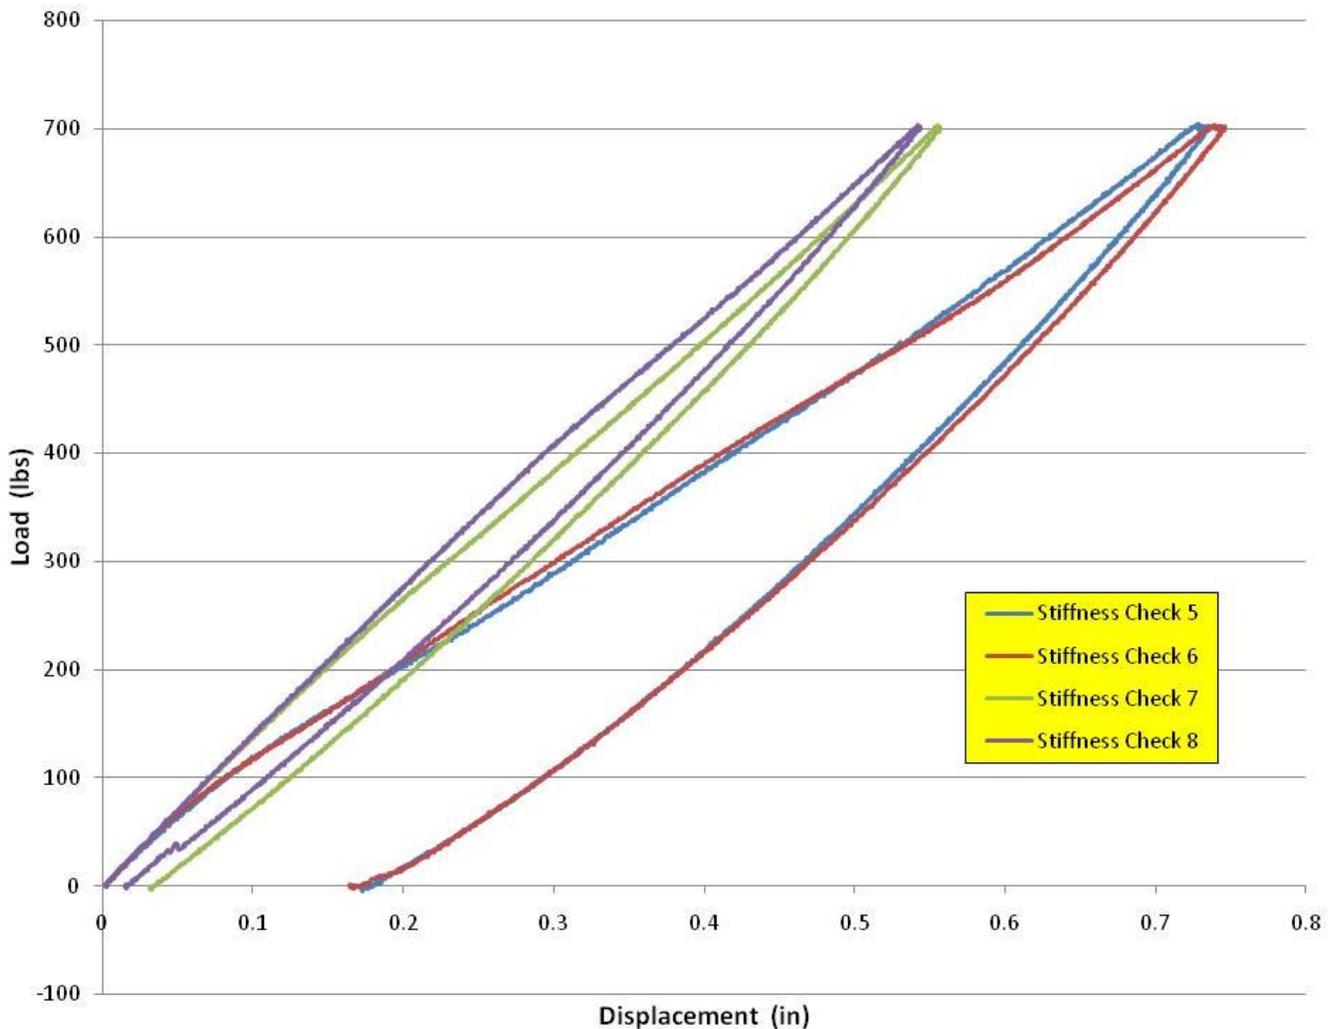
**Figure 8. Load vs. Displacement for Stiffness Checks 5-8**

Stiffness checks were again conducted prior to each load case for the second block of testing. Load as a function of displacement was recorded for each of the final four stiffness checks (Figure 8). As was the case with the first four stiffness checks, the stiffness of the test setup generally increased as more stiffness checks were performed.

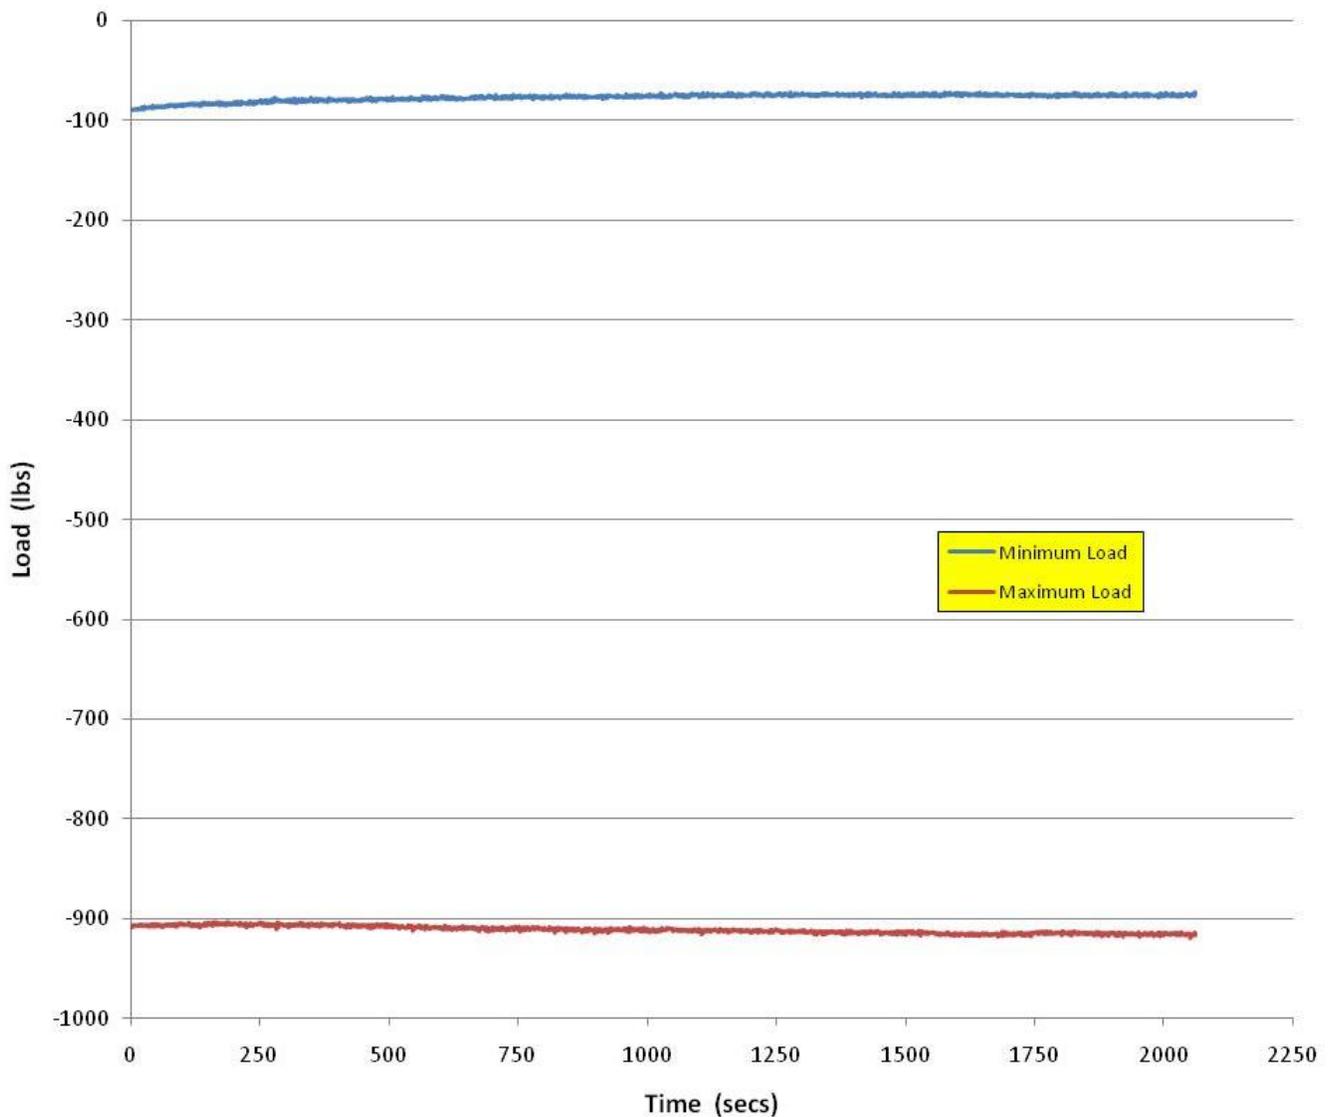
**Figure 9. Cyclic Load vs. Time, Case #1b**

The second cyclic HELLFIRE missiles loading spectrum was applied for 4,200 cycles. Load as a function of time for Cyclic Load Case #1b was recorded (Figure 9). The cyclic loading was performed at two hertz. The hydraulic actuator and load cell was subjected to displacement control thus the maximum and minimum displacement values were -1.07" and -0.29", respectively. The load curves are smooth indicating that no anomalies were recorded.

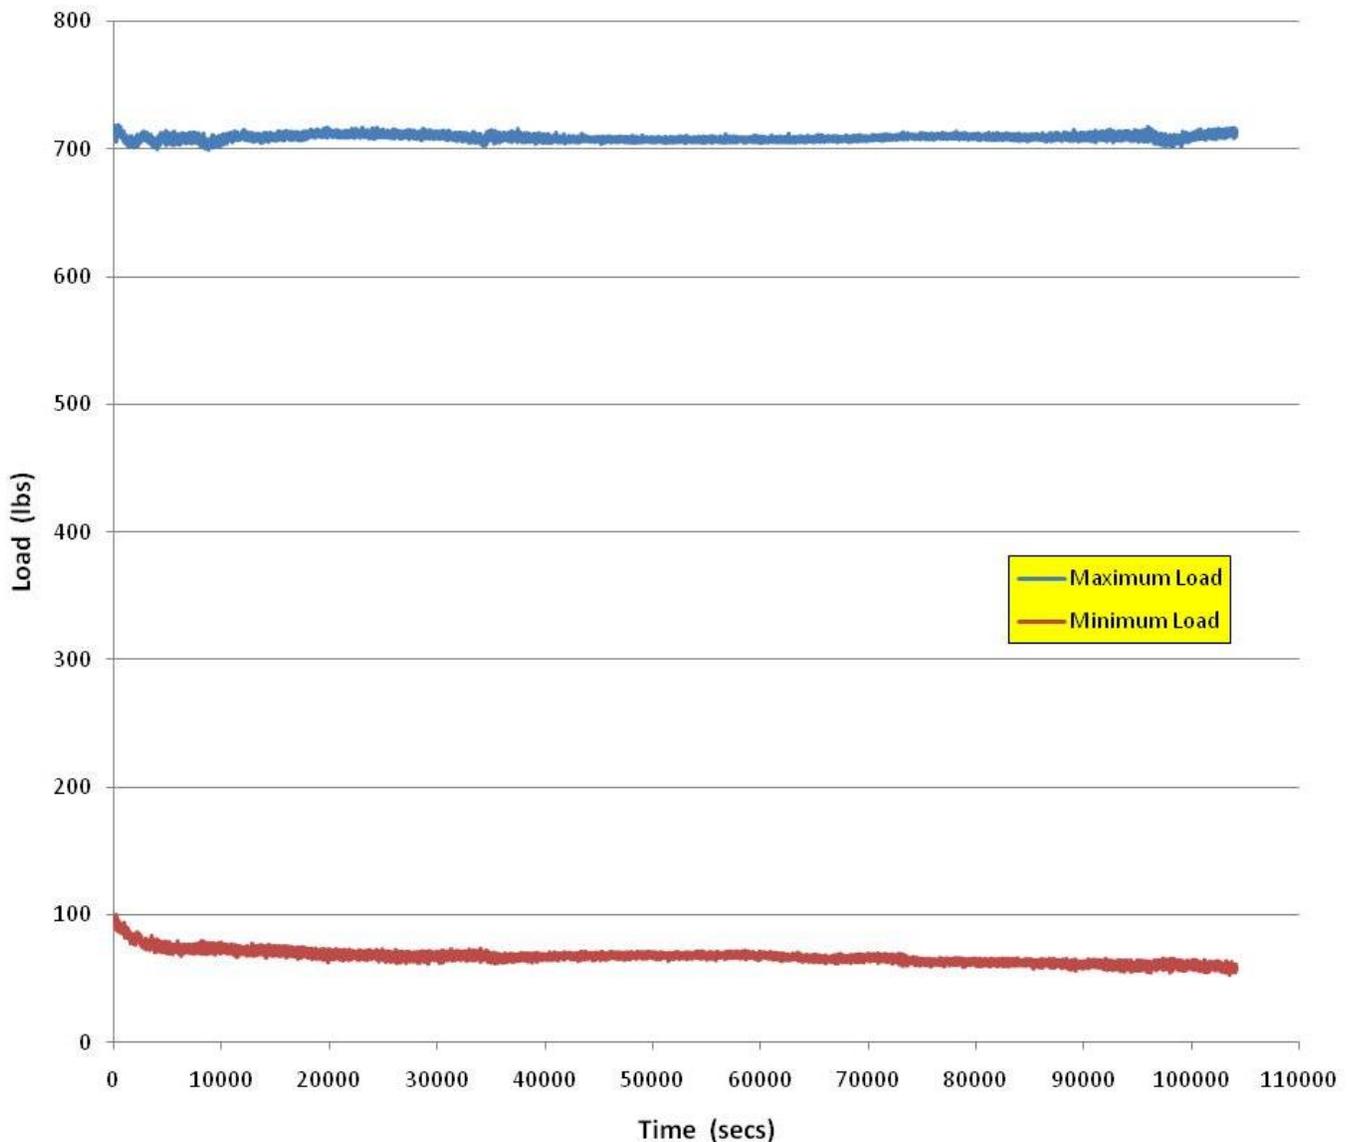
**Figure 10. Cyclic Load vs. Time, Case #2b**

The second cyclic .50 caliber machine gun loading spectrum was applied for 420,000 cycles. Load as a function of time for Cyclic Load Case #2b was recorded (Figure 10). The cyclic loading was performed at four hertz. The hydraulic actuator and load cell was subjected to displacement control thus the maximum and minimum displacement values were 0.66" and 0.19", respectively. The load curves are smooth indicating that no anomalies were recorded.

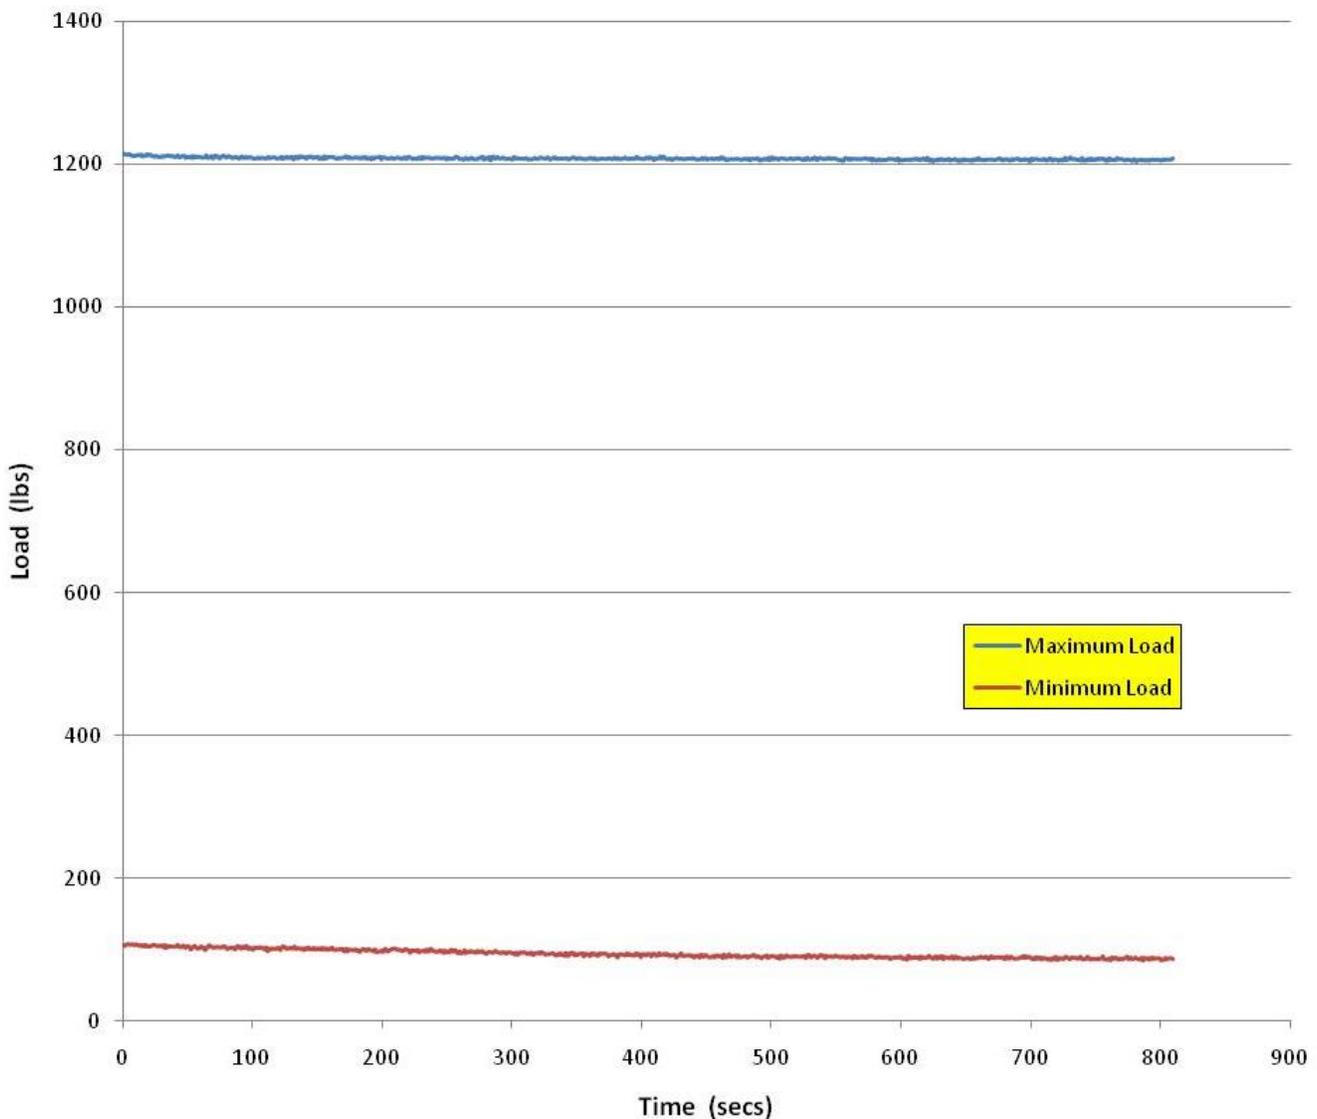
**Figure 11. Cyclic Load vs. Time, Case #3b**

The second cyclic Hydra rocket loading spectrum was applied for 42,000 cycles. Load as a function of time for Cyclic Load Case #3b was recorded (Figure 11). Only the first 810 seconds of data was recorded due to a data acquisition failure. The cyclic loading continued to run for the full 42,000 cycles without any anomalies reported. The cyclic loading was performed at three hertz. The hydraulic actuator and load cell was subjected to displacement control thus the maximum and minimum displacement values for this limited data set were 0.99" and 0.18", respectively.

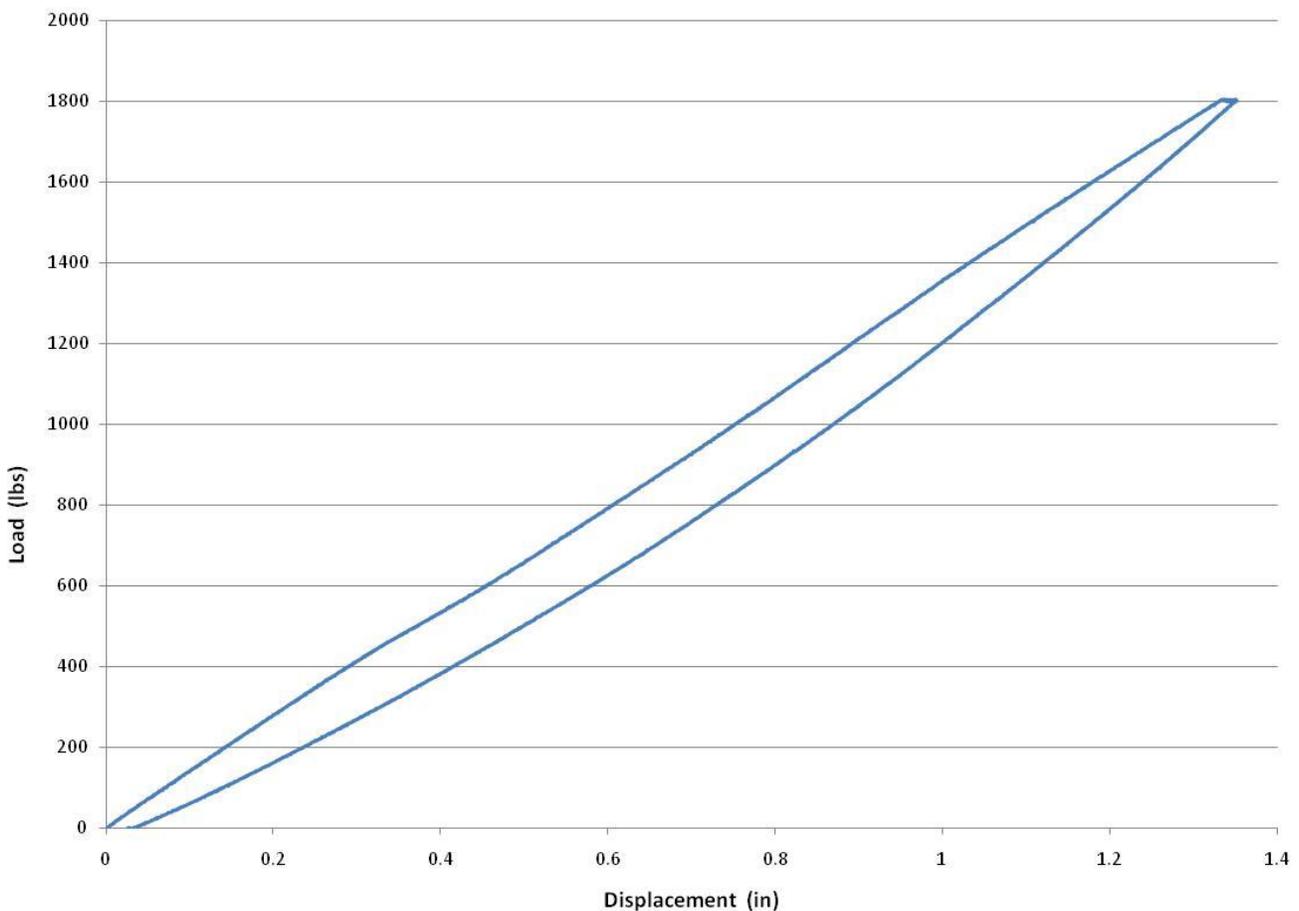
**Figure 12. Load vs. Displacement, Proof Load Case #1b**

Proof Load Case #1b simulates Hydra rocket loading and was conducted to demonstrate no stiffness or strength reduction occurred in the test article after the completion of the of the second block of cyclic loading. Proof Load Case #1b was conducted in the same manner as Proof Load Case #1a. Load as a function of displacement was recorded for Proof Load Case #1b (Figure 12). A slight decrease in maximum displacement occurred during Proof Load Case #1b compared to Proof Load Case #1a. The difference in displacement is less than 10% and can be considered negligible. Therefore, it is logical to conclude that no stiffness or strength reduction occurred as a result of the second block of cyclic loading.

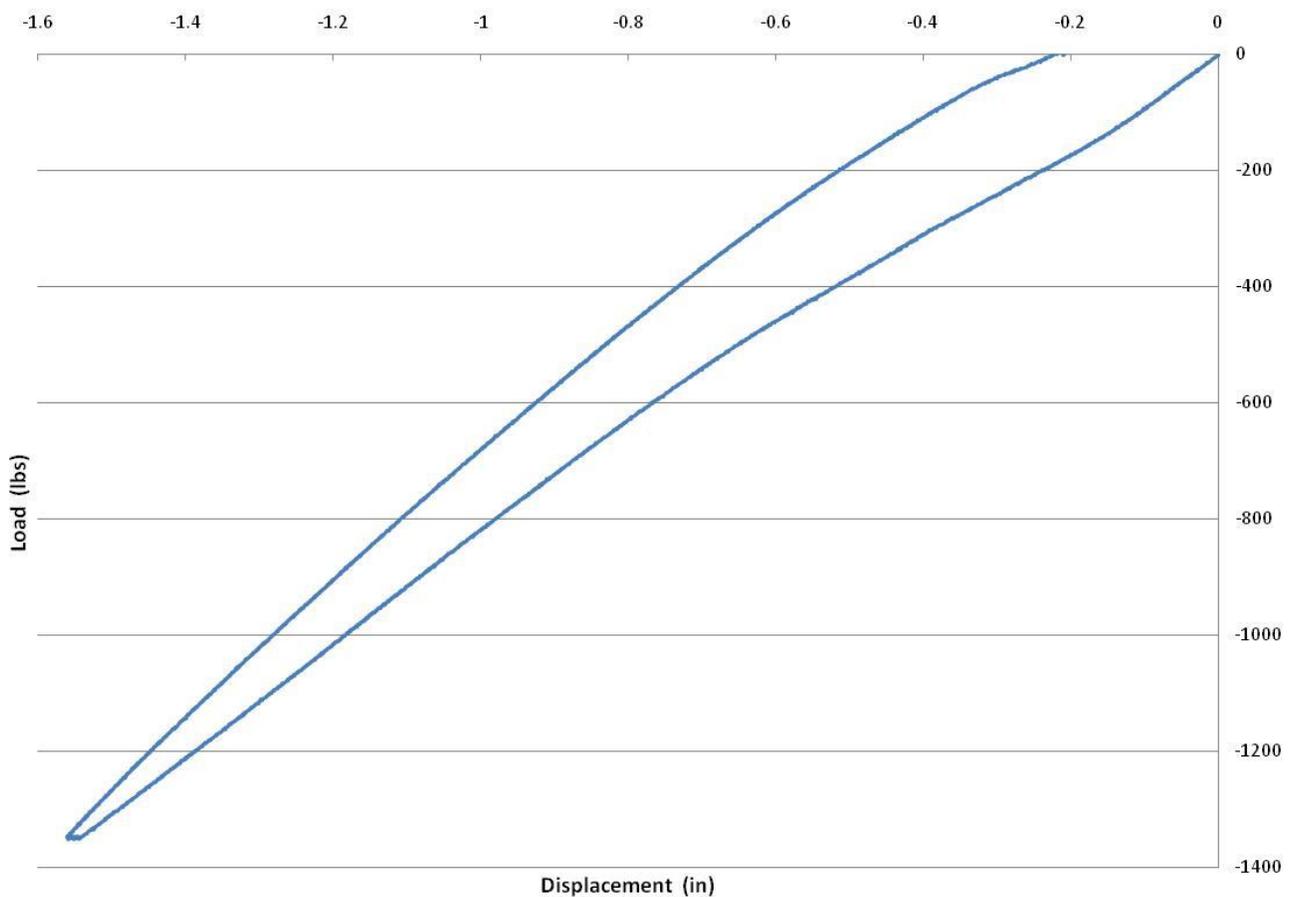
**Figure 13. Load vs. Displacement, Proof Load Case #2b**

Proof Load Case #2b simulates HELLFIRE loading and was conducted to demonstrate no stiffness or strength reduction occurred in the test article after the completion of the of the second block of cyclic loading. Proof Load Case #2b was conducted in the same manner as Proof Load Case #2a. Load as a function of displacement was recorded for Proof Load Case #2b (Figure 13). A slight increase in maximum displacement occurred during Proof Load Case #2b compared to Proof Load Case #2a. The difference in displacement is less than 10% and can be considered negligible. Therefore, it is logical to conclude that no stiffness or strength reduction occurred as a result of the second block of cyclic loading.

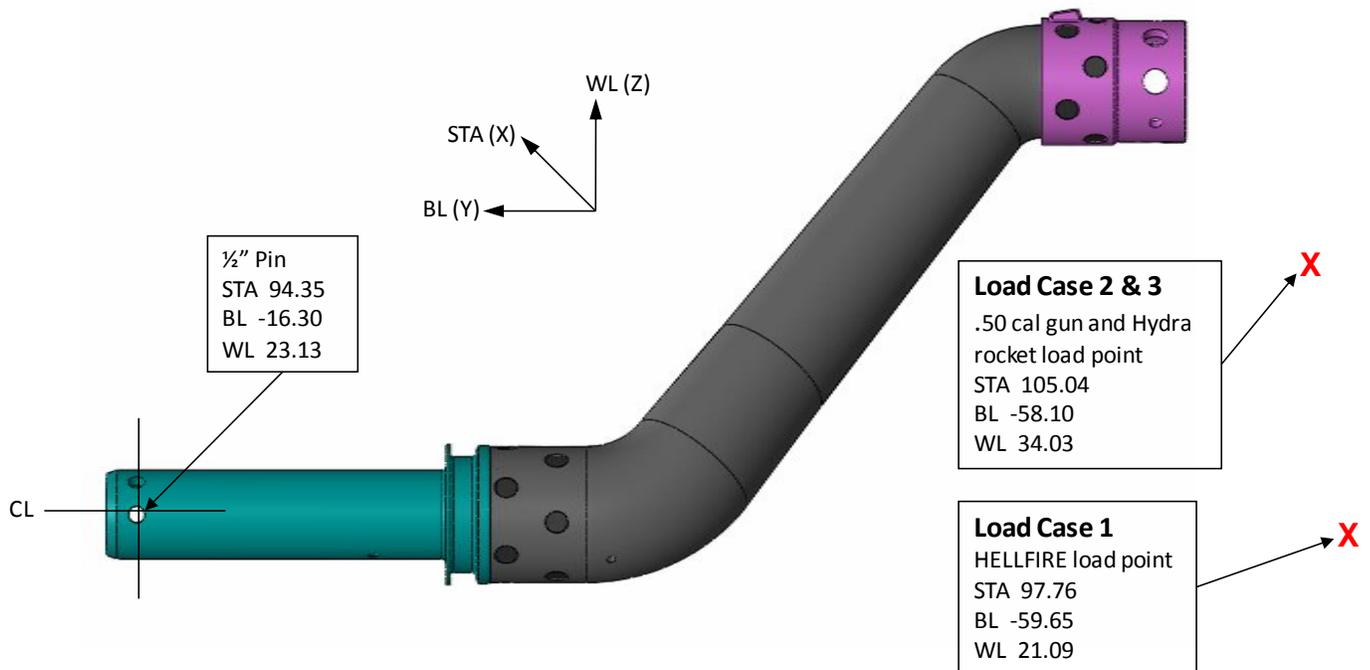
**Figure 1. CUWP Test Article Load Points**

The fatigue test plan will involve three different load cases with two different locations for load application as shown in Figure 1. Load Case 1 consists of the HELLFIRE missile thrust location at coordinates of STA 97.76, BL -59.65, WL 21.09. For the purposes of this test, it is assumed that the .50 caliber gun and Hydra rockets share the same load point which will be defined by Load Case 2 and 3 with coordinates of STA 105.04, BL -58.10, WL 34.03.

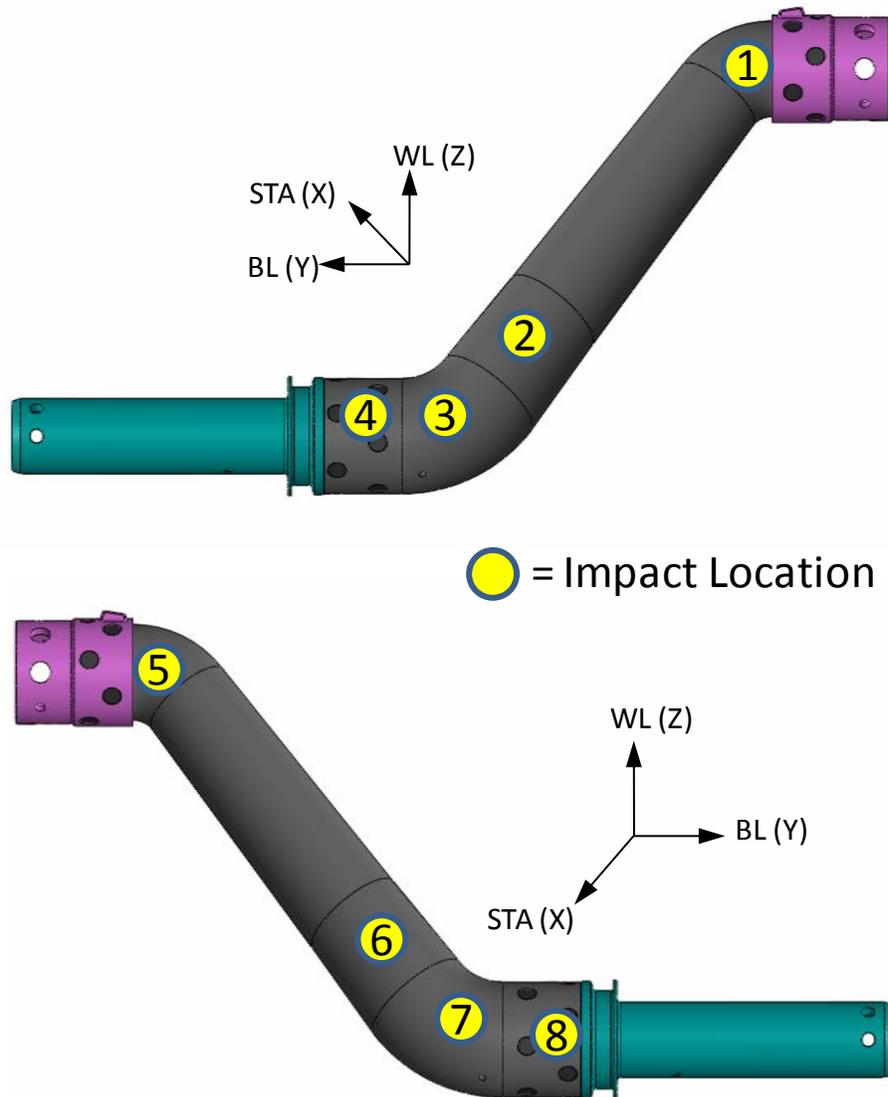
**Figure 2. CUWP Test Article Impact Locations**

After Load Case 3a is complete, the test article shall be subjected to energy impacts at locations shown in Figure 2. The minimum energy impact at these locations shall be 5 ft-lbs using a 0.5" diameter hemisphere impact tip. The locations indicated in Figure 2 are only approximate since there is a tolerance required for the placement of the impactor gun. After the impacts are performed, more precise coordinates will be stated in the final report.
