AATD TR10-D-95

# Composite Universal Weapons Pylon Damage Tolerance Test Report

29 October 2010

## **Composite Universal Weapons Pylon Fatigue Test Plan**

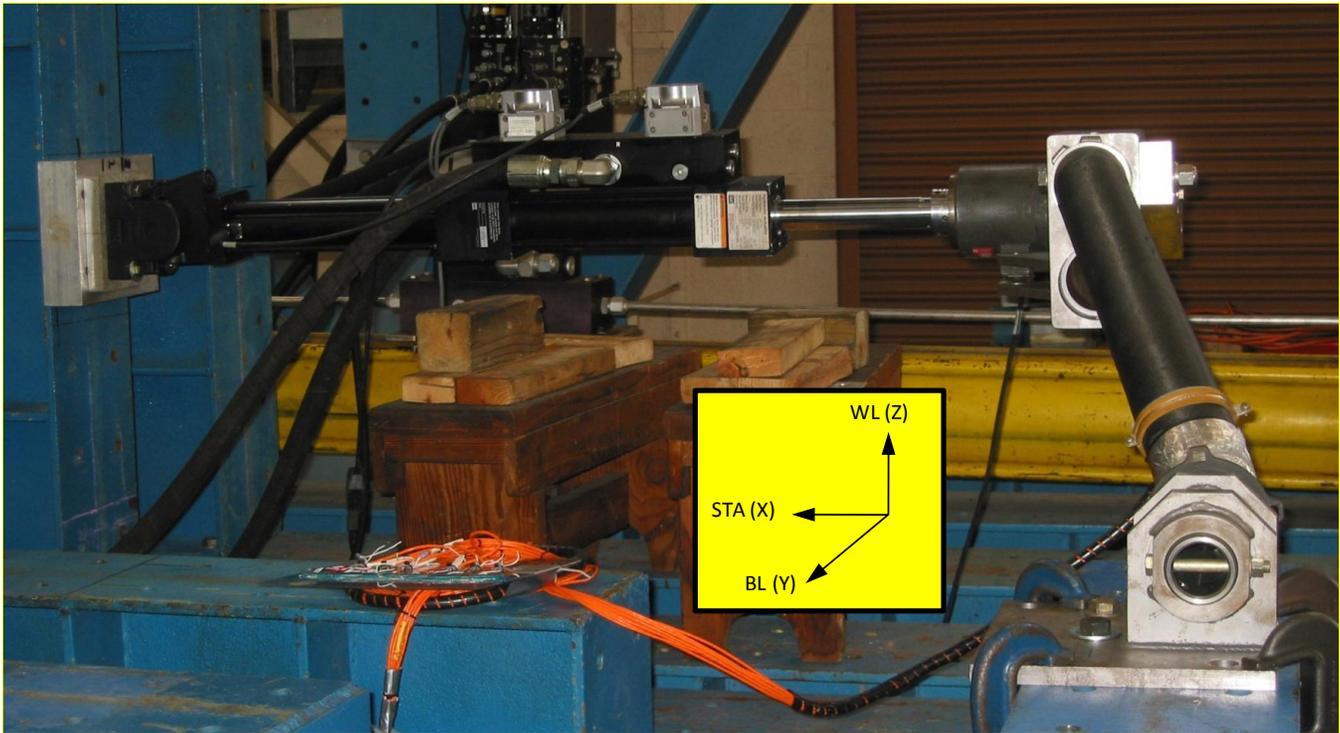
**Figure 3. CUWP Test Article and Fixture Setup**

The inboard end of the CUWP will be installed as a slip fit in a rigid support housing as shown in Figure 3. The part will be constrained by a close tolerance ½” pin installed at BL -16.30. This will constrain translational and rotational movement along the Y axis. The second constraint will be at the collet so that the collet is fixed in the area between of BL -18.0 and BL -21.5. BL -18.0 is where the collet stops providing support to the structure and BL -21.5 is where the aircraft terminates support. This will constrain translational and rotational movement along the X and Z axes.

The CUWP article/test fixture assembly will be mounted on the backstop with the same orientation as installed on the aircraft. Load application will be accomplished by a hydraulic actuator and load cell which will also be mounted to the backstop but independent of the test fixture. This independence is required to ensure that the reactive loads between the test article/fixture and the load application support do not cause fixture distortion during the actual test. The weight of the test fixture is approximately 71.4 lb. The force of the actuator acting down at the test fixture connection is approximately 52 lb.

The loads will be applied to a steel test fixture that mounts in the same manner as the weapons assembly. The load cell will be attached to the 1.5” thick 7075-T6 AL ALY arm using an eyebolt. This loading location and test configuration is shown in Figure 3. The test setup geometry will be configured for loading a left side mounted, aft canted CUWP. Depending on the load case being tested, the actual direction of the applied load vector (load cell orientation) is as follows:
