BASRAH INTERNATIONAL AIRPORT –  
TERMINAL AND TOWER  
RENOVATION  
BASRAH, IRAQ

**PROJECT NUMBER SIGIR-PA-06-049**

**JULY 24, 2006**

SUBJECT: Report on Project Assessment of the Basrah International Airport Terminal  
Tower Renovation, Basrah, Iraq (Report Number SIGIR-PA-06-049)

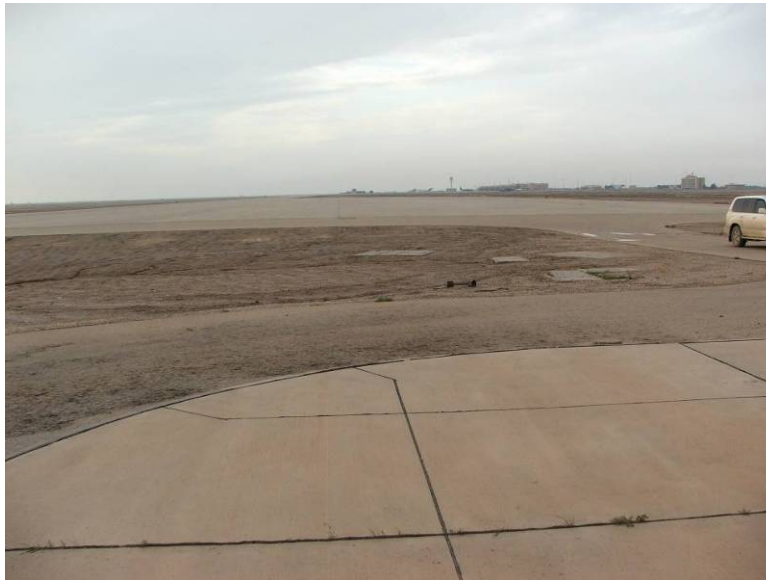
**Site Photo 2. View of runway and taxiway**

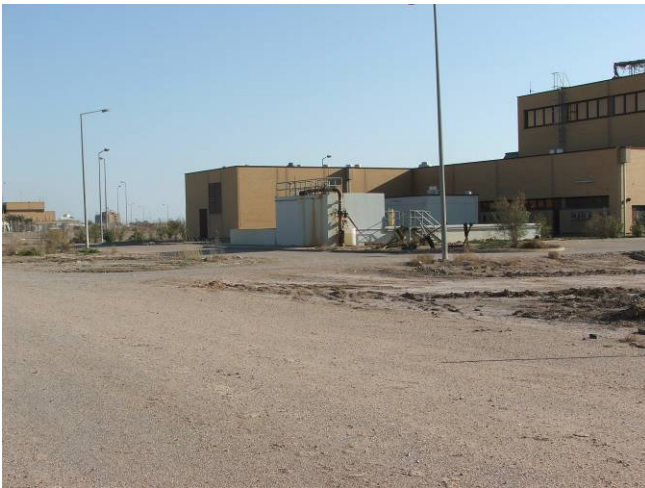
Water is supplied to above ground storage tanks at BIA from the sweet water canal via a pumping station and pipelines. BIA had an existing water treatment facility (original capacity of 220 cubic meters per hour ( $\text{m}^3/\text{h}$ )), which included clarification dosed with aluminum sulfate (alum) followed by filtration and chemical disinfection by chlorination. Dosing by alum, ferric chloride, phosphate, and soda takes place at various stages of treatment to achieve water conditioning and pH control. Treated water then passes through Reverse Osmosis (RO) filters before it is pumped into the supply distribution system and “process” water system. There is a separate fire suppression system which includes electric and diesel operated pumps and

**Site Photo 3. Exterior view of water treatment facility**

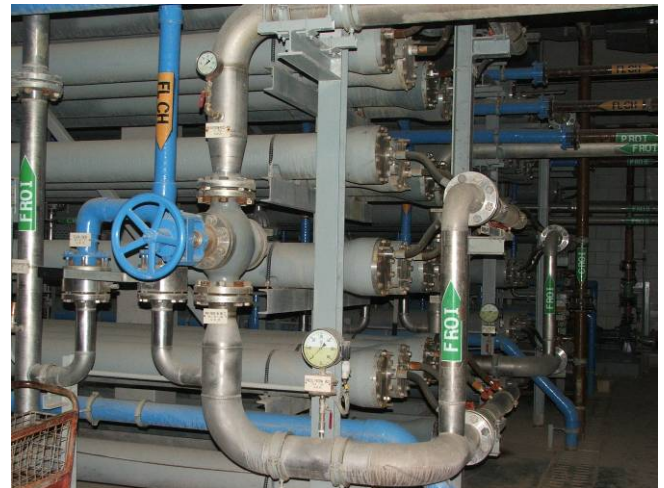
**Site Photo 4. Reverse Osmosis filters**

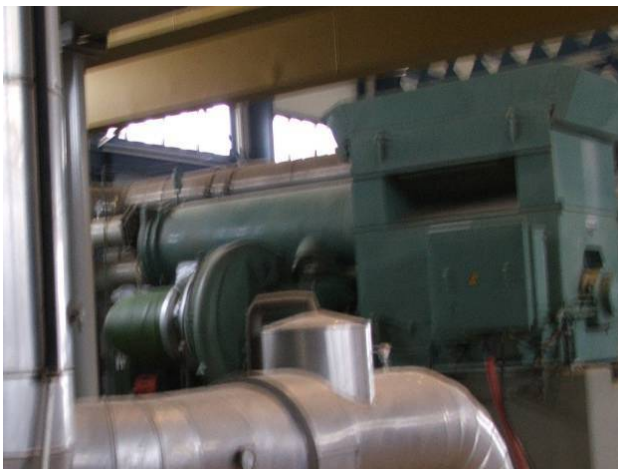
**Site Photo 5. Chiller unit inside plant facility**

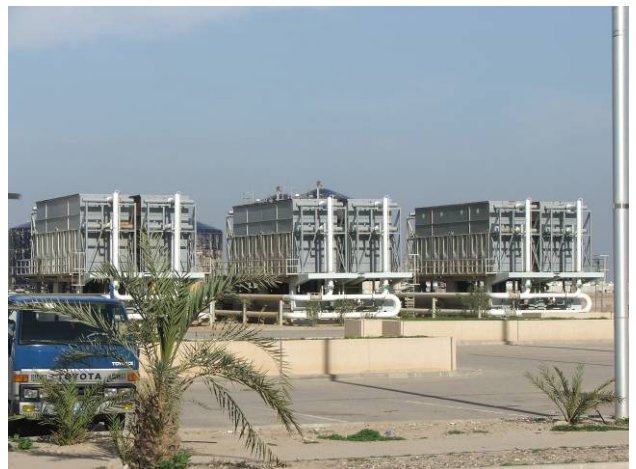
**Site Photo 6. Three pairs of the cooling towers located adjacent to the plant facility**

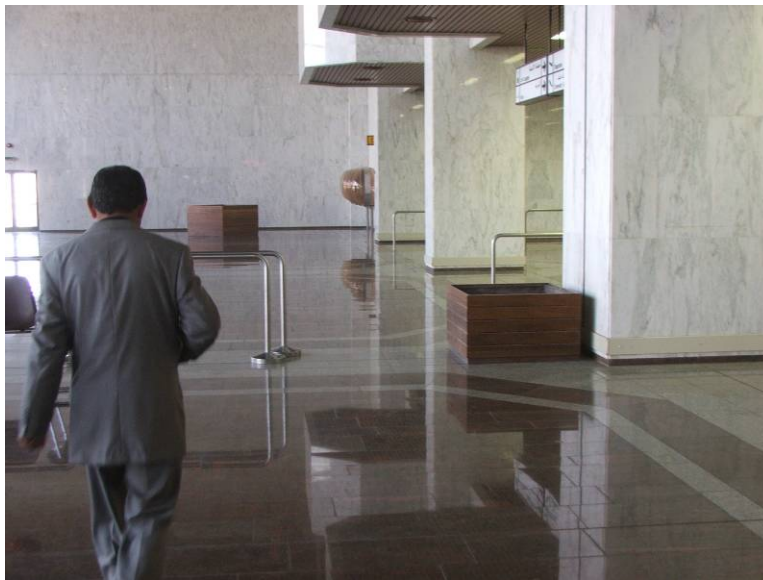
**Site Photo 7. Passenger terminal lobby**

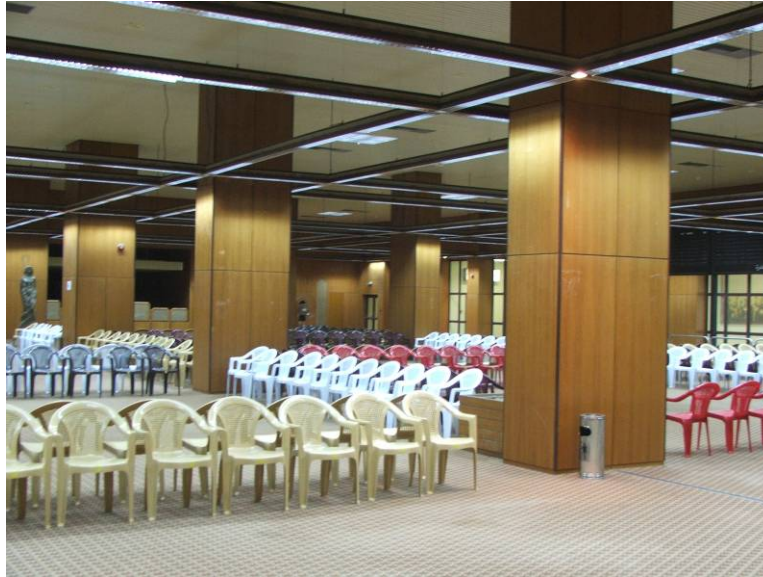
**Site Photo 8. Passenger terminal waiting area**

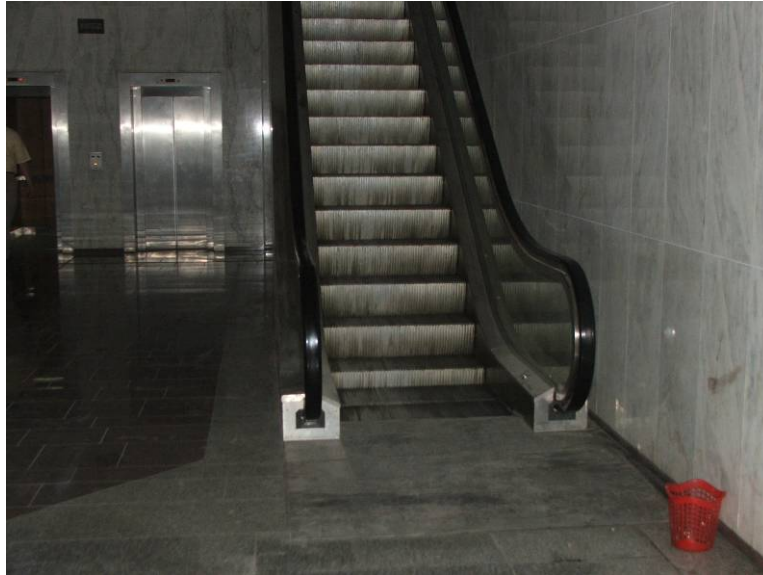
One elevator and one escalator were visited during the site assessment. Both were observed to be operational. Site Photo 9 shows one of the escalators and two elevators. The contractor certified the work that was completed, although the contractor did not certify the complete operation of the elevators.

**Site Photo 9. Escalator and two elevators (left) at passenger terminal**

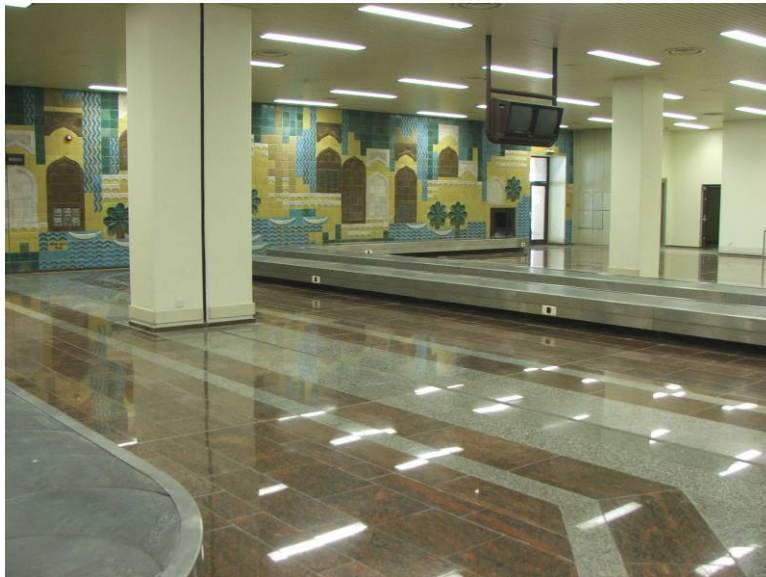
The baggage claim conveyors were located in an area which required cleaning and painting. The baggage claim conveyors appeared to be clean and functional, although the operation was not verified during the assessment. Site Photo 10 shows the condition of the baggage claim area during the assessment.

**Site Photo 10. Baggage claim area with conveyors**

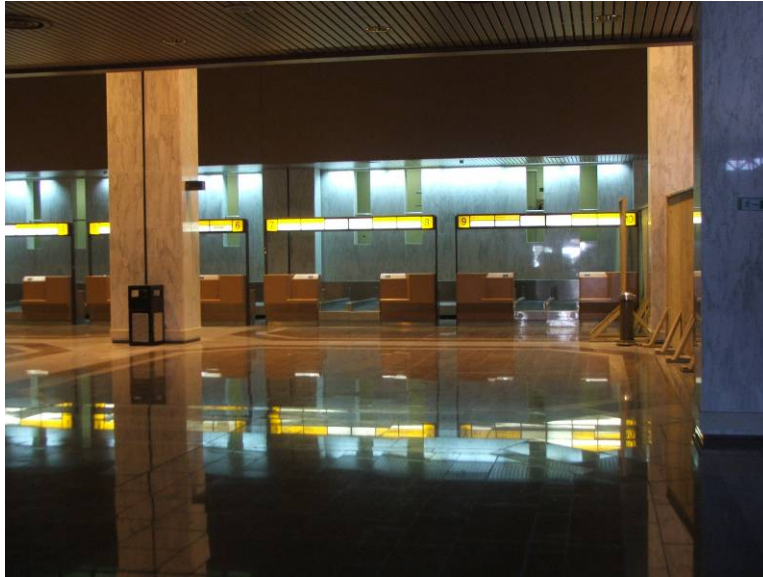
The contract and modification required the repair of ten domestic travel ticket counters, baggage scales, and conveyors. The domestic travel ticket counter area was observed during the assessment and appeared to be recently renovated. All lights were operational, the flooring was clean, and the ticket counter areas were well cleaned and appeared operational. Site Photo 11 shows the ticket counter area located inside the airport passenger terminal.

**Site Photo 11. Passenger terminal ticketing area**

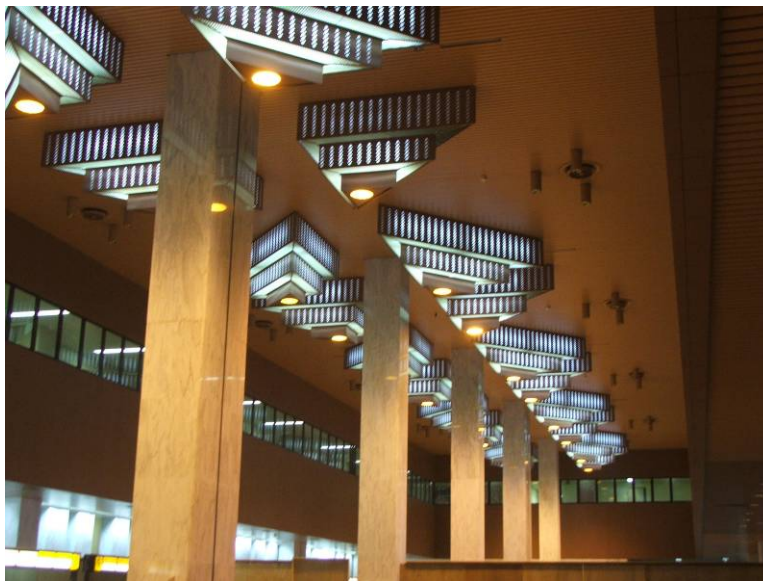
The contract required the repair or replacement of electrical lighting on the 1<sup>st</sup> and 2<sup>nd</sup> floor of the passenger terminal. Ceiling lights in the ticketing area as well as the 1<sup>st</sup> and 2<sup>nd</sup> floor administrative area were observed to be operational at the time of the site visit. Site Photo 12 shows the operational lighting in the ticketing area of the passenger terminal.

**Site Photo 12. Operational lighting in ticket area of passenger terminal**

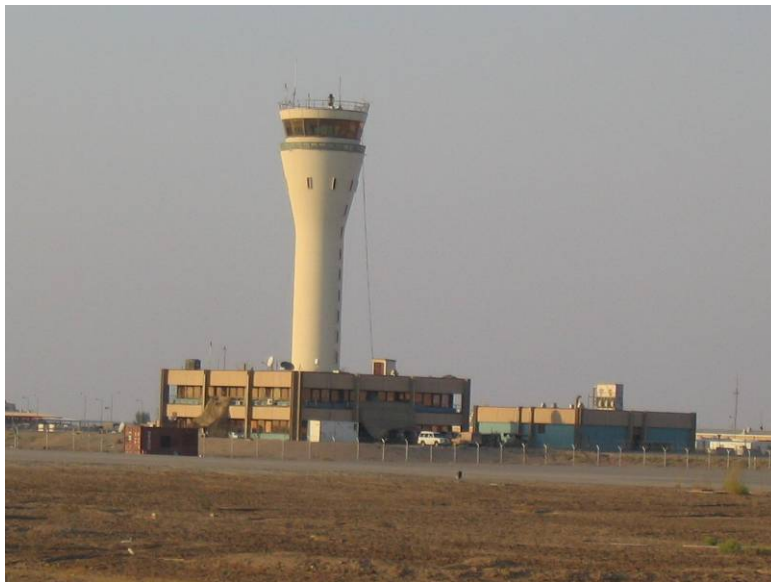
The original “defective” cooling towers were not observed on site. The ATC HVAC system was not operating at the time of the site assessment because processed water required for operation was not available. The USACE QAR stated the system requires pH balanced “processed” water generated at the BIA water treatment facility. The water treatment facility was not operational and was not producing and supplying the required processed water. The processed water system was temporarily activated in order to produce and supply processed water for the testing and commissioning of the HVAC units.

**Site Photo 13. Air Traffic Control tower (Courtesy of USACE)**

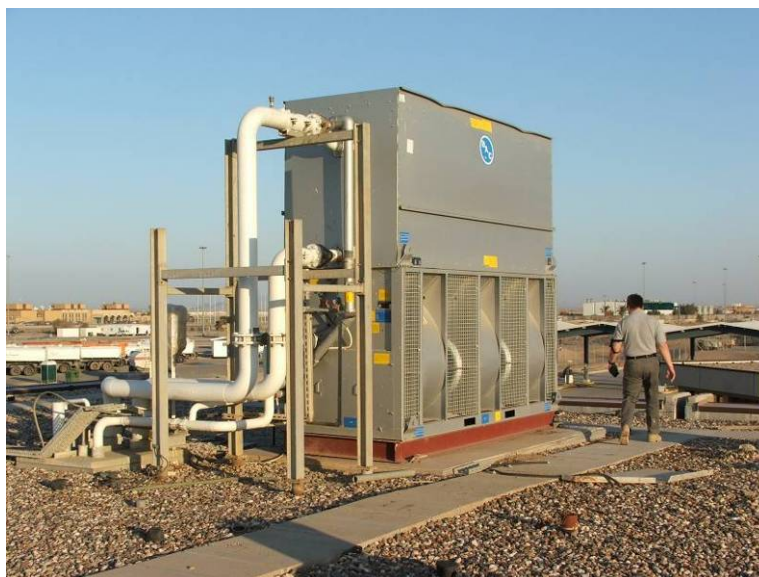
The contract required the removal of existing cooling towers and the supply and installation of new cooling towers, compressors, and chiller control panels. At the time of the assessment, one Baltimore Air Coil unit was observed installed on the roof of the tower administration building, located adjacent to the ATC. The unit was listed as model number VXI-50-3 with serial numbers H05-0950. The electrical

controls and piping appeared to complete. This unit was a direct replacement (same model number) of the previous existing cooling tower.

**Site Photo 14. Roof mounted cooling tower located at ATC administration building**

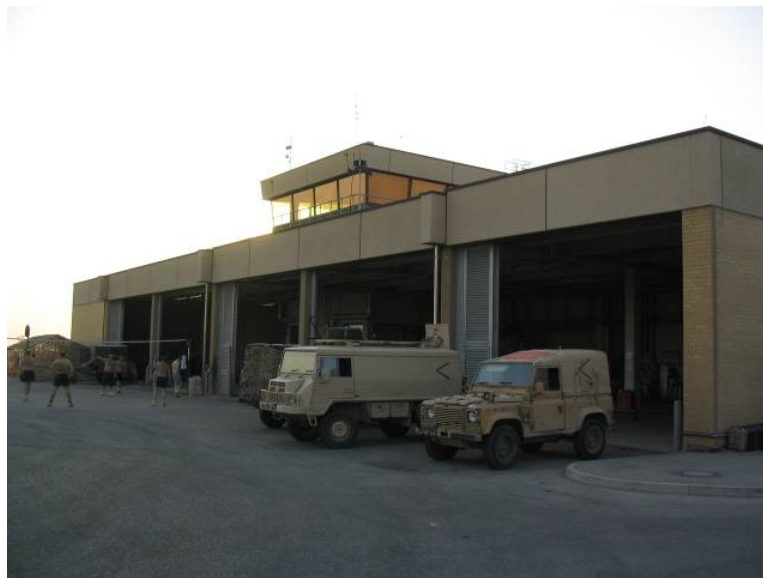
The electrical controls and piping appeared to complete. The units were a direct replacement (same model number) as the previous existing cooling towers. The original “defective” cooling towers were not observed on site. The fire station HVAC system was not operating at the time of the site assessment because processed water required for operation was not available. As with the HVAC system at the ATC, the USACE QAR stated the system requires pH balanced “processed” water generated at the BIA water treatment facility. The water treatment facility was not operational and was not producing and supplying the required processed water. The processed water system was temporarily activated in order to produce and supply processed water for the testing and commissioning of the HVAC units.

**Site Photo 15. Exterior front of fire station (Courtesy of USACE)**

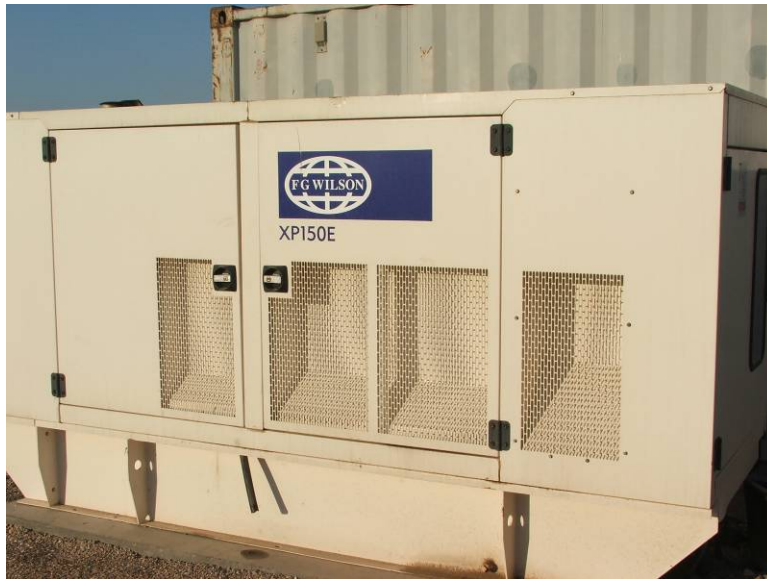
**Site Photo 16. Generator set located at the fire station**

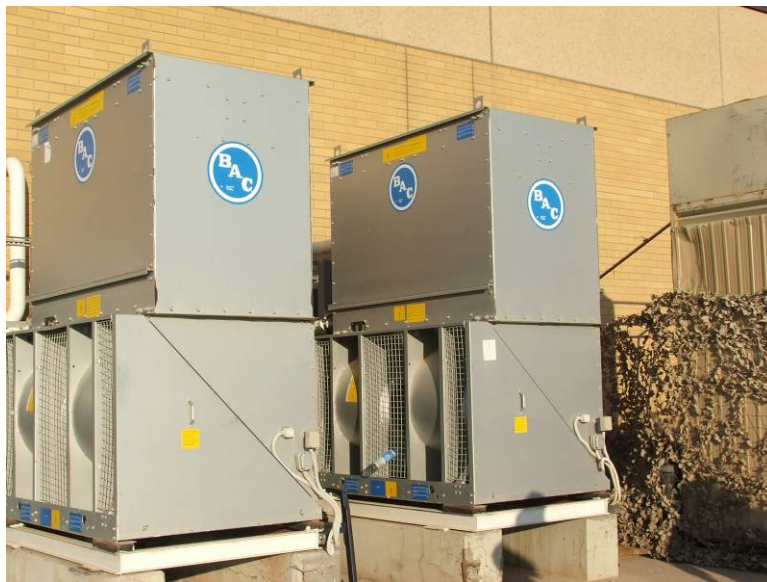
In addition, the contract required the removal of existing cooling towers and the supply and installation of new cooling towers, compressors, and chiller control panels. At the time of the assessment, two Baltimore Air Coil units were observed installed behind the fire station, mounted on existing concrete mounts. The two units were listed as model number VXI-18-2X with serial numbers H05-0948 and H05-0949.

**Site Photo 17. HVAC cooling towers located at fire station**

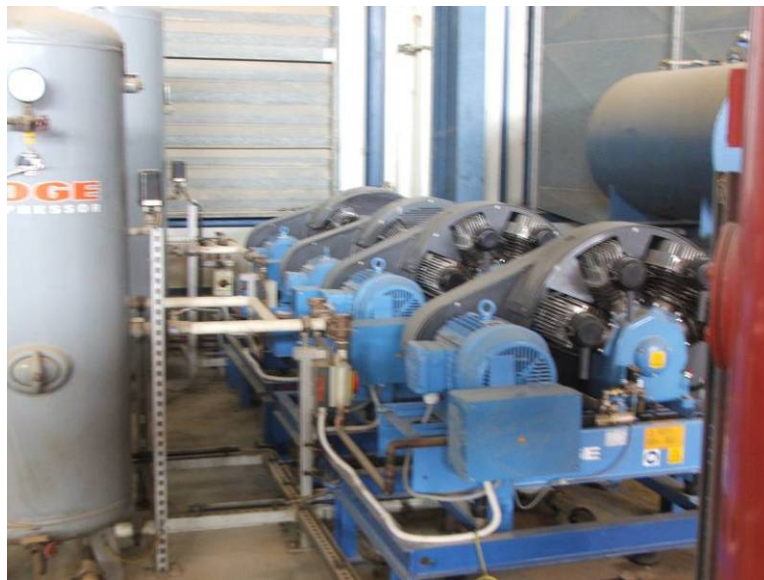
The contract required the overhaul and warranty of three-1700 ton chiller and six cooling towers, inspection, maintenance, and calibration of all primary/secondary chilled water and condenser systems and pumps, supply and installation of new air compressors, and inspection, maintenance, and commission of one boiler unit. Review of USACE project documents show the systems were renovated and commissioned 23 August 2005 and the turnover document signed 22 May 2006. During the site assessment, all systems were observed intact and appeared that maintenance activities were not on-going. New compressor pumps were observed installed in the plant facility.

**Site Photo 18. Air compressor units located at plant facility**

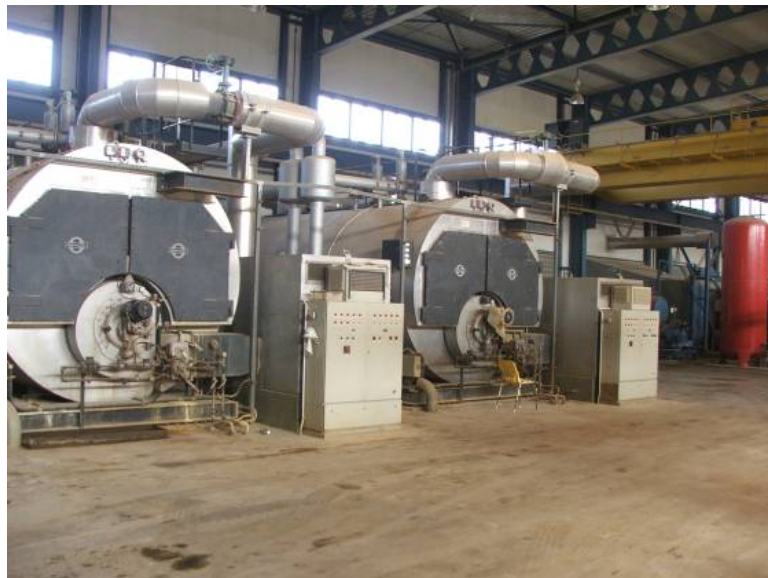
Operation of the chillers, cooling towers, pumps, compressors, and boiler units could not be verified during the site visit because processed water required for operation was not available. The USACE QAR stated the system requires pH balanced “processed” water generated at the BIA water treatment facility. The water treatment facility was not operational and was not producing and supplying the required processed water. The processed water system was temporarily activated in order to produce and supply processed water for the testing and commissioning of the HVAC units. In addition, the boiler unit operates on diesel fuel. The fuel tanks are located adjacent to the plant facility, but it was reported that the fuel pumps were not operational.

**Site Photo 19. Boiler units located at plant facility**
