**INSPECTION OF KOHI GIRLS' SCHOOL CONSTRUCTION
PROJECT IN KAPISA PROVINCE:
CONSTRUCTION DELAYS RESOLVED,
BUT SAFETY CONCERNS REMAIN**

SUBJECT: SIGAR Inspection Report 10-4: Inspection of Kohi Girls' School Construction Project in Kapisa Province: Construction Delays Resolved, But Safety Concerns Remain

Summary of Report: SIGAR Inspection 10-4 October 26, 2009 Inspection of Kohi Girls' School Construction Project in Kapisa Province: Construction Delays Resolved, But Safety Concerns Remain

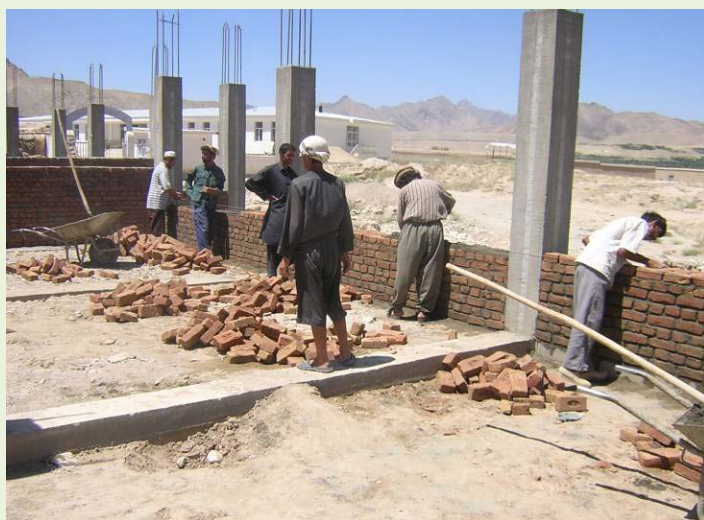
Laborers working to complete the Kohi Girls' School in August 2009. (Photo provided by SIGAR)

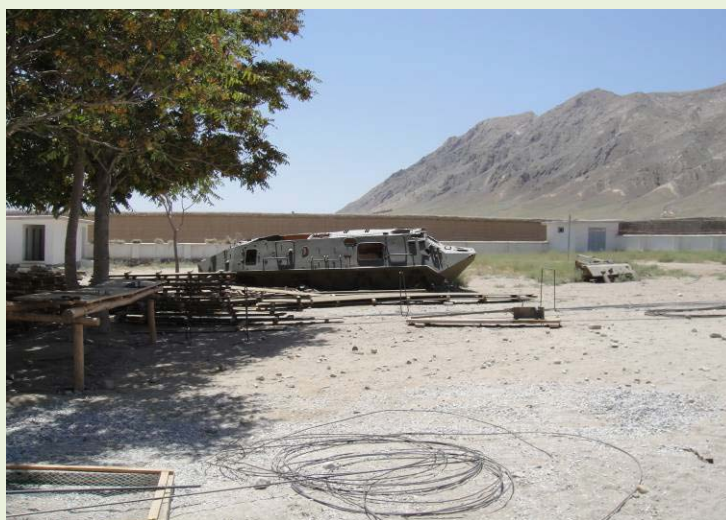
- *Presence of War-Related Debris Next to Construction Site:* SIGAR noted that the presence of potentially hazardous war-related debris on property that is shared by both the newly constructed girls' school and an adjoining boys' school. Based on discussions with PRT officials, SIGAR believes the debris should have been removed at the start of the project as part of the site preparation phase.

The war-debris filled yard that the Kohi Girls' School shares with an existing boys' school presents hazards to students unless cleared. (Photo provided by SIGAR)

That the Commander, Kapisa PRT, in partnership with the Kapisa Provincial authorities, develop a plan for the removal of war-related debris from areas adjacent to the Kohi Girls' school construction project.

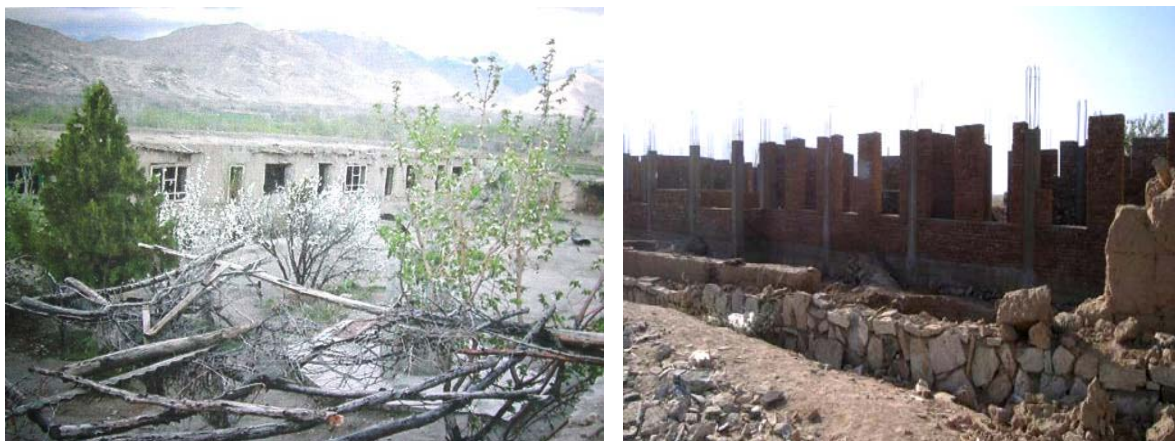
The site, which is owned by the Provincial Ministry of Education, had a number of dilapidated structures that had to be demolished and removed in order to make room for the school compound. The site also shares access points and a school yard with an existing boys' school built several years earlier. At the time of SIGAR's second onsite inspection in August, it was estimated that the project was approximately 30 percent complete. (See Site Photos 1 and 2)

Site Photos 1 and 2: Views of the Kohi Girls' School site before construction (left) commenced in April 2009 and during the SIGAR inspection in August 2009 (right). (Photos provided by Kapisa PRT)

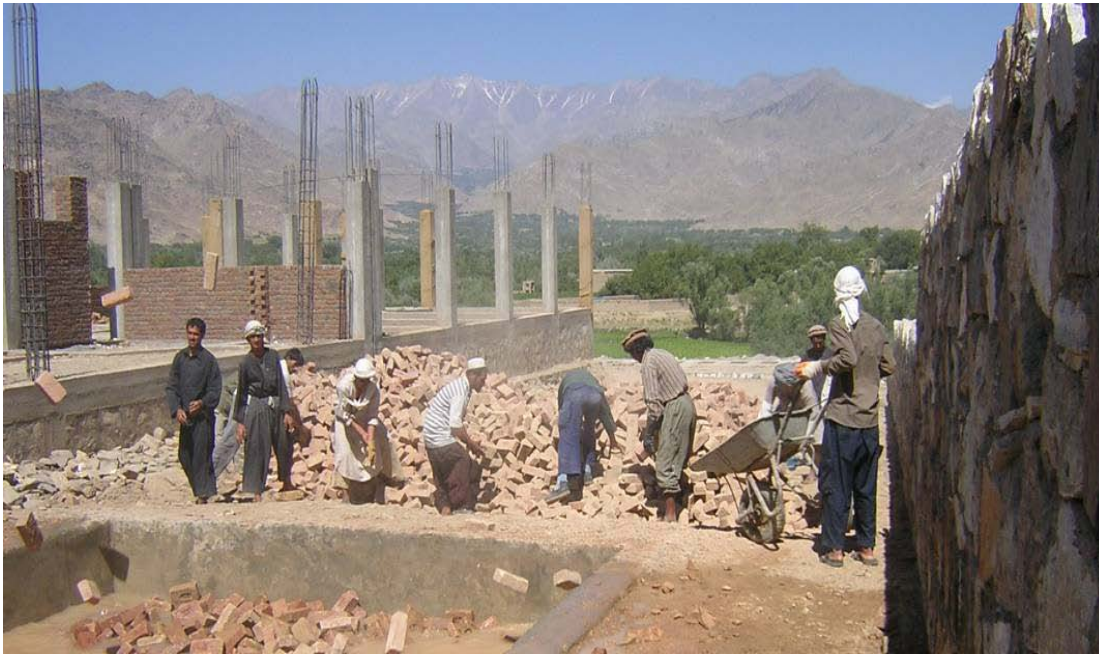
Site Photo 3: Laborers working to complete the Kohi Girls' School in August 2009. Projects such as this one provide legitimate local employment while allowing workers to develop new skills. (Photo provided by SIGAR)

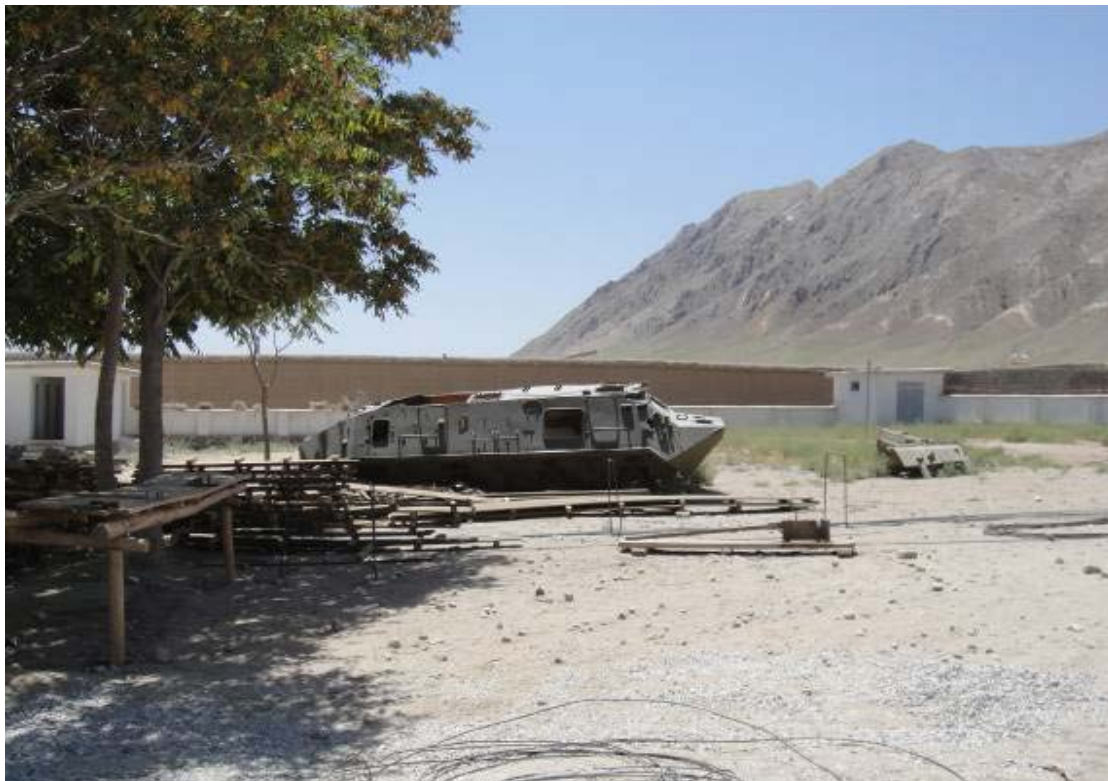
Site Photo 4: A destroyed armored military vehicle and other war-related debris raise concerns of hazardous objects being present on land adjacent to the school construction site. (Photo provided by SIGAR)

SIGAR noted that the school is being built adjacent to an existing boys' secondary school that had been constructed several years earlier by the Afghan government with international donor funds. SIGAR observed extensive debris and rubble on the grounds of the boys' school that was apparently left over from fighting in the area which occurred years earlier and has never been cleared. This school yard will be a shared point of access to both the girls' school and the boys' School once construction is completed. SIGAR observed parts of several destroyed armored military vehicles on this school yard (see Site Photos 4 and 5).

Both the PRT engineer and school officials acknowledged that the presence of such war-related debris raises the possibility that hazards from unexploded ordnance exist and that such debris poses risks to users of both schools. SIGAR asked why such objects had not been cleared earlier as part of the site preparation phase of the project. The School Director stated that removal of such war debris is the responsibility of the Ministry of Defense. SIGAR believes the presence of war-related objects adjacent to the school grounds raises serious safety concerns that should be immediately addressed.

SIGAR recommends that the Commander, Kapisa PRT, in partnership with the Kapisa provincial authorities, develop a plan for the removal of war-related debris from areas adjacent to the Kohi Girls' School construction project.

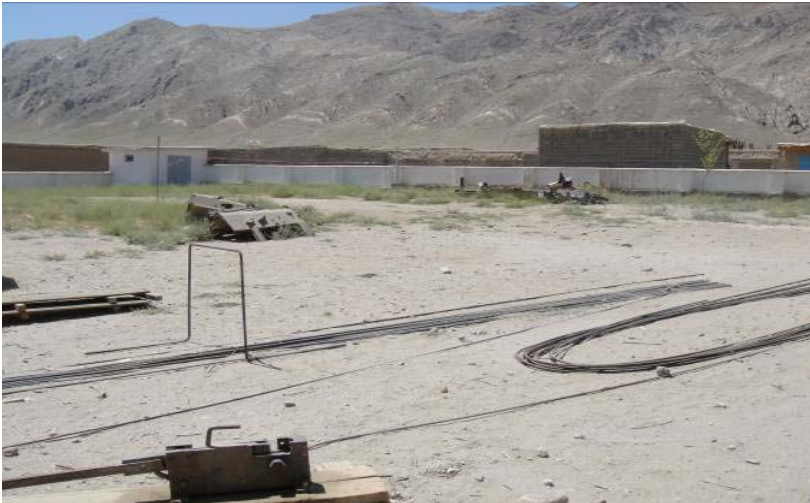
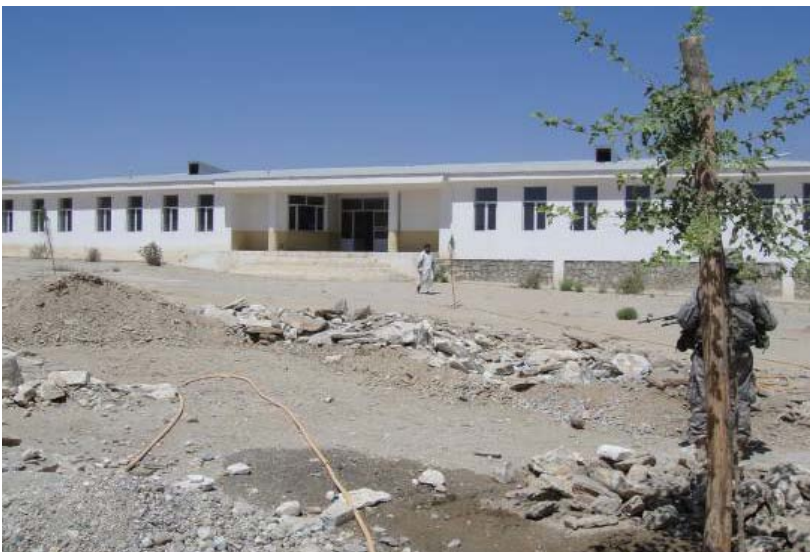
Site Photos 5 and 6: Views of the school yard that the Kohi Girls' School shares with the adjacent boys' school (left). SIGAR believes that the statement of work should have included removal of such hazards. (Photos provided by SIGAR)

SIGAR is concerned that the hazards relating to war-related debris in the vicinity of the school may not have been fully examined during the development phase of this project. SIGAR believes the presence of such war-related debris has created a safety hazard that needs to be addressed.
